Hurricane Katrina - What Happened?

Tulane University
Field Trip
Updated April 14, 2007

Levee Breaches in New Orleans during Hurricane Katrina

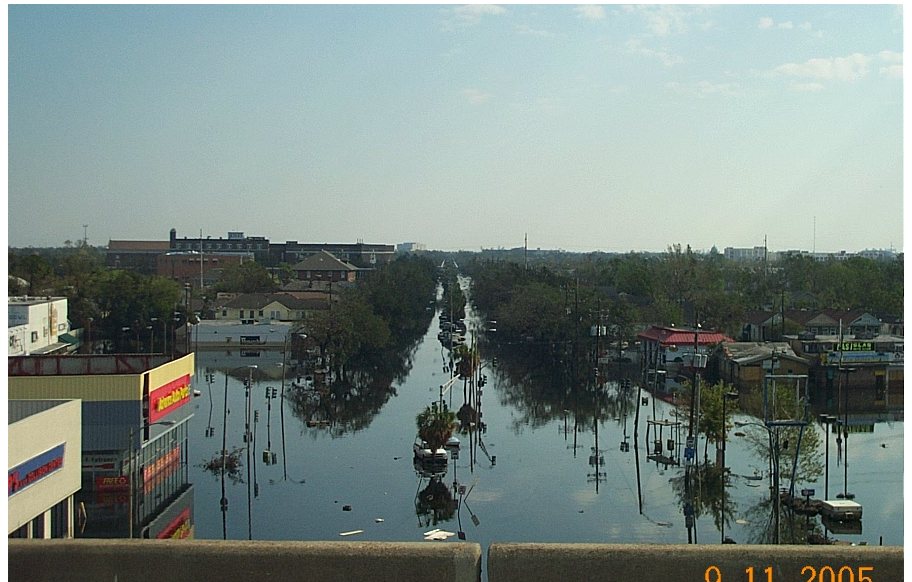
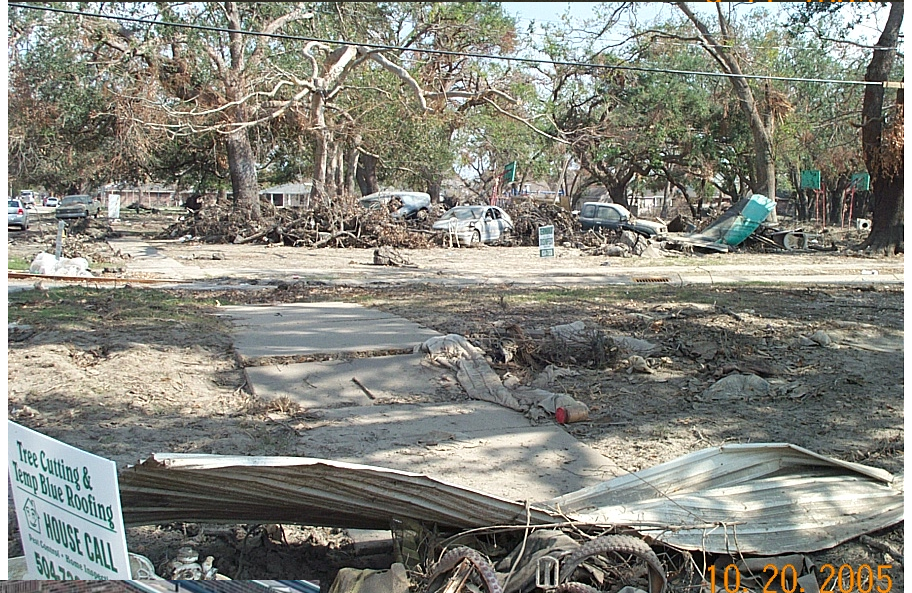
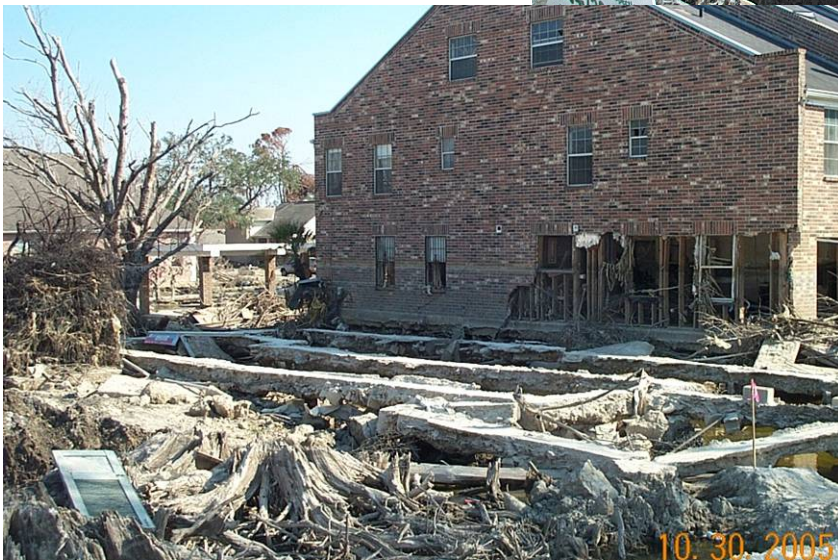
Photos - Top - looking north from I-10 overpass over Carrollton Ave. Middle - cars and other debris in park on Fleur de Lis near 17th St. Canal breach. Bottom - missing house and Cypress stumps at 17th St. Canal Breach (photos by Stephen Nelson)

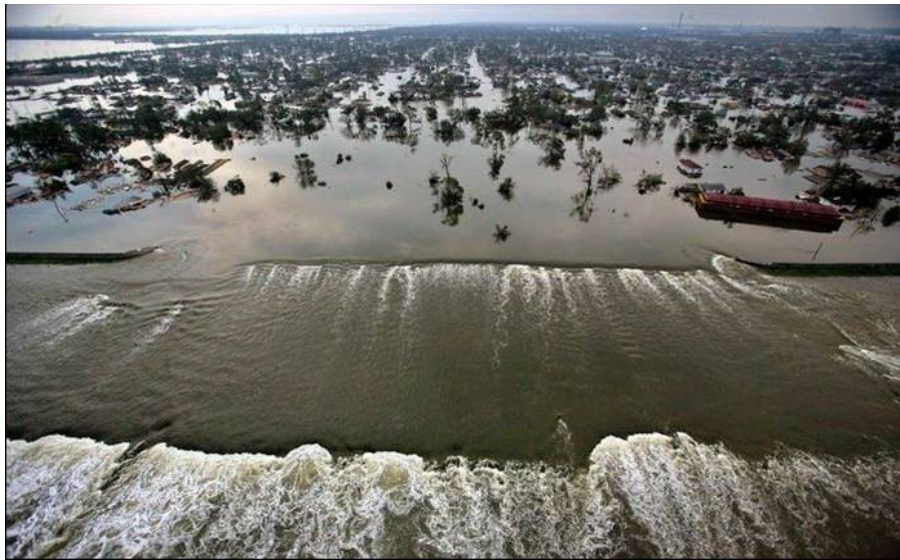
At about 7:45 AM the levees on the east side of the Industrial Canal bordering the Lower Ninth Ward (Stop 1) were breached by surge waters in the Industrial Canal (Figs. 8, 9, 10 & 11). The photographs in Fig. 8 and 10 show the breached levee two days after the storm and the image in Fig. 11 shows the same area in Mid-March 2006 after repair of the floodwall had begun. Note that in Fig. 8, water was running back into the Industrial Canal from the Lower Ninth Ward. Note also that both Figs. 8 and 10 show a barge which came to rest in the Lower Ninth Ward, having floated through the breach from the Industrial Canal.

Figure 8. The large breach in the Industrial canal that flooded the Lower Ninth Ward could have been caused by a barge crashing through the floodwall during Katrina. Alternatively the barge could have floated in after the levee and floodwall were breached. Note the barge in the photo above. Note also that at the time of this photo water was running out of the Lower Ninth Ward back into the Industrial Canal. (Source - Vincent Laforet, AFP/Getty Images)

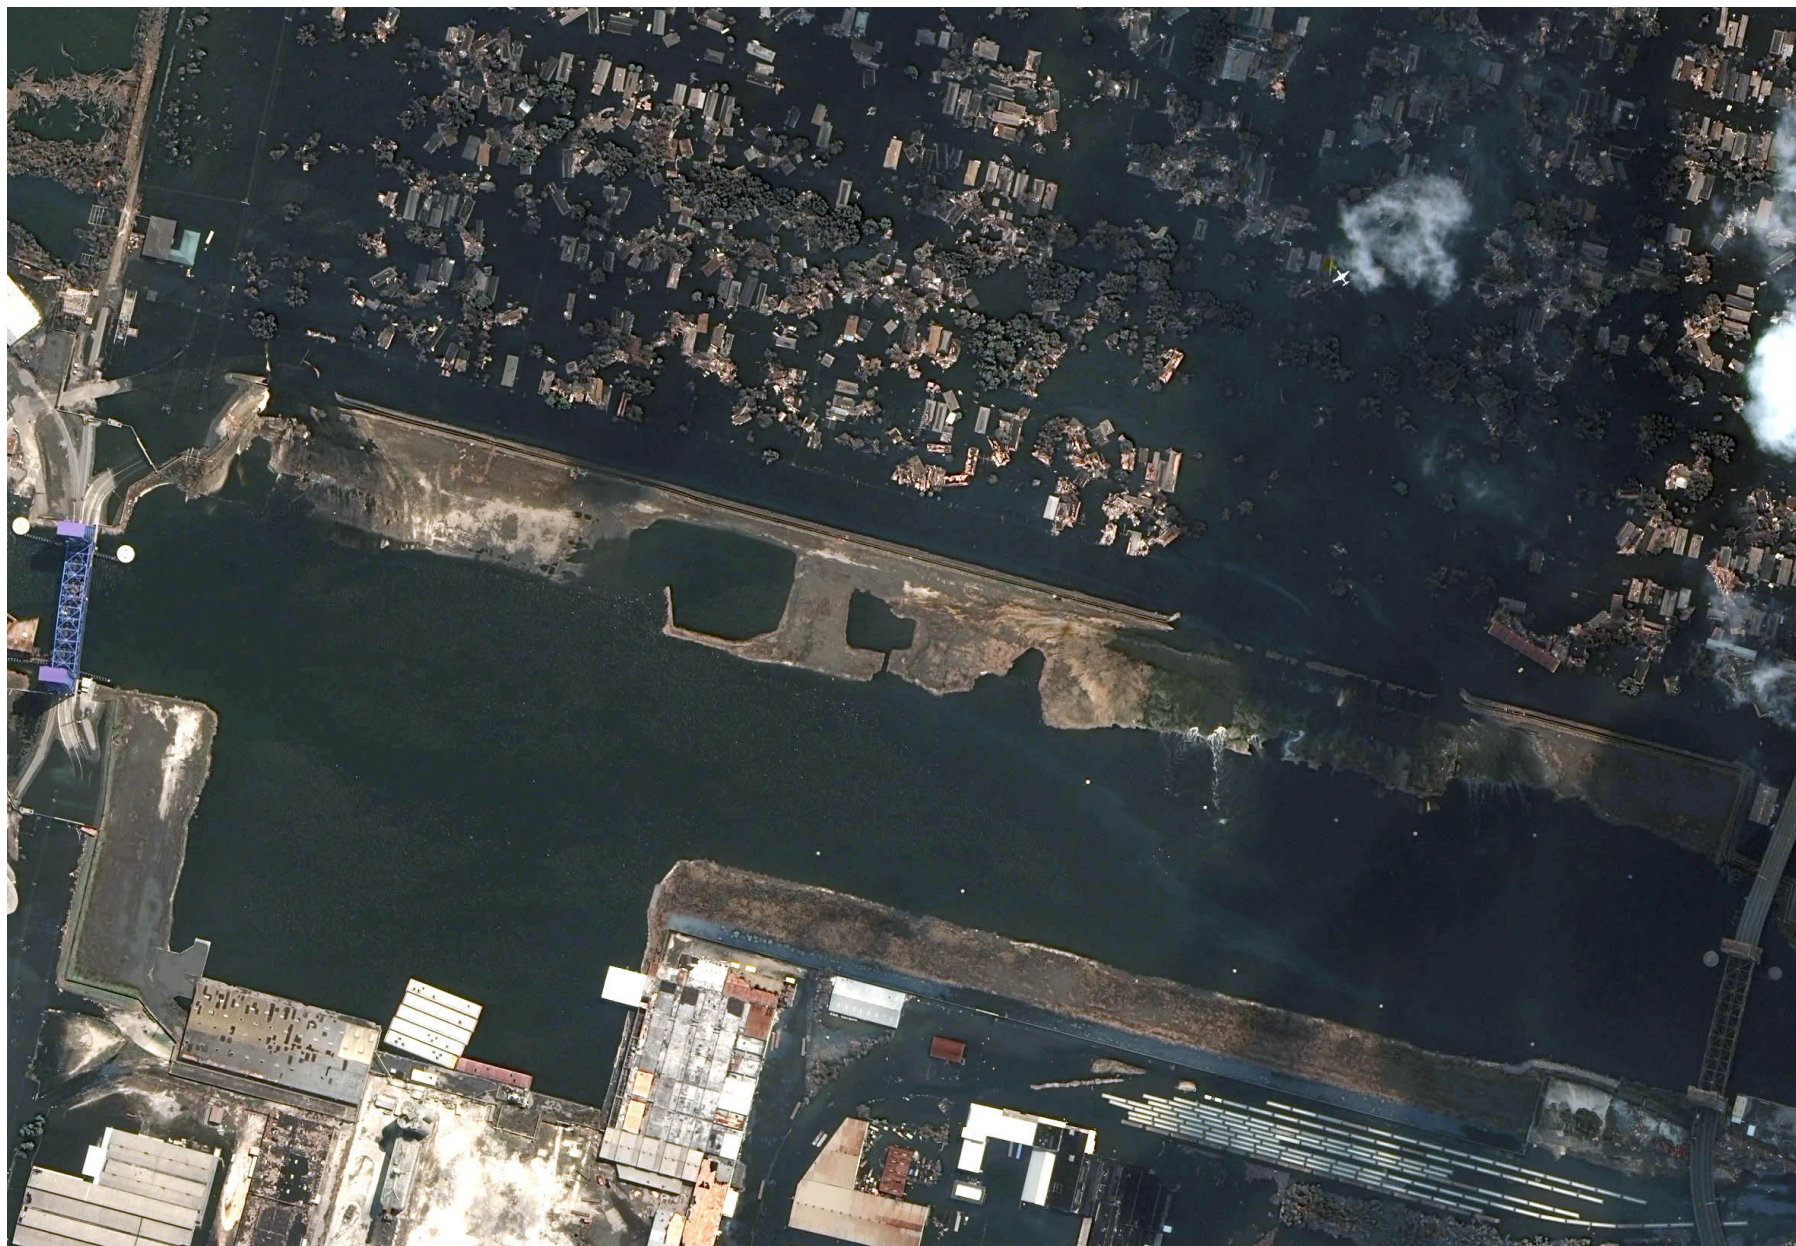
In both cases, all houses were removed in the areas immediately in front of the breaches (Figures 10, 11, 13, 14 & 15) and in areas between the breaches the rush of water was forceful enough to lift houses off their foundations and float them around until they collided with other houses and either came to rest or broke apart to form piles of rubble (Figs. 10 and 11). The floodwall and underlying sheet pilings were strewn into the first few blocks of the Lower 9th Ward like a ribbon (Figures 13, 14, and 15).

Figure 10. Air photograph of the area where the Industrial Canal Levee was breached to flood the Lower Ninth Ward. Image acquired Sept. 3, 2005
Source: National Oceanic and Atmospheric Administration's National Geodetic Survey, Katrina Images - <http://ngs.woc.noaa.gov/katrina/>

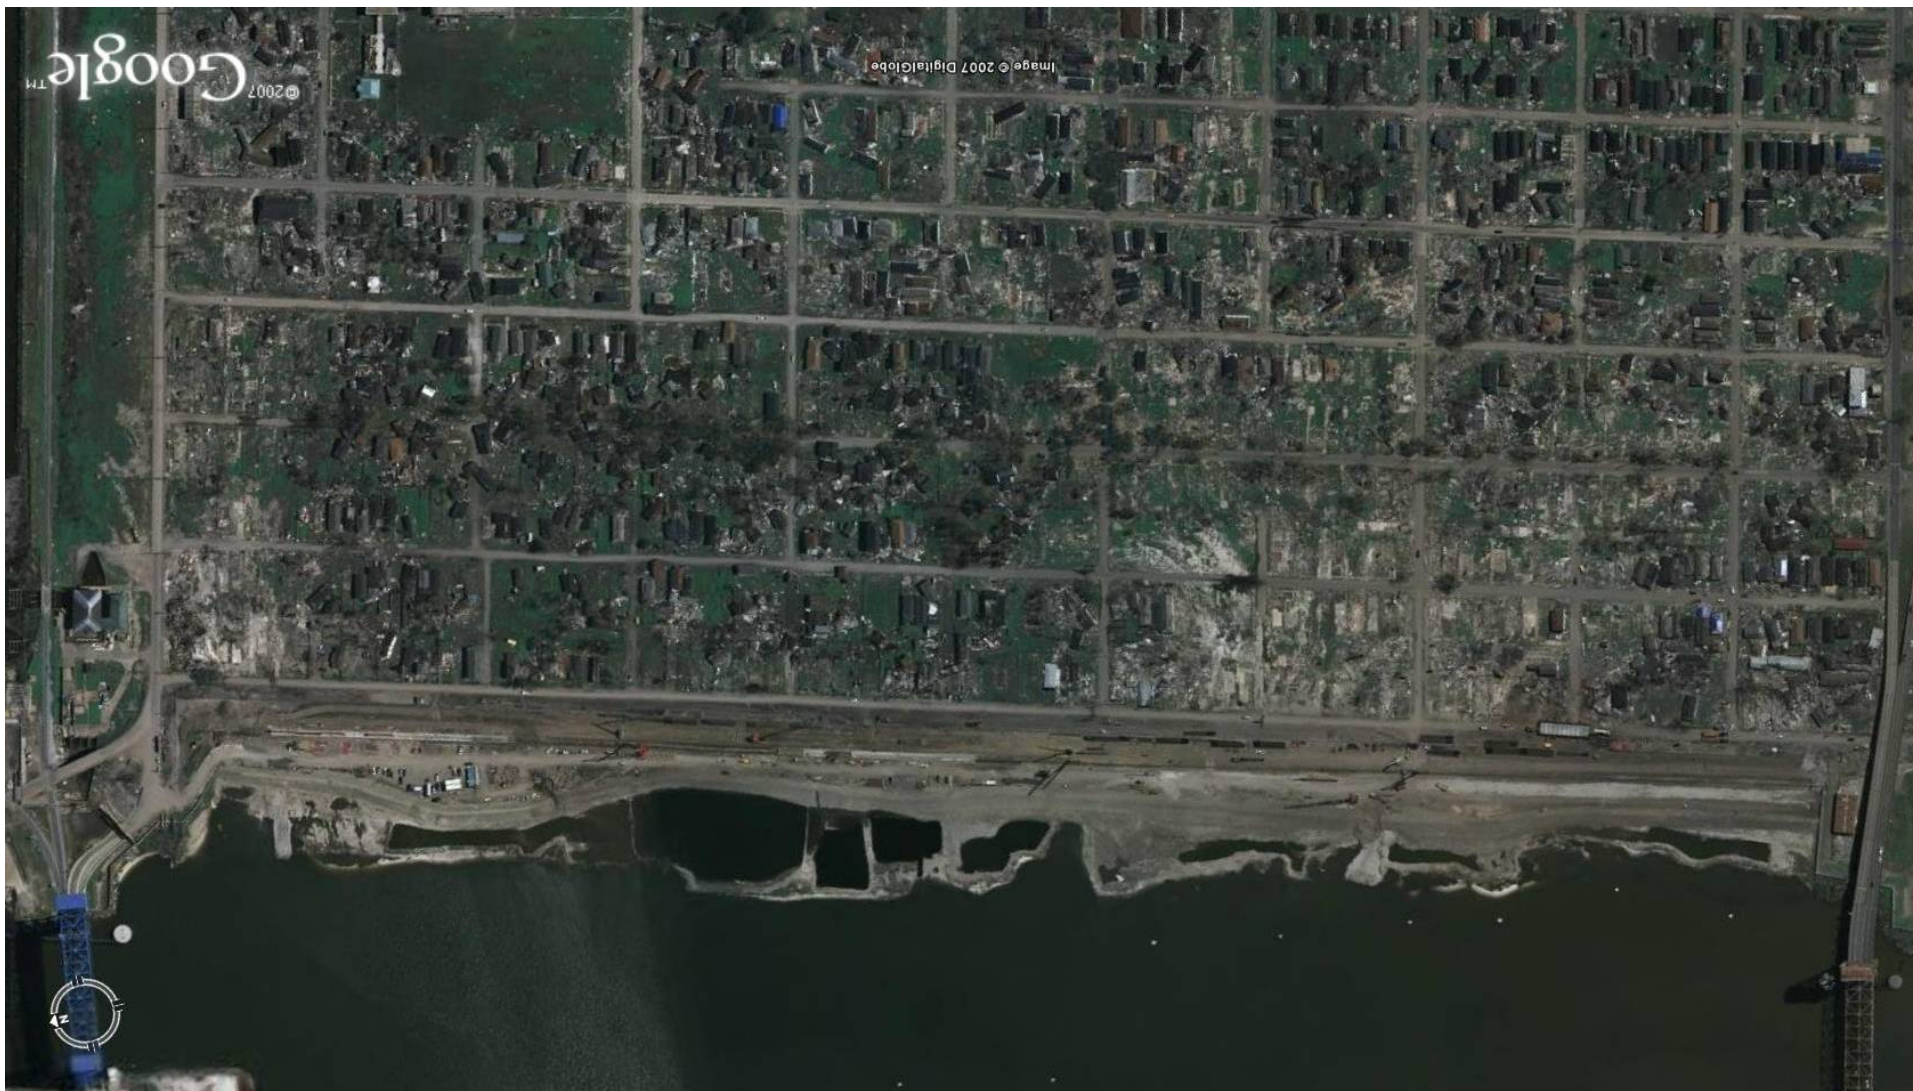
Figure 11. Google Earth image of the area where the Industrial Canal Levee was breached to flood the Lower Ninth Ward. Image acquired around mid-March, 2006.

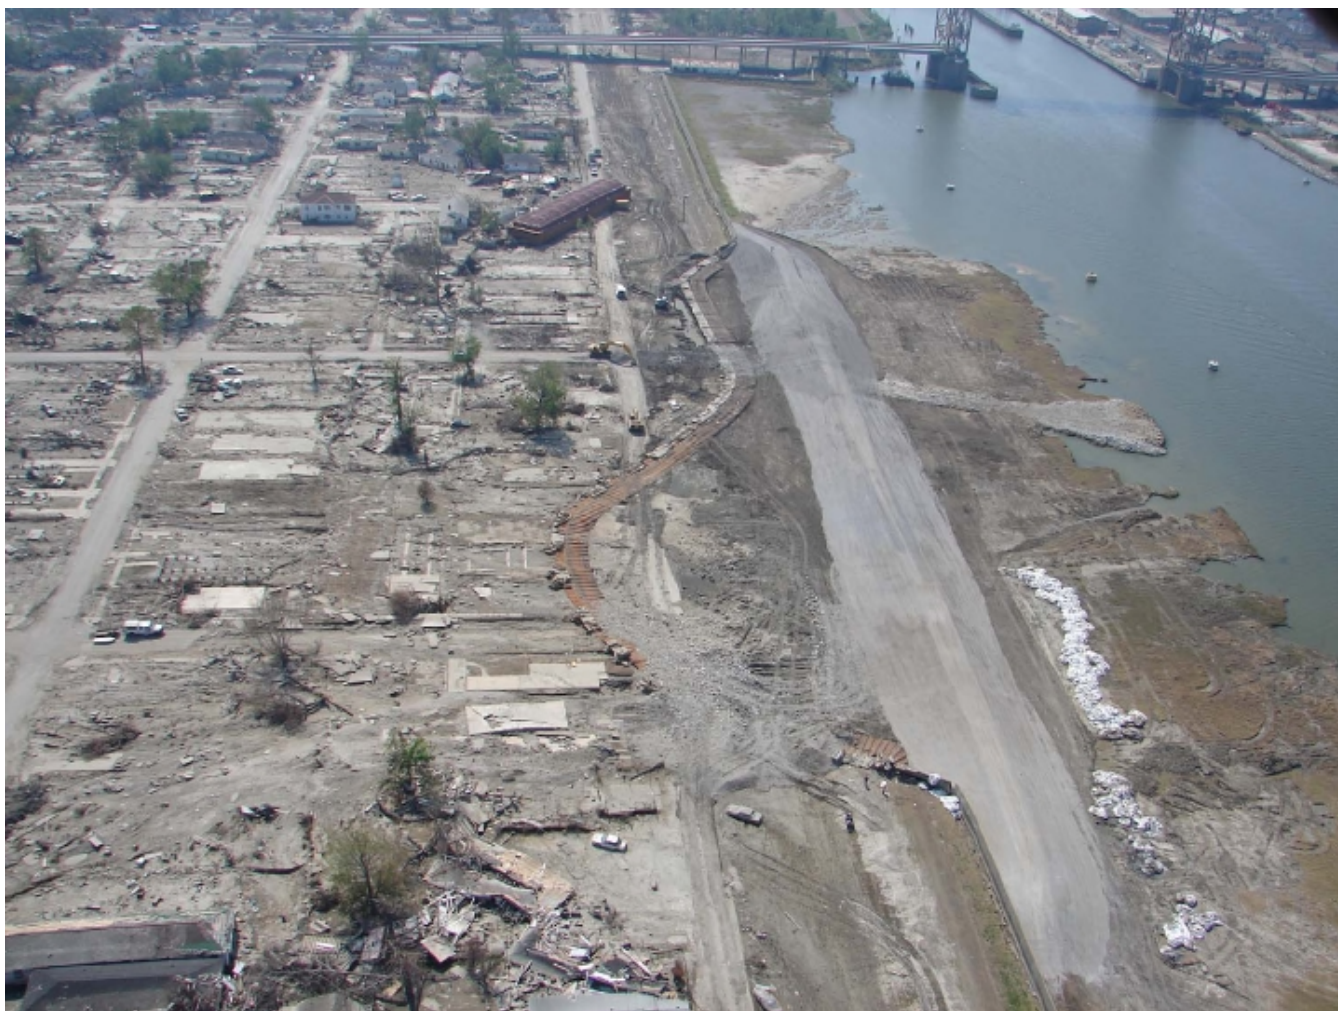
Figure 14. View of southern breach on the Industrial Canal, looking South. Note the floodwall and sheet piling (brown) strewn through the Lower Ninth Ward neighborhood where all houses were removed by the force of water coming through the breach. Gray deposits on right are breach repair gravels. Note barge near in the center near the top of the photo. Photo by L. Harder - Independent Levee Investigation Team Draft Final Report (2006).

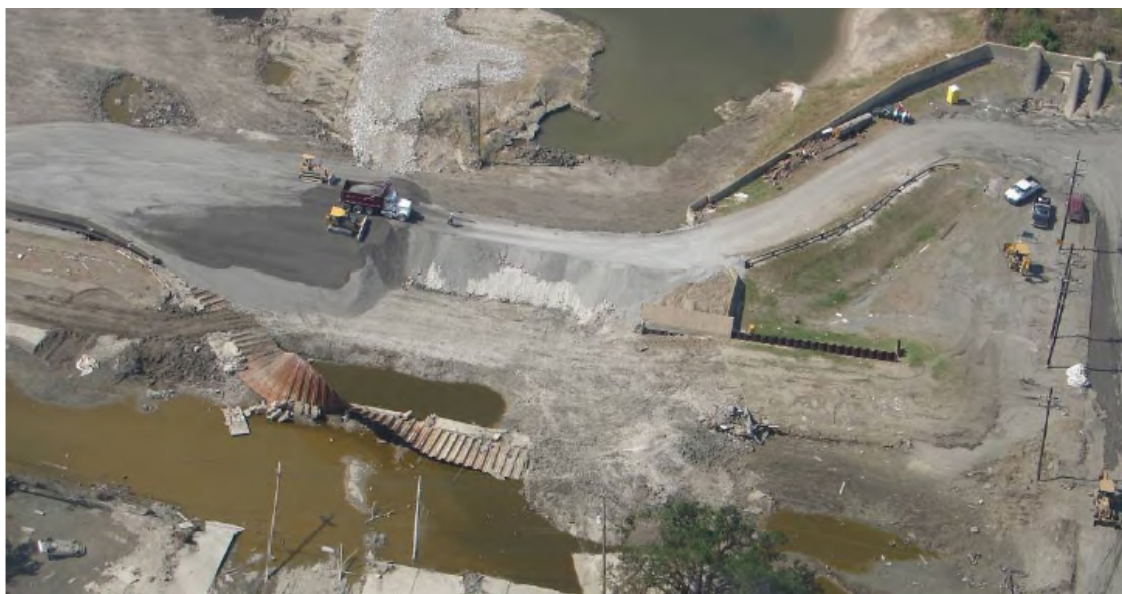
Figure 15. Aerial view of the north breach on Industrial Canal. Photo by L. Harder - Independent Levee Investigation Team Draft Final Report (2006).

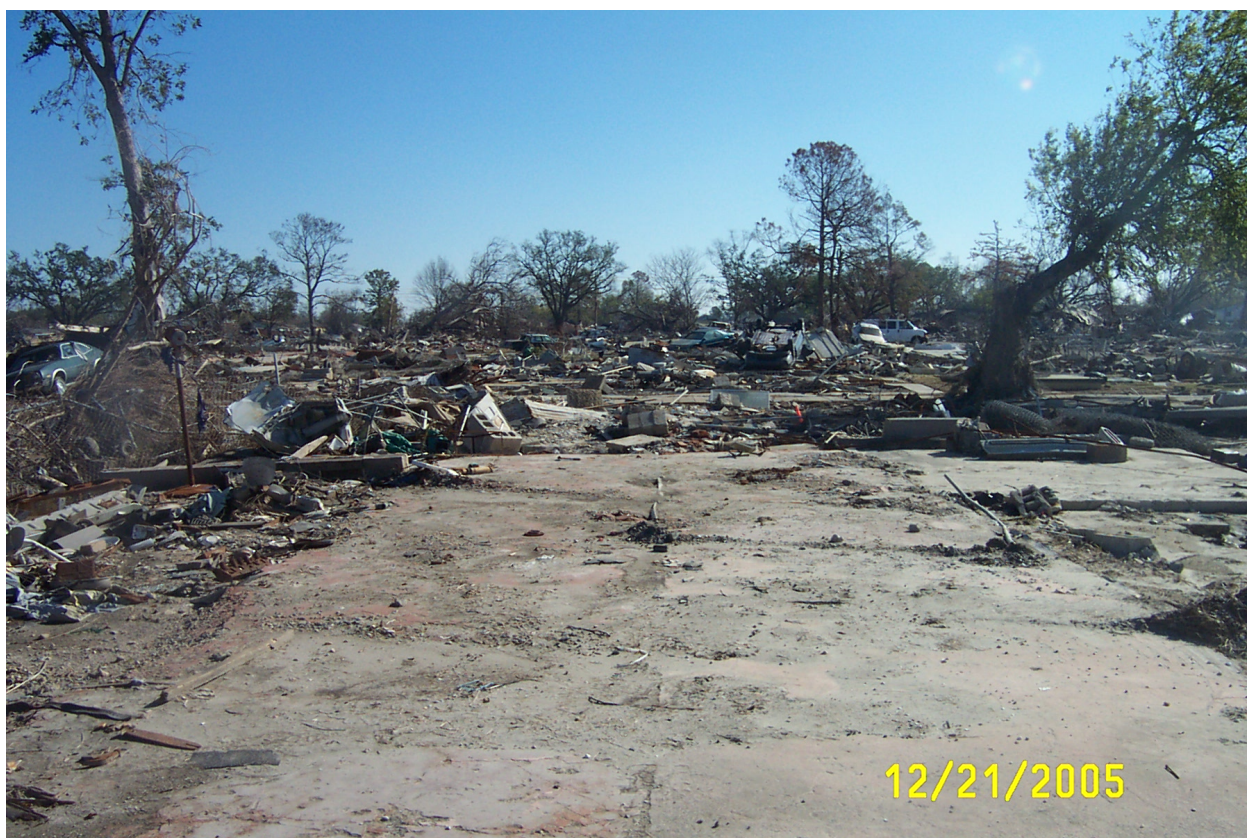
Figure 16. View of Lower Ninth Ward looking East as it appeared in December, 2005.

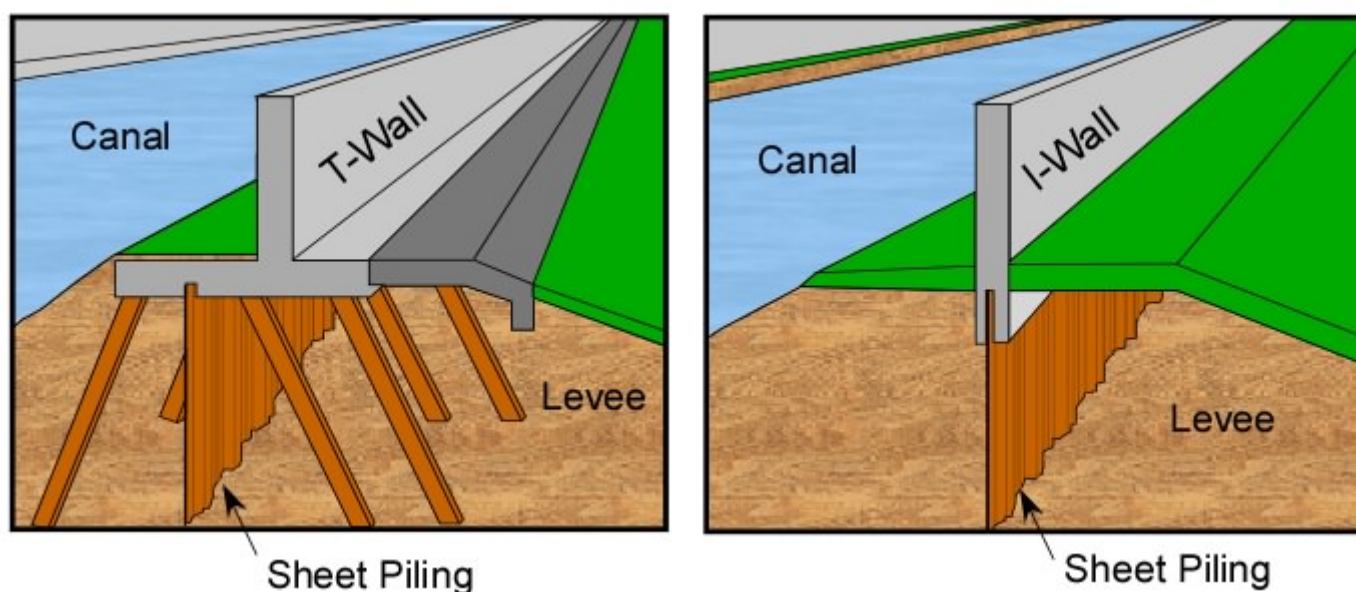
Figure 17. Most pre-Katrina floodwalls in New Orleans were built with the I-wall design (right). In repairing failed floodwall sections after Katrina, the T-wall design (left) was used.

Stop 1 is in the Lower 9th Ward, where we can see into, but not enter, the breach repair. All of the broken floodwall and most of the remaining floodwall have been removed as of mid-February, 2006, and a new floodwall has been completed as of mid-June. The new floodwall rises to an elevation of 14.5 feet above sea level. The floodwall present at the time of Katrina rose to only 12.5 feet above sea level. The old floodwall was an I-wall that was cemented into $\frac{3}{4}$ " – thick steel sheet pilings that extended to a depth of 8 feet below sea level (Figure 16). The new floodwall is the much more stable T-wall design, which, in cross-section looks like an inverted T (Fig. 17).

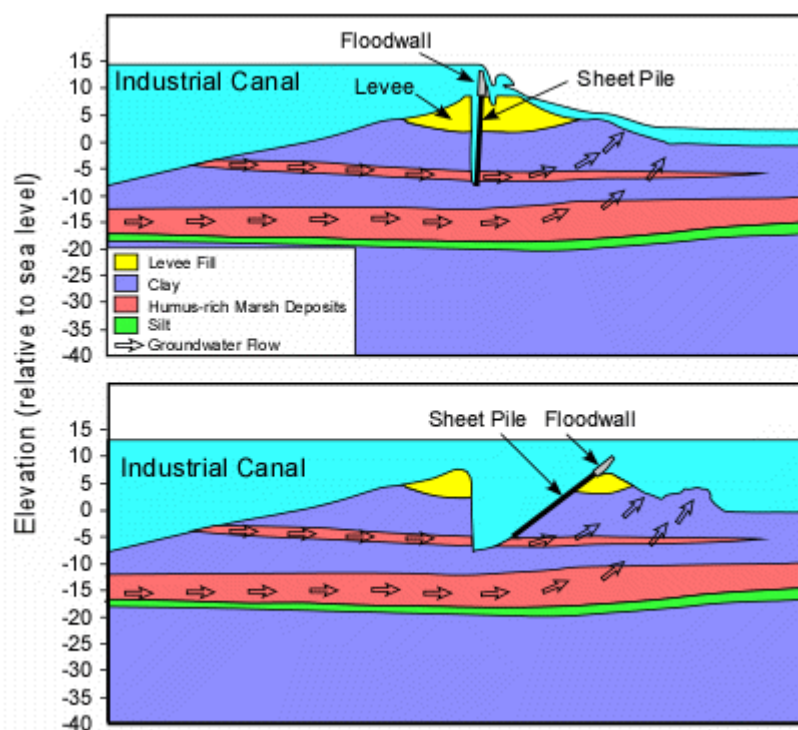
Although the Interagency Performance Evaluation Task Force (IPET, 2006) suggested that the main cause of failure here was the result of the surge waters in the Industrial Canal overtopping the floodwall and eroding away the levee on the protected side, the Independent Levee Investigation Team (ILIT, 2006) disputes this. They do agree that erosion of the levee on the protected side could have contributed, but their analysis indicates that the geological conditions present in the subsurface along with the shallow depth to the tip of the sheet pilings resulted in hydraulic piping beneath the sheet pilings which undermined the levee and caused it and the floodwall to collapse. Two layers of highly permeable marsh deposits occur at a shallow depth below the levee (Figure 19). According to the analysis of ILIT (2006), the added pressure in the canal forced water through these permeable layers and out at the toe of the levee on the protected side, thus removing support for the floodwall and levee.

Figure 19. Possible failure mechanism at the Industrial Canal Levee breach in near the Lower 9th Ward

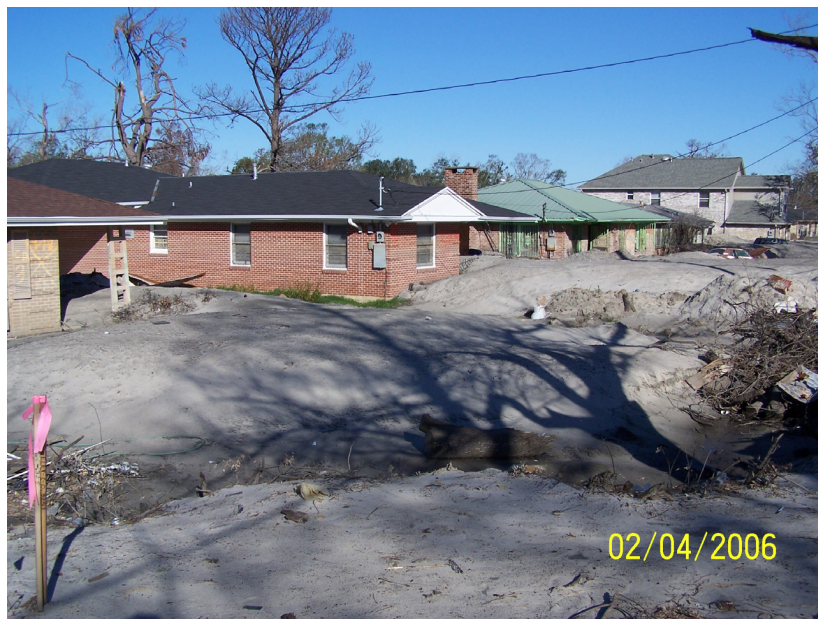
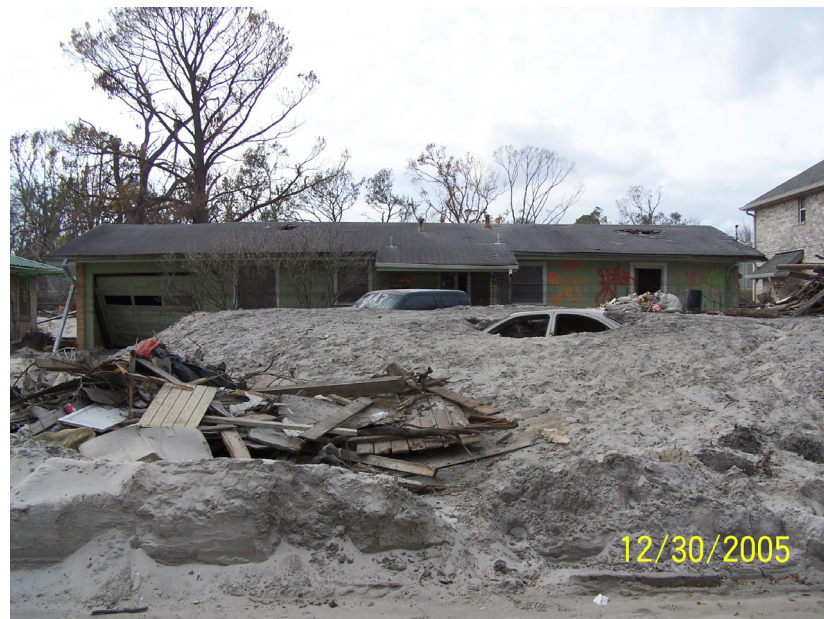
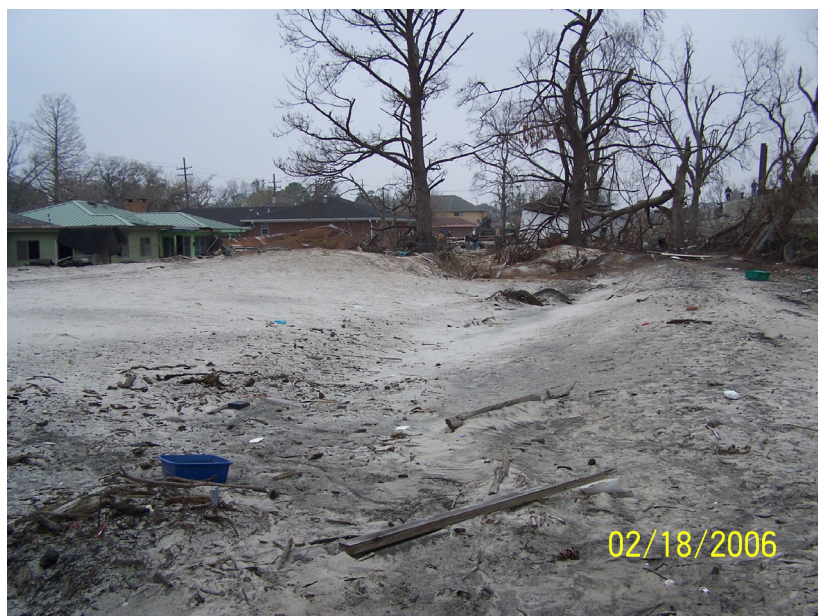
Figure 22. Sand deposits near the south breach of the London Avenue canal. (a) sand ridges deposited in the wake of houses as the currents flowed down the driveways between the houses. (b) Sand deposits that buried two cars in front of house on Warrington Drive. (c) Ridges of sand filling the back yards of houses along Warrington Drive, just north of the breach. As of March 1, 2006, most of the sand in the front yards had been removed and as of mid January, 2007 most of the sand in the backyards had been removed.

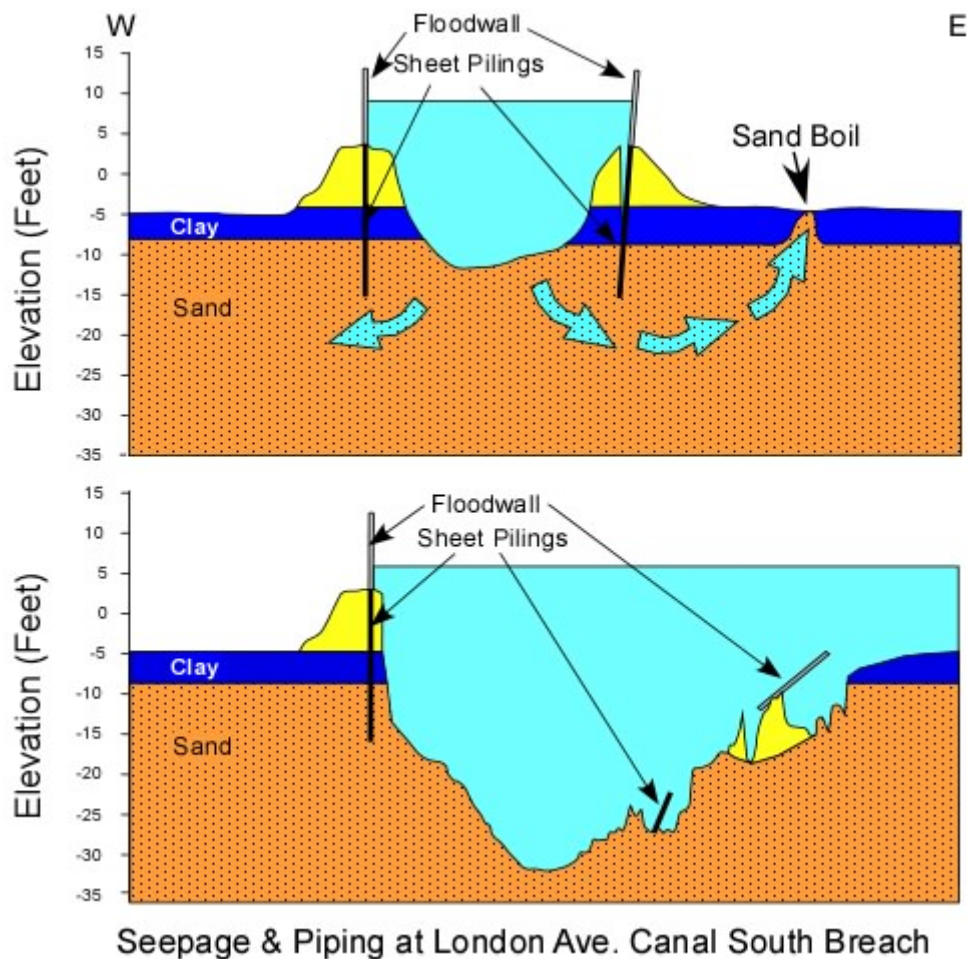
Figure 25. Geological cross section across the London Ave. Canal based on borings 16 and 51 (Figs. 23 and 29), shown at time of estimated high water during Katrina's storm surge. The sands form a permeable layer through which groundwater originating in the canal can penetrate and move below the sheet pilings and up to the surface (top diagram), eventually undermining the levee and causing a blowout completely removing a section of levee and carrying sand into the neighborhood. The shape of the canal bottom is based on depth soundings undertaken by the U.S. Army Corps of Engineers on September 5, 2005.

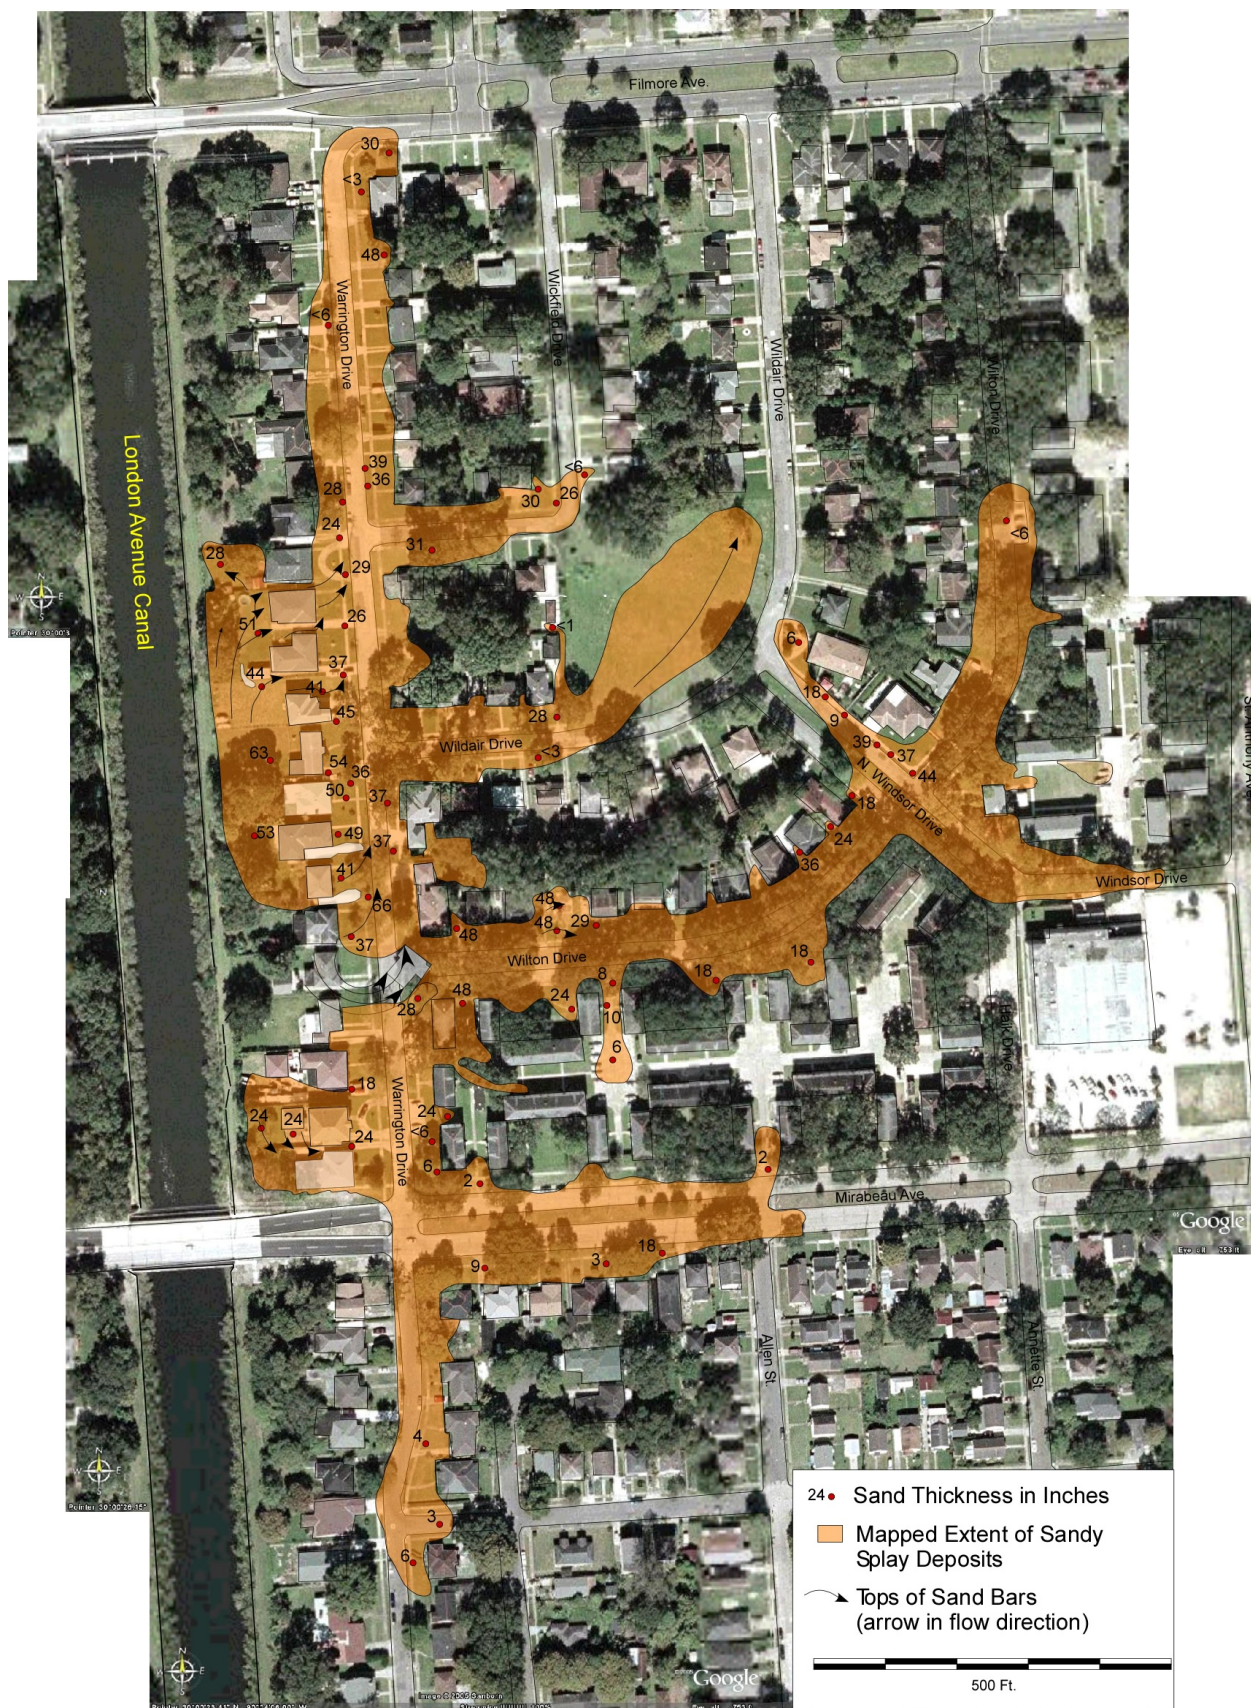
Figure 26 shows our preliminary map of the extent of the sand that scoured from the bottom of the London Ave. Canal and the blowout hole beneath the levee and deposited throughout the neighborhood. The distribution and thickness of the actual deposit was controlled by current velocity and barriers such as houses, fences, and hedges. For more information on the sand deposits at this locality, see Nelson and Leclair (2006).

Our estimate of the volume of sand deposited in the neighborhood is about 932,000 ft³. Such a volume would cover a football field, from end to end (including the end zones) with over 16 feet of sand. Engineers working on the breach repair have reported that they had to dig to a depth of 30 feet below sea level to completely remove gravel and sand bags used to plug the breach in the first few days after Katrina. A conservative estimate of the volume of this hole is about 330,000 ft³. This only accounts for about 35% of the volume of sand found in the neighborhood, and implies that the canal bottom, both upstream and downstream from the breach, was scoured to an unknown depth. This raises questions about the stability of the levee/floodwall system outside the breach area if the canal bottom is now in permeable sand in these areas.

Figure 26. Preliminary map of sand deposits (by S. A. Nelson) from the Mirabeau Ave. Breach on the London Ave. Canal. Underlying image is a composite from Google Earth.

The repair operation has only been done in the area of the breach. The operation involved digging out the material used in the initial emergency repair, filling it with clay and constructing a T-wall to replace the missing I-wall. Fortunately, the Corps of Engineers is now completing removable floodgates near the mouths of the London Ave, Orleans, and 17th St. canals near Lake Pontchartrain. These floodgates will be closed in the event of a hurricane and should prevent storm surge from reaching onto the floodwalls in the canals. If the gates are closed, however, the pumps at the southern end of the canals cannot be used to pump rainwater out of the city. Thus, the Corps is in the process of building pumping stations at the Lake (where they should have been built in the first place), but full pumping capacity will not be available for the 2006 hurricane season. Still rainwater flooding is better than having Lake Pontchartrain drain into the city.

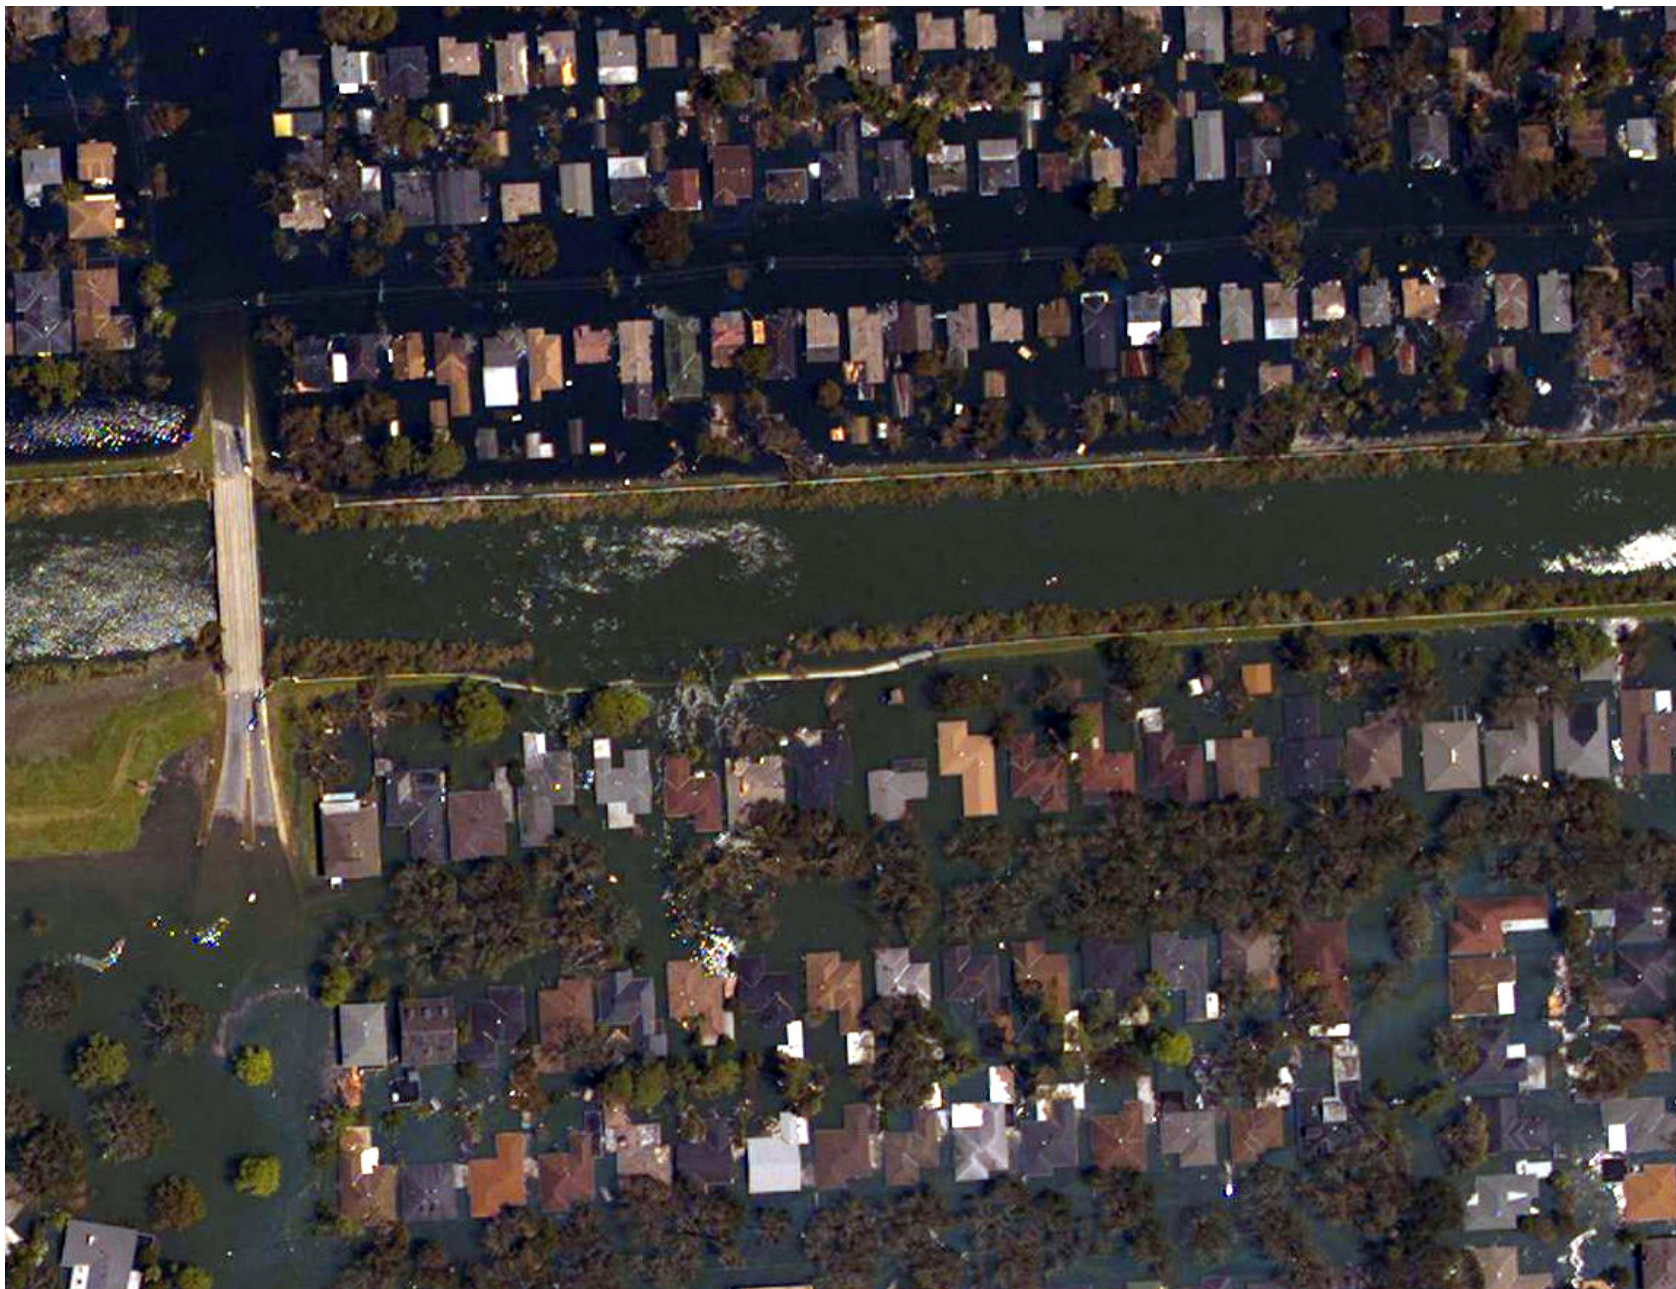
Figure 28. Air photograph of the area where the London Avenue Canal levee was breached near Robert E. Lee Ave. and Pratt Drive (Stop 3). Drive. Image acquired Aug. 31, 2005. Source: National Oceanic and Atmospheric Administration's National Geodetic Survey, Katrina Images - <http://ngs.woc.noaa.gov/katrina/>

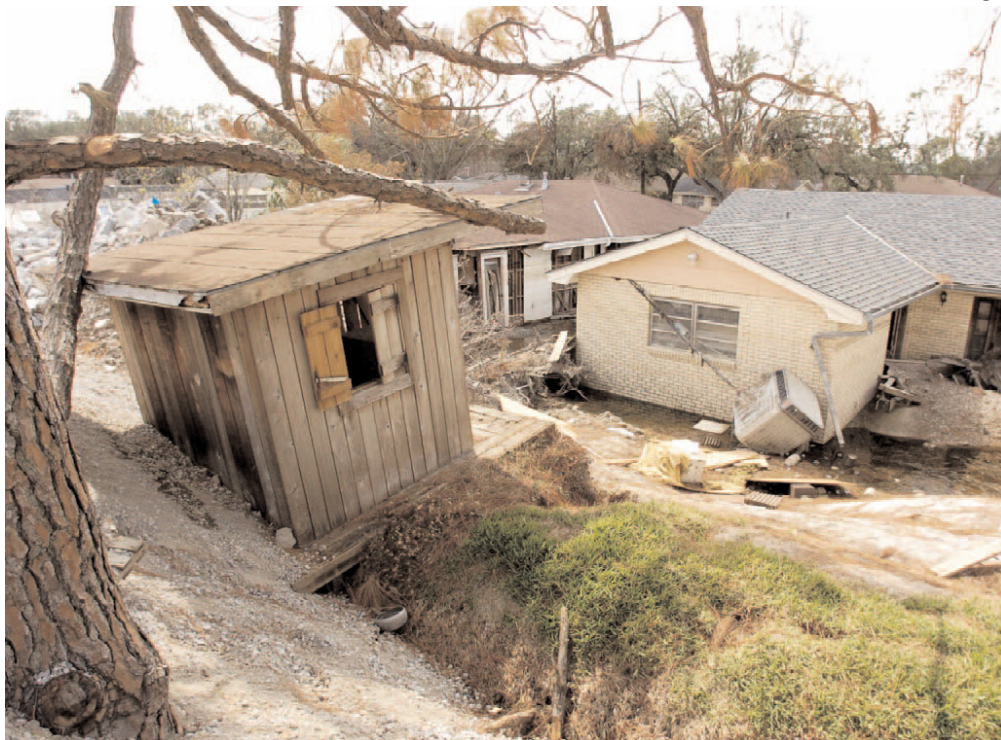
From this position on the levee north of Robert E. Lee Blvd., one can also observe the “distressed” floodwall on the east side of the canal. The floodwall is leaning away from the canal, but did not breach, probably because the west side breached and relieved the pressure on the east side (As of early May, 2006, the distressed floodwall has been removed and replaced by sheet piling and as of June, 2006, the floodwall had been replaced by a T-wall).

Figure 31. Water in the canal at the north breach of the London Ave. Canal puts lateral pressure on the floodwall and sheet piling along with water driven through sand under the sheet pilings (and possibly through peat, depending on the depth to which the sheet pilings actually were driven) pushes up the ground outside of the canal in a phenomenon known as heave. This would eventually provide a flow path for water which would undermine the levee and cause its collapse. This may have been responsible for the eventual collapse of the floodwall on the west side of the canal resulting in the breach. The floodwall on the east side of the canal was distressed, but did not breach.

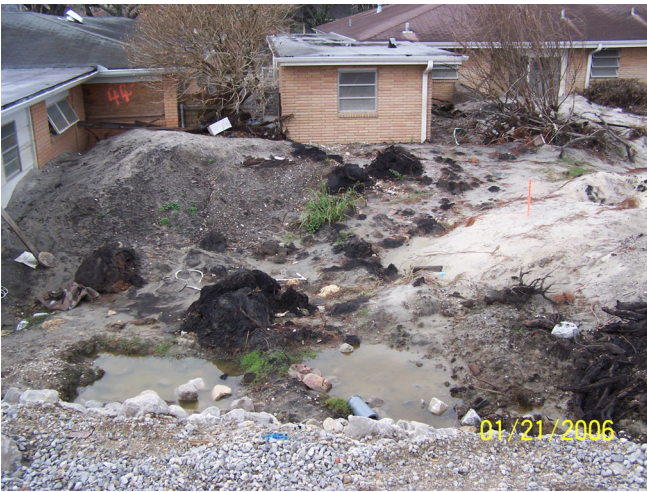
After the water was drained from the area, deposits of sand along with blocks of peat were observed to have filled the street and the backyards of houses along Pratt Drive (Figs. 32 and 33). The sand deposits were similar to the ones observed at the Mirabeau Ave. breach, but also contain blocks of peat as expected from the geologic cross sections shown in Figure 29.

Figure 32. Sand deposits and peat blocks (black) behind homes on Pratt Drive at the North breach of the London Ave. Canal.

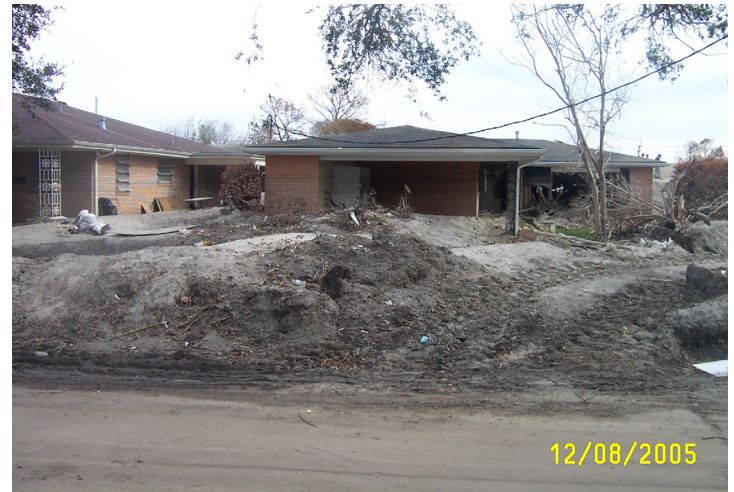
Figure 33. Sand deposits in front of houses on Pratt Drive at the the North breach of the London Ave. Canal.
