Hurricane Katrina - What Happened?

Tulane University
Field Trip
Updated April 14, 2007

Levee Breaches in New Orleans during Hurricane Katrina

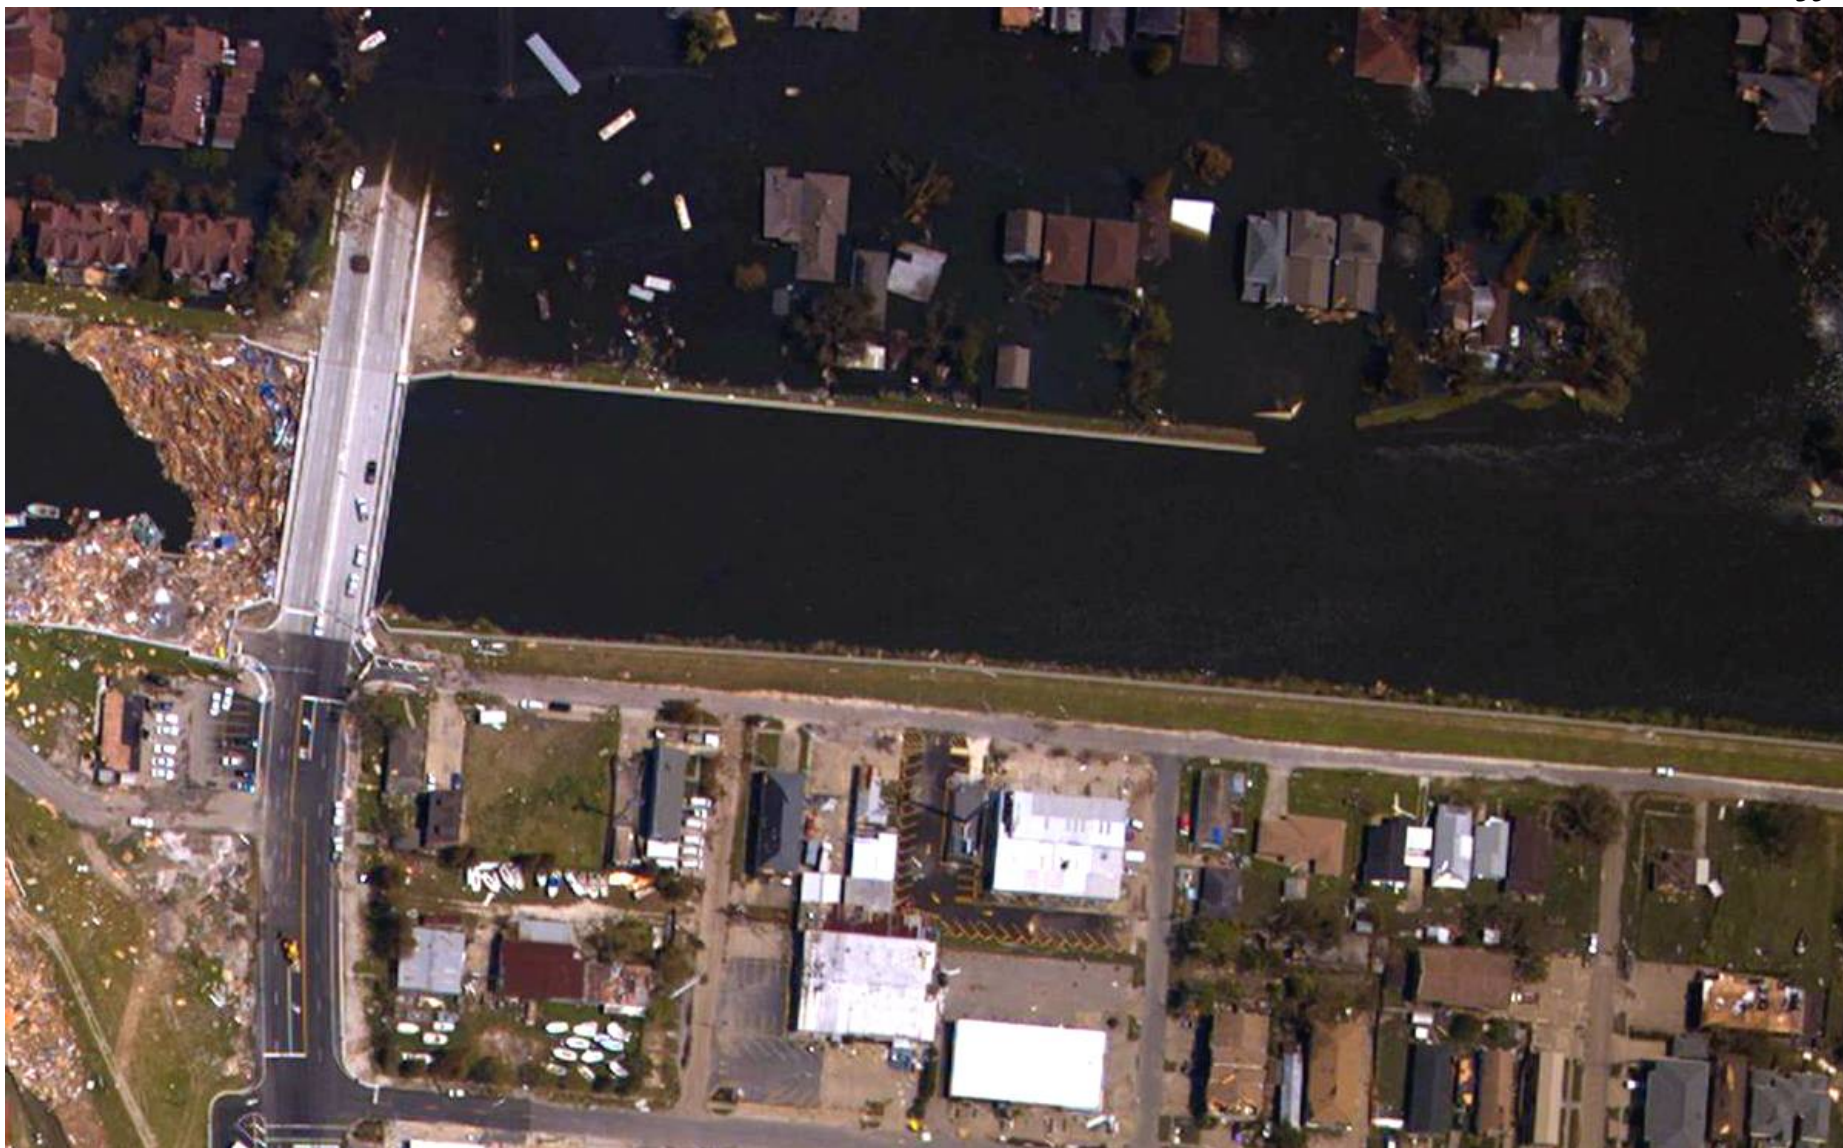
Figure 35. Air photograph of the area where the 17th Street Canal Levee was breached near Belaire Drive (stop 5). Image acquired Aug. 31, 2005. Source: National Oceanic and Atmospheric Administration's National Geodetic Survey, Katrina Images - <http://ngs.woc.noaa.gov/katrina/>

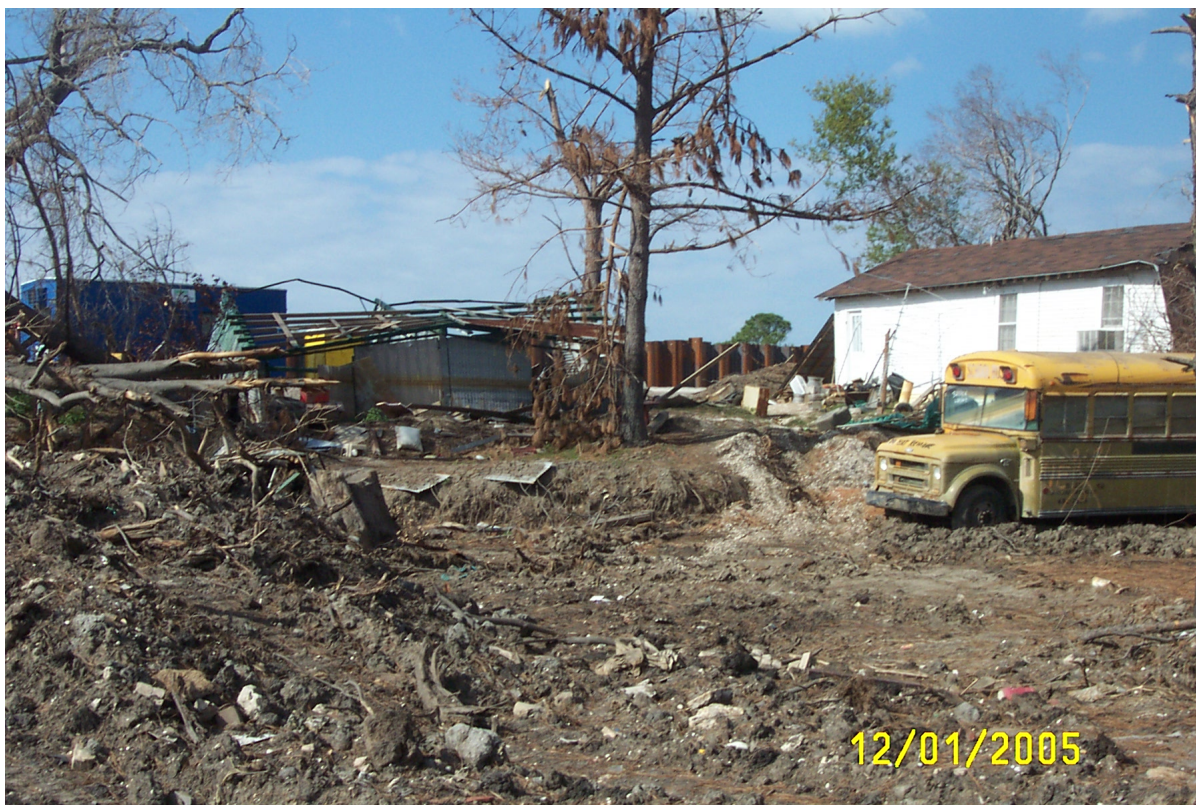
Figure 38. . Slide toe (at abrupt change in slope in front of school bus) where levee and neighborhood were displaced about 45 feet toward the viewer.

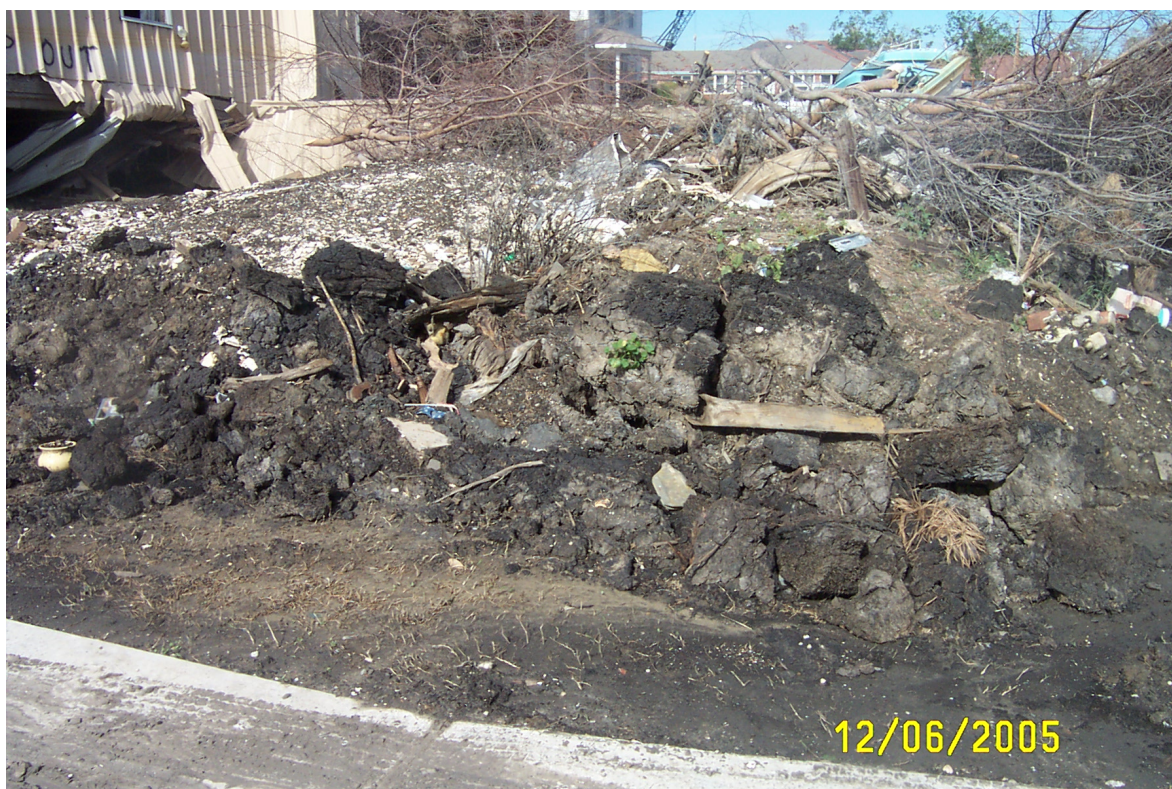
Before the debris was completely removed from the neighborhood, large blocks of peat were present throughout the neighborhood, some of which could be found a block away to the east near Fleur de Lis Blvd. Examples of the peat blocks before their removal can be seen in Figure 39 and the upper right photograph in Figure 43.

Figure 39. Blocks of Peat along Belaire Drive near the 17th St. Canal levee breach

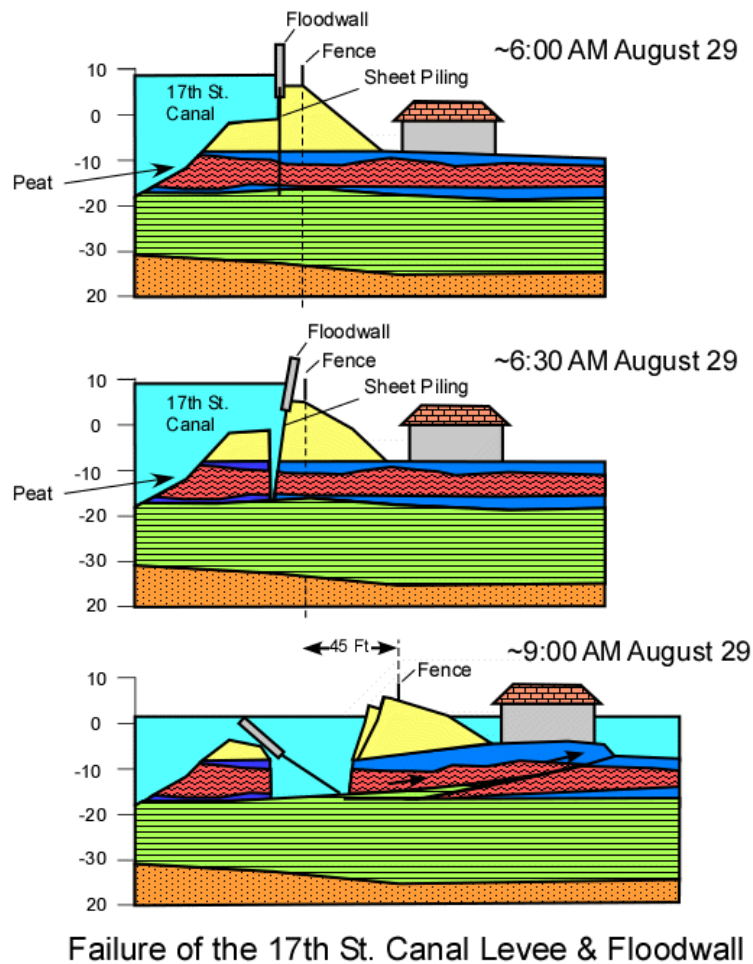
Failure of the 17th St. Canal Levee & Floodwall

The most recent information from the Interagency Performance Evaluation Task Force (IPET) [2006] suggests that the floodwall and levee failed at the 17th St. Canal as a result of water level rising to an elevation of about 8 feet above sea level in the canal. The floodwalls were designed to have tops at an elevation of 14 feet above sea level, but IPET data indicate that by the time of Katrina the tops of the floodwalls on the 17th Street Canal were about 12.5 feet above sea level. Thus, IPET estimates that water levels in the canal were still 4 feet below the tops. IPET has collected eyewitness accounts and scoured the neighborhood for clocks that were stopped as a result of the flooding in order to determine the time of the breach. One eyewitness account suggests that the floodwall at the breach area was leaning to the protected side at about 6:30 AM on August 29 and other accounts suggest that the breach was open by about 9:00 AM. This, along with levee breach experiments conducted on scale models in a large centrifuge led IPET to suggest that as water levels rose in the canal, the floodwall and sheet piling was pushed outward toward the land side, opening a gap between the levee and the floodwall on the canal side. This gap allowed water to seep down along the sheet piling and eventually push the levee on the protected side outward away from the canal. Based on sections of the breached levee observed in the breach area, IPET suggests that the failure did not occur along the peat layer, but along a layer of weak clay at the base of the peat. This clay layer was thrust over and through the peat as illustrated in Figure 41.

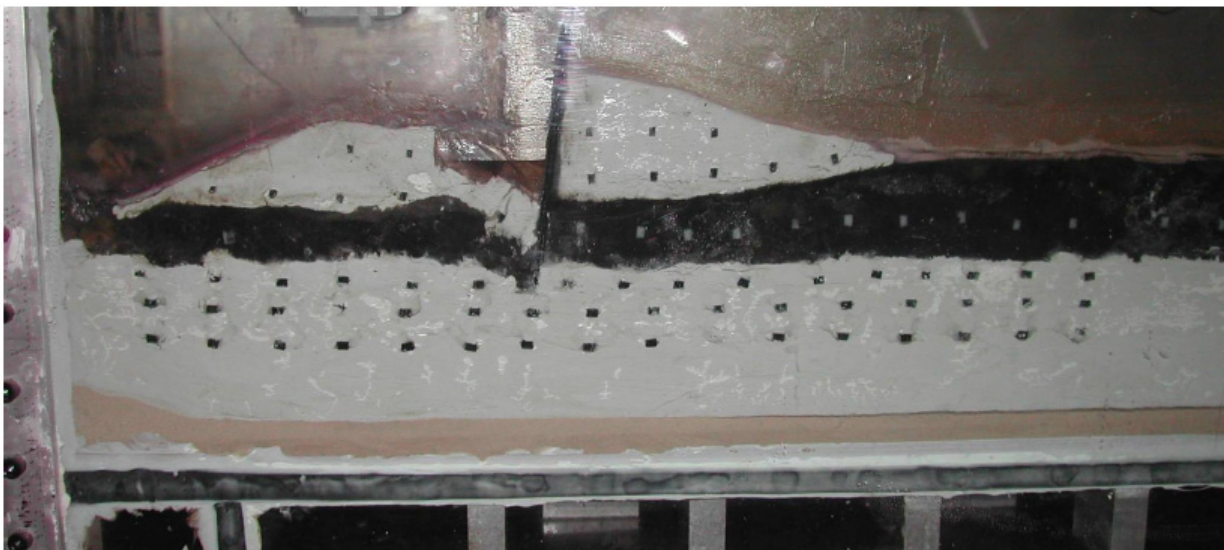
A photograph of the end result of IPET's scale model centrifuge experiment is shown in Figure 42. The canal side (on the left in the photograph) next to the sheet piling is seen to have dropped down as a result of the floodwall moving toward the right (toward the protected side). Indeed in the end result of the experiment, the levee, peat layer, and upper part of the underlying clay layer all have moved to the protected side. Viewing the complete video of the experimental run (<https://ipet.wes.army.mil/>), however, shows that the initial failure occurred either in the peat layer or at the peat – clay interface, and only when the sheet pile started to move to the right, away from the canal, did the upper part of the clay layer also move. Furthermore, the only part of the clay layer that moved was the part immediately in front of the tip of the sheet pile, and it only moved because it was being pushed along by the sheet pile.

Figure 42. Photograph of failed levee and floodwall in IPET's scale model centrifuge experiment representing the 17th St. Canal. The white at the top is clay and represents the levee. This overlies the dark peat layer, which in turn overlies another white clay layer meant to represent the estuary deposits beneath the peaty marsh deposits. Small rectangles were initially laid out in a rectangular grid and can be used to determine how much deformation has occurred during the experiment. (IPET, 2006).

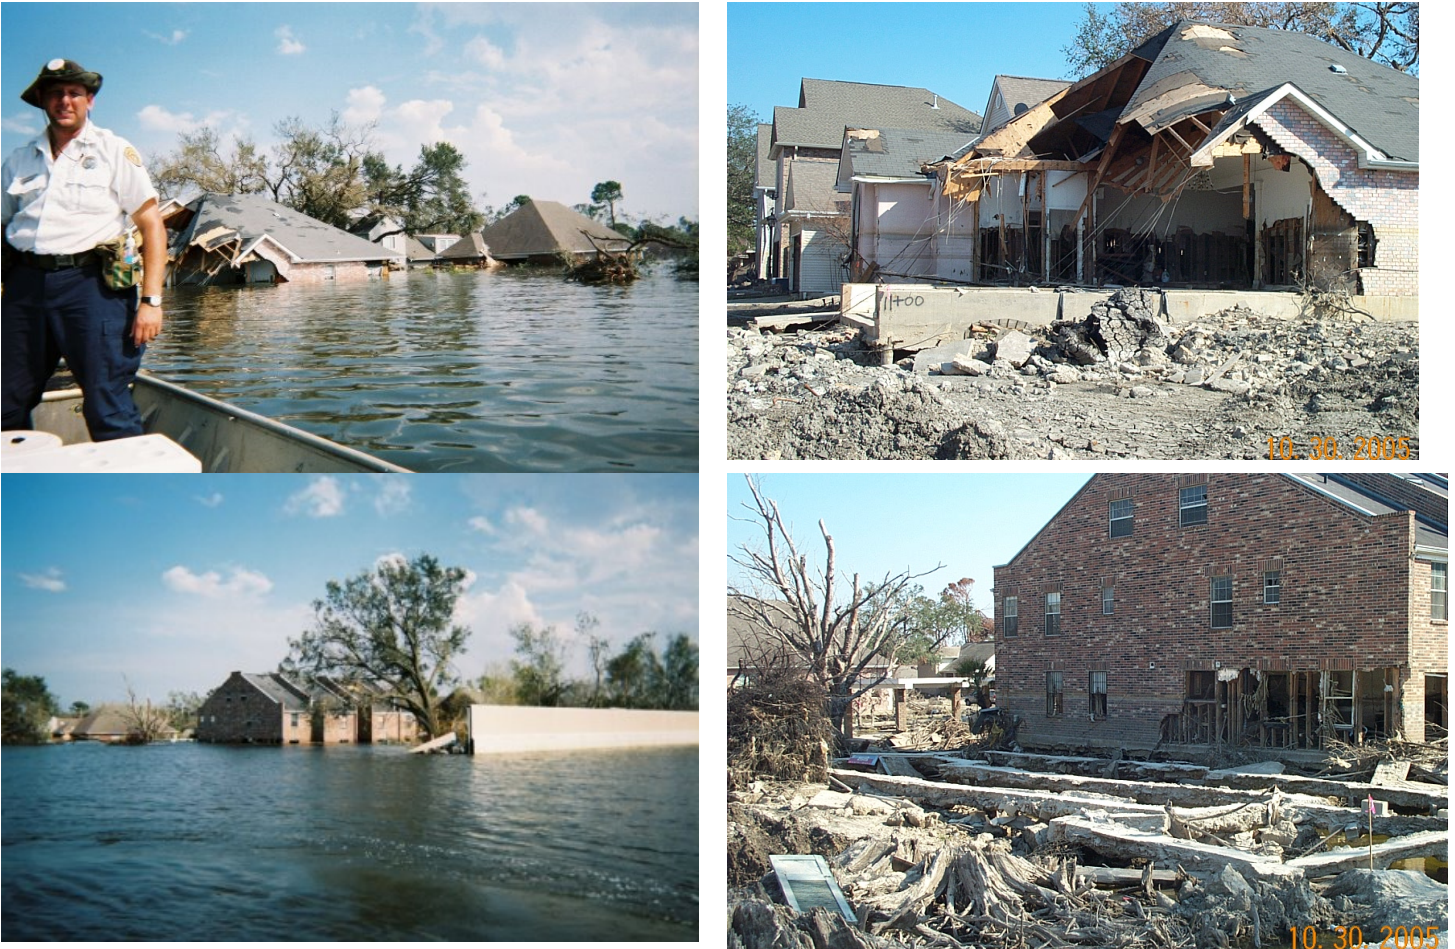
Figure 43. Comparison of water levels on Sept. 1, 2005 (photos on left by Kevin Himmel), with water lines on same structures indicate lines left by standing water are about 1.5 to 2 feet lower than the maximum water level. Note large block of peat in photo at the upper right. In photo at lower right, note the chainwall foundation of a house that was removed by the burst of water when the levee was breached and the cypress stump from a tree that was probably cut down 100 years ago when this Lakeview neighborhood was reclaimed from the cypress swamp.

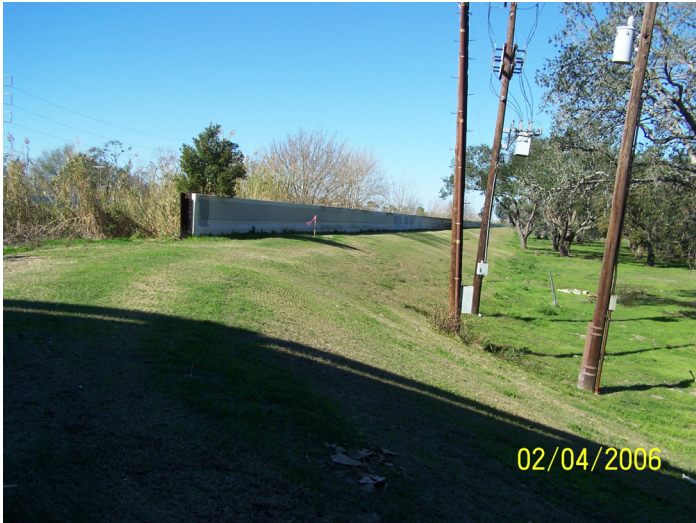
Figure 45. End of floodwall on Orleans Canal just north of I-610 overpass near Marconi Ave. (Stop 6)

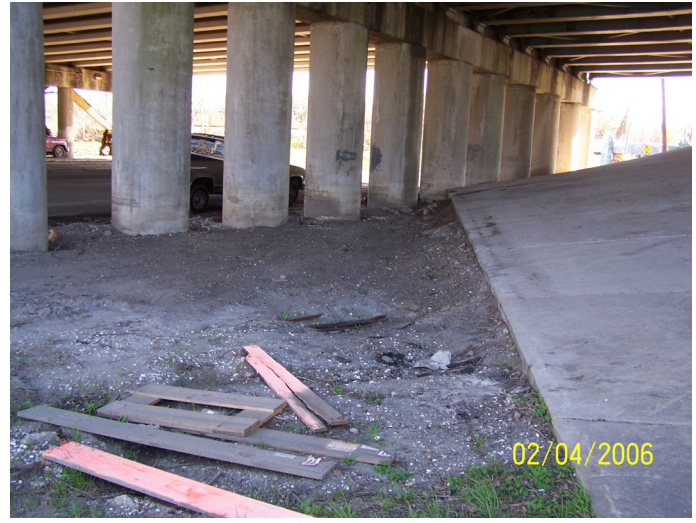
Figure 46. Erosion around the support structures for I-610 near Orleans Canal on Marconi Ave (Stop 6).

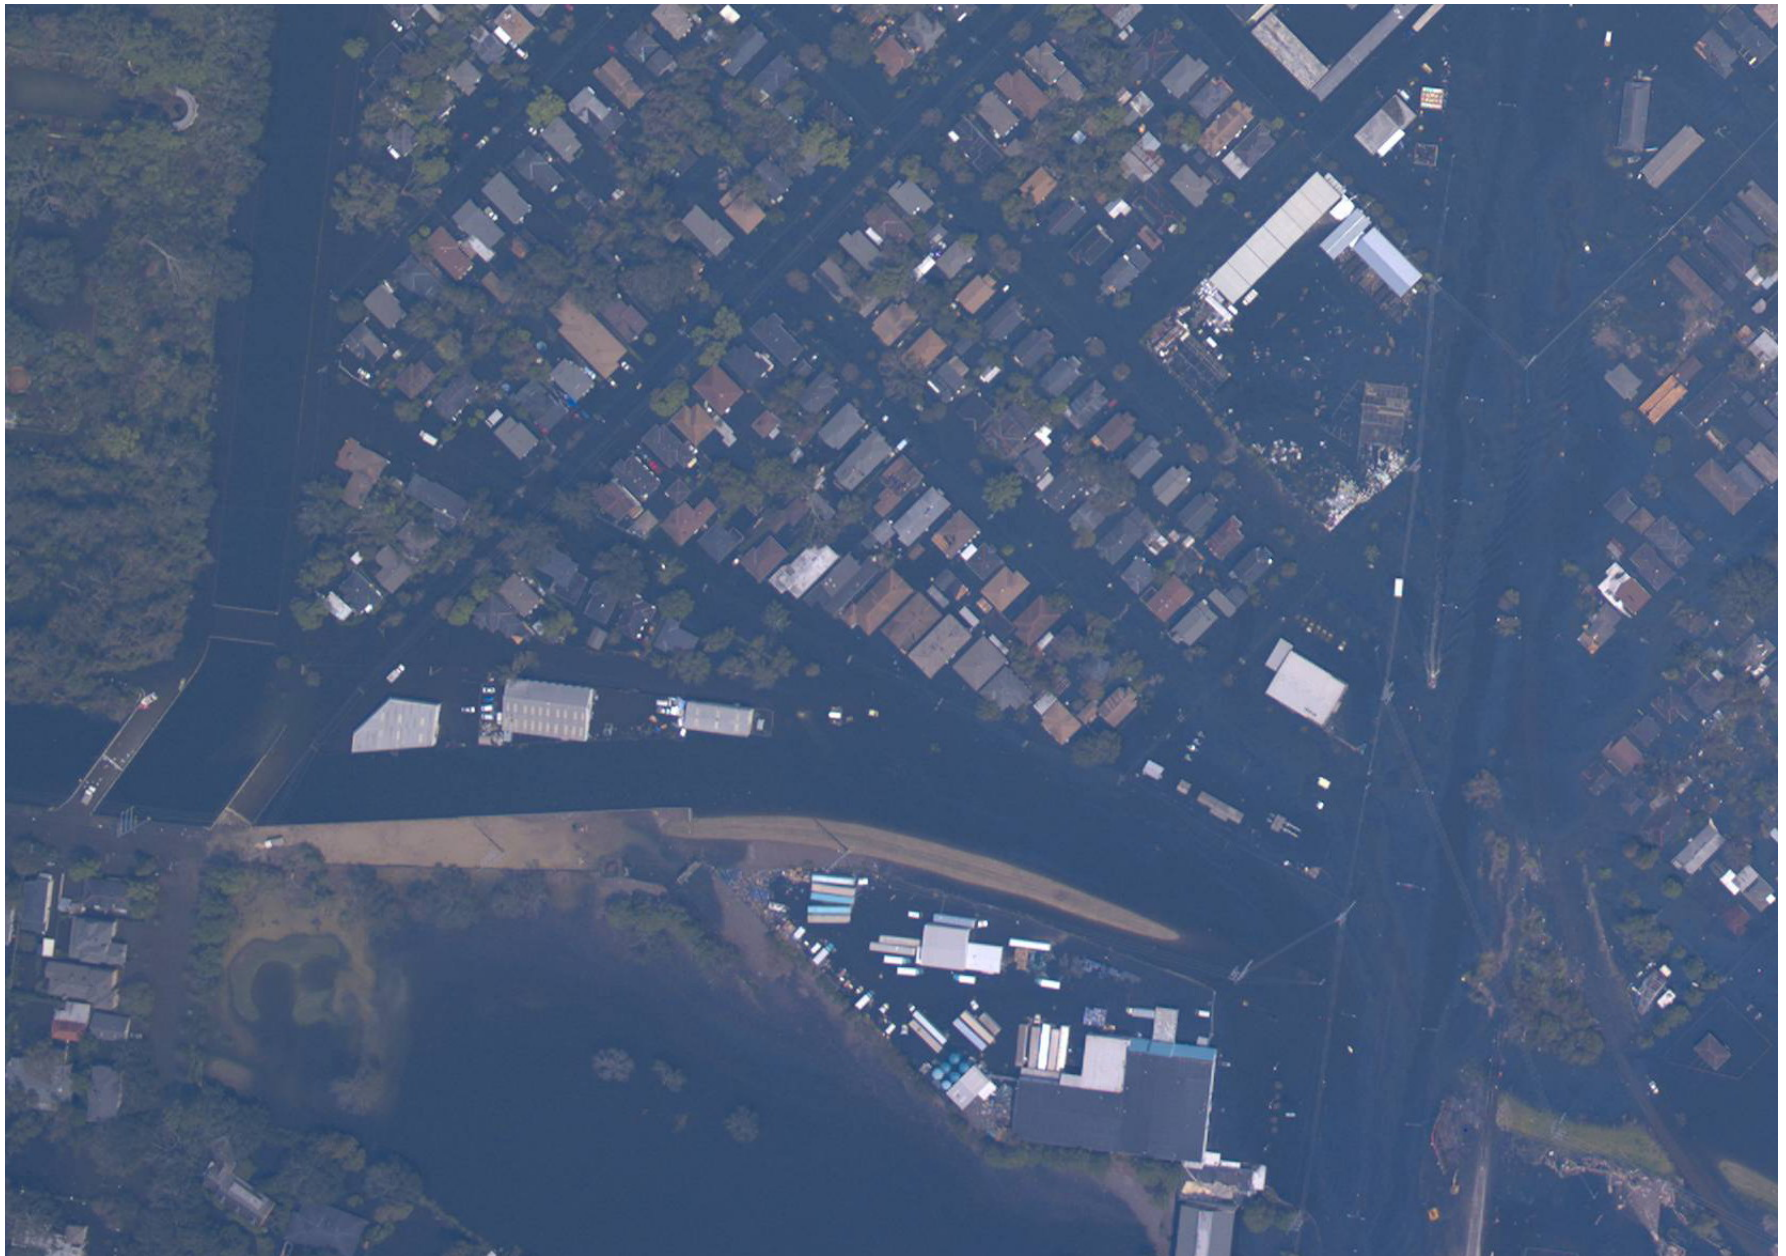
Figure 48. Air photograph of the area where the water from the 17th Street Canal Levee Breach ran back into Old Metairie, near Orpheum and Palm (stop 6). Image acquired Aug. 31, 2005. Source: National Oceanic and Atmospheric Administration's National Geodetic Survey, Katrina Images - <http://ngs.woc.noaa.gov/katrina/>
