Hurricane Katrina - What Happened?

Tulane University
Field Trip
May 27, 2006

Stephen A. Nelson
Department of Earth &
Environmental Sciences
snelson@tulane.edu

Levee Breaches in New Orleans during Hurricane Katrina

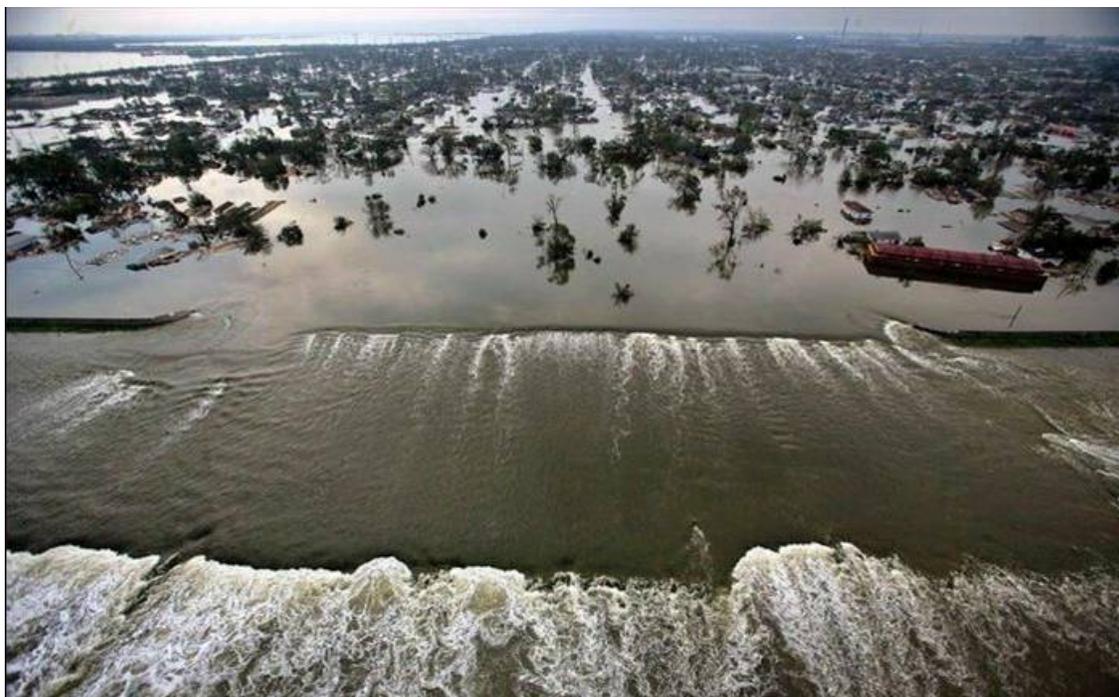
Figure 8. The large breach in the Industrial canal that flooded the Lower Ninth Ward could have been caused by a barge crashing through the floodwall during Katrina. Alternatively the barge could have floated in after the levee and floodwall were breached. Note the barge in the photo above. Note also that at the time of this photo water was running out of the Lower Ninth Ward back into the Industrial Canal. (Source - Vincent Laforet, AFP/Getty Images)

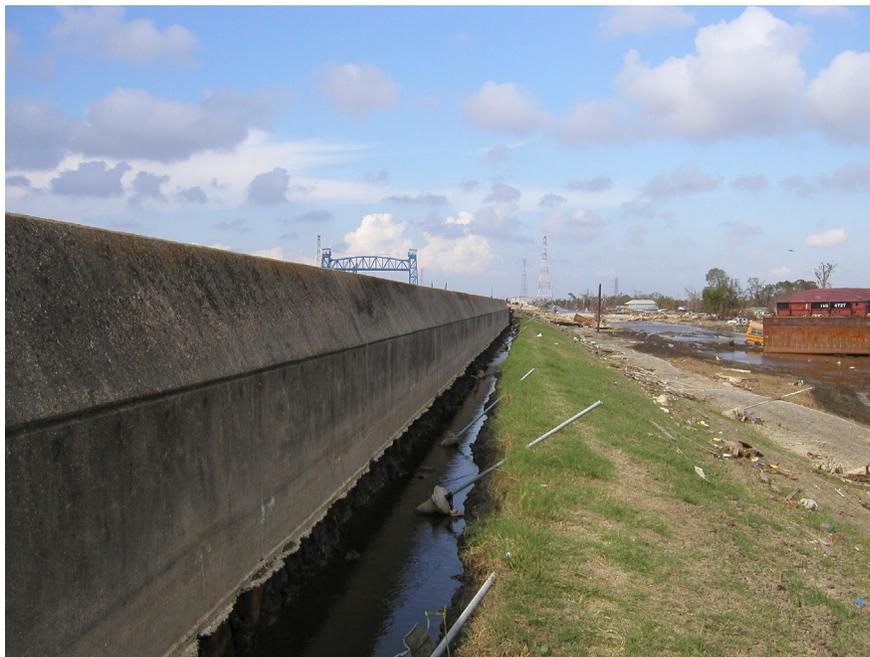
Photographs available on the U.S. Army Corps of Engineers, Interagency Performance Evaluation Task Force (IPET) web site and reproduced in Figure 11, show that along portions of the floodwall that did not fail, water flowing over the top of the floodwall eroded trenches on the protected side of the levee. It is likely that this erosion eventually removed enough support on the protected side that the floodwalls and their underlying sheet piling eventually toppled into the protected side of the canal sending a huge surge of water into the Lower 9th Ward. This occurred at two places along the Industrial Canal levee. The shorter (about 200 foot-long) breach occurred just to the south of Florida Avenue and the longer breach (approximately 1,000 feet long) occurred between N. Galvez and N. Roman Streets (Figures 9 & 10). In both cases, the rush of water was forceful enough to lift houses off their foundations and float them around until they collided with other houses and either came to rest or broke apart to form piles of rubble. The floodwall and underlying sheet pilings were strewn

Figure 11. Looking North along the floodwall of the Industrial Canal levee showing trenches eroded by water from the Industrial Canal that overtopped the floodwall. Photo from U.S. Army Corps of Engineers IPET web site, taken October 4, 2005.

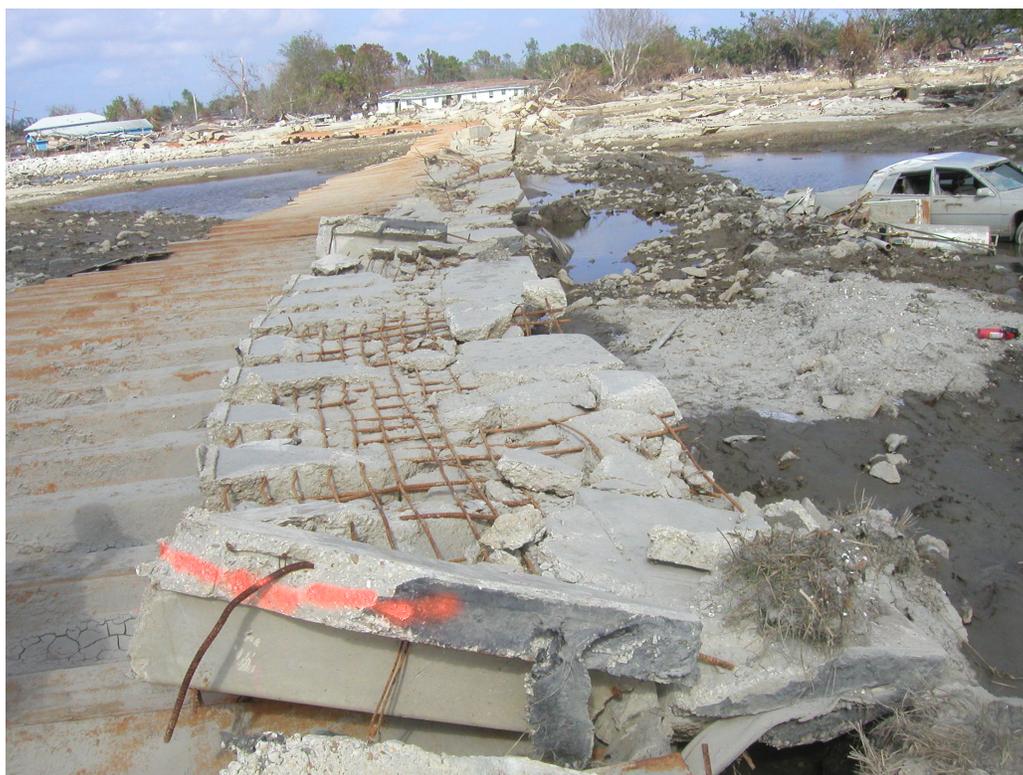
into the first block of the Lower 9th Ward like a ribbon (Figure 12). Figure 13 shows a possible failure mechanism for the floodwall and levee along the industrial canal.

Figure 12. Floodwall and sheet piling strewn into Lower 9th Ward at the southern (larger) breach on the Industrial Canal. Photo from U.S. Army Corps of Engineers IPET web site, taken October 4, 2005.

If the field trip is going to Alternate Stop A, in the Lower 9th Ward, we can see into, but not enter, the breach repair. All of the broken floodwall and most of the remaining floodwall have been removed as of mid-February, 2006, and a new floodwall is being constructed as of mid-March. Most of the streets have been cleared, but many displaced cars, the rubble piles of former homes, and foundations of many homes remain, clearly showing the force of the floodwaters that poured through the breach. The barge that went through the breach was being removed as of March 1, 2006.

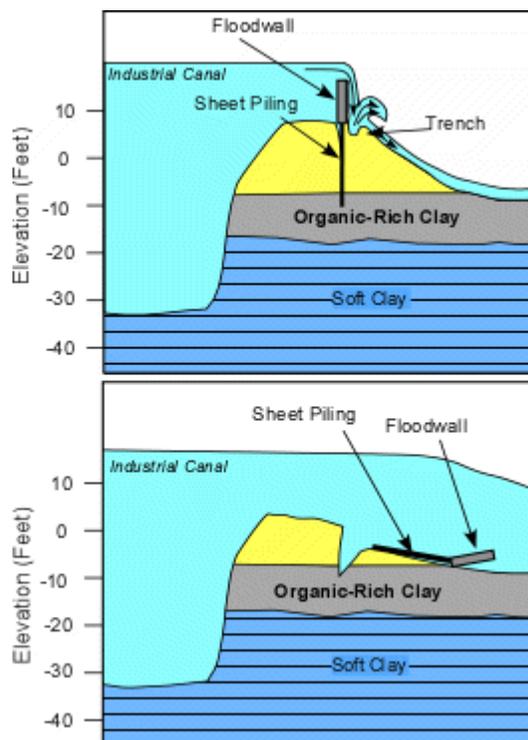
It is important to note that levees in St. Bernard Parish, New Orleans East, and along the Industrial Canal failed because the water from the storm surge was high enough to overtop these levees. In short, the levees were just not high enough to offer protection from a storm of this magnitude. Furthermore, along the east side of the Industrial Canal, the fact that the levees were not armored to protect against erosion from water flowing over the top of the floodwall, coupled with the poor design of the floodwall/sheet piling system, led to catastrophic failure of the floodwall and levee.

Sand is a highly permeable material. This means that water can easily be transported between the sand grains, especially when the weight due to overlying water is increased due to the added height of the water column during a storm surge. This increases the pressure and could force the water through the pore spaces in the sand and back up to the surface on the other side of the levee. If enough flow takes place the sand will be picked up by the flowing groundwater and eventually form an underground channel. This could undermine the levee and cause it to collapse. The principle is illustrated in Figure 17 with a simple thought experiment. The underflow (called seepage or siphoning) is the apparent cause of the collapse at this section of the London Ave. Canal. The “As built” design specifications indicate that the sheet pilings (which should form an impermeable barrier to pressure induced flow in the sand) were placed to a depth of 14 feet below sea level (U.S. Army Corps of Engineers, 1994 and IPET web site), one can see from the cross section in Figure 18, that the water still has a path back to the surface if it flows as groundwater beneath the sheet pilings. Note that in order to prevent such siphoning, the sheet pilings would need to be placed to a depth of about 50 feet below sea-level where they would penetrate a layer of clay.

Figure 13. Possible failure mechanism at the Industrial Canal Levee breach in near the Lower 9th Ward.

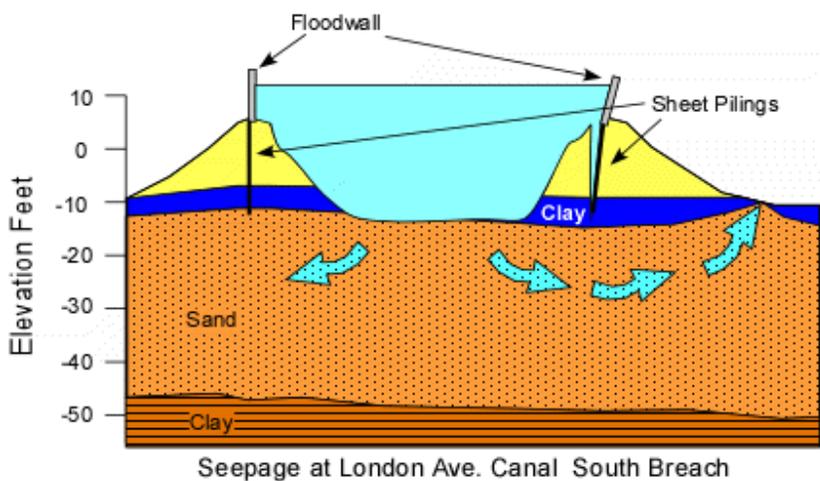
Figure 18. Geological cross section across the London Ave. Canal based on borings 16 and 51 (Figs. 15 and 22), shown at time of estimated high water during Katrina’s storm surge. The sands form a permeable layer through which groundwater originating in the canal can penetrate and move below the sheet pilings and up to the surface, eventually undermining the levee and leading to its collapse.

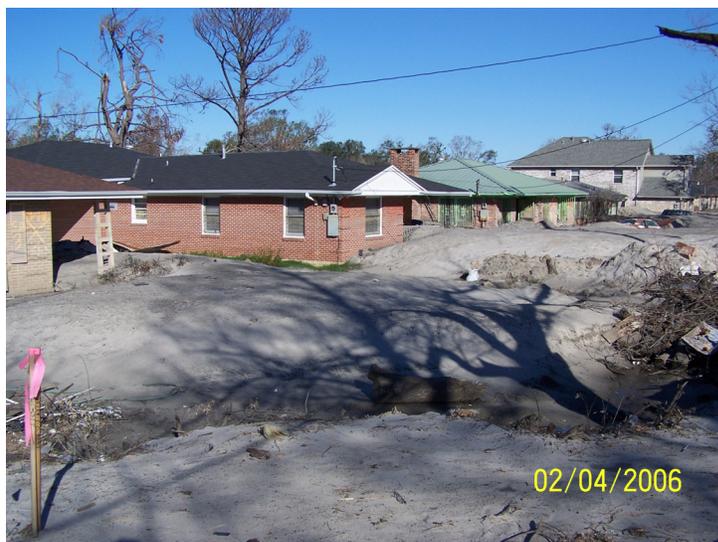
Notice the large deposits of sand that occur throughout the neighborhood. As of March 1, 2006 most of the sand has been removed from in front of the houses, but much remains in their back yards. The sand in these deposits did not originate from the canal water or lake water that was pushed into the canal during Katrina. Instead, it appears to have originated from beneath the levee. A geologic cross-section constructed from data on soil borings (done in 1986) (U.S. Army Corps of Engineers, 1989) from the banks of the London Avenue Canal is shown Figure 16. The cross-sections clearly show the presence of sand at a depth beginning between 10 and 15 feet below sea level. This sand is the same Pine Island beach sand that was deposited in the area between 4,000 and 5,000 years ago as shown in Figures 2 and 3.

Figure 19. Sand deposits on Warrington drive showing deposition in the wake of houses as the currents flowed down the driveways between the houses. As of March 1, 2006, most of the sands deposits have been removed.

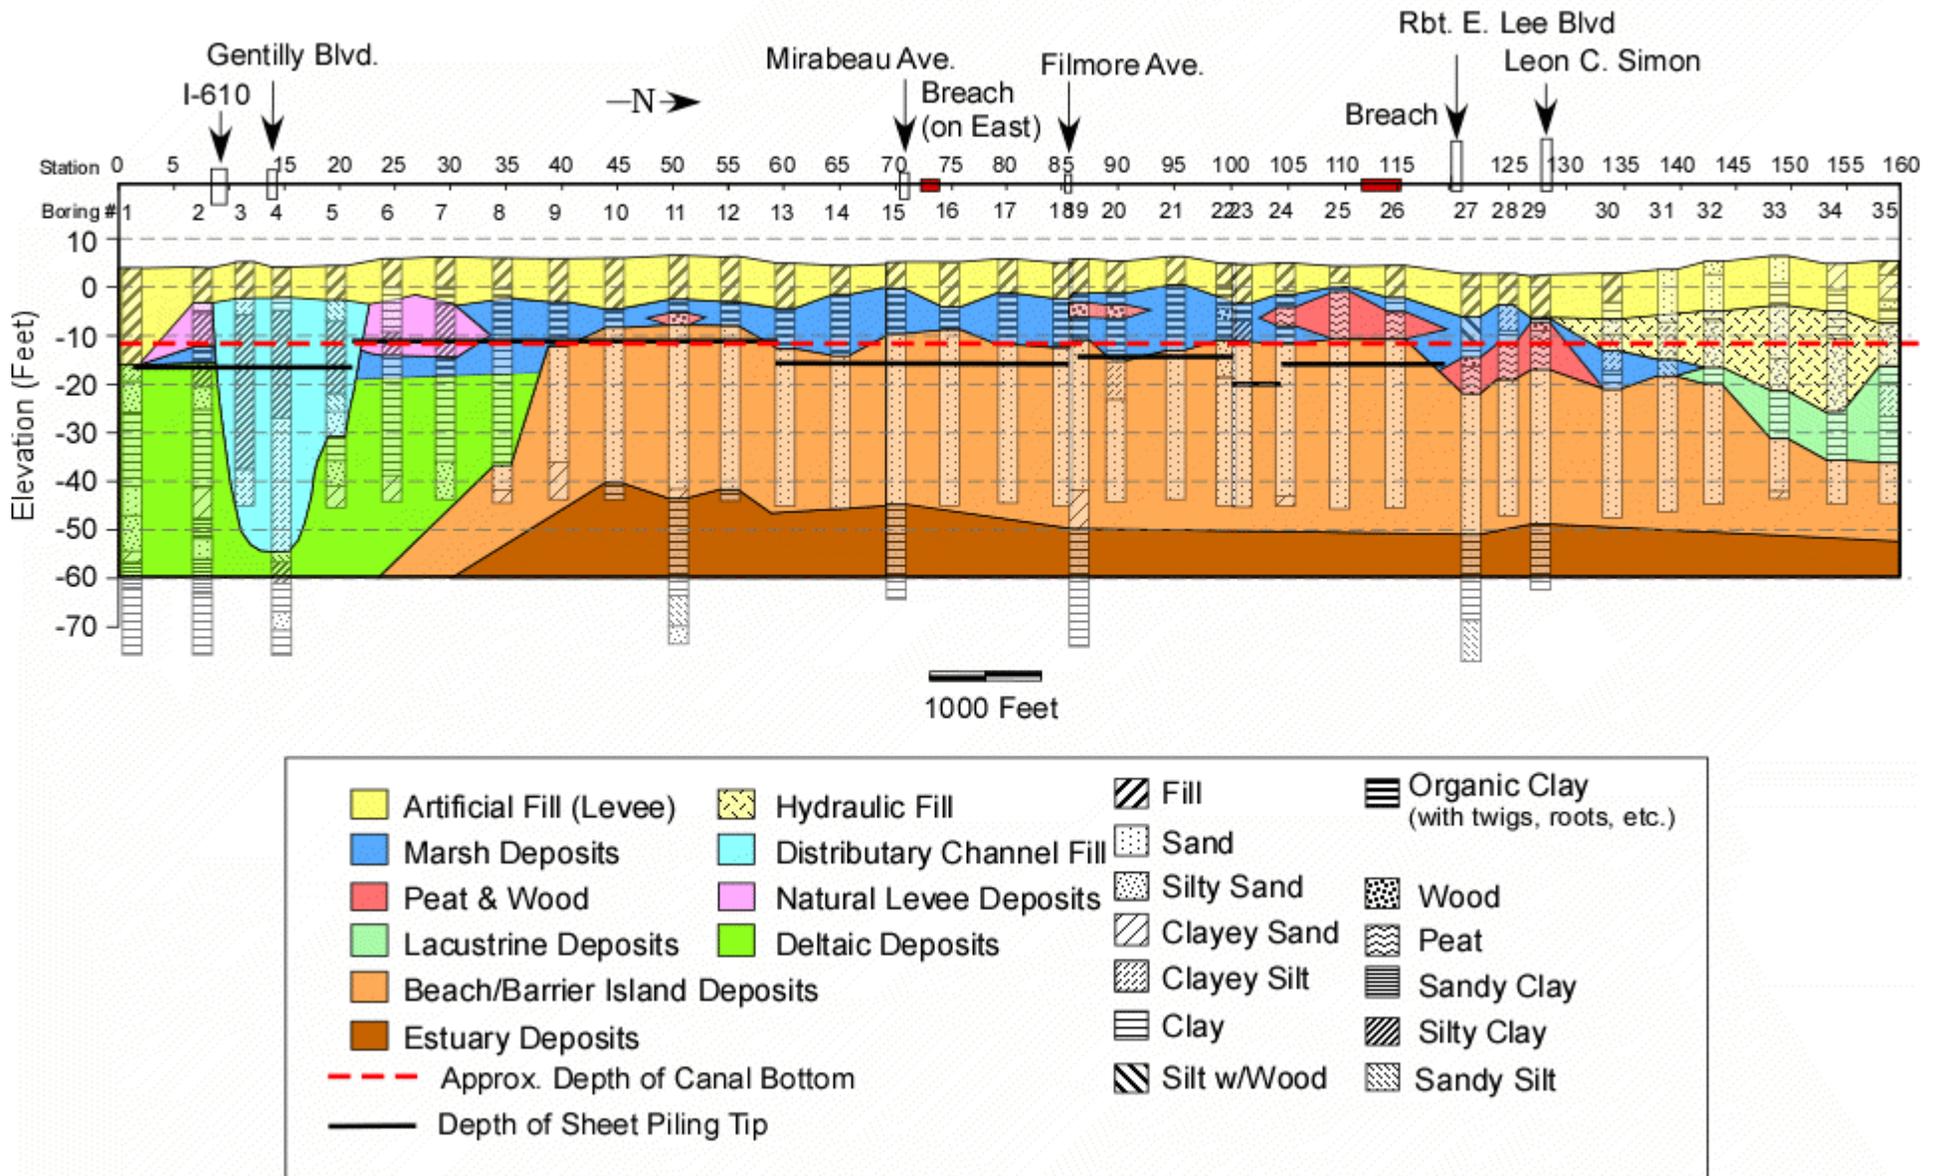
Due to changes in construction activity at the breach, we may or may not be able to walk into the breach. The breach is about 400 feet wide. A geologic cross section of the west side of the levee is shown in Figure 23. Note that the conditions beneath the surface are similar to those at the Mirabeau Ave. breach, with a sand layer about 12 feet below sea-level. Here a peat layer is also observed. Peat is organic matter (vegetation that is in the process of decay). It represents material accumulated in swampy areas and indicates that this area was a swamp in the not too distant past. Peat is very porous and has the additional property that it shrinks when it is dried out and expands when water is added. The presence of peat can make for very unstable soil conditions.

Although the “as built” design documents (U.S. Army Corps of Engineers, 1994) show that the depth of the sheet pilings were at 14 feet below sea-level, water still had access to the peat layer and thus the peat layer could have played a role in the collapse of the levee. Another phenomenon that was observed here was that of ground heave in the area of collapse. Water, and perhaps expanding peat, apparently pushed up the levee and land surface on the west side of the canal prior to collapse of the levee. This is illustrated in Figures 24 and 25. Although the clubhouse shown in figure 24 has been removed during the repair of the levee, the house (with the mispositioned air conditioner compressor) is the 5th house south of Robert E. Lee Blvd. on Pratt Drive.

A short walk down Pratt Drive or along the levee breach reveals the presence of thick bodies of sand scoured from the bottom of the canal. These deposits are similar to the ones observed at the Mirabeau Ave. breach, but also contain blocks of peat as expected from the geologic cross sections shown in figure 23.

Figure 23. Geological cross-section along the west side of the London Avenue Canal constructed from data in U.S. Army Corps of Engineers (1989).

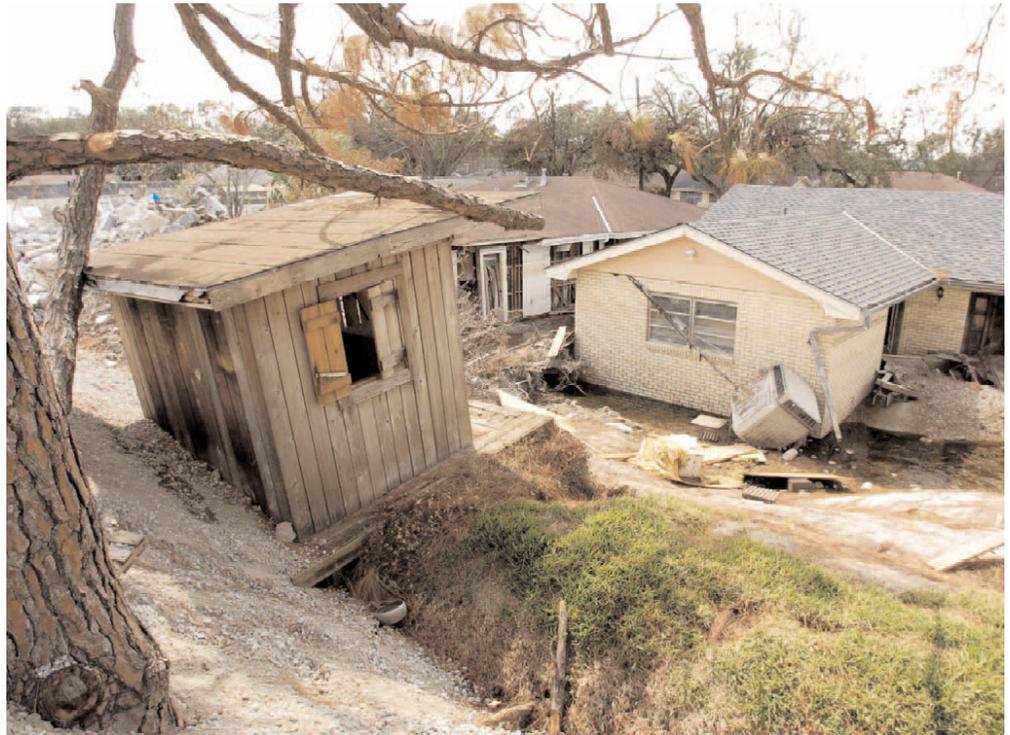
Figure 25. Water driven through sand under the sheet pilings (and possibly through peat, depending on the depth to which the sheet pilings actually were driven) pushes up the ground outside of the canal in a phenomenon known as heave. This could eventually provide a flow path for water which would undermine the levee and cause its collapse. This may have been responsible for the eventual collapse of the floodwall resulting in the breach.

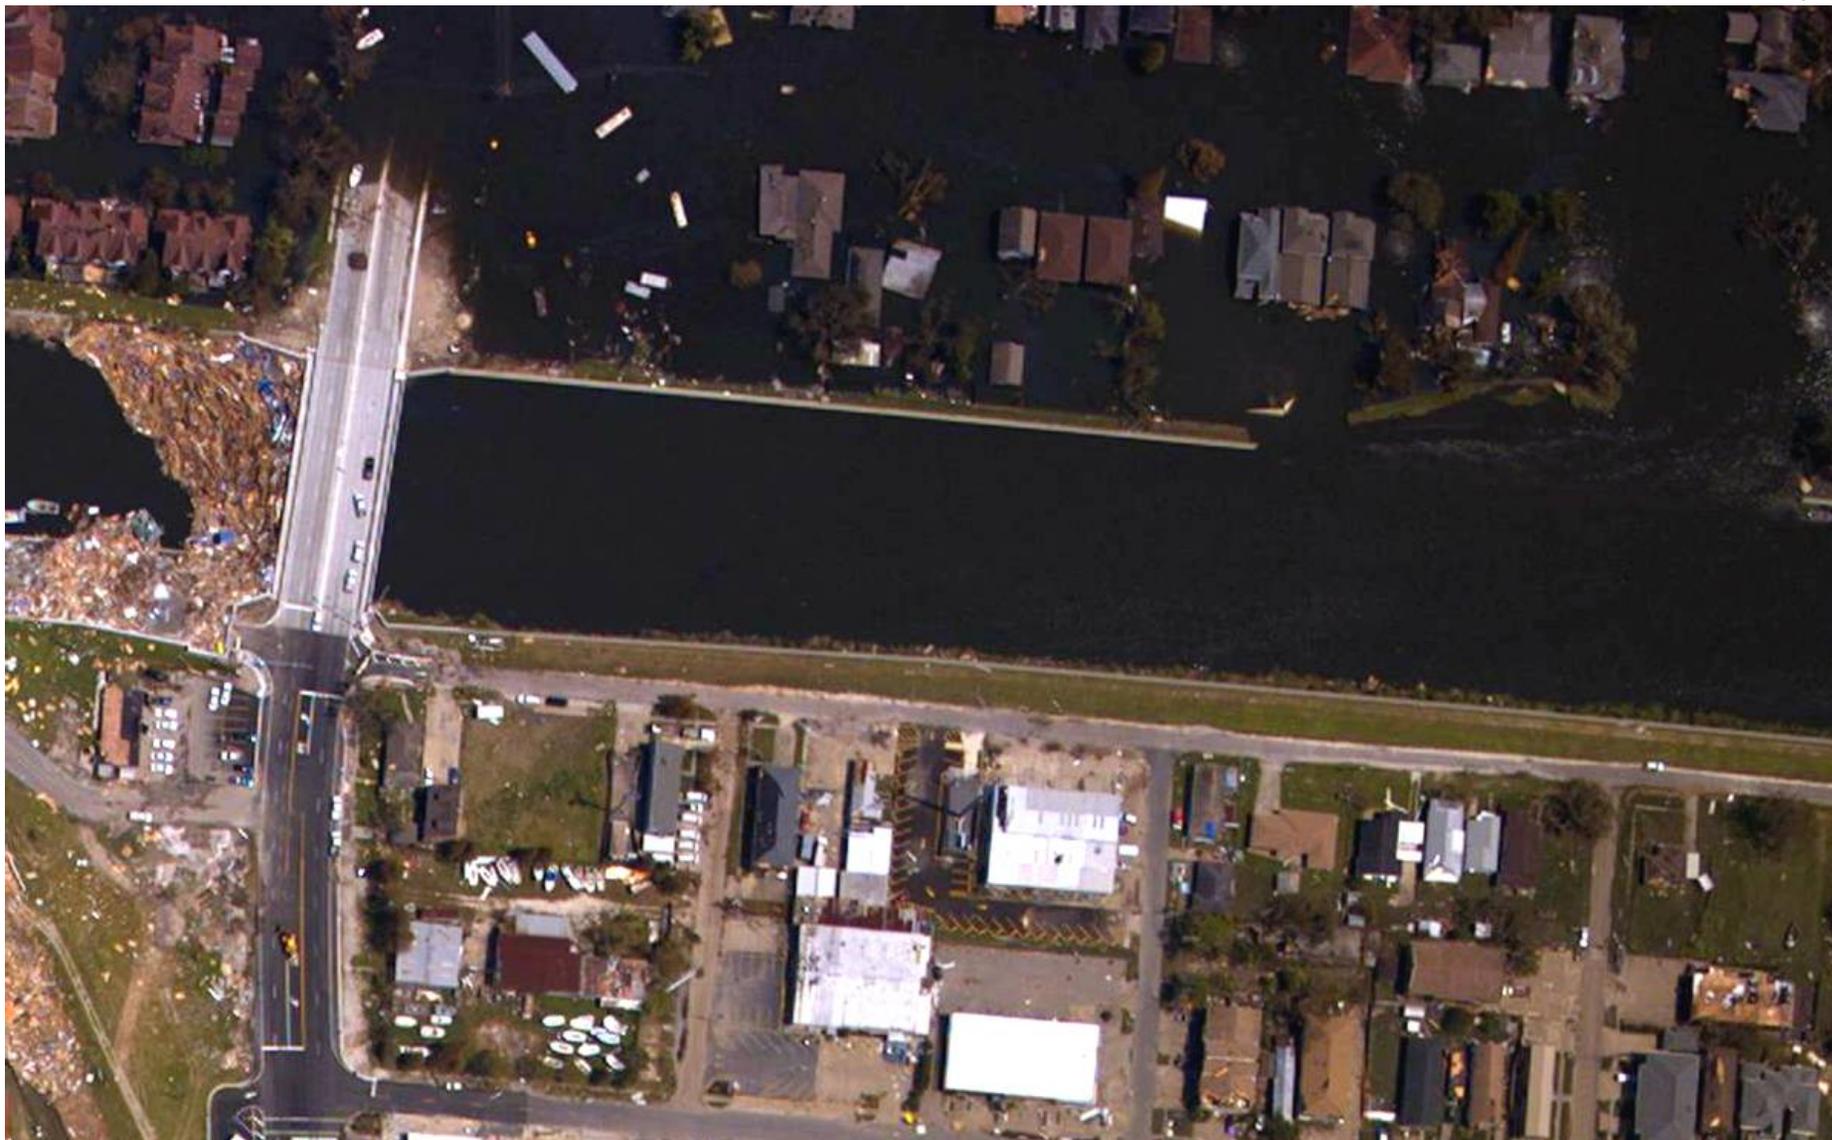
Note that the breach occurred along Belaire Drive where, like the along the London Avenue Canal, houses are backed up against the levee. Here, the main part of the breach occurred in a recently cleared empty lot. A house to the south of the main part of the breach, built on a chain wall foundation, was completely removed. Natural gas from a line that fed the house can be seen bubbling up through the floodwater. Another house to the north of the empty lot was built on a slab. The house was destroyed, but the slab remains.

Also visible in Figure 27 is a section of the levee that was displaced eastward by about 45 feet. Although the floodwall that once crowned this levee is either buried or has been removed during the emergency repair work, the chain-link fence that sat atop the levee is still visible. The area in front of the displaced levee was pushed horizontally outward near the position of the yellow school bus. The toe of the slide is still visible and numerous blocks of peat can still be found in the area of the slide.

Figure 27. Air photograph of the area where the 17th Street Canal Levee was breached near Belaire Drive (stop 4). Image acquired Aug. 31, 2005. Source: National Oceanic and Atmospheric Administration's National Geodetic Survey, Katrina Images - <http://ngs.woc.noaa.gov/katrina/>

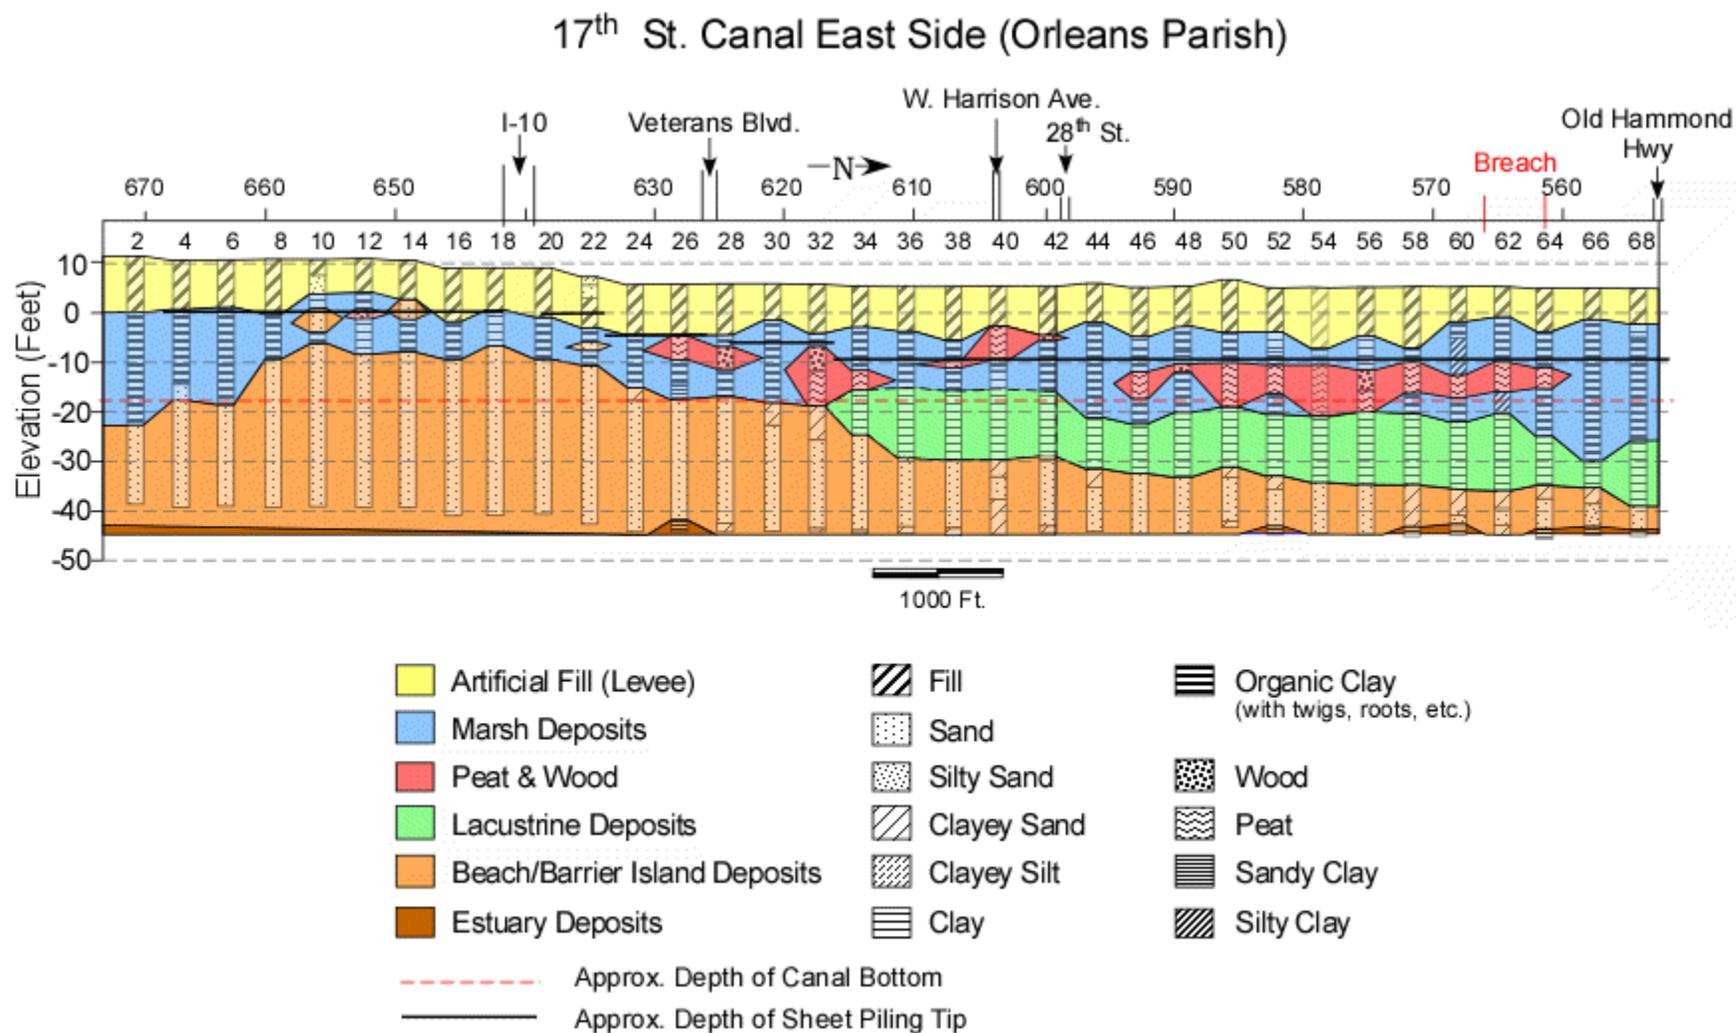
Figure 28. Geological cross-section along the eastern side of the 17th St. Canal (based on data in the U.S. Army Corps of Engineers design documents (1990). Notable in the cross-section is the peat layer that occurs in the area of the breach.

Figure 28 shows a geological cross section along the levee of the 17th street canal. The most notable feature of the cross section is the peat layer observed at depths between about 8 and 15 feet below sea level in the area of and to the south of the breach.

A series of articles in the Times Picayune, by John McQuaid, Bob Marshall, and Mark Schleifstein, and Shiela Grissett (see references section) discuss the role of the peat layer, the possible design flaws, and the possible mistakes made during the construction of the 17th St. Canal levee and floodwall system. Figure 28 summarizes the possible cause of failure. Although initial seismic tests performed on the sheet pilings suggested that they were only driven to a depth of 10 feet below sea level (Marshall, November 9, 2005; Olson Engineering, 2005), when sheet piles immediately adjacent to the breach were pulled they were shown to be at the design specification of 17 feet below sea level (Schleifstein, December 13, 2005); Schleifstein and Marshall, December 14, 2005; Marshall, December 19, 2005). Even at this depth, the sheet pilings would not have been deep enough to prevent failure (Marshall, November 30, 2005 & December 30, 2005), and were not even as deep as the bottom of the canal.

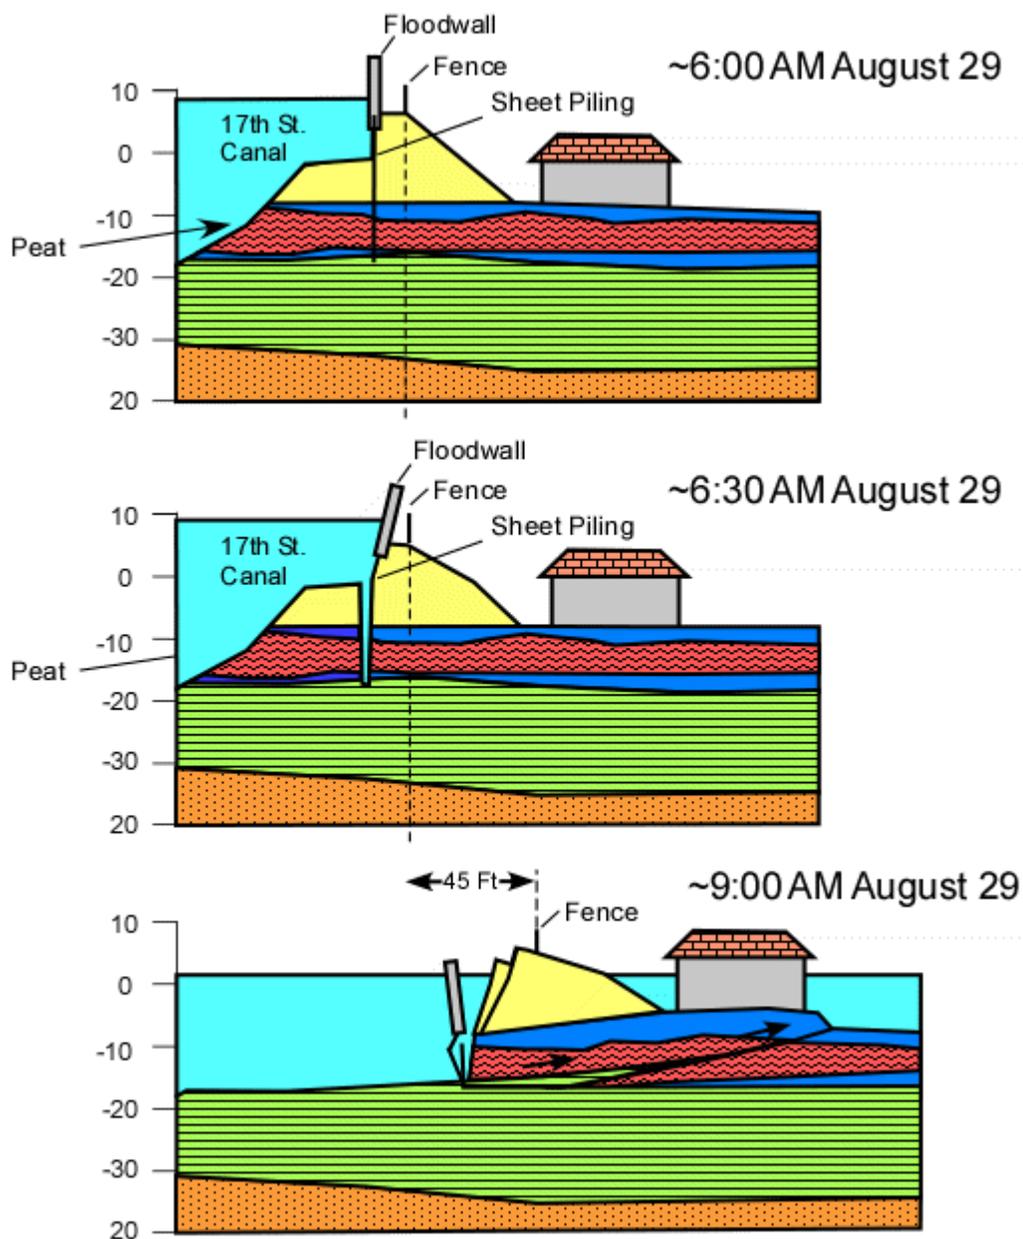
Failure of the 17th St. Canal Levee & Floodwall

The most recent information from the Interagency Performance Evaluation Task Force (IPET) [2006] suggests that the floodwall and levee failed at the 17th St. Canal as a result of water level rising to an elevation of about 8 feet above sea level in the canal. The floodwalls were designed to have tops at an elevation of 14 feet above sea level, but IPET data indicate that by the time of Katrina the tops of the floodwalls on the 17th Street Canal were about 12.5 feet above sea level. Thus, IPET estimates that water levels in the canal were still 4 feet below the tops. IPET has collected eyewitness accounts and scoured the neighborhood for clocks that were stopped as a result of the flooding in order to determine the time of the breach. One eyewitness account suggests that the floodwall at the breach area was leaning to the protected side at about 6:30 AM on August 29 and other accounts suggest that the breach was open by about 9:00 AM. This along with levee breach experiments conducted scale models in a large centrifuge led IPET to suggest that as water levels rose in the canal, the floodwall and sheet piling was pushed outward toward the land side, opening a gap between the levee and the floodwall on the canal side. This gap allowed water to seep down along the sheet piling and eventually push the levee on the protected side outward away from the canal. Based on sections of the breached levee observed in the breach area, IPET suggests that the failure did not occur along the peat layer, but along a layer of weak clay at the base of the peat. This clay layer was thrust over and through the peat as illustrated in Figure 29.

Figure 29. Diagrammatic cross sections across the 17 the Canal in the vicinity of the breach (based partially on a sketch in Seed and others [2005] and IPET (2006).

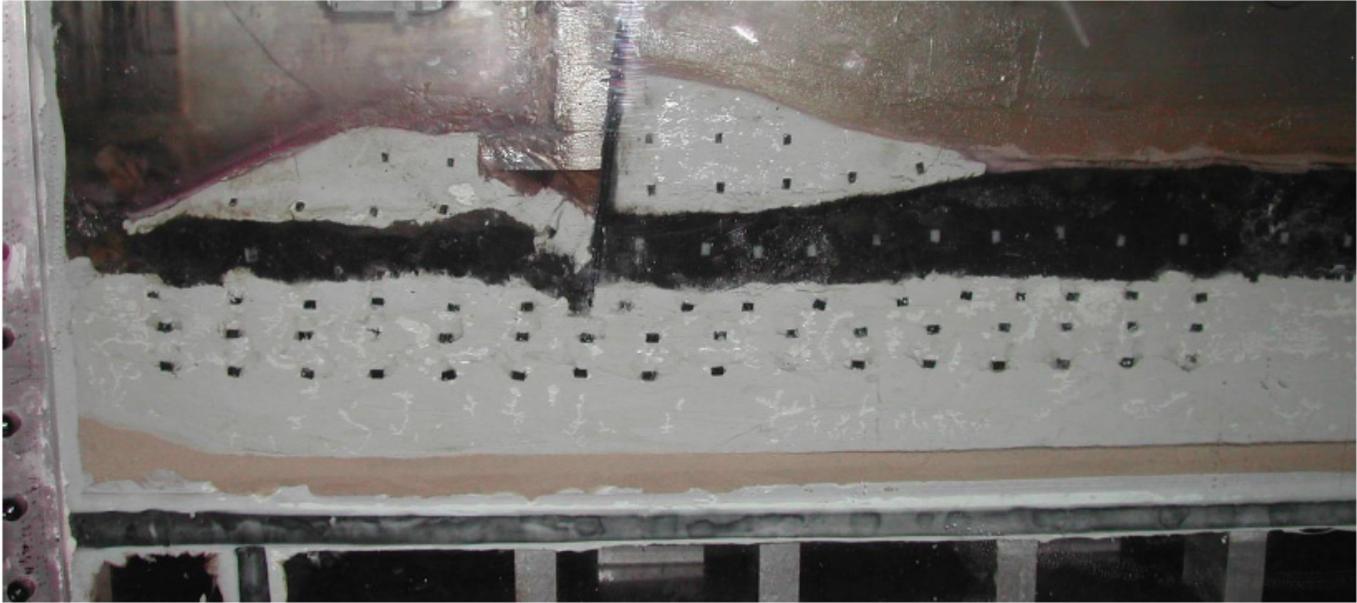
A photograph of the end result of IPET's scale model centrifuge experiment is shown in Figure 30. The canal side (on the left in the photograph) next to the sheet piling is seen to have dropped down as a result of the floodwall moving toward the right (toward the protected side). Indeed in the end result of the experiment, the levee, peat layer, and upper part of the underlying clay layer all have moved to the protected side. Viewing the complete video of the experimental run (<https://ipet.wes.army.mil/>), however, shows that the initial failure occurred either in the peat layer or at the peat – clay interface, and only when the sheet pile started to move to the right, away from the canal, did the upper part of the clay layer also move. Furthermore, the only part of the

clay layer that moved was the part immediately in front of the tip of the sheet pile, and it only moved because it was being pushed along by the sheet pile.

Figure 30. Photograph of failed levee and floodwall in IPET's scale model centrifuge experiment representing the 17th St. Canal. The white at the top is clay and represents the levee. This overlies the dark peat layer, which in turn overlies another white clay layer meant to represent the estuary deposits beneath the peaty marsh deposits. Small rectangles were initially layed out in a rectangular grid and can be used to determine how much deformation has occurred during the experiment. (IPET, 2006).

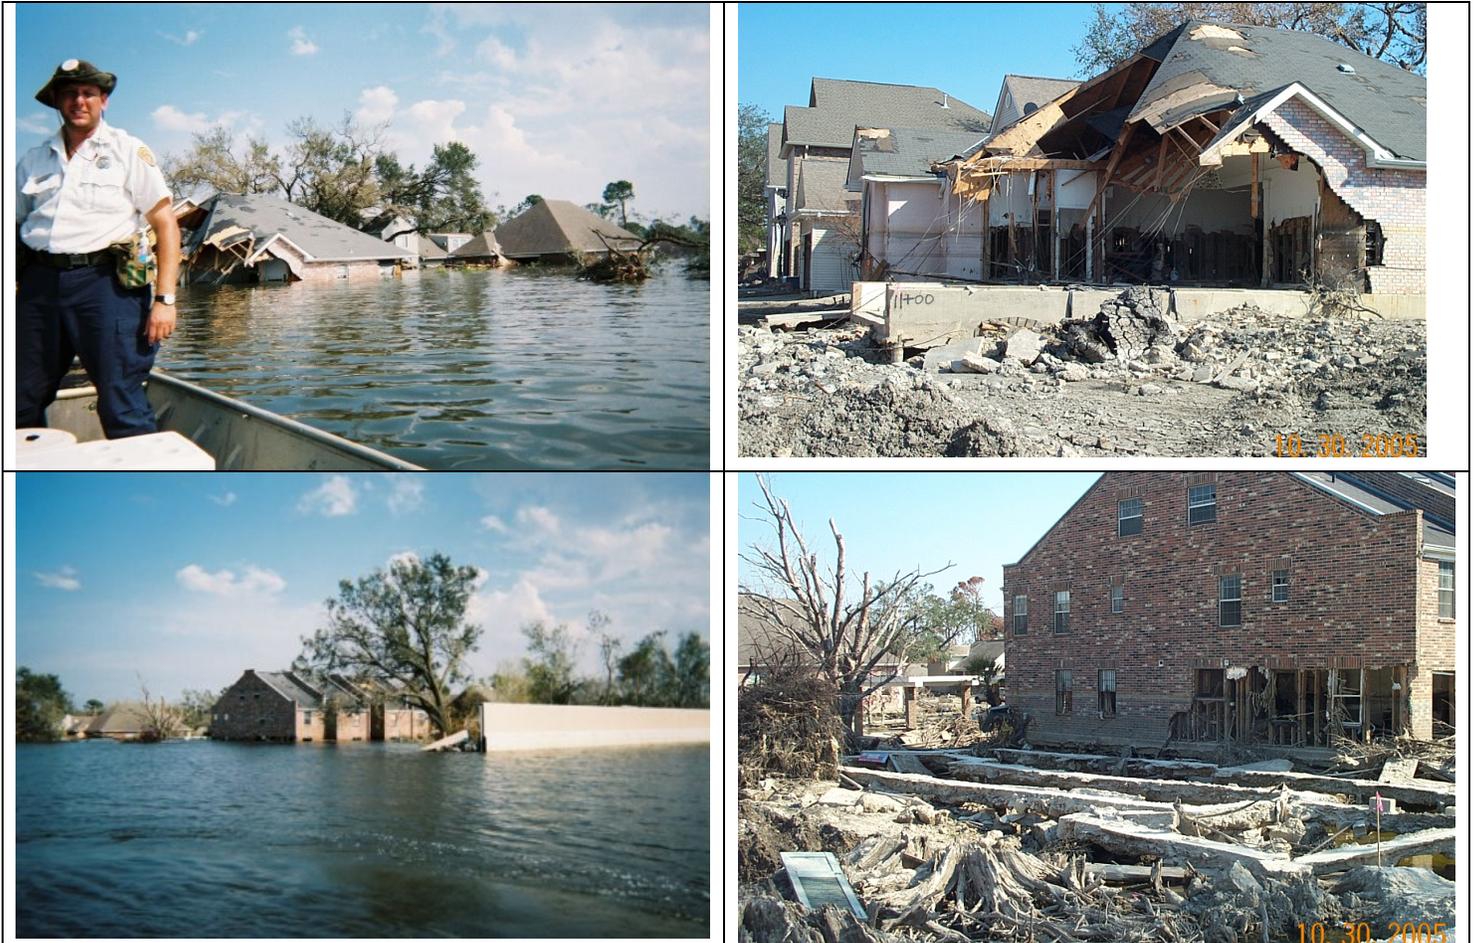
Although throughout the field trip we have seen the water line (scum line) left by standing water, this line does not represent the maximum flood depth. As seen in Figure 31, comparison of the photos on the left, taken when the water level was near its maximum with the water line left on the same structures (photos on the right) indicate that the maximum flood depth was about 1.5 to 2 feet higher than the line left by standing water.

Figure 31. Comparison of water levels on Sept.1, 2005 (photos on left by Kevin Himmel), with water lines on same structures indicate lines left by standing water are about 1.5 to 2 feet lower than the maximum water level.
