Hurricane Katrina - What Happened?

Tulane University
Field Trip
August 5, 2006

Levee Breaches in New Orleans during Hurricane Katrina

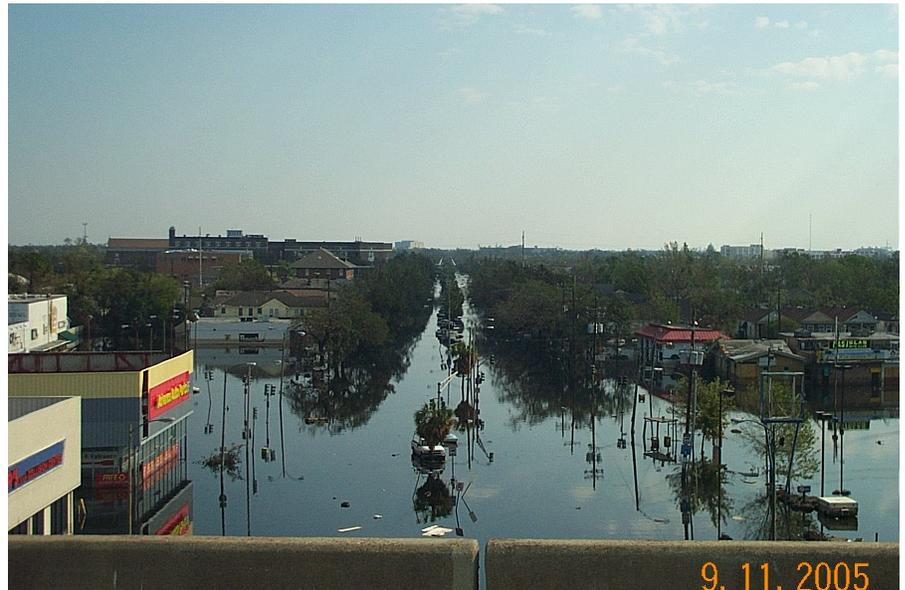
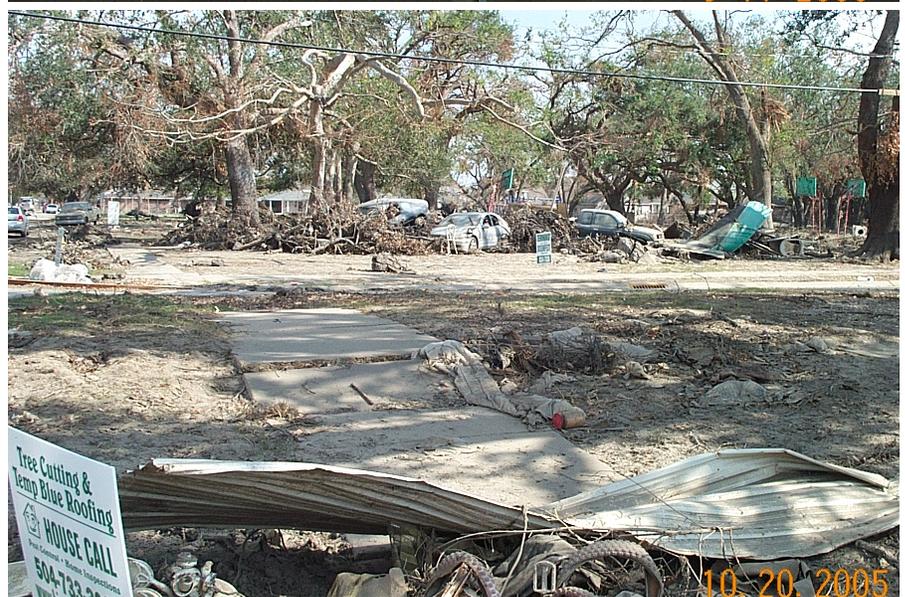
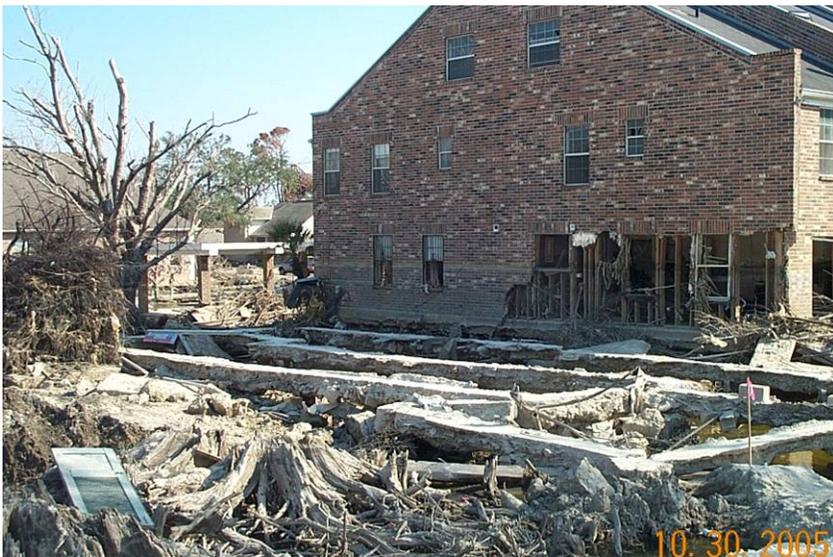
Photos - Top - looking north from I-10 overpass over Carrollton Ave. Middle - cars and other debris in park on Fleur de Lis near 17th St. Canal breach. Bottom - missing house and Cyprus stumps at 17th St. Canal Breach (photos by Stephen Nelson)

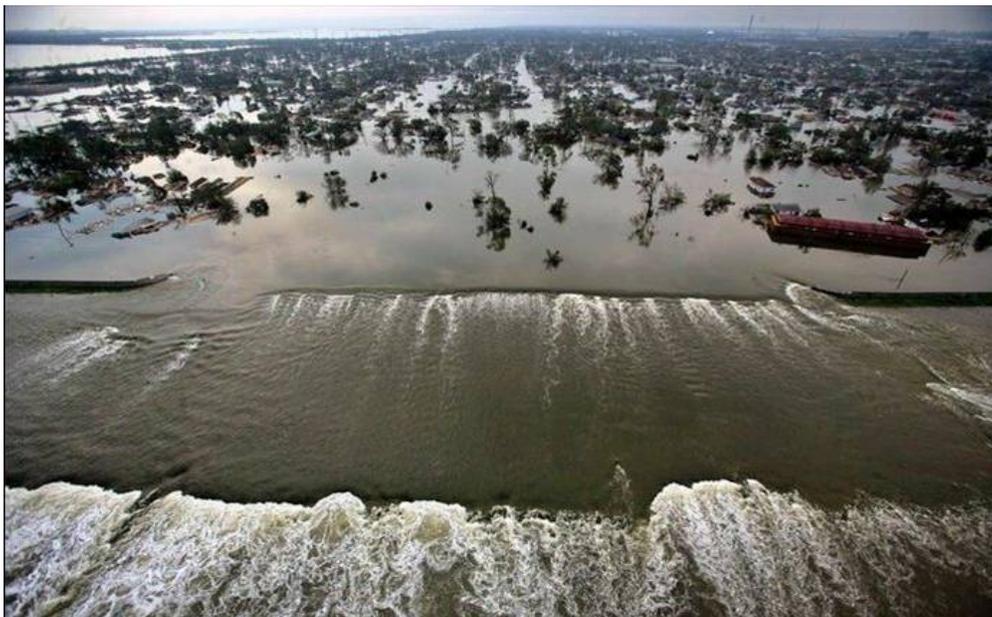
Figure 8. The large breach in the Industrial canal that flooded the Lower Ninth Ward could have been caused by a barge crashing through the floodwall during Katrina. Alternatively the barge could have floated in after the levee and floodwall were breached. Note the barge in the photo above. Note also that at the time of this photo water was running out of the Lower Ninth Ward back into the Industrial Canal. (Source - Vincent Laforet, AFP/Getty Images)

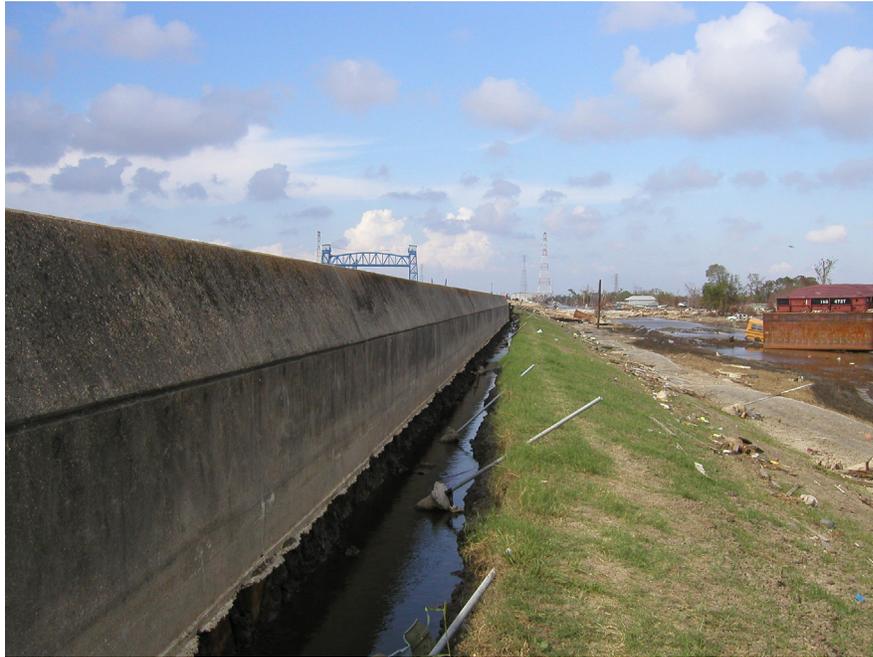
Photographs available on the U.S. Army Corps of Engineers, Interagency Performance Evaluation Task Force (IPET) web site and reproduced in Figure 11, show that along portions of the floodwall that did not fail, water flowing over the top of the floodwall eroded trenches on the protected side of the levee. It is likely that this erosion could have removed enough support on the protected side that the floodwalls and their underlying sheet piling eventually toppled into the protected side of the canal sending a huge surge of water into the Lower 9th Ward. Levee/Floodwall failures occurred at two places along the Industrial Canal levee. The longer breach (approximately 1,000 feet long) occurred between N. Galvez and N. Roman Streets (Figures 8, 10, & 13). The shorter (about 200 foot-long) breach occurred just to the south of Florida Avenue (Figures 10 & 14).

Figure 11. Looking North along the floodwall of the Industrial Canal levee showing trenches eroded by water from the Industrial Canal that overtopped the floodwall. Photo from U.S. Army Corps of Engineers IPET web site, taken October 4, 2005.

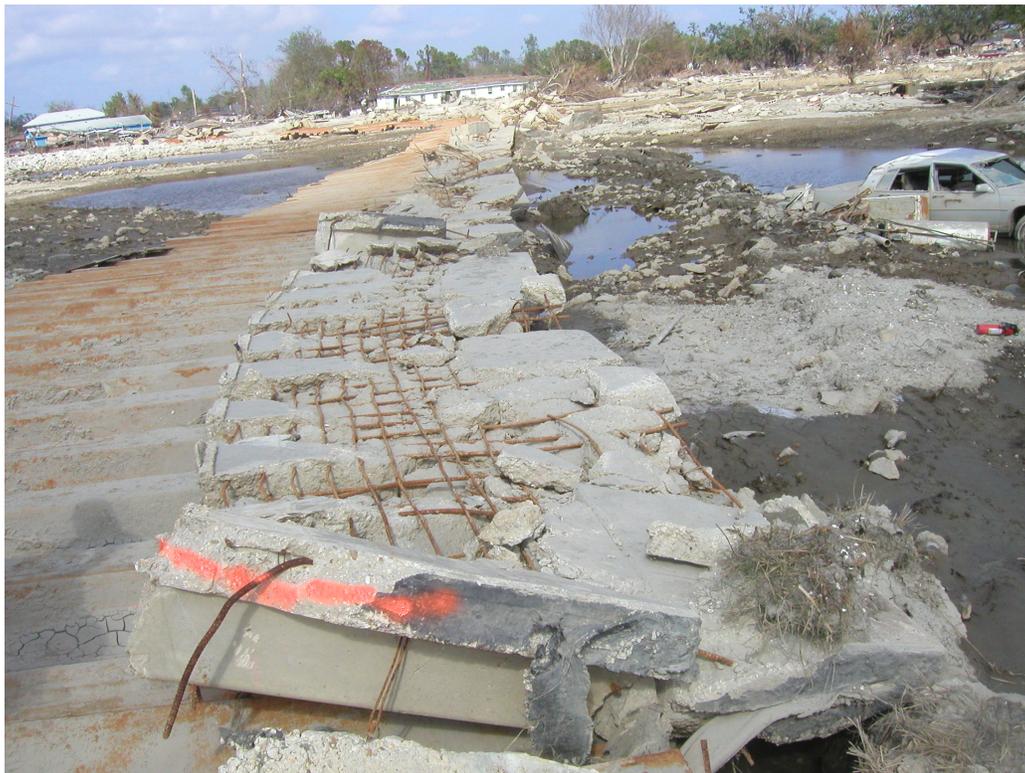
In both cases, all houses were removed in the areas immediately in front of the breaches (Figures 10 & 12, 13 & 15) and in areas between the breaches the rush of water was forceful enough to lift houses off their foundations and float them around until they collided with other houses and either came to rest or broke apart to form piles of rubble (Figure 10). The floodwall and underlying sheet pilings were strewn into the first few blocks of the Lower 9th Ward like a ribbon (Figures 12, 13, and 14).

Figure 12. Floodwall and sheet piling strewn into Lower 9th Ward at the southern (larger) breach on the Industrial Canal. Photo from U.S. Army Corps of Engineers IPET web site, taken October 4, 2005.

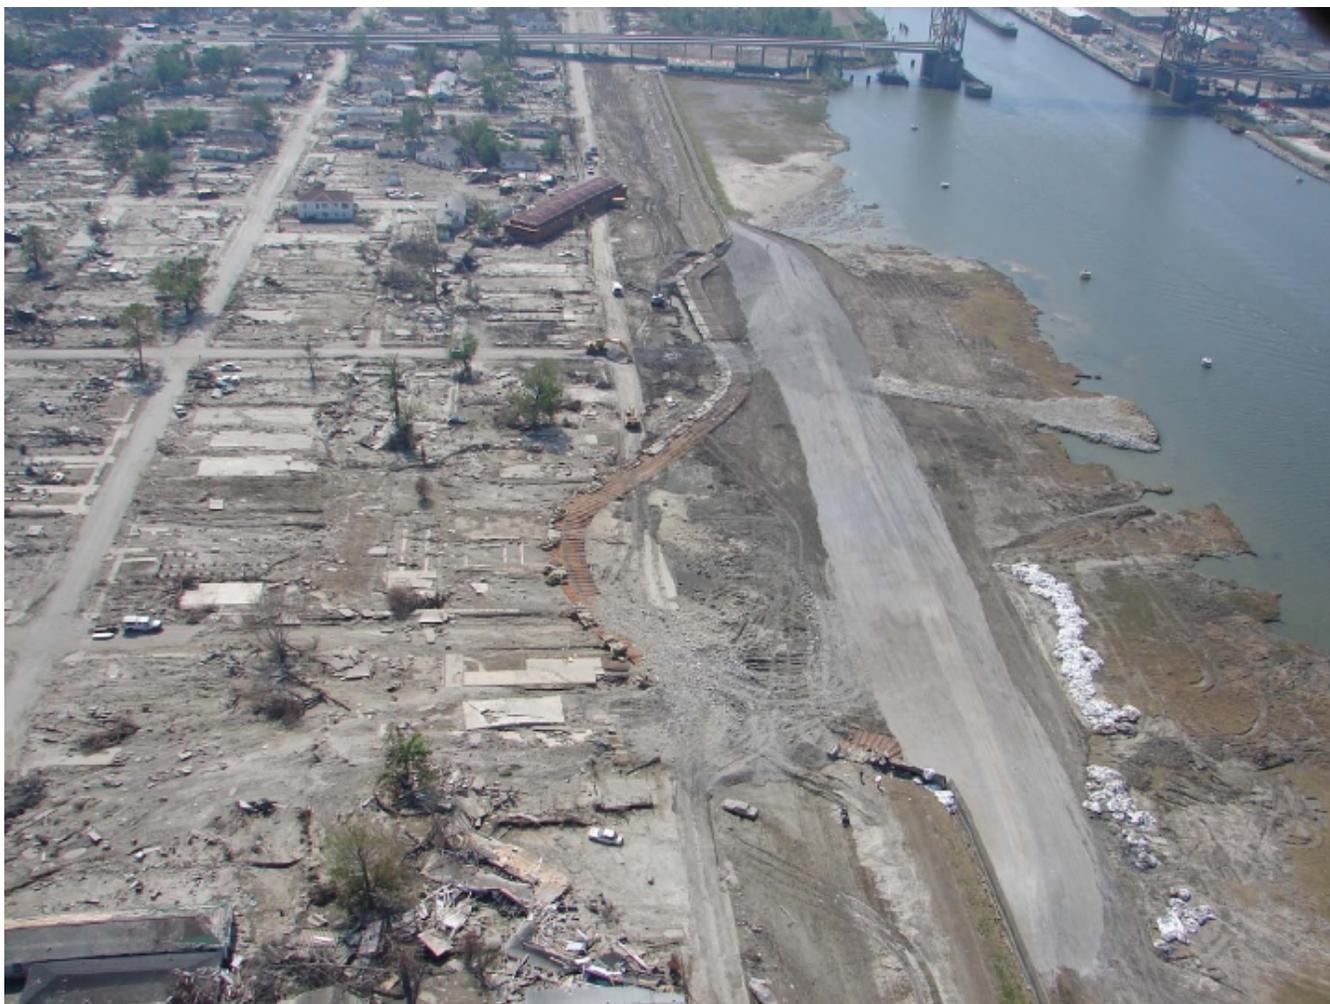
Figure 13. View of southern breach on the Industrial Canal, looking South. Note the floodwall and sheet piling (brown) strewn through the Lower Ninth Ward neighborhood where all houses were removed by the force of water coming through the breach. Gray deposits on right are breach repair gravels. Note barge near in the center near the top of the photo. Photo by L. Harder - Independent Levee Investigation Team Draft Final Report (2006).

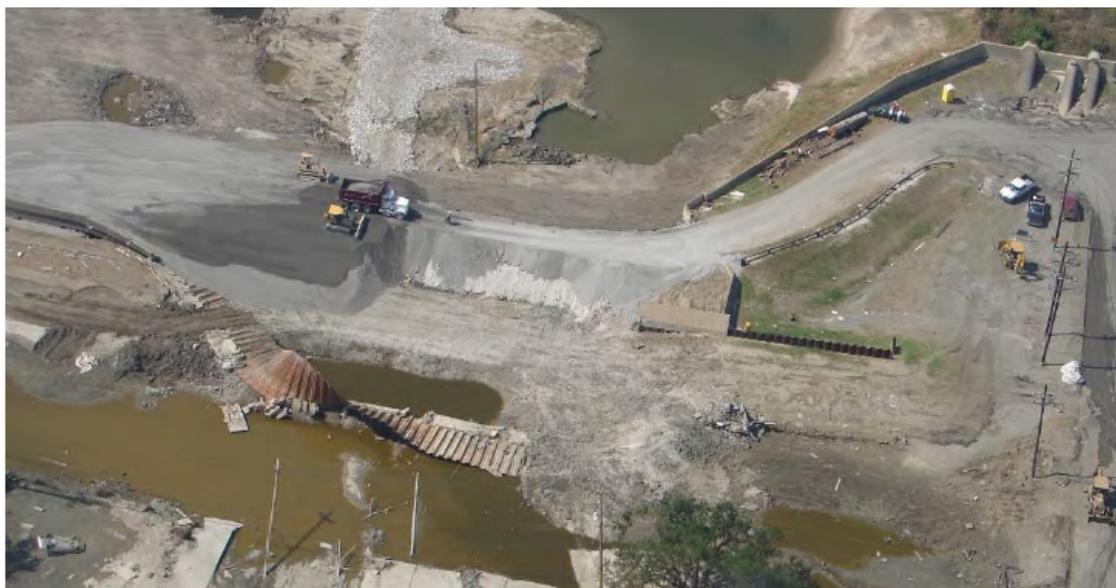
Figure 14. Aerial view of the north breach on Industrial Canal. Photo by L. Harder - Independent Levee Investigation Team Draft Final Report (2006).

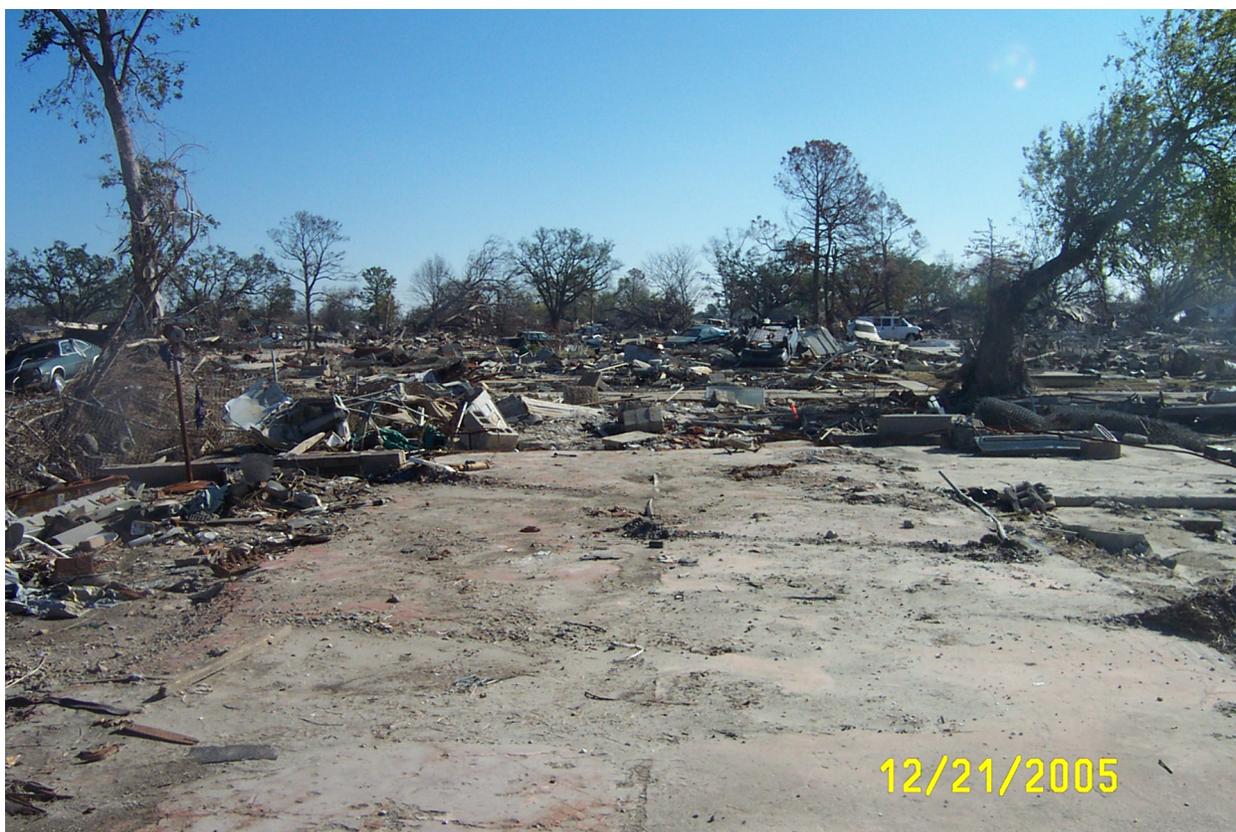
Figure 15. View of Lower Ninth Ward looking East as it appeared in December, 2005.

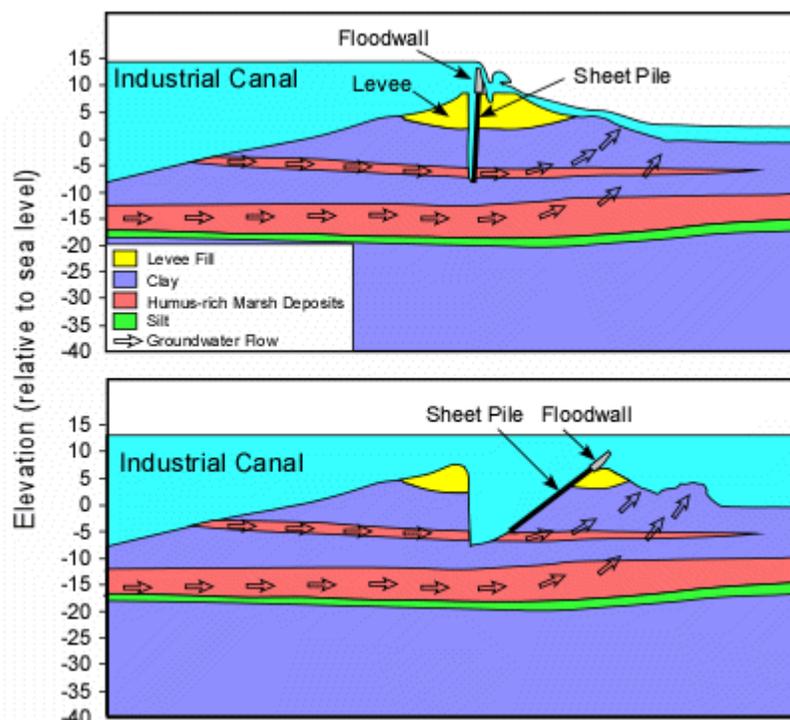
Although the Interagency Performance Evaluation Task Force (IPET, 2006) suggested that the main cause of failure here was the result of the surge waters in the Industrial Canal overtopping the flood wall and eroding away the levee on the protected side, the Independent Levee Investigation Team (ILIT, 2006) disputes this. They do agree that erosion of the levee on the protected side could have contributed, their analysis indicates that the geological conditions present in the subsurface along with the shallow depth to the tip of the sheet pilings resulted in hydraulic piping beneath the sheet pilings which undermined the levee and caused it and the floodwall to collapse. Two layers of highly permeable marsh deposits occur at a shallow depths below the levee. According to the analysis of ILIT (2006), the added pressure in the canal forced water through these permeable layers and out at the toe of the levee on the protected side (Figure 16), thus removing support for the floodwall and levee.

Figure 16. Possible failure mechanism at the Industrial Canal Levee breach in near the Lower 9th Ward

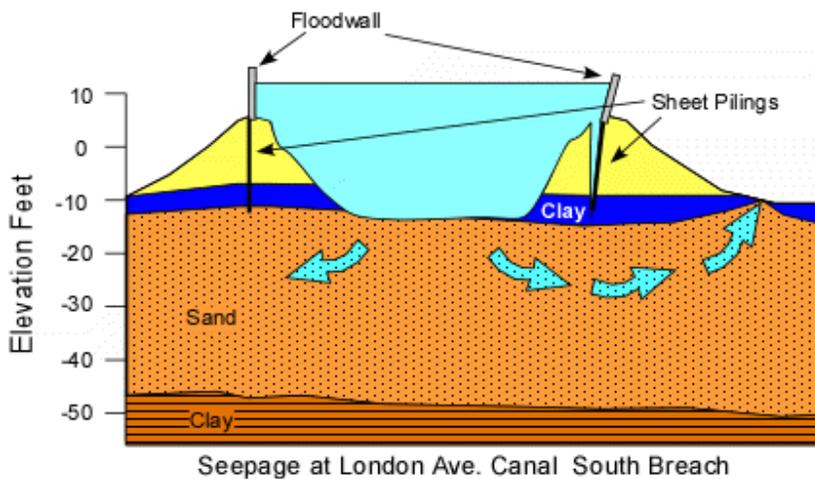
Figure 21. Geological cross section across the London Ave. Canal based on borings 16 and 51 (Figs. 19 and 26), shown at time of estimated high water during Katrina’s storm surge. The sands form a permeable layer through which groundwater originating in the canal can penetrate and move below the sheet pilings and up to the surface, eventually undermining the levee and leading to its collapse.

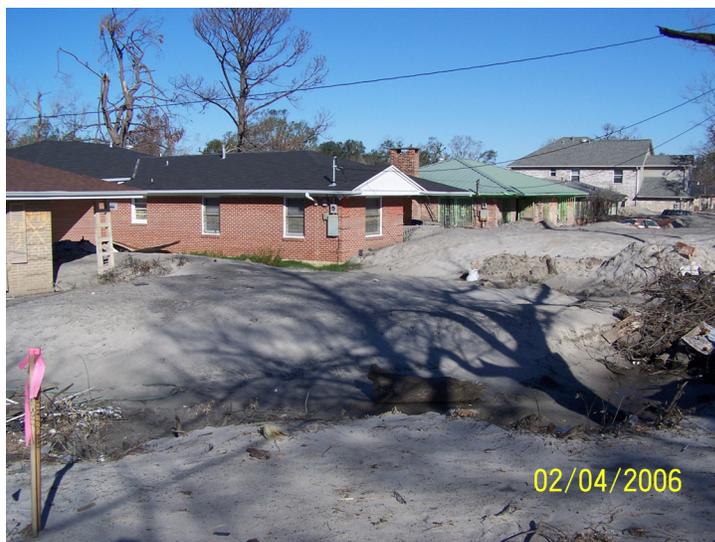
Figure 22 is a view looking down Warrington Drive before the sand deposits were removed in mid-February, 2006. Figure 23 shows my preliminary map of the extent of the sand that was likely scoured out of the bottom of the London Ave. Canal and deposited throughout the neighborhood. My preliminary estimate of the volume of sand deposited in the neighborhood is about 932,000 ft³. Such a volume would cover a football field, from end to end (including the end zones) with over 16 feet of sand. The volume is apparently larger than the hole produced by the breach, and thus scour must have occurred on the bottom of the canal, both upstream and downstream from the breach. The distribution and thickness of the actual deposit was controlled by current velocity and barriers such as houses, fences, and hedges. For more information on the sand deposits at this locality, see Nelson and Leclair (2006).

Figure 22. Sand deposits on Warrington drive showing deposition in the wake of houses as the currents flowed down the driveways between the houses. As of March 1, 2006, most of the sands deposits have been removed.

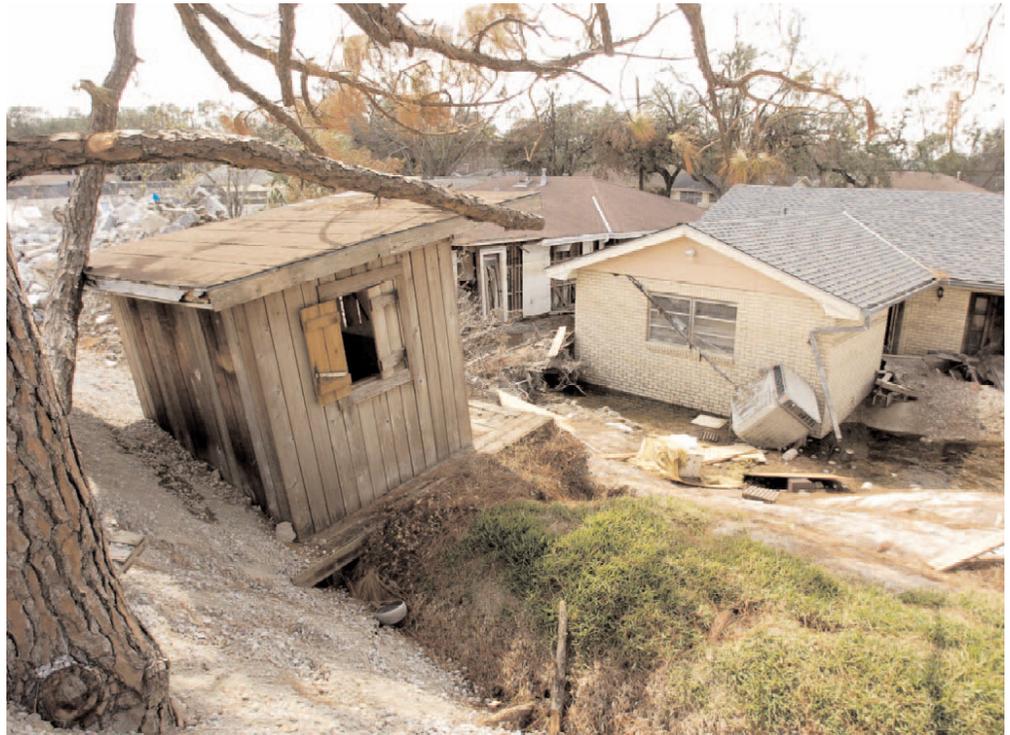
Figure 28. Water driven through sand under the sheet pilings (and possibly through peat, depending on the depth to which the sheet pilings actually were driven) pushes up the ground outside of the canal in a phenomenon known as heave. This could eventually provide a flow path for water which would undermine the levee and cause its collapse. This may have been responsible for the eventual collapse of the floodwall resulting in the breach.

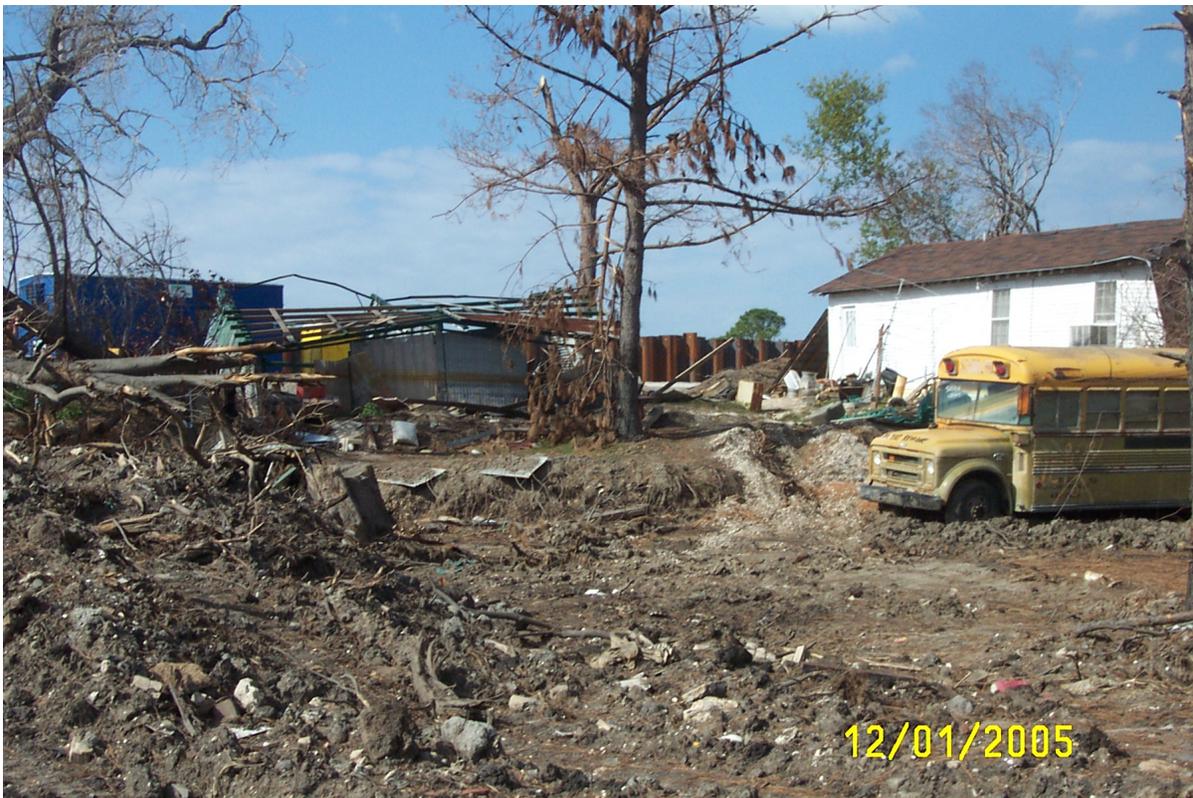
Figure 33. Slide toe (at abrupt change in slope in front of school bus) where levee and neighborhood were displaced about 45 feet toward the viewer.

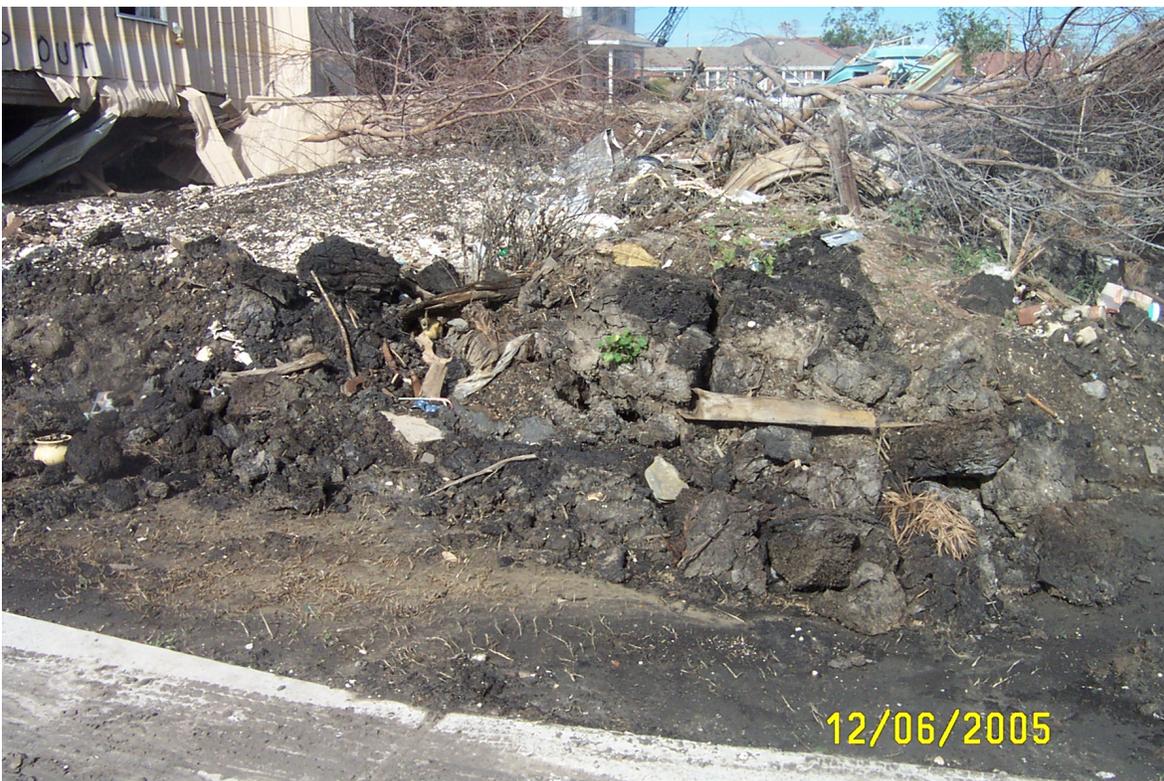
Before the debris was completely removed from the neighborhood, large blocks of peat were present throughout the neighborhood, some of which could be found a block away to the east near Fleur de Lis Blvd. Examples of the peat blocks before their removal can be seen in Figures 34 and the lower right of Figure 38.

Figure 34. Blocks of Peat along Belaire Drive near the 17th St. Canal levee breach

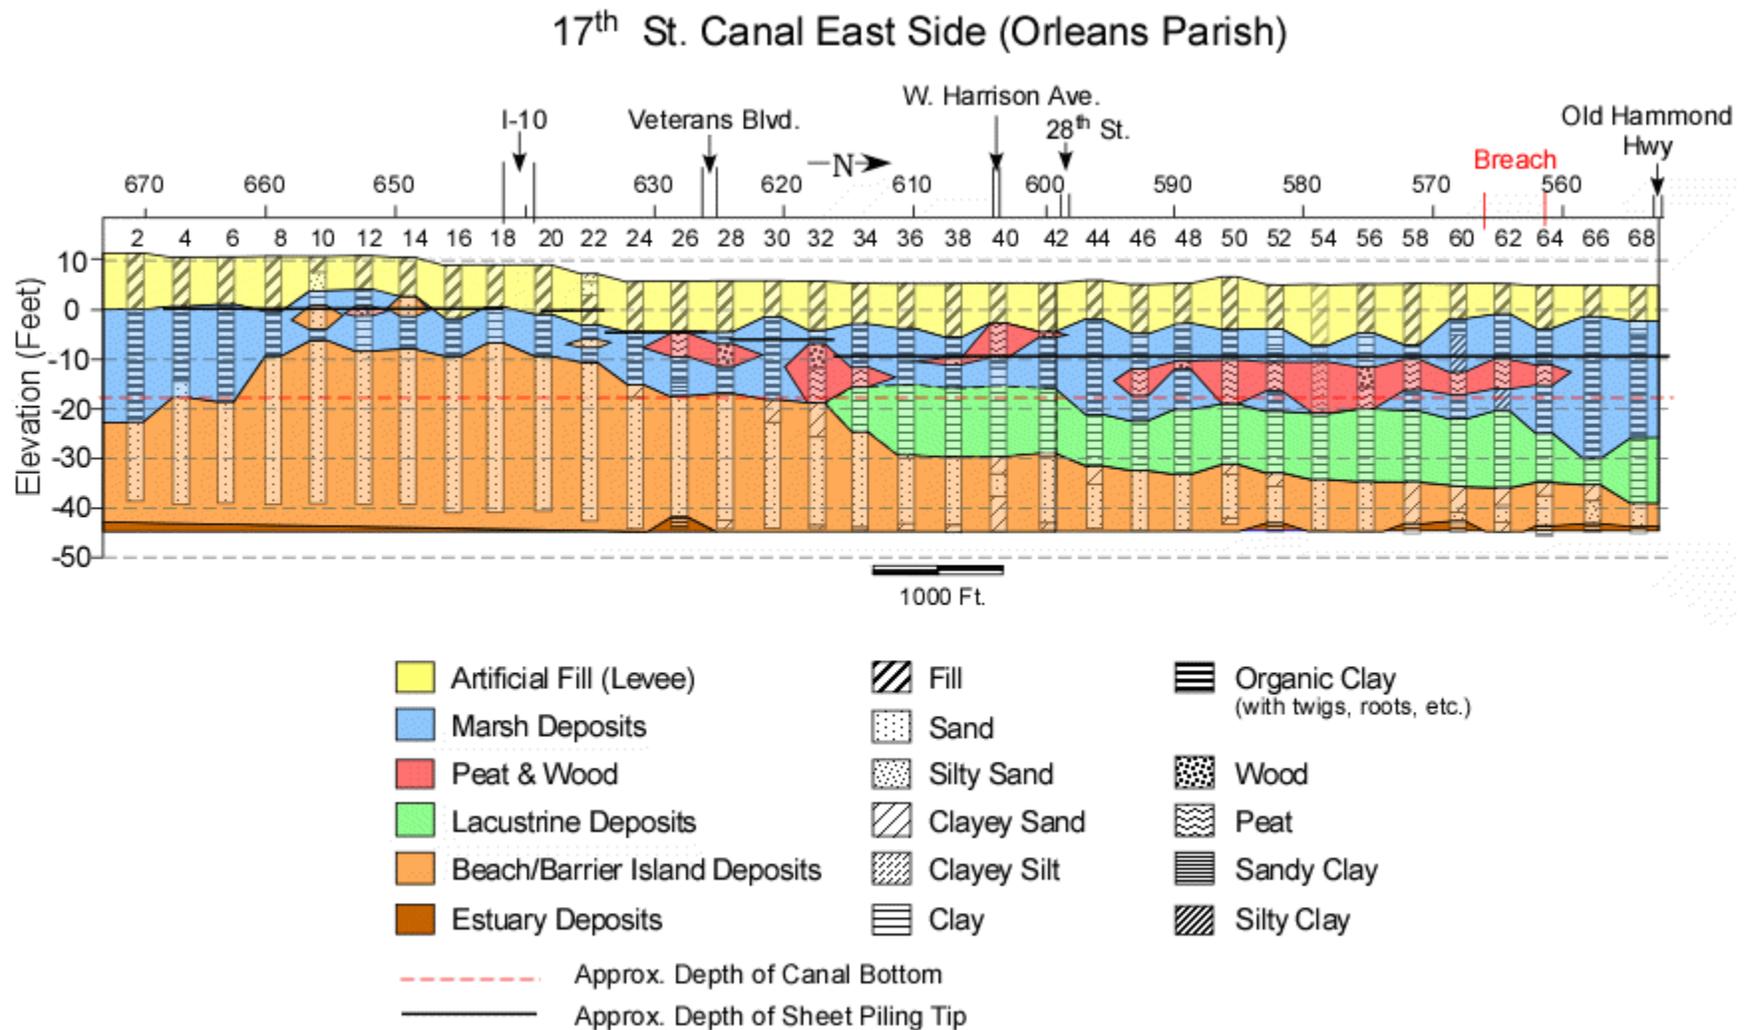
Figure 35 shows a geological cross section along the levee of the 17th street canal. The most notable feature of the cross section is the peat layer observed at depths between about 8 and 15 feet below sea level in the area of and to the south of the breach.

Figure 35. Geological cross-section along the eastern side of the 17th St. Canal (based on data in the U.S. Army Corps of Engineers design documents (1990). Notable in the cross-section is the peat layer that occurs in the area of the breach.

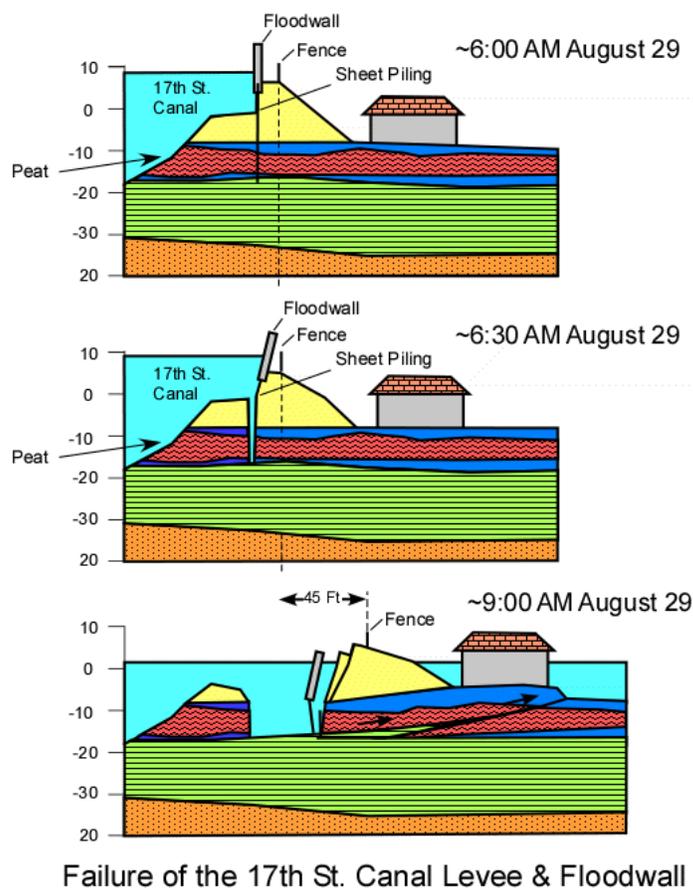
The most recent information from the Interagency Performance Evaluation Task Force (IPET) [2006] suggests that the floodwall and levee failed at the 17th St. Canal as a result of water level rising to an elevation of about 8 feet above sea level in the canal. The floodwalls were designed to have tops at an elevation of 14 feet above sea level, but IPET data indicate that by the time of Katrina the tops of the floodwalls on the 17th Street Canal were about 12.5 feet above sea level. Thus, IPET estimates that water levels in the canal were still 4 feet below the tops. IPET has collected eyewitness accounts and scoured the neighborhood for clocks that were stopped as a result of the flooding in order to determine the time of the breach. One eyewitness account suggests that the floodwall at the breach area was leaning to the protected side at about 6:30 AM on August 29 and other accounts suggest that the breach was open by about 9:00 AM. This along with levee breach experiments conducted scale models in a large centrifuge led IPET to suggest that as water levels rose in the canal, the floodwall and sheet piling was pushed outward toward the land side, opening a gap between the levee and the floodwall on the canal side. This gap allowed water to seep down along the sheet piling and eventually push the levee on the protected side outward away from the canal. Based on sections of the breached levee observed in the breach area, IPET suggests that the failure did not occur along the peat layer, but along a layer of weak clay at the base of the peat. This clay layer was thrust over and through the peat as illustrated in Figure 36.

Figure 36. Diagrammatic cross sections across the 17th St. Canal in the vicinity of the breach (based partially on a sketch in Seed and others [2005] and IPET (2006).

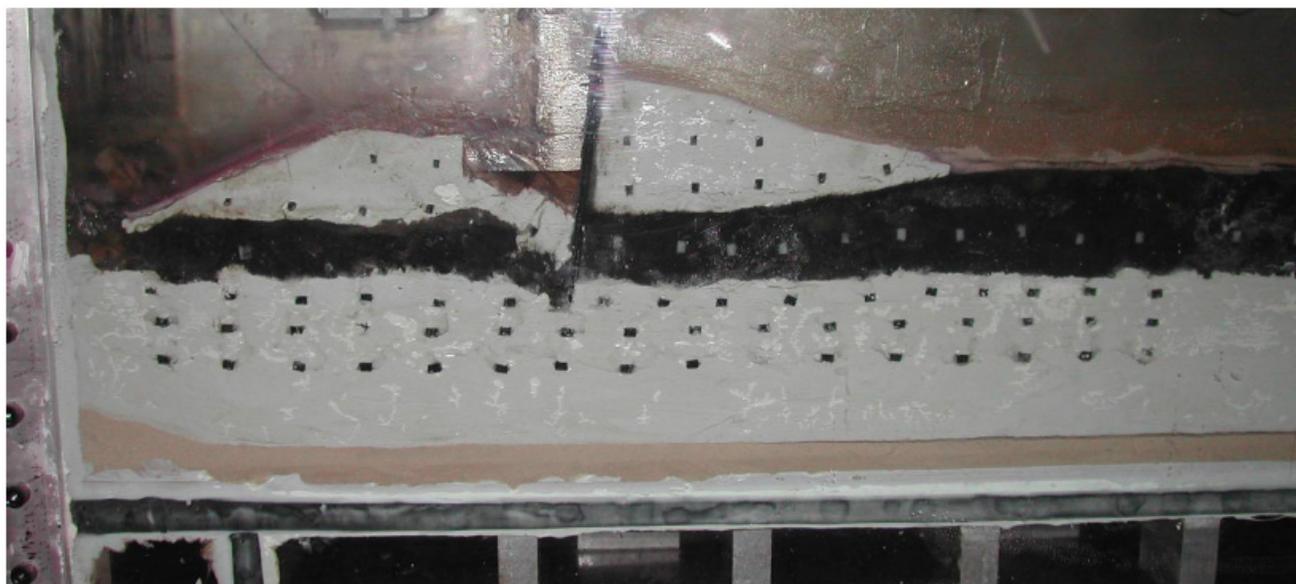
A photograph of the end result of IPET's scale model centrifuge experiment is shown in Figure 37. The canal side (on the left in the photograph) next to the sheet piling is seen to have dropped down as a result of the floodwall moving toward the right (toward the protected side). Indeed in the end result of the experiment, the levee, peat layer, and upper part of the underlying clay layer all have moved to the protected side. Viewing the complete video of the experimental run (<https://ipet.wes.army.mil/>), however, shows that the initial failure occurred either in the peat layer or at the peat – clay interface, and only when the sheet pile started to move to the right, away from the canal, did the upper part of the clay layer also move. Furthermore, the only part of the clay layer that moved was the part immediately in front of the tip of the sheet pile, and it only moved because it was being pushed along by the sheet pile.

Figure 37. Photograph of failed levee and floodwall in IPET's scale model centrifuge experiment representing the 17th St. Canal. The white at the top is clay and represents the levee. This overlies the dark peat layer, which in turn overlies another white clay layer meant to represent the estuary deposits beneath the peaty marsh deposits. Small rectangles were initially laid out in a rectangular grid and can be used to determine how much deformation has occurred during the experiment. (IPET, 2006).

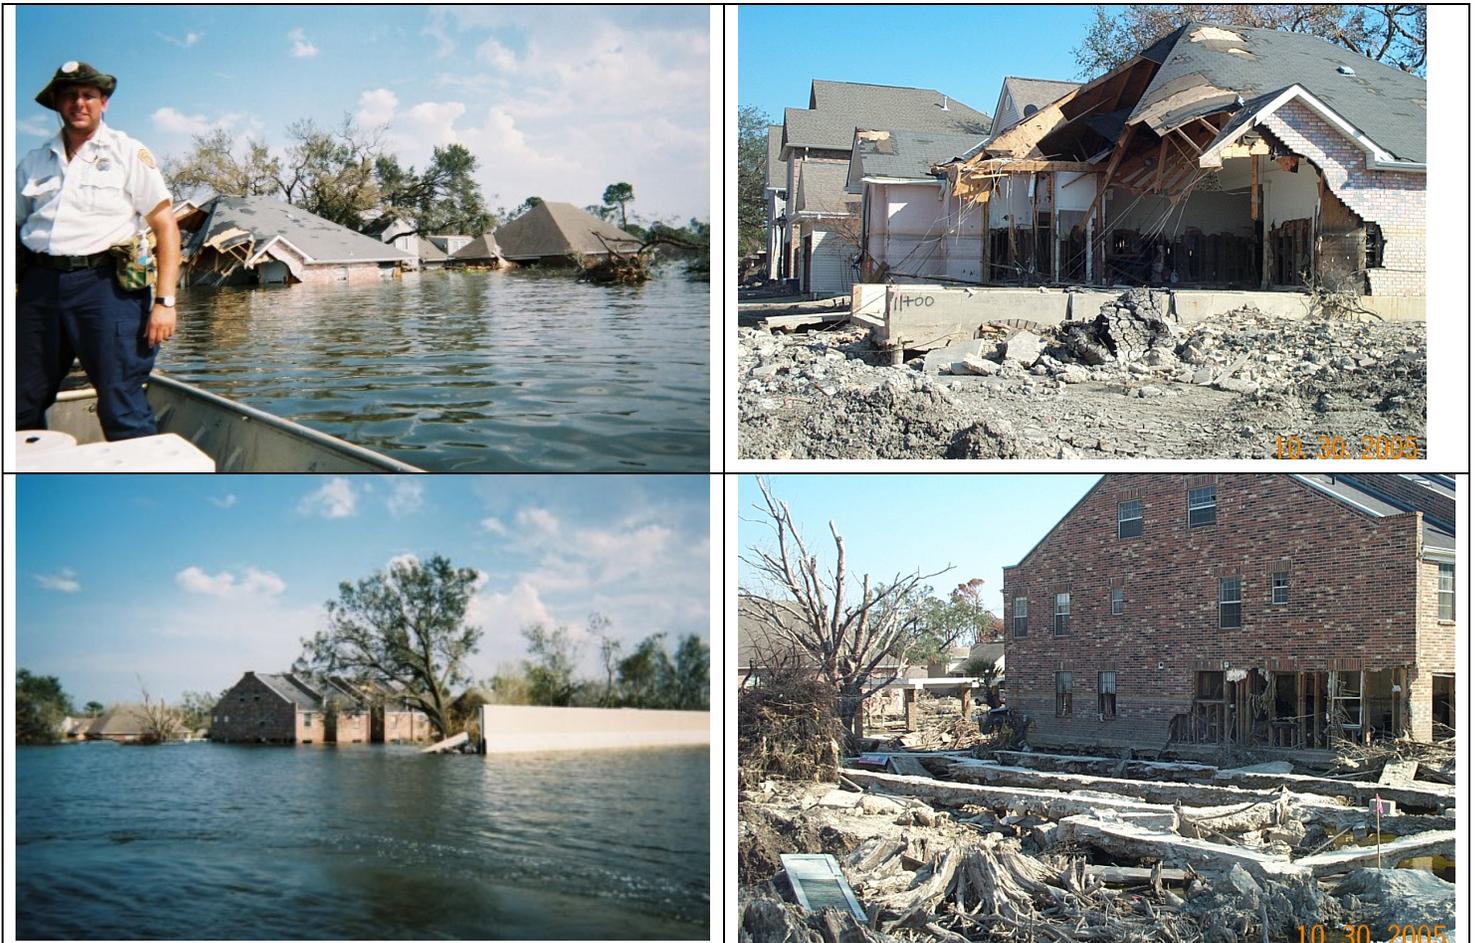
Although throughout the field trip we have seen the water line (scum line) left by standing water, this line does not represent the maximum flood depth. As seen in Figure 38, comparison of the photos on the left, taken when the water level was near its maximum with the water line left on the same structures (photos on the right) indicate that the maximum flood depth was about 1.5 to 2 feet higher than the line left by standing water.

Figure 38. Comparison of water levels on Sept. 1, 2005 (photos on left by Kevin Himmel), with water lines on same structures indicate lines left by standing water are about 1.5 to 2 feet lower than the maximum water level. Note large block of peat in photo at the upper right. In photo at lower right, note the chainwall foundation of a house that was removed by the burst of water when the levee was breached and the cypress stump from a tree that was probably cut down 100 years ago when this Lakeview neighborhood was reclaimed from the cypress swamp.

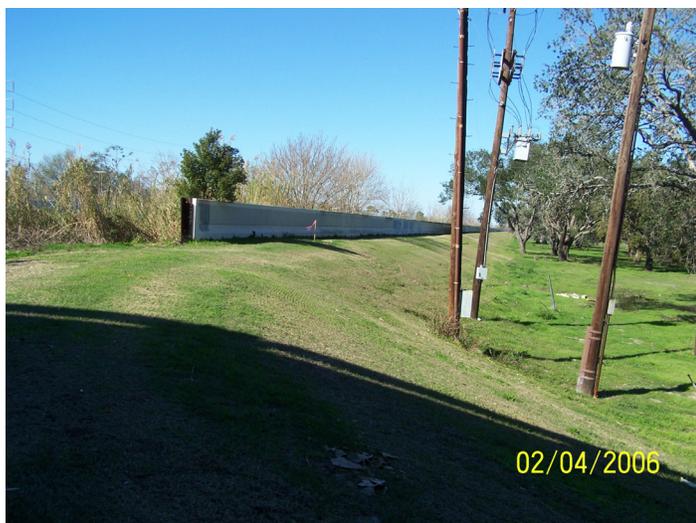
Stop 6 is at the levee of the Orleans Canal just under the I-610 overpass. As we walk up to the levee, note that the floodwall on the top of the levee abruptly ends about 40 yards north of the overpass (Figure 40). An approximately 200 yard gap thus exists in the flood protection on the canal between the end of the floodwall and Pump Station Number 7 to south on the other side of the overpass. A smaller gap exists on the other side of the canal as well. During Katrina, water from the Orleans Canal was flowing freely through this gap as evidenced by the erosion that occurred around the support structures for the freeway overpass (Figure 41). Fresh concrete has since been poured around the support structures and the levee has been raised about 2 feet from its pre-Katrina level in an attempt to fix the problem. Why was such an obvious gap in the flood protection system allowed to remain? The Independent Levee Investigation Team (2006) offer the following explanation. Apparently, the Orleans Sewerage and Water Board, who run the pump station, objected to the Corps of Engineers plan to built the floodwall right up to the wall of the pump station. They argued that the wall of the pump station was not strong enough to withstand the force of the water if it backed up in the canal, and would fail with the result that the city would flood when the wall failed. Of course the net result was that the city flooded as the water poured through the gap. Nevertheless, the relief of pressure in the canal may have prevented the floodwalls and levees elsewhere on the canal from failing.

Figure 40. End of floodwall on Orleans Canal just north of I-610 overpass near Marconi Ave.

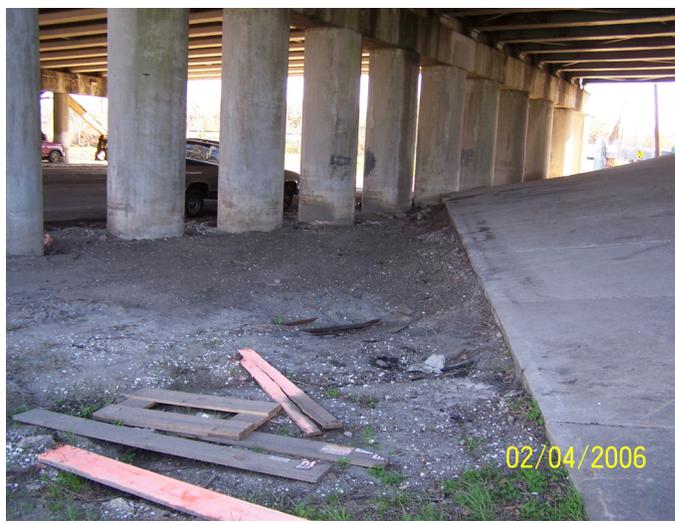
Figure 41. Erosion around the support structures for I-610 near Orleans Canal on Marconi Ave.
