Hurricane Katrina - What Happened?

Tulane University
Field Trip
August 9, 2006

Levee Breaches in New Orleans during Hurricane Katrina

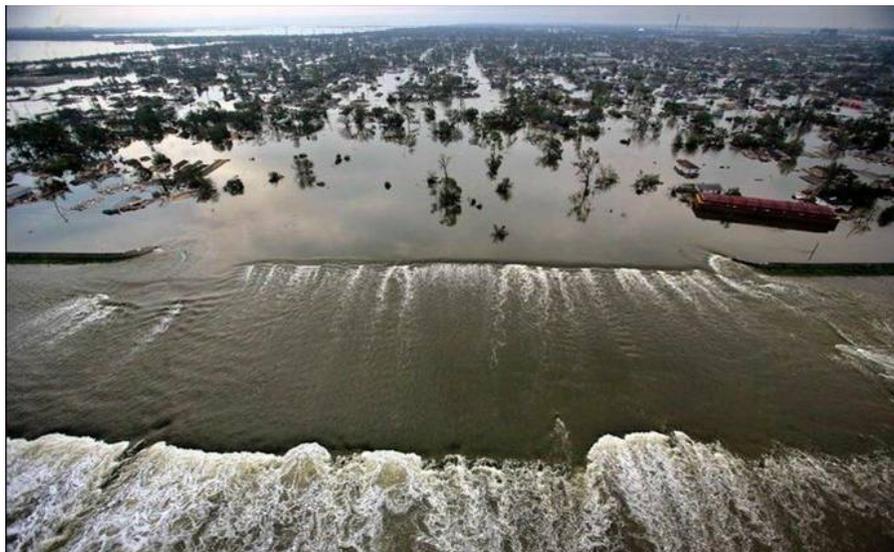
Figure 8. The large breach in the Industrial canal that flooded the Lower Ninth Ward could have been caused by a barge crashing through the floodwall during Katrina. Alternatively the barge could have floated in after the levee and floodwall were breached. Note the barge in the photo above. Note also that at the time of this photo water was running out of the Lower Ninth Ward back into the Industrial Canal. (Source - Vincent Laforet, AFP/Getty Images)

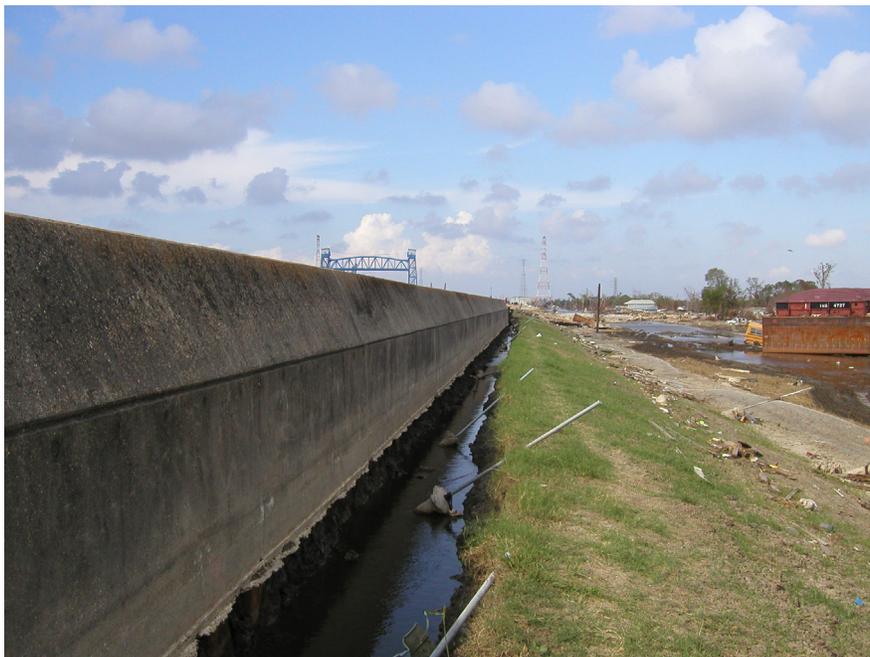
Photographs available on the U.S. Army Corps of Engineers, Interagency Performance Evaluation Task Force (IPET) web site and reproduced in Figure 11, show that along portions of the floodwall that did not fail, water flowing over the top of the floodwall eroded trenches on the protected side of the levee. It is likely that this erosion could have removed enough support on the protected side that the floodwalls and their underlying sheet piling eventually toppled into the protected side of the canal sending a huge surge of water into the Lower 9th Ward. Levee/Floodwall failures occurred at two places along the Industrial Canal levee. The longer breach (approximately 1,000 feet long) occurred between N. Galvez and N. Roman Streets (Figures 8, 10, & 13). The shorter (about 200 foot-long) breach occurred just to the south of Florida Avenue (Figures 10 & 14).

Figure 11. Looking North along the floodwall of the Industrial Canal levee showing trenches eroded by water from the Industrial Canal that overtopped the floodwall. Photo from U.S. Army Corps of Engineers IPET web site, taken October 4, 2005.

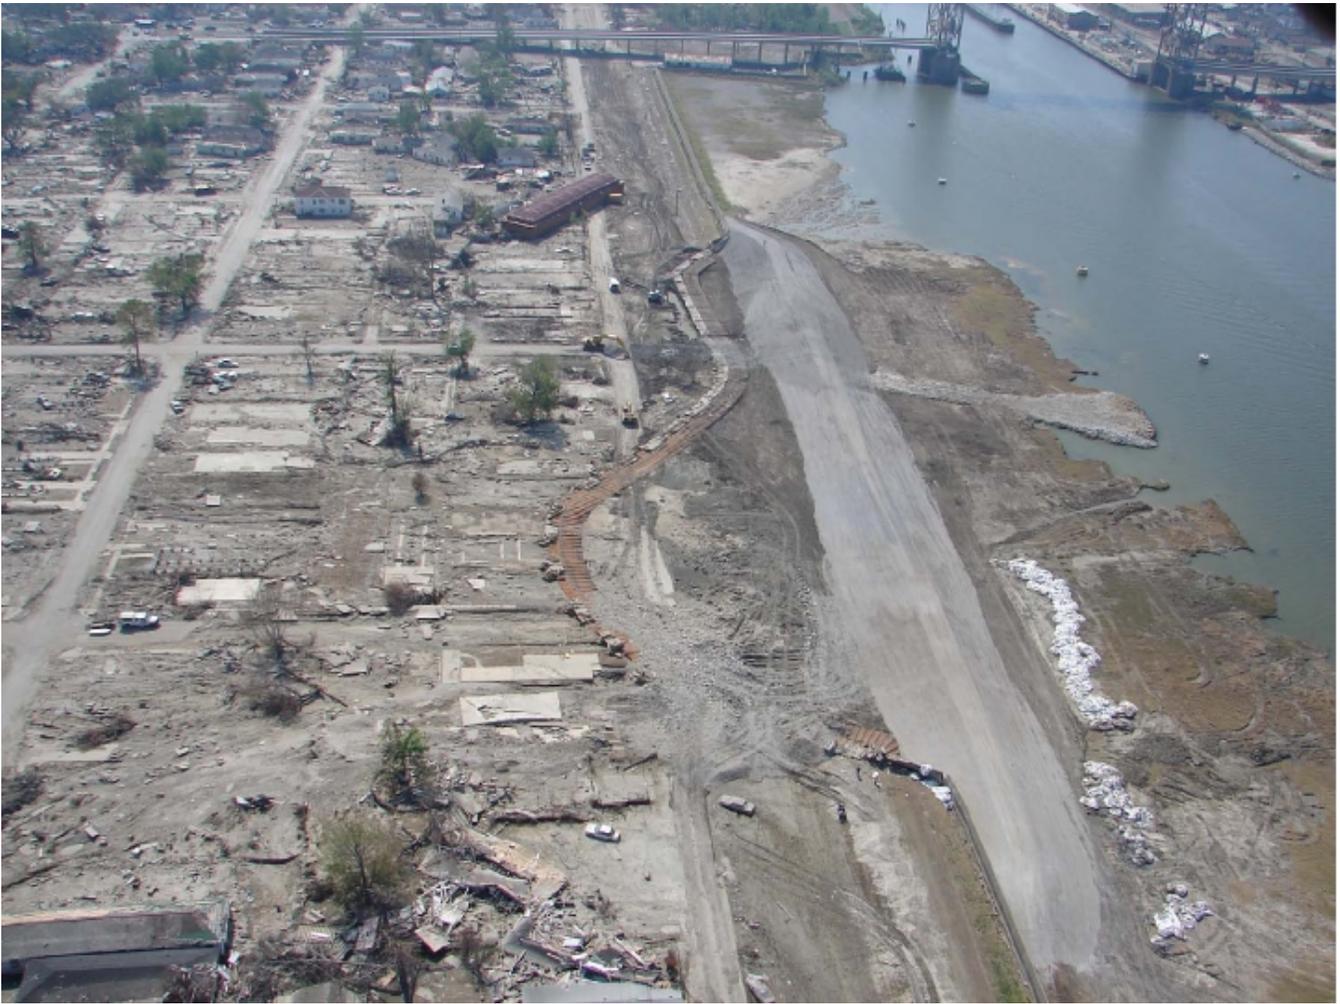
Figure 13. View of southern breach on the Industrial Canal, looking South. Note the floodwall and sheet piling (brown) strewn through the Lower Ninth Ward neighborhood where all houses were removed by the force of water coming through the breach. Gray deposits on right are breach repair gravels. Note barge near in the center near the top of the photo. Photo by L. Harder - Independent Levee Investigation Team Draft Final Report (2006).

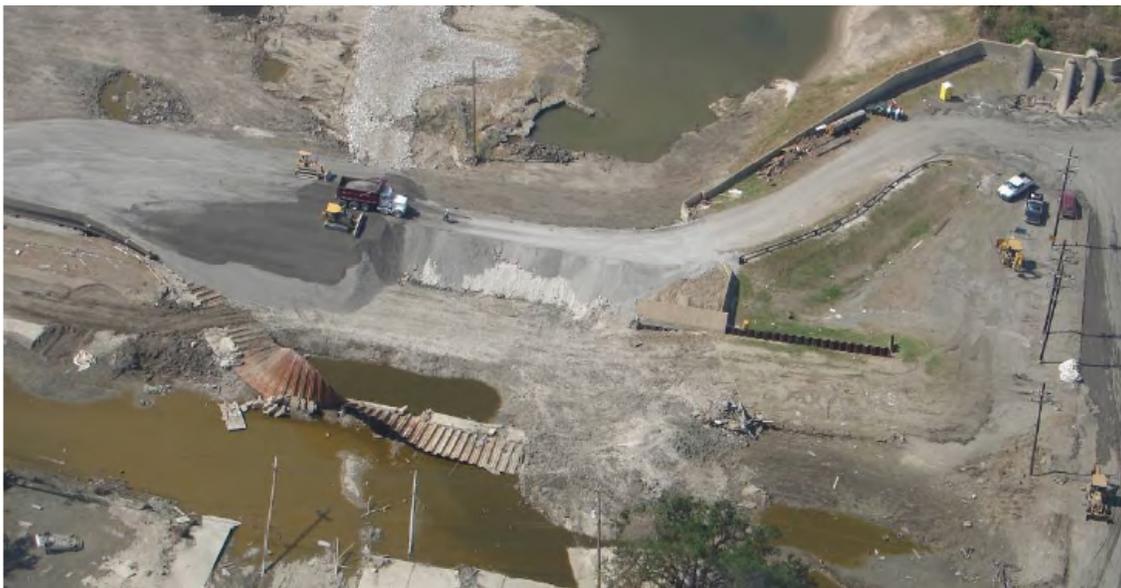
Figure 14. Aerial view of the north breach on Industrial Canal. Photo by L. Harder - Independent Levee Investigation Team Draft Final Report (2006).

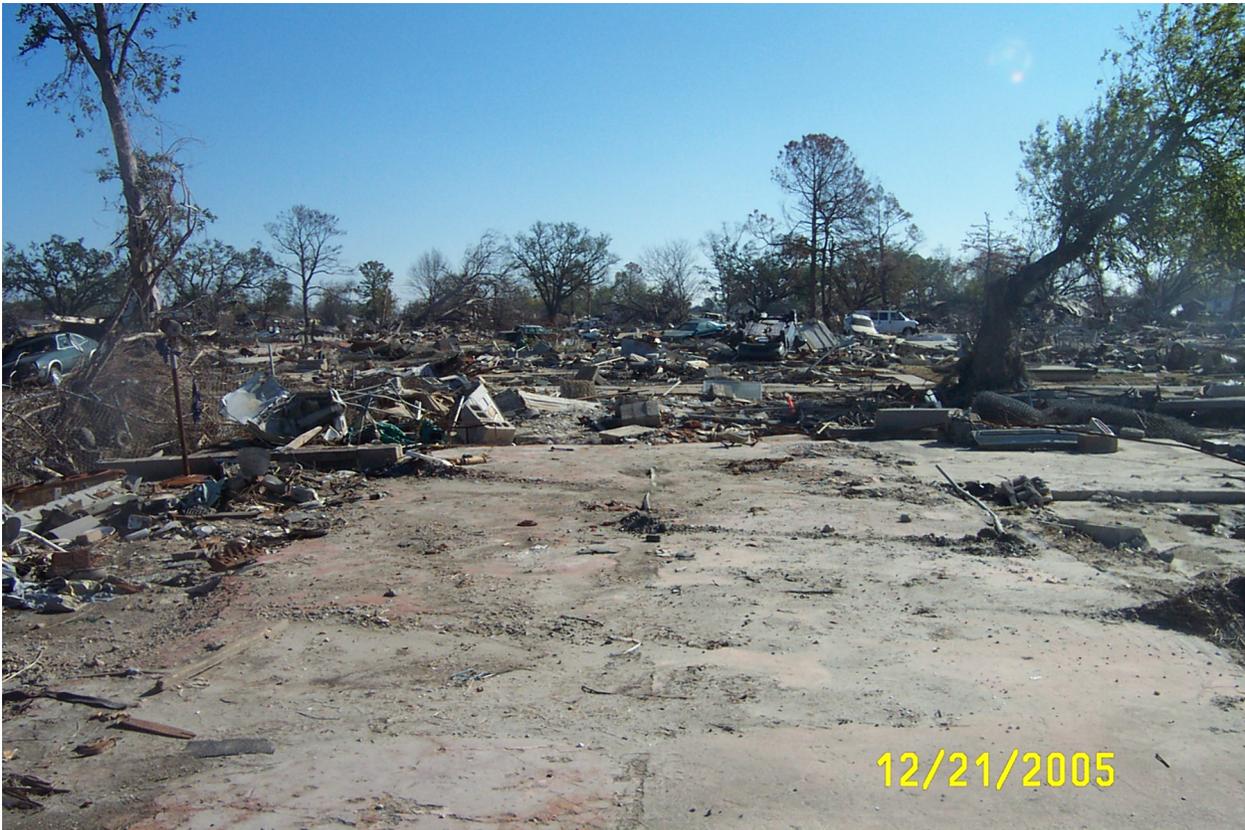
Figure 15. View of Lower Ninth Ward looking East as it appeared in December, 2005.

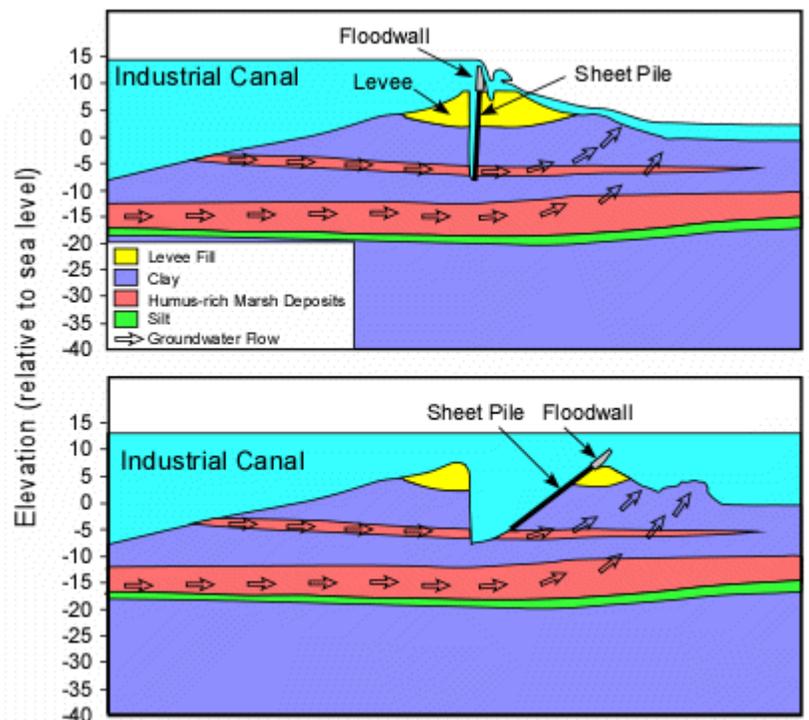
Although the Interagency Performance Evaluation Task Force (IPET, 2006) suggested that the main cause of failure here was the result of the surge waters in the Industrial Canal overtopping the floodwall and eroding away the levee on the protected side, the Independent Levee Investigation Team (ILIT, 2006) disputes this. They do agree that erosion of the levee on the protected side could have contributed, but their analysis indicates that the geological conditions present in the subsurface along with the shallow depth to the tip of the sheet pilings resulted in hydraulic piping beneath the sheet pilings which undermined the levee and caused it and the floodwall to collapse. Two layers of highly permeable marsh deposits occur at a shallow depth below the levee (Figure 16). According to the analysis of ILIT (2006), the added pressure in the canal forced water through these permeable layers and out at the toe of the levee on the protected side, thus removing support for the floodwall and levee.

Figure 16. Possible failure mechanism at the Industrial Canal Levee breach in near the Lower 9th Ward

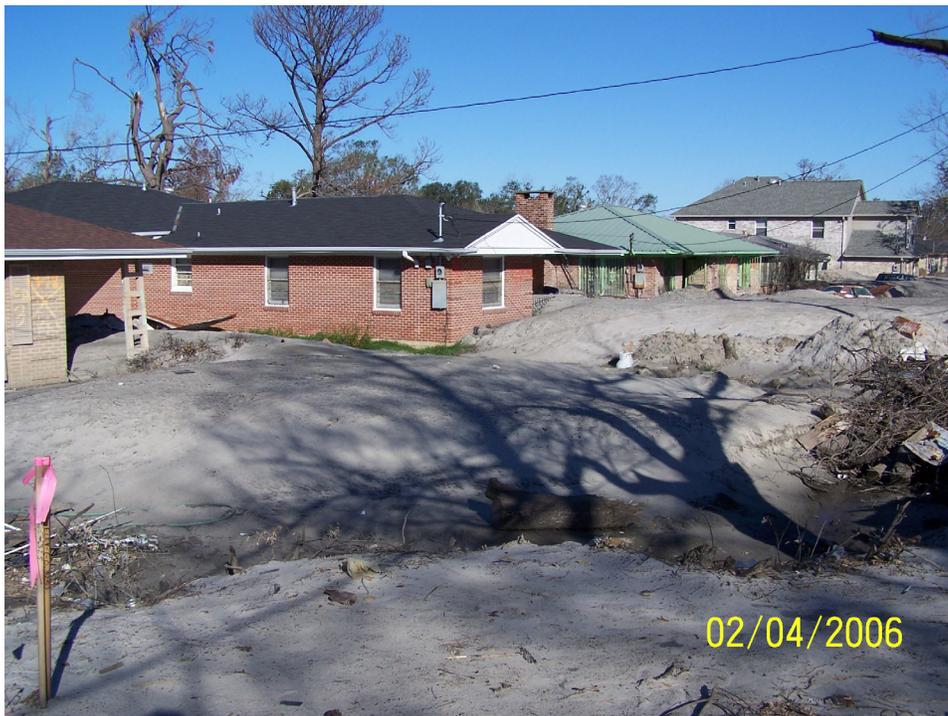
Figure 22. Sand deposits on Warrington drive showing deposition in the wake of houses as the currents flowed down the driveways between the houses. As of March 1, 2006, most of the sand deposits have been removed.

Our estimate of the volume of sand deposited in the neighborhood is about 932,000 ft³. Such a volume would cover a football field, from end to end (including the end zones) with over 16 feet of sand. Engineers working on the breach repair have reported that they had to dig to a depth of 30 feet below sea level to completely remove gravel and sand bags used to plug the breach in the first few days after Katrina. A conservative estimate of the volume of this hole is about 330,000 ft³. This only accounts for about 35% of the volume of sand found in the neighborhood, and implies that the canal bottom, both upstream and downstream from the breach, was scoured to an unknown depth. This raises questions about the stability of the levee/floodwall system outside the breach area if the canal bottom is now in permeable sand in these areas.

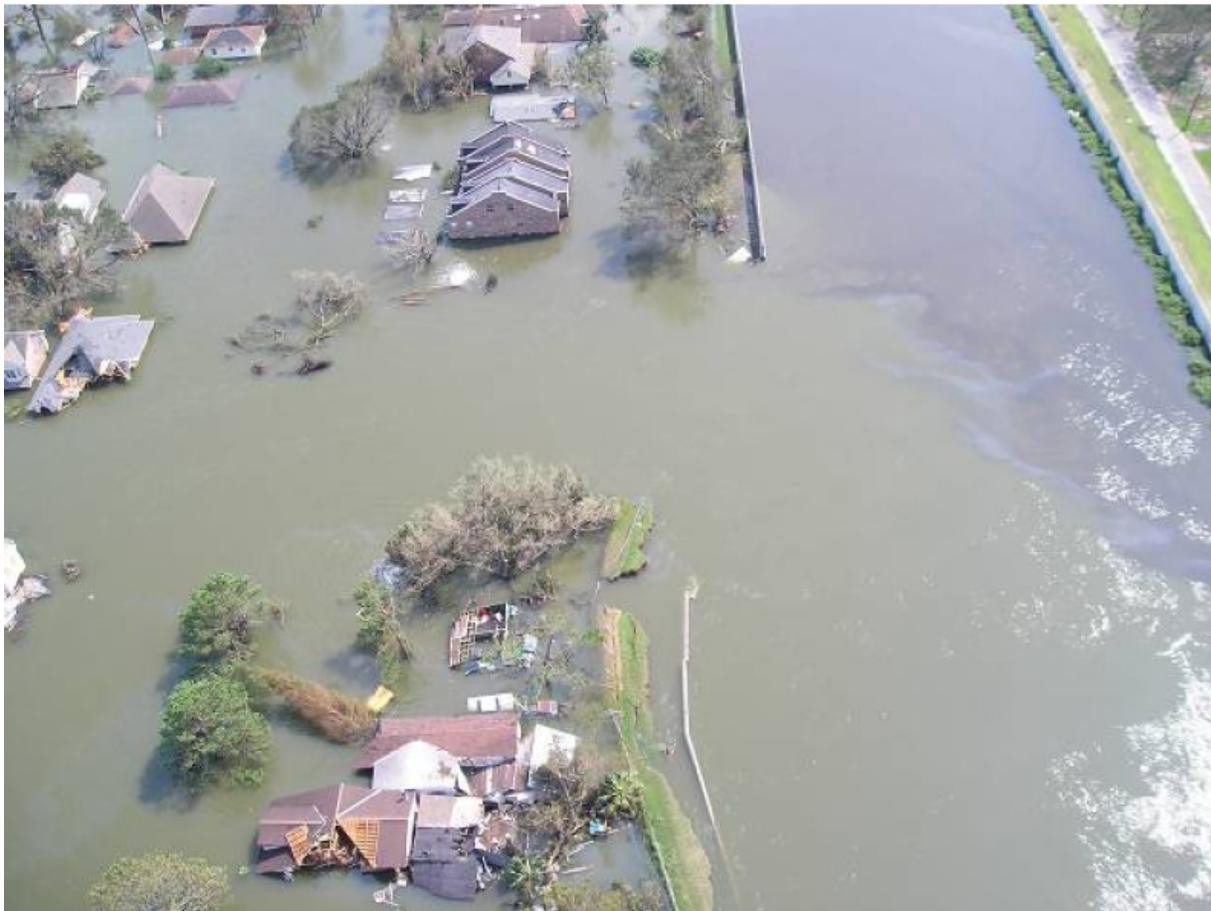
Figure 31. View of 17th St. Canal breach looking toward south. Note displaced floodwall and levee just below the missing section of the levee.

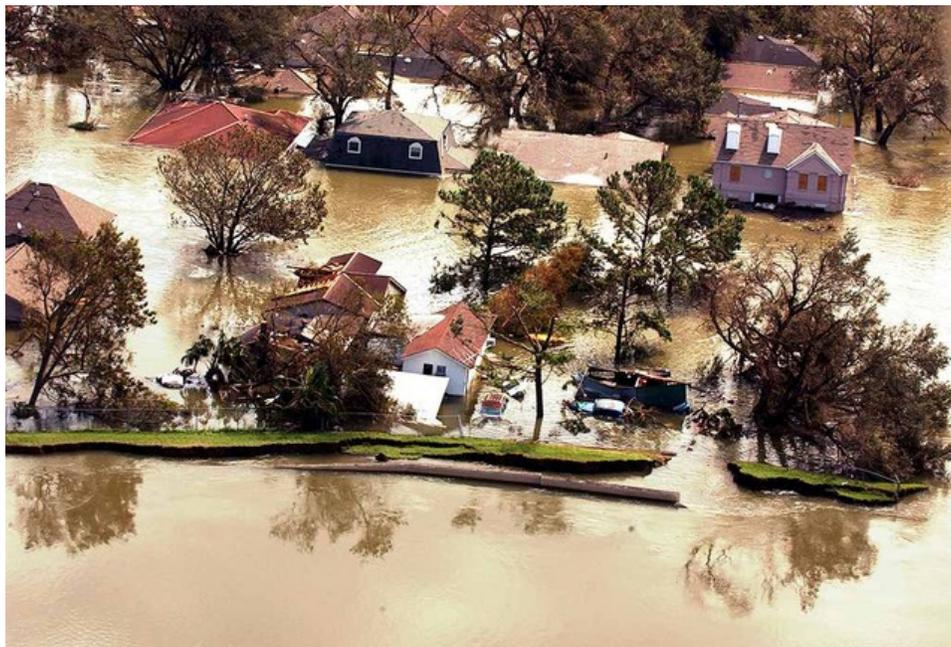
Figure 32. View of 17th St. Canal breach looking toward east. Note fractures in the displaced part of the levee. Photo by J. Augustino FEMA.

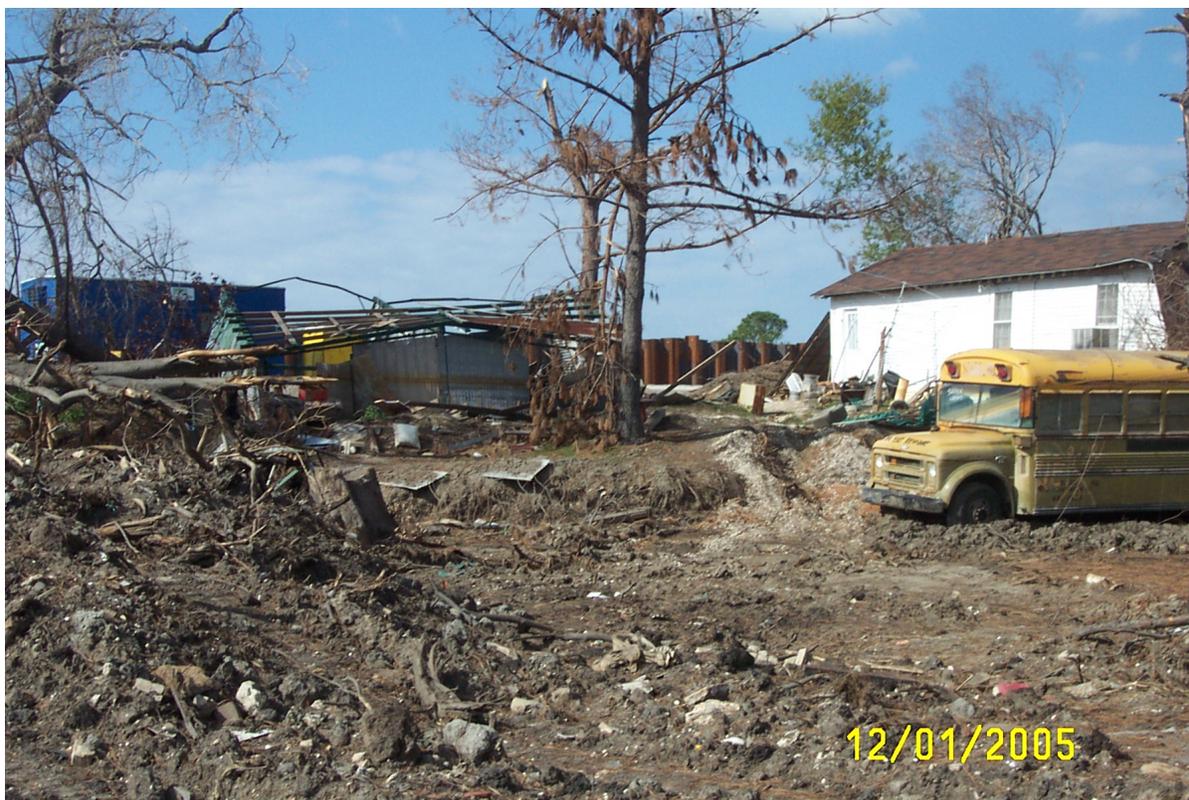
Figure 33. Slide toe (at abrupt change in slope in front of school bus) where levee and neighborhood were displaced about 45 feet toward the viewer.

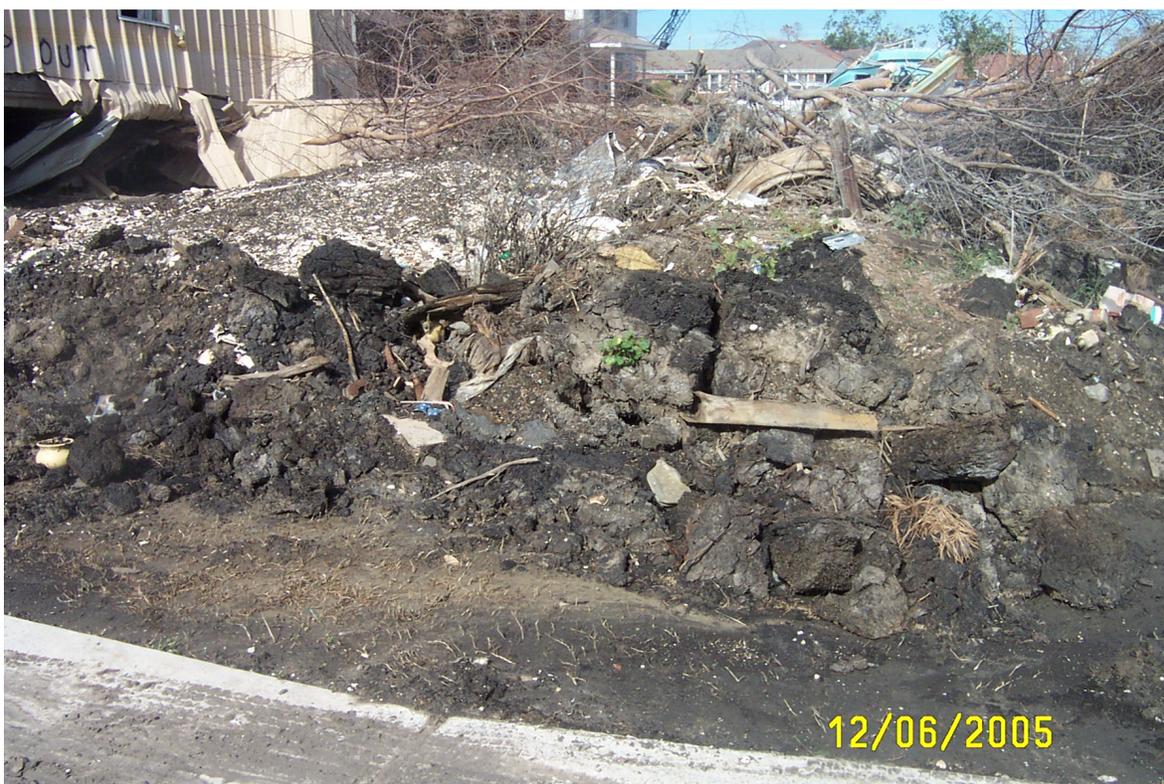
Before the debris was completely removed from the neighborhood, large blocks of peat were present throughout the neighborhood, some of which could be found a block away to the east near Fleur de Lis Blvd. Examples of the peat blocks before their removal can be seen in Figures 34 and the lower right of Figure 38.

Figure 34. Blocks of Peat along Belaire Drive near the 17th St. Canal levee breach

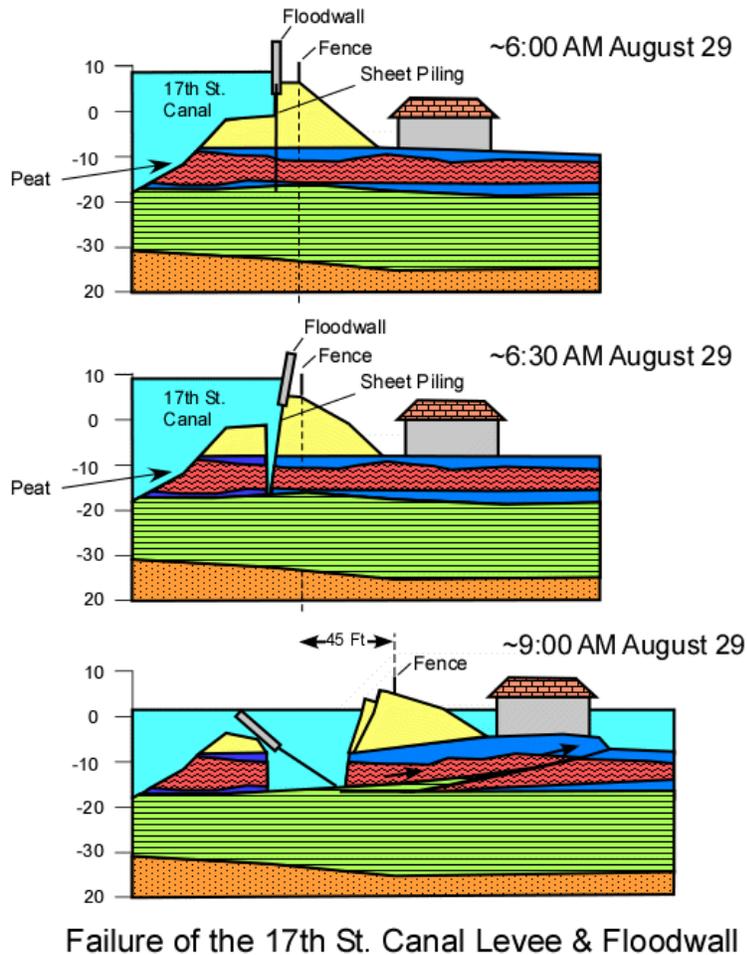
The most recent information from the Interagency Performance Evaluation Task Force (IPET) [2006] suggests that the floodwall and levee failed at the 17th St. Canal as a result of water level rising to an elevation of about 8 feet above sea level in the canal. The floodwalls were designed to have tops at an elevation of 14 feet above sea level, but IPET data indicate that by the time of Katrina the tops of the floodwalls on the 17th Street Canal were about 12.5 feet above sea level. Thus, IPET estimates that water levels in the canal were still 4 feet below the tops. IPET has collected eyewitness accounts and scoured the neighborhood for clocks that were stopped as a result of the flooding in order to determine the time of the breach. One eyewitness account suggests that the floodwall at the breach area was leaning to the protected side at about 6:30 AM on August 29 and other accounts suggest that the breach was open by about 9:00 AM. This, along with levee breach experiments conducted on scale models in a large centrifuge led IPET to suggest that as water levels rose in the canal, the floodwall and sheet piling was pushed outward toward the land side, opening a gap between the levee and the floodwall on the canal side. This gap allowed water to seep down along the sheet piling and eventually push the levee on the protected side outward away from the canal. Based on sections of the breached levee observed in the breach area, IPET suggests that the failure did not occur along the peat layer, but along a layer of weak clay at the base of the peat. This clay layer was thrust over and through the peat as illustrated in Figure 36.

Figure 36. Diagrammatic cross sections across the 17th St. Canal in the vicinity of the breach (based partially on a sketch in Seed and others [2005] and IPET (2006).

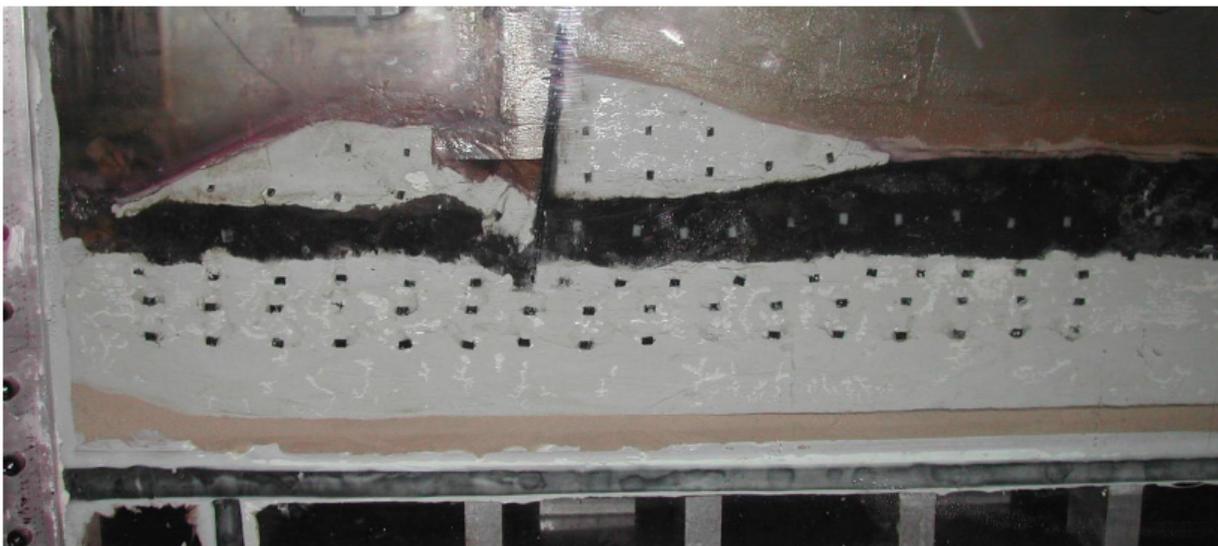
A photograph of the end result of IPET's scale model centrifuge experiment is shown in Figure 37. The canal side (on the left in the photograph) next to the sheet piling is seen to have dropped down as a result of the floodwall moving toward the right (toward the protected side). Indeed in the end result of the experiment, the levee, peat layer, and upper part of the underlying clay layer all have moved to the protected side. Viewing the complete video of the experimental run (<https://ipet.wes.army.mil/>), however, shows that the initial failure occurred either in the peat layer or at the peat – clay interface, and only when the sheet pile started to move to the right, away from the canal, did the upper part of the clay layer also move. Furthermore, the only part of the clay layer that moved was the part immediately in front of the tip of the sheet pile, and it only moved because it was being pushed along by the sheet pile.

Figure 37. Photograph of failed levee and floodwall in IPET's scale model centrifuge experiment representing the 17th St. Canal. The white at the top is clay and represents the levee. This overlies the dark peat layer, which in turn overlies another white clay layer meant to represent the estuary deposits beneath the peaty marsh deposits. Small rectangles were initially laid out in a rectangular grid and can be used to determine how much deformation has occurred during the experiment. (IPET, 2006).

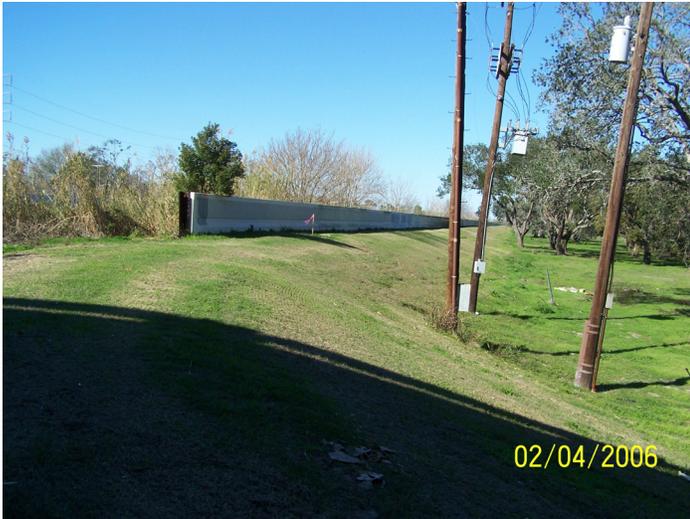
Figure 40. End of floodwall on Orleans Canal just north of I-610 overpass near Marconi Ave.

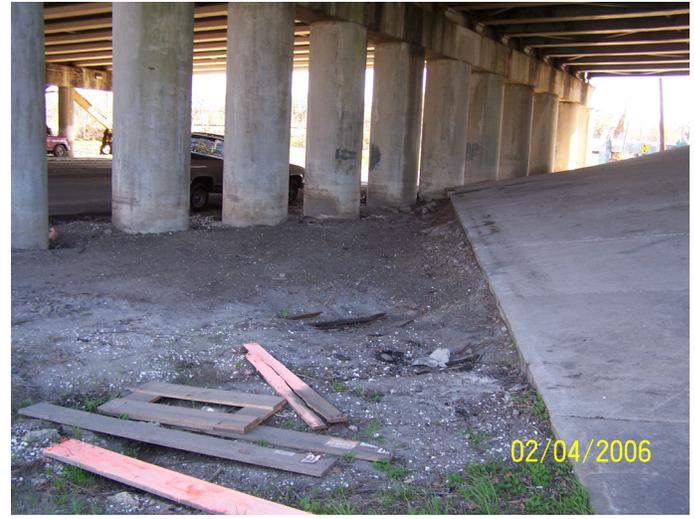
Figure 41. Erosion around the support structures for I-610 near Orleans Canal on Marconi Ave.
