Hurricane Katrina - What Happened? The Geology of the Katrina Disaster in New Orleans Field Trip Guide

April 21, 2013

Stephen A. Nelson
Department of Earth &
Environmental Sciences
Tulane University
New Orleans, LA
snelson@tulane.edu

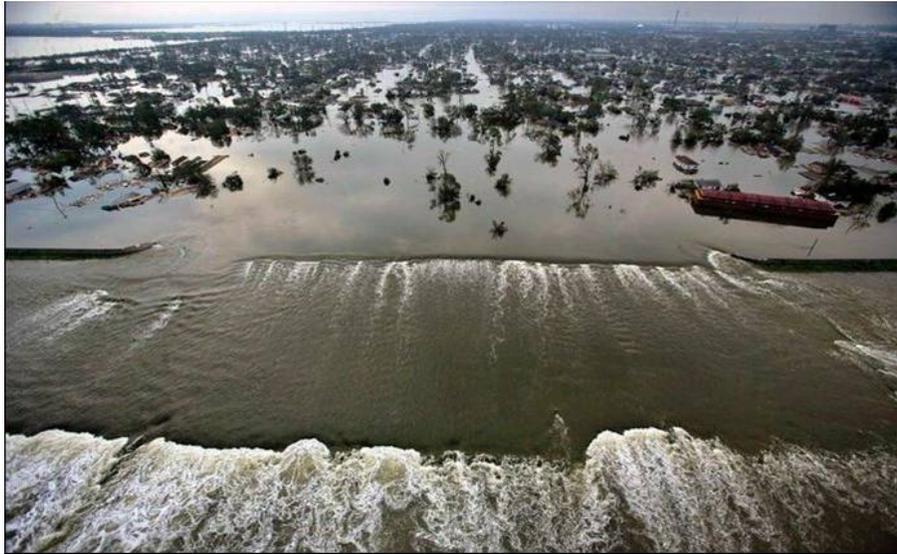
Figure 13. The large breach in the Industrial canal that flooded the Lower Ninth Ward could have been caused by a barge crashing through the floodwall during Katrina. Alternatively the barge could have floated in after the levee and floodwall were breached. Note the barge in the photo above. Note also that at the time of this photo water was running out of the Lower Ninth Ward back into the Industrial Canal. (Source - Vincent Laforet, AFP/Getty Images)

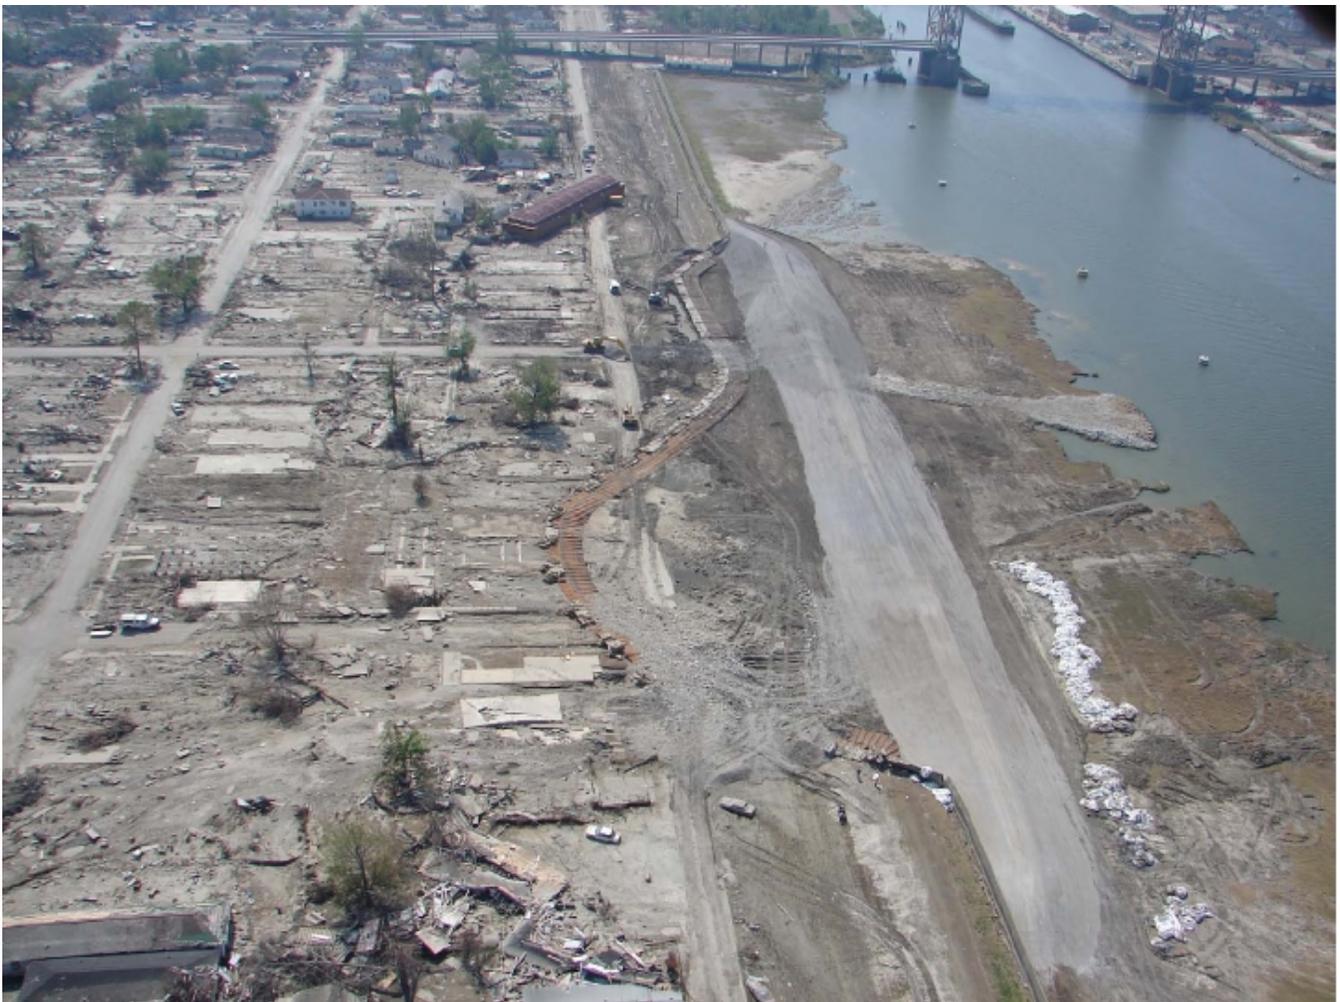
All houses and most trees were removed by the incoming water in the areas immediately in front of the breaches (Figs. 11, 12, 13, & 14) and in areas between the breaches the rush of water was forceful enough to lift houses off their foundations and float them around until they collided with other houses and either came to rest or broke apart to form piles of rubble (Fig. 11). The floodwall and underlying sheet pilings were strewn into the first few blocks of the Lower 9th Ward like a ribbon (Figures 14, 15, and 16).

Figure 14. View of southern breach on the Industrial Canal, looking South. Note the floodwall and sheet piling (brown) strewn through the Lower Ninth Ward neighborhood where all houses were removed by the force of water coming through the breach. Gray deposits on right are breach repair gravels. Note barge near in the center near the top of the photo. Photo by L. Harder - Independent Levee Investigation Team Final Report (2006).

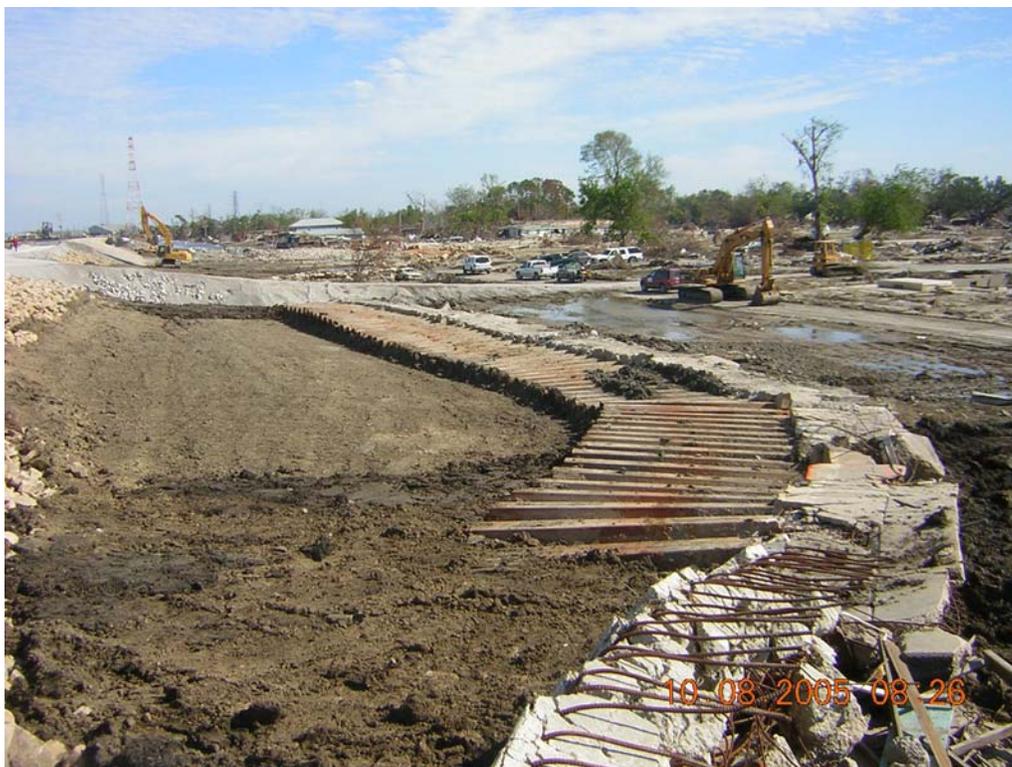
Figure 15. Floodwall and sheet piling strewn into Lower 9th Ward at the southern (larger) breach on the Industrial Canal. Photo from U.S. Army Corps of Engineers IPET web site.

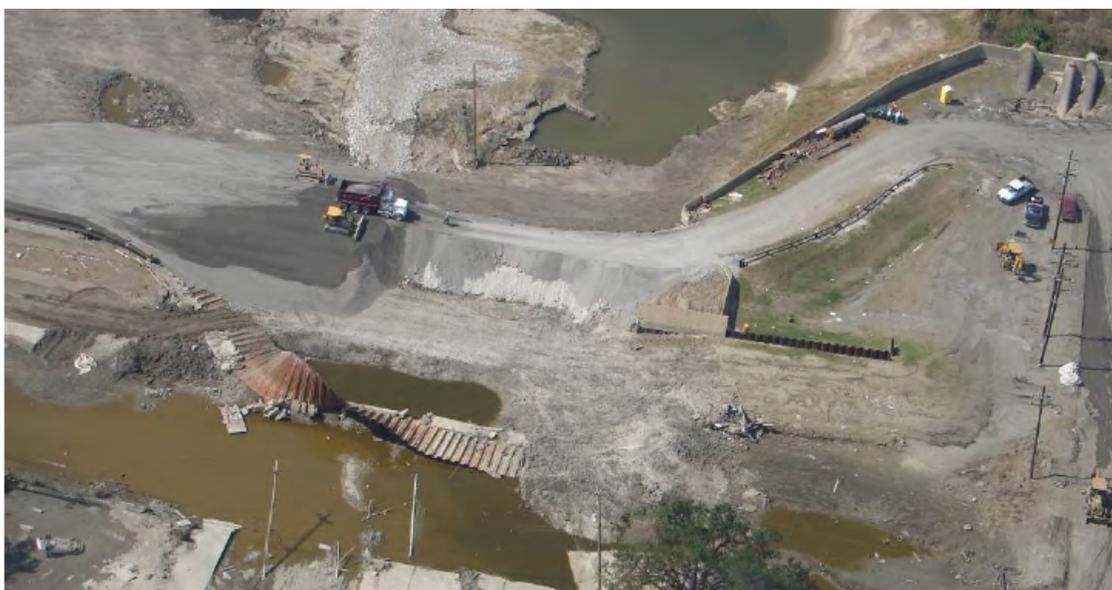
Figure 16. Aerial view of the north breach on Industrial Canal. Photo by L. Harder - Independent Levee Investigation Team Final Report (2006).

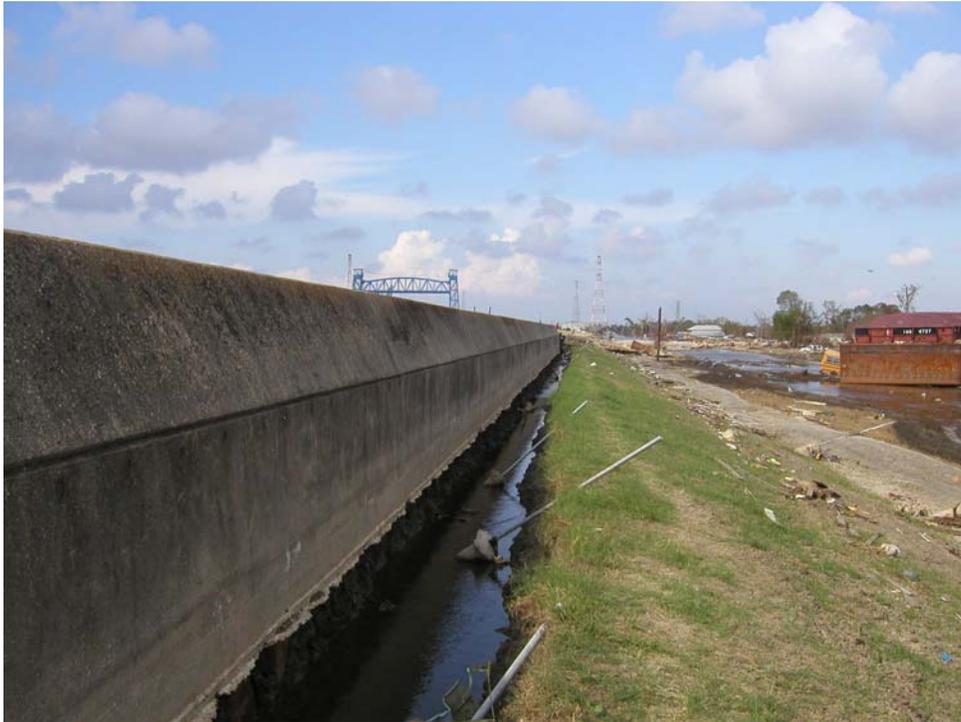
Photographs available on the U.S. Army Corps of Engineers, Interagency Performance Evaluation Task Force (IPET) web site and reproduced in Figure 17, show that along portions of the floodwall that did not fail, water flowing over the top of the floodwall eroded trenches on the protected side of the levee. It is likely that this could have removed enough support on the protected side that the floodwalls and their underlying sheet piling eventually toppled into the protected side of the canal sending a huge surge of water into the Lower 9th Ward.

Figure 17. Looking North along the floodwall of the Industrial Canal levee showing trenches eroded by water from the Industrial Canal that overtopped the floodwall. Breached section is just beyond the barge and barely discernable in this view. Florida Avenue Bridge (blue) in upper center. Photo from U.S. Army Corps of Engineers IPET web site, taken October 4, 2005.

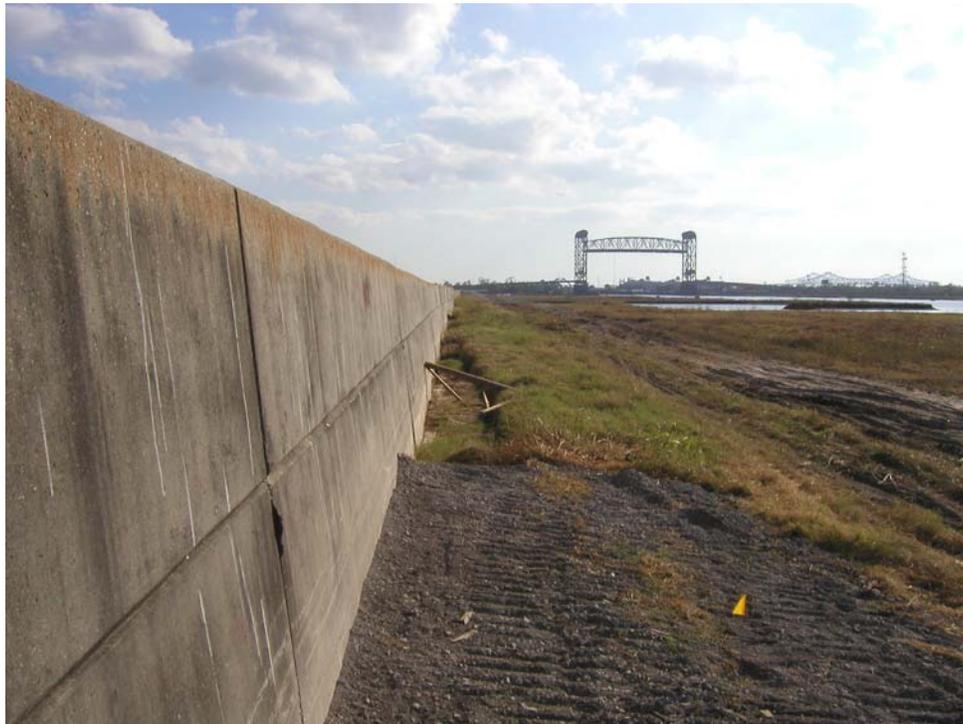
Figure 18. Looking South along the floodwall of the Industrial Canal on the inside of the floodwall between the two breaches showing the floodwall leaning toward the left (east) with a block of the levee next to the floodwall dropped down (near center of picture). Claiborne Ave. Bridge in right center. Photo from U.S. Army Corps of Engineers IPET web site, taken October 4, 2005.

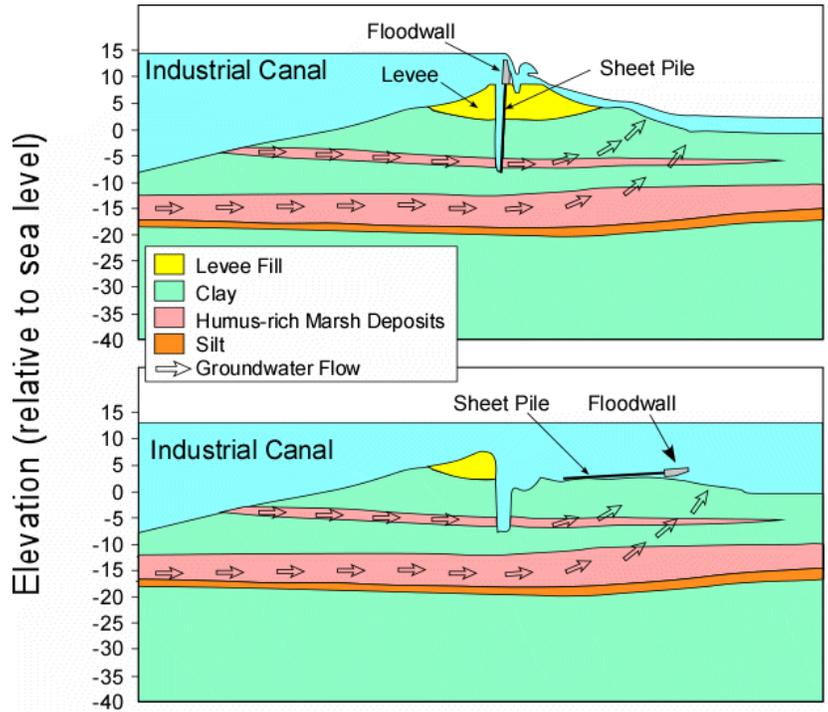
Although the floodwalls along the Industrial Canal were built in the 1970s, in 1985, the research branch of the Army Corps of Engineers conducted experiments on the I-wall design. They constructed a levee and enclosure in the Atchafalaya Basin (to the southwest of New Orleans) and began filling the area next to the levee and sheet pile floodwall with water. As the water rose against the floodwall, deflections of the floodwall began to occur and a gap opened on the water side of the floodwall which allowed the full hydrostatic force of the water to penetrate to the tip of the sheet piling (Jackson, 1988, Oner and others, 1997). This type of floodwall failure is illustrated in Figure 20. These findings were apparently never communicated to those in the Corps responsible for the design and construction of floodwalls in New Orleans (Marshall, March 14, 2006). The leaning floodwall seen in Figure 18 clearly shows that this also happened on the Industrial Canal floodwall during Hurricane Katrina. The force of the water pushing the wall outward toward the protected side coupled with removal of support by erosion caused by the water pouring over the top of the floodwall was the most likely cause of the catastrophic failures on the east side of the Industrial Canal (Fig. 21).

The Interagency Performance Evaluation Task Force (IPET, 2006) agreed that the main cause of failure here was the result of the surge waters in the Industrial Canal overtopping the floodwall and eroding away the levee on the protected side, but the Independent Levee Investigation Team (ILIT, 2006) suggests another cause. They do agree that erosion of the levee on the protected side could have contributed, but their analysis indicates that the geological conditions present in the subsurface along with the shallow depth to the tip of the sheet pilings resulted in hydraulic piping beneath the sheet pilings which undermined the levee and caused it and the floodwall to collapse. Two layers of highly permeable marsh deposits occur at a shallow depth below the levee (Fig. 21). According to the analysis of ILIT (2006), the added pressure in the canal forced water through these permeable layers and out at the toe of the levee on the protected side, thus removing support for the floodwall and levee.

Figure 21. Possible failure mechanism at the Industrial Canal Levee breach in near the Lower 9th Ward

At Stop 1 in the Lower 9th Ward, one now sees that the entire floodwall between the two bridges (Claiborne to the south and Florida Avenue to the North – the blue colored bridge) has been replaced with a T-wall with a top elevation at 14.5 feet above sea level, the level it was supposed to have attained prior to Katrina. This new floodwall was completed in mid-June, 2006. The original I-wall is still present along the other side of the Industrial Canal as well as to the south and north of the new T-wall. The only improvement made to the levees where the I-walls still exist is concrete armoring has been added to the base of the I-wall to prevent the erosion of the levee should water come over the top of the wall again.

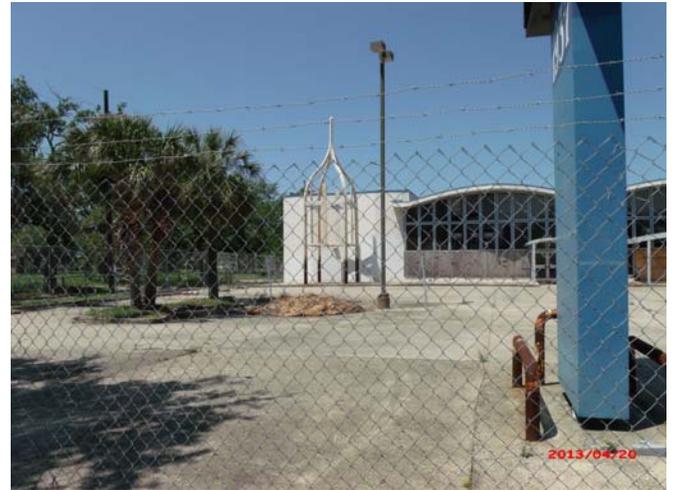
Figure 26. Church at the corner of St. Anthony and Mirabeau showing the standing water line and rusted church steeple.

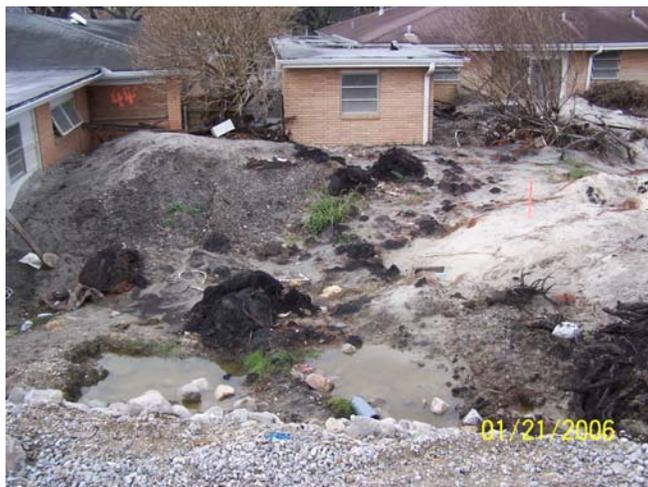
After the water was drained from the area, deposits of sand along with blocks of peat were observed to have filled the street and the backyards of houses along Pratt Drive (Figs. 39 and 40). The sand deposits were similar to the ones observed at the Mirabeau Ave. breach, but also contain blocks of peat as expected from the geologic cross section shown in Figure 36. The sand was not as extensive as the deposits at the southern Mirabeau breach, only reaching a thickness of about 3 feet, and only filling the street in front of the breach, but not extending into the back yards of houses on the other side of the street.

Figure 39. Sand deposits and peat blocks (black) behind homes on Pratt Drive at the North breach of the London Ave. Canal. Note the sand boil on the right. Gray material in the foreground is gravel used in the repair of the breach.

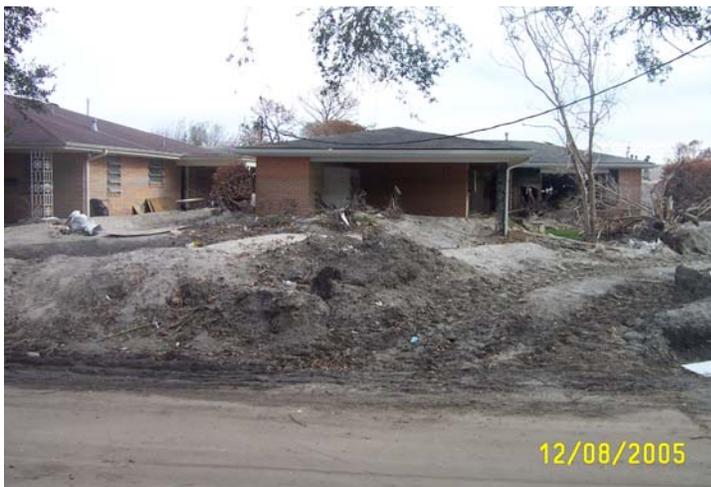
Figure 40. Sand deposits in front of houses on Pratt Drive at the North breach of the London Ave. Canal.

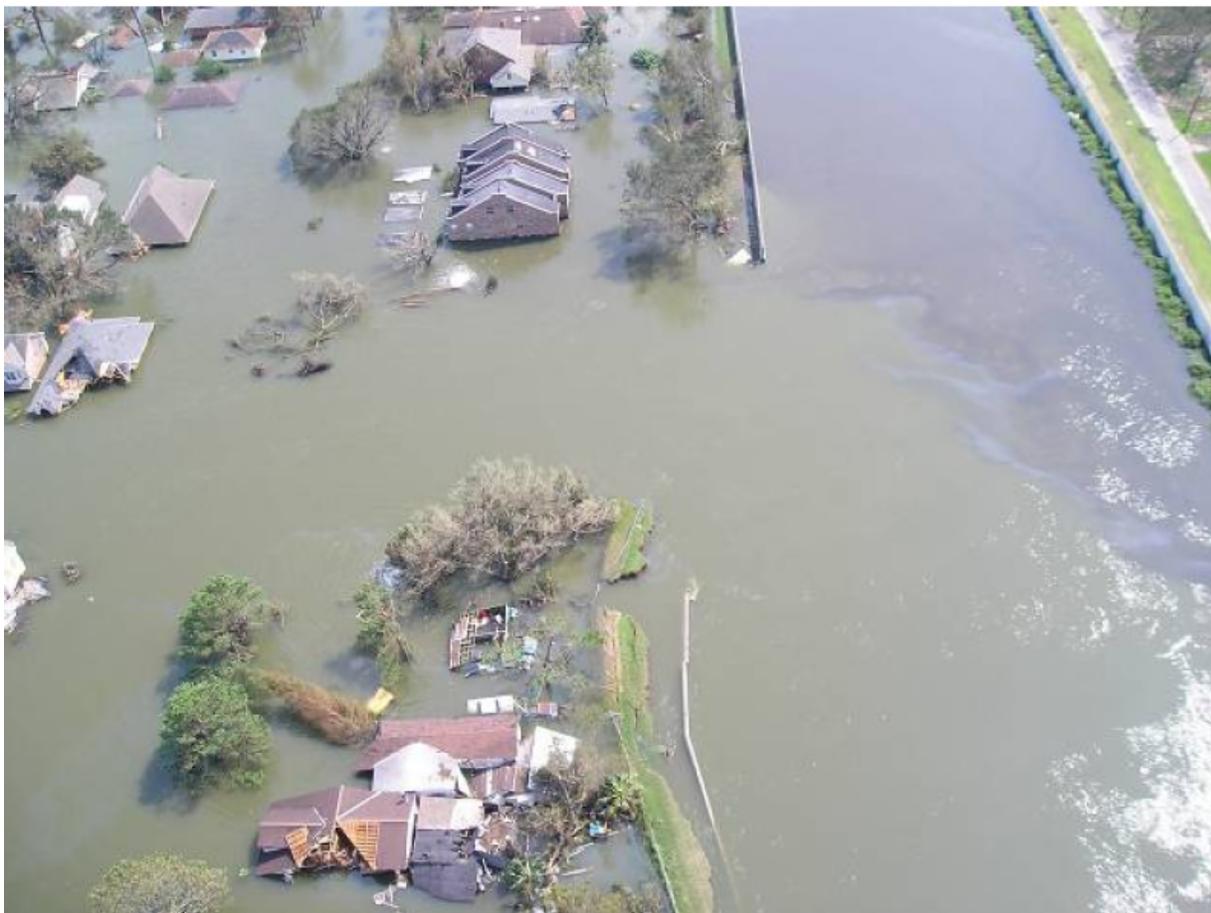
Figure 43. View of 17th St. Canal breach looking toward south. Note displaced floodwall and levee just below the missing section of the levee. Photo from IPET Report .

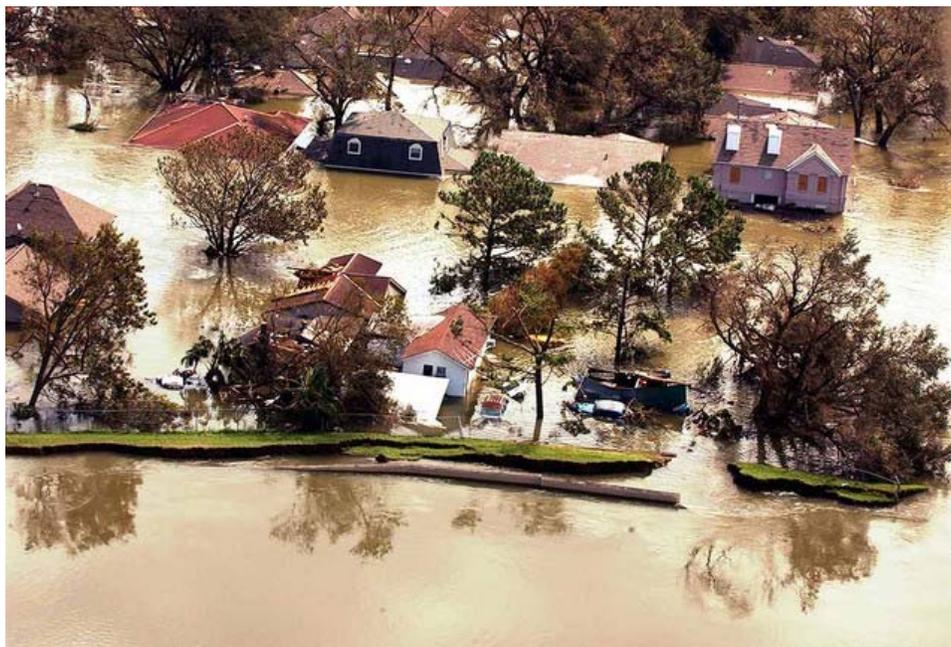
Figure 44. View of 17th St. Canal breach looking toward east. Note fractures in the displaced part of the levee. Photo by J. Augustino FEMA.

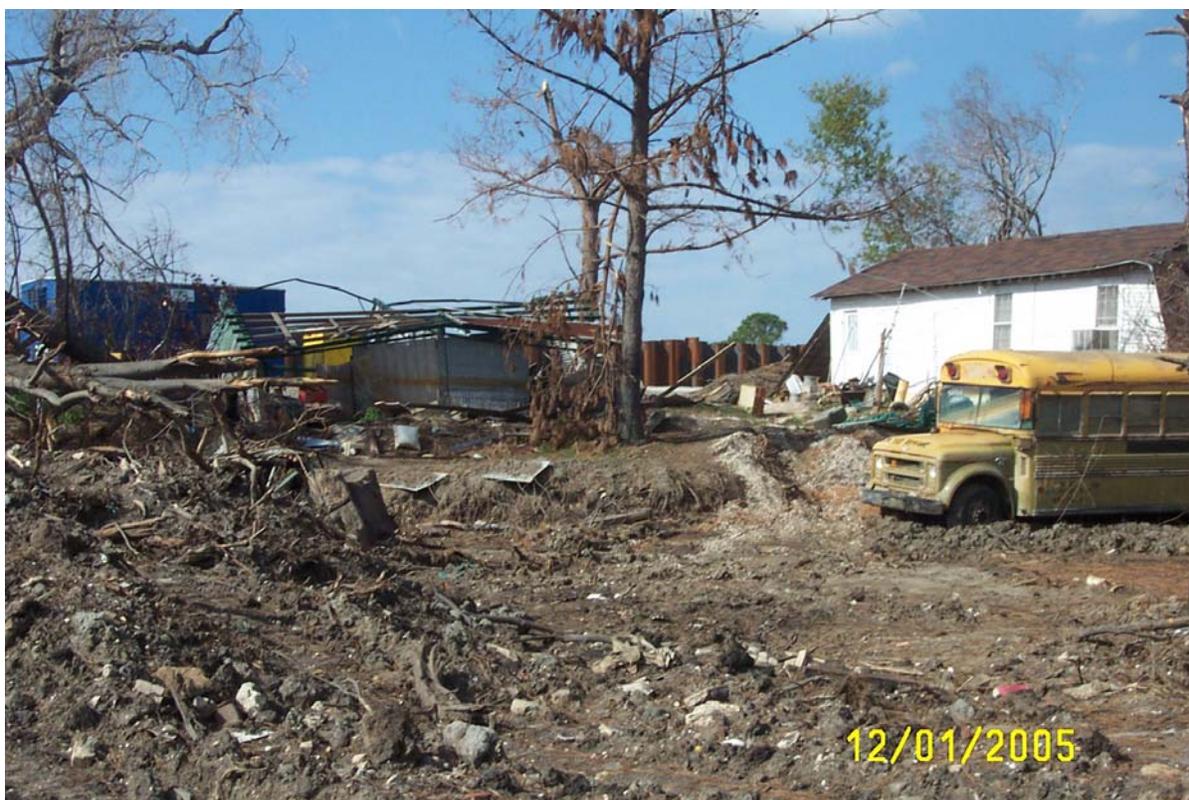
Figure 45. . Slide toe (at abrupt change in slope in front of school bus) where levee and neighborhood were displaced about 45 feet toward the viewer.

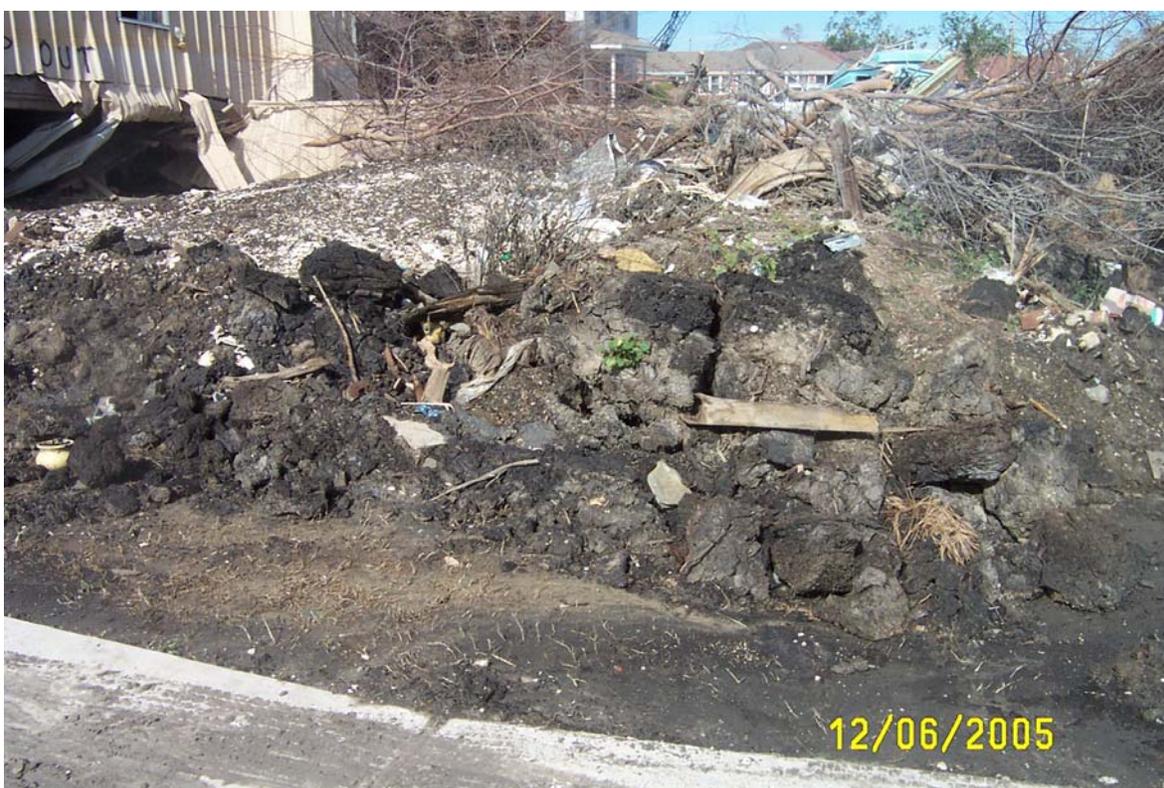
Before the debris was completely removed, large blocks of peat were present throughout the neighborhood, some of which could be found a block away to the east near Fleur de Lis Blvd. Examples of the peat blocks before their removal can be seen in Figure 46 and the upper right photograph in Figure 51.

Figure 46. Blocks of Peat along Belaire Drive near the 17th St. Canal levee breach

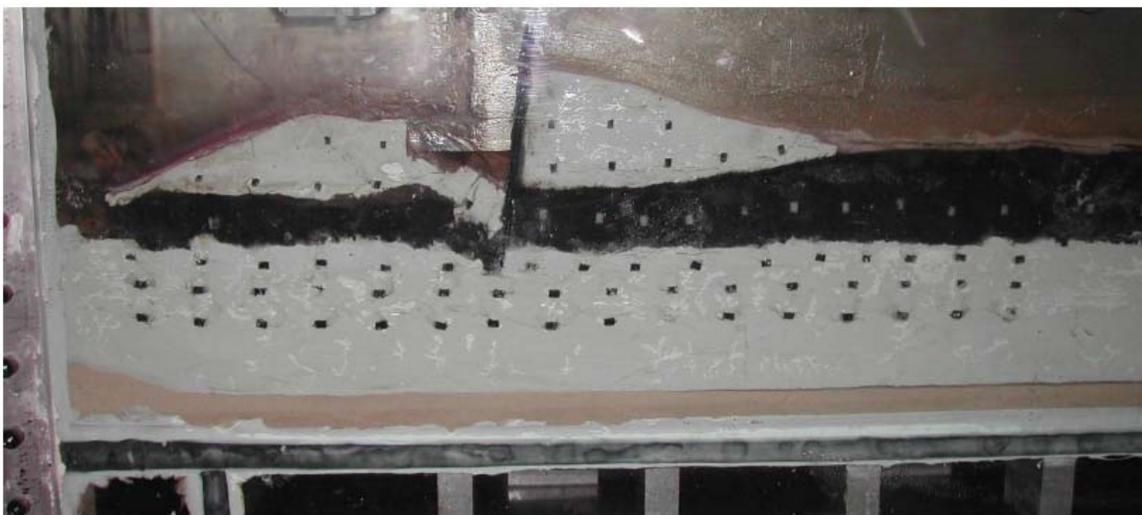
Figure 49. Photograph of failed levee and floodwall in IPET's scale model centrifuge experiment representing the 17th St. Canal. The white at the top is clay and represents the levee. This overlies the dark peat layer, which in turn overlies another white clay layer meant to represent the estuary deposits beneath the peaty marsh deposits. Small rectangles were initially laid out in a rectangular grid and can be used to determine how much deformation has occurred during the experiment. (IPET, 2006).

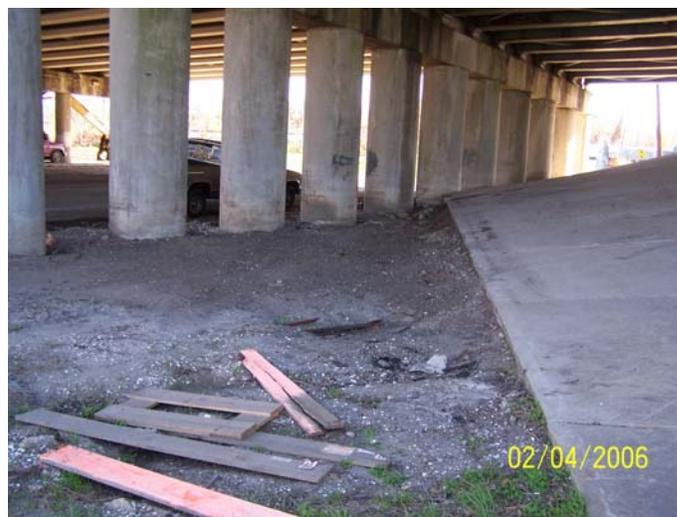
Figure 54. Erosion around the support structures for I-610 near Orleans Canal on Marconi Ave (Stop 9).
