Hurricane Katrina - What Happened? The Geology of the Katrina Disaster in New Orleans

AEG Field Trip
September 16 & 20, 2008

Stephen A. Nelson
Department of Earth &
Environmental Sciences
snelson@tulane.edu

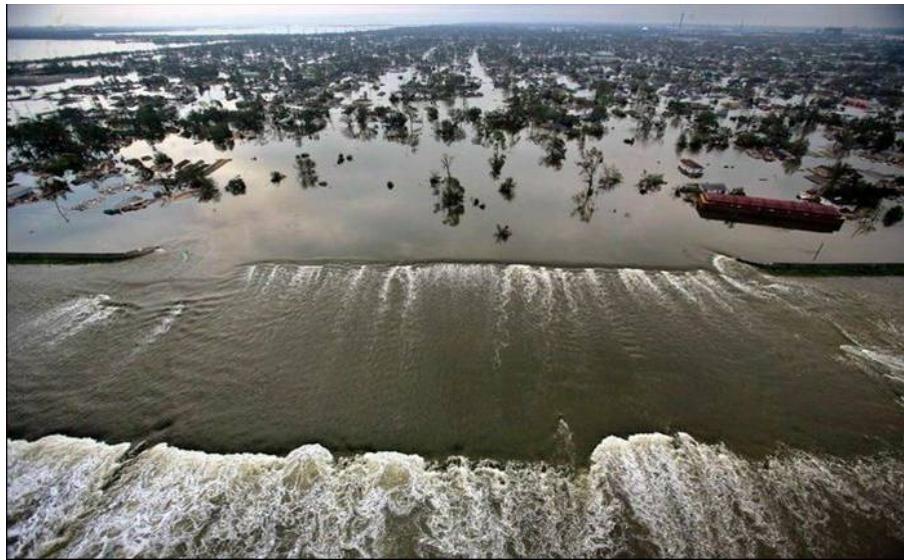
Figure 13. The large breach in the Industrial canal that flooded the Lower Ninth Ward could have been caused by a barge crashing through the floodwall during Katrina. Alternatively the barge could have floated in after the levee and floodwall were breached. Note the barge in the photo above. Note also that at the time of this photo water was running out of the Lower Ninth Ward back into the Industrial Canal. (Source - Vincent Laforet, AFP/Getty Images)

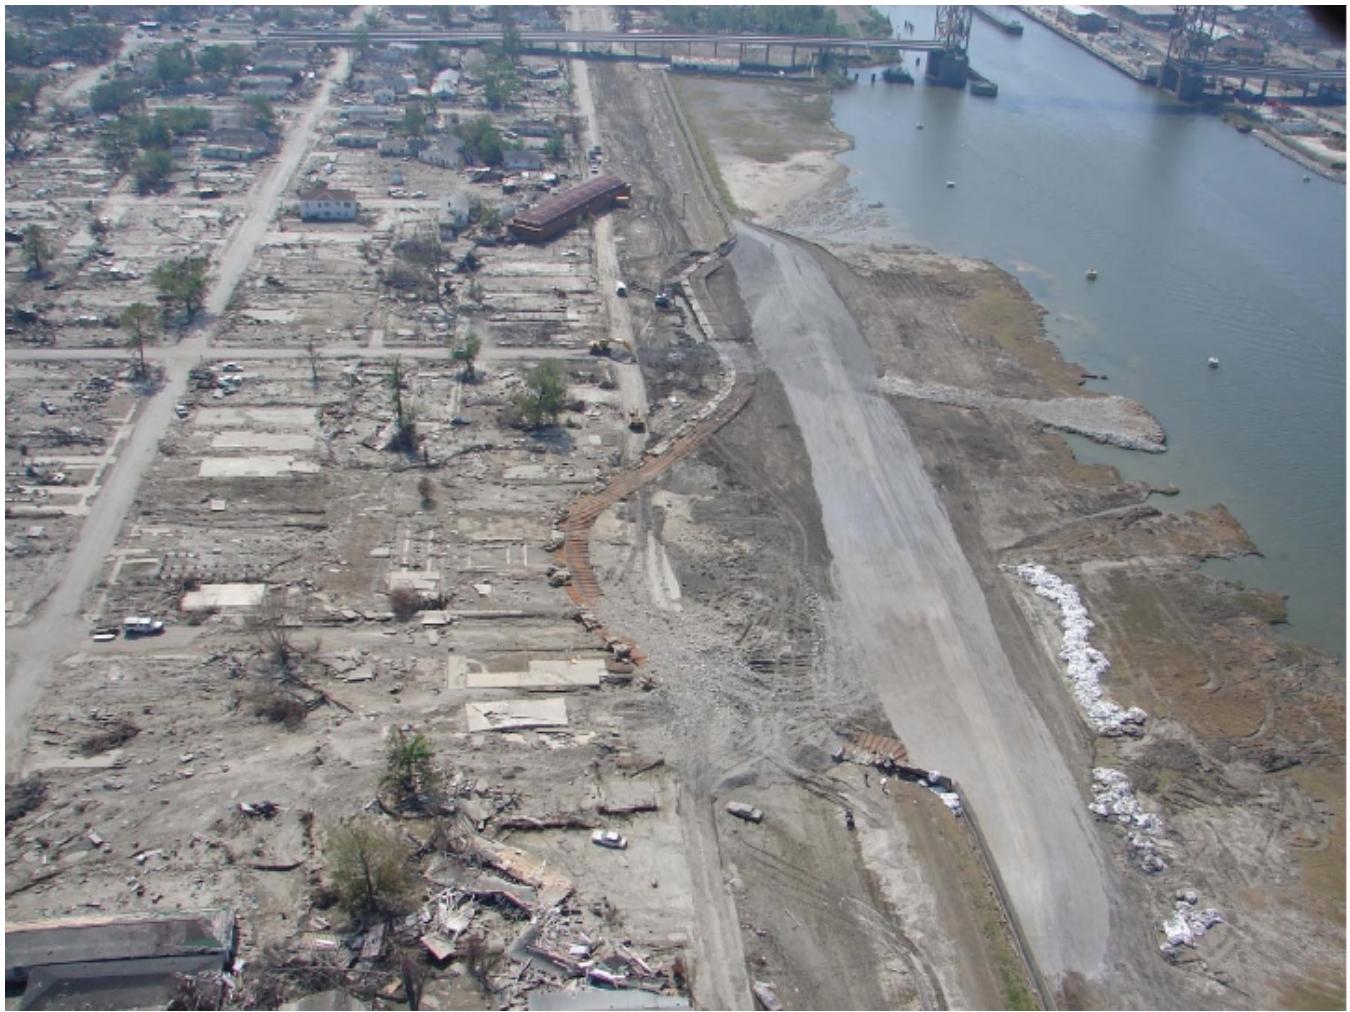
Figure 14. View of southern breach on the Industrial Canal, looking South. Note the floodwall and sheet piling (brown) strewn through the Lower Ninth Ward neighborhood where all houses were removed by the force of water coming through the breach. Gray deposits on right are breach repair gravels. Note barge near in the center near the top of the photo. Photo by L. Harder - Independent Levee Investigation Team Final Report (2006).

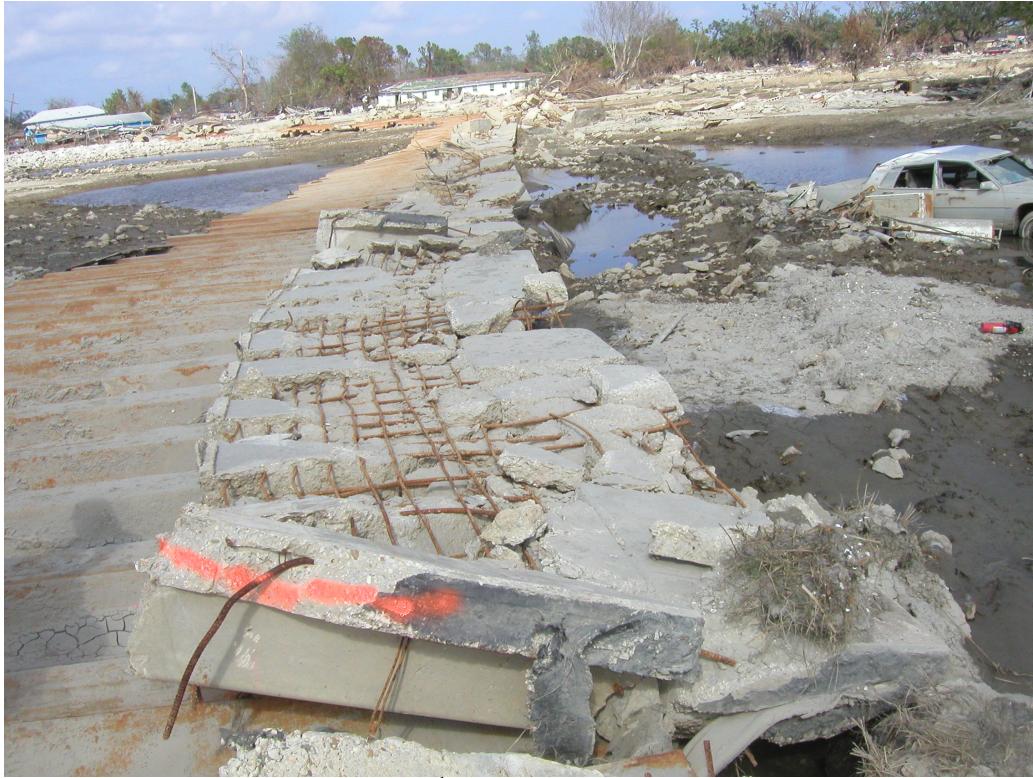
Figure 15. Floodwall and sheet piling strewn into Lower 9th Ward at the southern (larger) breach on the Industrial Canal. Photo from U.S. Army Corps of Engineers IPET web site, taken October 4, 2005.

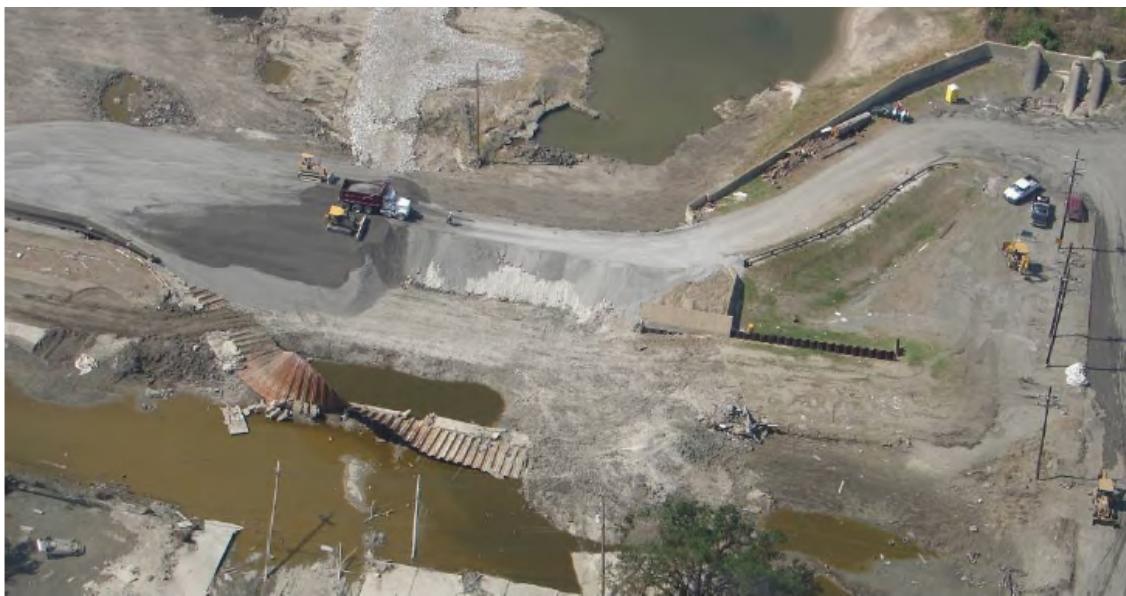
Figure 16. Aerial view of the north breach on Industrial Canal. Photo by L. Harder - Independent Levee Investigation Team Final Report (2006).

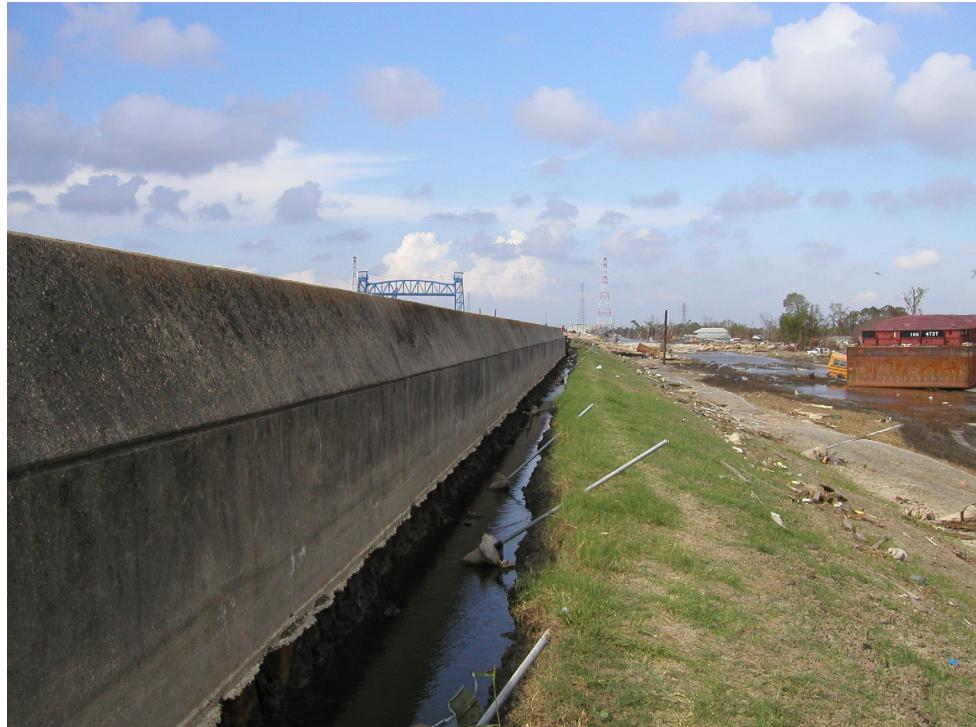
Photographs available on the U.S. Army Corps of Engineers, Interagency Performance Evaluation Task Force (IPET) web site and reproduced in Figure 17, show that along portions of the floodwall that did not fail, water flowing over the top of the floodwall eroded trenches on the protected side of the levee. It is likely that this could have removed enough support on the protected side that the floodwalls and their underlying sheet piling eventually toppled into the protected side of the canal sending a huge surge of water into the Lower 9th Ward.

Figure 17. Looking North along the floodwall of the Industrial Canal levee showing trenches eroded by water from the Industrial Canal that overtopped the floodwall. Breached section is just beyond the barge and barely discernable in this view. Florida Avenue Bridge (blue) in upper center. Photo from U.S. Army Corps of Engineers IPET web site, taken October 4, 2005.

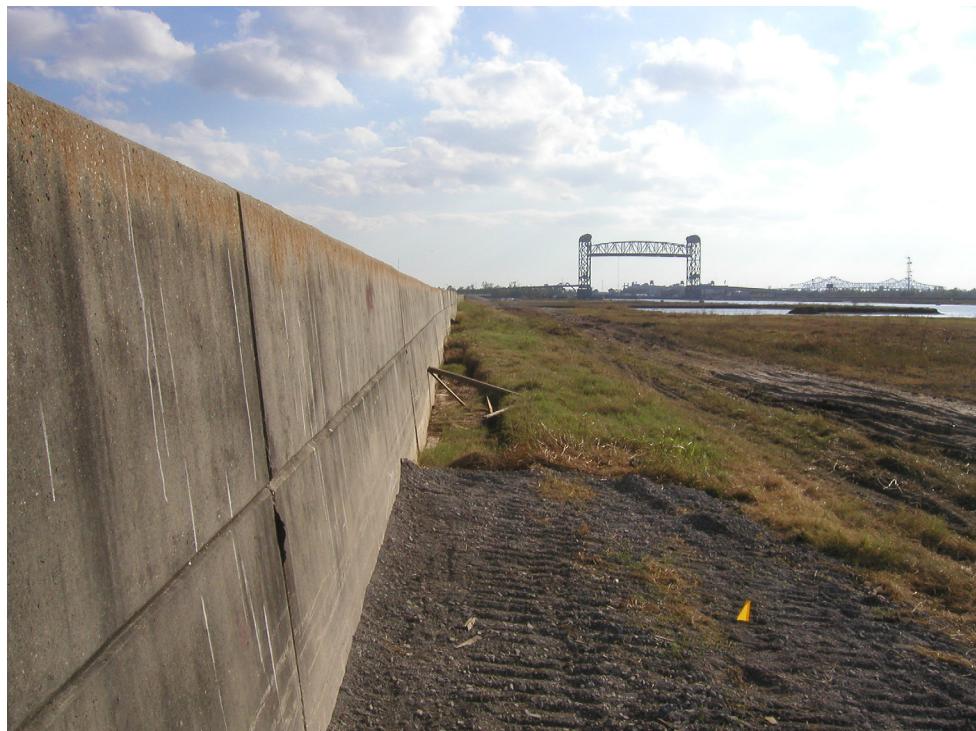
Figure 18. Looking South along the floodwall of the Industrial Canal on the inside of the floodwall between the two breaches showing the floodwall leaning toward the left (east) with a block of the levee next to the floodwall dropped down (near center of picture). Claiborne Ave. Bridge in right center. Photo from U.S. Army Corps of Engineers IPET web site, taken October 4, 2005.

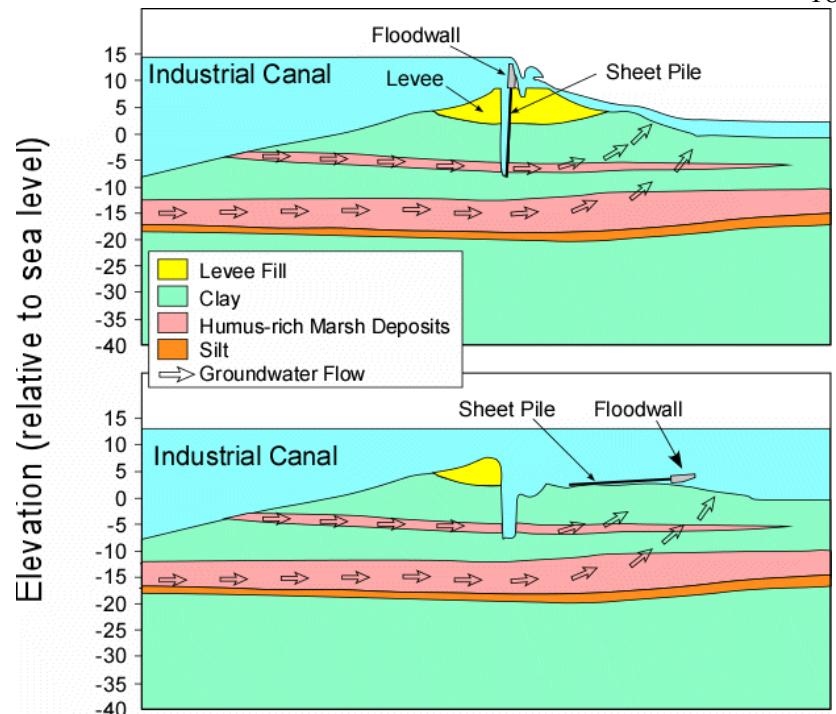
The Interagency Performance Evaluation Task Force (IPET, 2006) agreed that the main cause of failure here was the result of the surge waters in the Industrial Canal overtopping the floodwall and eroding away the levee on the protected side, but the Independent Levee Investigation Team (ILIT, 2006) suggests another cause. They do agree that erosion of the levee on the protected side could have contributed, but their analysis indicates that the geological conditions present in the subsurface along with the shallow depth to the tip of the sheet pilings resulted in hydraulic piping beneath the sheet pilings which undermined the levee and caused it and the floodwall to collapse. Two layers of highly permeable marsh deposits occur at a shallow depth below the levee (Fig. 21). According to the analysis of ILIT (2006), the added pressure in the canal forced water through these permeable layers and out at the toe of the levee on the protected side, thus removing support for the floodwall and levee.

Figure 21. Possible failure mechanism at the Industrial Canal Levee breach in near the Lower 9th Ward

At Stop 1 in the Lower 9th Ward, one now sees that the entire floodwall between the two bridges (Claiborne to the south and Florida Avenue to the North – the blue colored bridge) has been replaced with a T-wall with a top elevation at 14.5 feet above sea level, the level it was supposed to have attained prior to Katrina. This new floodwall was completed in mid-June, 2006. The original I-wall is still present along the other side of the Industrial Canal as well as to the south and north of the new T-wall. The only improvement made to the levees where the I-walls still exist is concrete armoring has been added to the base of the I-wall to prevent the erosion of the levee should water come over the top of the wall again.

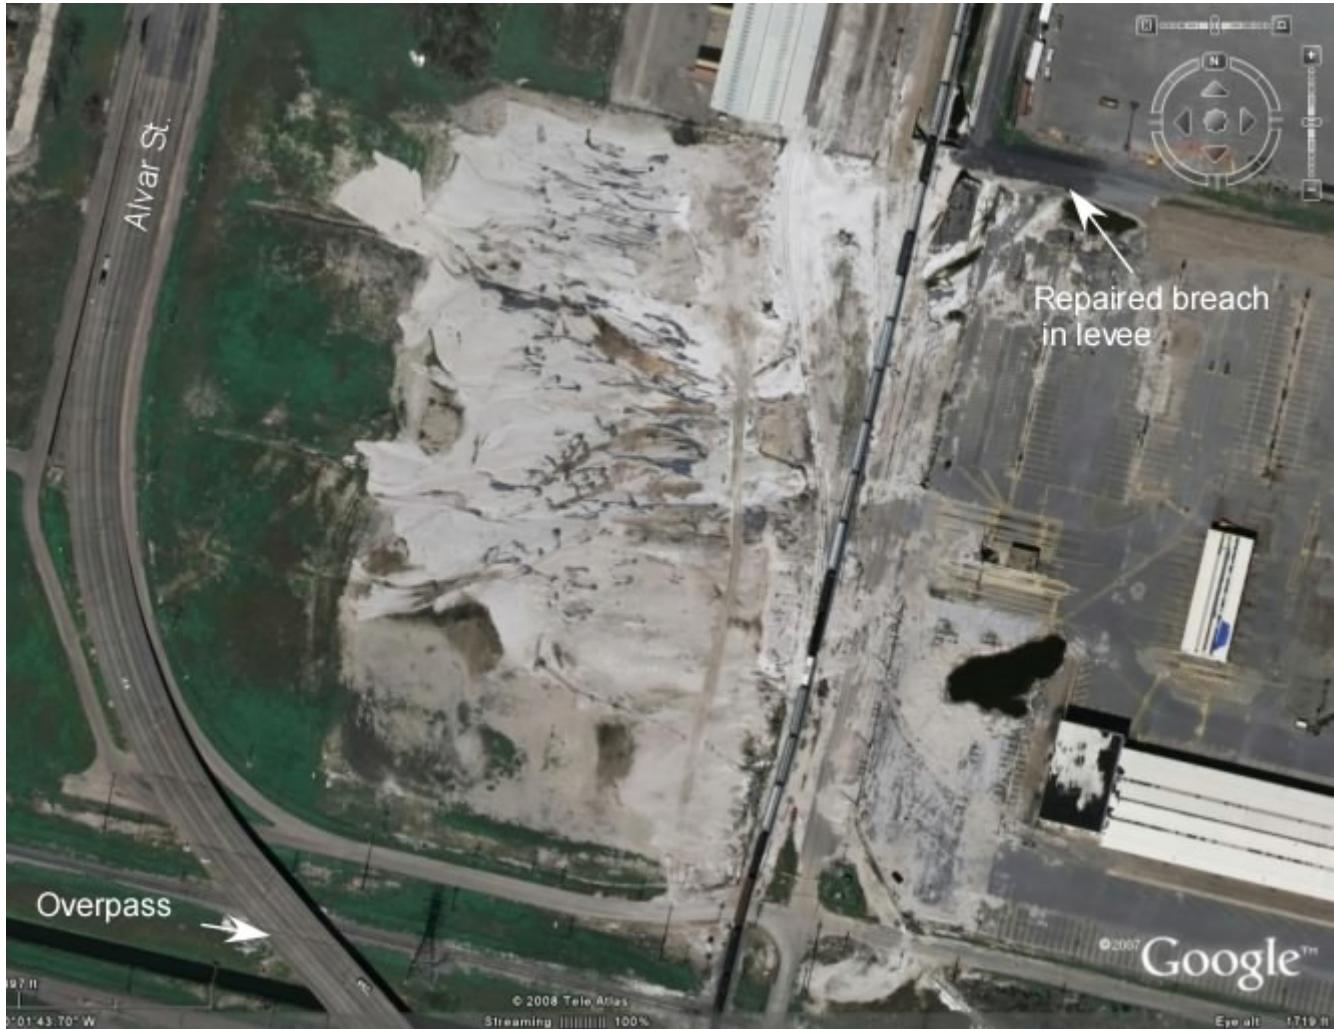
Figure 23. Google Image (acquired around May, 2006) of area near overpass to Alvar St. showing location of breached levee and deposits of shells (white material in center of image) that resulted from the breach. Industrial Canal is off the image to the right (east).

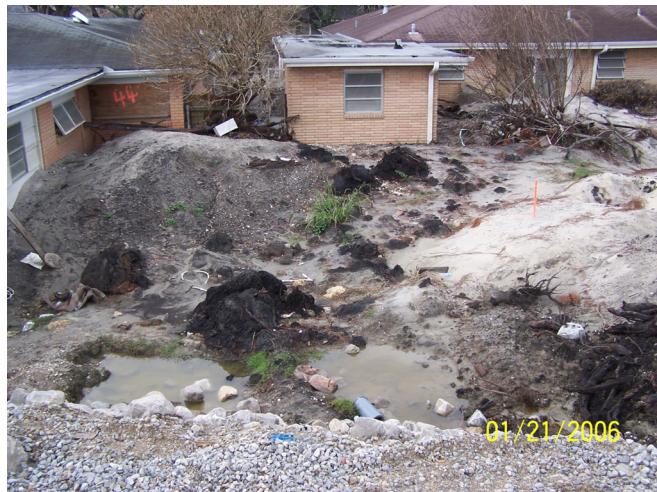
After the water was drained from the area, deposits of sand along with blocks of peat were observed to have filled the street and the backyards of houses along Pratt Drive (Figs. 36 and 37). The sand deposits were similar to the ones observed at the Mirabeau Ave. breach, but also contain blocks of peat as expected from the geologic cross section shown in Figure 33. The sand was not as extensive as the deposits at the southern Mirabeau breach, only reaching a thickness of about 3 feet, and only filling the street in front of the breach, but not extending into the back yards of houses on the other side of the street.

Figure 36. Sand deposits and peat blocks (black) behind homes on Pratt Drive at the North breach of the London Ave. Canal. Note the sand boil on the right. Gray material in the foreground is gravel used in the repair of the breach.

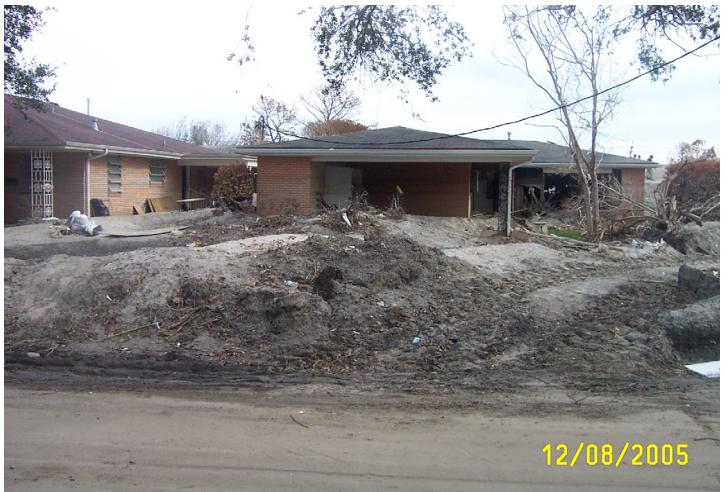
Figure 37. Sand deposits in front of houses on Pratt Drive at the North breach of the London Ave. Canal.

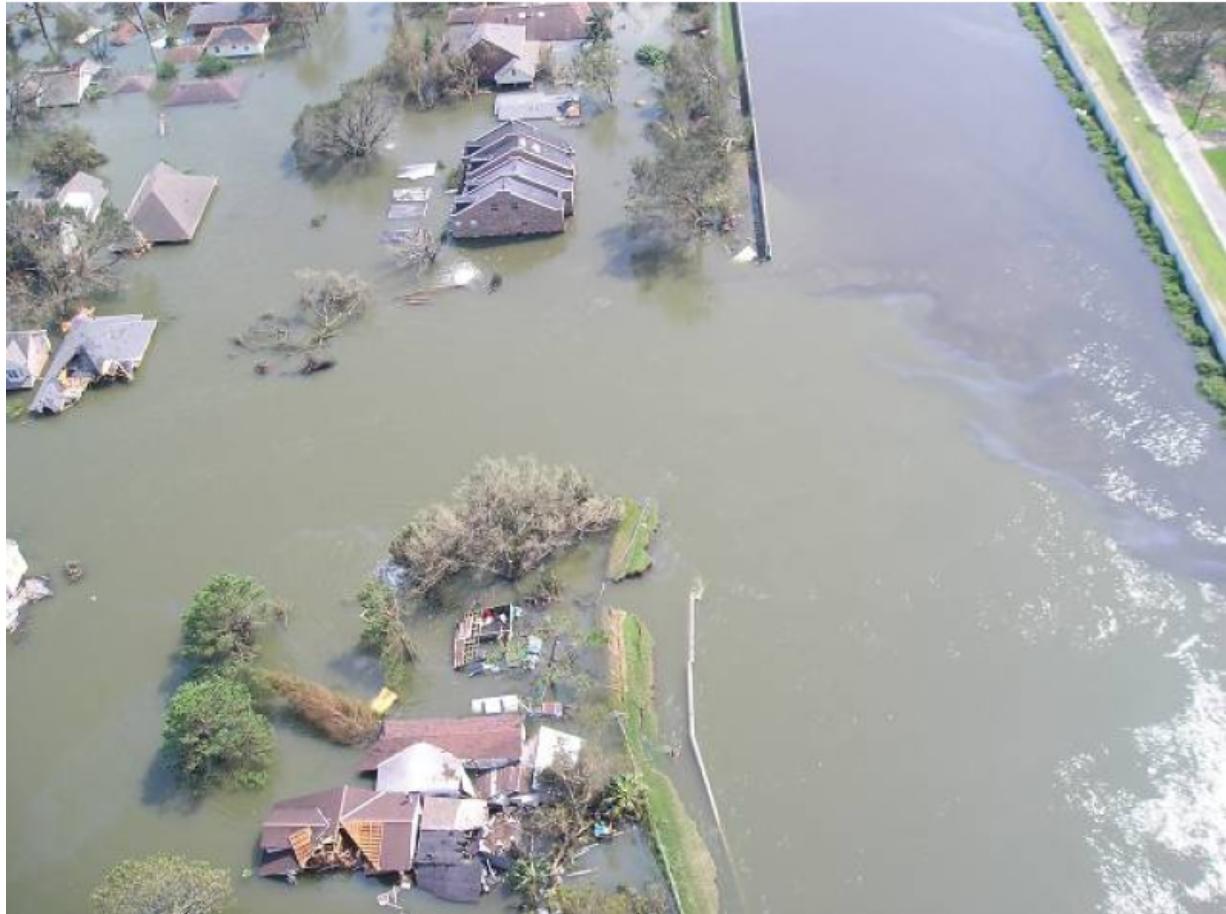
Figure 40. View of 17th St. Canal breach looking toward south. Note displaced floodwall and levee just below the missing section of the levee. Photo from IPET Interim Report 2.

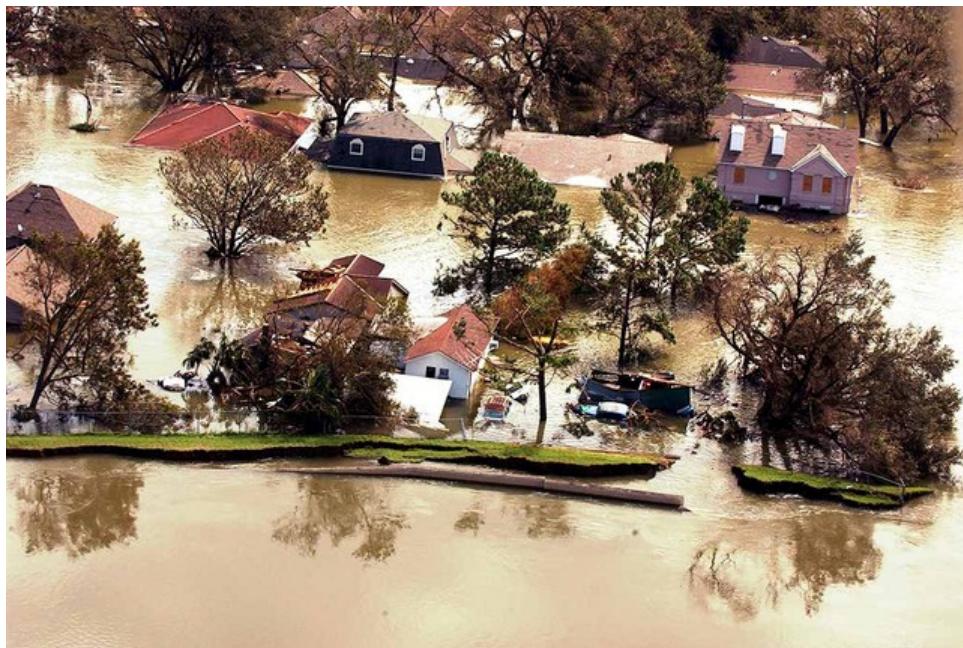
Figure 41. View of 17th St. Canal breach looking toward east. Note fractures in the displaced part of the levee. Photo by J. Augustino FEMA.

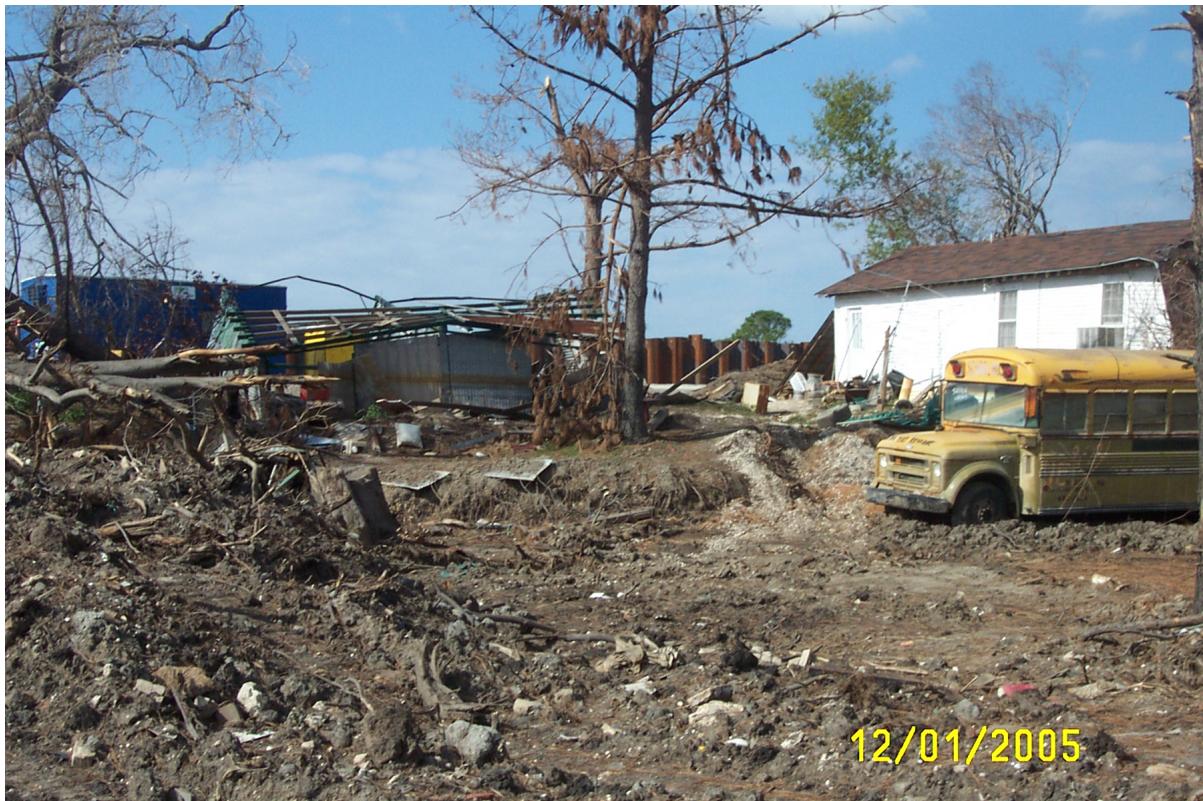
Figure 42. . Slide toe (at abrupt change in slope in front of school bus) where levee and neighborhood were displaced about 45 feet toward the viewer.

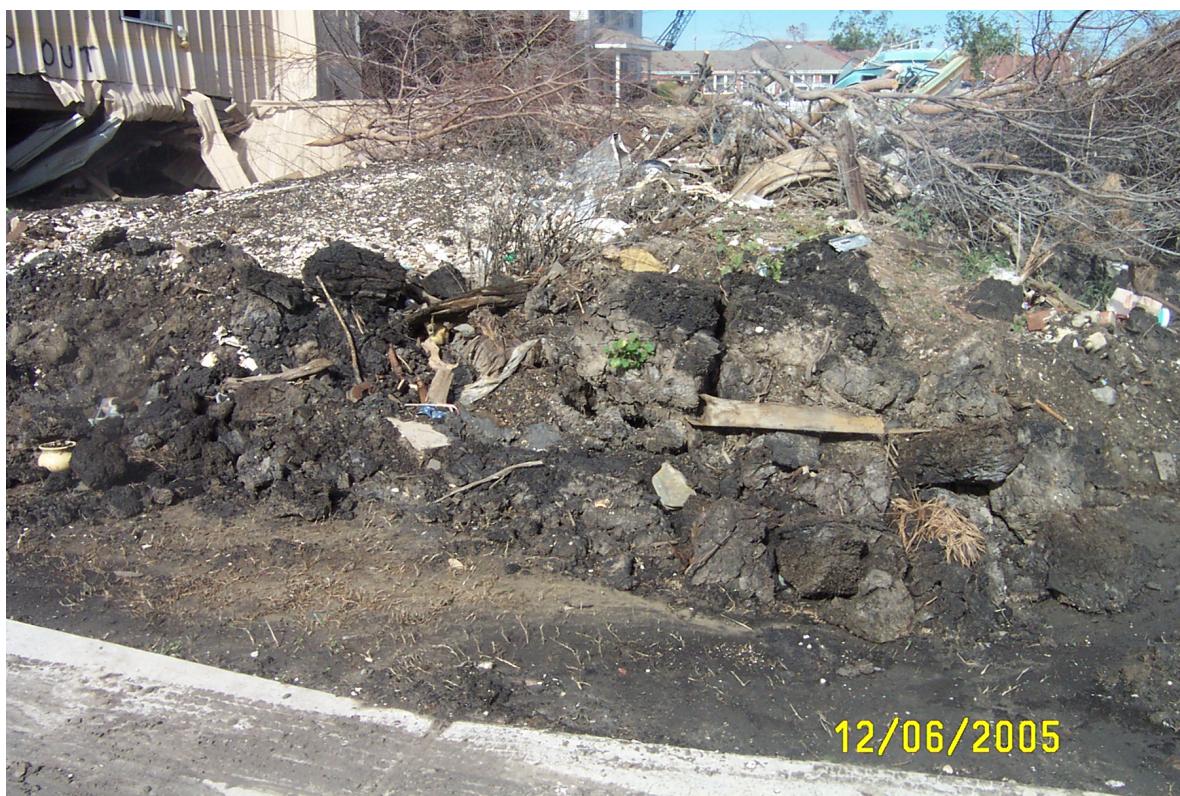
Before the debris was completely removed, large blocks of peat were present throughout the neighborhood, some of which could be found a block away to the east near Fleur de Lis Blvd. Examples of the peat blocks before their removal can be seen in Figure 43 and the upper right photograph in Figure 48.

Figure 43. Blocks of Peat along Belaire Drive near the 17th St. Canal levee breach

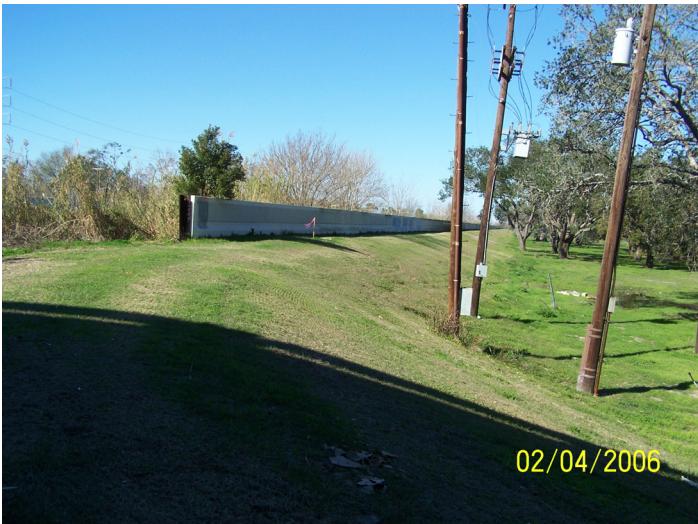
Figure 50. End of floodwall on Orleans Canal just north of I-610 overpass near Marconi Ave. (Stop 6)

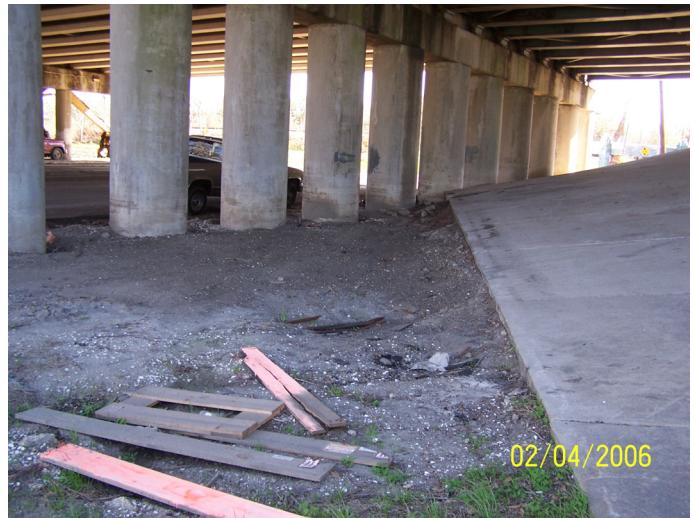
Figure 51. Erosion around the support structures for I-610 near Orleans Canal on Marconi Ave (Stop 6).
