Overview of New Orleans Levee Failures: Lessons Learned and Their Impact on National Levee Design and Assessment

G. L. Sills, P.E., M.ASCE¹; N. D. Vroman, P.E.²; R. E. Wahl, P.E., M.ASCE³; and N. T. Schwanz, P.E.⁴

DOI: 10.1061/(ASCE)1090-0241(2008)134:5(556)

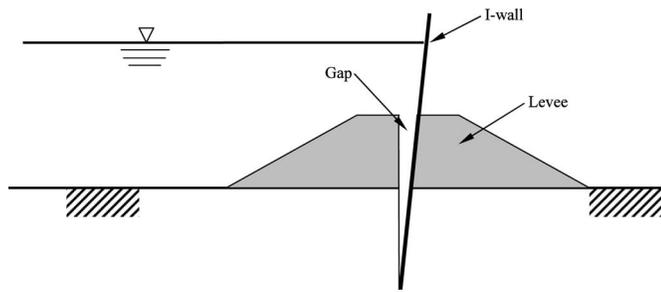
Fig. 3. Diagram of I-wall gap

levee, where it exited through the marsh layer. In addition, all three methods show that the formation of a gap between the sheet-pile wall and the canal-side portion of the levee was an essential element in the development of the failure. Results of all three methods are consistent with the observations made during field investigations soon after the storm (IPET 2006, Vol. 5).

During the postfailure field investigations, a gap on the floodside of the wall was observed along the I-walls near the breach. Significant wall movement near the breach indicated that deep-seated movements occurred in the foundation. A timeline of events pieced together from data from hydrographs and eyewitness accounts provided evidence that this breach occurred before canal waters reached the top of the floodwall. Slope stability analysis was performed on a representative section of the north breach of IHNC. The slope stability analysis indicated that a foundation failure was likely. This foundation failure resulted from differences between the actual conditions and assumptions used as the basis for the design. Those differences are: (1) the ground surface beyond the toe of the levee at the north breach location was lower than the landside ground surface in the design cross section; and (2) the design analyses did not consider the possibility of a gap forming behind the wall as shown in Fig. 3, allowing water to fill the gap and increasing the load on the wall.

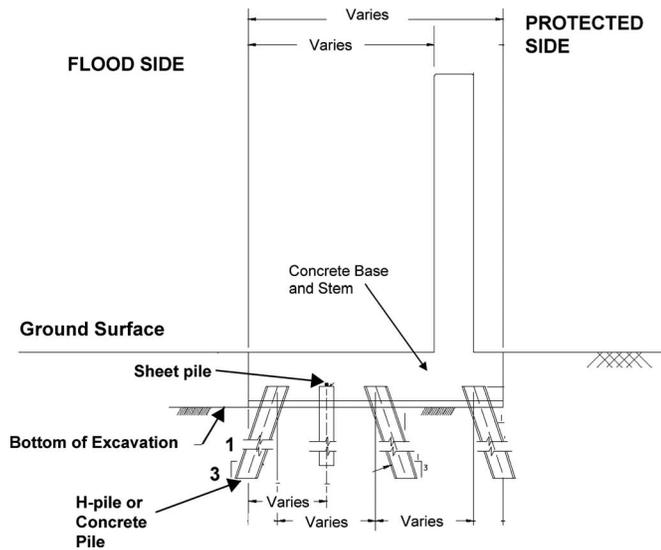
Fig. 4. Typical T-wall cross section

Driving temporary steel sheet piling and placing earth fill on the landward side closed the breaches along the outfall canals until concrete T-walls could be built. Knowing that performance problems existed with the composite levee/I-wall barriers, TFG chose to replace the failed wall sections using T-walls supported on deep piled foundations with sheet-pile seepage cutoff. Repairs could not wait until forensic studies were completed so conservative measures were made to reestablish protection. Sheet-pile lengths were selected to cut off any underlying sand strata that might have a hydraulic connection to the canal. Additionally, designers felt that T-walls offered good protection because of their resiliency and good performance during Katrina.

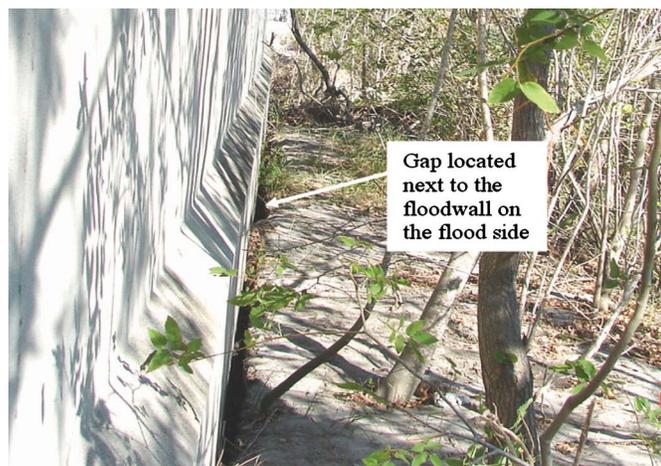
For both the north and south breaches, the formation of a gap between the canal side levee and the floodwall likely had a major impact on the performance of the I-wall and levee during Katrina. At the London Avenue Canal, the formation of a gap down to the sand resulted in another consequence that destabilized the levee by providing a path for water to flow down into the sand layer. This contributed to high pore-water pressures and led to instability of the levee/sheet-pile wall. Other factors that likely contributed to high pore-water pressures and instability were storm surge scour of fine grained sediments lining the canal that isolated the

Fig. 5. Gap found near north London Avenue Canal breach
