Hurricane Katrina - What Happened? The Geology of the Katrina Disaster in New Orleans

Field Trip Guide Updated 9-17-2009

Stephen A. Nelson
Department of Earth &
Environmental Sciences
snelson@tulane.edu

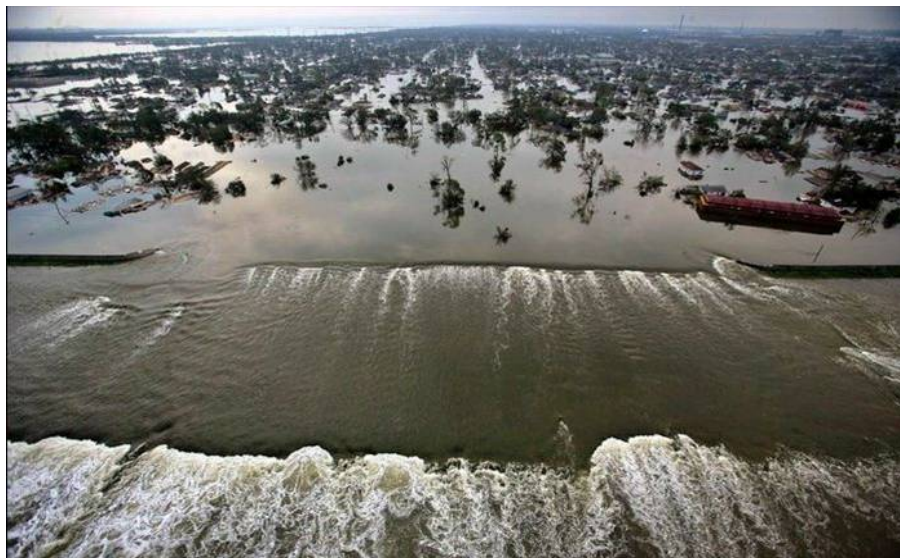
Figure 13. The large breach in the Industrial canal that flooded the Lower Ninth Ward could have been caused by a barge crashing through the floodwall during Katrina. Alternatively the barge could have floated in after the levee and floodwall were breached. Note the barge in the photo above. Note also that at the time of this photo water was running out of the Lower Ninth Ward back into the Industrial Canal. (Source - Vincent Laforet, AFP/Getty Images)

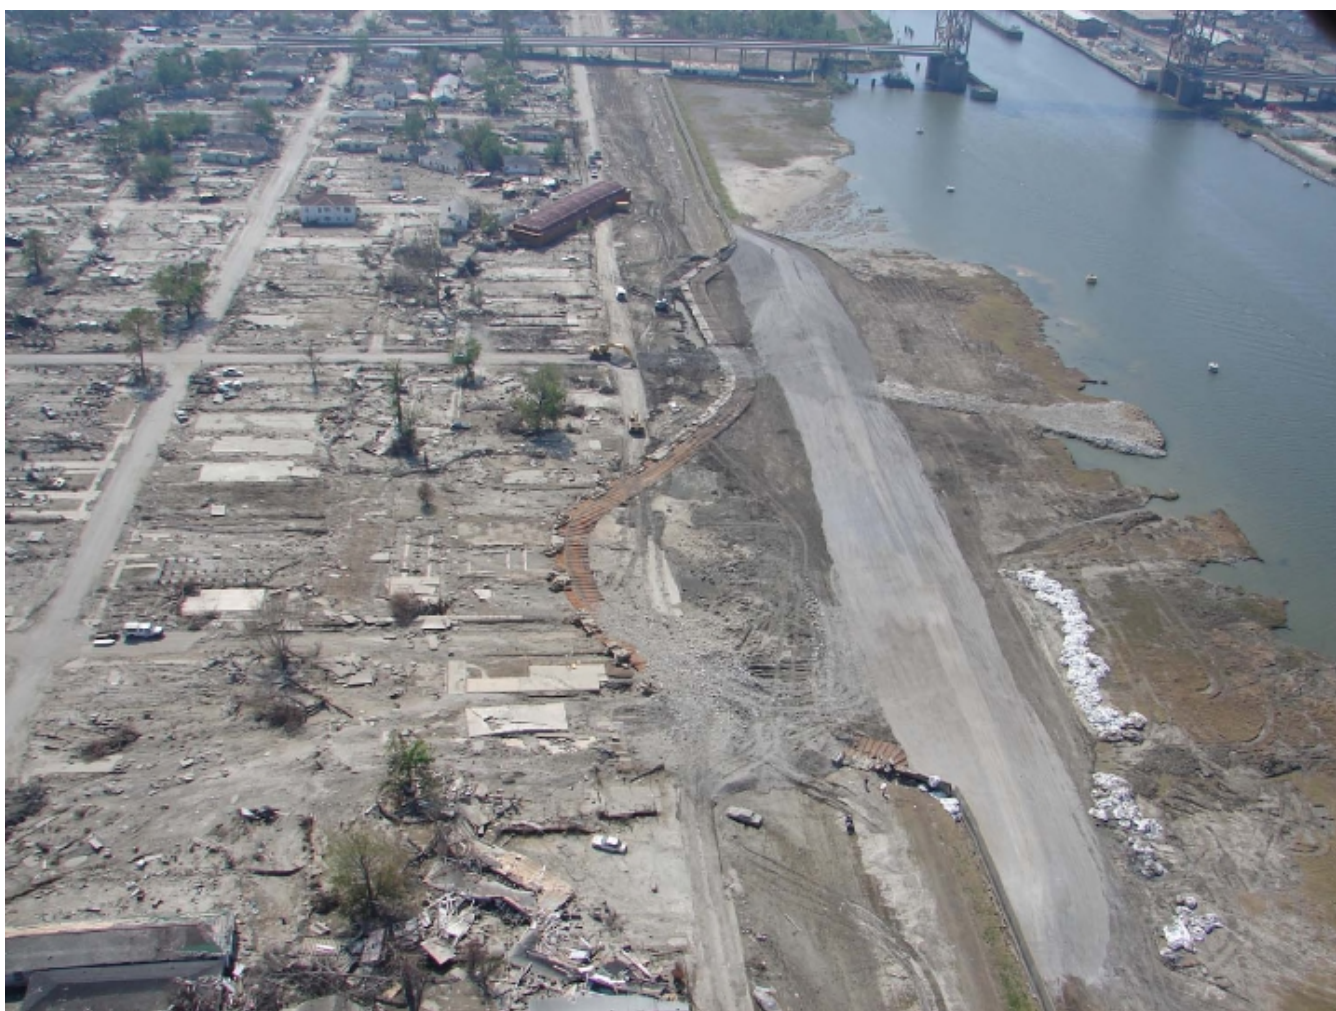
Figure 14. View of southern breach on the Industrial Canal, looking South. Note the floodwall and sheet piling (brown) strewn through the Lower Ninth Ward neighborhood where all houses were removed by the force of water coming through the breach. Gray deposits on right are breach repair gravels. Note barge near in the center near the top of the photo. Photo by L. Harder - Independent Levee Investigation Team Final Report (2006).

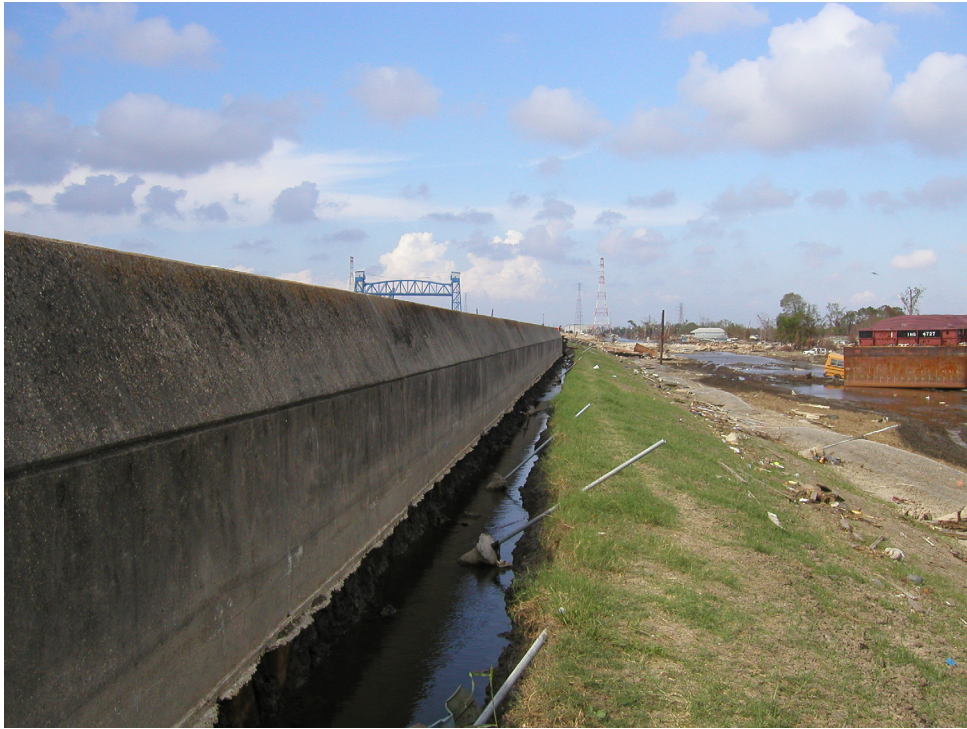
Photographs available on the U.S. Army Corps of Engineers, Interagency Performance Evaluation Task Force (IPET) web site and reproduced in Figure 17, show that along portions of the floodwall that did not fail, water flowing over the top of the floodwall eroded trenches on the protected side of the levee. It is likely that this could have removed enough support on the protected side that the floodwalls and their underlying sheet piling eventually toppled into the protected side of the canal sending a huge surge of water into the Lower 9th Ward.

Figure 17. Looking North along the floodwall of the Industrial Canal levee showing trenches eroded by water from the Industrial Canal that overtopped the floodwall. Breached section is just beyond the barge and barely discernable in this view. Florida Avenue Bridge (blue) in upper center. Photo from U.S. Army Corps of Engineers IPET web site, taken October 4, 2005.

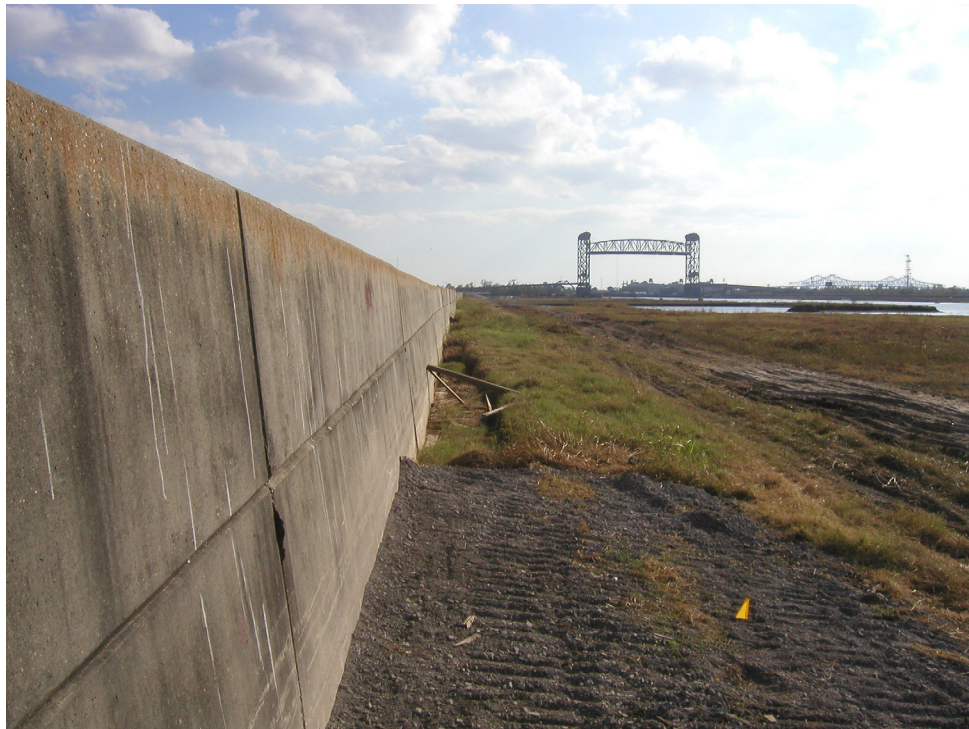
Figure 18. Looking South along the floodwall of the Industrial Canal on the inside of the floodwall between the two breaches showing the floodwall leaning toward the left (east) with a block of the levee next to the floodwall dropped down (near center of picture). Claiborne Ave. Bridge in right center. Photo from U.S. Army Corps of Engineers IPET web site, taken October 4, 2005.

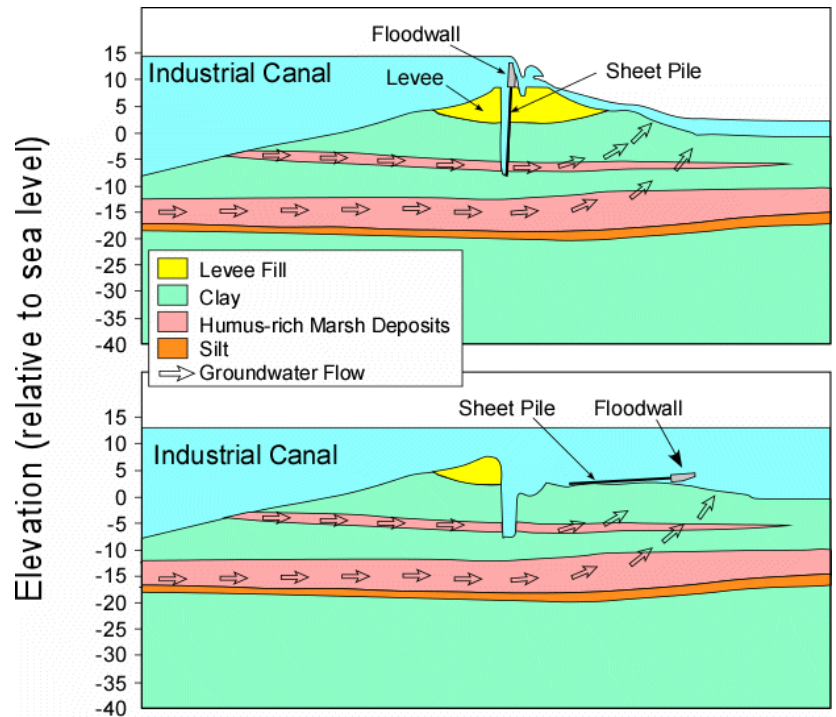
Although the floodwalls along the Industrial Canal were built in the 1970s, in 1985, the research branch of the Army Corps of Engineers conducted experiments on the I-wall design. They constructed a levee and enclosure in the Atchafalaya Basin (to the southwest of New Orleans) and began filling the area next to the levee and sheet pile floodwall with water. As the water rose against the floodwall, deflections of the floodwall began to occur and a gap opened on the water side of the floodwall which allowed the full hydrostatic force of the water to penetrate to the tip of the sheet piling (Jackson, 1988, Oner and others, 1997). This type of floodwall failure is illustrated in Figure 20. These findings were apparently never communicated to those in the Corps responsible for the design and construction of floodwalls in New Orleans (Marshall, March 14, 2006). The leaning floodwall seen in Figure 18 clearly shows that this also happened on the Industrial Canal floodwall during Hurricane Katrina. The force of the water pushing the wall outward toward the protected side coupled with removal of support by erosion caused by the water pouring over the top of the floodwall was the most likely cause of the catastrophic failures on the east side of the Industrial Canal (Fig. 21).

The Interagency Performance Evaluation Task Force (IPET, 2006) agreed that the main cause of failure here was the result of the surge waters in the Industrial Canal overtopping the floodwall and eroding away the levee on the protected side, but the Independent Levee Investigation Team (ILIT, 2006) suggests another cause. They do agree that erosion of the levee on the protected side could have contributed, but their analysis indicates that the geological conditions present in the subsurface along with the shallow depth to the tip of the sheet pilings resulted in hydraulic piping beneath the sheet pilings which undermined the levee and caused it and the floodwall to collapse. Two layers of highly permeable marsh deposits occur at a shallow depth below the levee (Fig. 21). According to the analysis of ILIT (2006), the added pressure in the canal forced water through these permeable layers and out at the toe of the levee on the protected side, thus removing support for the floodwall and levee.

Figure 21. Possible failure mechanism at the Industrial Canal Levee breach in near the Lower 9th Ward

At Stop 1 in the Lower 9th Ward, one now sees that the entire floodwall between the two bridges (Claiborne to the south and Florida Avenue to the North – the blue colored bridge) has been replaced with a T-wall with a top elevation at 14.5 feet above sea level, the level it was supposed to have attained prior to Katrina. This new floodwall was completed in mid-June, 2006. The original I-wall is still present along the other side of the Industrial Canal as well as to the south and north of the new T-wall. The only improvement made to the levees where the I-walls still exist is concrete armoring has been added to the base of the I-wall to prevent the erosion of the levee should water come over the top of the wall again.

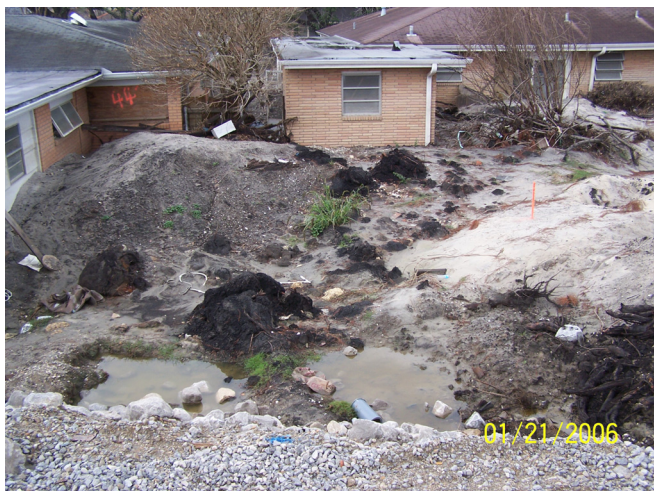
After the water was drained from the area, deposits of sand along with blocks of peat were observed to have filled the street and the backyards of houses along Pratt Drive (Figs. 37 and 38). The sand deposits were similar to the ones observed at the Mirabeau Ave. breach, but also contain blocks of peat as expected from the geologic cross section shown in Figure 33. The sand was not as extensive as the deposits at the southern Mirabeau breach, only reaching a thickness of about 3 feet, and only filling the street in front of the breach, but not extending into the back yards of houses on the other side of the street.

Figure 37. Sand deposits and peat blocks (black) behind homes on Pratt Drive at the North breach of the London Ave. Canal. Note the sand boil on the right. Gray material in the foreground is gravel used in the repair of the breach.

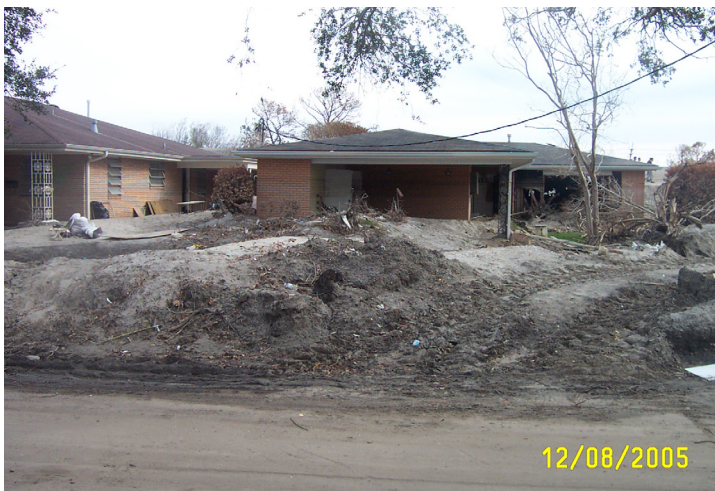
Figure 38. Sand deposits in front of houses on Pratt Drive at the North breach of the London Ave. Canal.

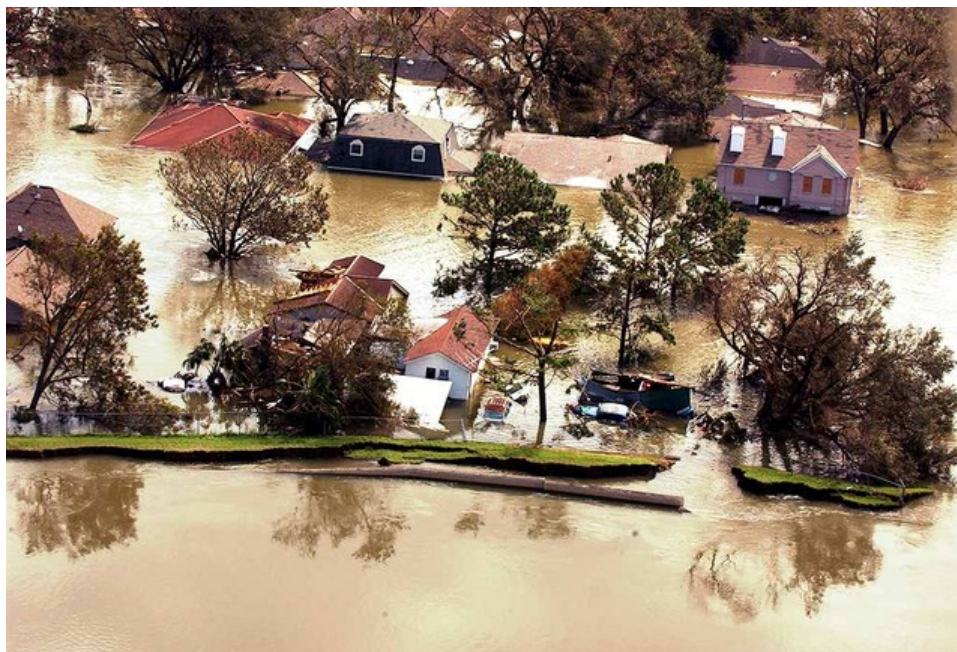
Figure 42. View of 17th St. Canal breach looking toward east. Note fractures in the displaced part of the levee. Photo by J. Augustino FEMA.

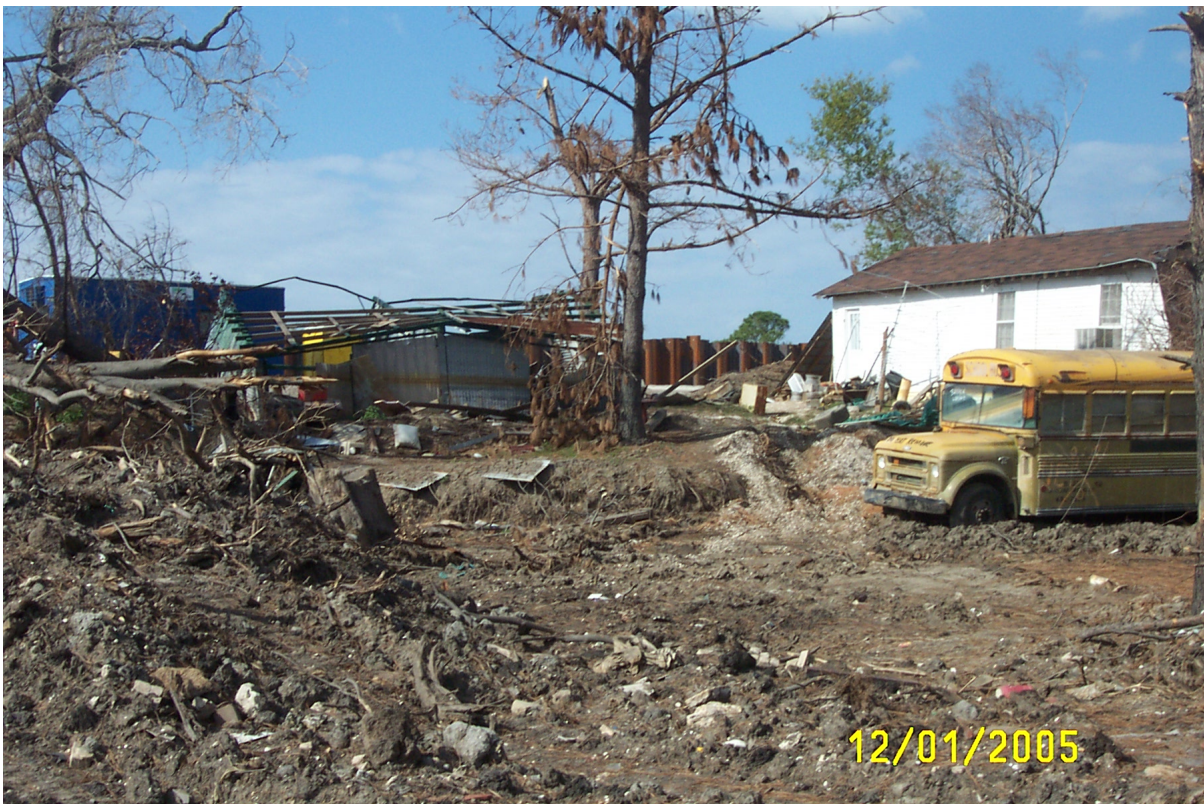
Figure 43. Slide toe (at abrupt change in slope in front of school bus) where levee and neighborhood were displaced about 45 feet toward the viewer.

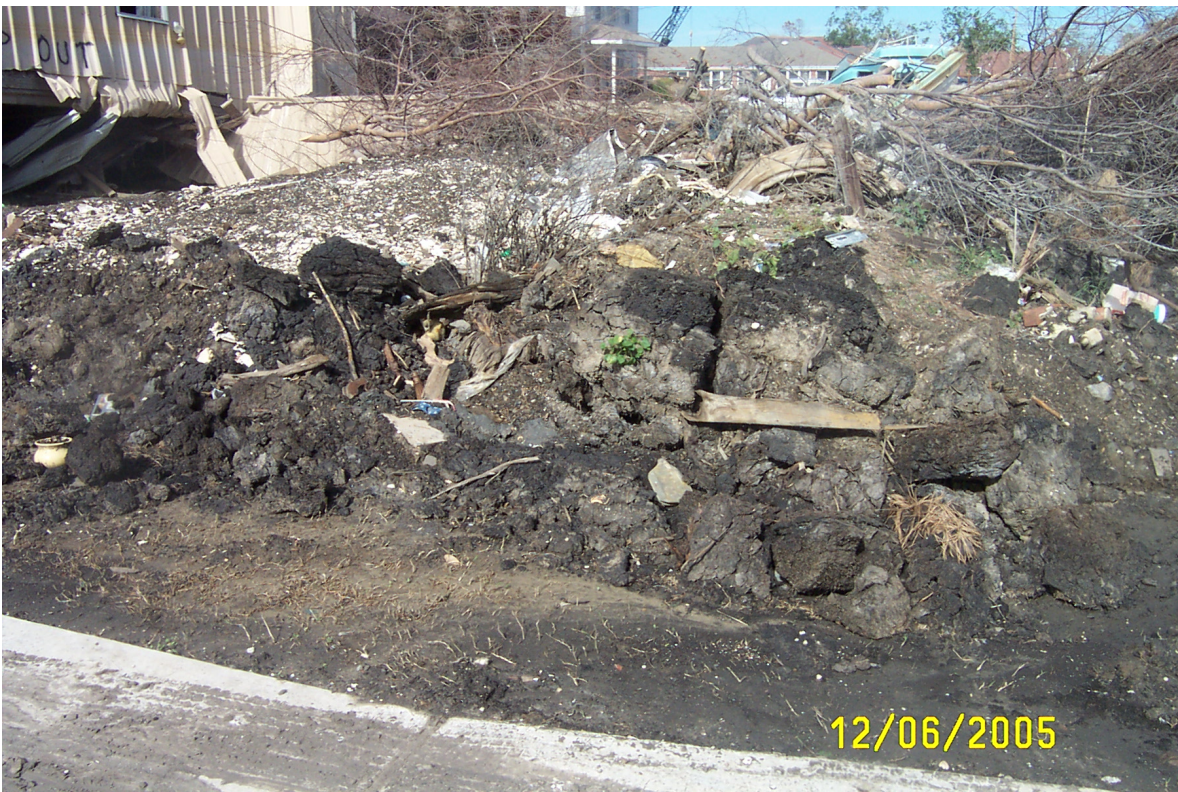
Before the debris was completely removed, large blocks of peat were present throughout the neighborhood, some of which could be found a block away to the east near Fleur de Lis Blvd. Examples of the peat blocks before their removal can be seen in Figure 44 and the upper right photograph in Figure 49.

Figure 44. Blocks of Peat along Belaire Drive near the 17th St. Canal levee breach

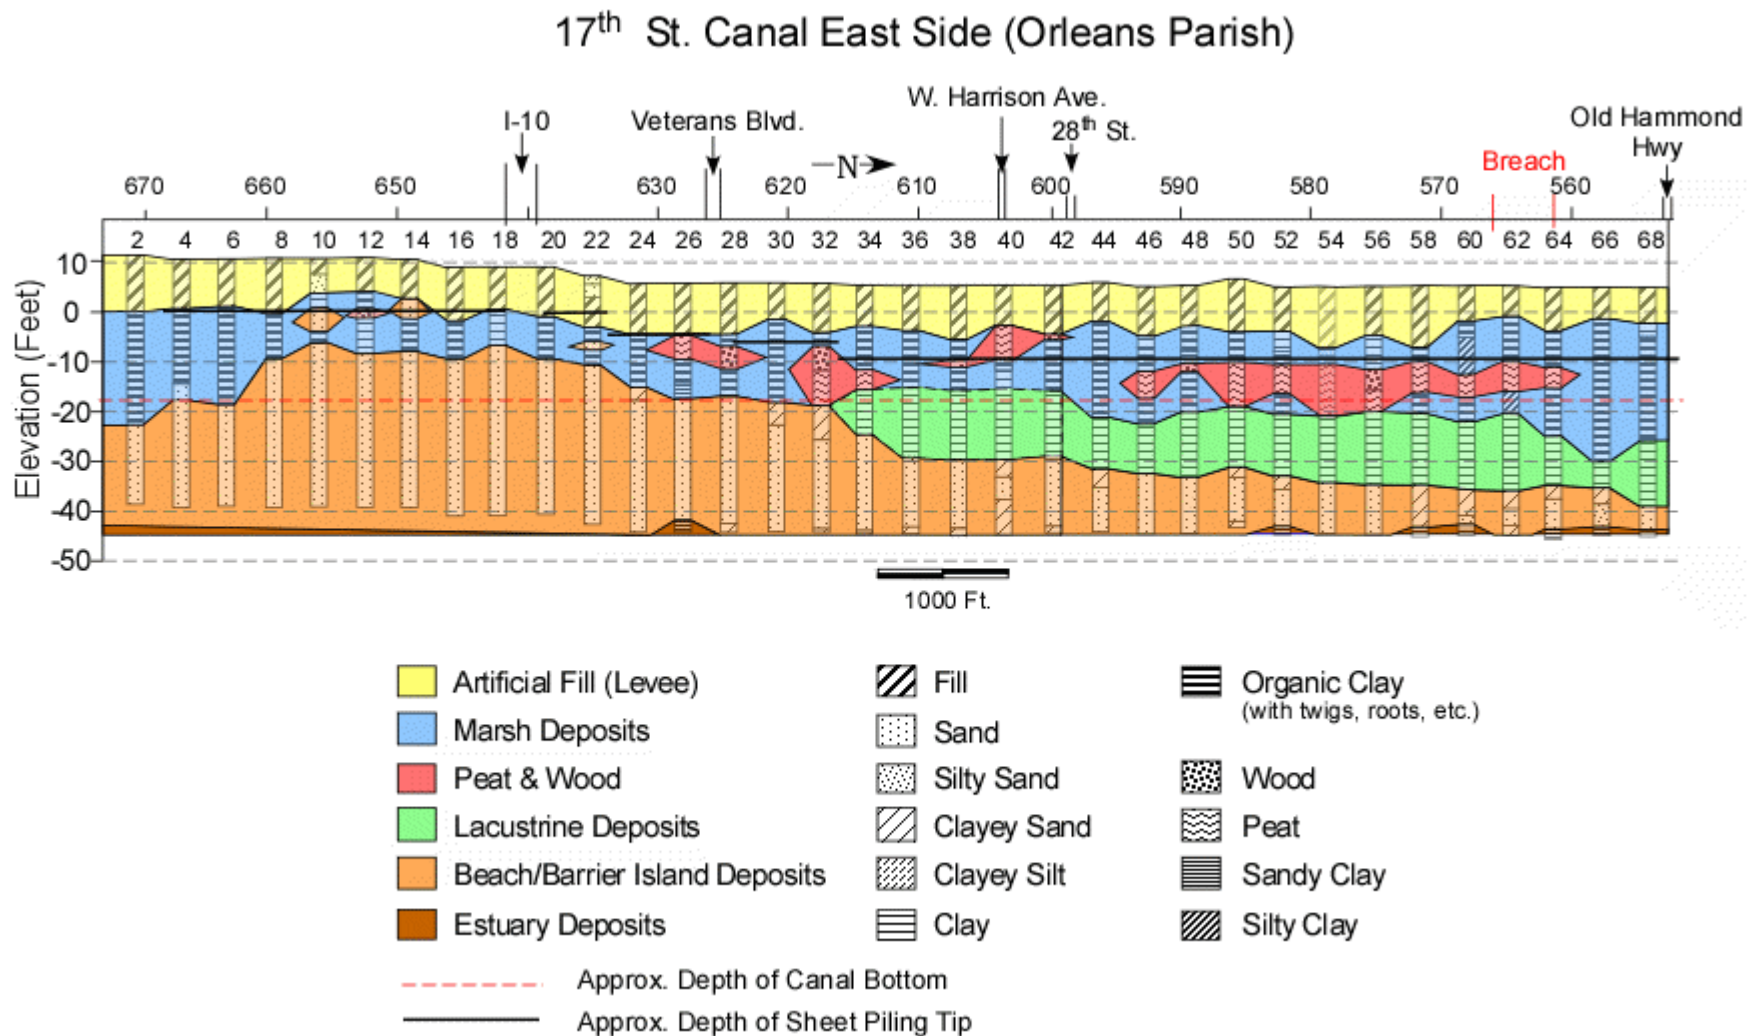
Figure 45 shows a geological cross section along the levee of the 17th street canal. The most notable feature of the cross section is the peat layer observed at depths between about 8 and 15 feet below sea level in the area of and to the south of the breach.

Figure 45. Geological cross-section along the eastern side of the 17th St. Canal (based on data in the U.S. Army Corps of Engineers design documents (1990)). Notable in the cross-section is the peat layer that occurs in the area of the breach. Depth to sheet piling tips is highly uncertain due to inconsistent information available from the U.S. Army Corps of Engineers. The set of as built available on the IPET web site plans (from which the sheet piling depths in this figure were used), show a depth of 10 feet in the area of the breach, yet the Corps claimed and later confirmed by pulling a sheet pile near the breach, that the sheet piles actually extended to 17.5 ft. below sea-level.

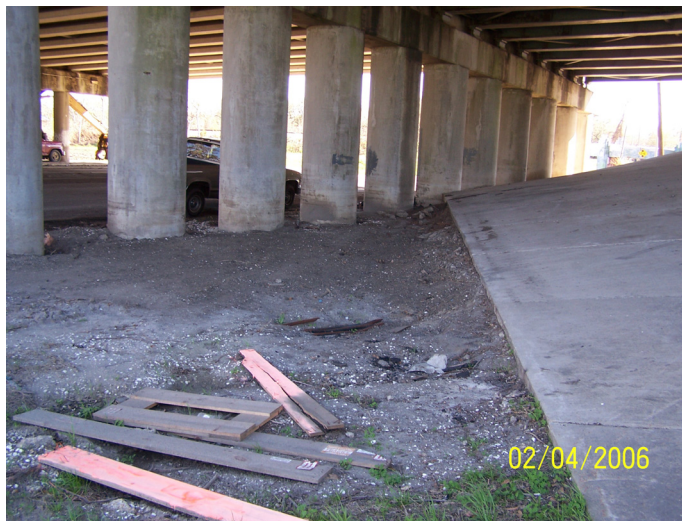
Figure 51. Erosion around the support structures for I-610 near Orleans Canal on Marconi Ave (Stop 6).
