# Hurricane Katrina - What Happened?

Tulane University  
Field Trip  
November 12, 2006

Stephen A. Nelson  
Department of Earth &  
Environmental Sciences  
snelson@tulane.edu

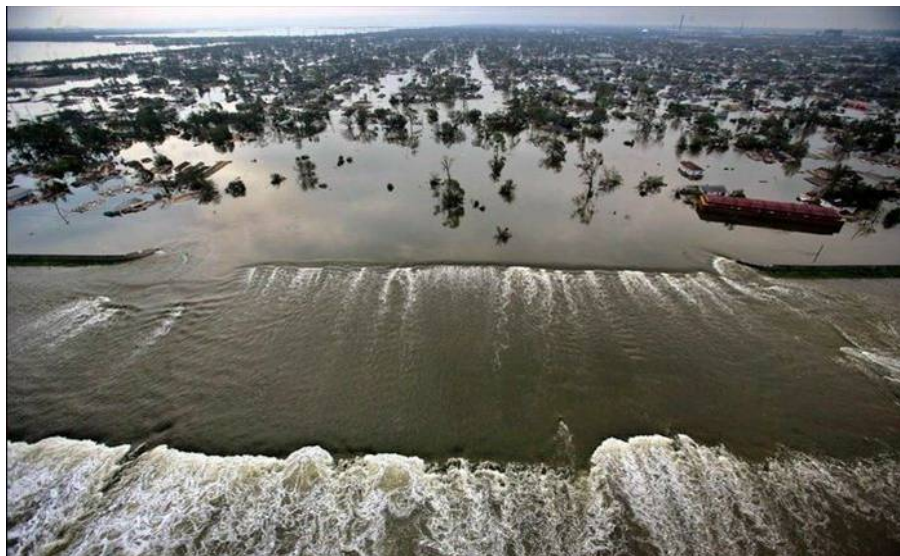
**Figure 8.** The large breach in the Industrial canal that flooded the Lower Ninth Ward could have been caused by a barge crashing through the floodwall during Katrina. Alternatively the barge could have floated in after the levee and floodwall were breached. Note the barge in the photo above. Note also that at the time of this photo water was running out of the Lower Ninth Ward back into the Industrial Canal. (Source - Vincent Laforet, AFP/Getty Images)

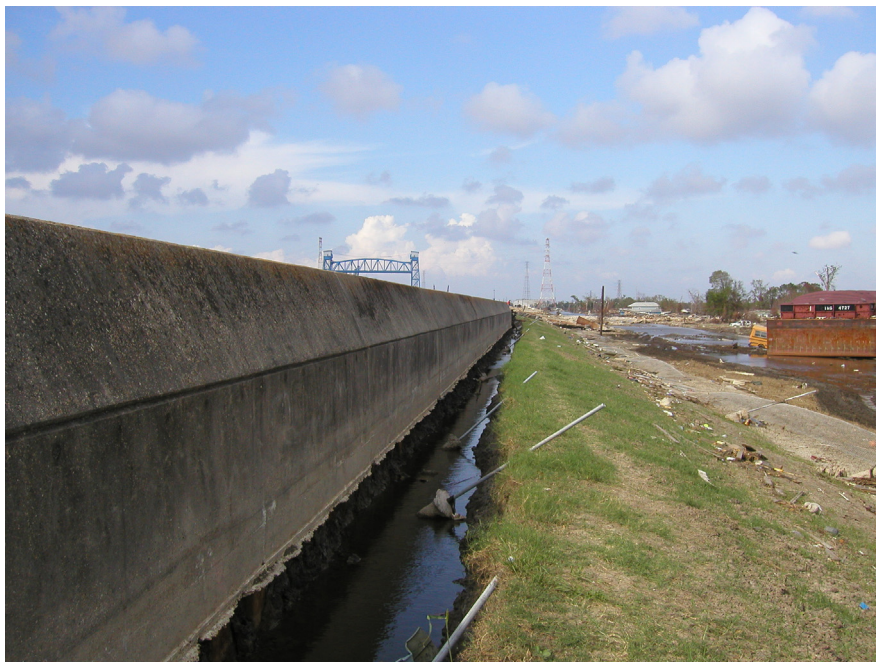
Photographs available on the U.S. Army Corps of Engineers, Interagency Performance Evaluation Task Force (IPET) web site and reproduced in Figure 11, show that along portions of the floodwall that did not fail, water flowing over the top of the floodwall eroded trenches on the protected side of the levee. It is likely that this erosion could have removed enough support on the protected side that the floodwalls and their underlying sheet piling eventually toppled into the protected side of the canal sending a huge surge of water into the Lower 9<sup>th</sup> Ward. Levee/Floodwall failures occurred at two places along the Industrial Canal levee. The longer breach (approximately 1,000 feet long) occurred between N. Galvez and N. Roman Streets (Figures 8, 10, & 13). The shorter (about 200 foot-long) breach occurred just to the south of Florida Avenue (Figures 10 & 14).

**Figure 11.** Looking North along the floodwall of the Industrial Canal levee showing trenches eroded by water from the Industrial Canal that overtopped the floodwall. Photo from U.S. Army Corps of Engineers IPET web site, taken October 4, 2005.

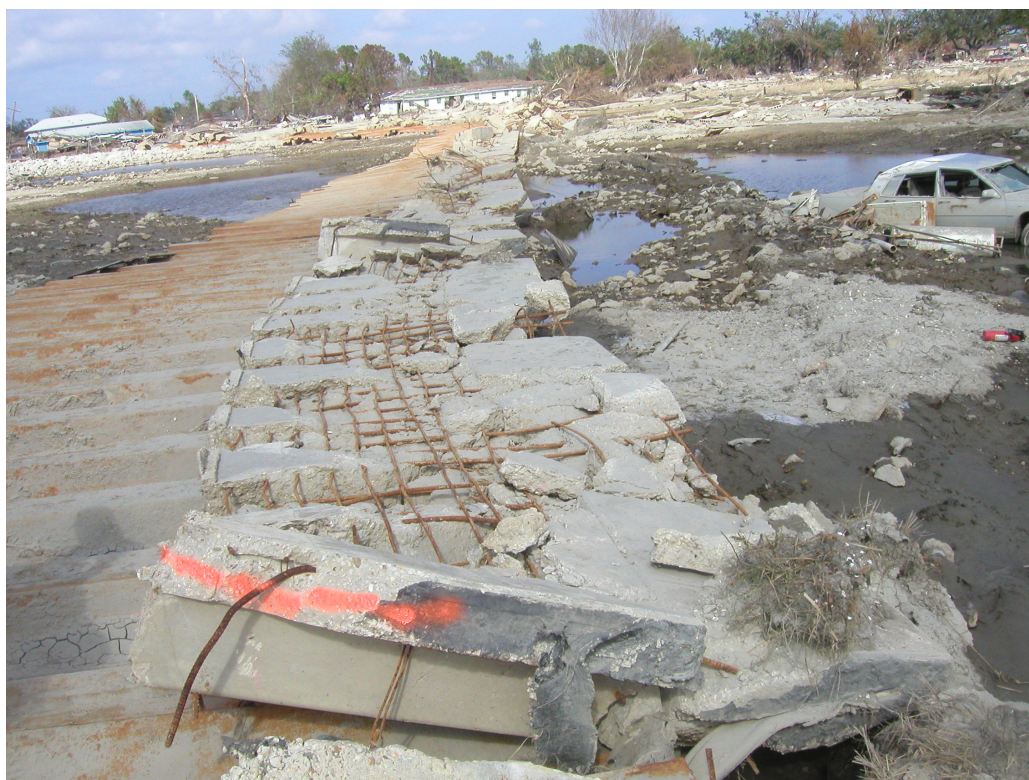
**Figure 12.** Floodwall and sheet piling strewn into Lower 9<sup>th</sup> Ward at the southern (larger) breach on the Industrial Canal. Photo from U.S. Army Corps of Engineers IPET web site, taken October 4, 2005.

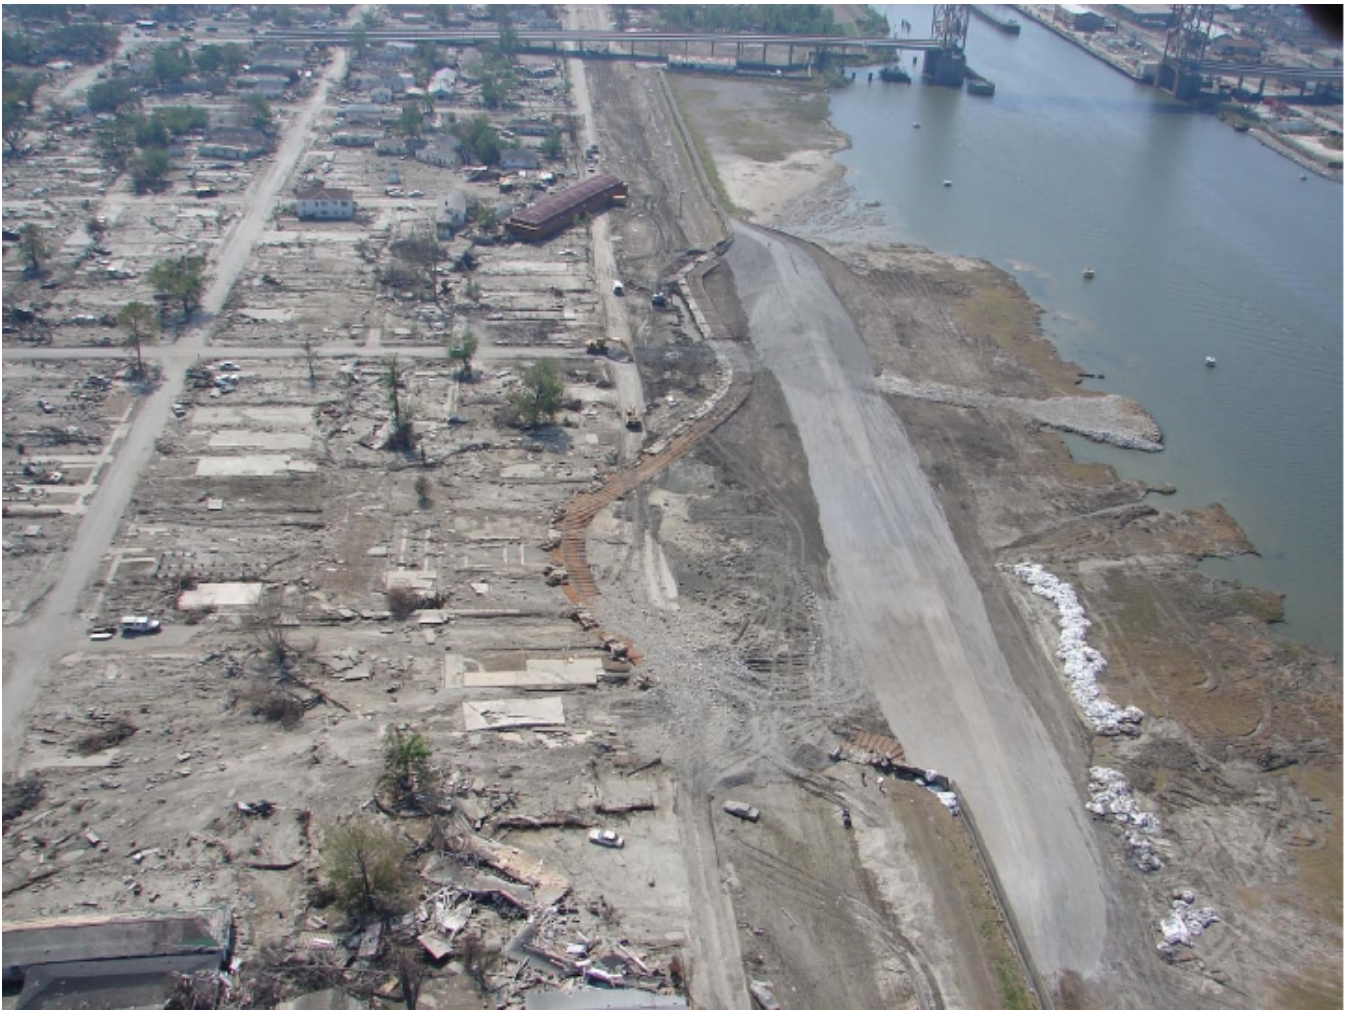
**Figure 13.** View of southern breach on the Industrial Canal, looking South. Note the floodwall and sheet piling (brown) strewn through the Lower Ninth Ward neighborhood where all houses were removed by the force of water coming through the breach. Gray deposits on right are breach repair gravels. Note barge near in the center near the top of the photo. Photo by L. Harder - Independent Levee Investigation Team Draft Final Report (2006).

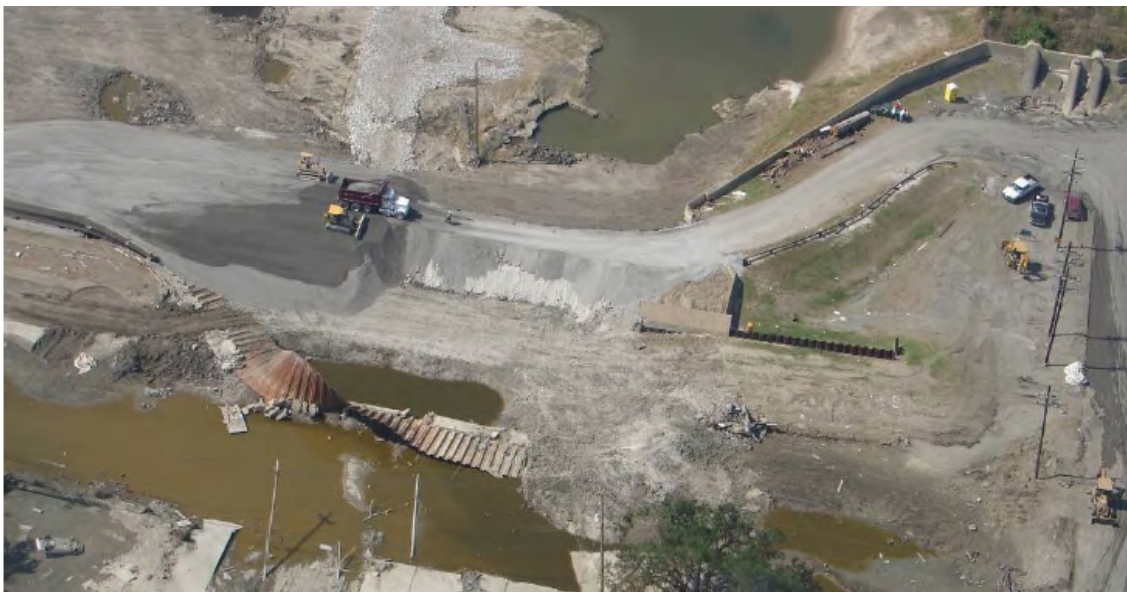
**Figure 14.** Aerial view of the north breach on Industrial Canal. Photo by L. Harder - Independent Levee Investigation Team Draft Final Report (2006).

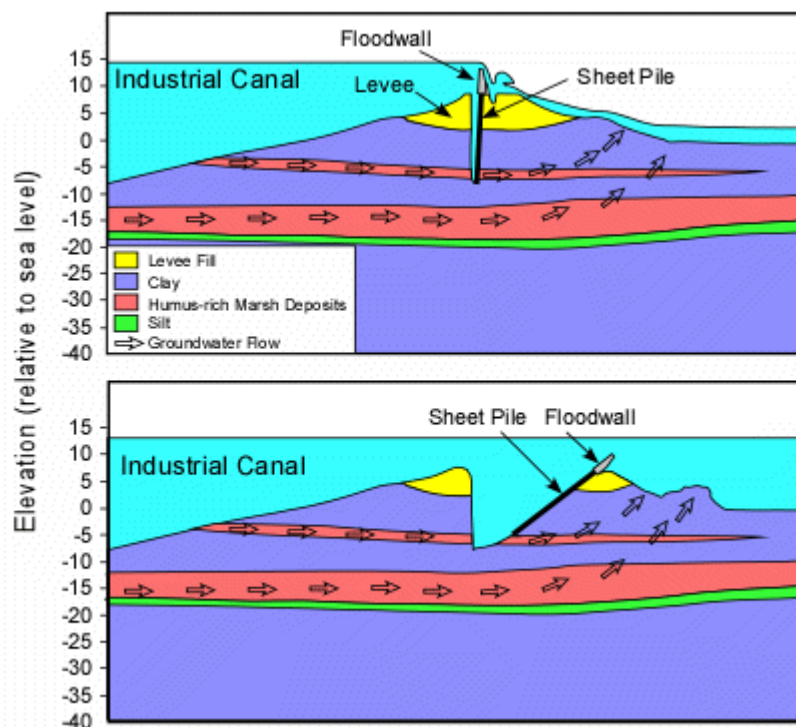
Although the Interagency Performance Evaluation Task Force (IPET, 2006) suggested that the main cause of failure here was the result of the surge waters in the Industrial Canal overtopping the floodwall and eroding away the levee on the protected side, the Independent Levee Investigation Team (ILIT, 2006) disputes this. They do agree that erosion of the levee on the protected side could have contributed, but their analysis indicates that the geological conditions present in the subsurface along with the shallow depth to the tip of the sheet pilings resulted in hydraulic piping beneath the sheet pilings which undermined the levee and caused it and the floodwall to collapse. Two layers of highly permeable marsh deposits occur at a shallow depth below the levee (Figure 16). According to the analysis of ILIT (2006), the added pressure in the canal forced water through these permeable layers and out at the toe of the levee on the protected side, thus removing support for the floodwall and levee.

**Figure 16.** Possible failure mechanism at the Industrial Canal Levee breach in near the Lower 9<sup>th</sup> Ward

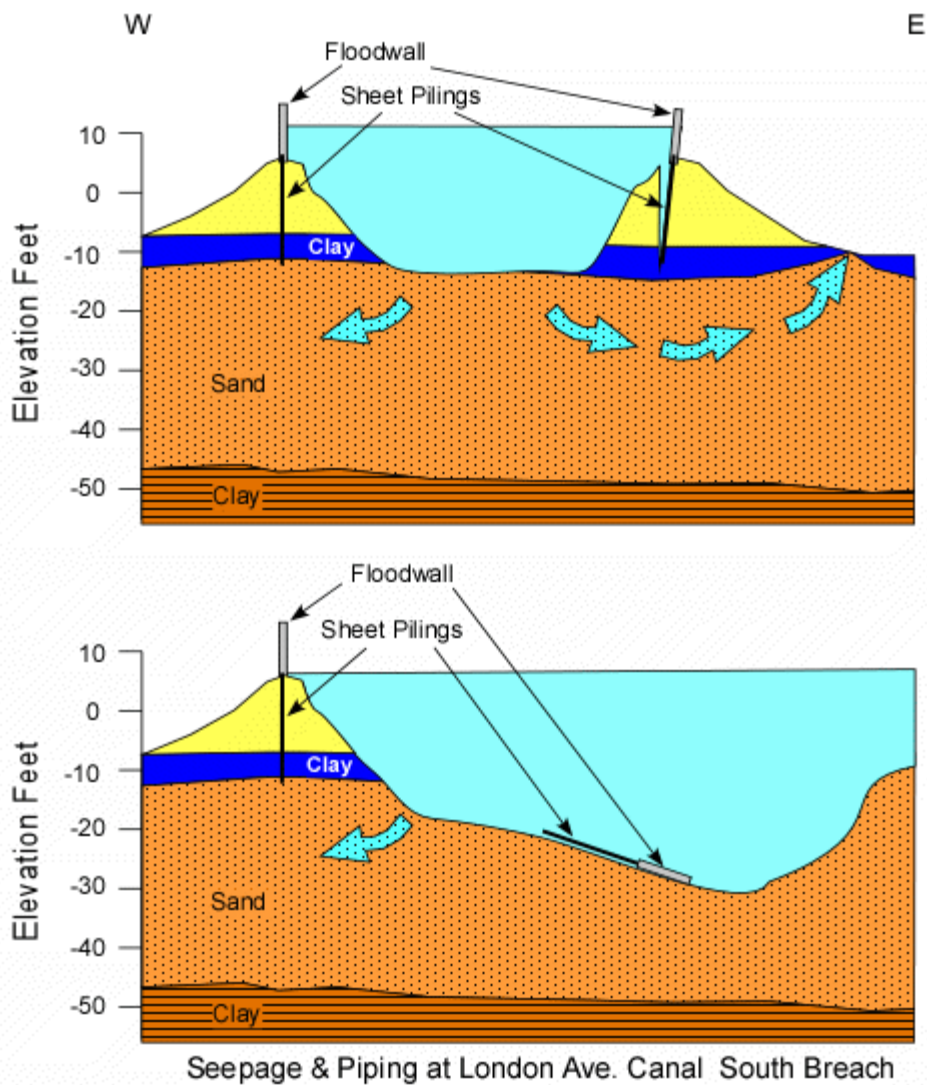
Sand is a highly permeable material. This means that water can easily be transported between the sand grains, especially when the weight due to overlying water is increased due to the added height of the water column during a storm surge. This increases the pressure and could force the water through the pore spaces in the sand and back up to the surface on the other side of the levee. If enough flow takes place the sand will be picked up by the flowing groundwater and eventually form an underground channel. This could undermine the levee and cause it to collapse. The principle is illustrated in Figure 20 with a simple thought experiment. The underflow (called seepage or siphoning) is the apparent cause of the collapse at this section of the London Ave. Canal. The "As built" design specifications indicate that the sheet pilings (which should form an impermeable barrier to pressure induced flow in the sand) were placed to a depth of 14 feet below sea level (U.S. Army Corps of Engineers, 1994), one can see from the cross section in Figure 21, that the water still has a path back to the surface if it flows as groundwater beneath the sheet pilings. Note that in order to prevent such siphoning, the sheet pilings would need to be placed to a depth of about 50 feet below sea-level where they would penetrate a layer of clay. Clay, because the individual mineral grains stick together and thus reduce pore space and interconnection between pores, is much more impermeable than is sand.

**Figure 21.** Geological cross section across the London Ave. Canal based on borings 16 and 51 (Figs. 19 and 26), shown at time of estimated high water during Katrina's storm surge. The sands form a permeable layer through which groundwater originating in the canal can penetrate and move below the sheet piling and up to the surface (top diagram), eventually undermining the levee and causing a blowout completely removing a section of levee and carrying sand into the neighborhood.

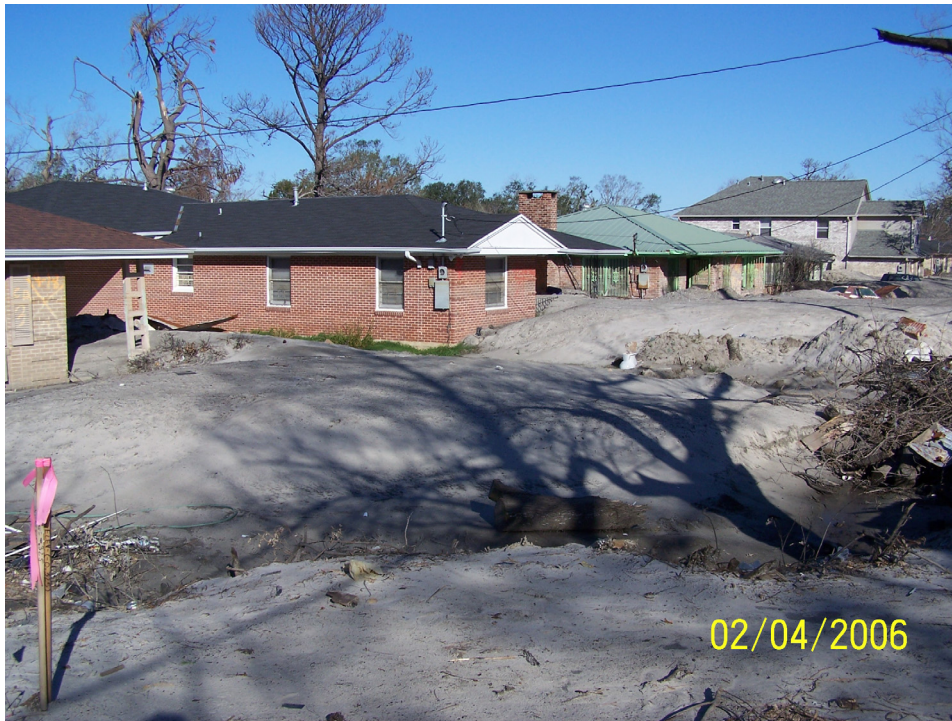
Figure 22 is a view looking down Warrington Drive before the sand deposits were removed in mid-February, 2006. Figure 23 shows our preliminary map of the extent of the sand that scoured from the bottom of the London Ave. Canal and the blowout hole beneath the levee and deposited throughout the neighborhood. The distribution and thickness of the actual deposit was controlled by current velocity and barriers such as houses, fences, and hedges. For more information on the sand deposits at this locality, see Nelson and Leclair (2006).

**Figure 22.** Sand deposits on Warrington drive showing deposition in the wake of houses as the currents flowed down the driveways between the houses. As of March 1, 2006, most of the sand deposits have been removed.

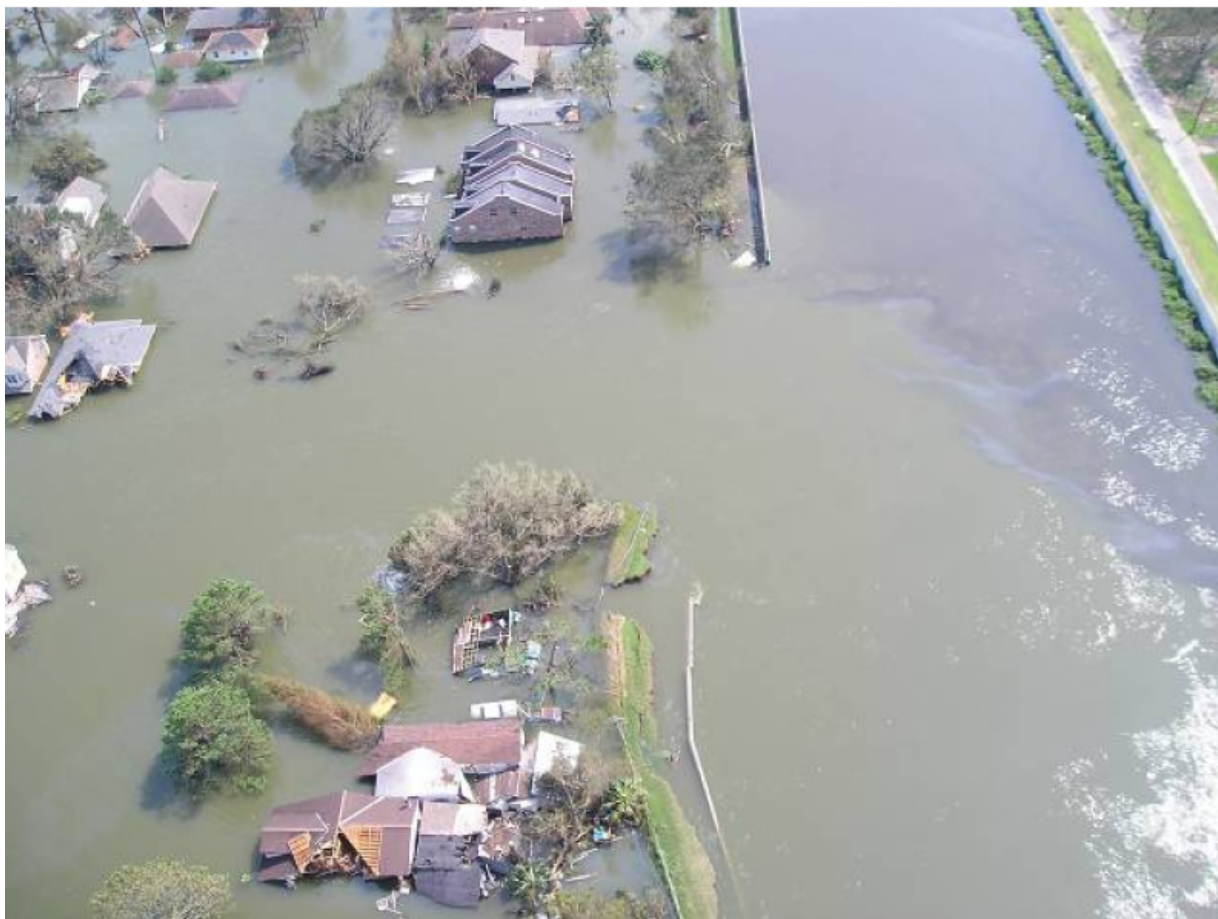
**Figure 31.** View of 17<sup>th</sup> St. Canal breach looking toward south. Note displaced floodwall and levee just below the missing section of the levee.

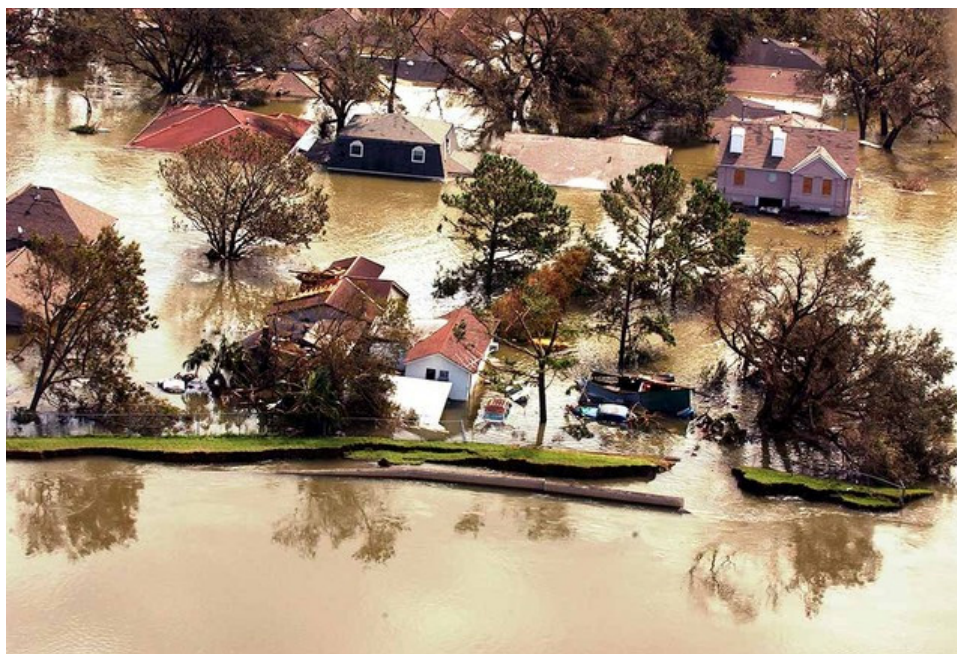
**Figure 32.** View of 17<sup>th</sup> St. Canal breach looking toward east. Note fractures in the displaced part of the levee. Photo by J. Augustino FEMA.

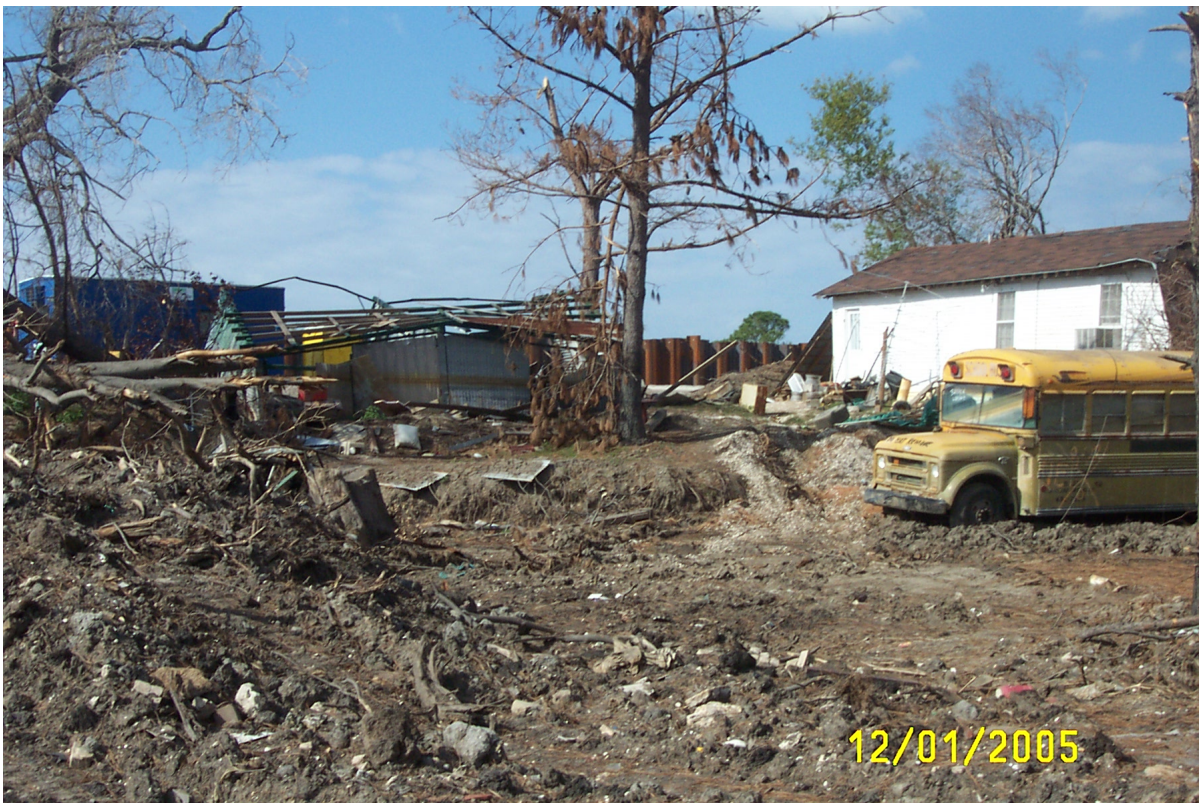
**Figure 33.** Slide toe (at abrupt change in slope in front of school bus) where levee and neighborhood were displaced about 45 feet toward the viewer.

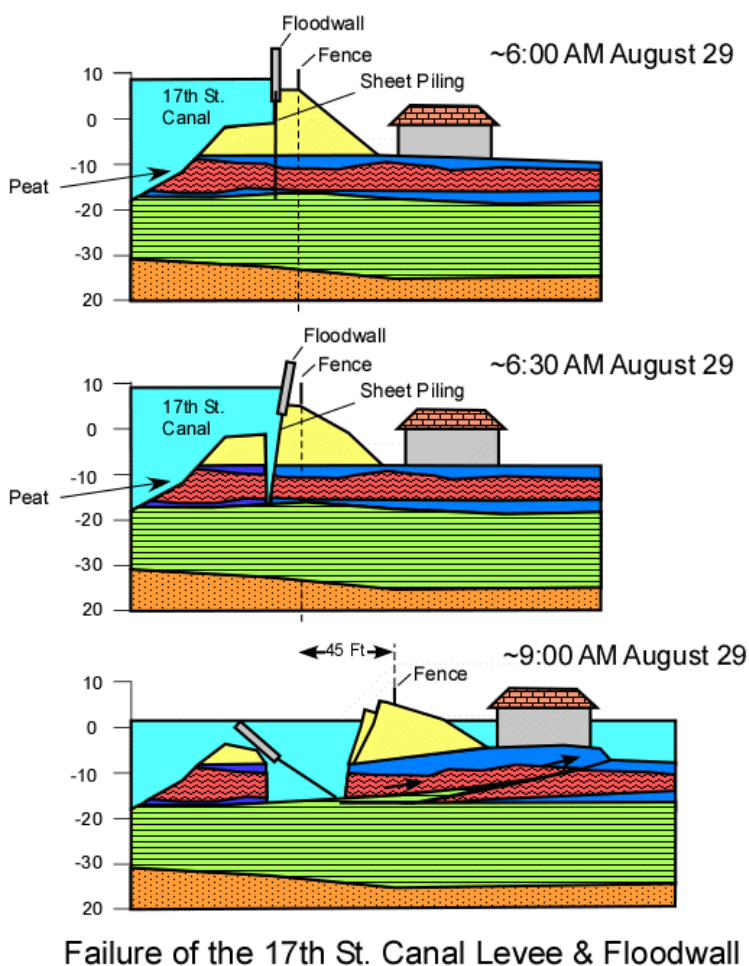
The most recent information from the Interagency Performance Evaluation Task Force (IPET) [2006] suggests that the floodwall and levee failed at the 17<sup>th</sup> St. Canal as a result of water level rising to an elevation of about 8 feet above sea level in the canal. The floodwalls were designed to have tops at an elevation of 14 feet above sea level, but IPET data indicate that by the time of Katrina the tops of the floodwalls on the 17<sup>th</sup> Street Canal were about 12.5 feet above sea level. Thus, IPET estimates that water levels in the canal were still 4 feet below the tops. IPET has collected eyewitness accounts and scoured the neighborhood for clocks that were stopped as a result of the flooding in order to determine the time of the breach. One eyewitness account suggests that the floodwall at the breach area was leaning to the protected side at about 6:30 AM on August 29 and other accounts suggest that the breach was open by about 9:00 AM. This, along with levee breach experiments conducted on scale models in a large centrifuge led IPET to suggest that as water levels rose in the canal, the floodwall and sheet piling was pushed outward toward the land side, opening a gap between the levee and the floodwall on the canal side. This gap allowed water to seep down along the sheet piling and eventually push the levee on the protected side outward away from the canal. Based on sections of the breached levee observed in the breach area, IPET suggests that the failure did not occur along the peat layer, but along a layer of weak clay at the base of the peat. This clay layer was thrust over and through the peat as illustrated in Figure 36.

**Figure 36.** Diagrammatic cross sections across the 17<sup>th</sup> St. Canal in the vicinity of the breach (based partially on a sketch in Seed and others [2005] and IPET (2006).

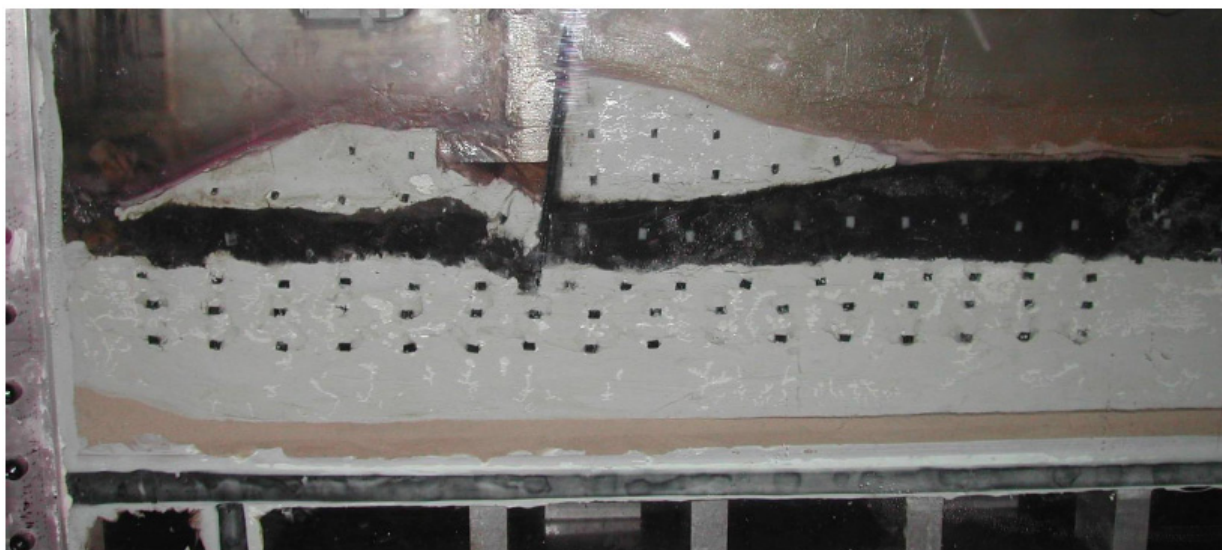
A photograph of the end result of IPET's scale model centrifuge experiment is shown in Figure 37. The canal side (on the left in the photograph) next to the sheet piling is seen to have dropped down as a result of the floodwall moving toward the right (toward the protected side). Indeed in the end result of the experiment, the levee, peat layer, and upper part of the underlying clay layer all have moved to the protected side. Viewing the complete video of the experimental run (<https://ipet.wes.army.mil/>), however, shows that the initial failure occurred either in the peat layer or at the peat – clay interface, and only when the sheet pile started to move to the right, away from the canal, did the upper part of the clay layer also move. Furthermore, the only part of the clay layer that moved was the part immediately in front of the tip of the sheet pile, and it only moved because it was being pushed along by the sheet pile.

**Figure 37.** Photograph of failed levee and floodwall in IPET's scale model centrifuge experiment representing the 17<sup>th</sup> St. Canal. The white at the top is clay and represents the levee. This overlies the dark peat layer, which in turn overlies another white clay layer meant to represent the estuary deposits beneath the peaty marsh deposits. Small rectangles were initially laid out in a rectangular grid and can be used to determine how much deformation has occurred during the experiment. (IPET, 2006).

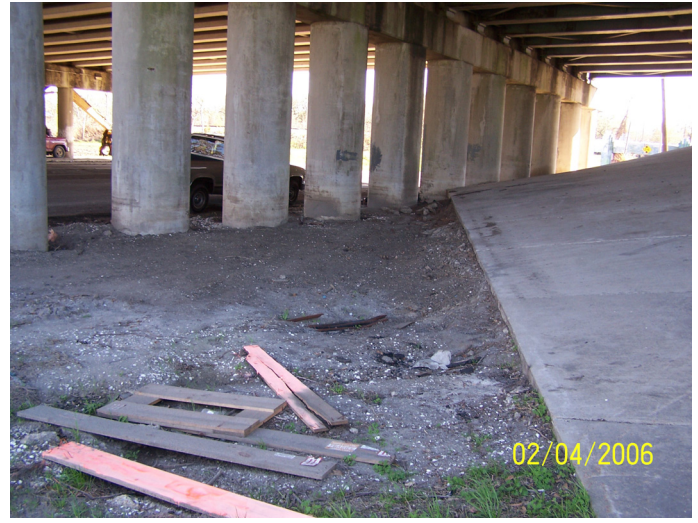
**Figure 41.** Erosion around the support structures for I-610 near Orleans Canal on Marconi Ave.
