Hurricane Katrina - What Happened? The Geology of the Katrina Disaster in New Orleans

Field Trip Guide Updated 8-08-2008

Stephen A. Nelson
Department of Earth &
Environmental Sciences
snelson@tulane.edu

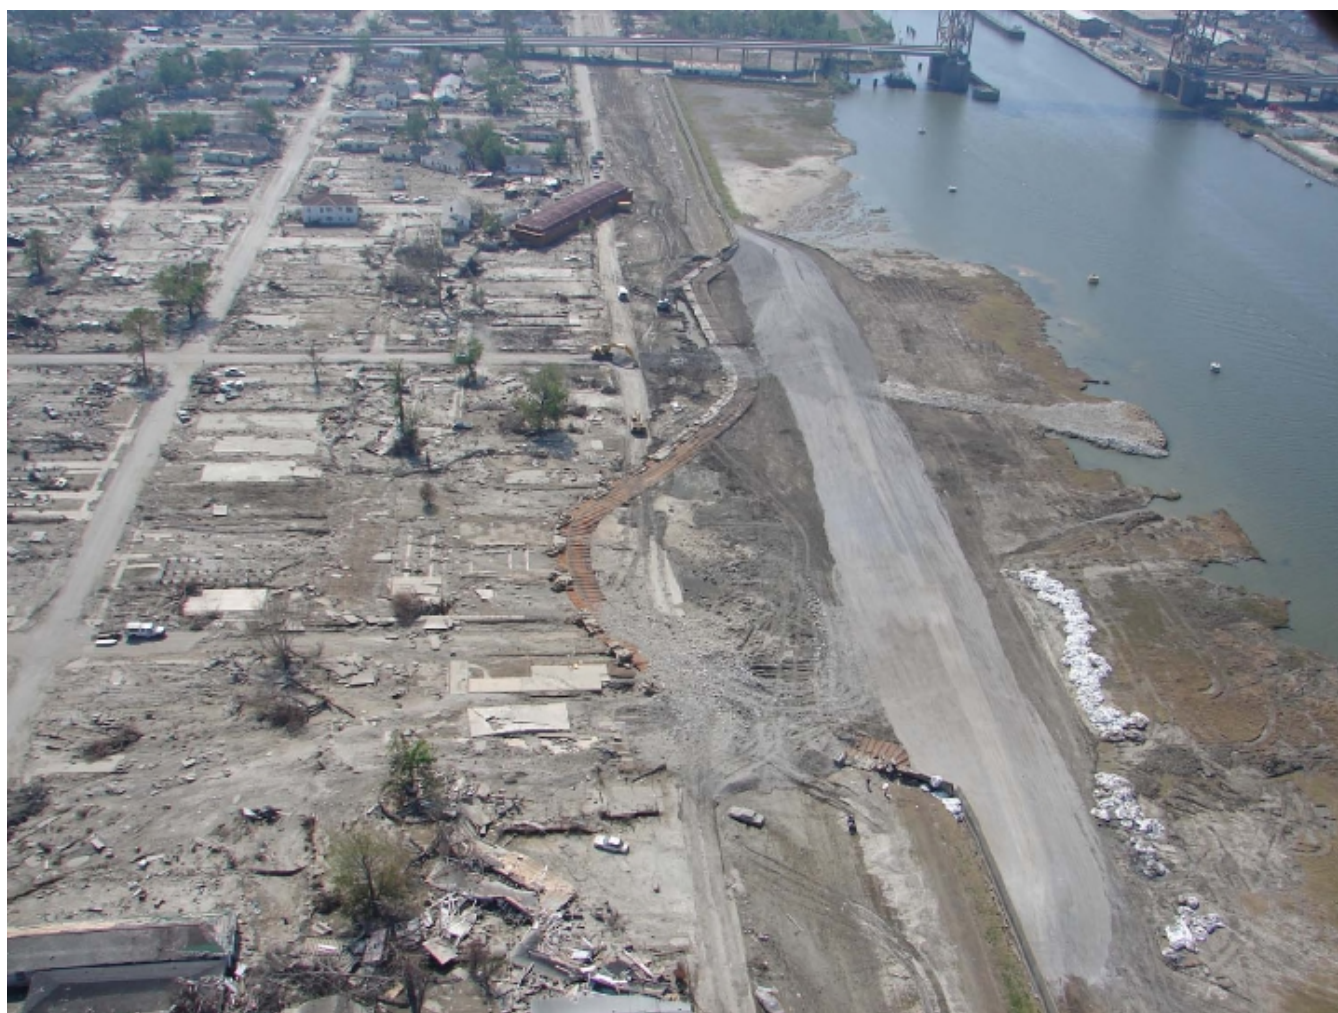
All houses and most trees were removed in the areas immediately in front of the breaches (Figs. 11, 12, 13, & 14) and in areas between the breaches the rush of water was forceful enough to lift houses off their foundations and float them around until they collided with other houses and either came to rest or broke apart to form piles of rubble (Fig. 11). The floodwall and underlying sheet pilings were strewn into the first few blocks of the Lower 9th Ward like a ribbon (Figures 14, 15, and 16).

Figure 14. View of southern breach on the Industrial Canal, looking South. Note the floodwall and sheet piling (brown) strewn through the Lower Ninth Ward neighborhood where all houses were removed by the force of water coming through the breach. Gray deposits on right are breach repair gravels. Note barge near in the center near the top of the photo. Photo by L. Harder - Independent Levee Investigation Team Final Report (2006).

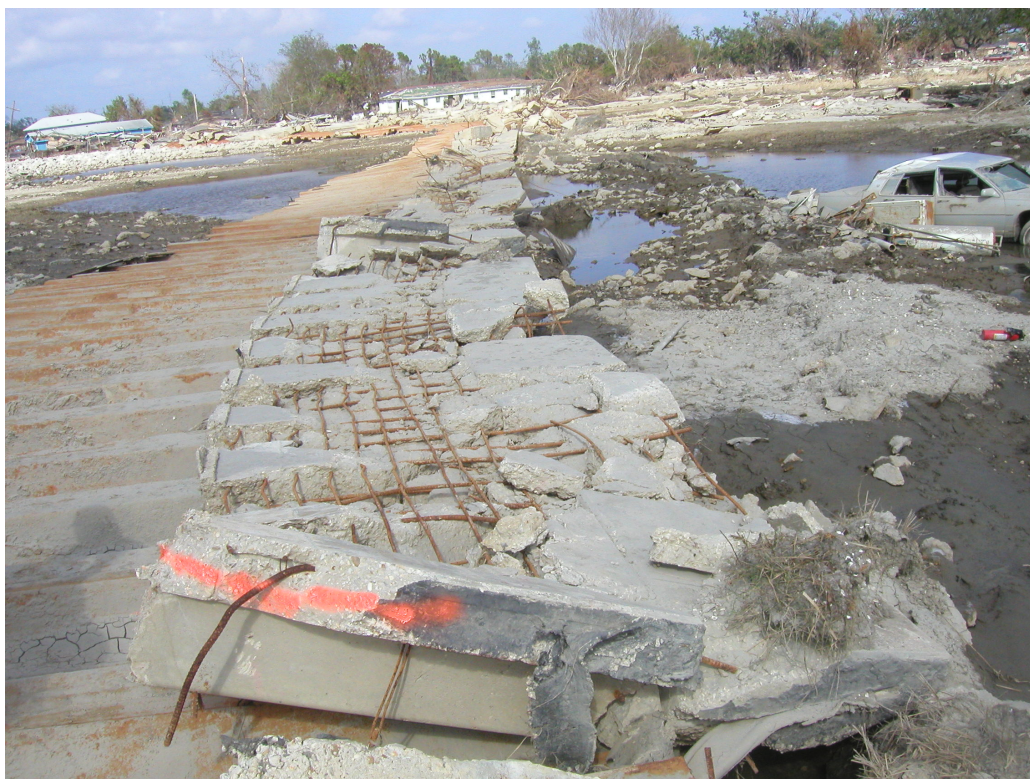
Figure 15. Floodwall and sheet piling strewn into Lower 9th Ward at the southern (larger) breach on the Industrial Canal. Photo from U.S. Army Corps of Engineers IPET web site, taken October 4, 2005.

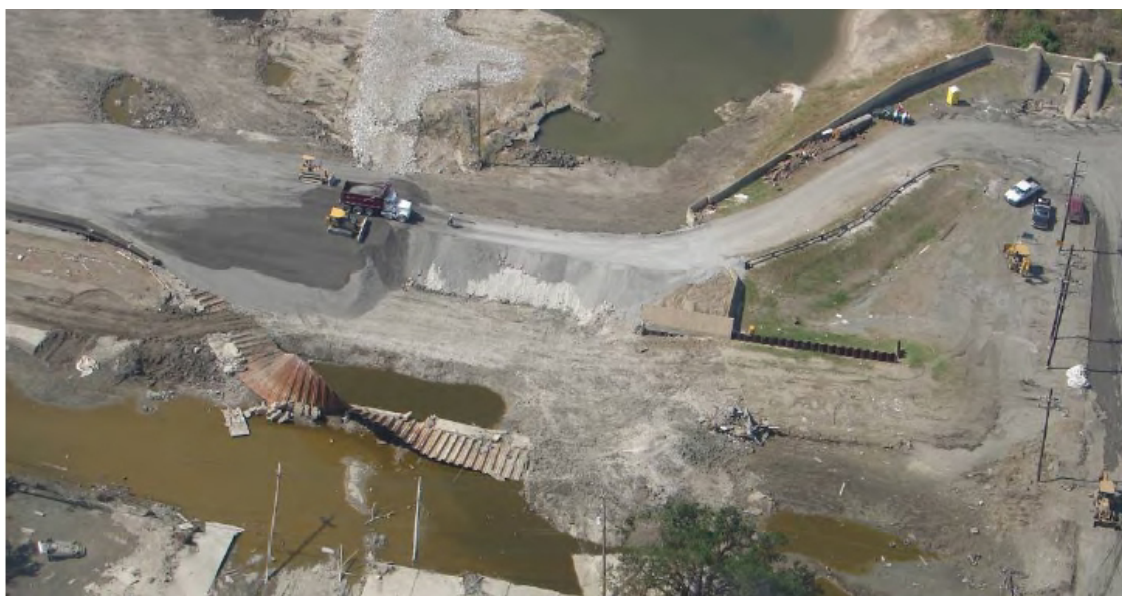
Figure 16. Aerial view of the north breach on Industrial Canal. Photo by L. Harder - Independent Levee Investigation Team Final Report (2006).

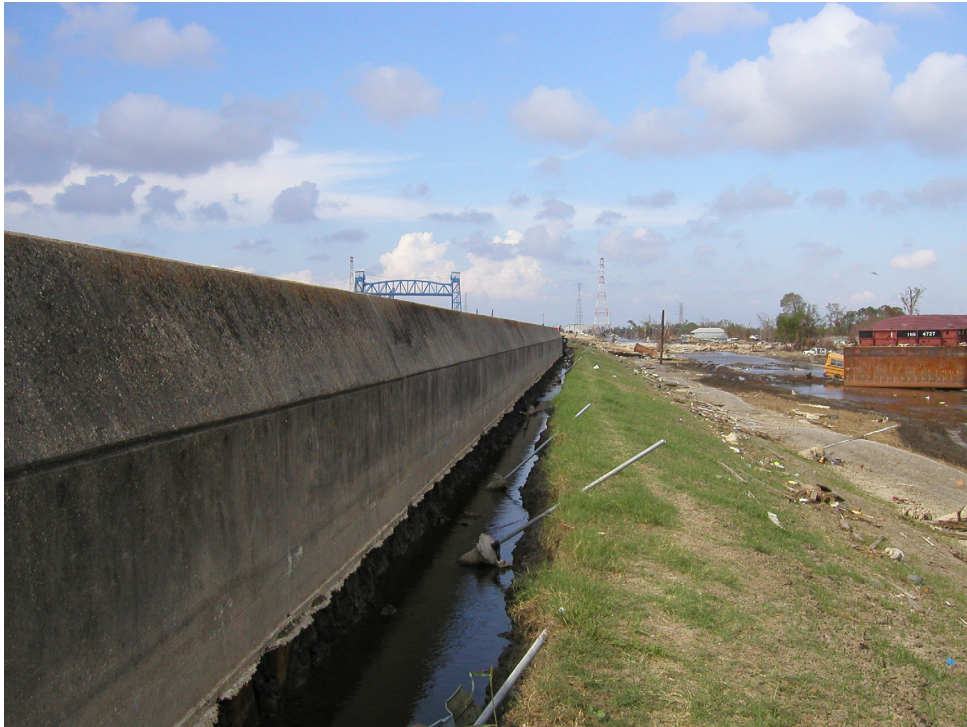
Photographs available on the U.S. Army Corps of Engineers, Interagency Performance Evaluation Task Force (IPET) web site and reproduced in Figure 17, show that along portions of the floodwall that did not fail, water flowing over the top of the floodwall eroded trenches on the protected side of the levee. It is likely that this could have removed enough support on the protected side that the floodwalls and their underlying sheet piling eventually toppled into the protected side of the canal sending a huge surge of water into the Lower 9th Ward.

Figure 17. Looking North along the floodwall of the Industrial Canal levee showing trenches eroded by water from the Industrial Canal that overtopped the floodwall. Breached section is just beyond the barge and barely discernable in this view. Florida Avenue Bridge (blue) in upper center. Photo from U.S. Army Corps of Engineers IPET web site, taken October 4, 2005.

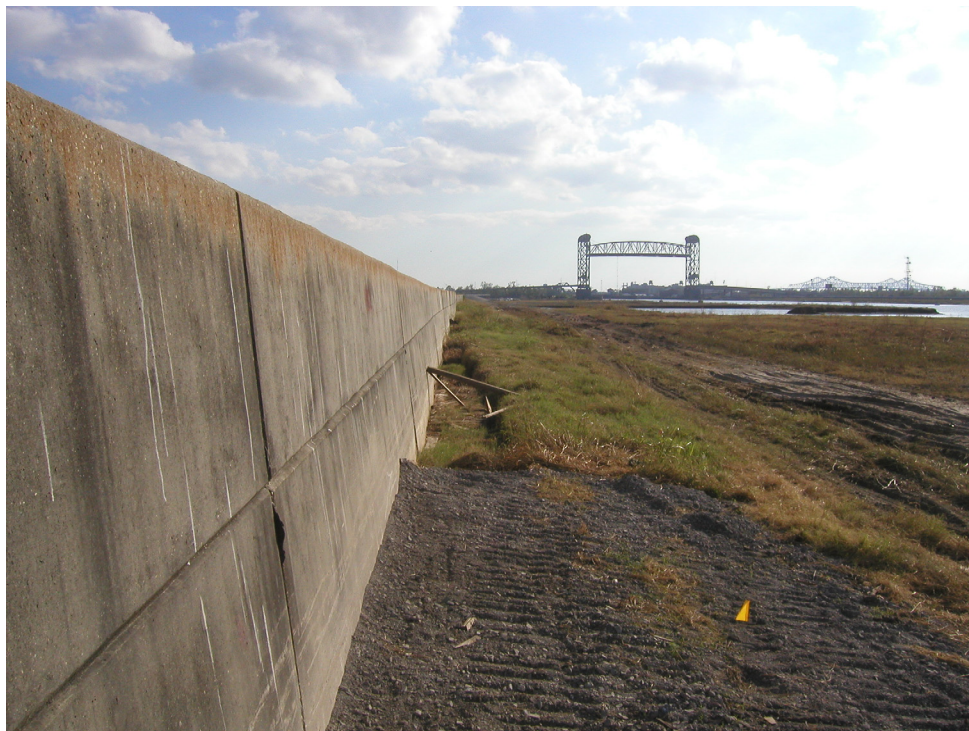
Figure 18. Looking South along the floodwall of the Industrial Canal on the inside of the floodwall between the two breaches showing the floodwall leaning toward the left (east) with a block of the levee next to the floodwall dropped down (near center of picture). Claiborne Ave. Bridge in right center. Photo from U.S. Army Corps of Engineers IPET web site, taken October 4, 2005.

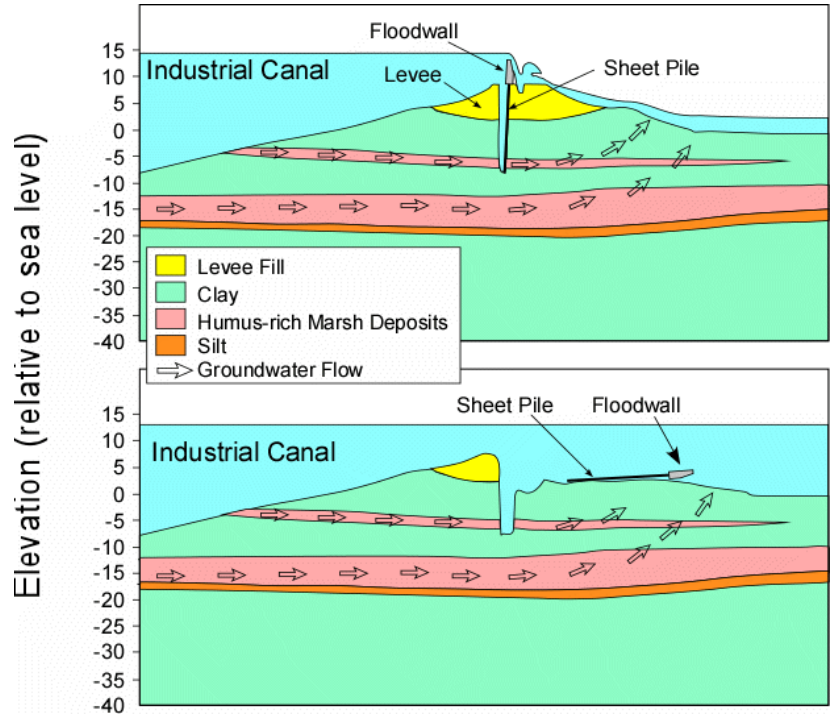
The Interagency Performance Evaluation Task Force (IPET, 2006) agreed that the main cause of failure here was the result of the surge waters in the Industrial Canal overtopping the floodwall and eroding away the levee on the protected side, but the Independent Levee Investigation Team (ILIT, 2006) suggests another cause. They do agree that erosion of the levee on the protected side could have contributed, but their analysis indicates that the geological conditions present in the subsurface along with the shallow depth to the tip of the sheet pilings resulted in hydraulic piping beneath the sheet pilings which undermined the levee and caused it and the floodwall to collapse. Two layers of highly permeable marsh deposits occur at a shallow depth below the levee (Fig. 21). According to the analysis of ILIT (2006), the added pressure in the canal forced water through these permeable layers and out at the toe of the levee on the protected side, thus removing support for the floodwall and levee.

Figure 21. Possible failure mechanism at the Industrial Canal Levee breach in near the Lower 9th Ward

At Stop 1 in the Lower 9th Ward, one now sees that the entire floodwall between the two bridges (Claiborne to the south and Florida Avenue to the North – the blue colored bridge) has been replaced with a T-wall with a top elevation at 14.5 feet above sea level, the level it was supposed to have attained prior to Katrina. This new floodwall was completed in mid-June, 2006. The original I-wall is still present along the other side of the Industrial Canal as well as to the south and north of the new T-wall. The only improvement made to the levees where the I-walls still exist is concrete armoring has been added to the base of the I-wall to prevent the erosion of the levee should water come over the top of the wall again.

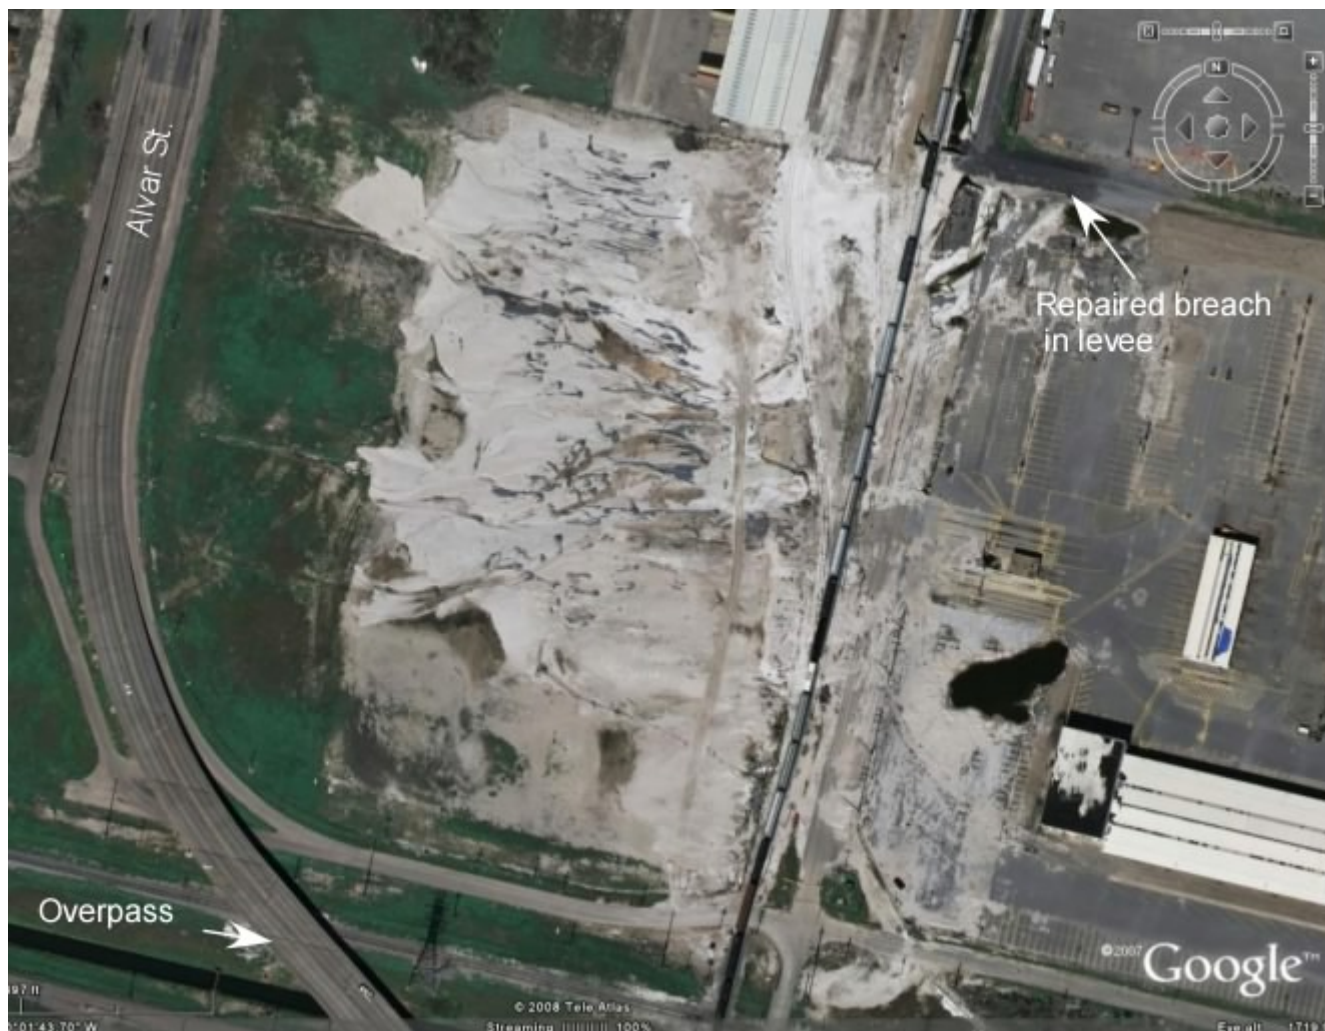
Figure 23. Google Image (acquired around May, 2006) of area near overpass to Alvar St. showing location of breached levee and deposits of shells (white material in center of image) that resulted from the breach. Industrial Canal is off the image to the right (east).

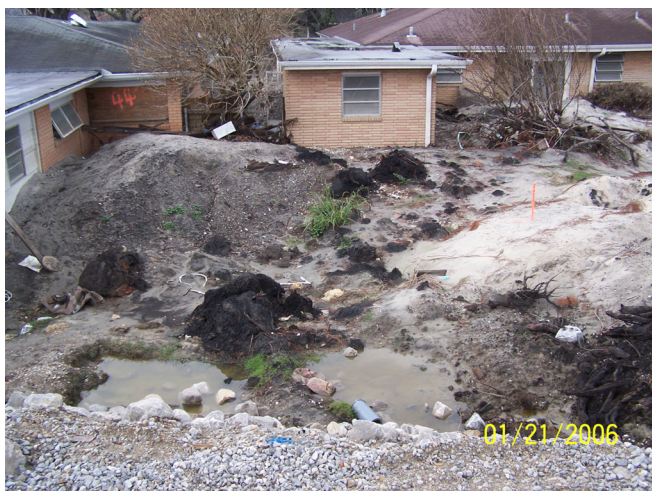
After the water was drained from the area, deposits of sand along with blocks of peat were observed to have filled the street and the backyards of houses along Pratt Drive (Figs. 36 and 37). The sand deposits were similar to the ones observed at the Mirabeau Ave. breach, but also contain blocks of peat as expected from the geologic cross section shown in Figure 33. The sand was not as extensive as the deposits at the southern Mirabeau breach, only reaching a thickness of about 3 feet, and only filling the street in front of the breach, but not extending into the back yards of houses on the other side of the street.

Figure 36. Sand deposits and peat blocks (black) behind homes on Pratt Drive at the North breach of the London Ave. Canal. Note the sand boil on the right. Gray material in the foreground is gravel used in the repair of the breach.

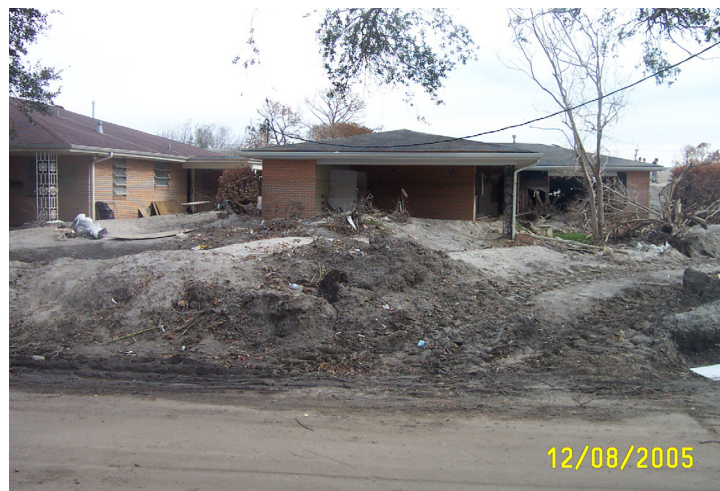
Figure 37. Sand deposits in front of houses on Pratt Drive at the North breach of the London Ave. Canal.

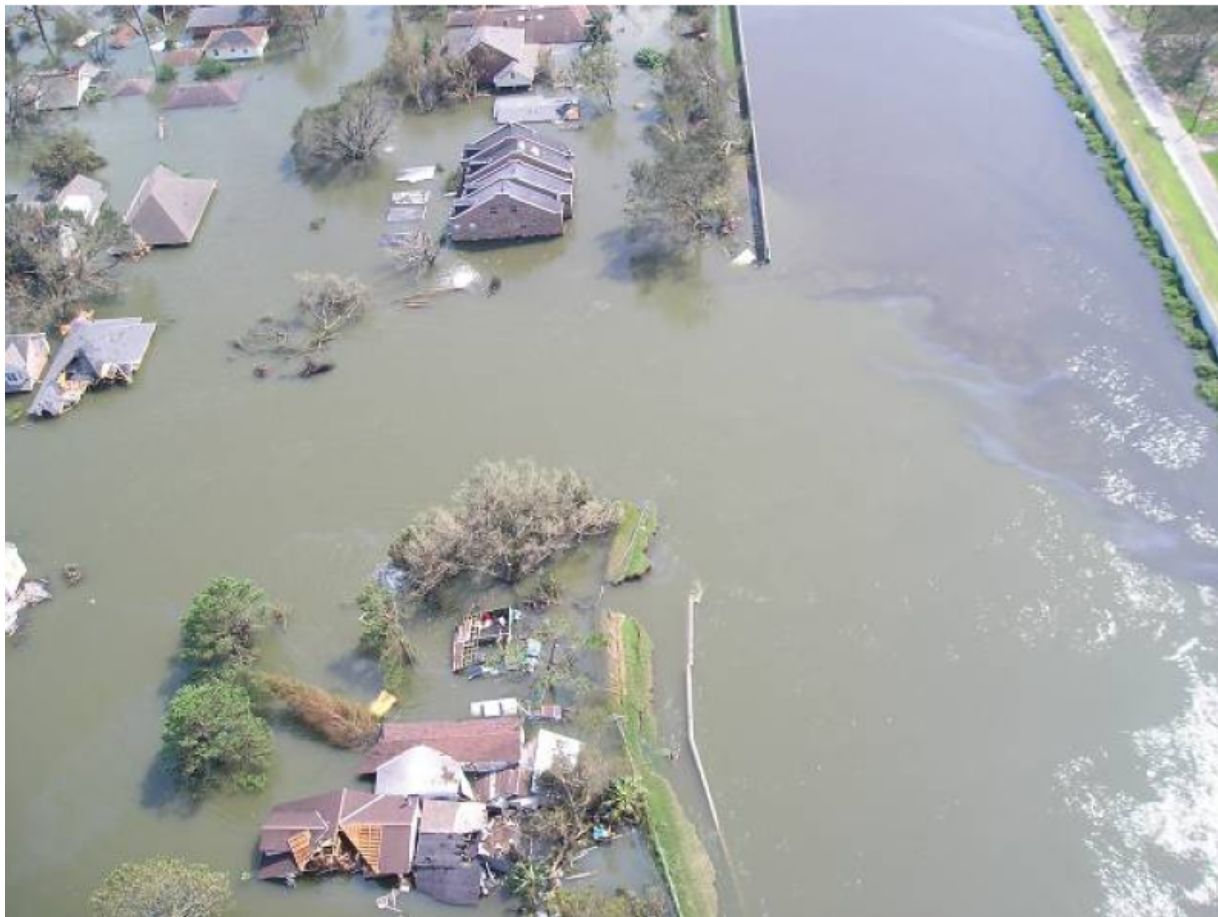
Figure 40. View of 17th St. Canal breach looking toward south. Note displaced floodwall and levee just below the missing section of the levee. Photo from IPET Interim Report 2.

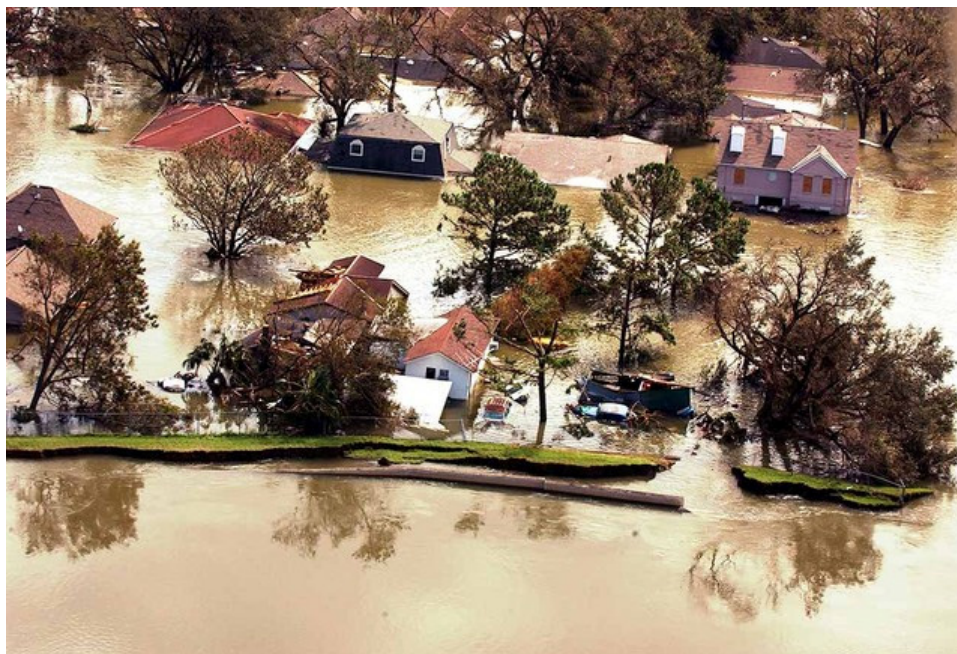
Figure 41. View of 17th St. Canal breach looking toward east. Note fractures in the displaced part of the levee. Photo by J. Augustino FEMA.

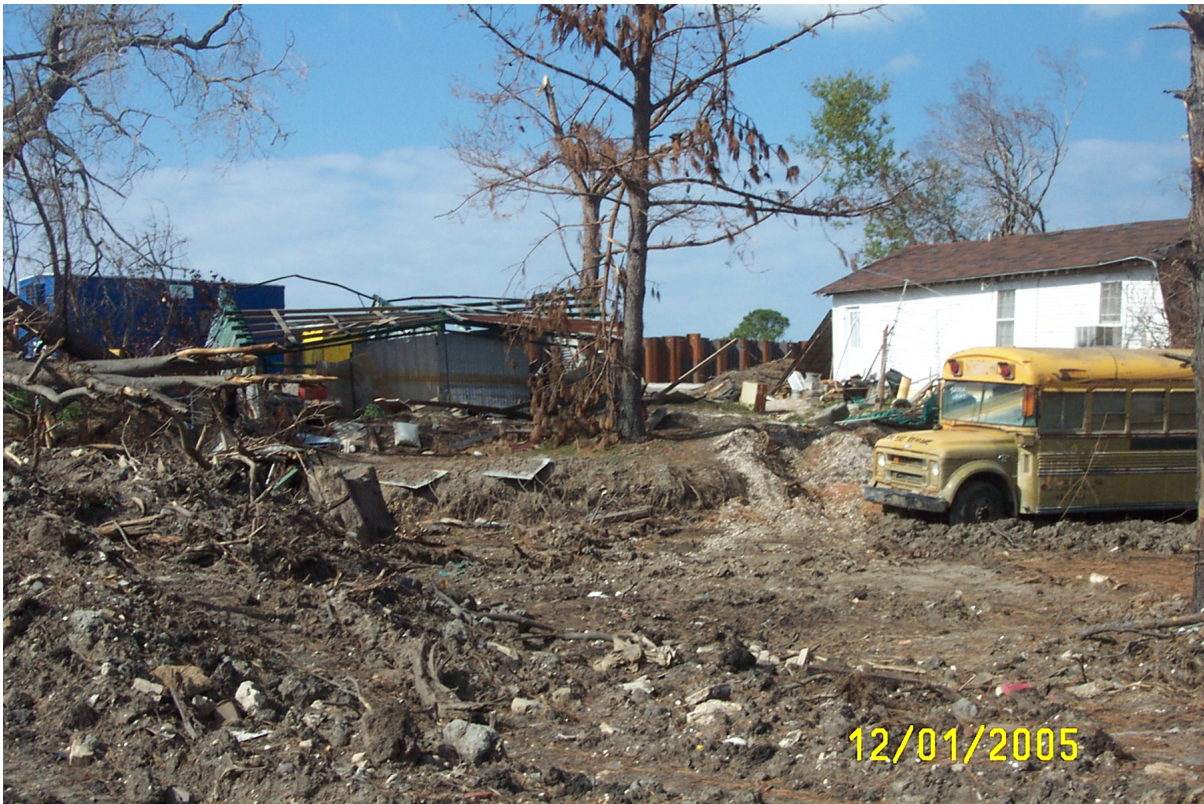
Figure 42. . Slide toe (at abrupt change in slope in front of school bus) where levee and neighborhood were displaced about 45 feet toward the viewer.

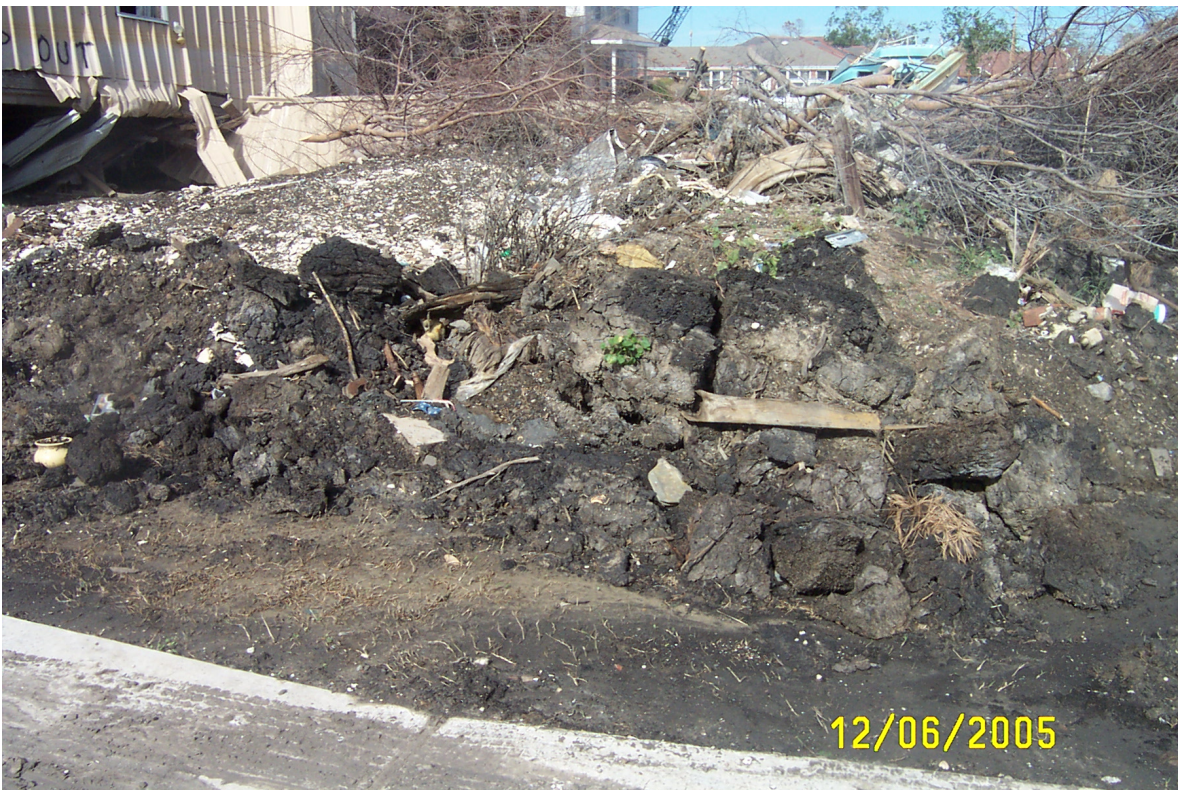
Before the debris was completely removed, large blocks of peat were present throughout the neighborhood, some of which could be found a block away to the east near Fleur de Lis Blvd. Examples of the peat blocks before their removal can be seen in Figure 43 and the upper right photograph in Figure 48.

Figure 43. Blocks of Peat along Belaire Drive near the 17th St. Canal levee breach

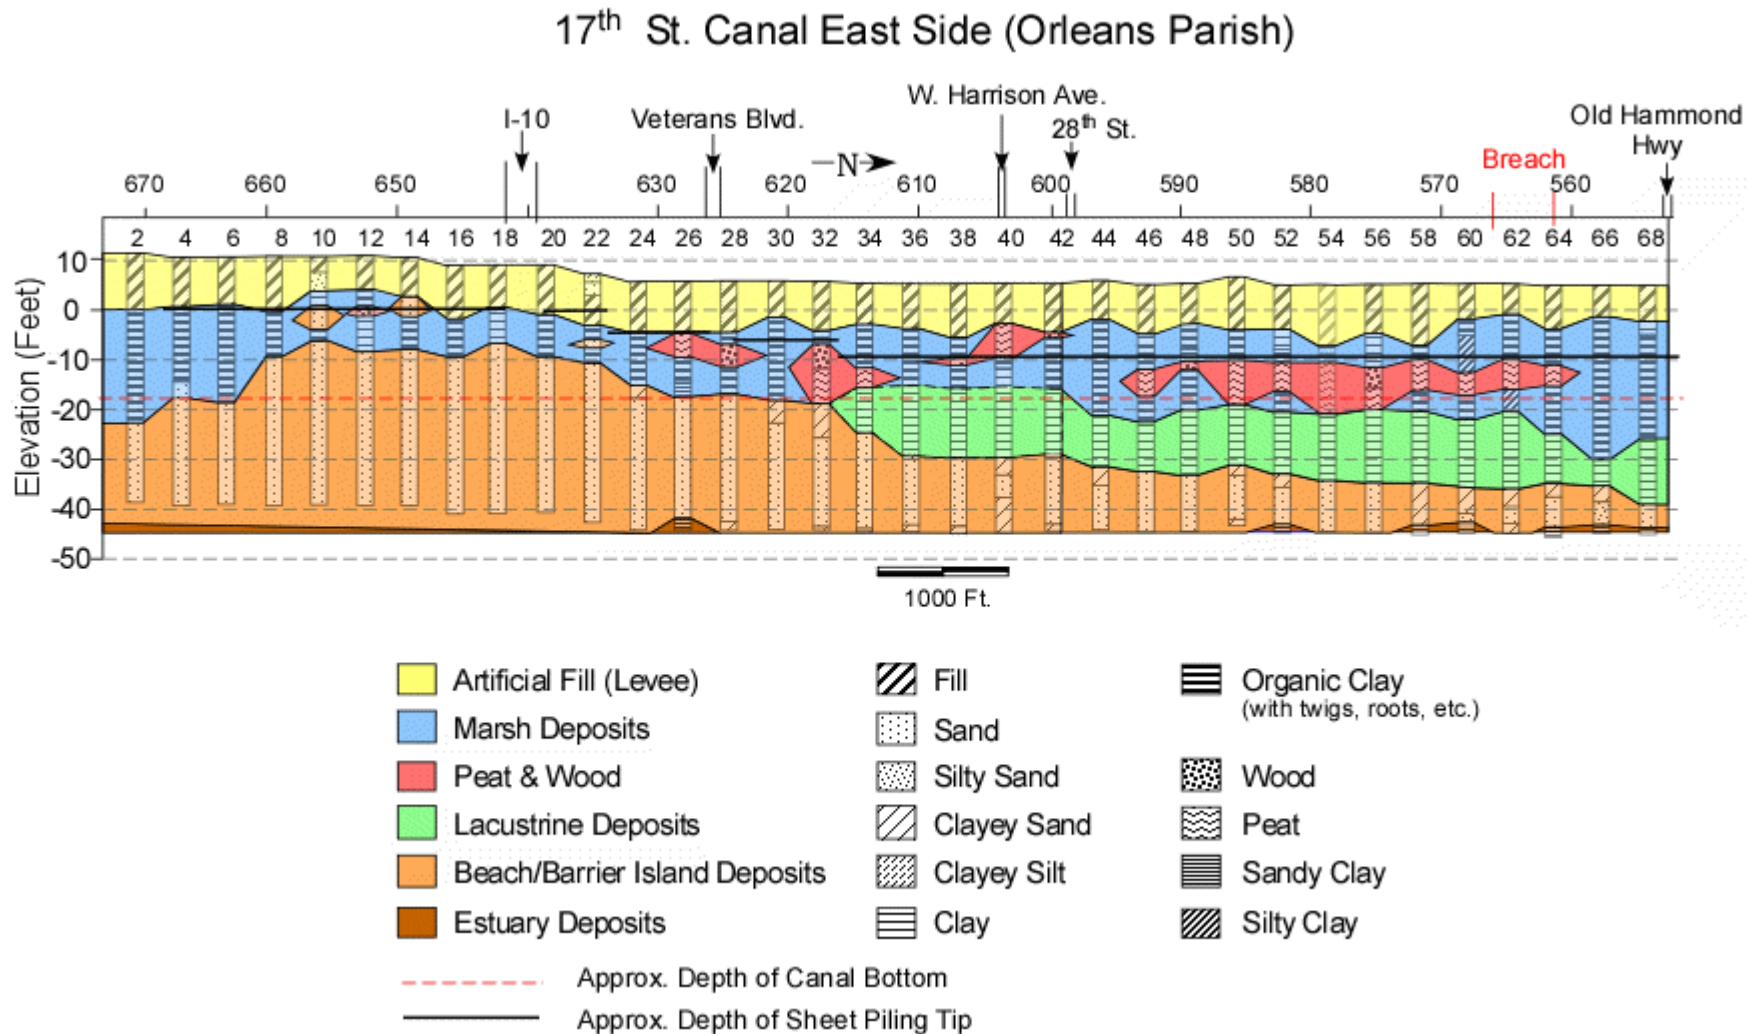
Figure 44 shows a geological cross section along the levee of the 17th street canal. The most notable feature of the cross section is the peat layer observed at depths between about 8 and 15 feet below sea level in the area of and to the south of the breach.

Figure 44. Geological cross-section along the eastern side of the 17th St. Canal (based on data in the U.S. Army Corps of Engineers design documents (1990)). Notable in the cross-section is the peat layer that occurs in the area of the breach. Depth to sheet piling tips is highly uncertain due to inconsistent information available from the U.S. Army Corps of Engineers. The set of as built available on the IPET web site plans (from which the sheet piling depths in this figure were used), show a depth of 10 feet in the area of the breach, yet the Corps claimed and later confirmed by pulling a sheet pile near the breach, that the sheet piles actually extended to 17.5 ft. below sea-level.

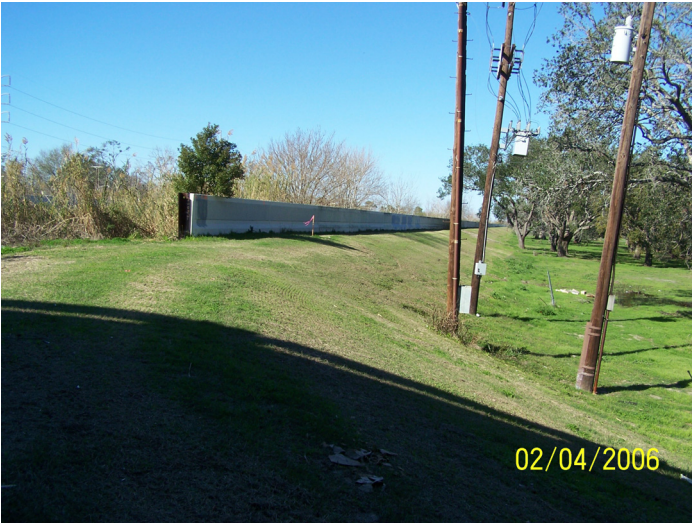
Figure 50. End of floodwall on Orleans Canal just north of I-610 overpass near Marconi Ave. (Stop 6)

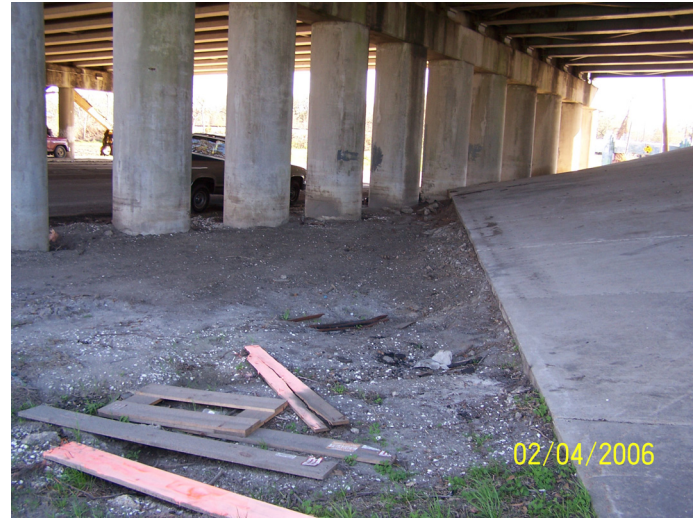
Figure 51. Erosion around the support structures for I-610 near Orleans Canal on Marconi Ave (Stop 6).
