TIDE-1220

Lessons Learned from Katrina and Reducing Vulnerability

Why did the Levees/Floodwalls Fail During Katrina?

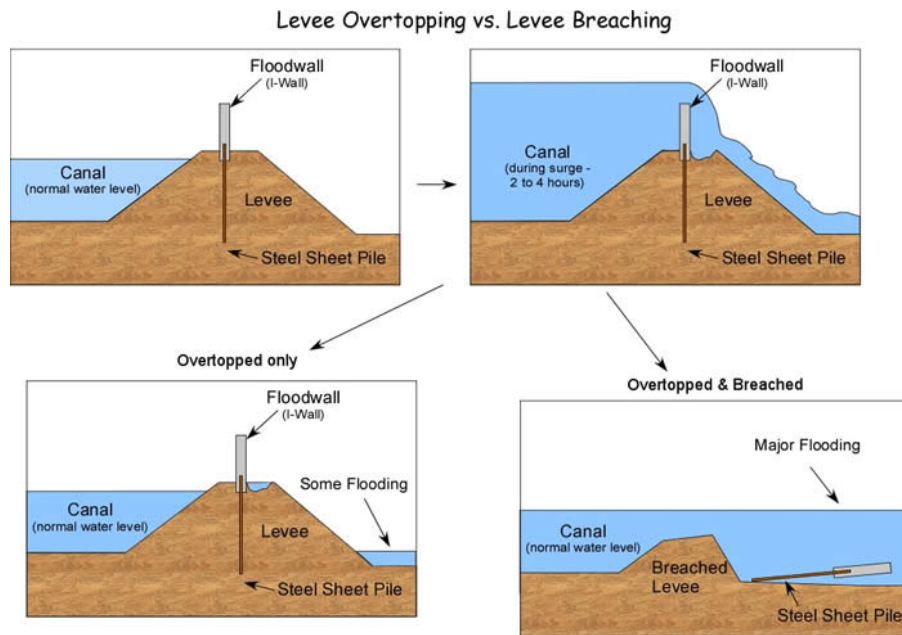
Figure 1

Levee overtopping, while it does allow water in to the protected area, is not as serious as levee/floodwall breaching (Figure 1)

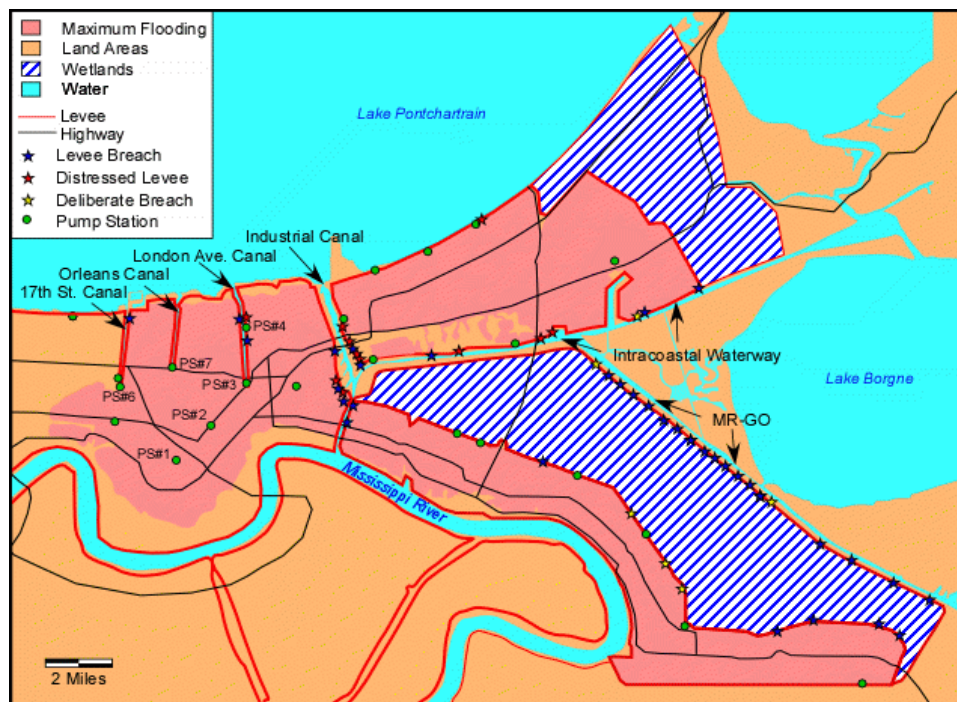
Figure 2

During Katrina, Mississippi River - Gulf Outlet (MR_GO) levees were overtopped resulting in breaching. This resulted in severe flooding in St. Bernard Parish. The levees were made of easily erodable spoil dredged from the shipping channel. The levees were not armored to prevent erosion (Figure 2).

- Along the MR-GO levees have been raised to 20 Feet above sea-level and a Standard has been adopted for clay used in levees to ensure that they will not be easily eroded by future storm surge.
- The MR-GO has been closed to shipping at the Bayou La Loutre Ridge, but this is not a surge barrier!

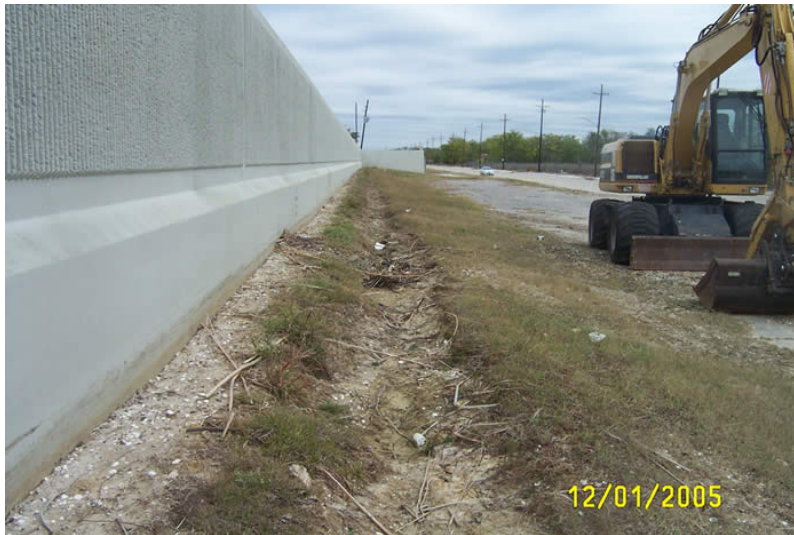
Figure 3

In the New Orleans Hurricane Protection System, no armoring was present at the base of floodwalls to prevent erosion if the floodwall was overtopped.

This resulted in erosion of the levees at the base of overtopped floodwalls (Figure 3).

Trench at base of floodwall on Lakefront levee in New Orleans East.

- Along the rest of the Industrial Canal, concrete splash pads have been placed on top to the levee at the base of the floodwalls to prevent erosion that would be caused by overtopping of the floodwall.
- All areas along the Industrial Canal remain vulnerable until the 100-year barrier system has been installed (by 2011). Construction started about 6 months ago (Figure 12)

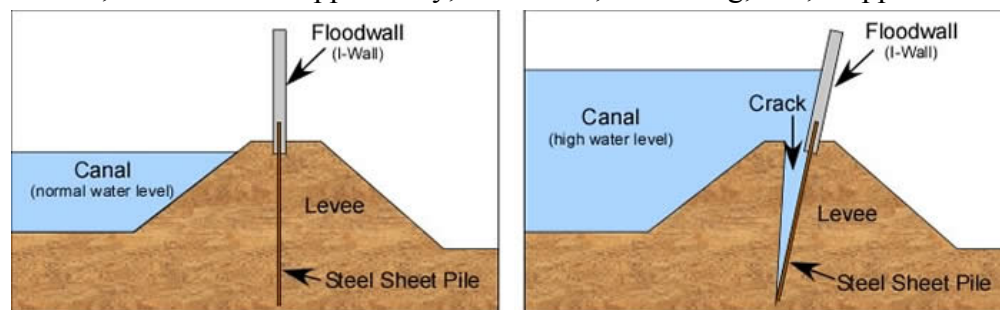
Figure 4

In 1985 Army Corps of Engineers research branch conducted tests on sheet pile flood walls with the same design that they were using for New Orleans' hurricane protection system. Found that they would likely fail! (Figure 4)

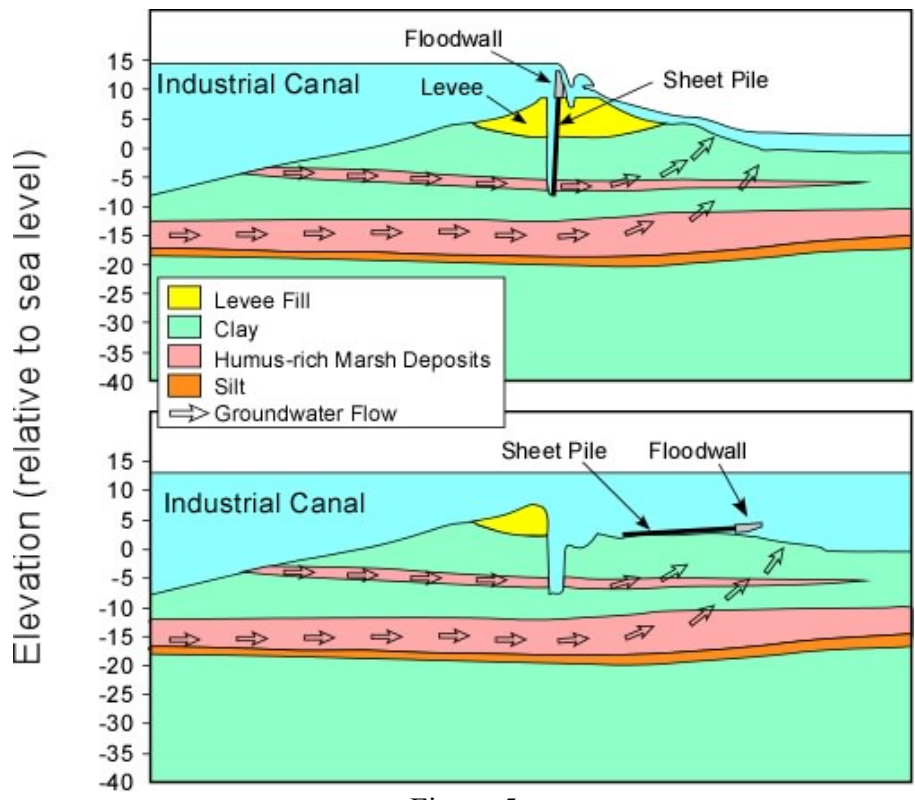
Figure 5

The combination of erosion due to the waterfall that resulted from overtopping and the force of the water acting to push the floodwall over, appears to have been largely responsible for the failure of the floodwalls on the east side of the Industrial Canal bordering the Lower 9th Ward (Figure 5)

- Along the Industrial Canal, the failed I- Wall has been replaced with T-Wall, but only adjacent to the Lower Ninth Ward (Figure 11).

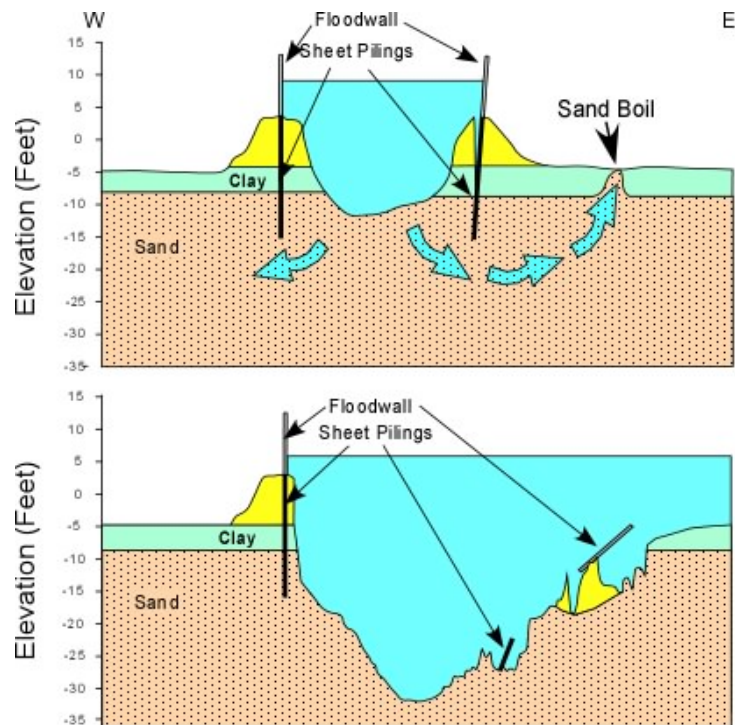
Figure 6

Failure of the levee on Floodwall on the east side of the London Avenue Canal was due to failure to drive sheet pilings deep enough to cut off underseepage through the sand underlying the canal and levee.

Failure at London Ave. Canal South Breach

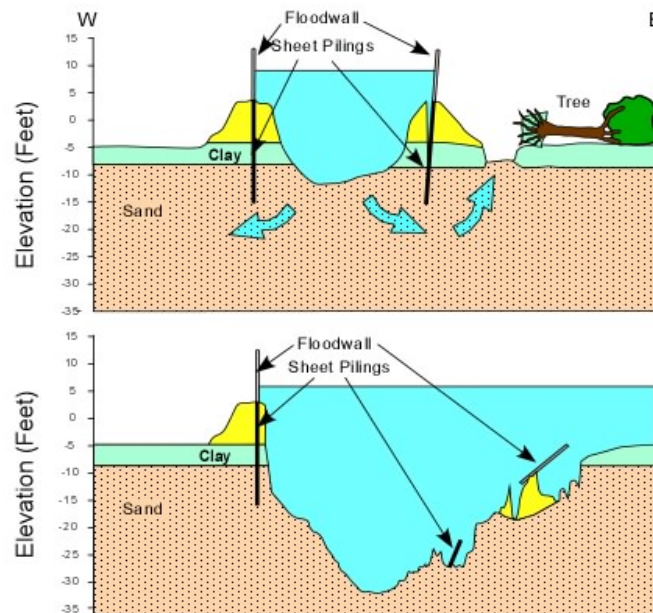
Figure 7

This failure could also have been initiated by uprooting of a tree by hurricane force winds to initiate the breach (Figure 7). In either case, the sheet piles were not driven deep enough to prevent the underseepage through the sand.

Alternative Hypothesis

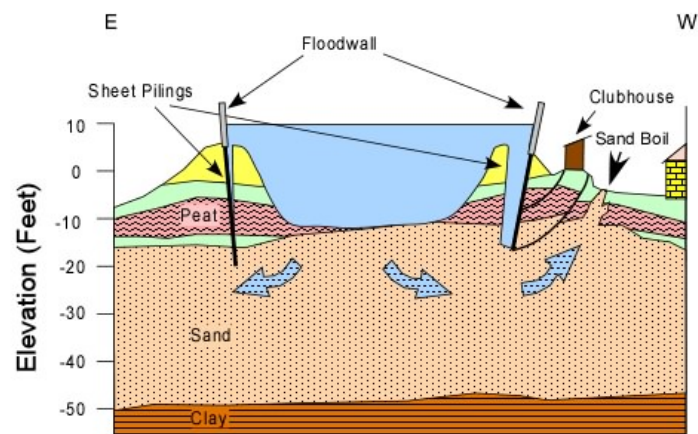
Figure 8

On the west side of the London Avenue Canal, a similar problem occurred. But, in this case, the pressure from the rising water seeping under the levee provided enough force to uplift the land in a process called heaving (Figure 8)

Heaving at London Ave. Canal North Breach

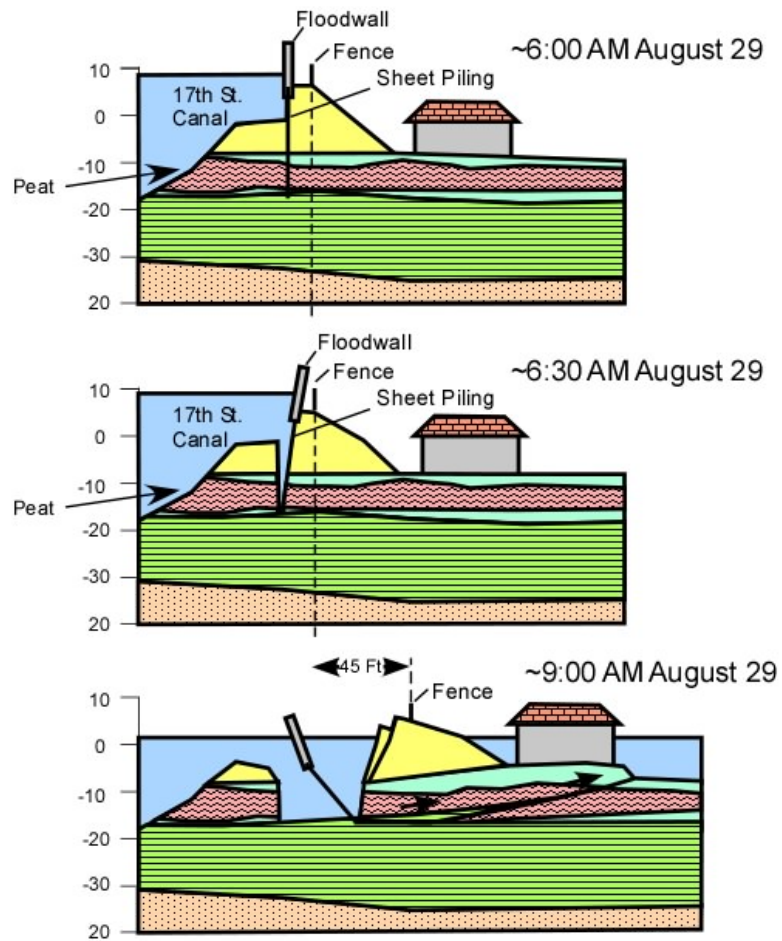
Figure 9

At the 17th St. Canal, (see Figures 41 and 42 in the field trip guide - <http://www.tulane.edu/~sanelson/Katrina>) a sliding mechanism, similar to the failure mechanism discovered by the Corps of Engineers experiments in 1985 (Figure 4) appears to have been the cause of the failure (Figure 9)

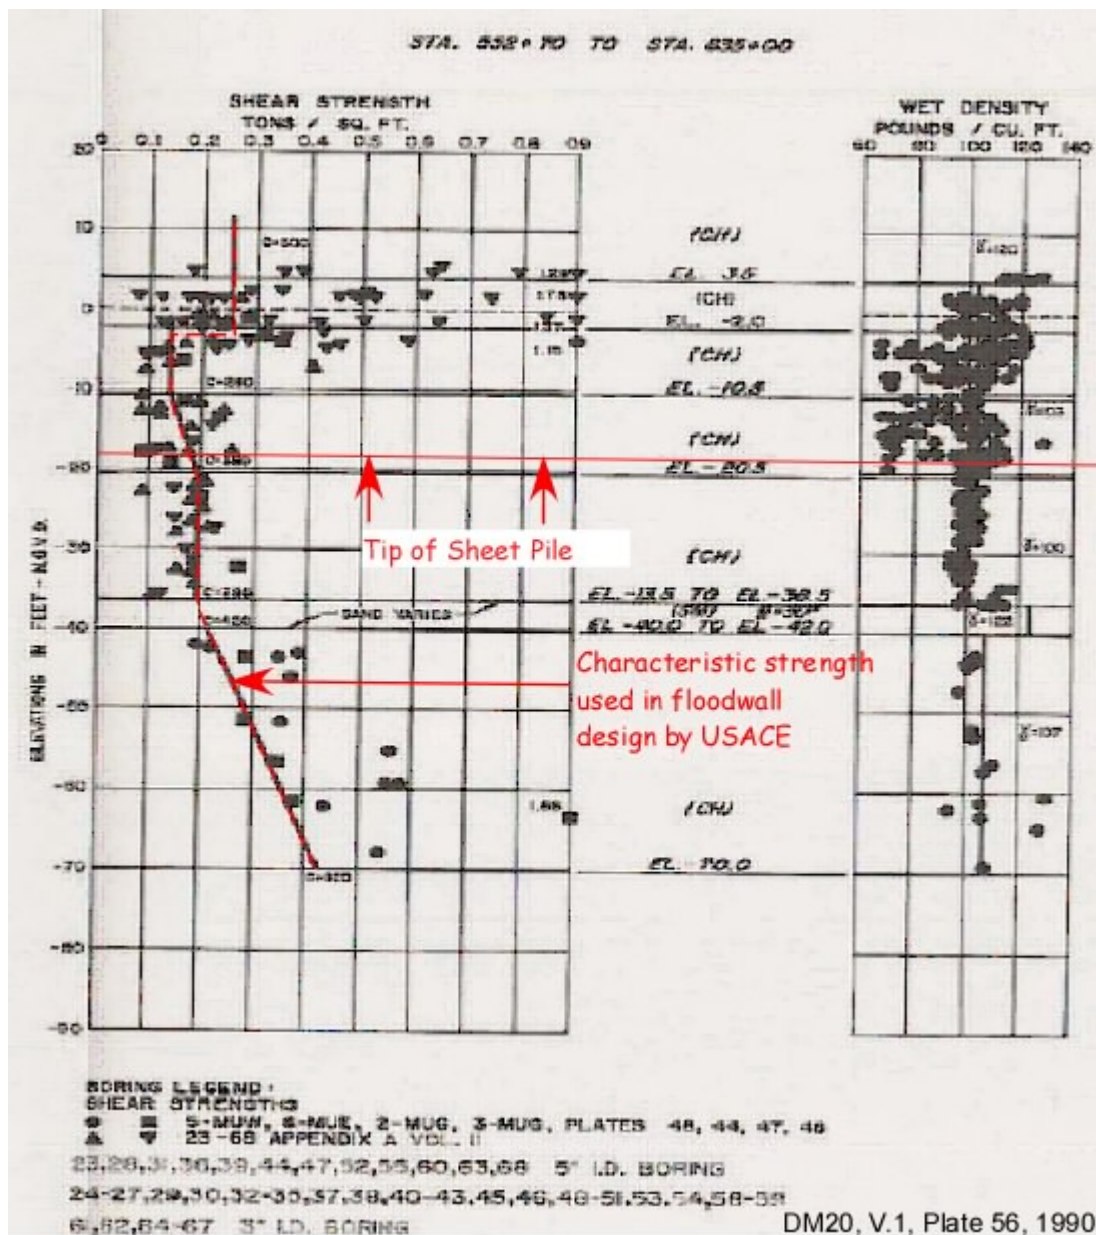
Figure 10

In this case the sheet piles were not even driven as deep as the bottom of the canal, but it is also seen that the design failed to take into account the low soil strengths below the levee (Figure 10).

Shear strength and wet density versus depth along an 1800 foot section of the 17th St. Canal which includes the area of the breach (from U.S. Army Corps of Engineers, 1990, the Design documents for the 17th St. Canal floodwall). The author has added the red lines and red labeling showing the depth to the tip of the sheet piles in the breach zone and the characteristic strength values as a function of depth that the Corps used to determine the stability of the floodwall system.
