# Bridge Structure Rehabilitation

## Field Application of Rapid Installation Method

**Anthony J. Lamanna**  
Assistant Professor

Department of Civil and  
Environmental Engineering  
Tulane University  
[lamanna@tulane.edu](mailto:lamanna@tulane.edu)

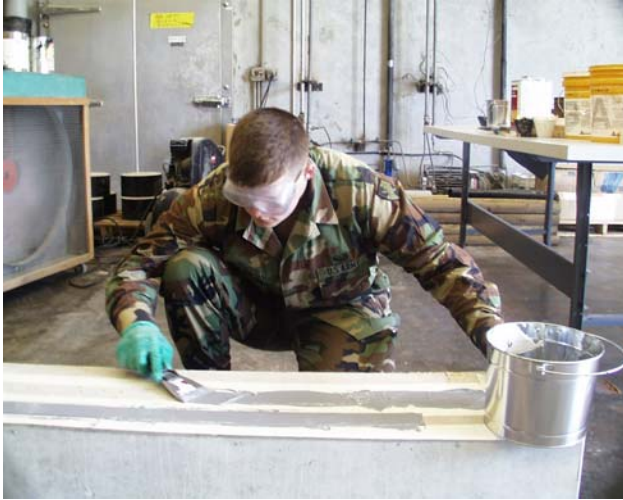
# Current Method of Bonding FRP

- Surface preparation
- Cure time
- Skilled labor

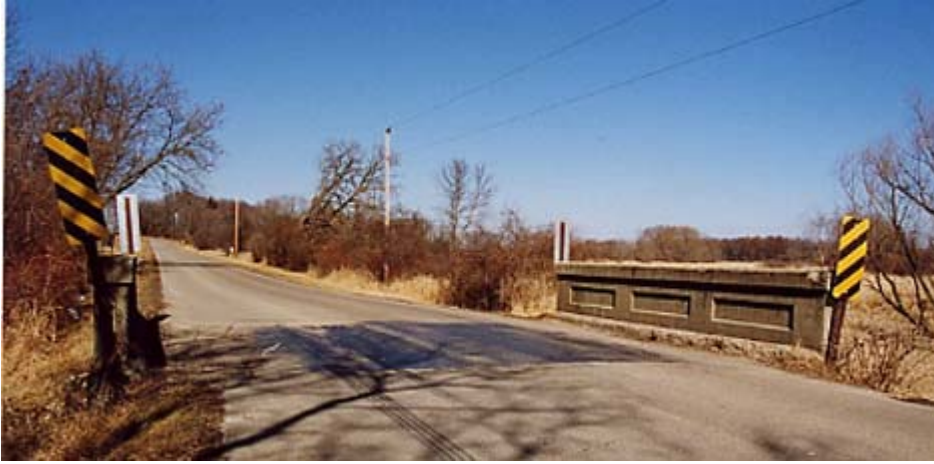
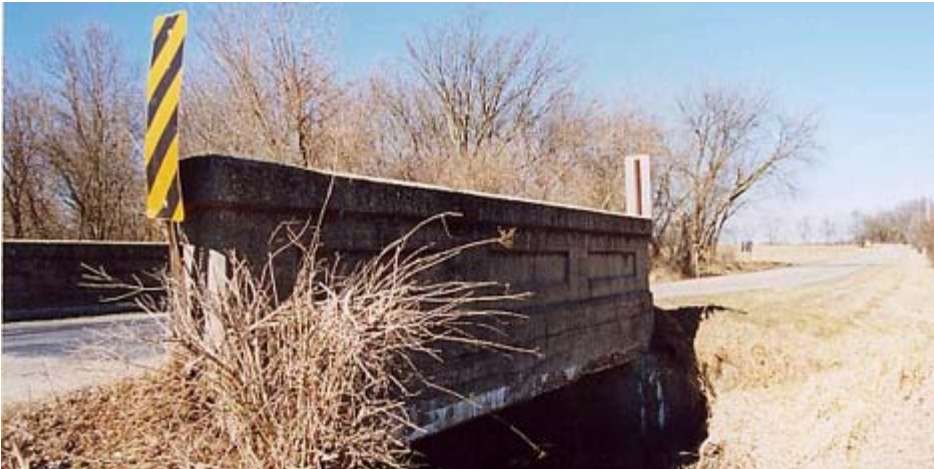
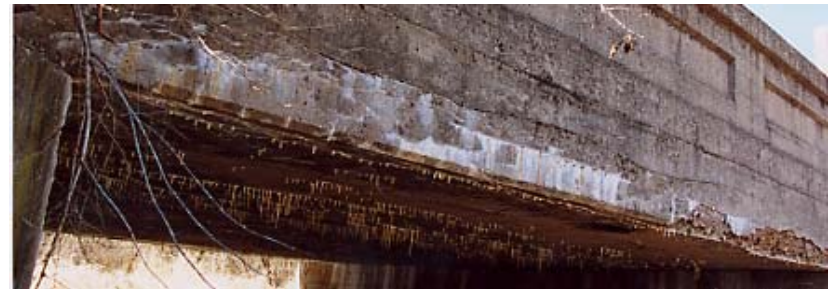
# Bridge Selection

- Flat slab bridge
- Constructed in 1930
- Designed for H15 truck loading
- HS 17.6 inventory rating
- HS 29.3 operating rating
- 32.7 sufficiency rating
- Efflorescence on edge of slab
- Scheduled for replacement 2003

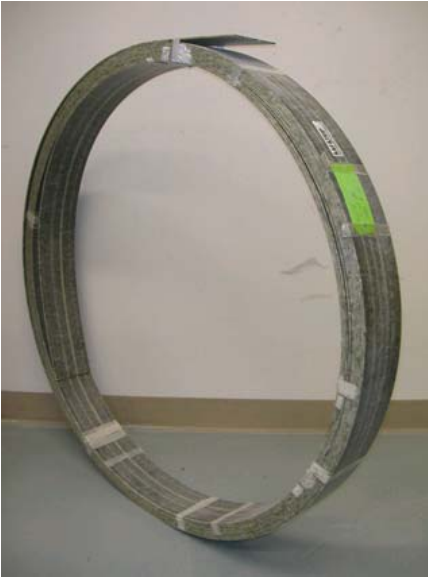
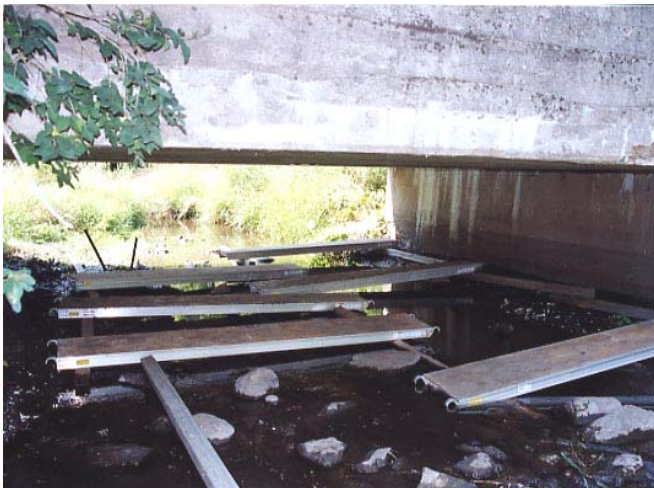
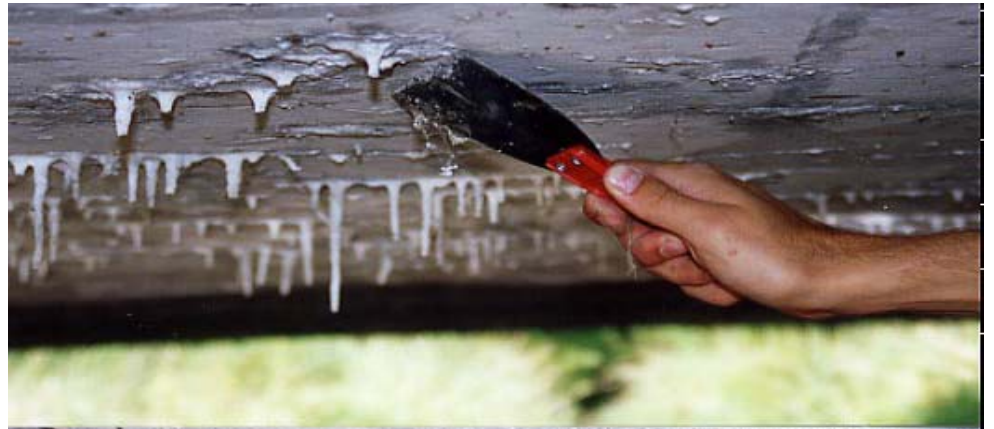
# Field Installation

Strip supplied in 100 ft rolls

Cut to 21 ft 2 in. lengths

Fastener locations marked & pre-drilled

Work platform constructed under bridge

Soft calcium removed with putty knife

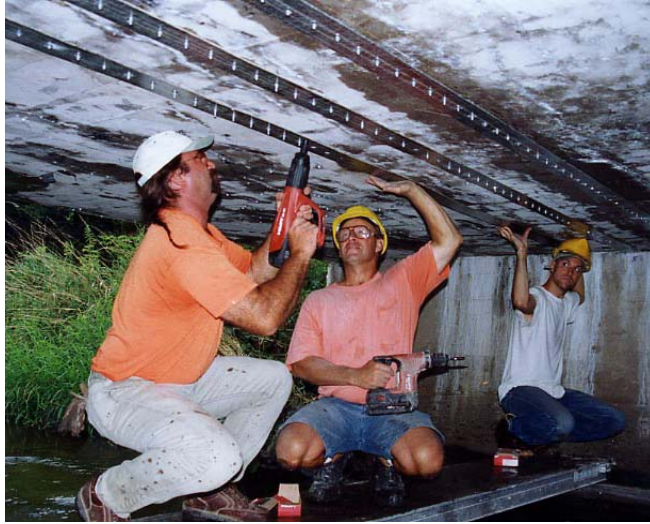
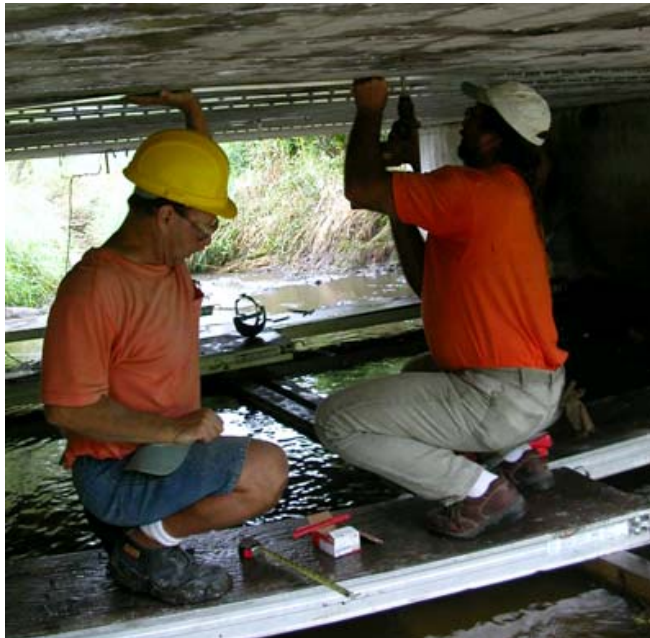
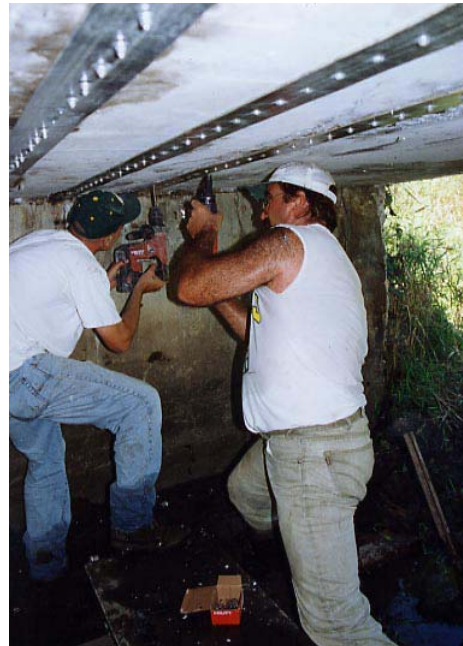
# Field Installation

Strip duct taped in position  
Midspan fastener installed  
Midspan to abutment, repeated  
15 minutes to position strip  
15 minutes to attach strip

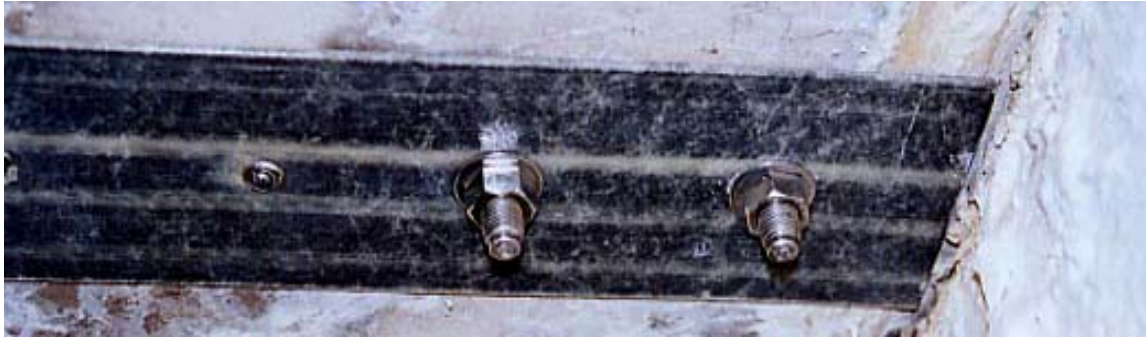
End Anchor Bolts

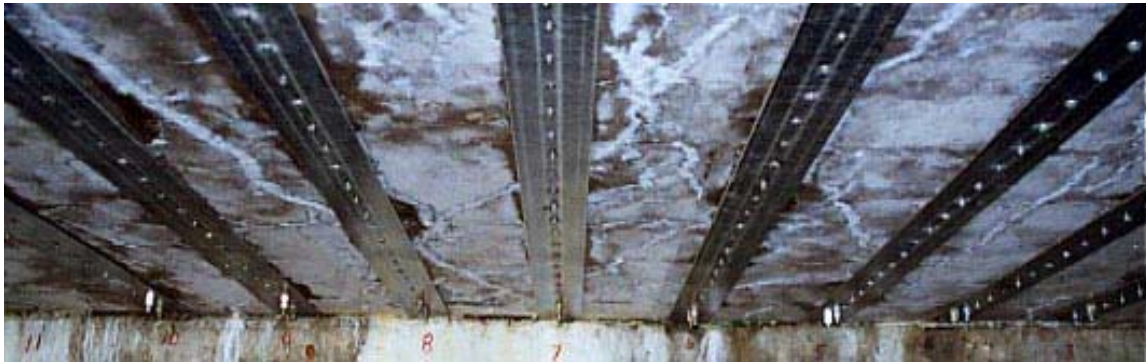
12" strip spacing

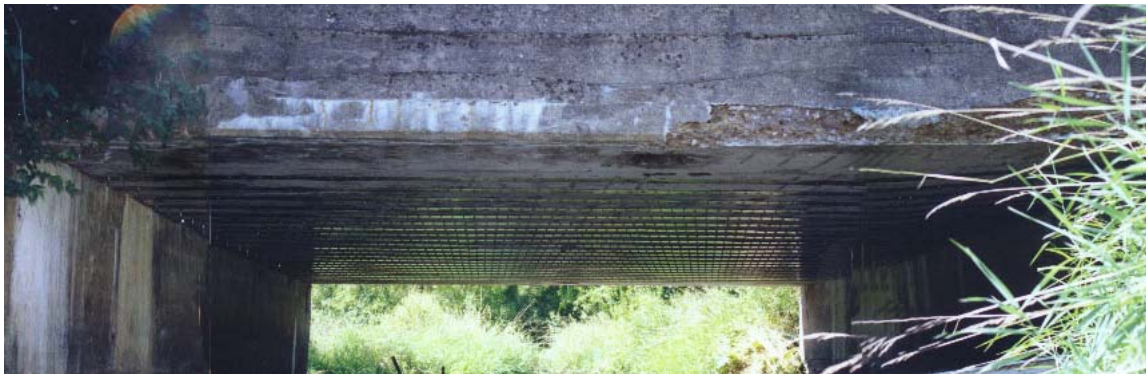
Strengthened bridge

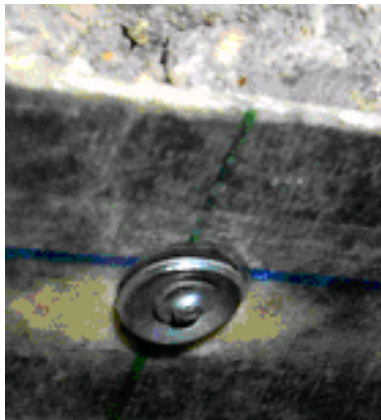
Over driven fastener

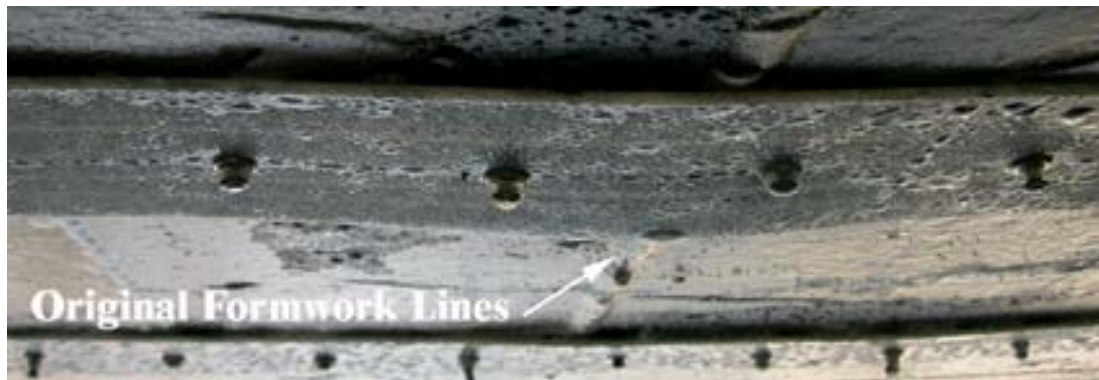
Out of plane variations

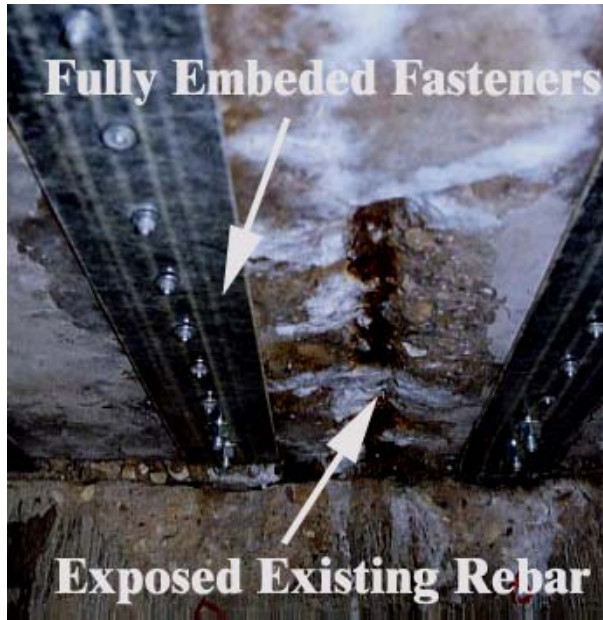
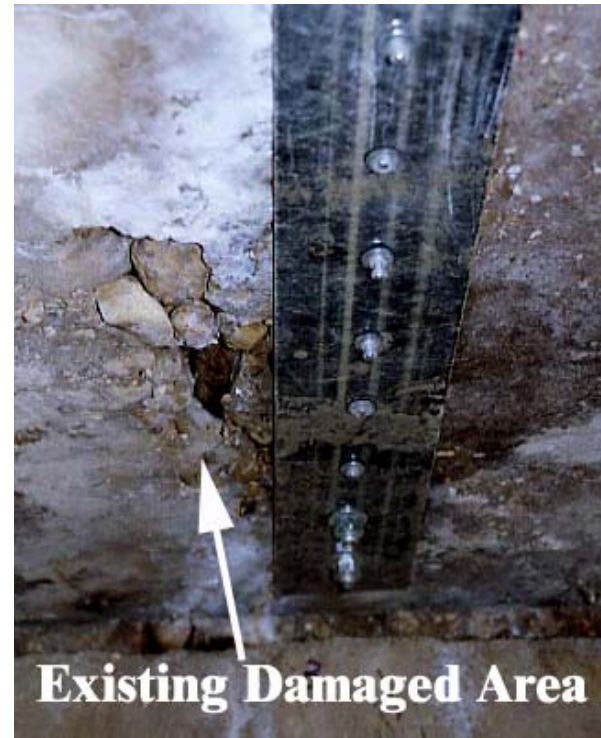
Strips relocated a few inches to avoid major damage

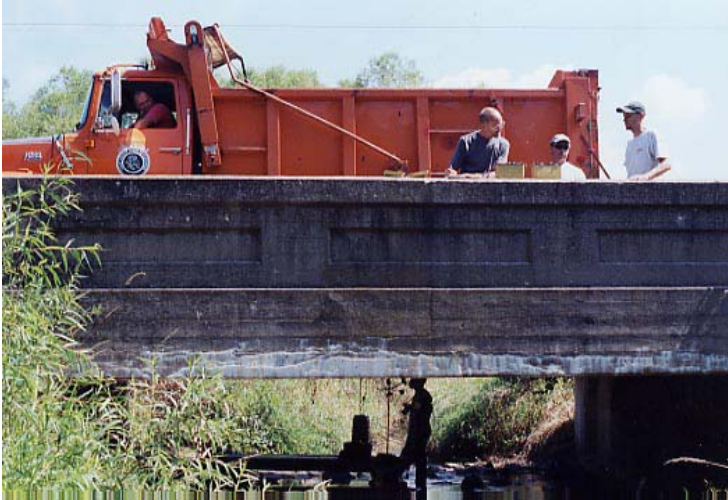
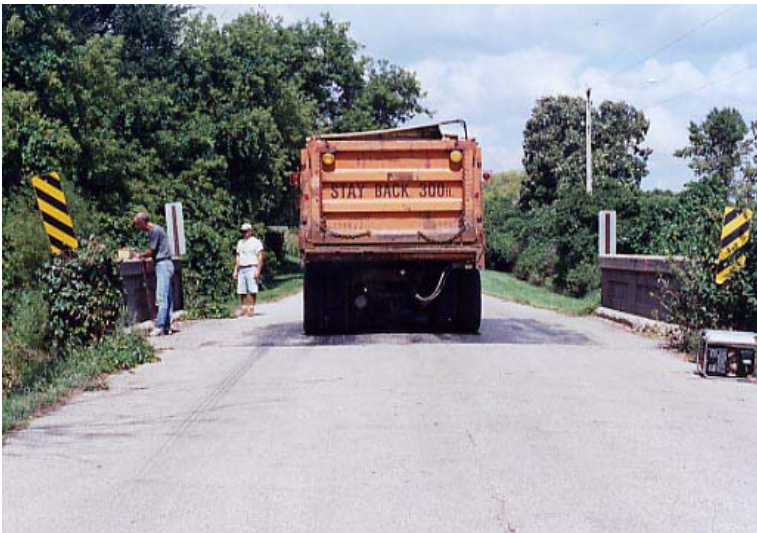
# Service Load Test

- 25.4 Tons

- Strains very small

(Strains reduced in some cases up to 88%)

- Strips left in place 1 year

- Service load test repeated

- Bridge tested to failure
