I-10 Twin Spans over Lake Pontchartrain

**Emergency Repairs**

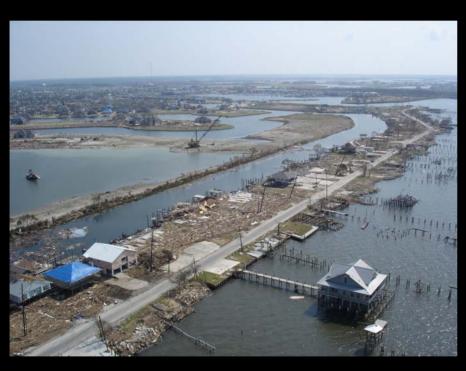
- Existing Site Conditions
  - No power, water, food
  - Limited access due to debris
  - Temporary bunkhouses, onsite trailers
  - Hauling in of food and water daily

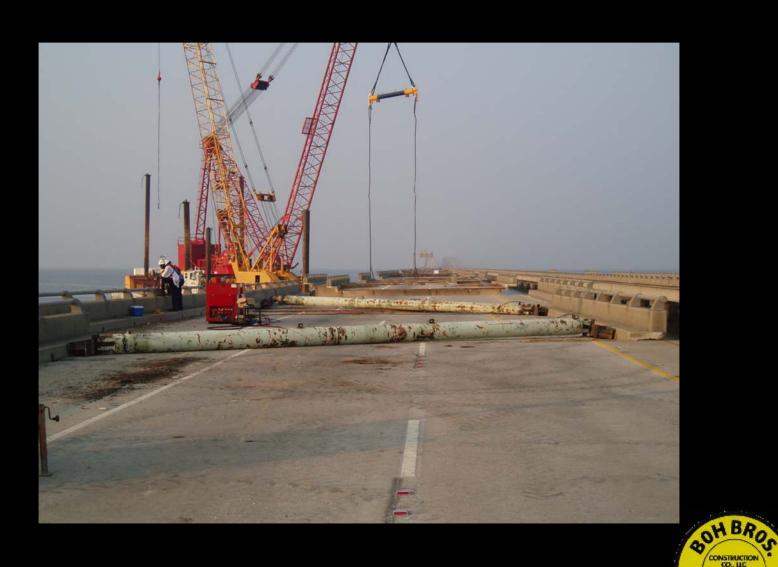
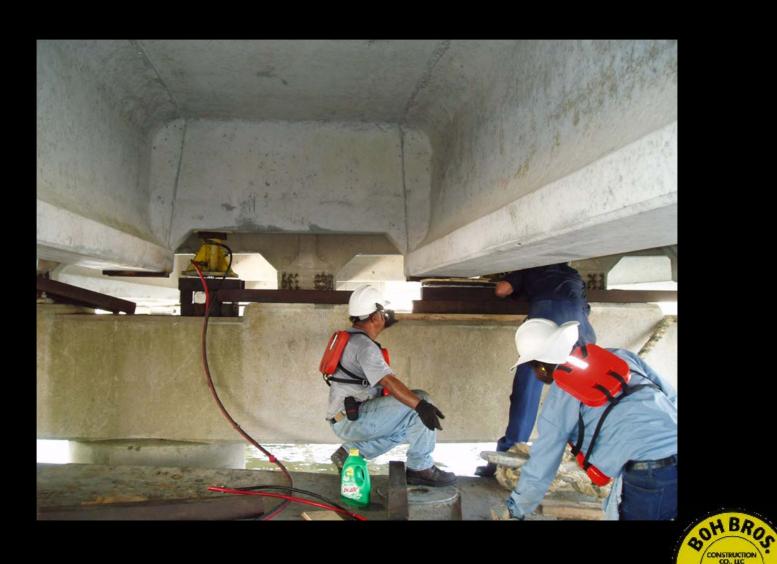
- Phase I Repair Procedures
  - Realignment
    - Jack and Slide
      - Used for realignments equal to or less than 5'
      - Jacks placed under the span
      - Teflon slide plates
      - Hydraulic rams on deck to position

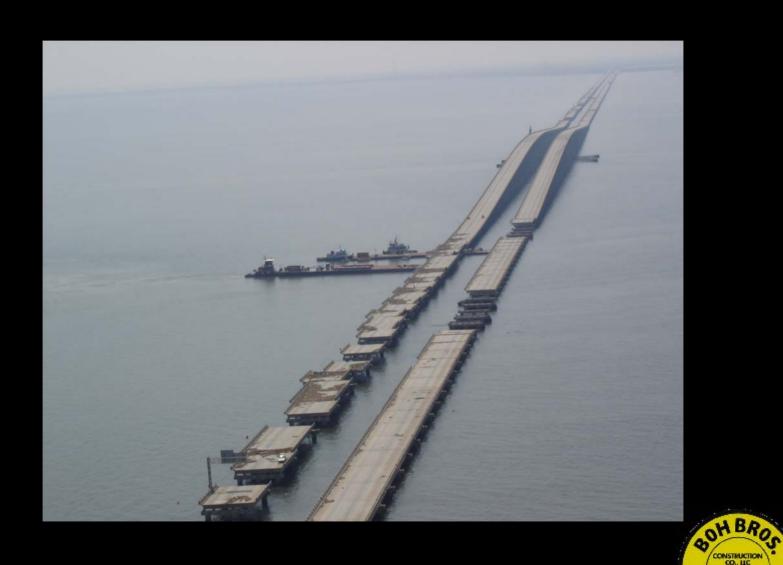
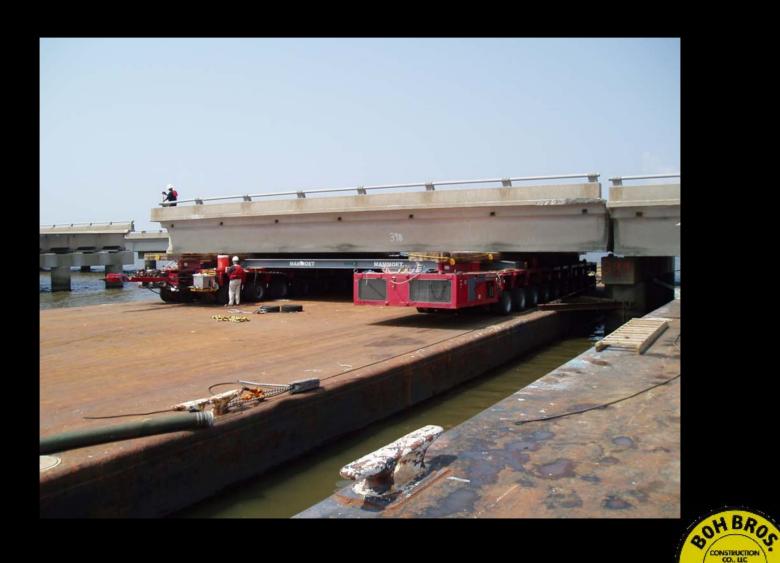
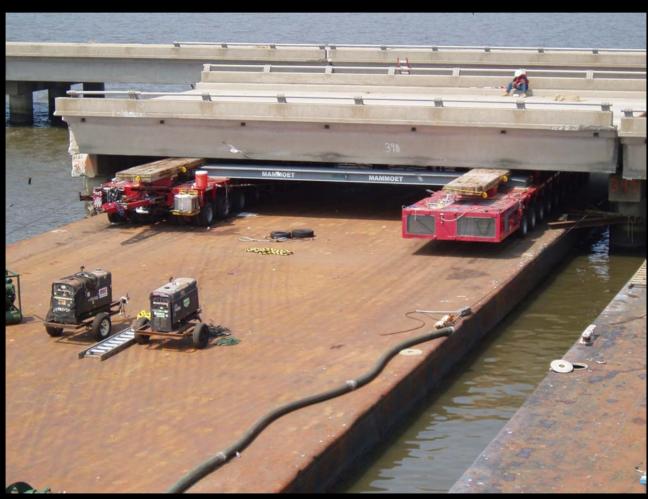
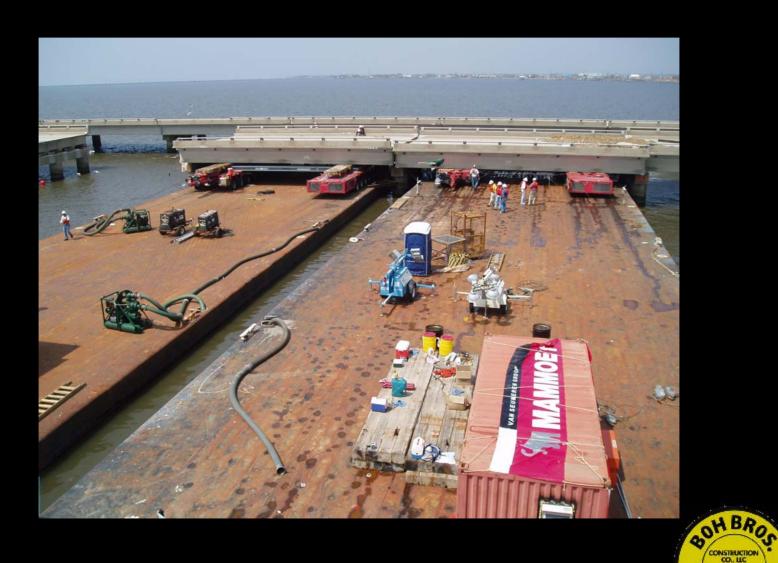
- Phase I Repair Procedures
  - Realignment
    - Goldhofer trailers
      - Used for realignments of all magnitude
      - Multi-directional hydraulic trailers on barge
      - Barge placed under span
      - Span lifted and positioned by trailers

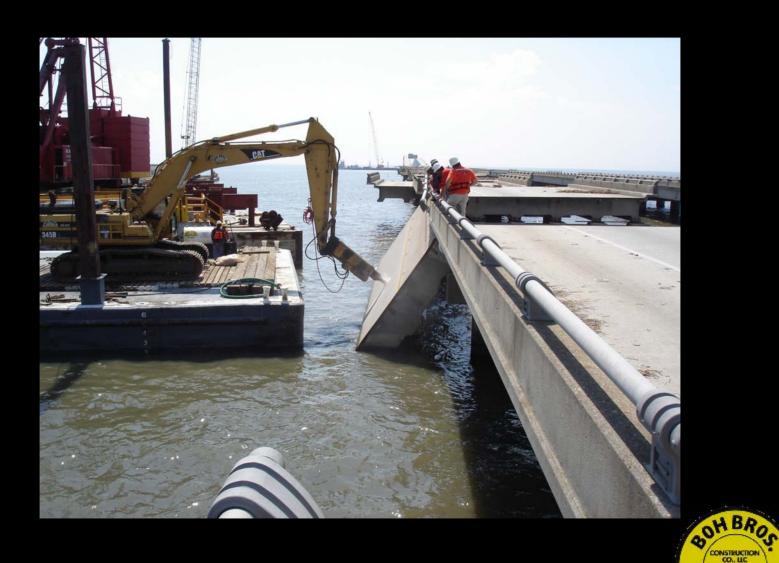
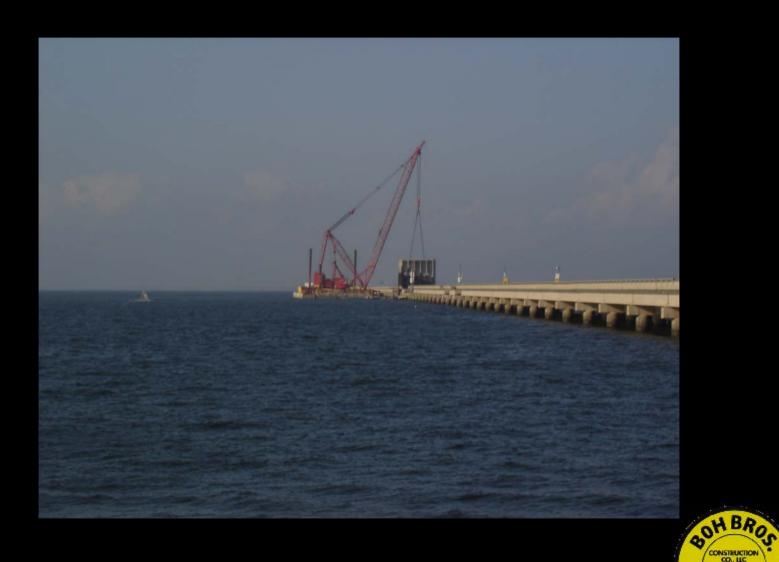
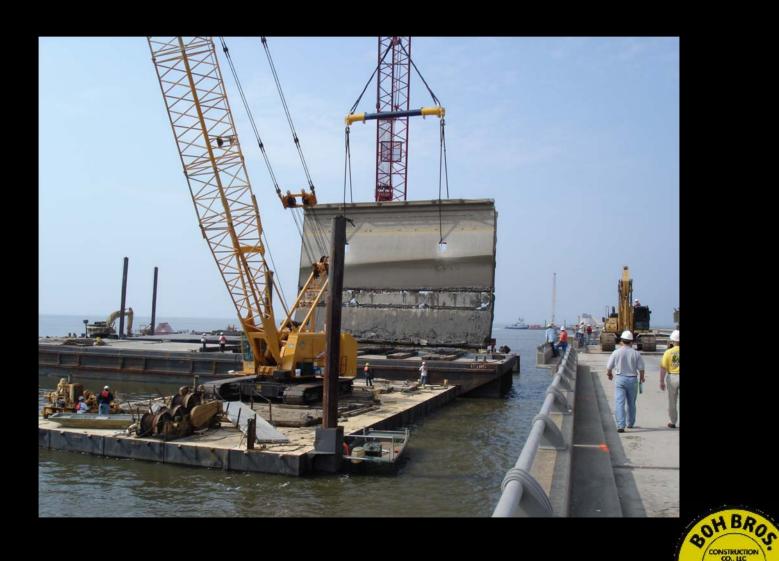
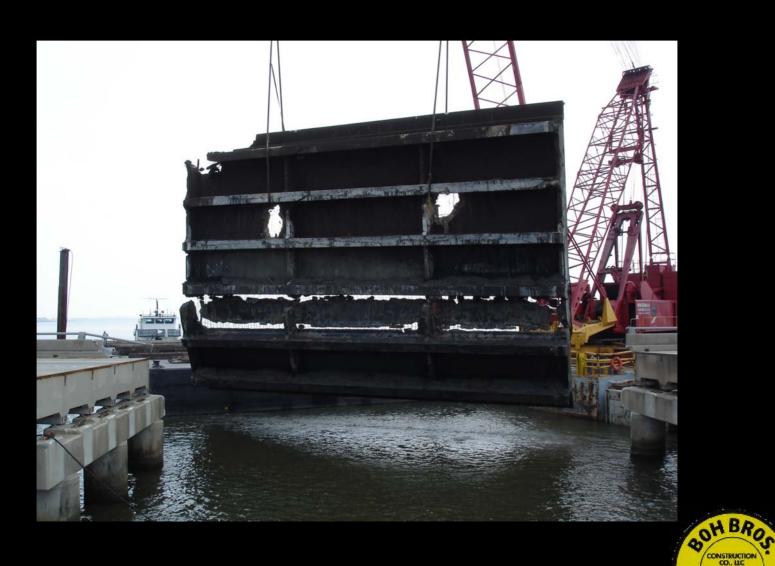
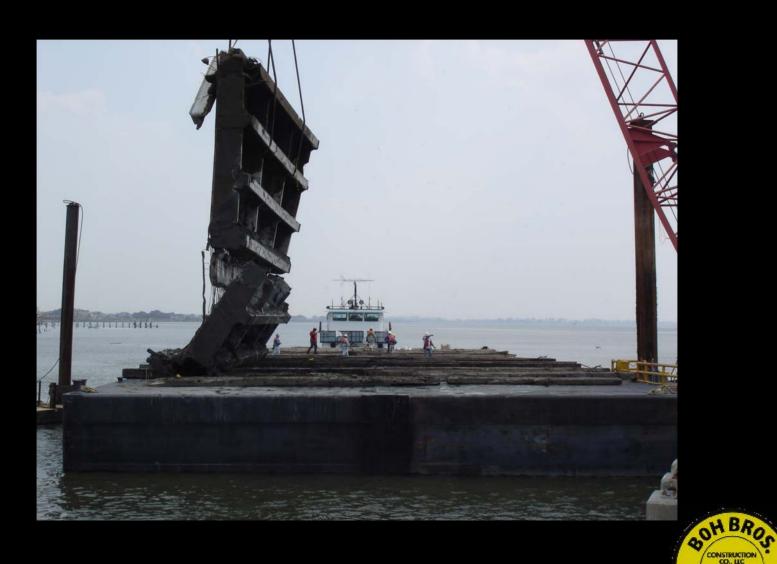
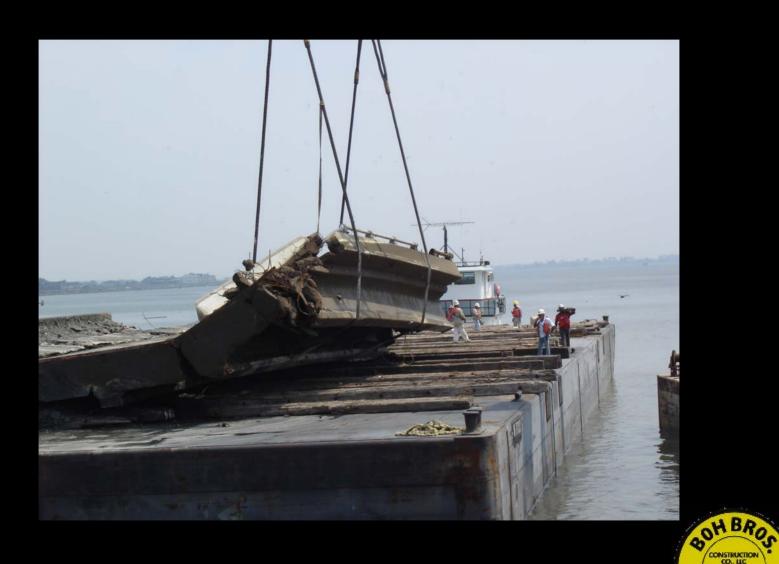
- Phase I Repair Procedures
  - Realignment
  - Removal
    - 285-ton span units
    - 4600 ringer crane
    - 3.5" cables
    - Underwater rigging
    - Remove & dispose offsite
  - Replacement
  - Screw Jacks and Cap Saddles
  - Helper Bents

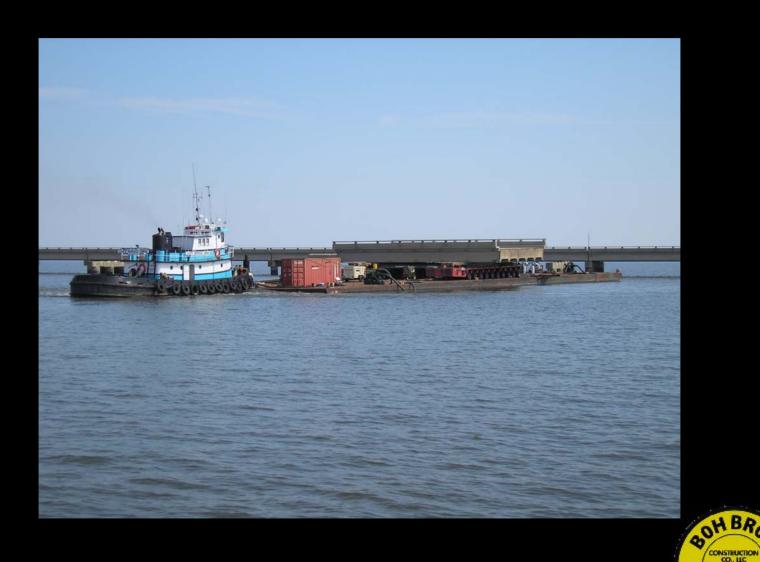
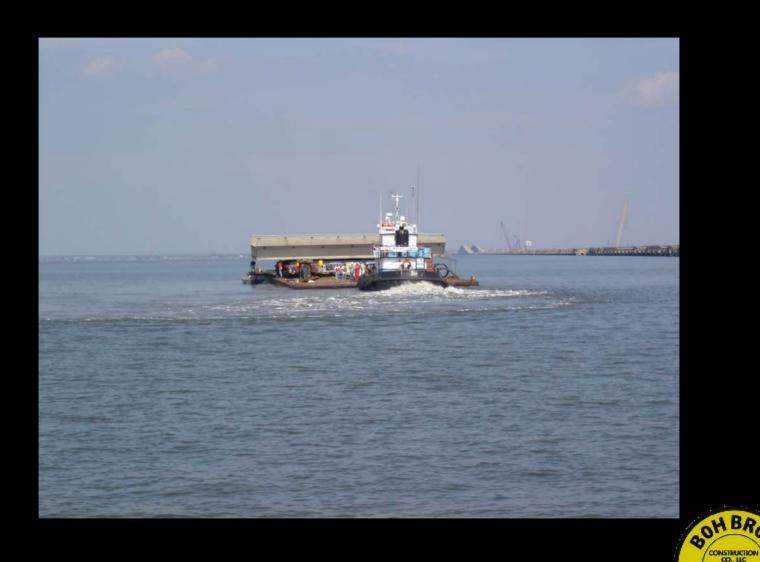
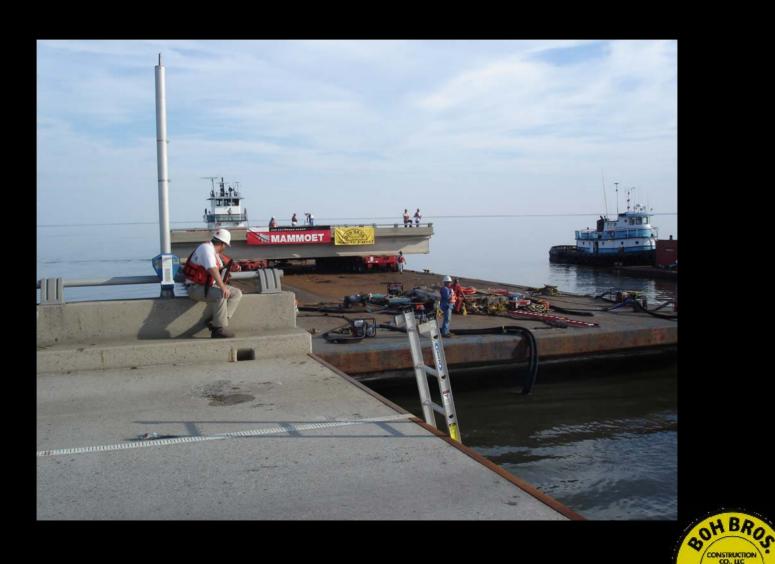
- Phase I Repair Procedures
  - Realignment
  - Removal
  - Replacement
    - Goldhofer trailers mounted on barges
    - Spans taken from westbound bridge
    - Transported to and placed on eastbound bridge
  - Screw Jacks and Cap Saddles
  - Helper Bents

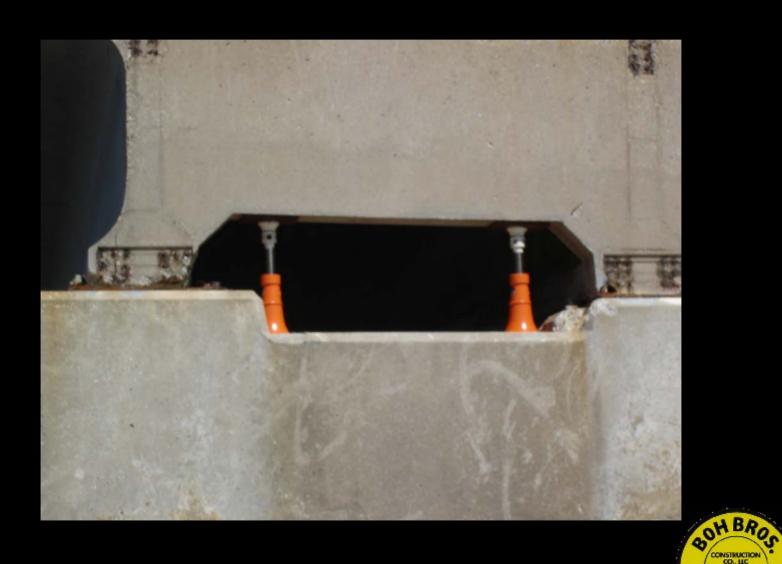
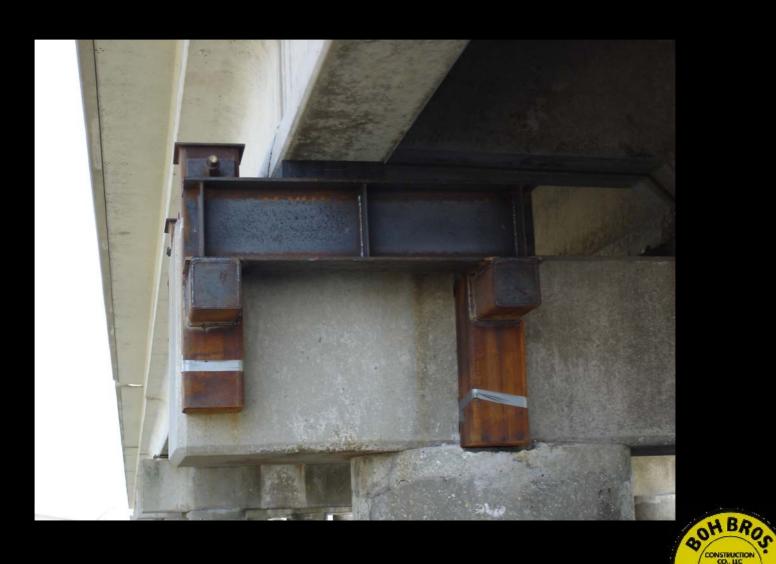
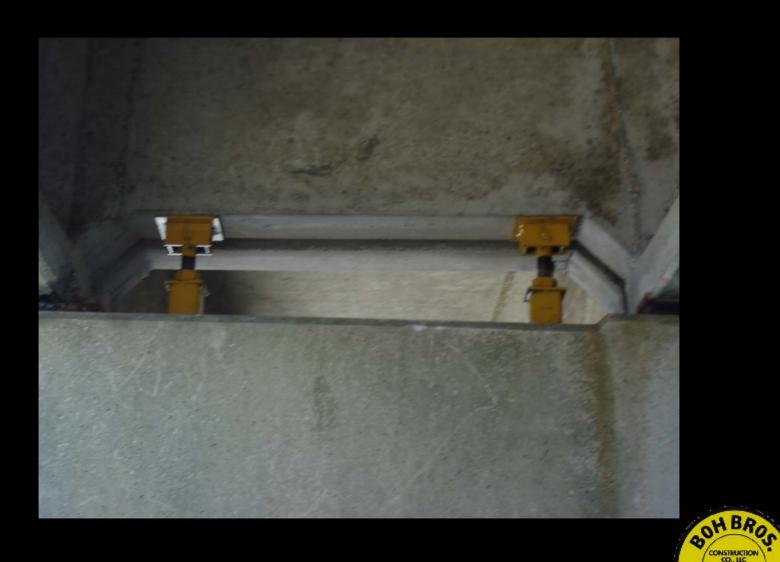
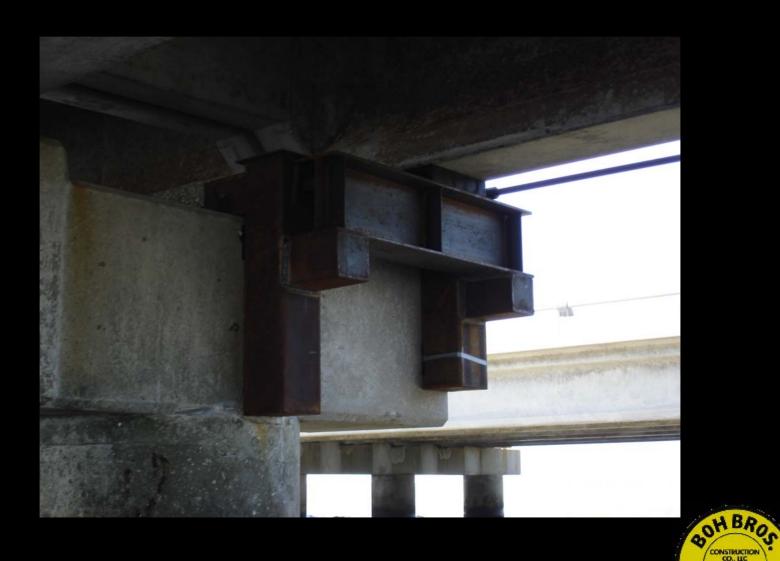
- Phase I Repair Procedures
  - Realignment
  - Removal
  - Replacement
  - Screw Jacks and Cap Saddles
    - Used to transfer load away from damaged girder ends
    - Screw jacks transfer vertical load to diaphragms
    - Cap Saddles transfer load into the girder
  - Helper Bents

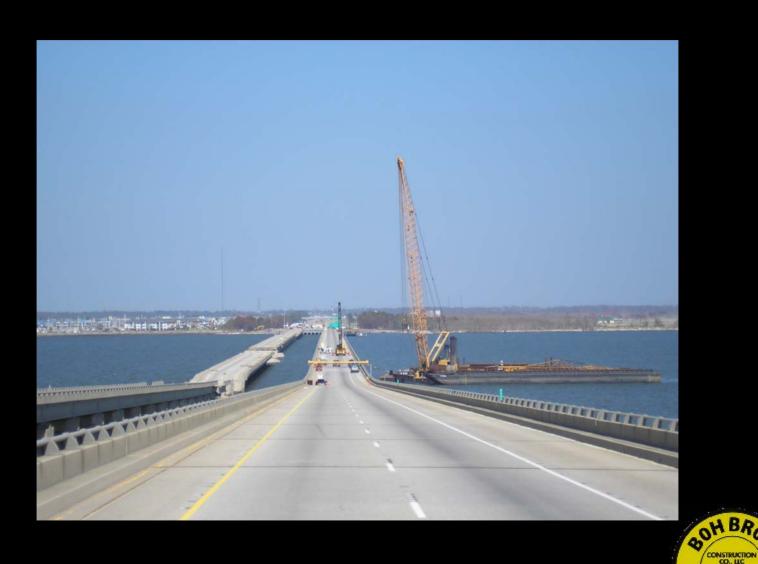
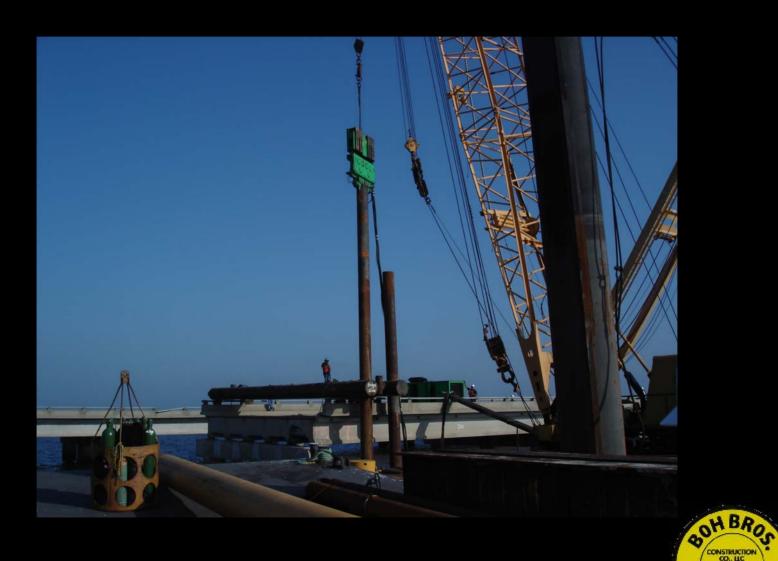
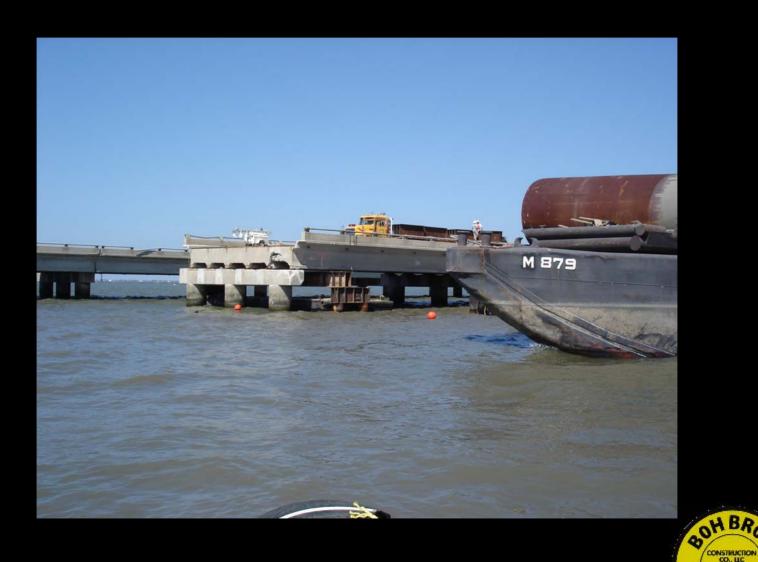
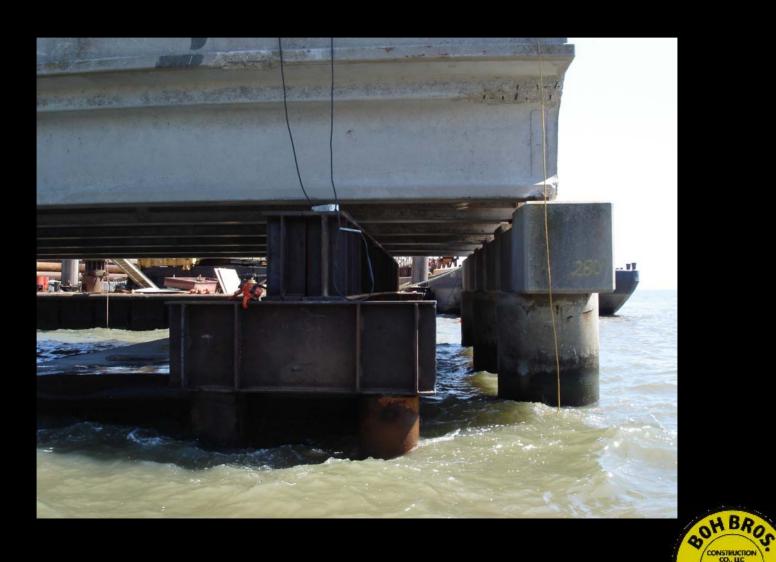
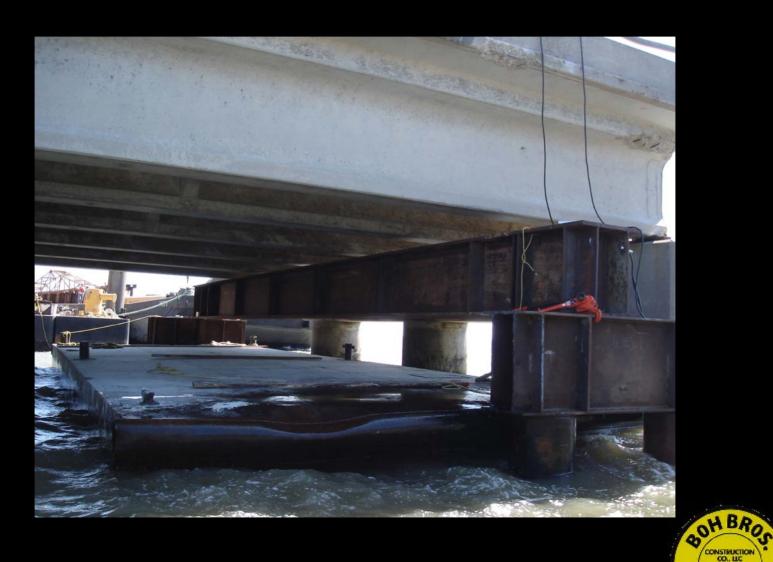
- Phase I Repair Procedures
  - Realignment
  - Removal
  - Replacement
  - Screw Jacks and Cap Saddles
  - Helper Bents
    - Used where girder ends were severely damaged
    - Transfer point of bearing into girder
    - Steel piles driven to support helper beam under girders

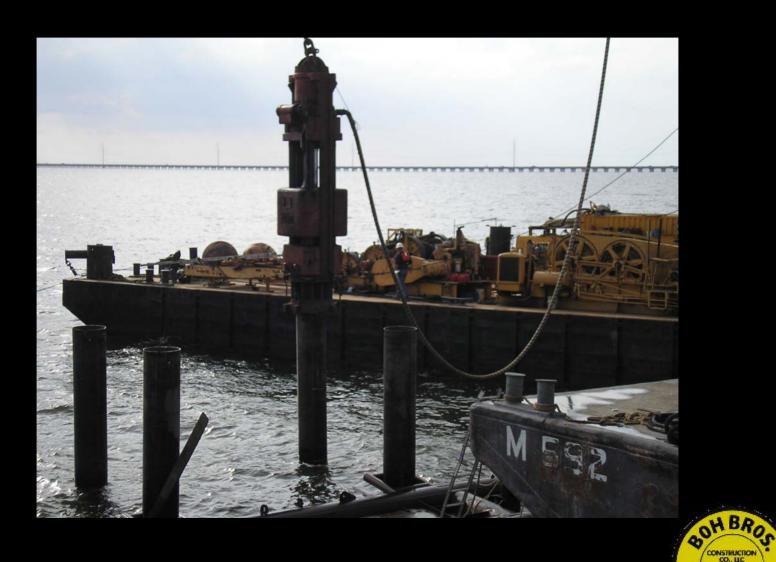
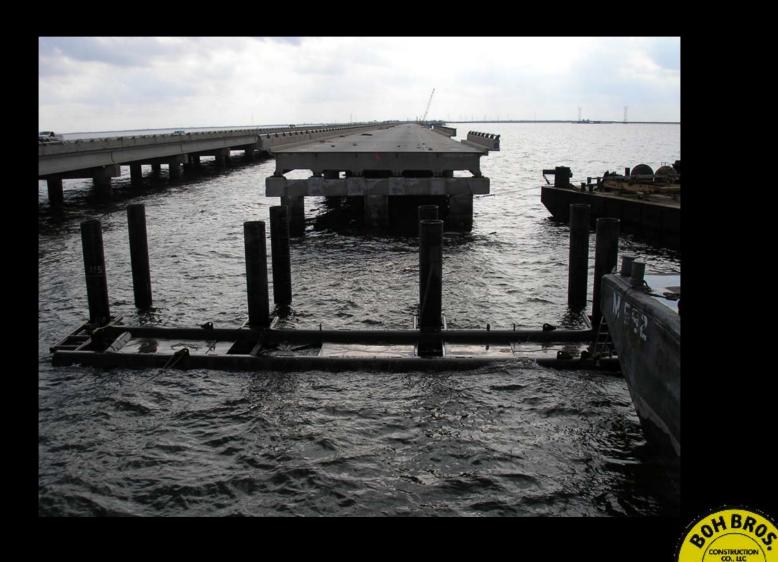
- Phase II Repair Procedures
  - Realignment
  - Removal
  - Replacement
  - Screw Jacks and Cap Saddles
  - Helper Bents
  - Replacement Bents
    - Used where bent was destroyed or missing
    - Steel piles and beams placed to support deck
  - Acrow Bridge

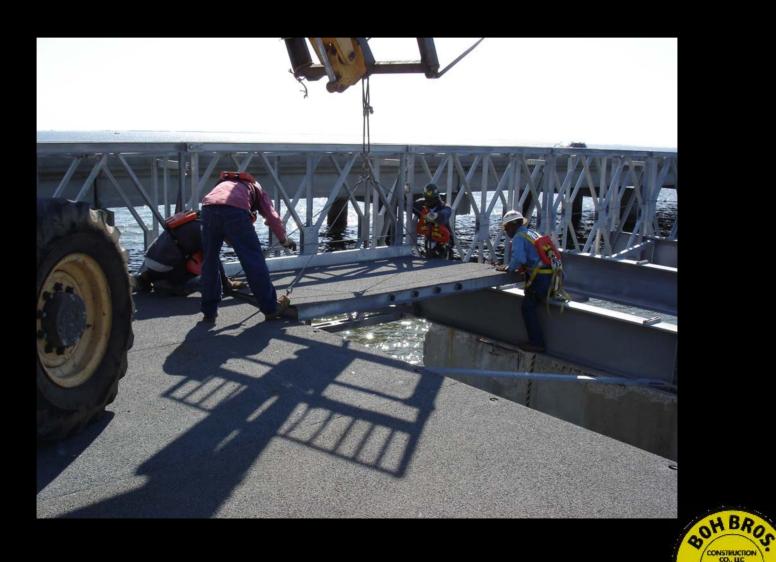
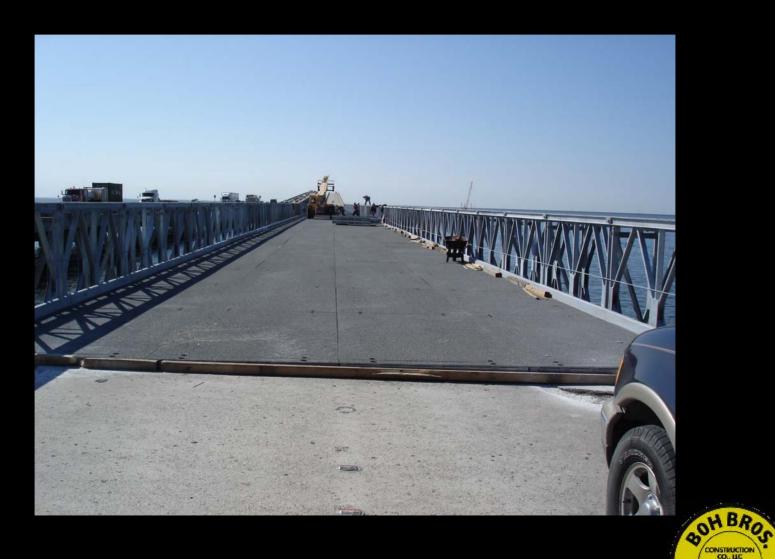
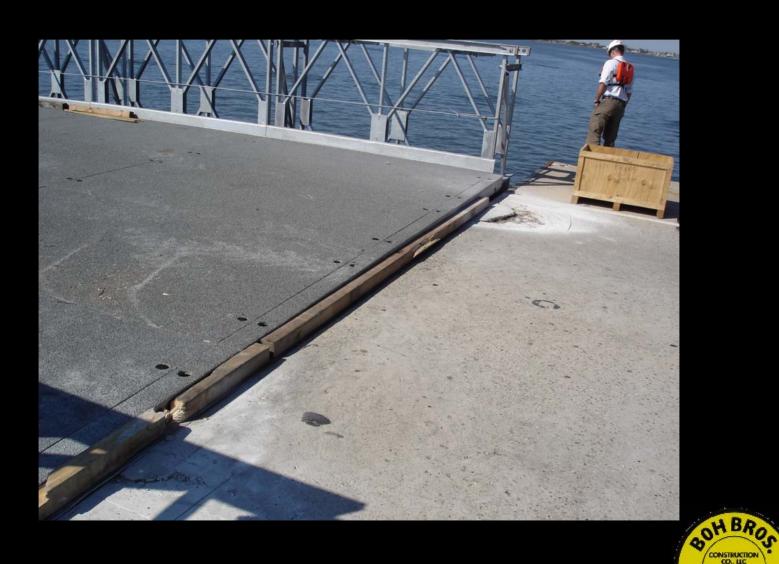
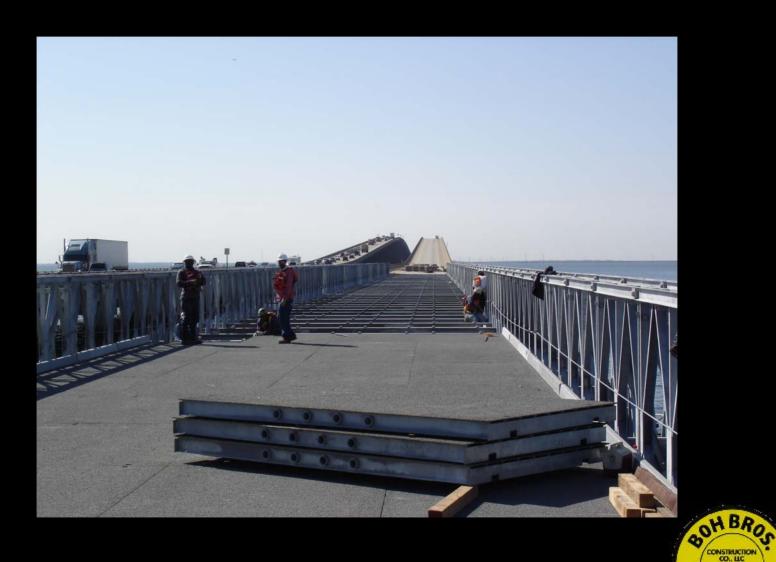
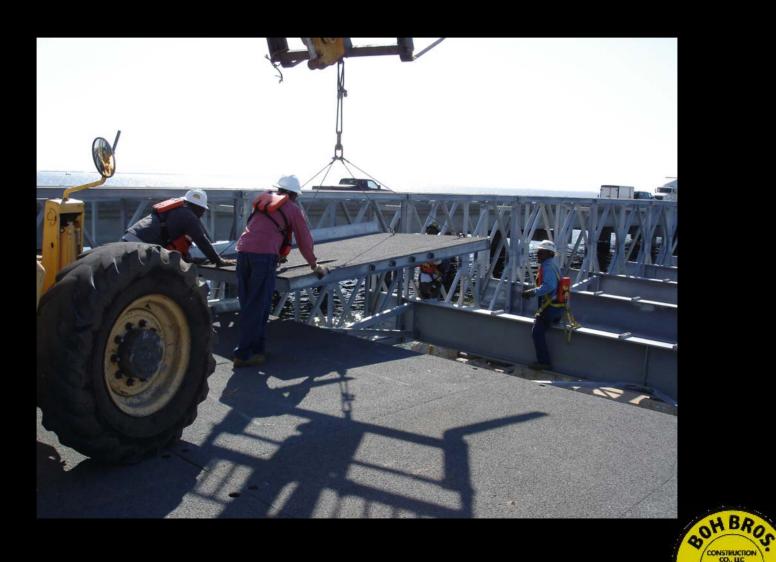
- Phase II Repair Procedures
  - Realignment
  - Removal
  - Replacement
  - Screw Jacks and Cap Saddles
  - Helper Bents
  - Replacement Bents
  - Acrow Bridge
    - Temporary metal truss bridge
    - Used to fill voids where spans were removed
    - Two Acrow spans 780' and 3320'
