Hurricane Katrina - What Happened?

Tulane University
Field Trip
Updated April 14, 2007

Levee Breaches in New Orleans during Hurricane Katrina

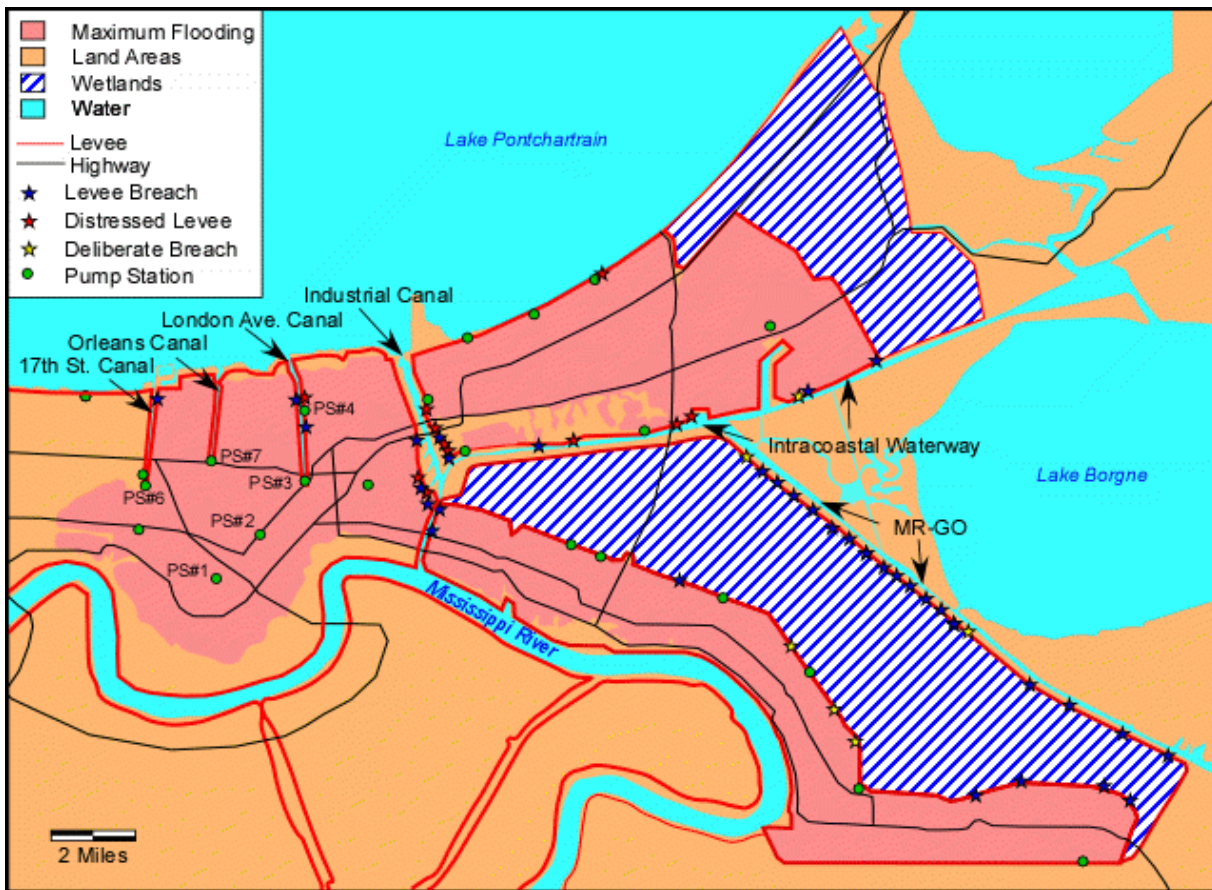
According to the chronology put together by the Interagency Performance Evaluation Task Force (IPET, 2006), the first flooding to occur in New Orleans took place between 4:30 – 5:00 AM along the west side of northern arm of the Industrial Canal (also known as the Inner Harbor Navigational Canal, a shipping channel completed in 1923) where the CSX railroad crosses the canal. Here, the floodgates were not working and sandbags were used to seal floodwalls (See Figure 7).

Figure 7. Map of maximum extent of flooding during Katrina modified and locations of breached levees after U.S. Army Corps of engineers-
<http://www.hq.usace.army.mil/cepa/katrina/pumps/pumps.html#New%20Orleans%20Pump%20Status> and Seed et al. (2005)

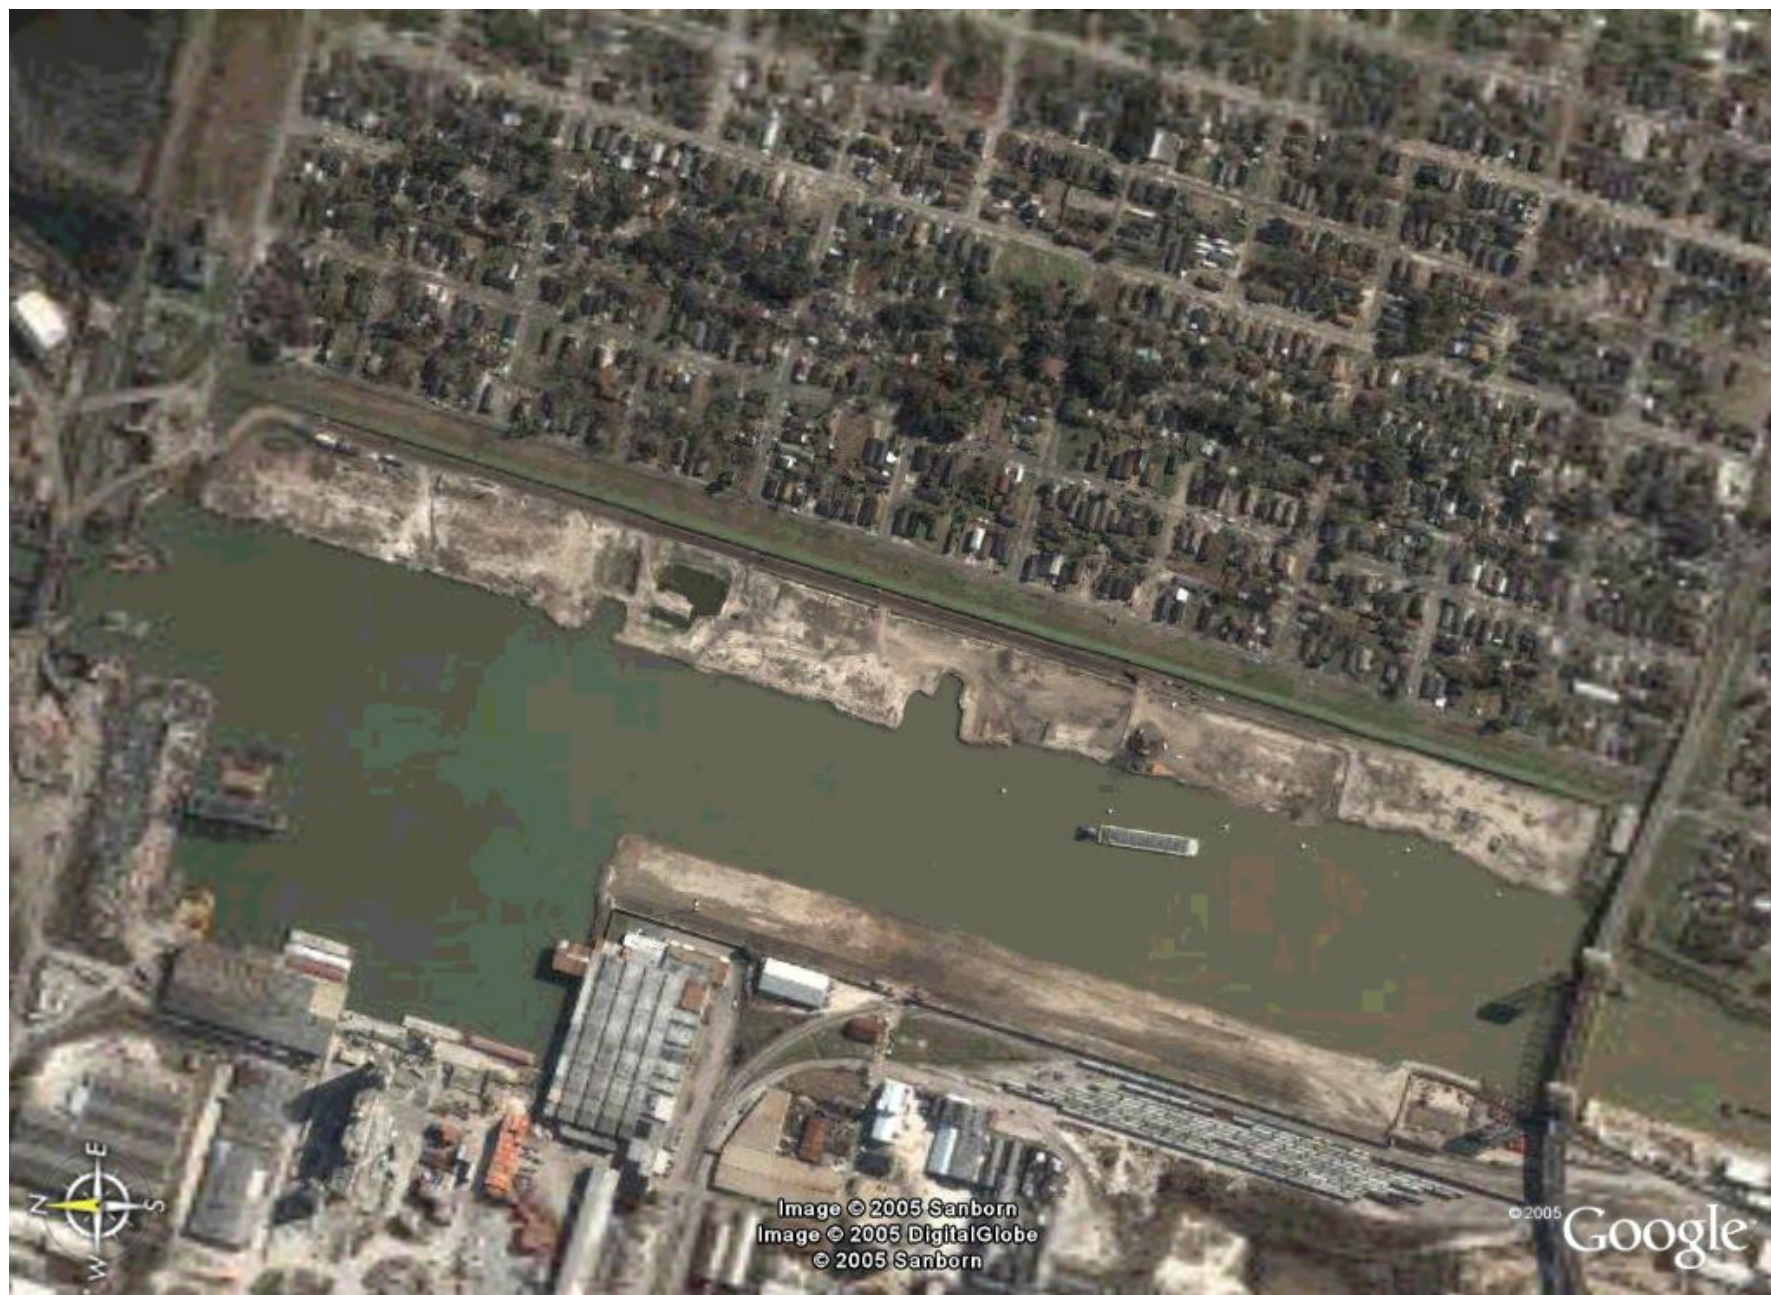
At about 7:45 AM the levees on the east side of the Industrial Canal bordering the Lower Ninth Ward (Stop 1) were breached by surge waters in the Industrial Canal (Figs. 8, 9, 10 & 11). The photographs in Fig. 8 and 10 show the breached levee two days after the storm and the image in Fig. 11 shows the same area in Mid-March 2006 after repair of the floodwall had begun. Note that in Fig. 8, water was running back into the Industrial Canal from the Lower Ninth Ward. Note also that both Figs. 8 and 10 show a barge which came to rest in the Lower Ninth Ward, having floated through the breach from the Industrial Canal.

Figure 9. Satellite image of the area along the Industrial Canal where the levee was later breached during Hurricane Katrina. (Source - Google Earth)

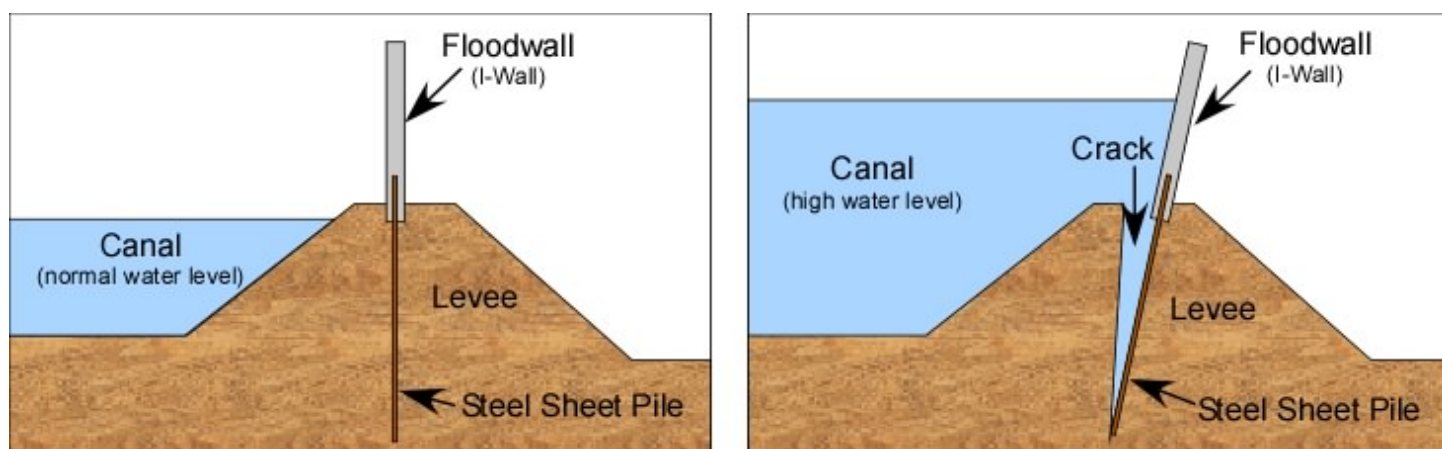
occur and a gap opened on the water side of the floodwall which allowed the full hydrostatic force of the water to penetrate to the tip of the sheet piling (Jackson, 1988, Oner and others, 1997). This type of floodwall failure is illustrated in Figure 18. These findings were apparently never communicated to those in the Corps responsible for the design and construction of floodwalls in New Orleans (Marshall, March 14, 2006).

Figure 19. Illustration of crack development as water in a canal rises on the floodwall and pushes outward on the floodwall as observed in 1985 experiments by U.S. Army Corps of Engineers.

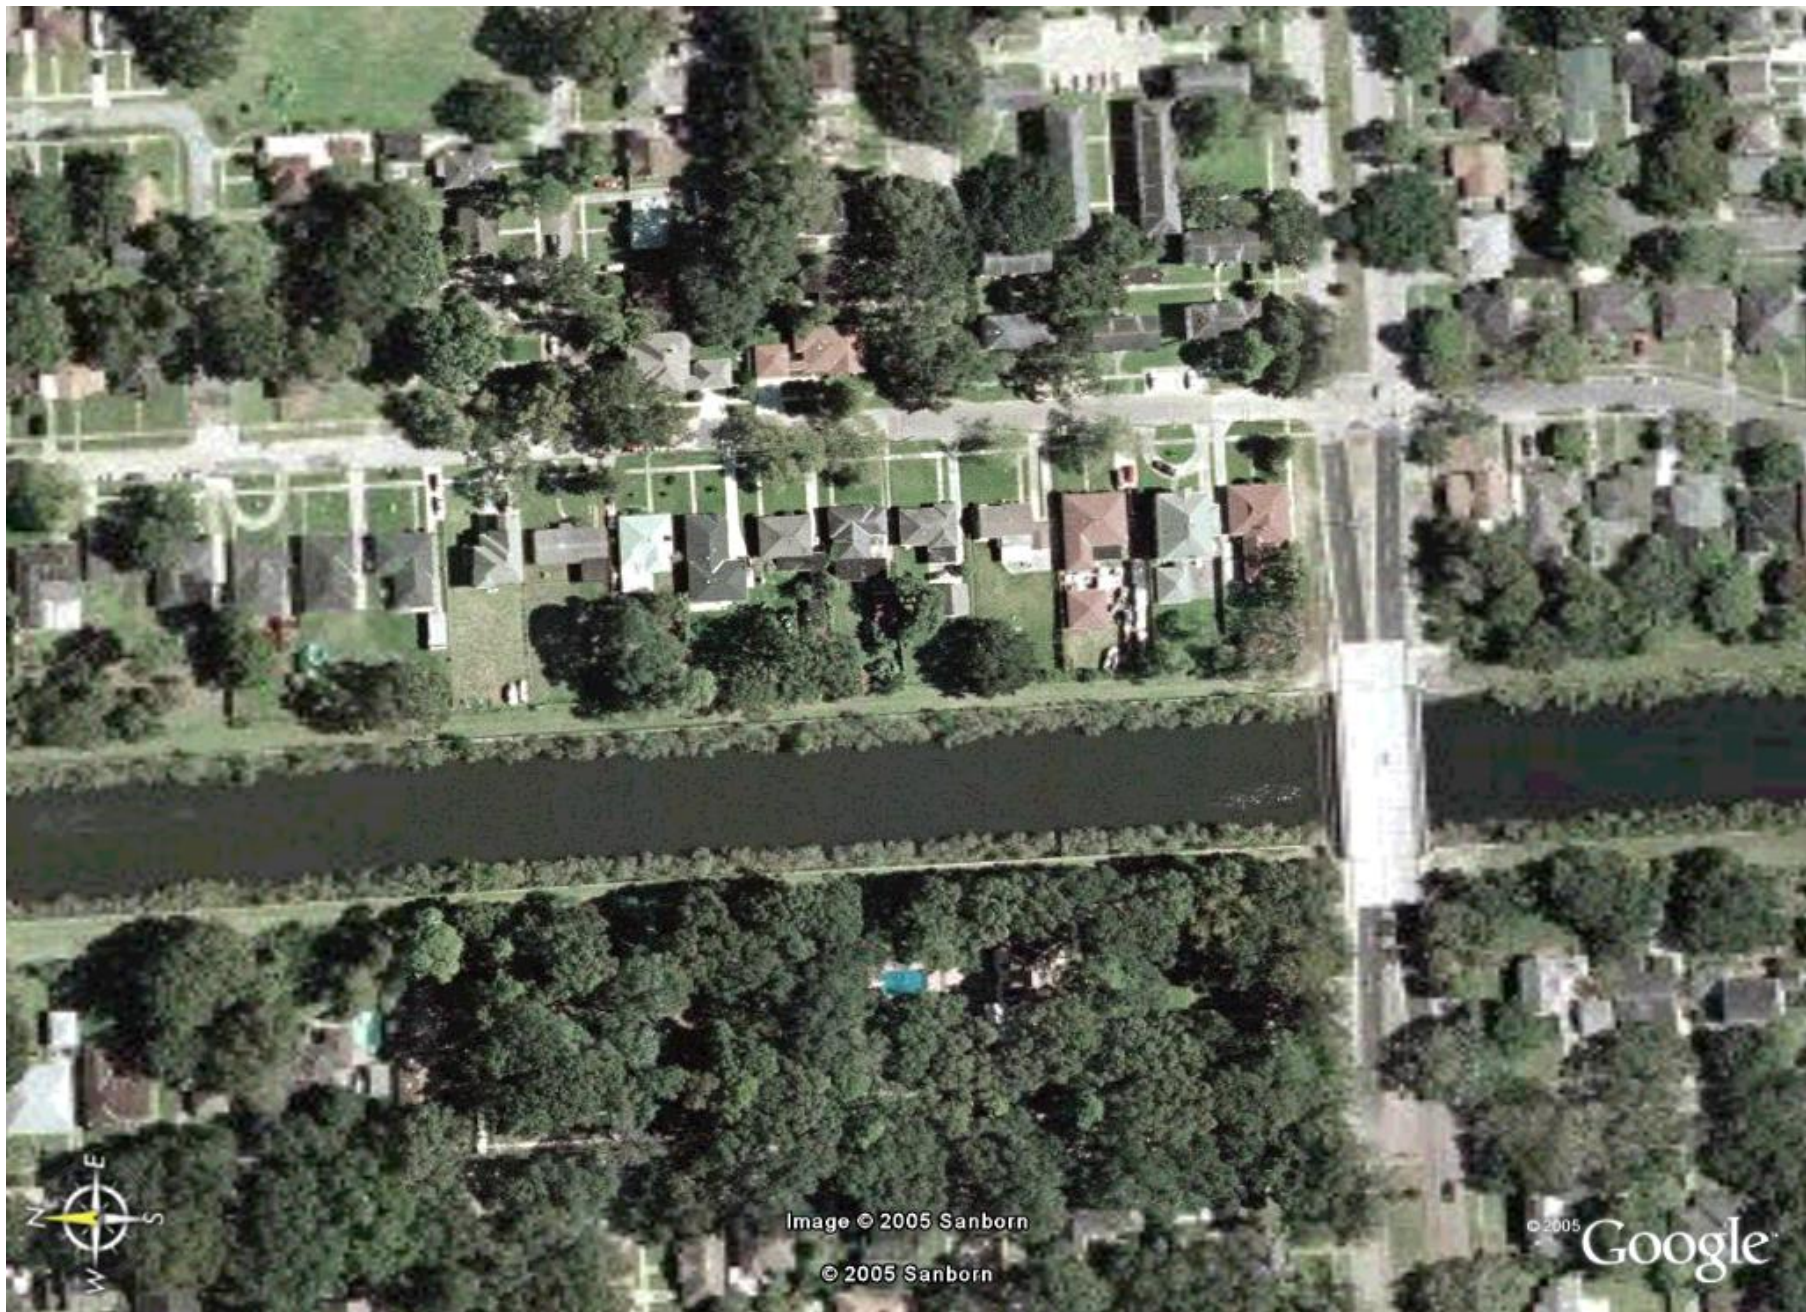
At stop 2 we will be able to walk up Warrington Drive and observe the levee breach which is currently under repair. We can observe the sand deposits, and cross bedding within the sand. Sand fills many of the houses, as well as the cars that were deposited here along with the sand (most have been removed as of mid-May, 2006).

Figure 20. Satellite image of the area along the London Avenue Canal near Mirabeau Ave. and Warrington Drive (Stop 2), where the levee was later breached during Hurricane Katrina. (Source - Google Earth)

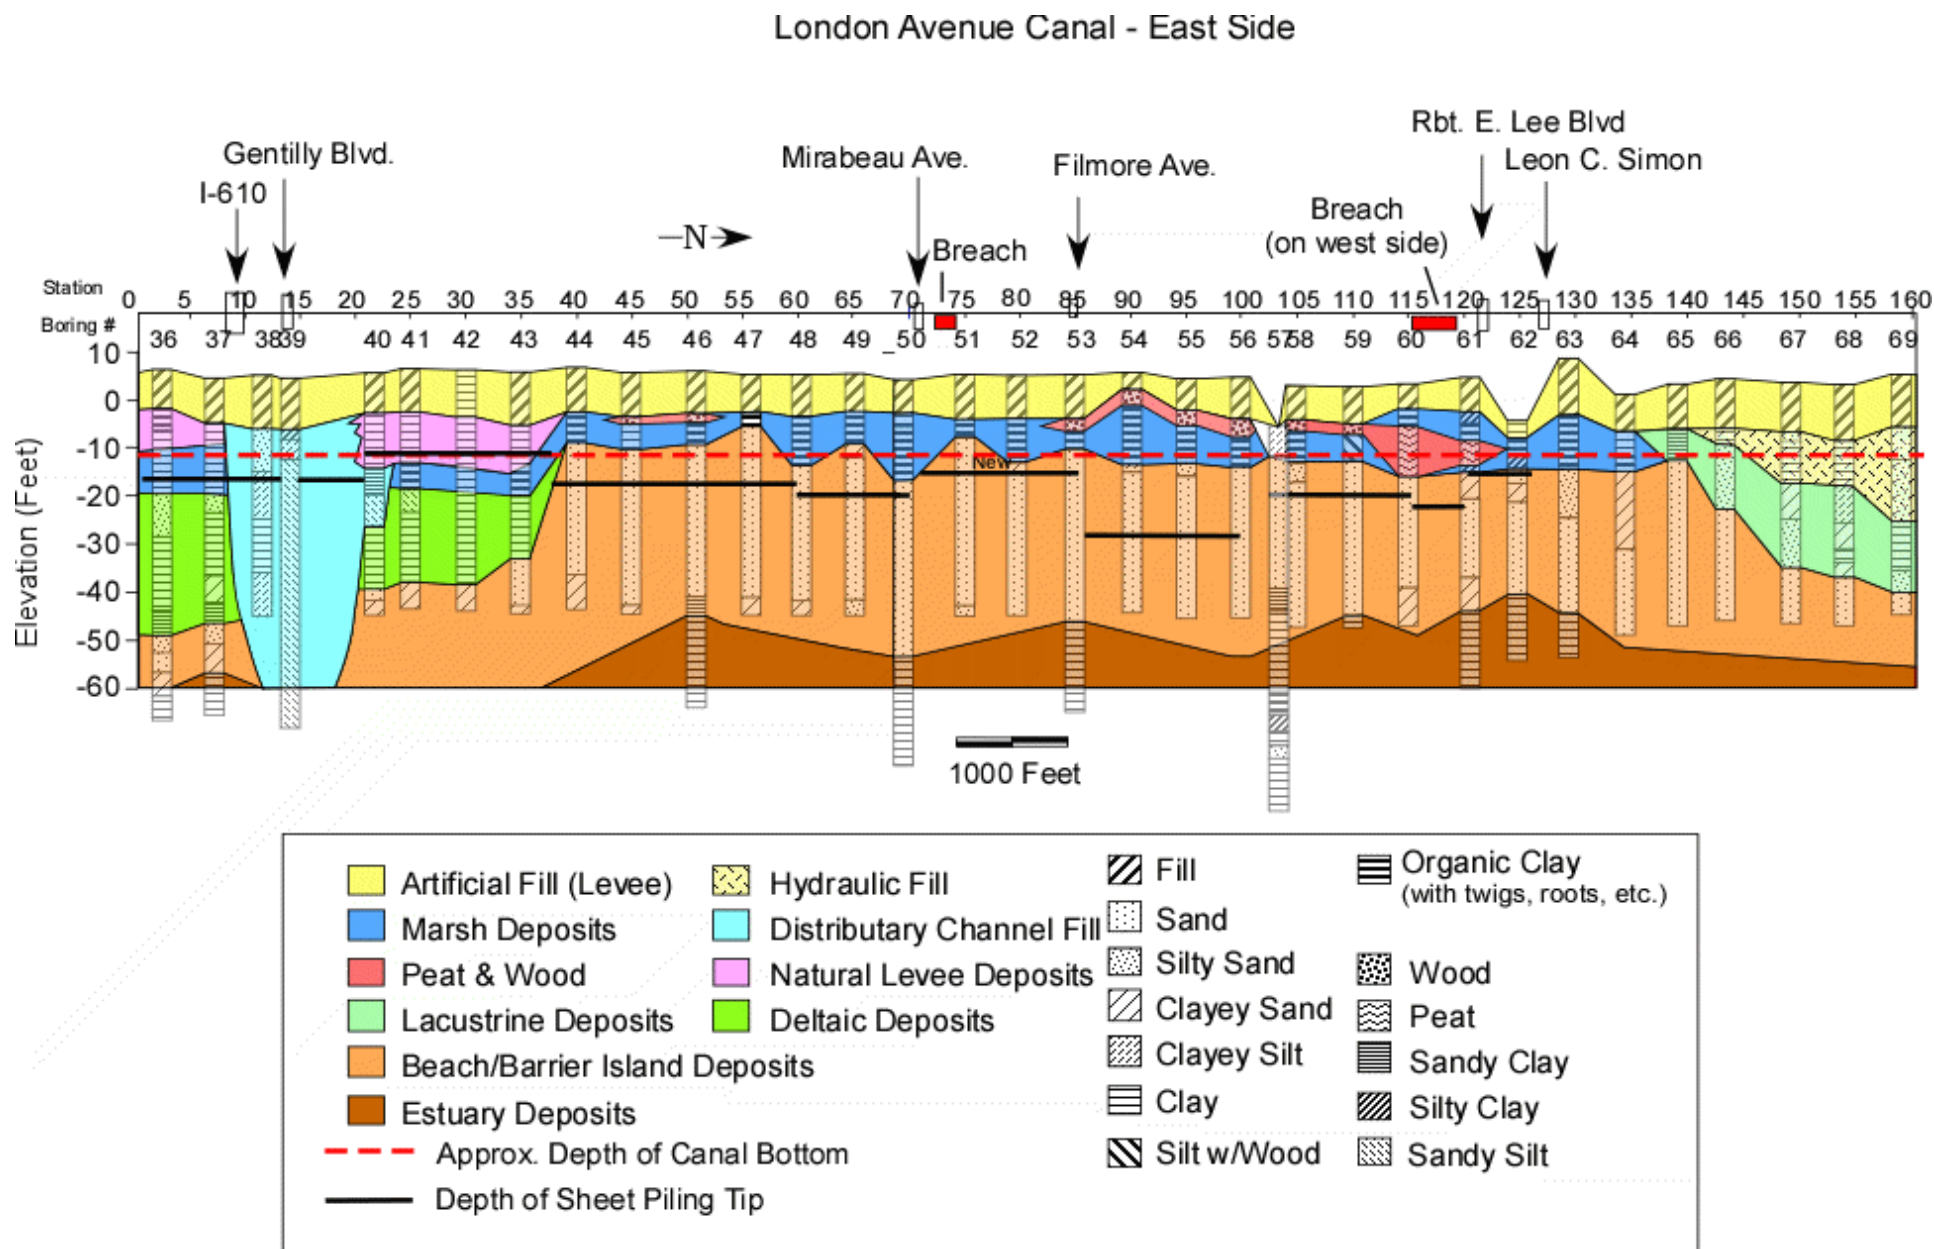
Figure 23. Geological cross-section along the east side of the London Avenue Canal constructed from data in U.S. Army Corps of Engineers (1989).

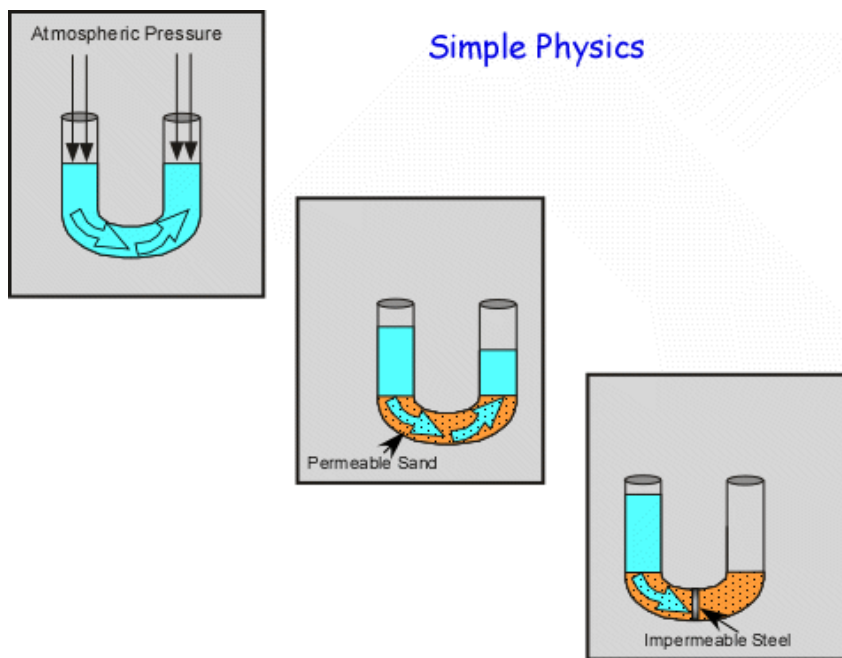
Sand is a highly permeable material. This means that water can easily be transported between the sand grains, especially when the weight due to overlying water is increased due to the added height of the water column during a storm surge. This increases the pressure and could force the water through the pore spaces in the sand and back up to the surface on the other side of the levee. If enough flow takes place the sand will be picked up by the flowing groundwater and eventually form an underground channel. This could undermine the levee and cause it to collapse. The principle is illustrated in Fig. 24 with a simple thought experiment. The underflow (called seepage or siphoning) is the apparent cause of the collapse at this section of the London Ave. Canal. The “As built” design specifications indicate that the sheet pilings (which should form an impermeable barrier to pressure induced flow in the sand) were placed to a depth of 14 feet below sea level (U.S. Army Corps of Engineers, 1994), one can see from the cross section in Fig. 25, that the water still has a path back to the surface if it flows as groundwater beneath the sheet pilings. Note that in order to prevent such siphoning, the sheet pilings would need to be placed to a depth of about 50 feet below sea-level where they would penetrate a layer of clay. Clay, because the individual mineral grains stick together and thus reduce pore space and interconnection between pores, is much more impermeable than is sand.

Figure 24. A simple thought experiment illustrates the principle of hydrostatic pressure by imagining a U-shaped glass tube. The water levels in each side of the tube rise to the same level because both sides of the tube are subject to the same pressure (atmospheric pressure). If a permeable material like sand is placed in the bottom of the tube and water is poured into one side, the water will find its way through the intricate pathways between the sand grains and will eventually, although not instantaneously rise to the same level on the other side of the tube. If an impermeable barrier is placed in the sand in the bottom of the tube, then the water will not get from one side to the other.

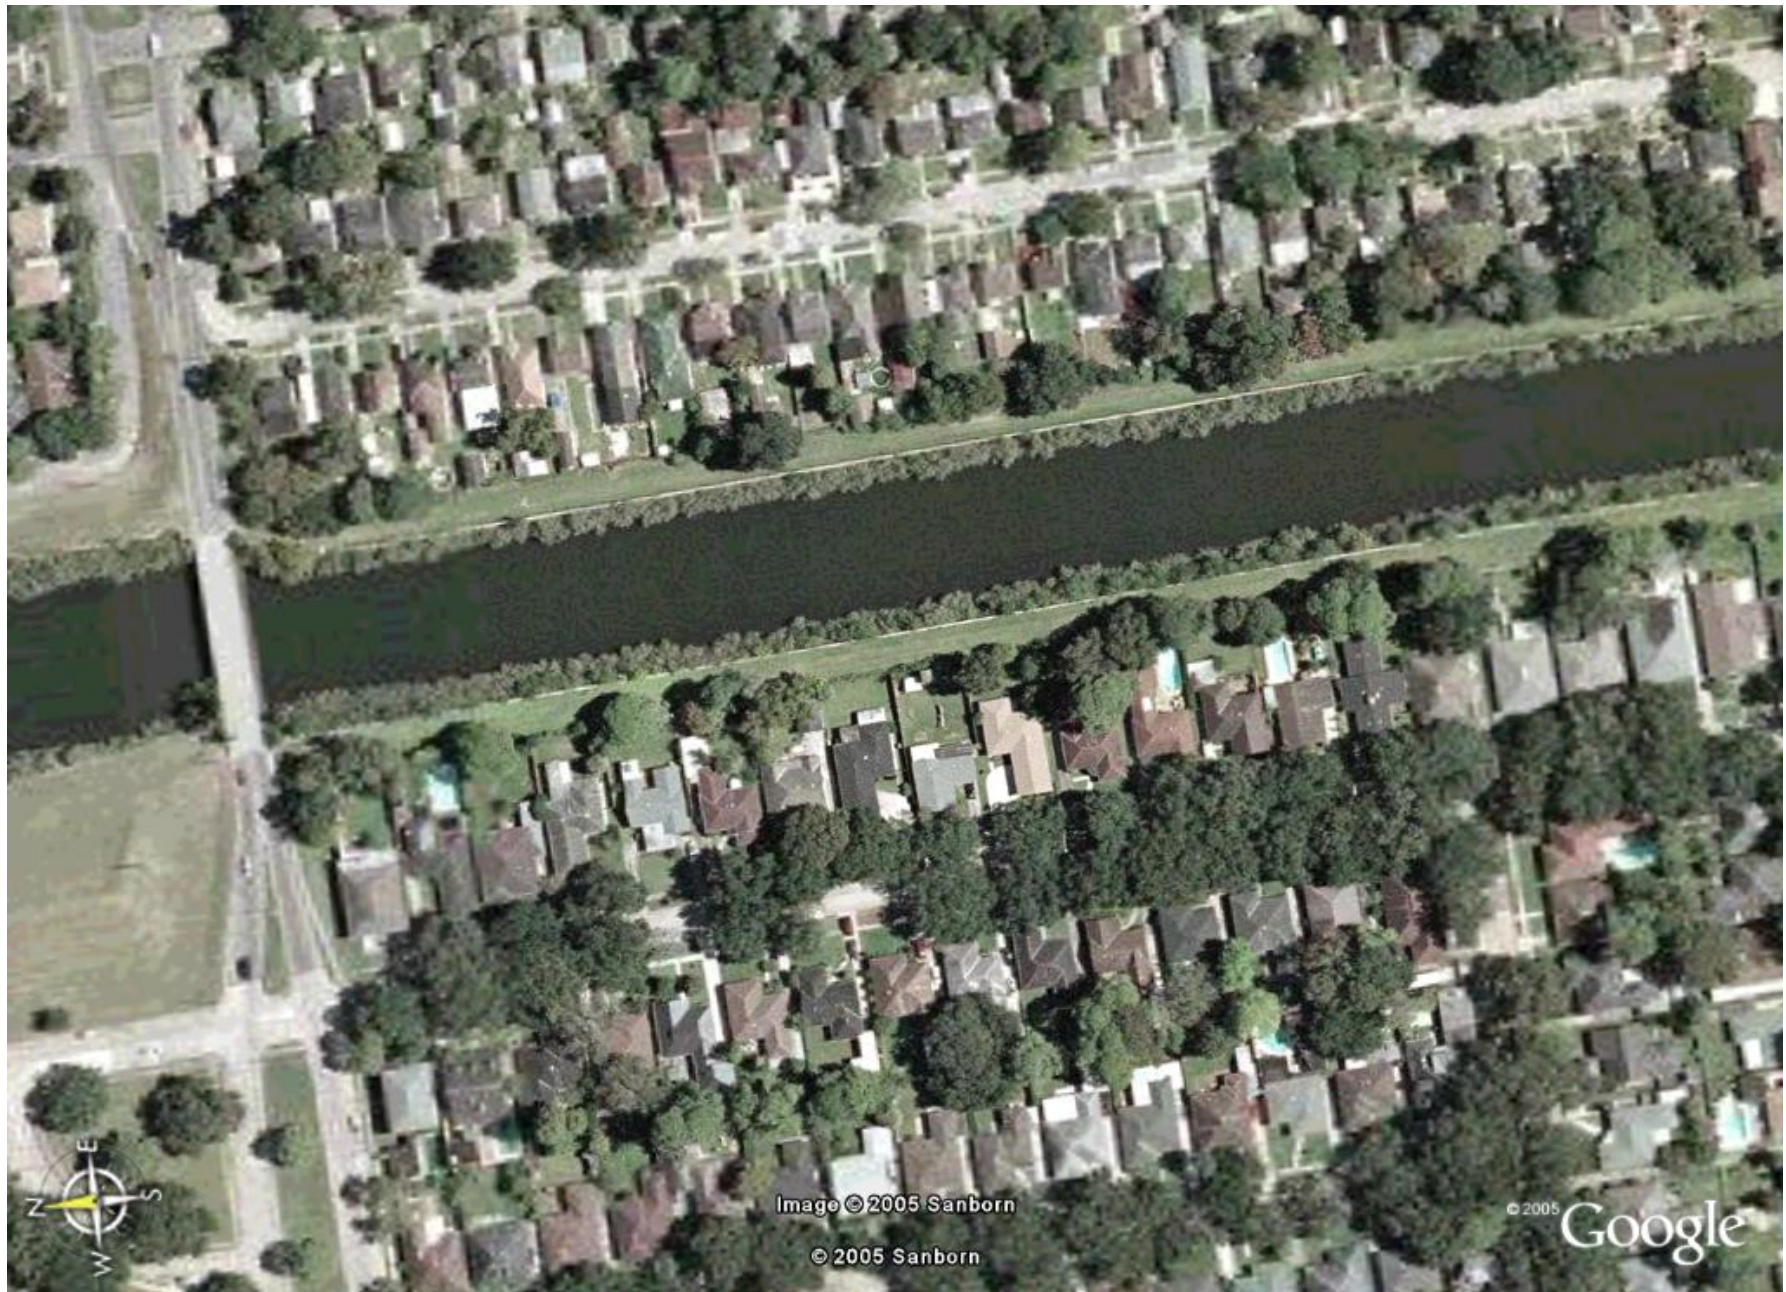
Stop 3 is near the intersection of Pratt Drive and Robert E. Lee Blvd. where the London Avenue Canal levee was breached on the west side of the canal. The estimated chronology suggested by IPET (2006) suggests that this breach also occurred sometime before 9:00 AM on August 29. Figure 27 shows an image of this area before Katrina. Figure 28 shows approximately the same area in an image taken on August 31 after the breach occurred and before the floodwaters had been pumped out.

Figure 27. Satellite image of the area along the London Avenue Canal near Robert E. Lee Blvd. and Pratt Drive (Stop 3), where the levee was later breached during Hurricane Katrina. (Source - Google Earth)

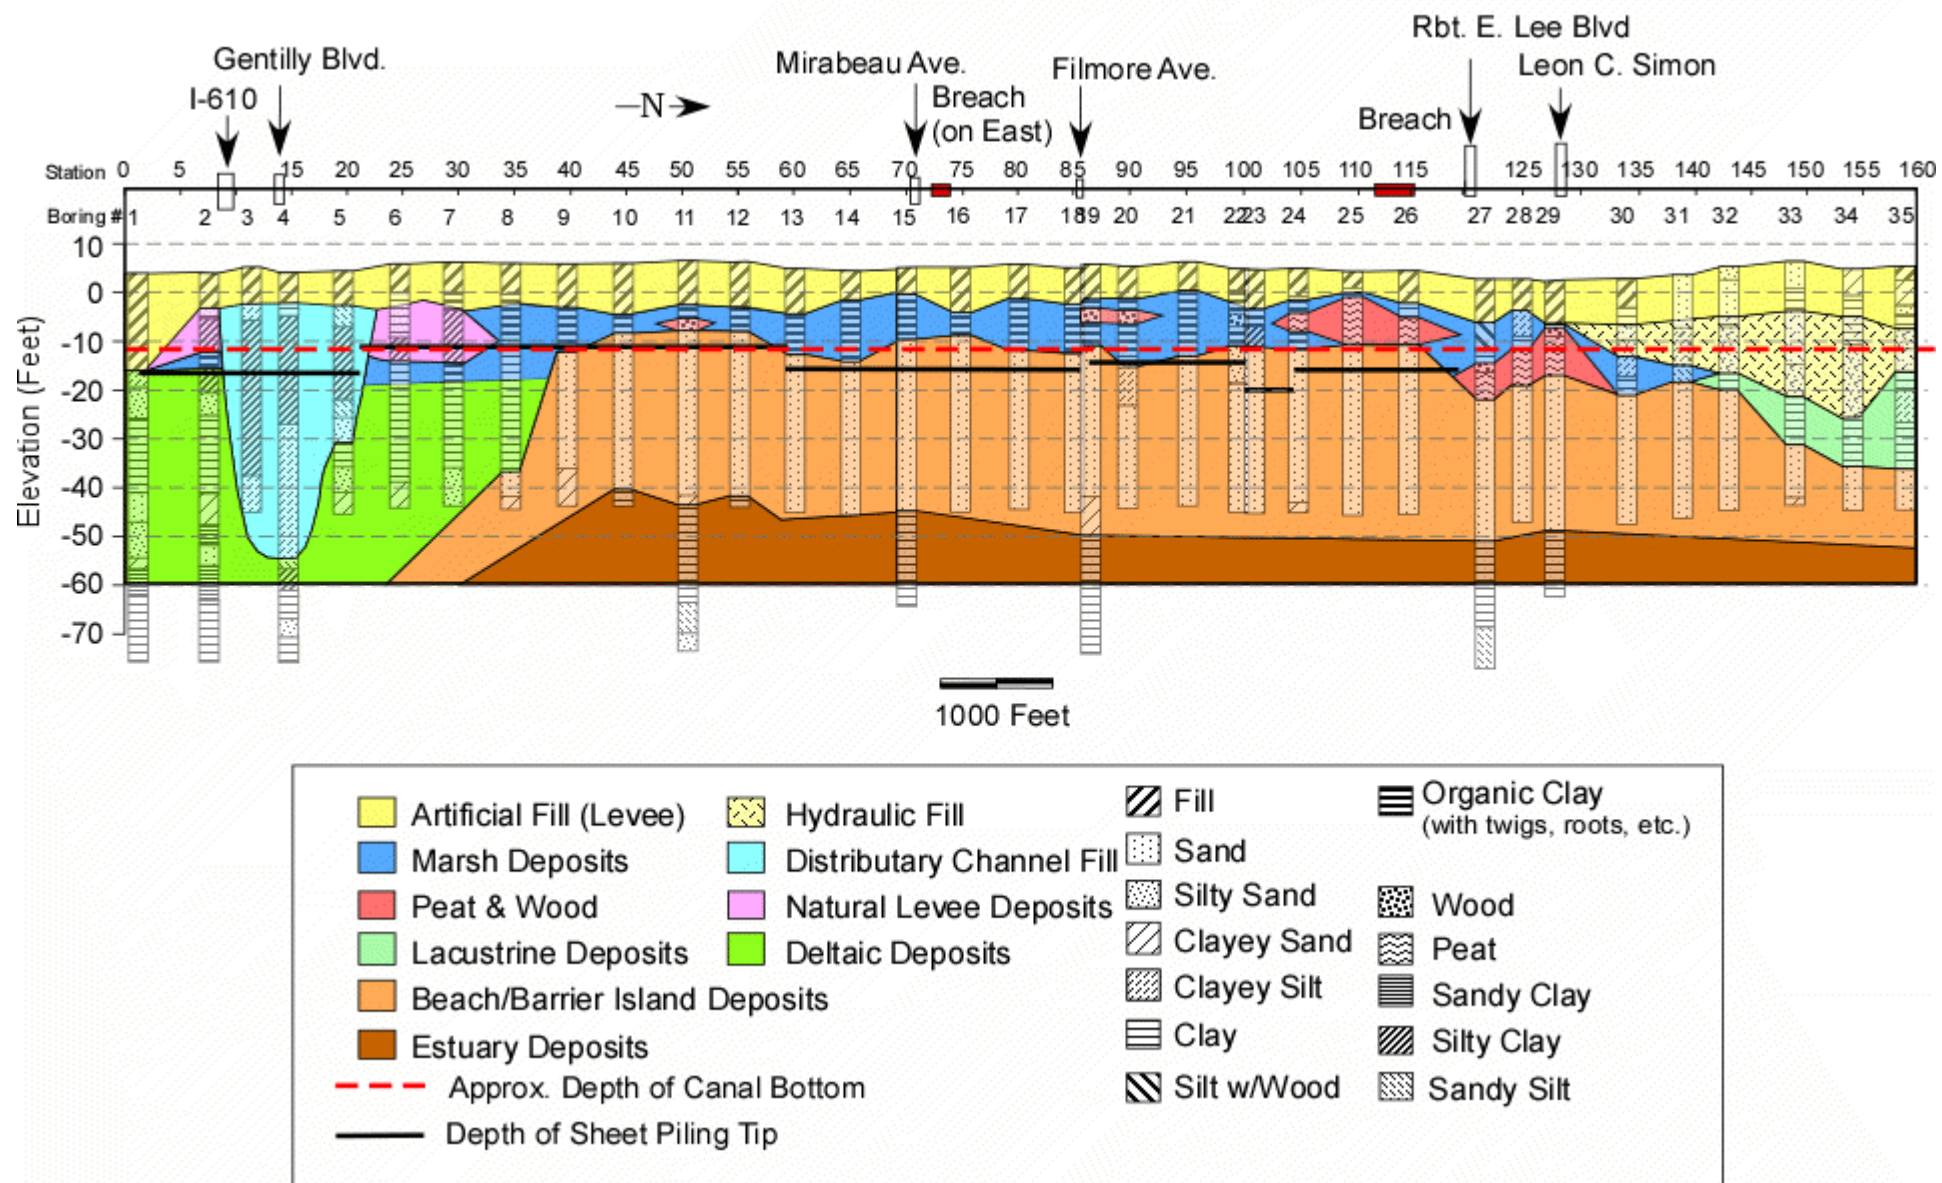
London Avenue Canal - West Side

A geologic cross section of the west side of the levee is shown in Figure 29. Note that the conditions beneath the surface are similar to those at the Mirabeau Ave. breach, with a sand layer about 12 feet below sea-level. Here a peat layer is also observed. Peat is organic matter (vegetation that is in the process of decay). It represents material accumulated in swampy areas and indicates that this area was a swamp in the not too distant past. Peat is very porous and has the additional property that it shrinks when it is dried out and expands when water is added. The presence of peat can make for very unstable soil conditions.

Although the “as built” design documents (U.S. Army Corps of Engineers, 1994) show that the depth of the sheet pilings were at 14 feet below sea-level, water still had access to the peat layer and thus the peat layer could have played a role in the collapse of the levee. Another phenomenon that was observed here was that of ground heave in the area of collapse. Water, and perhaps expanding peat, apparently pushed up the levee and land surface on the west side of the canal prior to collapse of the levee. This is illustrated in Figures 30 and 31. Although the clubhouse shown in Figure 30 has been removed during the repair of the levee, the house (with the mispositioned air conditioner compressor) is the 5th house south of Robert E. Lee Blvd. on Pratt Drive (this house was demolished in early November, 2006).

Figure 29. Geological cross-section along the west side of the London Avenue Canal constructed from data in U.S. Army Corps of Engineers (1989).

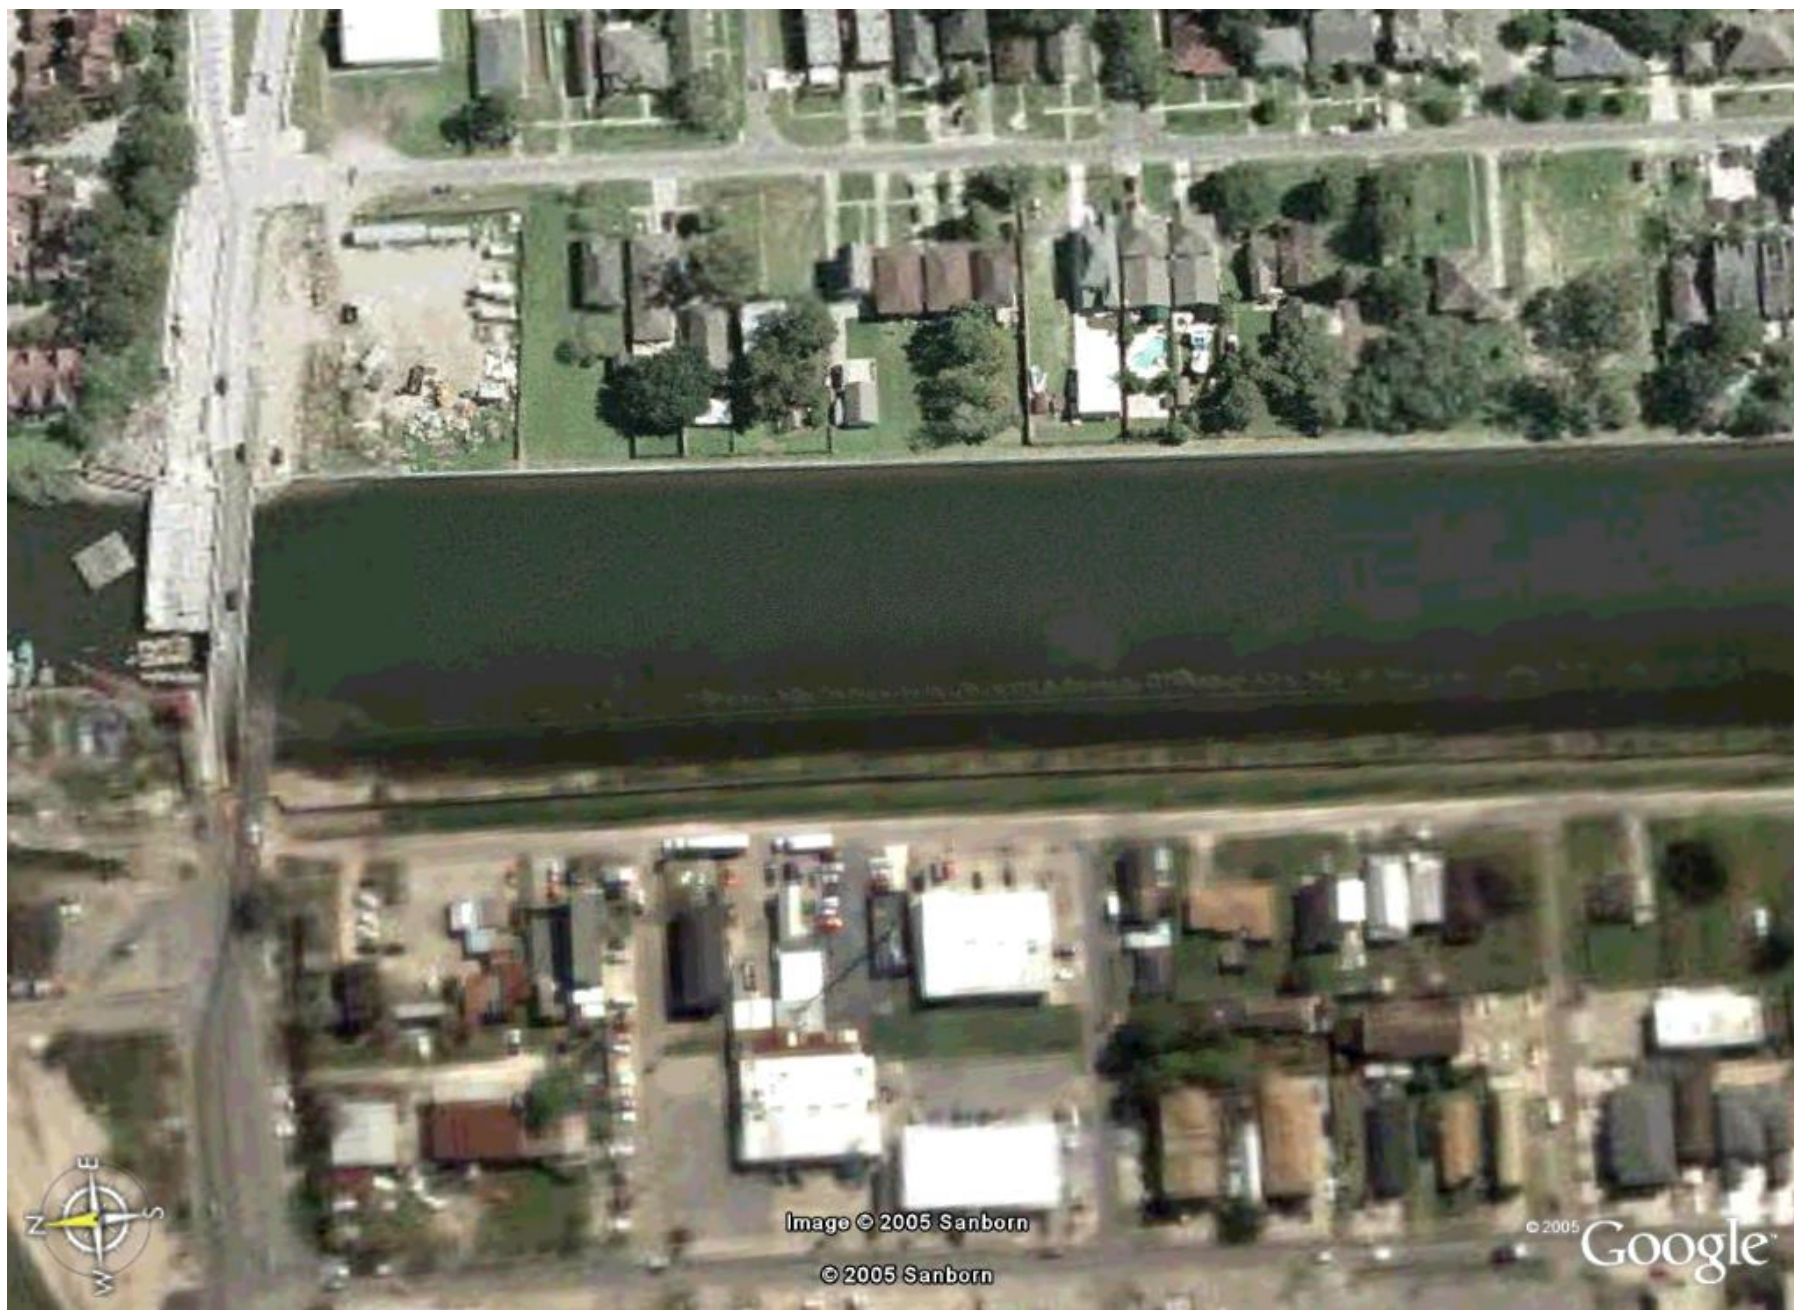
Stop 5 is in the area of the breach on the 17th St. Canal (also called the Metairie Outfall Canal). According to data presented by IPET (2006) this breach started at about 6:30 AM and was completely open by about 9:00 AM on August 29. It was reported to WWL radio by the New Orleans Fire Department at 11:00 AM. The breach occurred along a 200 ft. section of the levee on the Orleans Parish side of the canal. Figure 34 shows an aerial view of the breach area before Katrina and Figure 35 shows approximately the same area on August 31 as water was still flowing through the breach into Lakeview.

Figure 34. Satellite image of the area along the 17th Street Canal near the Old Hammond Highway Bridge (under construction), where the levee was later breached during Hurricane Katrina (stop 5). (Source - Google Earth)

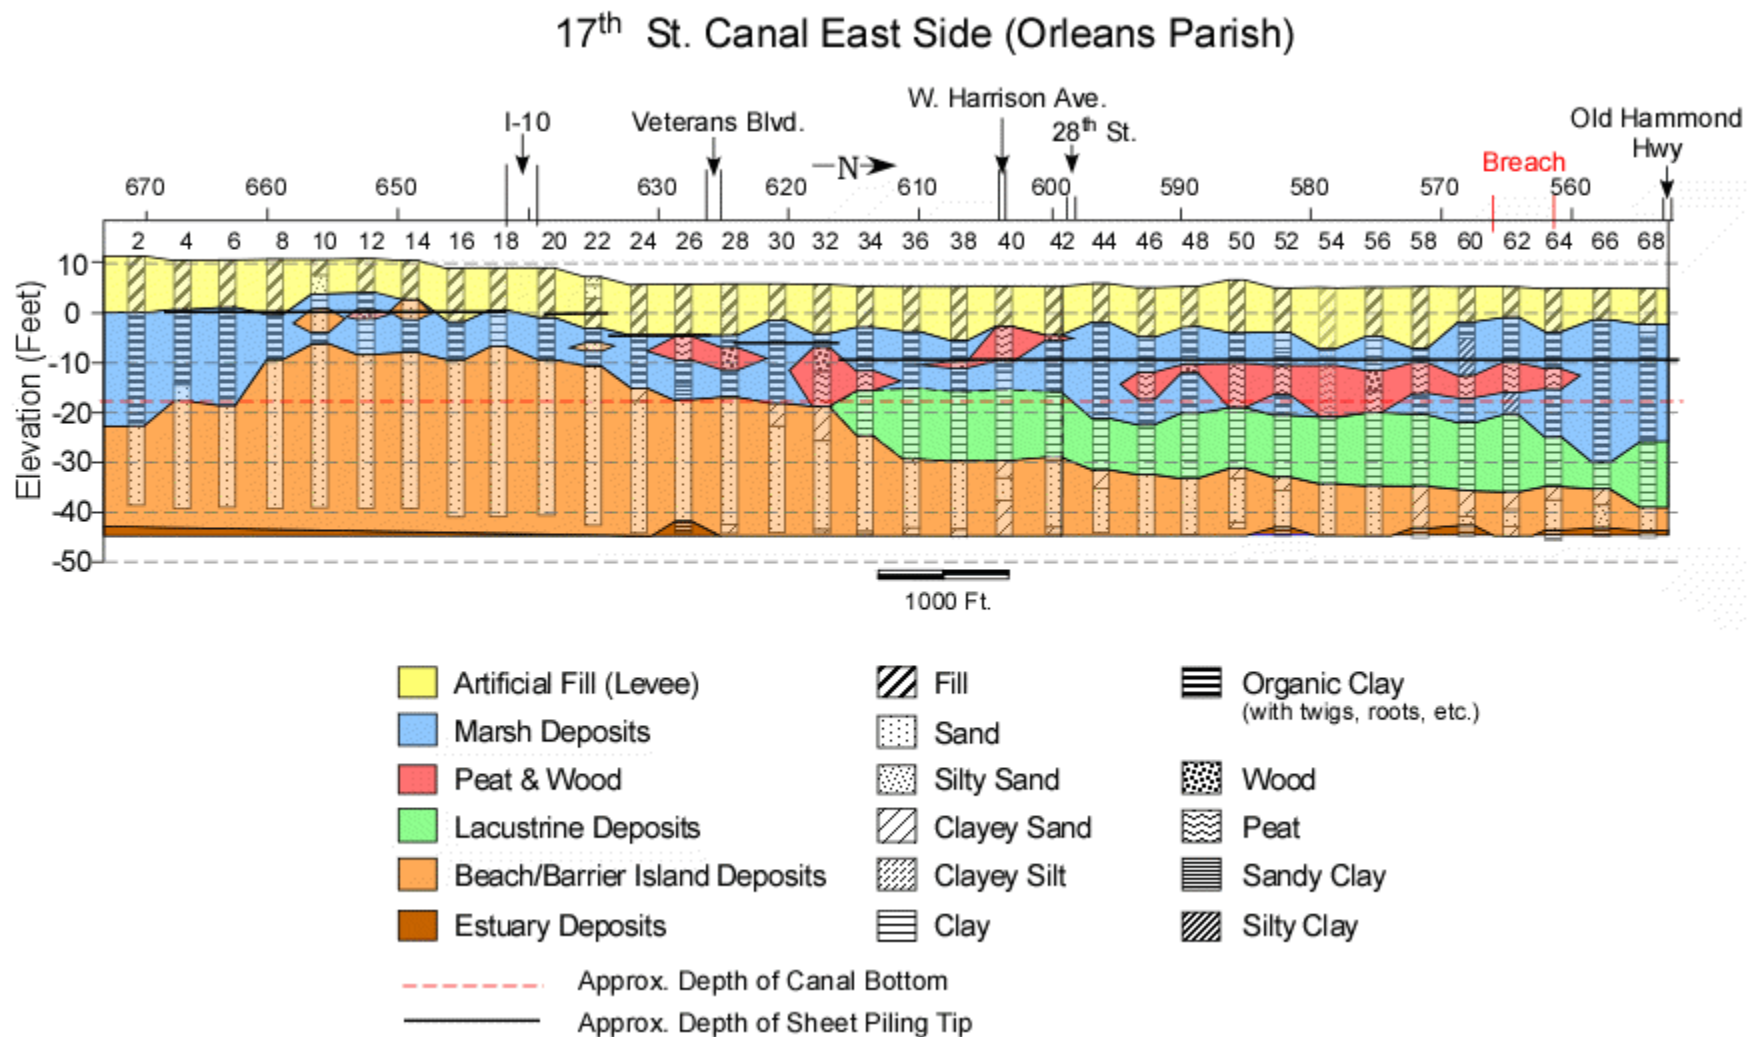
Figure 40 shows a geological cross section along the levee of the 17th street canal. The most notable feature of the cross section is the peat layer observed at depths between about 8 and 15 feet below sea level in the area of and to the south of the breach.

Figure 40. Geological cross-section along the eastern side of the 17th St. Canal (based on data in the U.S. Army Corps of Engineers design documents (1990)). Notable in the cross-section is the peat layer that occurs in the area of the breach. Depth to sheet piling tips is highly uncertain due to inconsistent information available from the U.S. Army Corps of Engineers. In the immediate vicinity of the breach, the sheet piling tips are known to extend to 17.5 ft. below sea-level.

The most recent information from the Interagency Performance Evaluation Task Force (IPET) [2006] suggests that the floodwall and levee failed at the 17th St. Canal as a result of water level rising to an elevation of about 8 feet above sea level in the canal. The floodwalls were designed to have tops at an elevation of 14 feet above sea level, but IPET data indicate that by the time of Katrina the tops of the floodwalls on the 17th Street Canal were about 12.5 feet above sea level. Thus, IPET estimates that water levels in the canal were still 4 feet below the tops. IPET has collected eyewitness accounts and scoured the neighborhood for clocks that were stopped as a result of the flooding in order to determine the time of the breach. One eyewitness account suggests that the floodwall at the breach area was leaning to the protected side at about 6:30 AM on August 29 and other accounts suggest that the breach was open by about 9:00 AM. This, along with levee breach experiments conducted on scale models in a large centrifuge led IPET to suggest that as water levels rose in the canal, the floodwall and sheet piling was pushed outward toward the land side, opening a gap between the levee and the floodwall on the canal side. This gap allowed water to seep down along the sheet piling and eventually push the levee on the protected side outward away from the canal. Based on sections of the breached levee observed in the breach area, IPET suggests that the failure did not occur along the peat layer, but along a layer of weak clay at the base of the peat. This clay layer was thrust over and through the peat as illustrated in Figure 41.
