Hurricane Katrina - What Happened?

Tulane University
Field Trip
Updated April 14, 2007

Levee Breaches in New Orleans during Hurricane Katrina

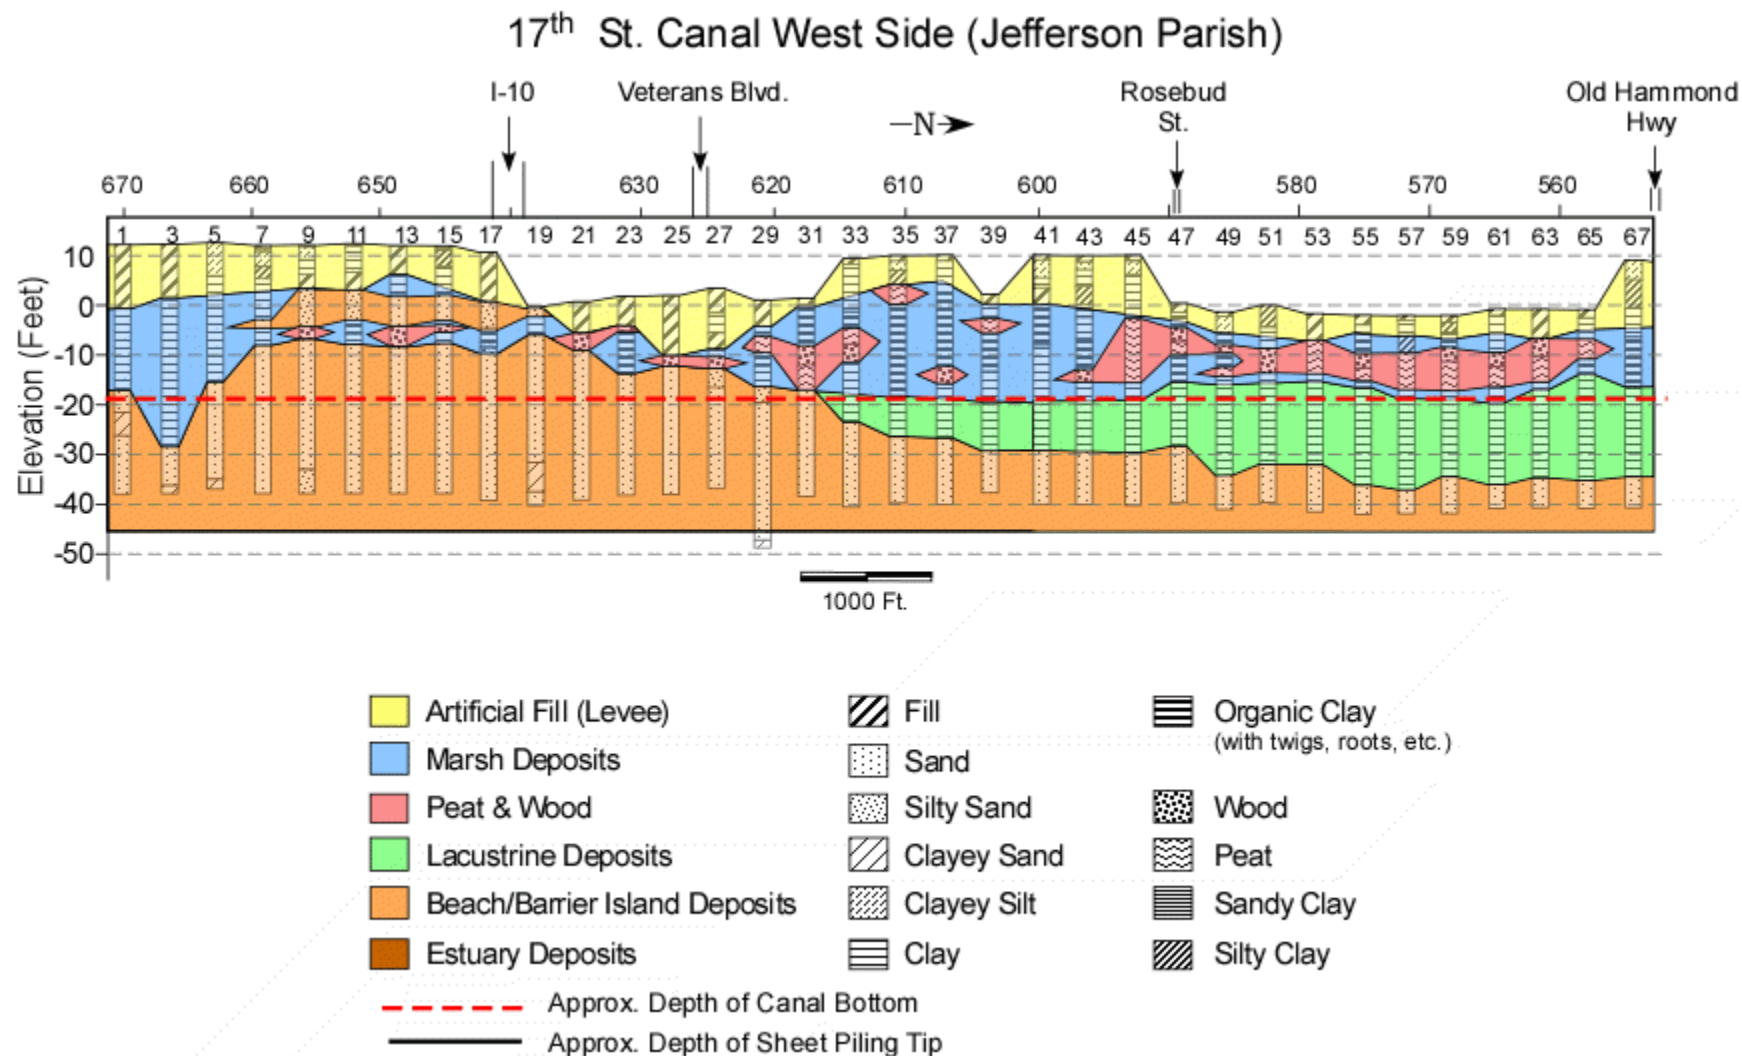
It is notable that the same peat layer and the same levee design and construction are present on the Jefferson Parish side of the canal, which by luck or the path of the storm, did not breach on August 29. Figures 44 shows a geological cross section of the west bank (Jefferson Parish side) of the 17th St. Canal constructed from data provided on the Army Corps of Engineers IPET web site - <https://ipet.wes.army.mil/> where it can be seen that the same geologic materials are present beneath the Jefferson Parish side as are found on the Orleans Parish side (compare with Figure 35). One major difference on the Jefferson Parish side is that a street occupies the area next to the levee and there are no trees, houses or swimming pools abutting the levee on that side.

Figure 44 Geologic cross section of the west bank of the 17th St. Canal constructed from data provided to the U.S. Army Corps of Engineers (1990). Note that levee heights appear inconsistent because some of the borings were taken at the toe of the levee rather than on the levee crest. Depth to the tip of the sheet pilings is currently not available for the west side of the 17th St. Canal, although Grissett (April 14, 2007) has information that the sheet pile tips extend only to about 4 feet below sea-level at southern end of the canal (south of Veterans Blvd.).

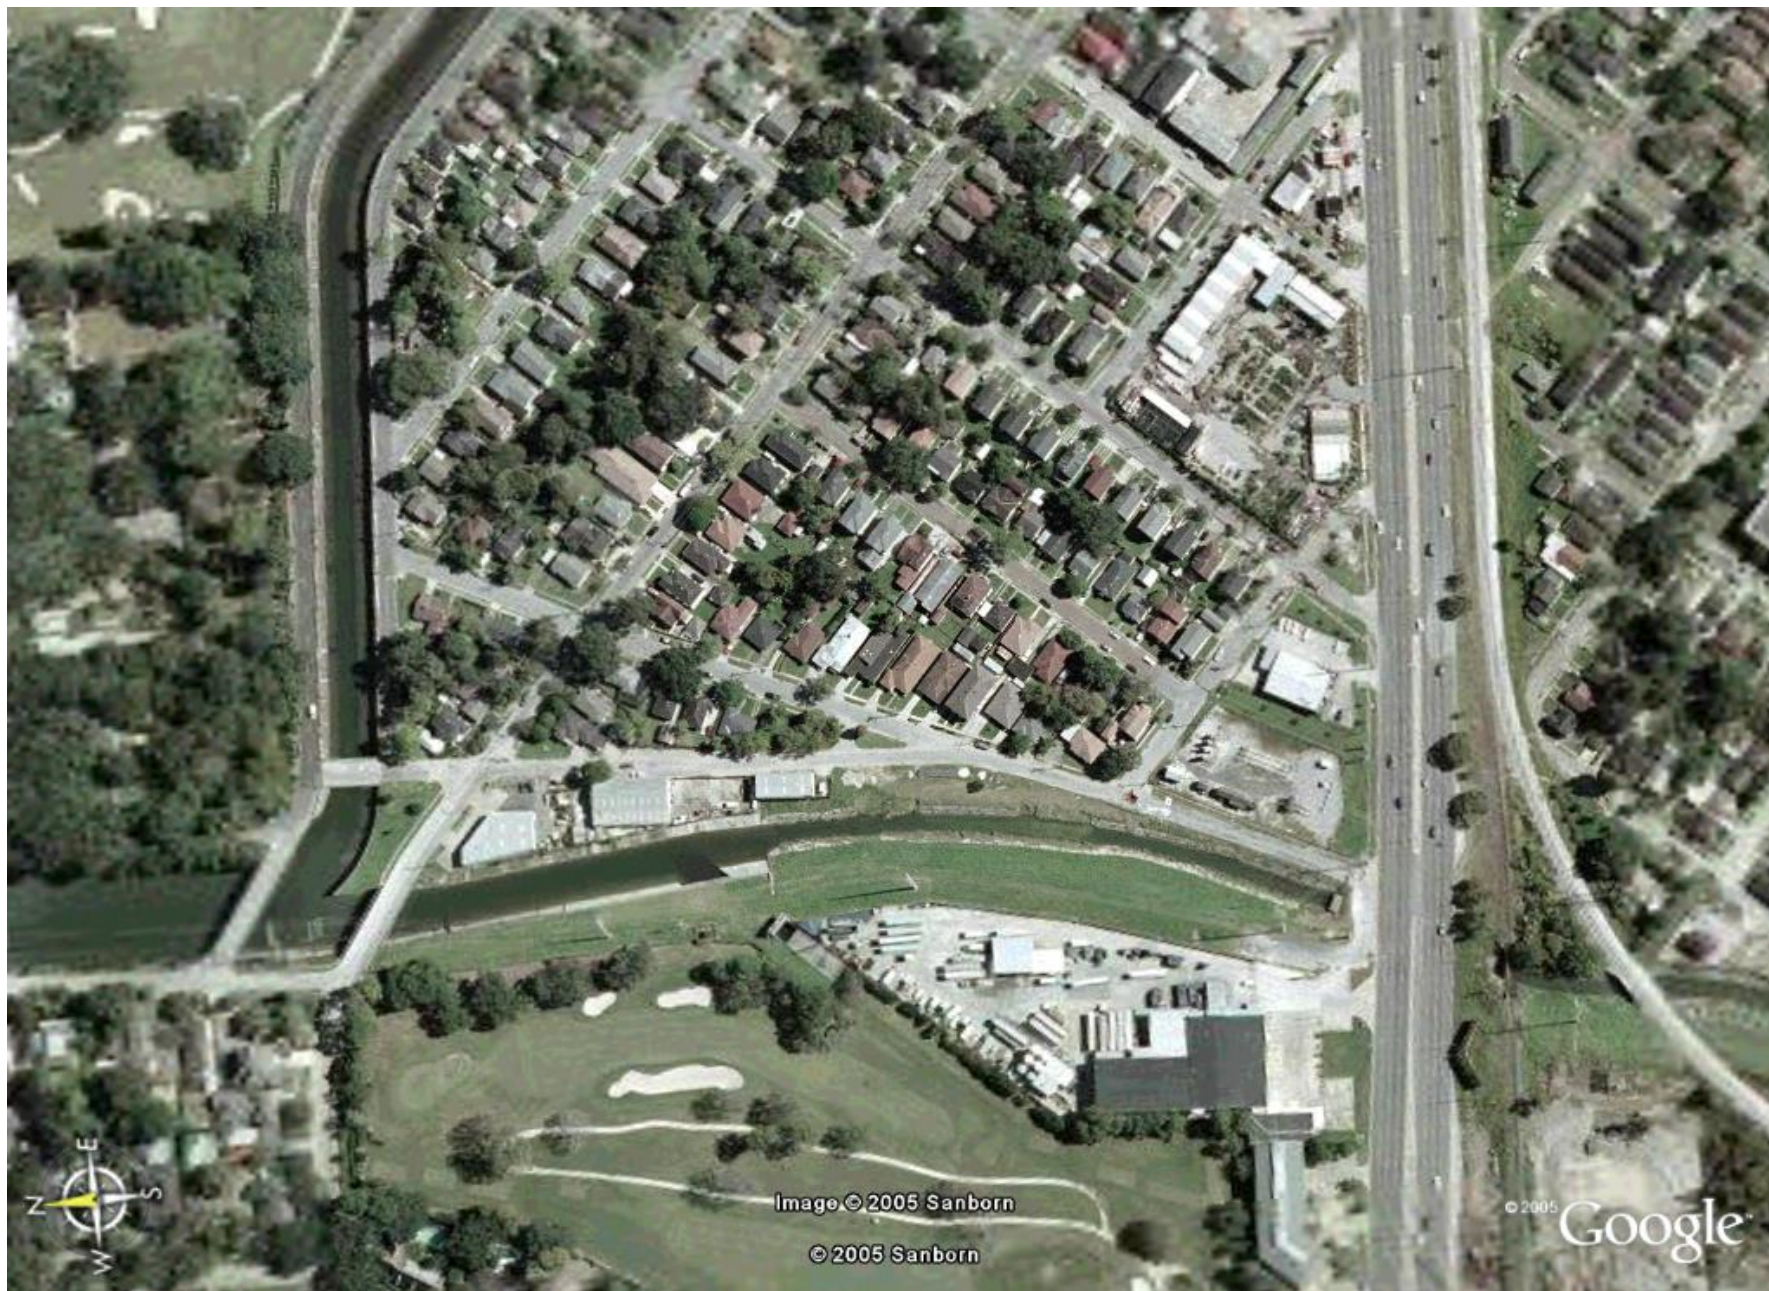
Stop 7 is that the corner of Orpheum Avenue and Northline Street. It is through this area and along Airline Drive south of here, that flood waters from the levee breaches in Orleans Parish reached into Jefferson Parish. The flooding occurred south of the Metairie Road (on the Metairie Ridge) and extended west to Causeway Blvd. and south to near the River. Figure 47 is a Google Earth image of the area at the junction of the Palmetto canal and the 17th St. canal before Katrina and Figure 48 shows approximately the same area on August 31. This area is at the southern end of the 17th St. Canal where the Palmetto Canal brings water from Pump Station #1 on Broad Street (Figure 7) into the 17th St. Canal where it is lifted by Pump Station #6 about 8 feet in elevation and pumped out to the Lake (or through the breach in the 17th St. Canal). The Palmetto Canal has a short floodwall (about 3 feet higher than the roadway). Note in Figure 48, how the floodwalls on the Palmetto Canal are completely covered by water. The two bridges over the 17th St. Canal are barely above water, but it is clear that water flowed over and around these bridges into Old Metairie. It is also clear that Airline Drive, to the south, was a conduit for water to enter Jefferson Parish.

Within a few days after the August 31 image was taken, Jefferson Parish constructed temporary rock and sandbag levees over these two bridges, across Airline Drive, and across Claiborne Ave./Jefferson Highway at the Jefferson/Orleans Parish boundary. These temporary levees were apparently constructed to prevent more flood water originating at the levee breaches in Orleans Parish from further flooding Jefferson Parish. Although the levee breaches in Orleans Parish were mostly stopped by the time the temporary levees at the Parish line were constructed, the damage had already been done. There are, however, reports that once these temporary levees were built, Jefferson Parish started pumping water out of Jefferson and back into Orleans Parish. If true, this would have increased the amount of water over that already standing in Orleans Parish while the levee breaches were being patched and before the pumps in Orleans parish could be started to remove the water from the severely flooded areas.

Figure 47. Satellite image of the area near the southern end of the 17th Street Canal near Old Metairie where water would enter Jefferson Parish from levee breaches in Orleans Parish during Hurricane Katrina (Stop 7). (Source - Google Earth)
