Hurricane Katrina - What Happened?

Tulane University
Field Trip
May 27, 2006

Stephen A. Nelson
Department of Earth &
Environmental Sciences
snelson@tulane.edu

Levee Breaches in New Orleans during Hurricane Katrina

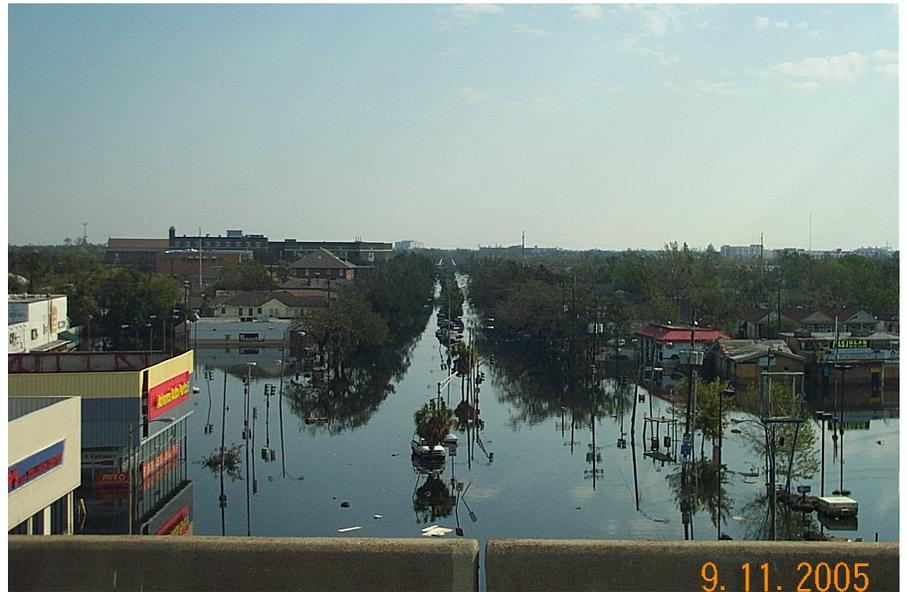
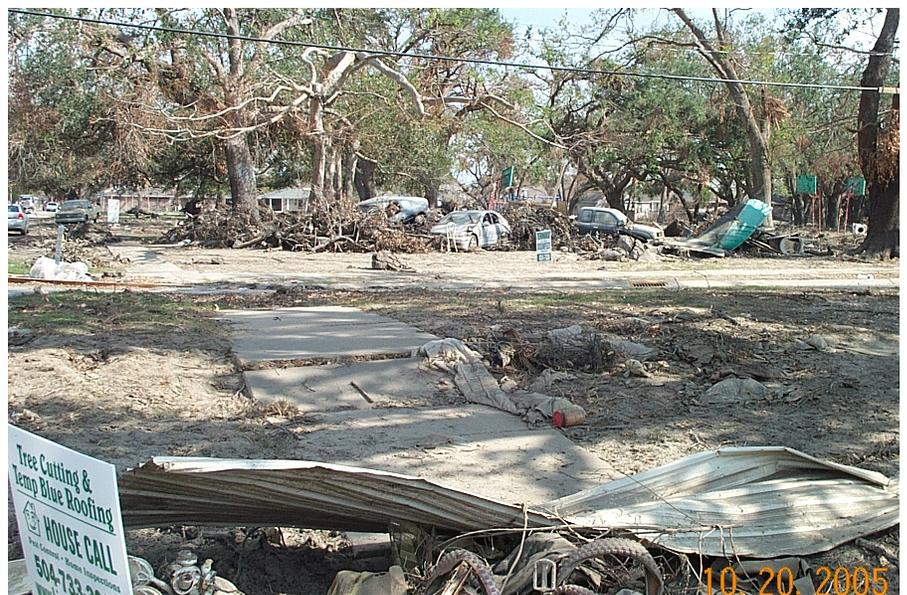
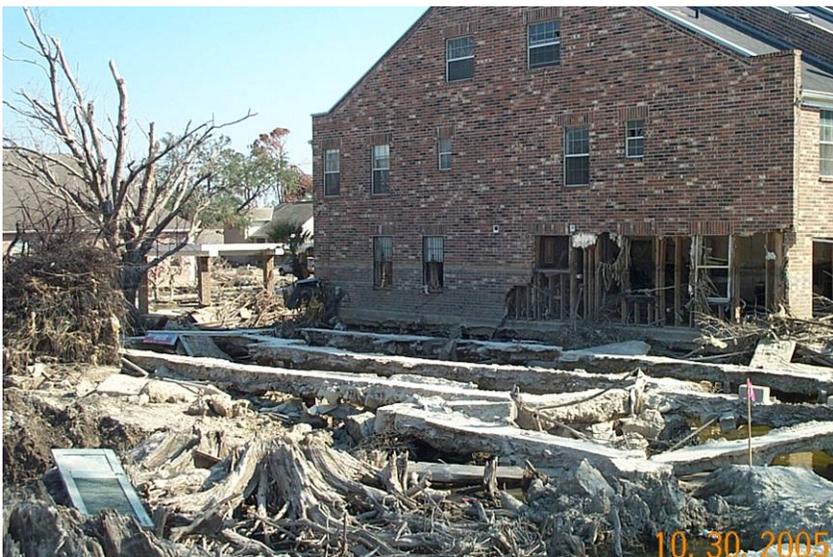
Photos - Top - looking north from I-10 overpass over Carrollton Ave. Middle - cars and other debris in park on Fleur de Lis near 17th St. Canal breach. Bottom - missing house and Cyprus stumps at 17th St. Canal Breach (photos by Stephen Nelson)

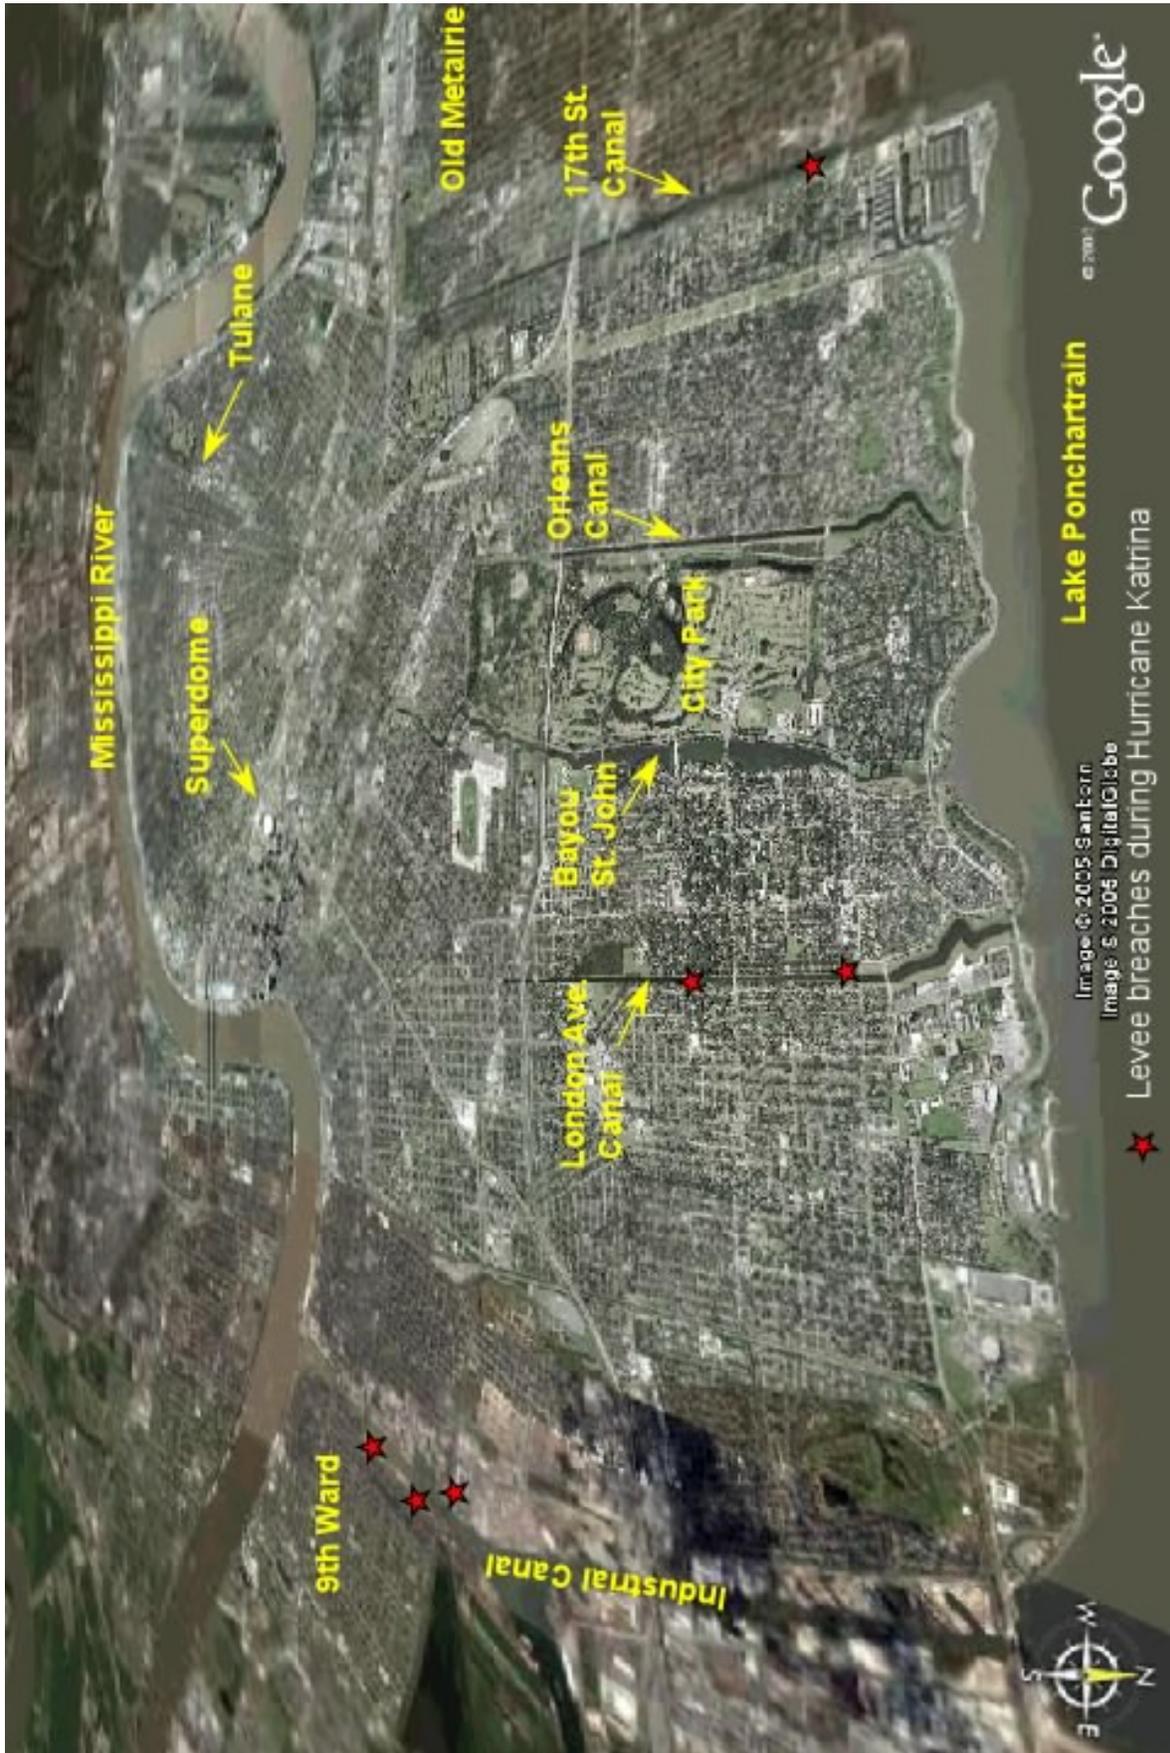
Figure 1. Google Earth oblique view of New Orleans showing location of levee breaches and important geographical features.

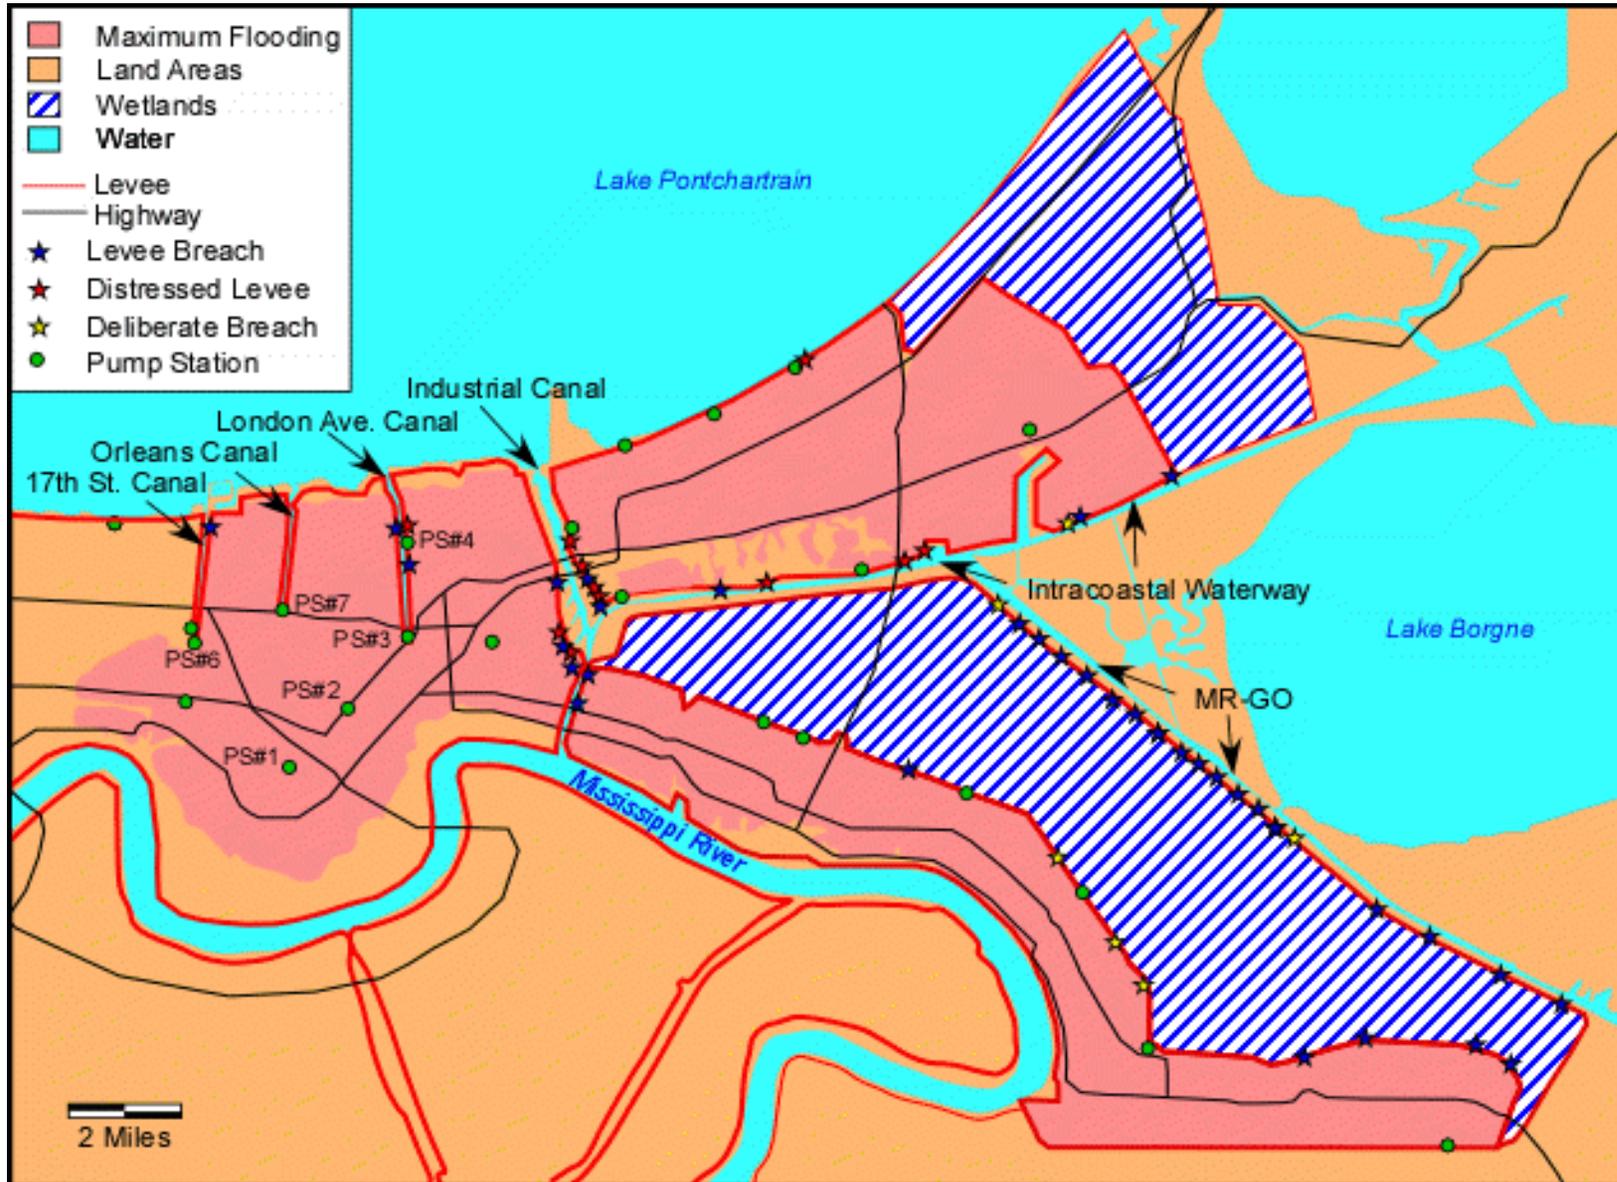
The first pumping station we encounter going north on Broad St. is Pump Station #1 (Fig. 7) which pumps water into the Palmetto Canal which then carries the water to Pump Station #6 where the water is elevated and pumped out to Lake Pontchartrain through the 17th St. Canal (also called the Metairie Outfall Canal).

Next is Pump Station #2 (Fig. 7) which pumps water into the Orleans Canal. Finally near the end of Broad St. in the north, we come to Pump Station #3 which pumps water into the London Ave. Canal and into Lake Pontchartrain.

Figure 7. Map of maximum extent of floodwaters during Katrina modified and locations of breached levees after U.S. Army Corps of engineers-
<http://www.hq.usace.army.mil/cepa/katrina/pumps/pumps.html#New%20Orleans%20Pump%20Status> and Seed et al. (2005).

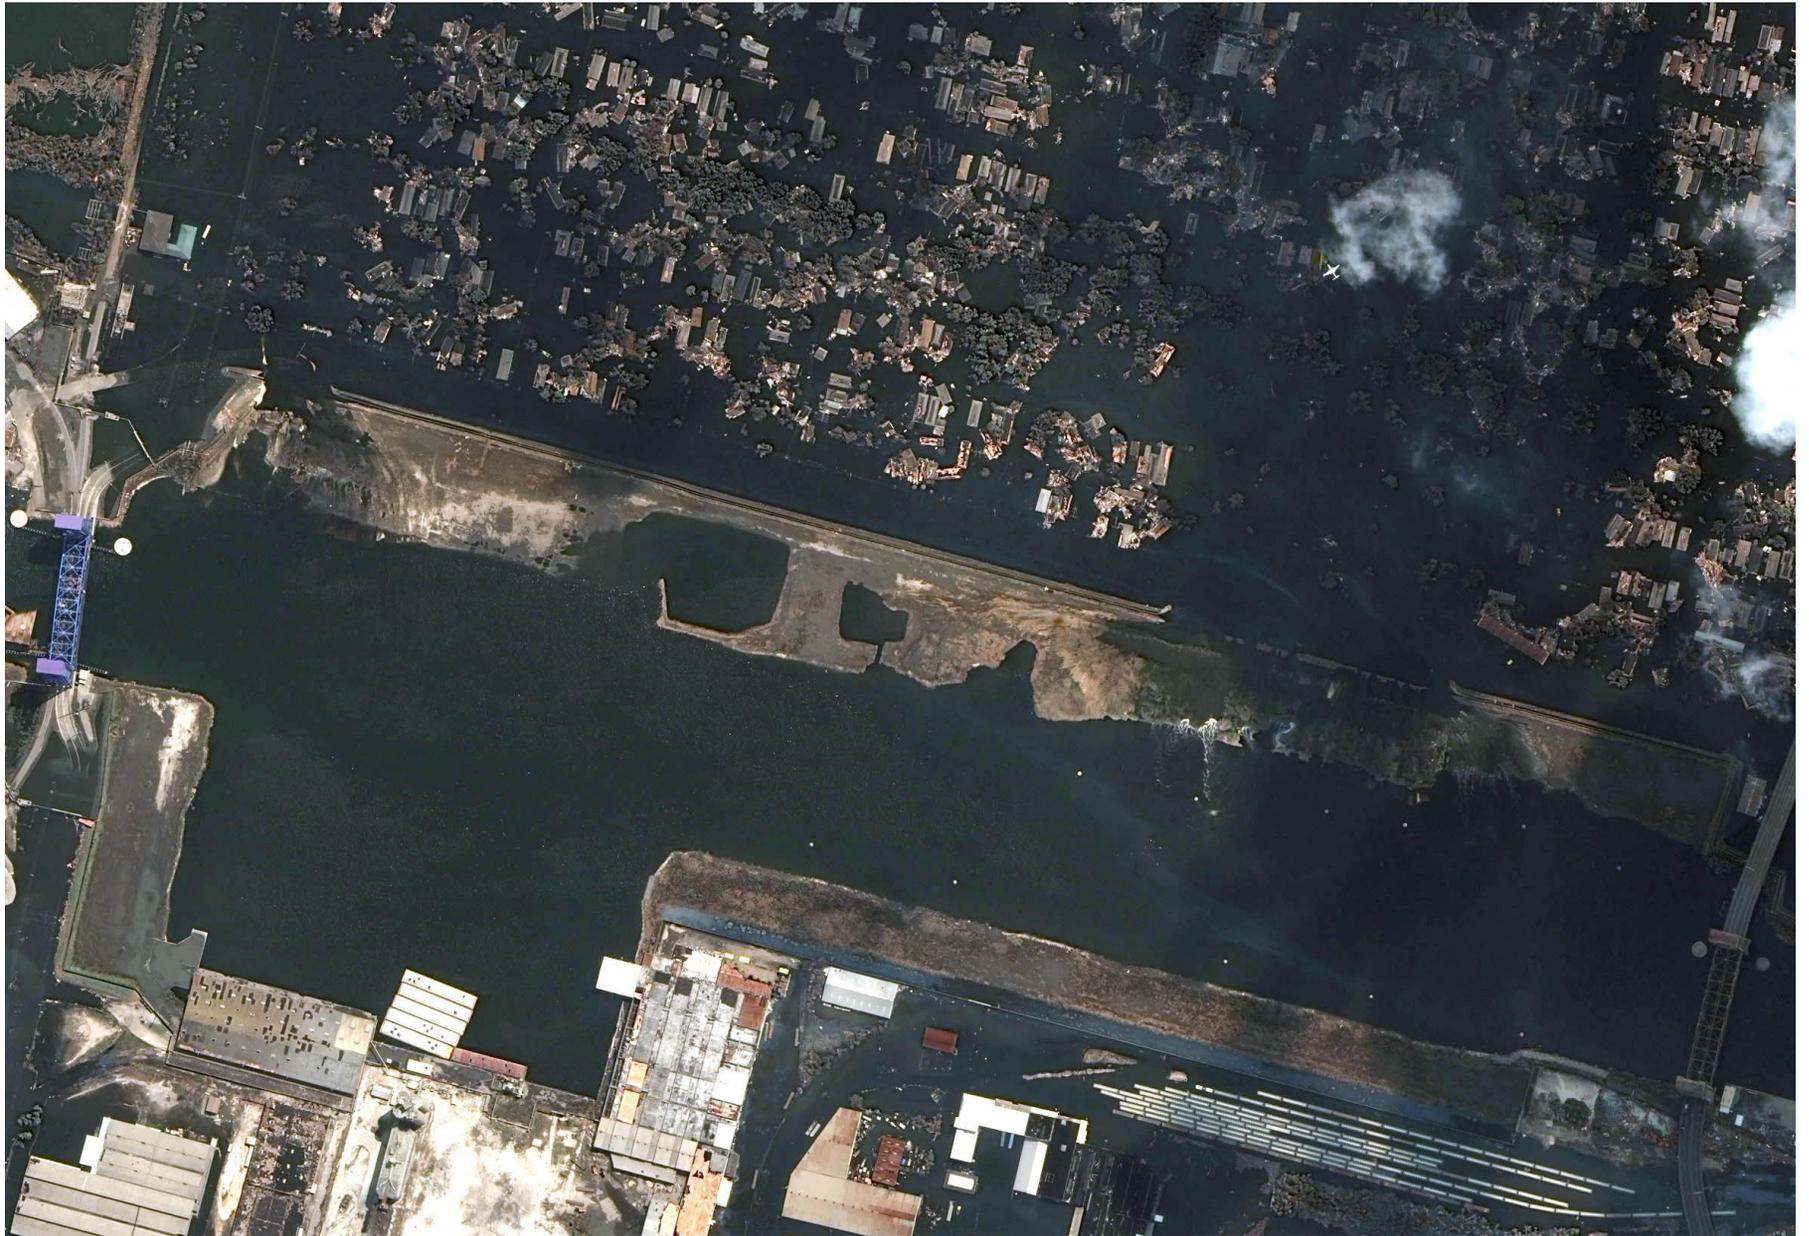
Figure 10. Air photograph of the area where the Industrial Canal Levee was breached to flood the Lower Ninth Ward. Image acquired Sept. 3, 2005
Source: National Oceanic and Atmospheric Administration's National Geodetic Survey, Katrina Images - <http://ngs.woc.noaa.gov/katrina/>

If the field trip is going to Alternate Stop A, in the Lower 9th Ward, we can see into, but not enter, the breach repair. All of the broken floodwall and most of the remaining floodwall have been removed as of mid-February, 2006, and a new floodwall is being constructed as of mid-March. Most of the streets have been cleared, but many displaced cars, the rubble piles of former homes, and foundations of many homes remain, clearly showing the force of the floodwaters that poured through the breach. The barge that went through the breach was being removed as of March 1, 2006.

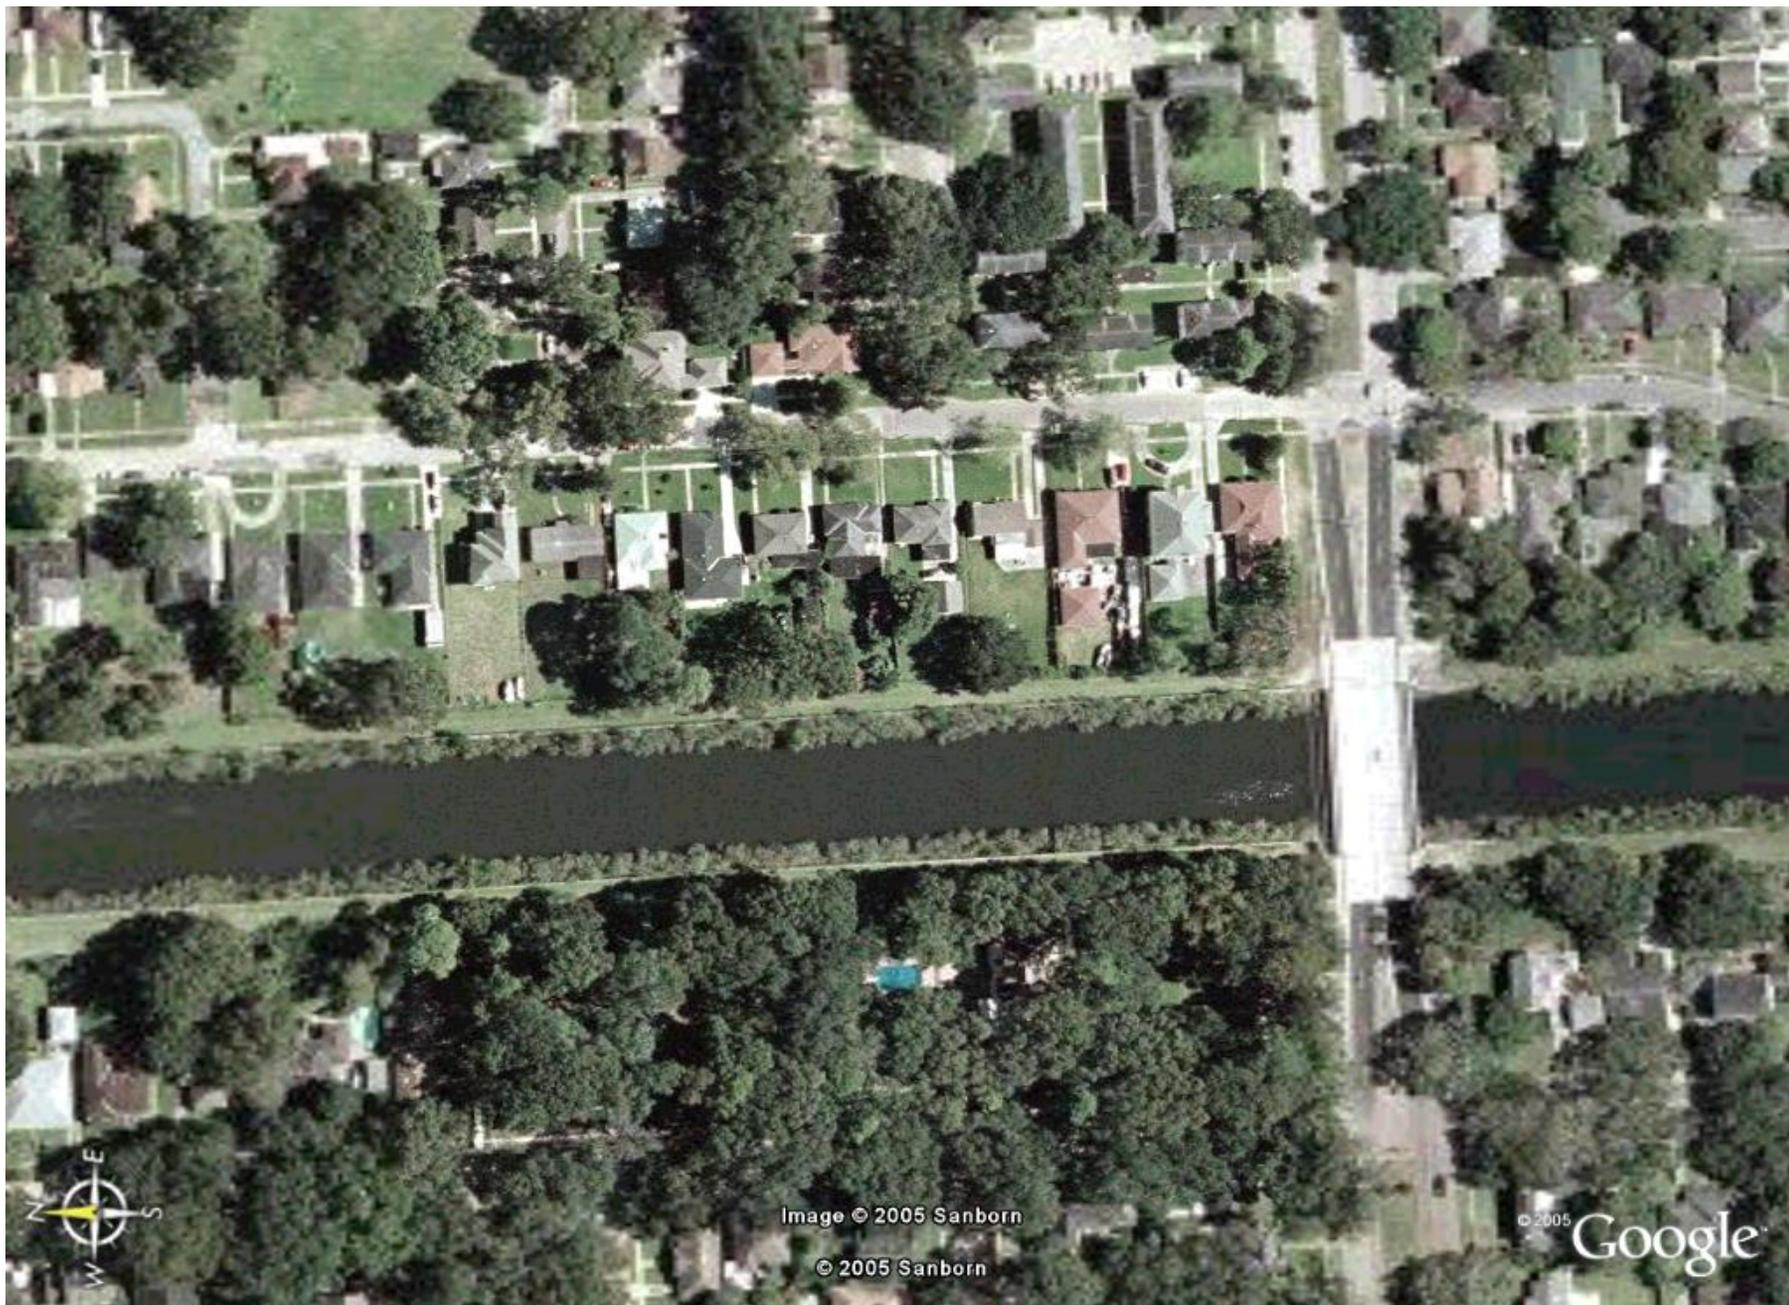
Stop 1 is at Mirabeau Avenue and the London Avenue Canal. According second preliminary IPET report (IPET 2006), the breach at this site occurred between 7:00 and 8:00 AM on August 29. winds were blowing out of the northeast pushing water from Lake Pontchartrain into the drainage canals. Figure 14 shows the area of the breach before Katrina and Figure 15 shows approximately the same view on August 31 when the breach was still active. A house in the center of the breach was moved out onto Warrington Drive (this house was demolished on about March 10, 2006). In figure 15, natural gas can be seen bubbling up through the flood waters at the location of the now displaced house. The breach here is about 200 feet wide and is currently under repair. At the present time seepage is still occurring through the sand bag and gravel fill that was used to repair the breach, although this could also be due to broken city water mains in the breach area.

Figure 14. Satellite image of the area along the London Avenue Canal near Mirabeau Ave. and Warrington Drive (Stop 1), where the levee was later breached during Hurricane Katrina. (Source - Google Earth)

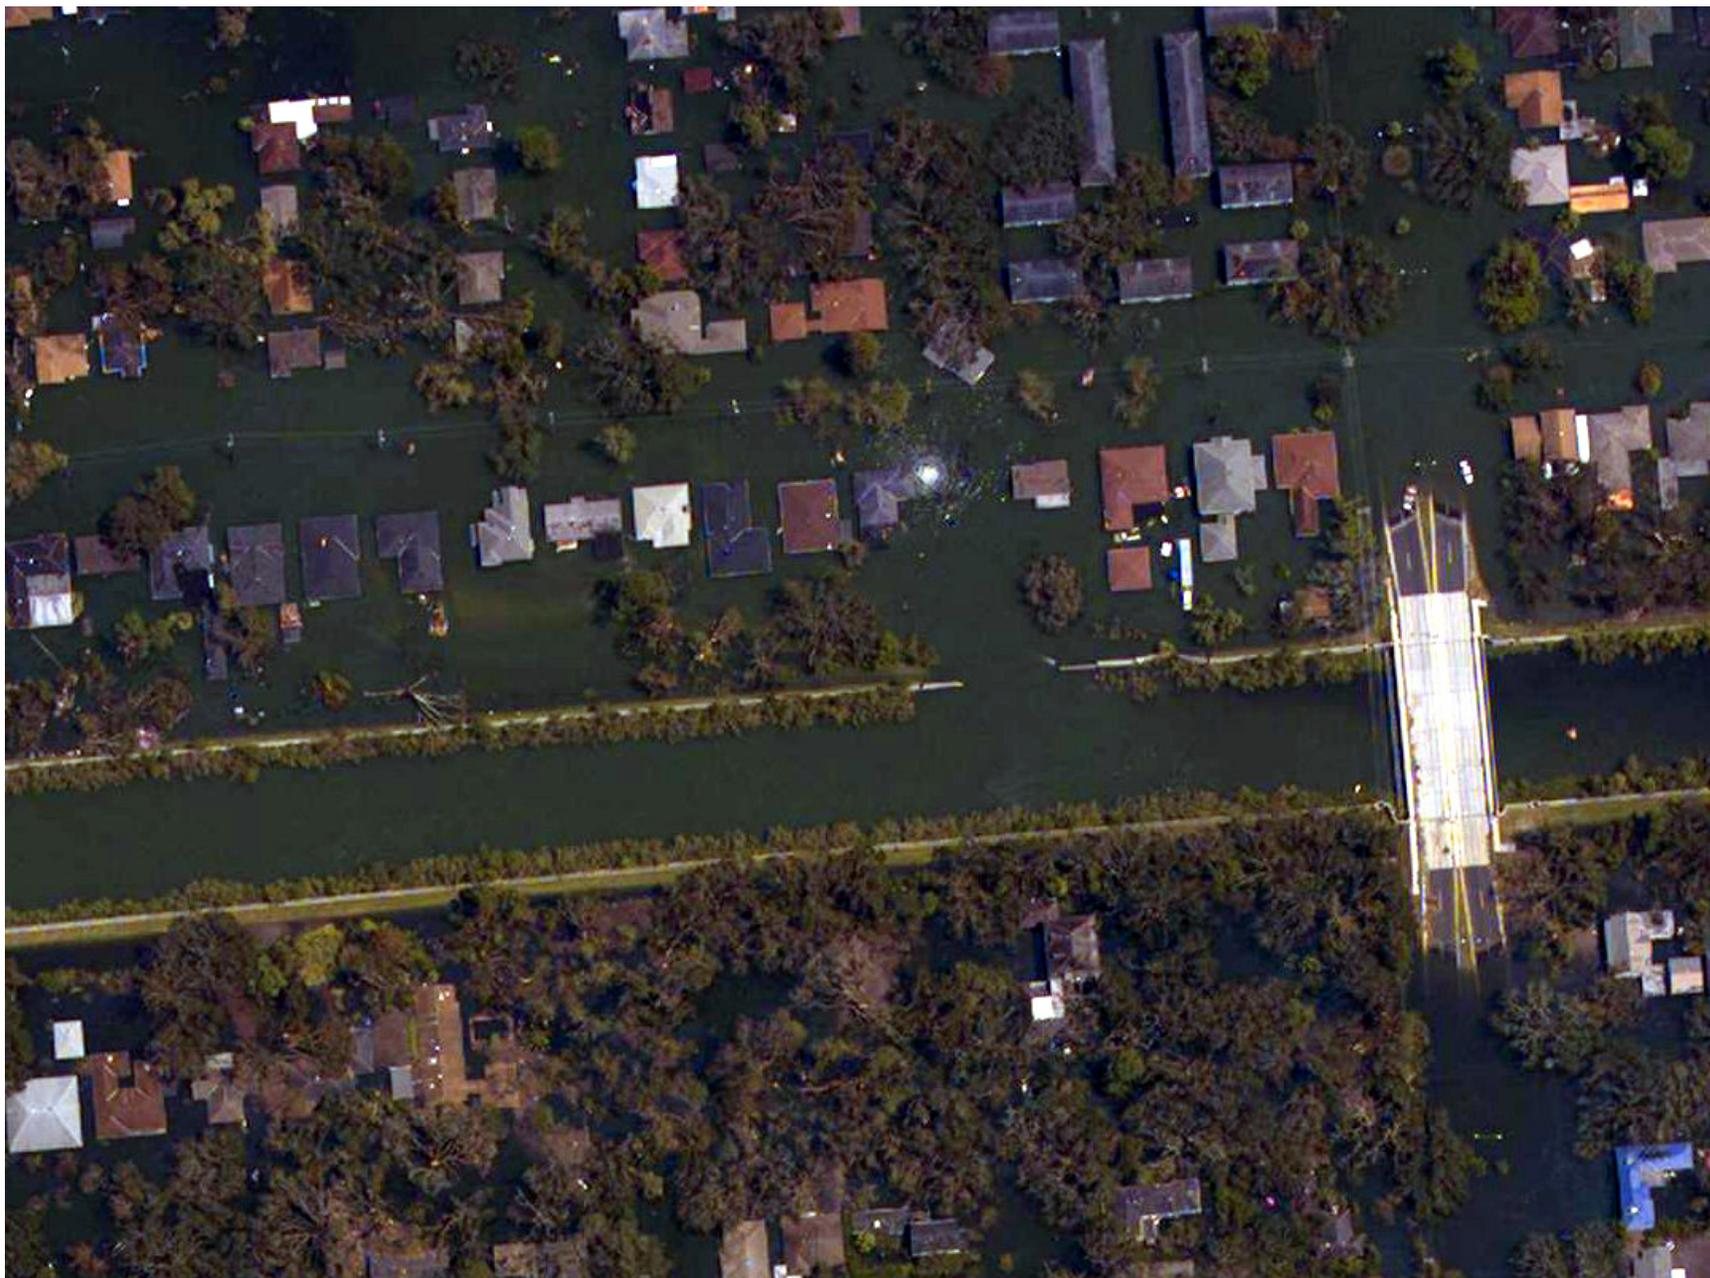
Figure 15. Air photograph of the area where the London Avenue Canal levee was breached near Mirabeau Ave. and Warrington Drive (Stop 1). Image acquired Aug. 31, 2005. Source: National Oceanic and Atmospheric Administration's National Geodetic Survey, Katrina Images - <http://ngs.woc.noaa.gov/katrina/>

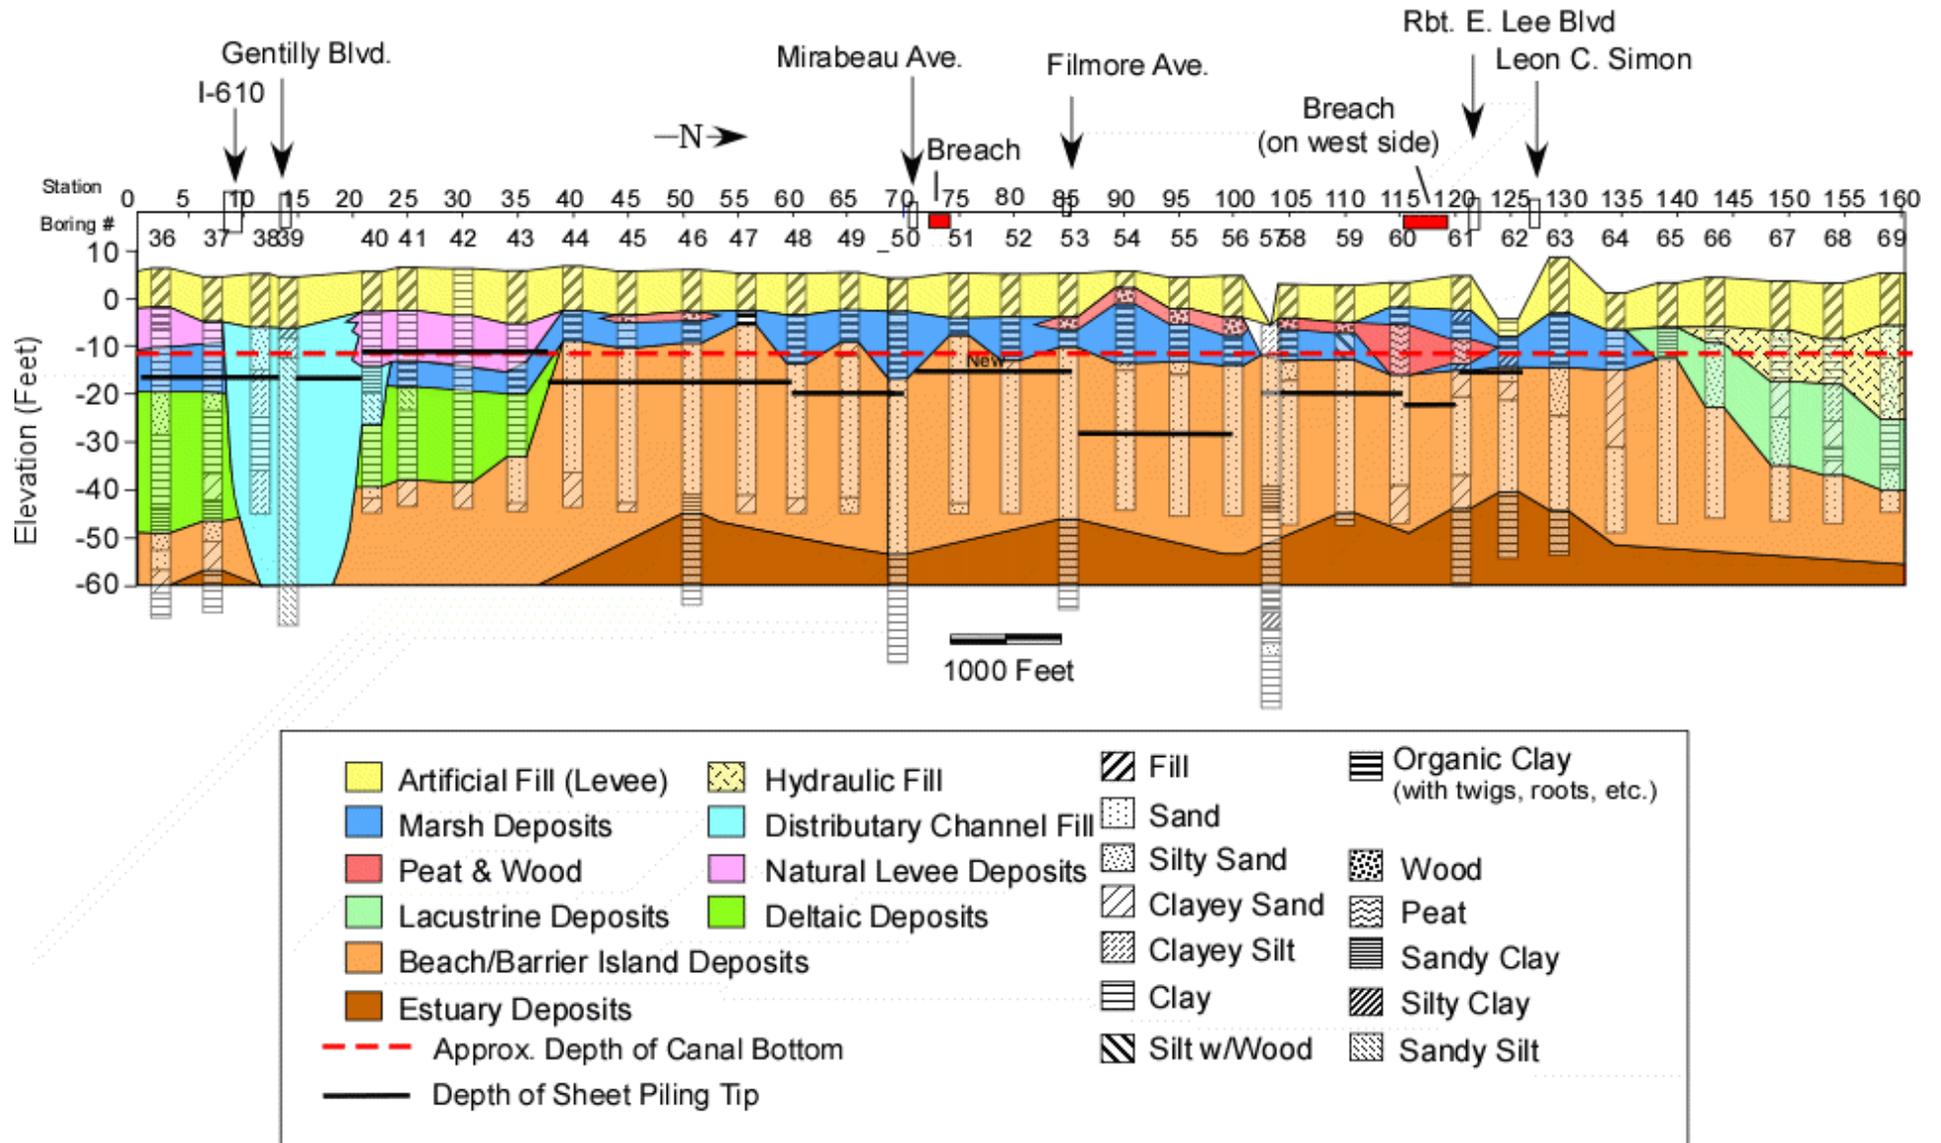
Figure 16. Geological cross-section along the east side of the London Avenue Canal constructed from data in U.S. Army Corps of Engineers (1989).

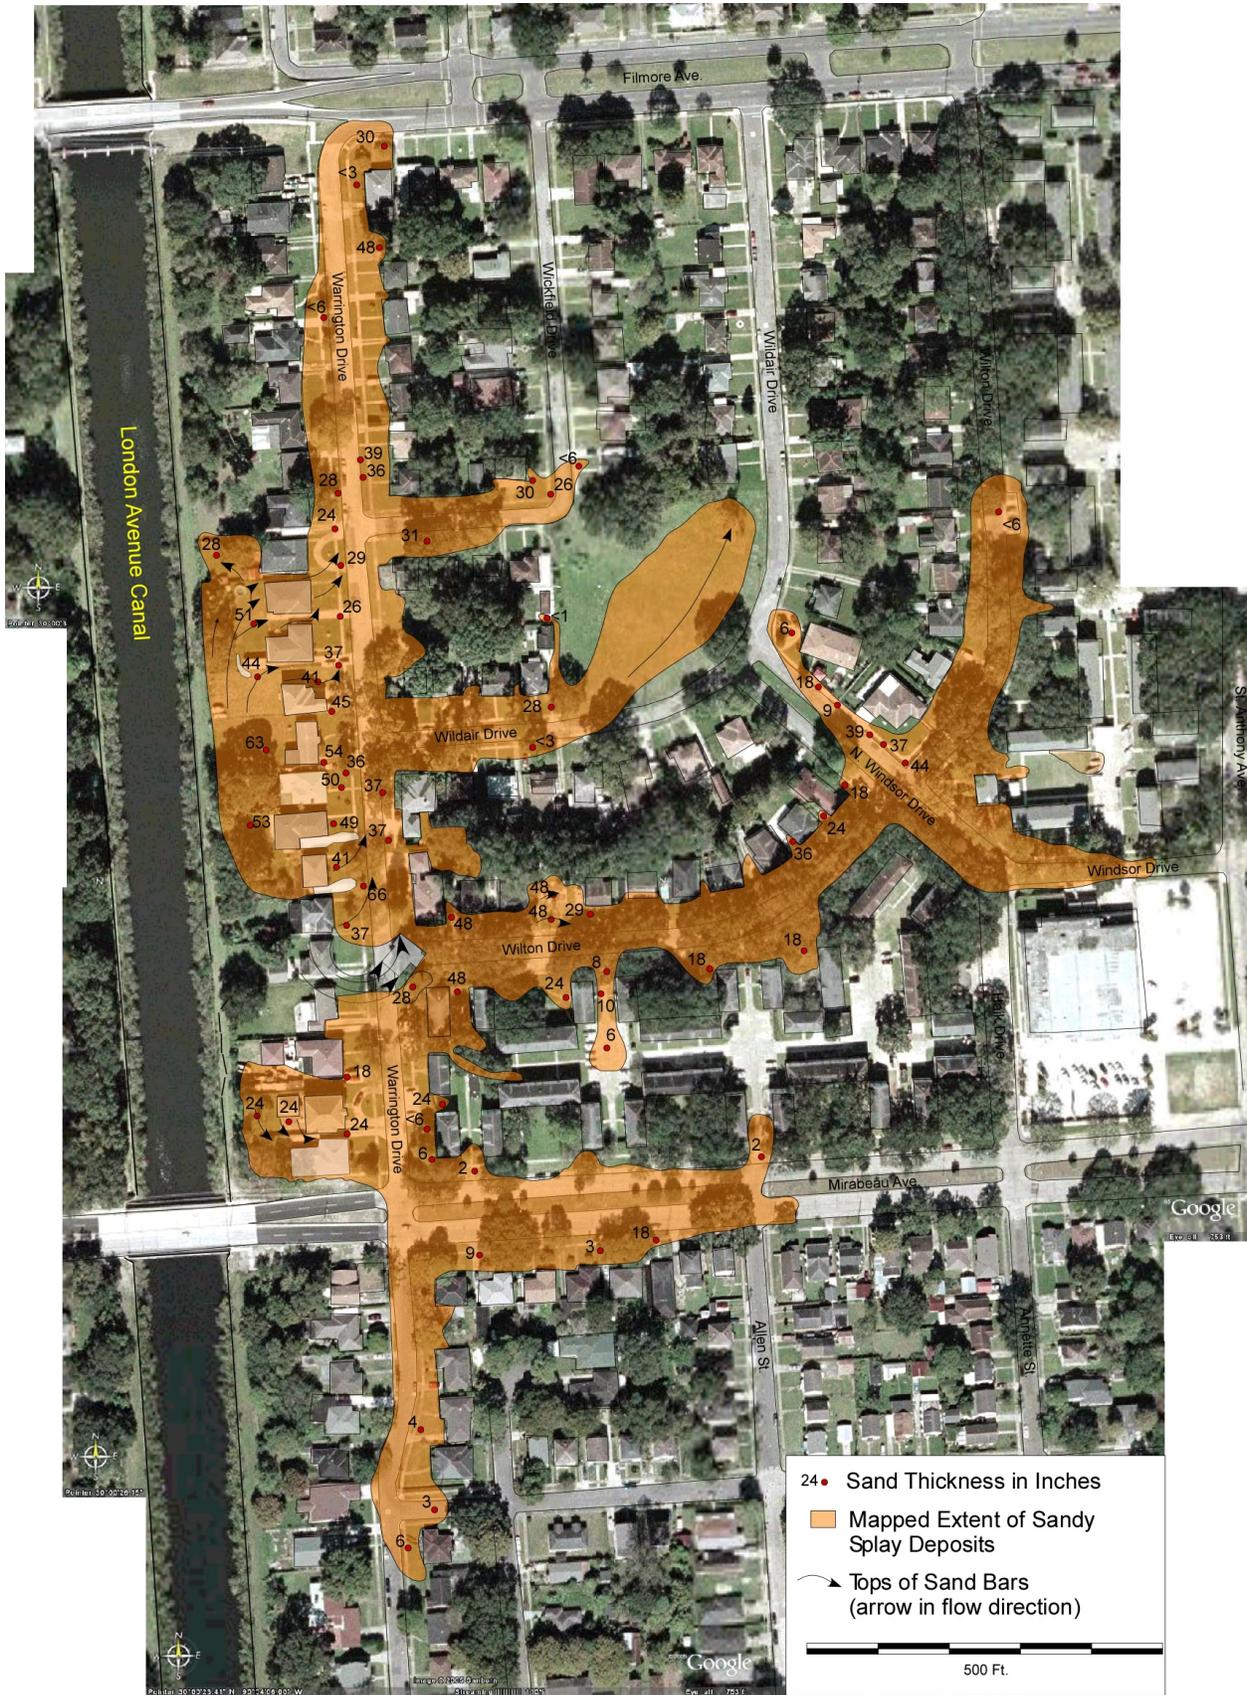
Figure 19 is a view looking down Warrington Drive before the sand deposits were removed in mid-February, 2006. Figure 20 shows my preliminary map of the extent of the sand that was likely scoured out of the bottom of the London Ave. Canal and deposited throughout the neighborhood. My preliminary estimate of the volume of sand deposited in the neighborhood is about 932,000 ft³. Such a volume would cover a football field, from end to end (including the end zones) with over 16 feet of sand. The volume is apparently larger than the hole produced by the breach, and thus scour must have occurred on the bottom of the canal, both upstream and downstream from the breach. The distribution and thickness of the actual deposit was controlled by current velocity and barriers such as houses, fences, and hedges.

Figure 20. Preliminary map of sand deposits (by S. A. Nelson) from the Mirabeau Ave. Breach on the London Ave. Canal. Underlying image is a composite from Google Earth.

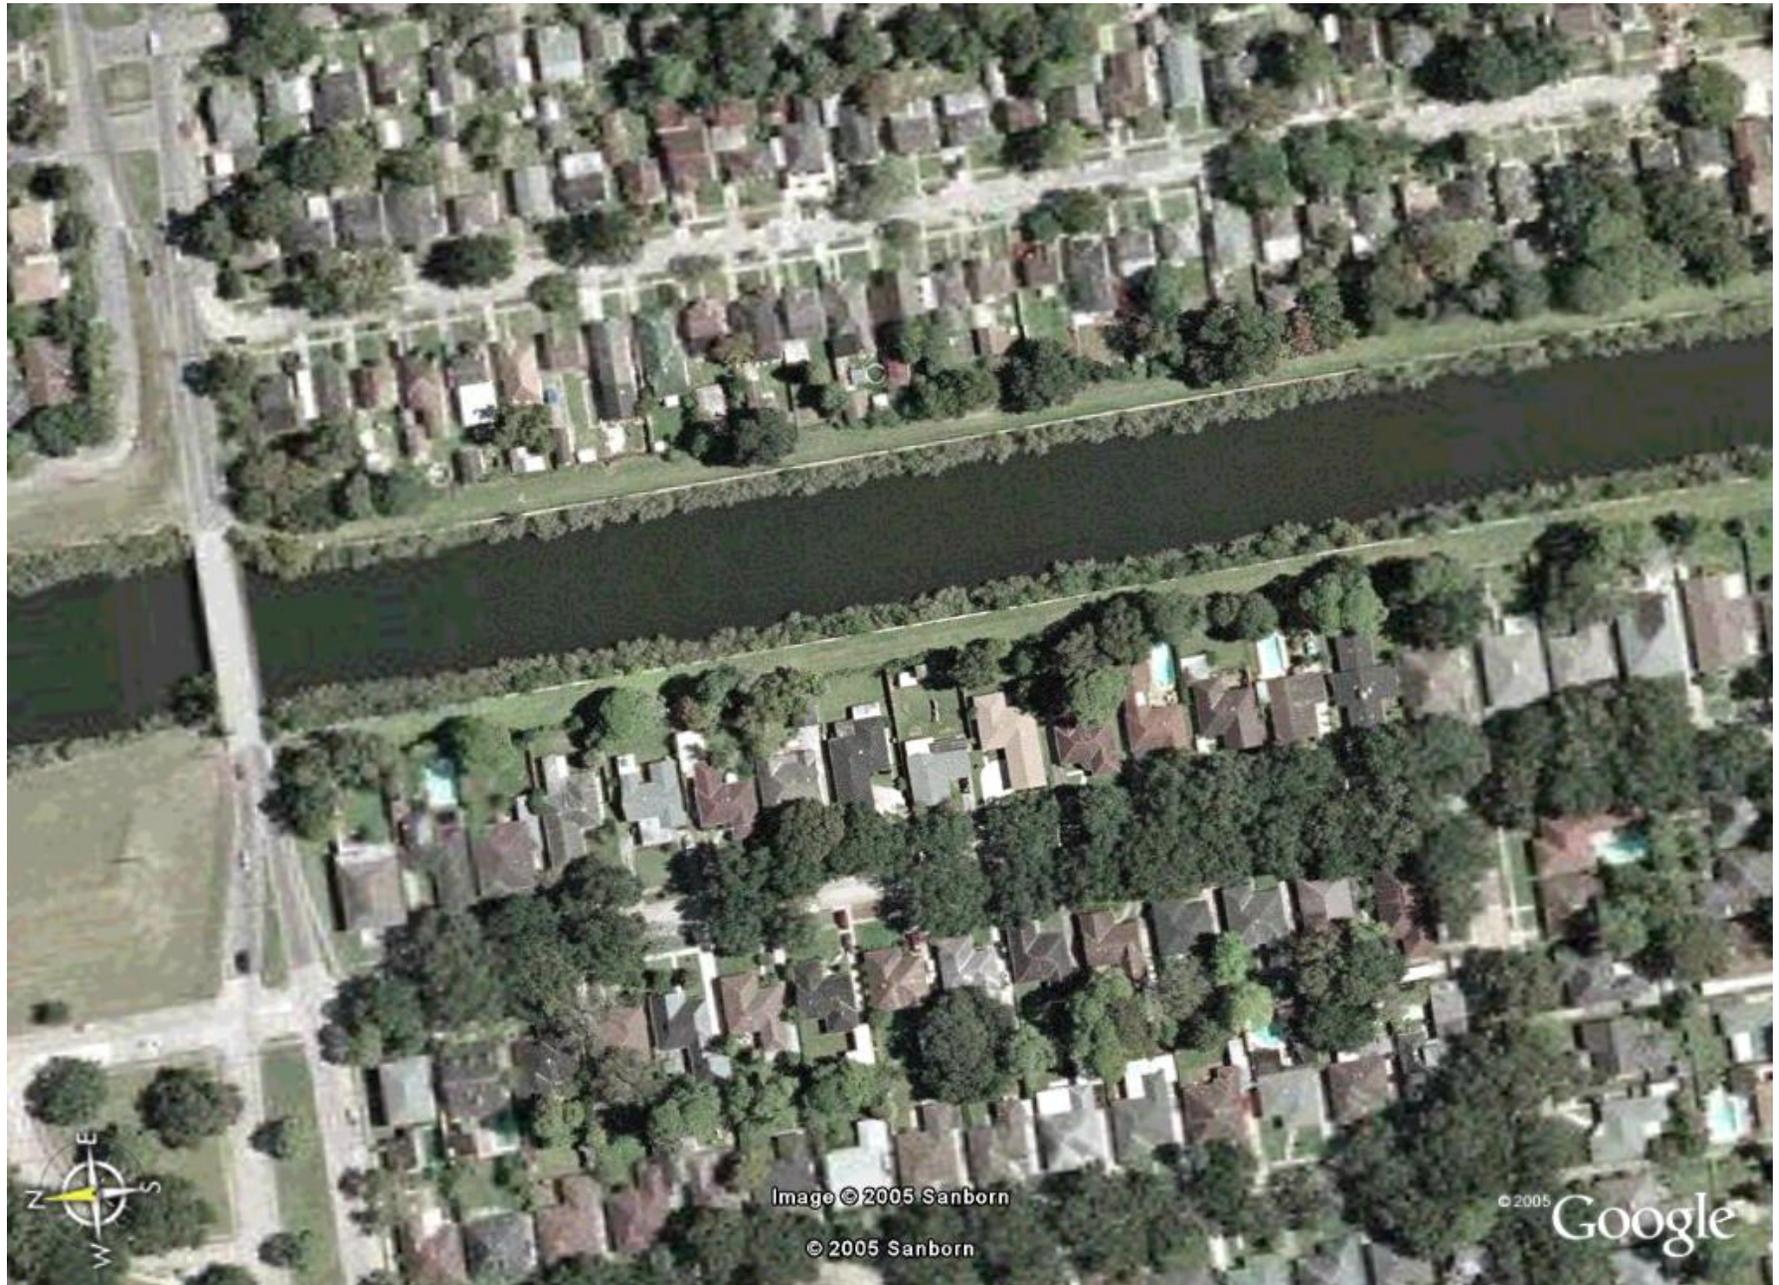
Stop 2 is near the intersection of Pratt Drive and Robert E. Lee Blvd. where the London Avenue Canal levee was breached on the west side of the canal. The estimated chronology suggested by IPET (2006) suggests that this breach also occurred sometime before 9:00 AM on August 29. Figure 21 shows an image of this area before Katrina. Figure 22 shows approximately the same area in an image taken on August 31 after the breach occurred and before the floodwaters had been pumped out.

Figure 21. Satellite image of the area along the London Avenue Canal near Robert E. Lee Blvd. and Pratt Drive (Stop 2), where the levee was later breached during Hurricane Katrina. (Source - Google Earth)

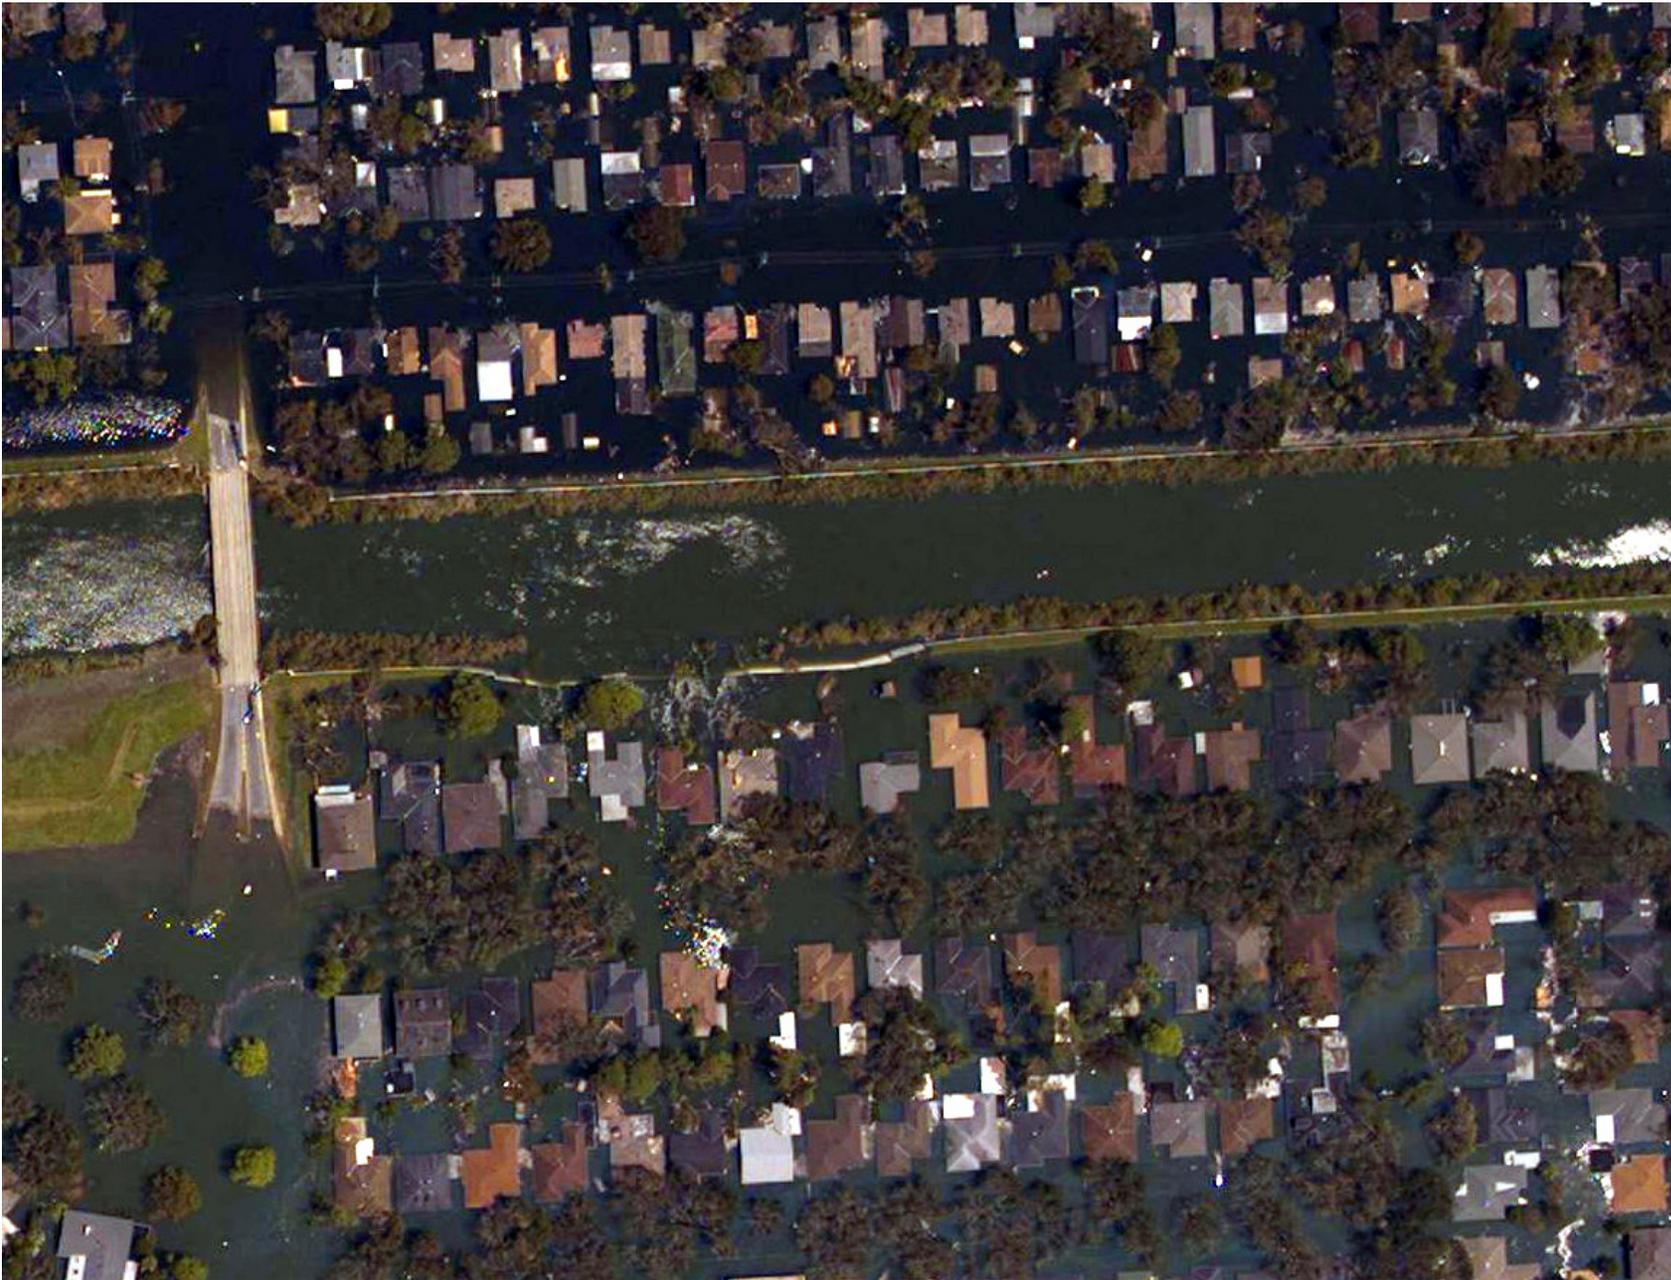
Figure 22. Air photograph of the area where the London Avenue Canal levee was breached near Robert E. Lee Ave. and Pratt Drive (Stop 2). Drive. Image acquired Aug. 31, 2005. Source: National Oceanic and Atmospheric Administration's National Geodetic Survey, Katrina Images - <http://ngs.woc.noaa.gov/katrina/>
