Hurricane Katrina - What Happened?

Tulane University
Field Trip
May 27, 2006

Stephen A. Nelson
Department of Earth &
Environmental Sciences
snelson@tulane.edu

Levee Breaches in New Orleans during Hurricane Katrina

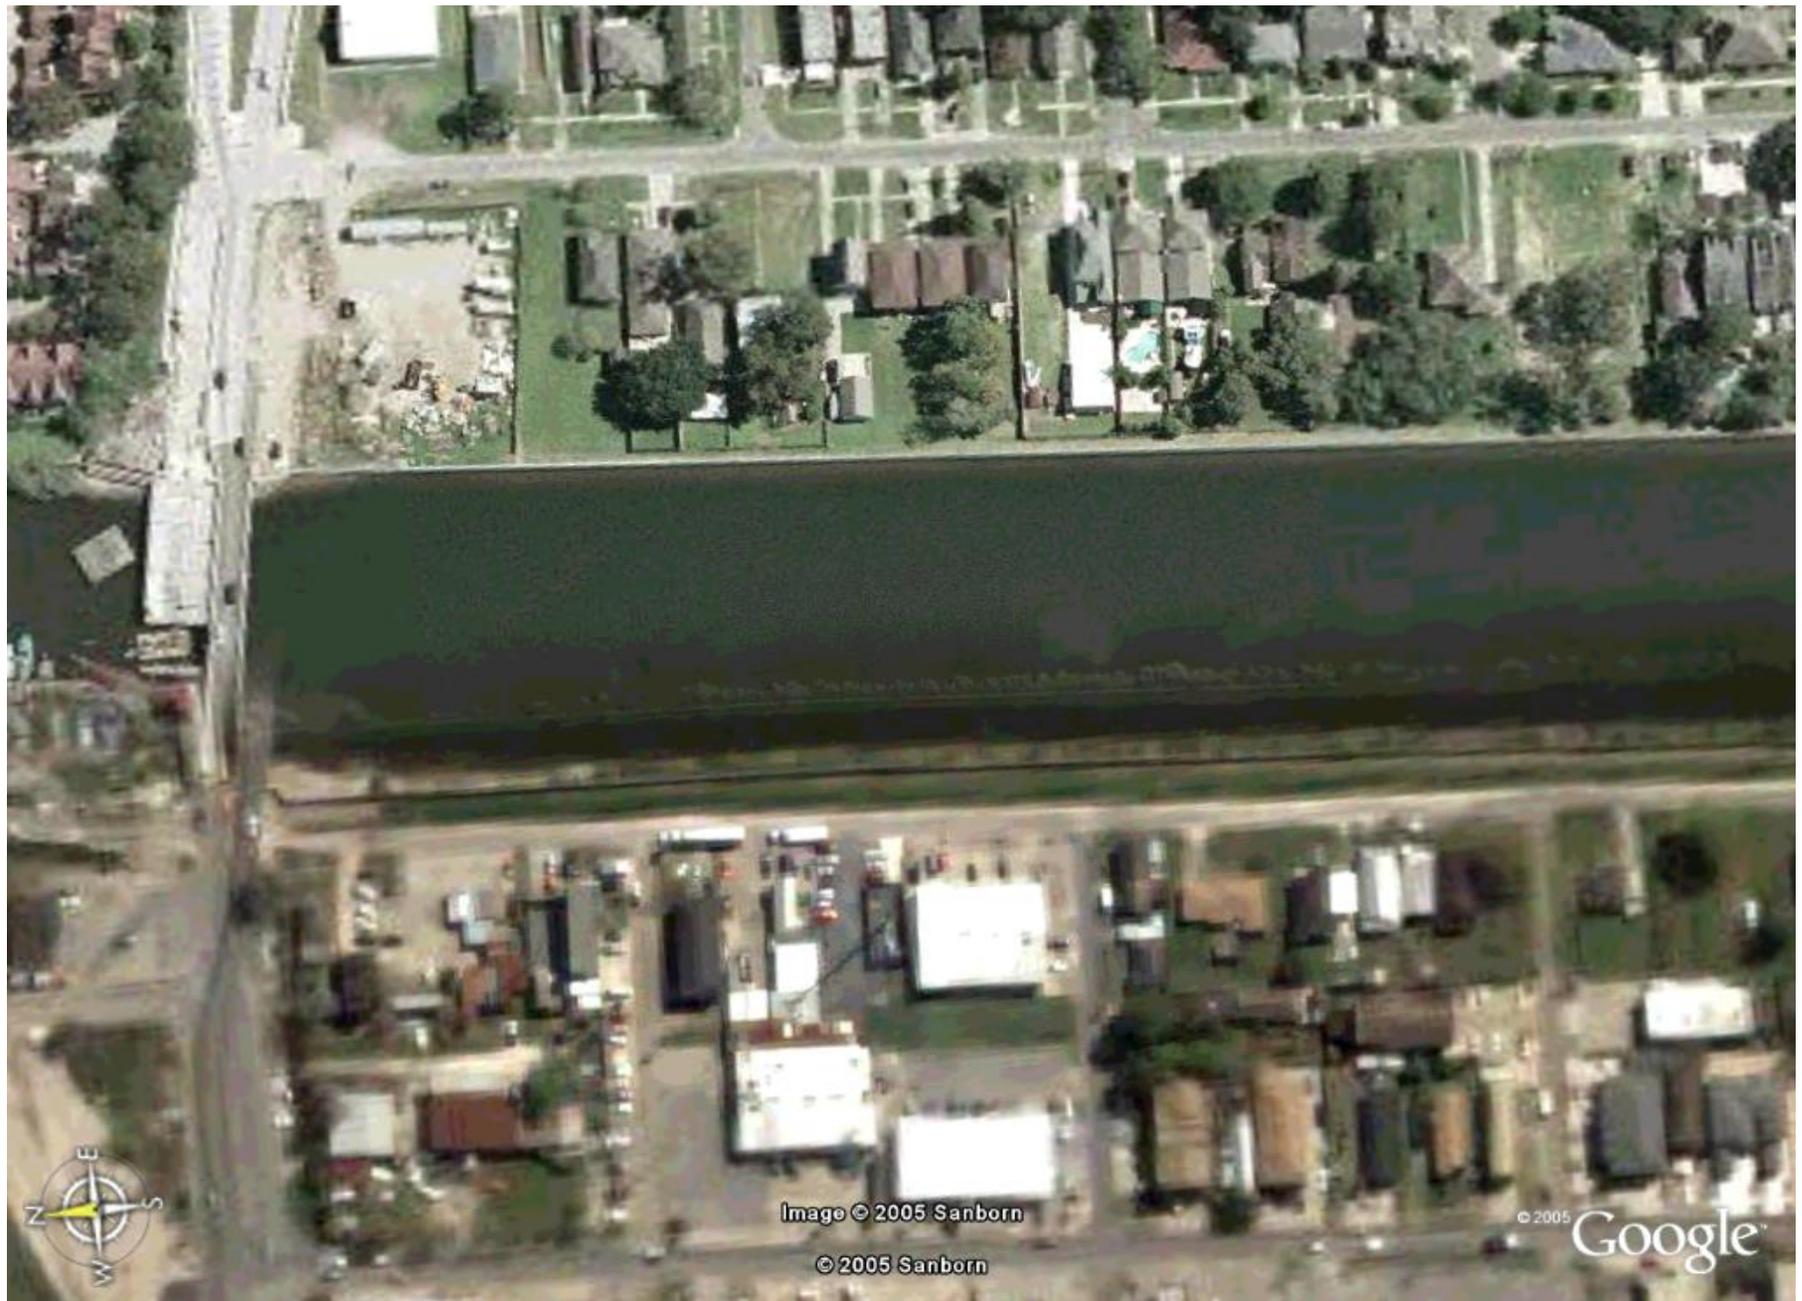
Stop 4 is in the area of the breach on the 17th St. Canal (also called the Metairie Outfall Canal). According to data presented by IPET (2006) this breach started at about 6:30 AM and was completely open by about 9:00 AM on August 29. It was reported to WWL radio by the New Orleans Fire Department at 11:00 AM. The breach occurred along a 200 ft. section of the levee on the Orleans Parish side of the canal. Figure 26 shows an aerial view of the breach area before Katrina and Figure 27 shows approximately the same area on August 31 as water was still flowing through the breach into Lakeview.

Figure 26. Satellite image of the area along the 17th Street Canal near the Old Hammond Highway Bridge (under construction), where the levee was later breached during Hurricane Katrina (stop 4). (Source - Google Earth)

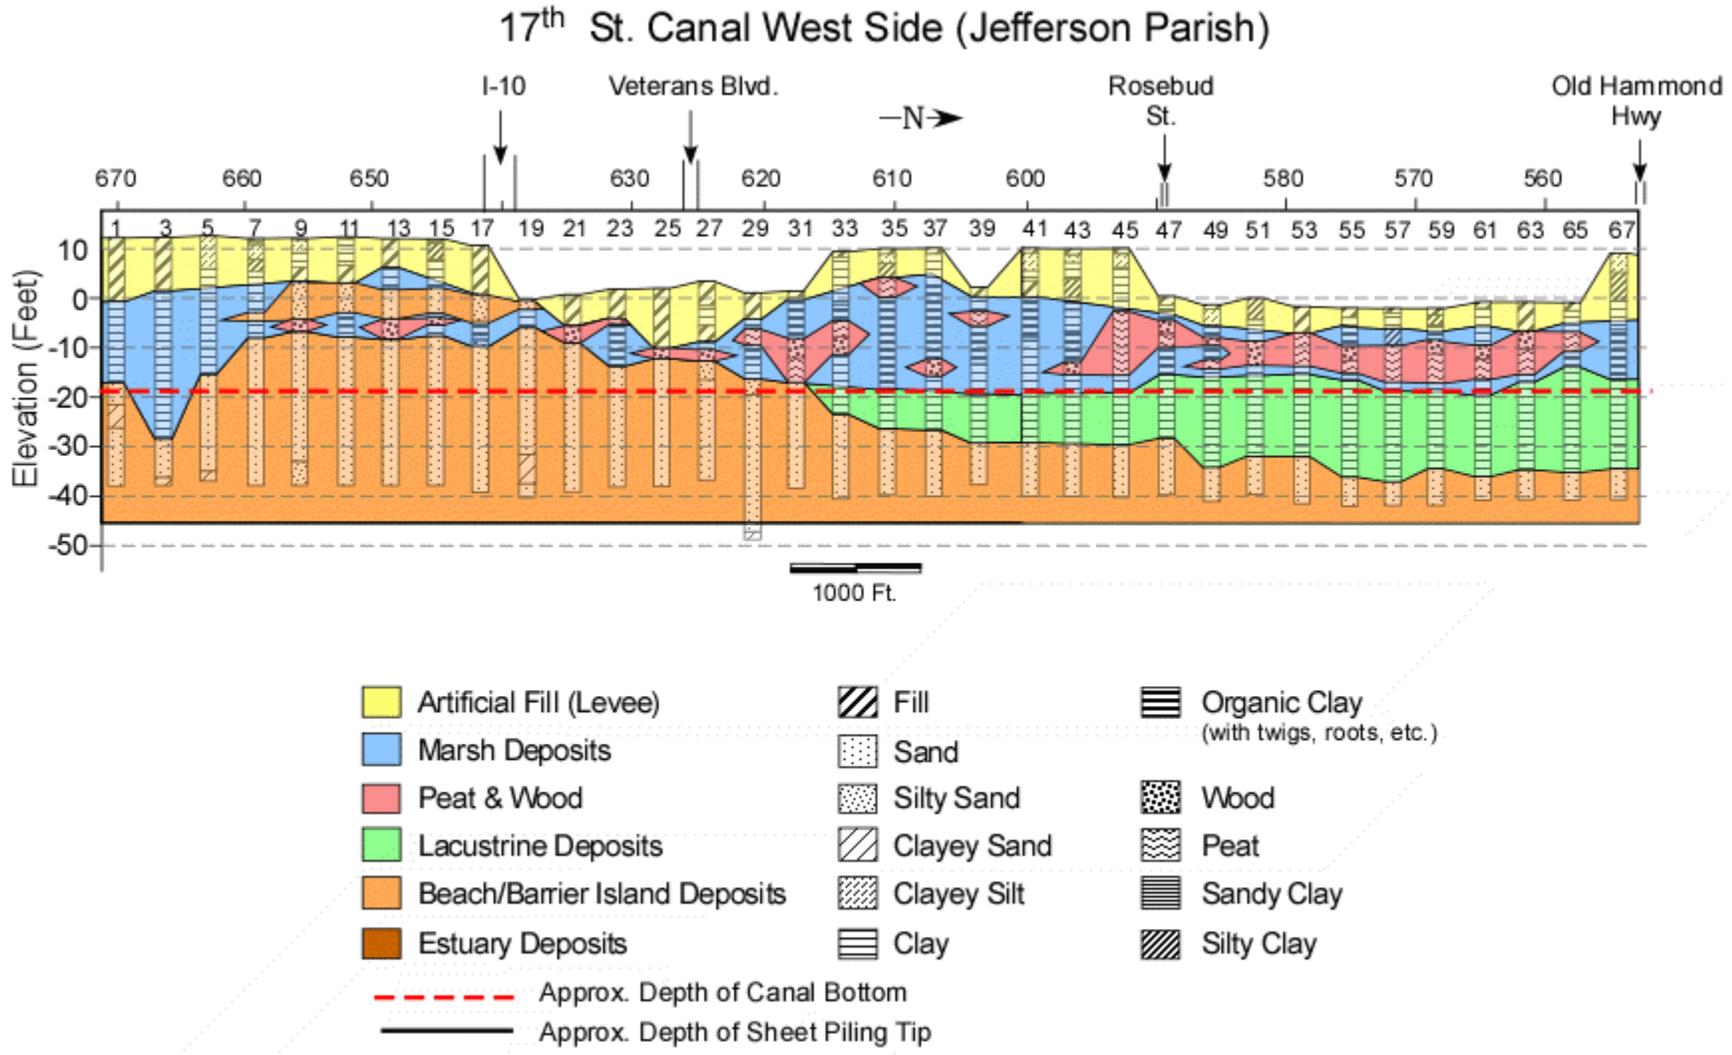
It is notable that the same peat layer and the same levee design and construction are present on the Jefferson Parish side of the canal, which by luck or the path of the storm, did not breach on August 29. Figures 32 shows a geological cross section of the west bank (Jefferson Parish side) of the 17th St. Canal constructed from data provided on the Army Corps of Engineers IPET web site - <https://ipet.wes.army.mil/> where it can be seen that the same geologic materials are present beneath the Jefferson Parish side as are found on the Orleans Parish side (compare with Figure 28).

Figure 32 Geologic cross section of the west bank of the 17th St. Canal constructed from data provided to the U.S. Army Corps of Engineers (1990).

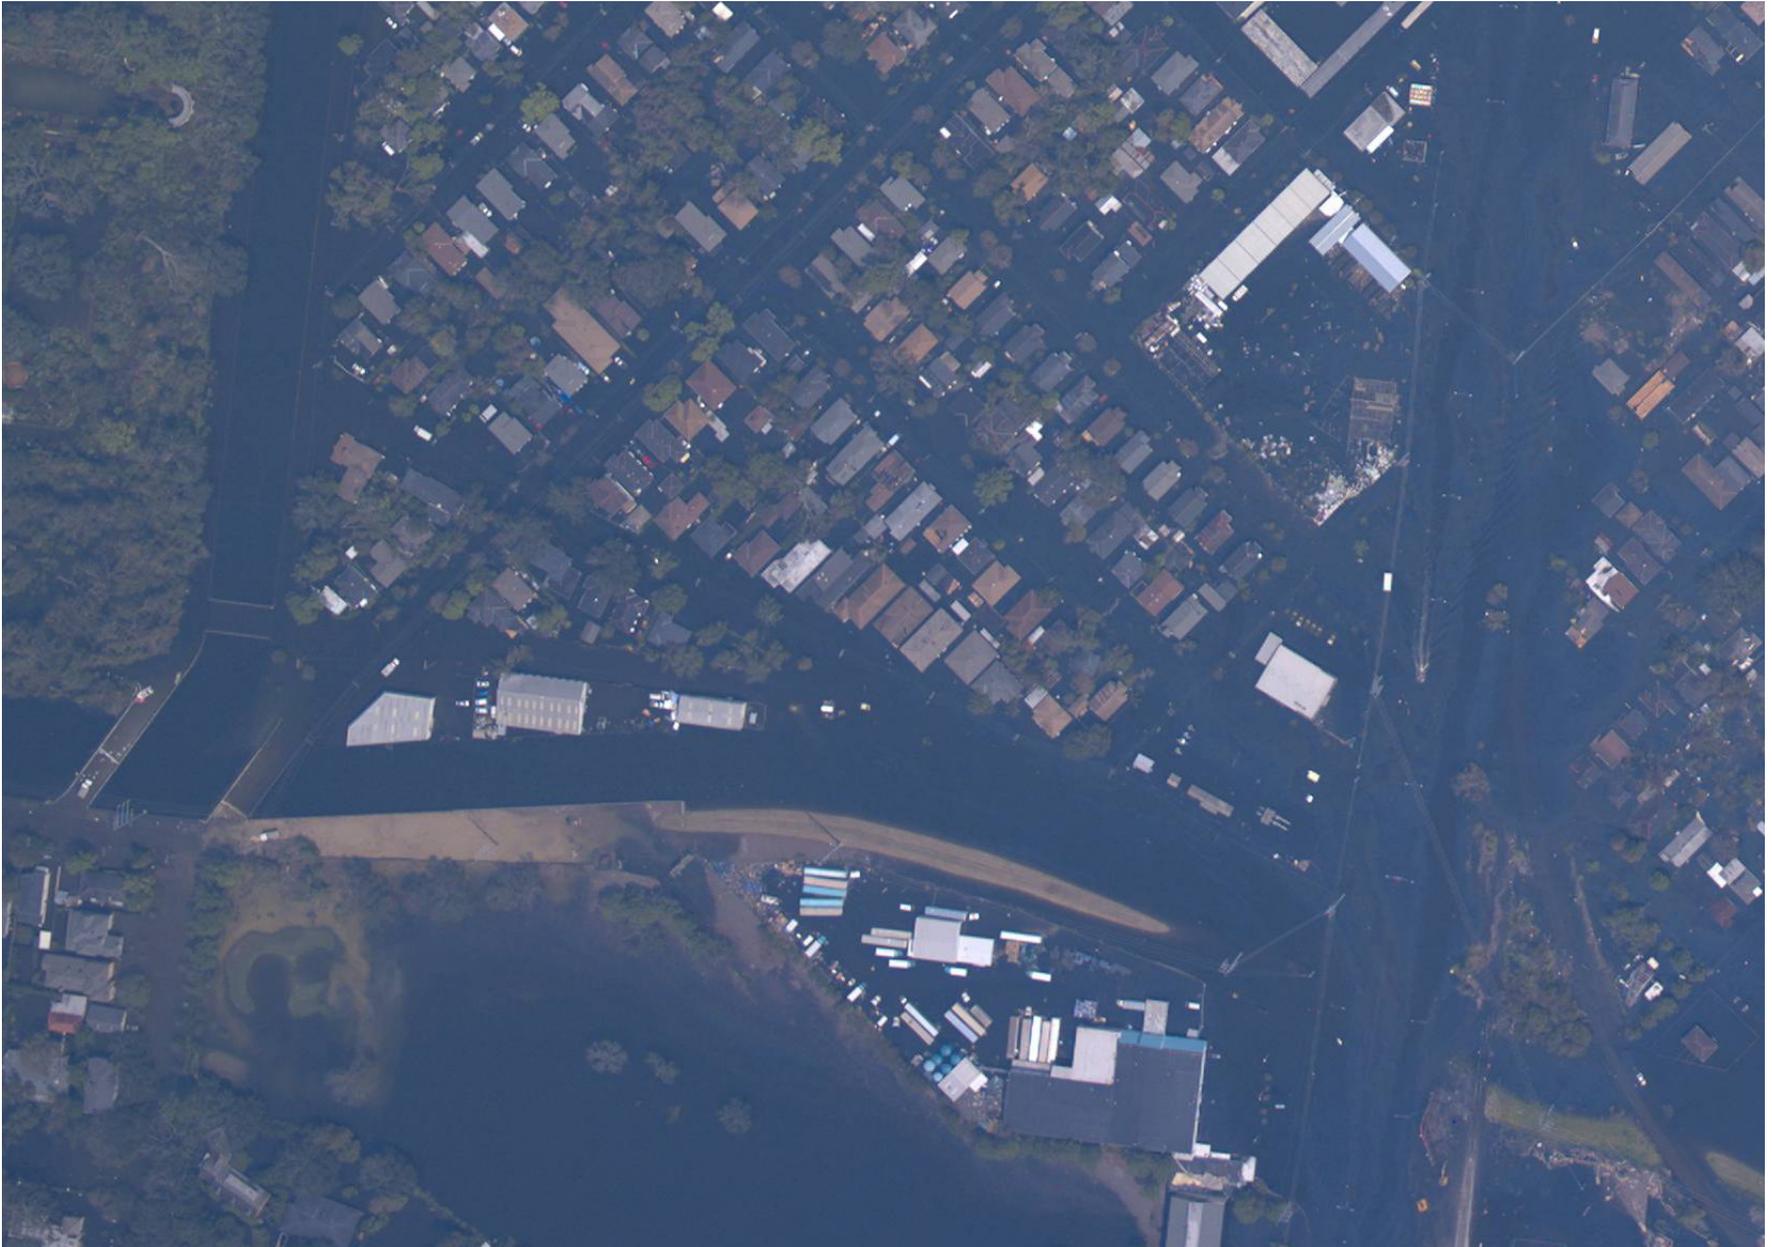
Stop 5 is that the corner of Orpheum Avenue and Northline Street. It is through this area and along Airline Drive south of here, that flood waters from the levee breaches in Orleans Parish reached into Jefferson Parish. The flooding occurred south of the Metairie Road (on the Metairie Ridge) and extended west to Causeway Blvd. and south to near the River. Figure 33 is a Google Earth image of the area at the junction of the Palmetto canal and the 17th St. canal before Katrina and Figure 34 shows approximately the same area on August 31. This area is at the southern end of the 17th St. Canal where the Palmetto Canal brings water from Pump Station #1 on Broad Street (Figure 7) into the 17th St. Canal where it is lifted by Pump Station #6 about 8 feet in elevation and pumped out to the Lake (or through the breach in the 17th St. Canal). The Palmetto Canal has a short floodwall (about 3 feet higher than the roadway). Note in Figure 33, how the floodwalls on the Palmetto Canal are completely covered by water. The two bridges over the 17th St. Canal are barely above water, but it is clear that water flowed over and around these bridges into Old Metairie. It is also clear that Airline Drive, to the south, was a conduit for water to enter Jefferson Parish.

Figure 34. Air photograph of the area where the water from the 17th Street Canal Levee Breach ran back into Old Metairie, near Orpheum and Palm (stop 5). Image acquired Aug. 31, 2005. Source: National Oceanic and Atmospheric Administration's National Geodetic Survey, Katrina Images - <http://ngs.woc.noaa.gov/katrina/>

Within a few days after the August 31 image was taken, Jefferson Parish constructed temporary rock and sandbag levees over these two bridges, across Airline Drive, and across Claiborne Ave./Jefferson Highway, and at the Jefferson/Orleans Parish boundary. These temporary levees were apparently constructed to prevent more flood water originating at the levee breaches in Orleans Parish from further flooding Jefferson Parish. Although the levee breaches in Orleans Parish were mostly stopped by the time the temporary levees at the Parish line were constructed, the damage had already been done. There are, however, reports that once these temporary levees were built, Jefferson Parish started pumping water out of Jefferson and back into Orleans Parish. If true, this would have increased the amount of water over that already standing in Orleans Parish while the levee breaches were being patched and before the pumps in Orleans parish could be started to remove the water from the severely flooded areas.
