Hurricane Katrina - What Happened?

Tulane University
Field Trip
August 5, 2006

Levee Breaches in New Orleans during Hurricane Katrina

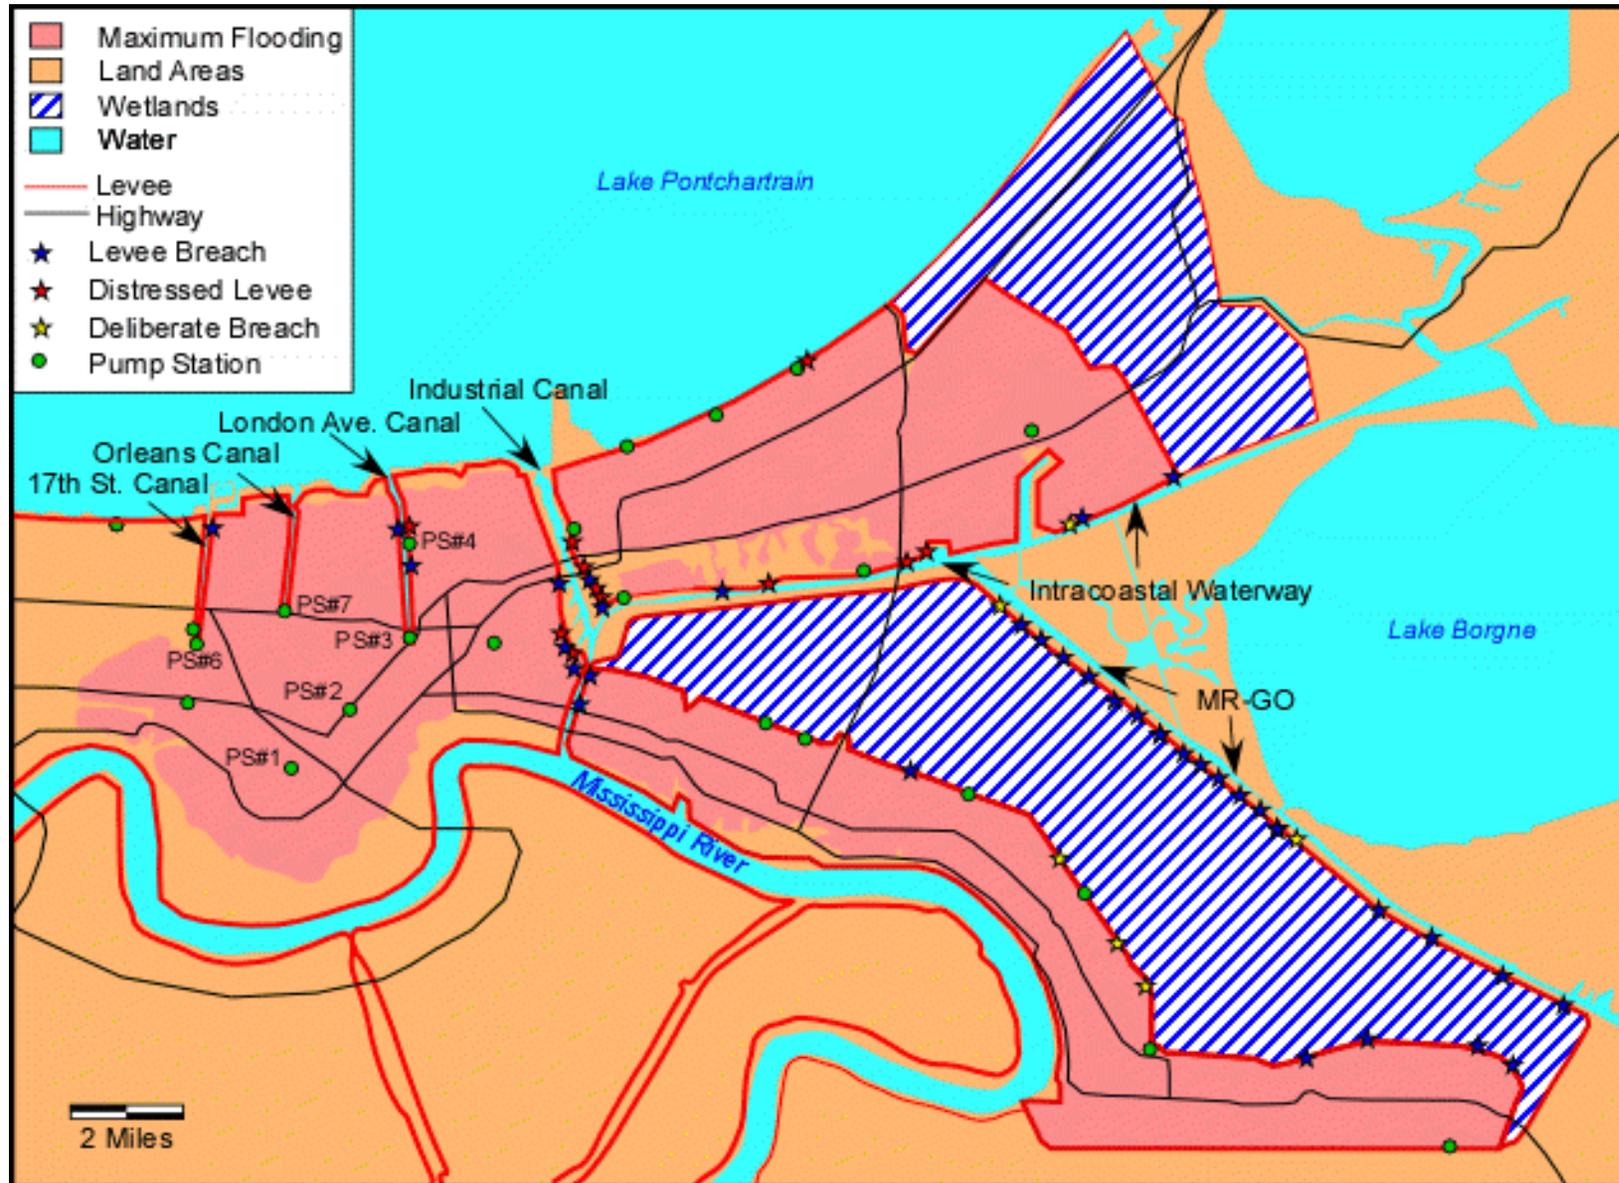
Figure 7. Map of maximum extent of floodwaters during Katrina modified and locations of breached levees after U.S. Army Corps of engineers-
<http://www.hq.usace.army.mil/cepa/katrina/pumps/pumps.html#New%20Orleans%20Pump%20Status> and Seed et al. (2005).

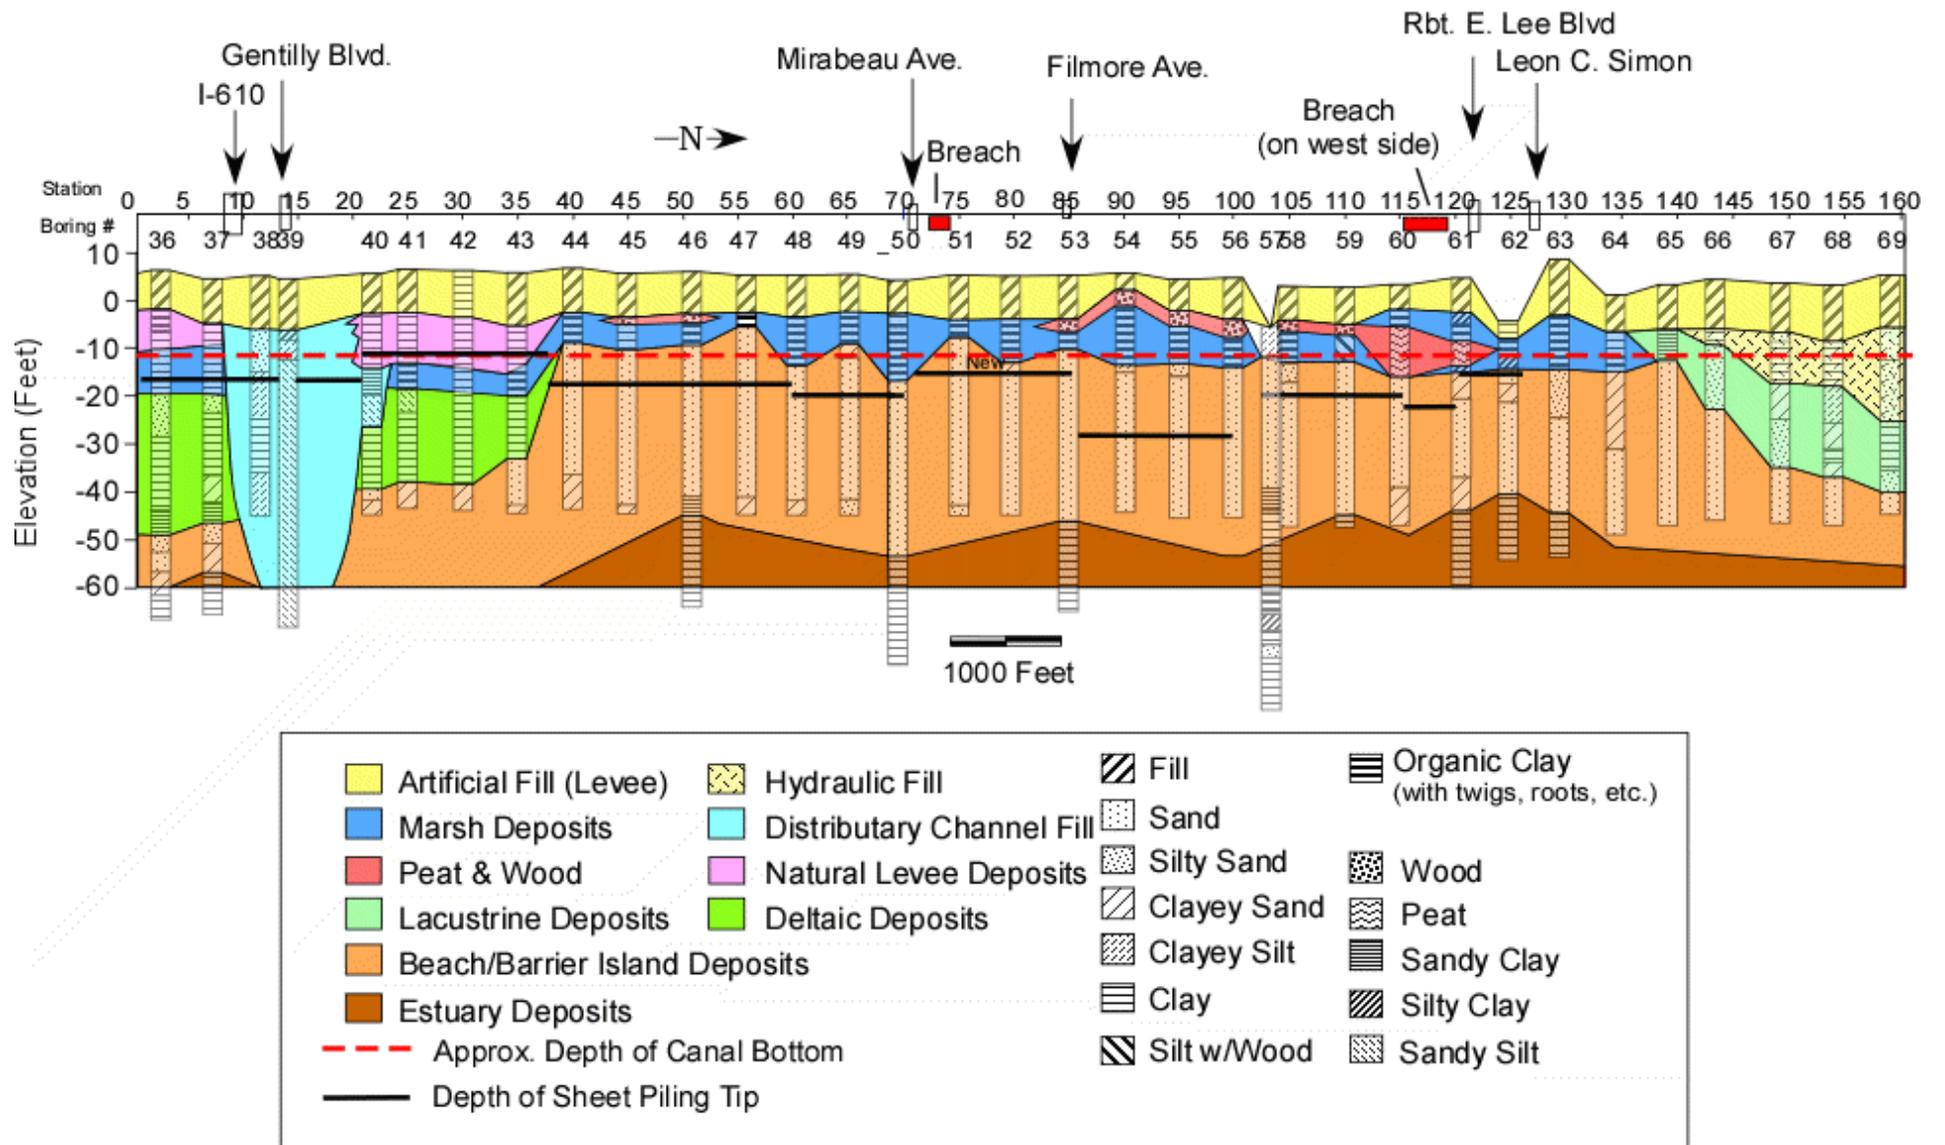
London Avenue Canal - East Side

Sand is a highly permeable material. This means that water can easily be transported between the sand grains, especially when the weight due to overlying water is increased due to the added height of the water column during a storm surge. This increases the pressure and could force the water through the pore spaces in the sand and back up to the surface on the other side of the levee. If enough flow takes place the sand will be picked up by the flowing groundwater and eventually form an underground channel. This could undermine the levee and cause it to collapse. The principle is illustrated in Figure 20 with a simple thought experiment. The underflow (called seepage or siphoning) is the apparent cause of the collapse at this section of the London Ave. Canal. The “As built” design specifications indicate that the sheet pilings (which should form an impermeable barrier to pressure induced flow in the sand) were placed to a depth of 14 feet below sea level (U.S. Army Corps of Engineers, 1994 and IPET web site), one can see from the cross section in Figure 21, that the water still has a path back to the surface if it flows as groundwater beneath the sheet pilings. Note that in order to prevent such siphoning, the sheet pilings would need to be placed to a depth of about 50 feet below sea-level where they would penetrate a layer of clay. Clay, because the individual mineral grains stick together and thus reduce pore space and interconnection between pores, is much more impermeable than is sand.

Figure 19. Geological cross-section along the east side of the London Avenue Canal constructed from data in U.S. Army Corps of Engineers (1989).

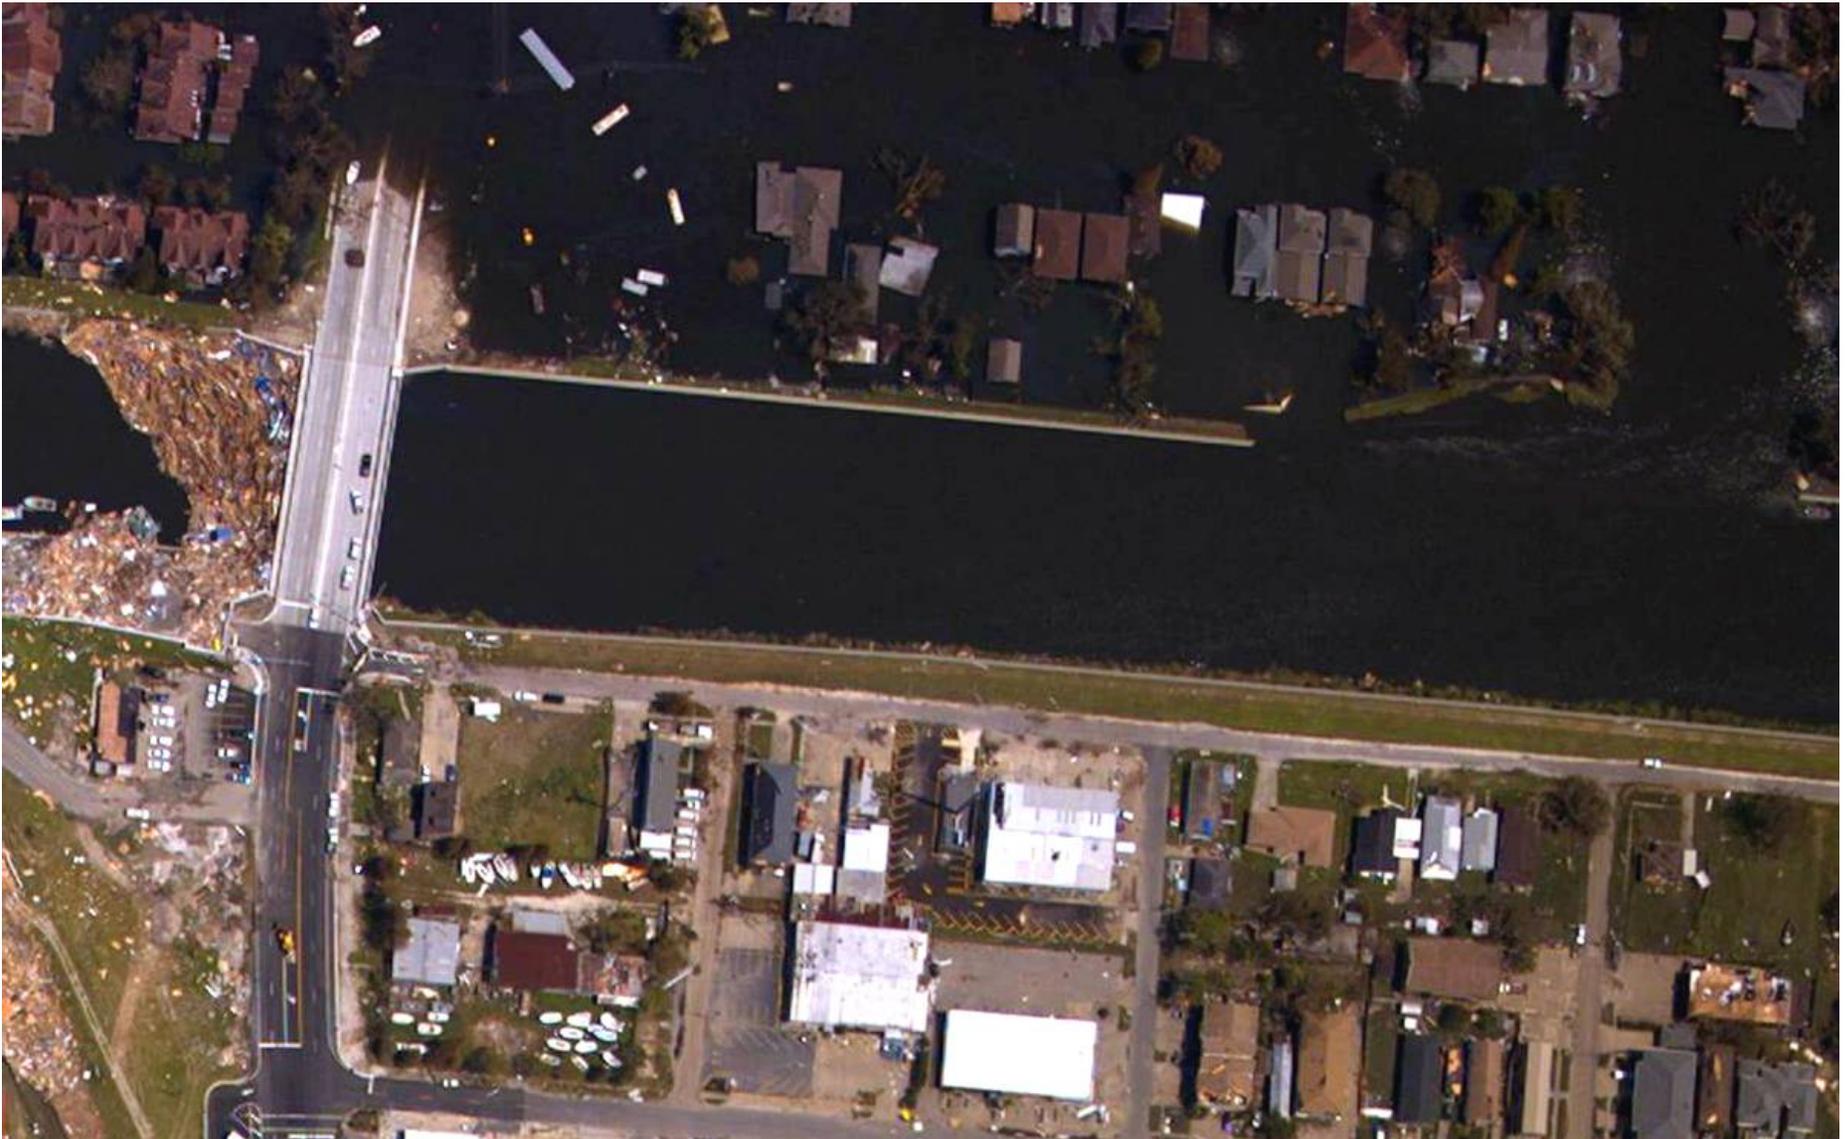
Note that the breach occurred along Belaire Drive where, like the along the London Avenue Canal, houses are backed up against the levee. Here, the main part of the breach occurred in a recently cleared empty lot. A house to the south of the main part of the breach, built on a chain wall foundation, was completely removed (see also the photo in the lower right of Figure 38). Natural gas from a line that fed the house can be seen bubbling up through the floodwater. Another house to the north of the empty lot was built on a slab. The house was destroyed, but the slab remains.

Also visible in Figure 30 is a section of the levee that was displaced eastward by about 45 feet. Figures 31 and 32 show oblique aerial views of this displaced levee and floodwall. The area in front of the displaced levee was pushed horizontally outward near the position of the yellow school bus. This can also be seen in Figure 33 where the toe of the slide block is seen as an abrupt change in slope of the ground surface.

Figure 30. Air photograph of the area where the 17th Street Canal Levee was breached near Belaire Drive (stop 5). Image acquired Aug. 31, 2005. Source: National Oceanic and Atmospheric Administration's National Geodetic Survey, Katrina Images - <http://ngs.woc.noaa.gov/katrina/>

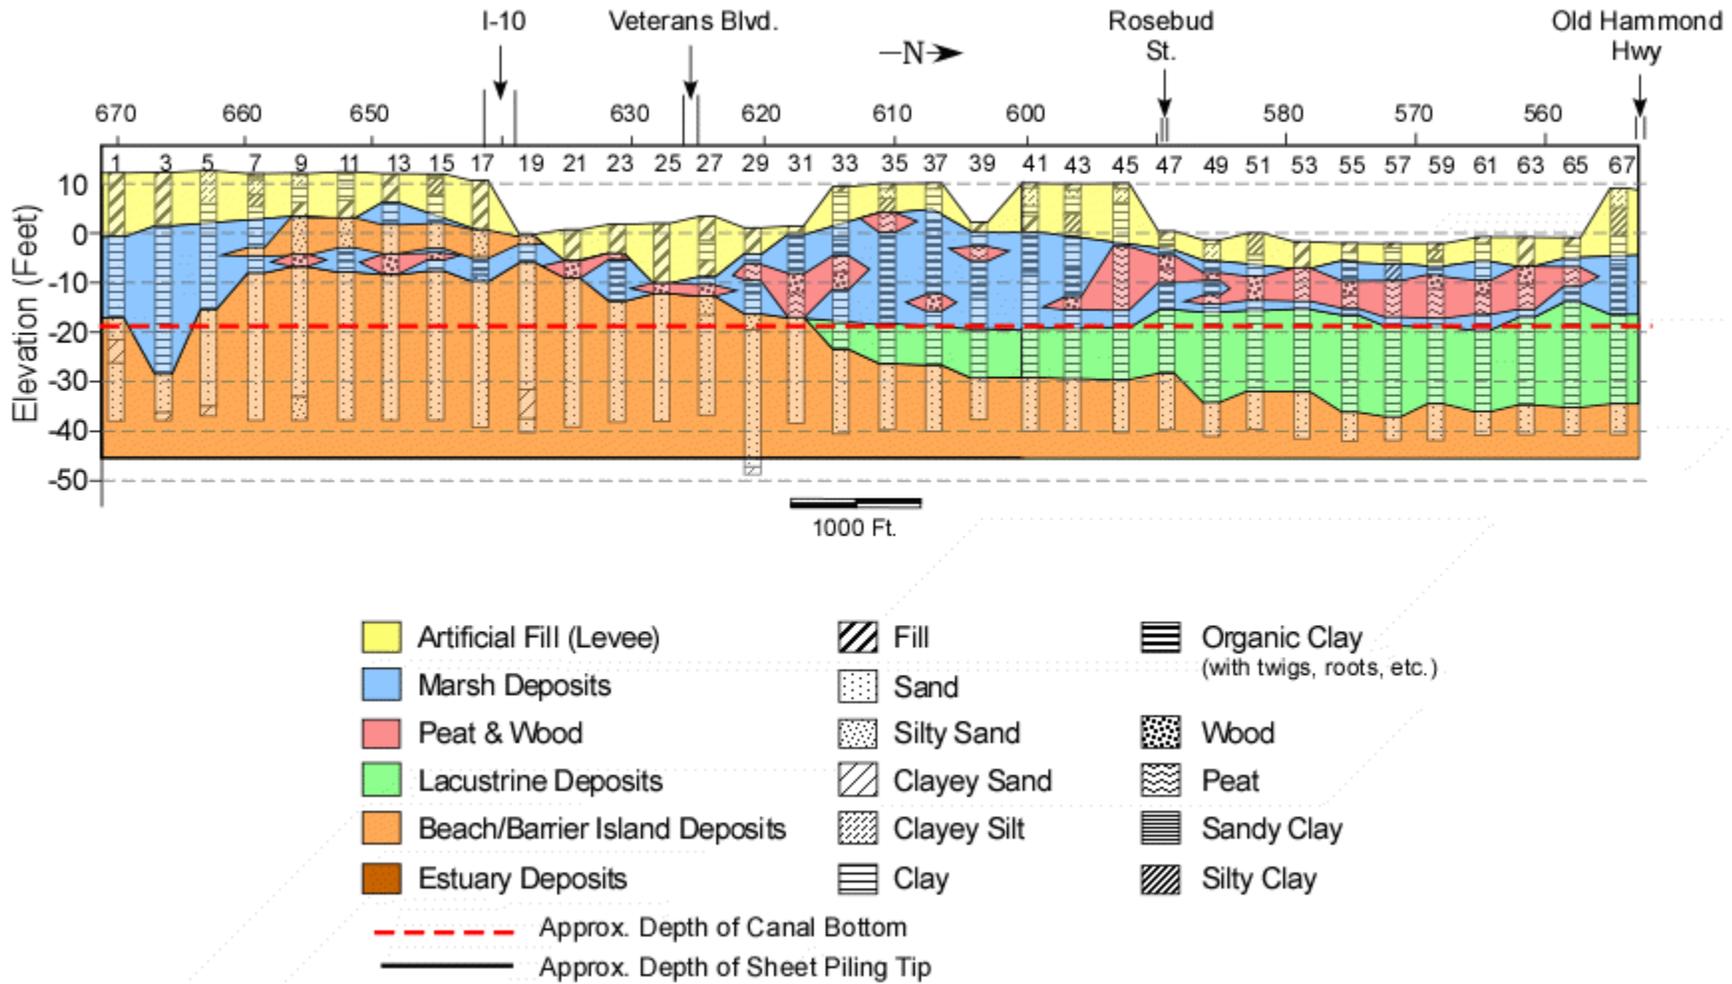
17th St. Canal West Side (Jefferson Parish)

It is notable that the same peat layer and the same levee design and construction are present on the Jefferson Parish side of the canal, which by luck or the path of the storm, did not breach on August 29. Figures 39 shows a geological cross section of the west bank (Jefferson Parish side) of the 17th St. Canal constructed from data provided on the Army Corps of Engineers IPET web site - <https://ipet.wes.army.mil/> where it can be seen that the same geologic materials are present beneath the Jefferson Parish side as are found on the Orleans Parish side (compare with Figure 35).

Figure 39 Geologic cross section of the west bank of the 17th St. Canal constructed from data provided to the U.S. Army Corps of Engineers (1990).

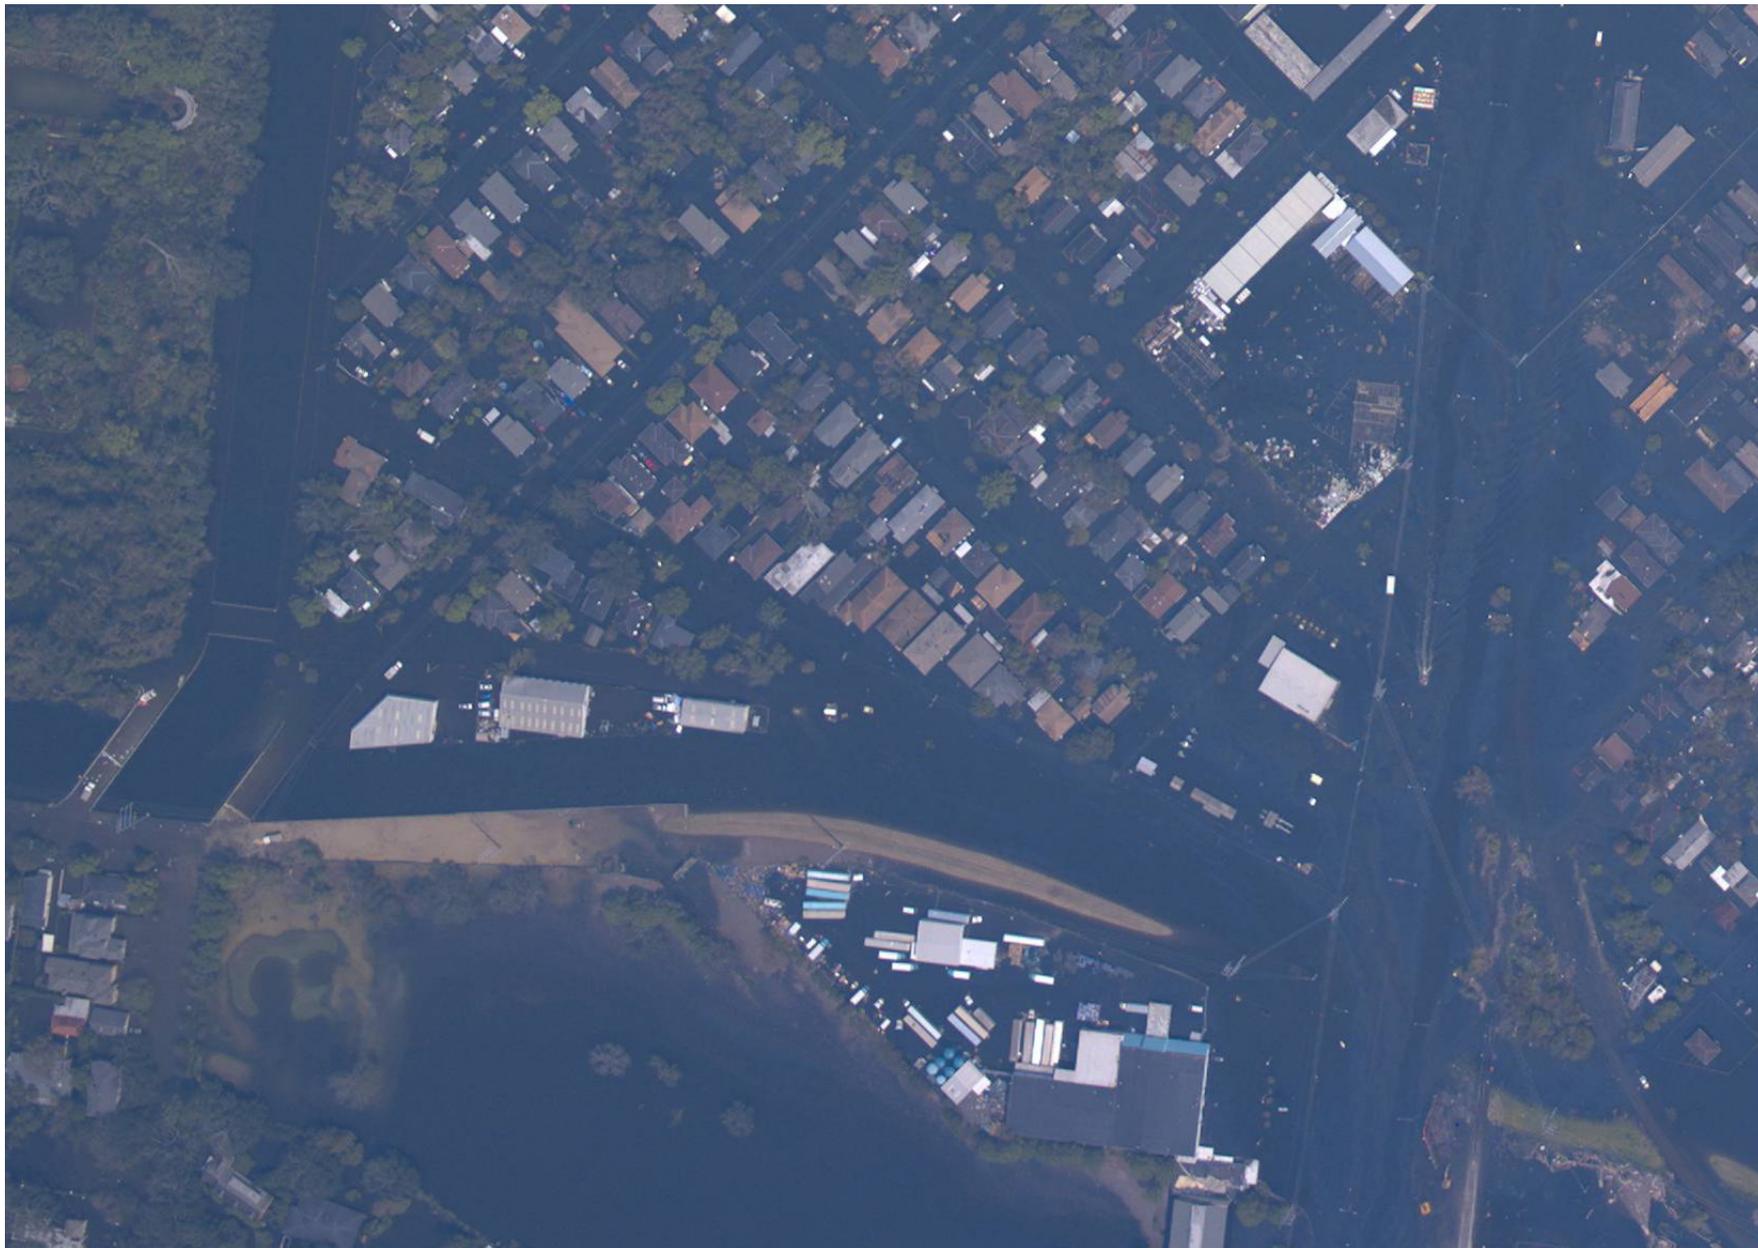
Stop 7 is that the corner of Orpheum Avenue and Northline Street. It is through this area and along Airline Drive south of here, that flood waters from the levee breaches in Orleans Parish reached into Jefferson Parish. The flooding occurred south of the Metairie Road (on the Metairie Ridge) and extended west to Causeway Blvd. and south to near the River. Figure 42 is a Google Earth image of the area at the junction of the Palmetto canal and the 17th St. canal before Katrina and Figure 43 shows approximately the same area on August 31. This area is at the southern end of the 17th St. Canal where the Palmetto Canal brings water from Pump Station #1 on Broad Street (Figure 7) into the 17th St. Canal where it is lifted by Pump Station #6 about 8 feet in elevation and pumped out to the Lake (or through the breach in the 17th St. Canal). The Palmetto Canal has a short floodwall (about 3 feet higher than the roadway). Note in Figure 43, how the floodwalls on the Palmetto Canal are completely covered by water. The two bridges over the 17th St. Canal are barely above water, but it is clear that water flowed over and around these bridges into Old Metairie. It is also clear that Airline Drive, to the south, was a conduit for water to enter Jefferson Parish.

Within a few days after the August 31 image was taken, Jefferson Parish constructed temporary rock and sandbag levees over these two bridges, across Airline Drive, and across Claiborne Ave./Jefferson Highway at the Jefferson/Orleans Parish boundary. These temporary levees were apparently constructed to prevent more flood water originating at the levee breaches in Orleans Parish from further flooding Jefferson Parish. Although the levee breaches in Orleans Parish were mostly stopped by the time the temporary levees at the Parish line were constructed, the damage had already been done. There are, however, reports that once these temporary levees were built, Jefferson Parish started pumping water out of Jefferson and back into Orleans Parish. If true, this would have increased the amount of water over that already standing in Orleans Parish while the levee breaches were being patched and before the pumps in Orleans parish could be started to remove the water from the severely flooded areas.

Figure 43. Air photograph of the area where the water from the 17th Street Canal Levee Breach ran back into Old Metairie, near Orpheum and Palm (stop 6). Image acquired Aug. 31, 2005. Source: National Oceanic and Atmospheric Administration's National Geodetic Survey, Katrina Images - <http://ngs.woc.noaa.gov/katrina/>
