Hurricane Katrina - What Happened?

Tulane University
Field Trip
August 9, 2006

Levee Breaches in New Orleans during Hurricane Katrina

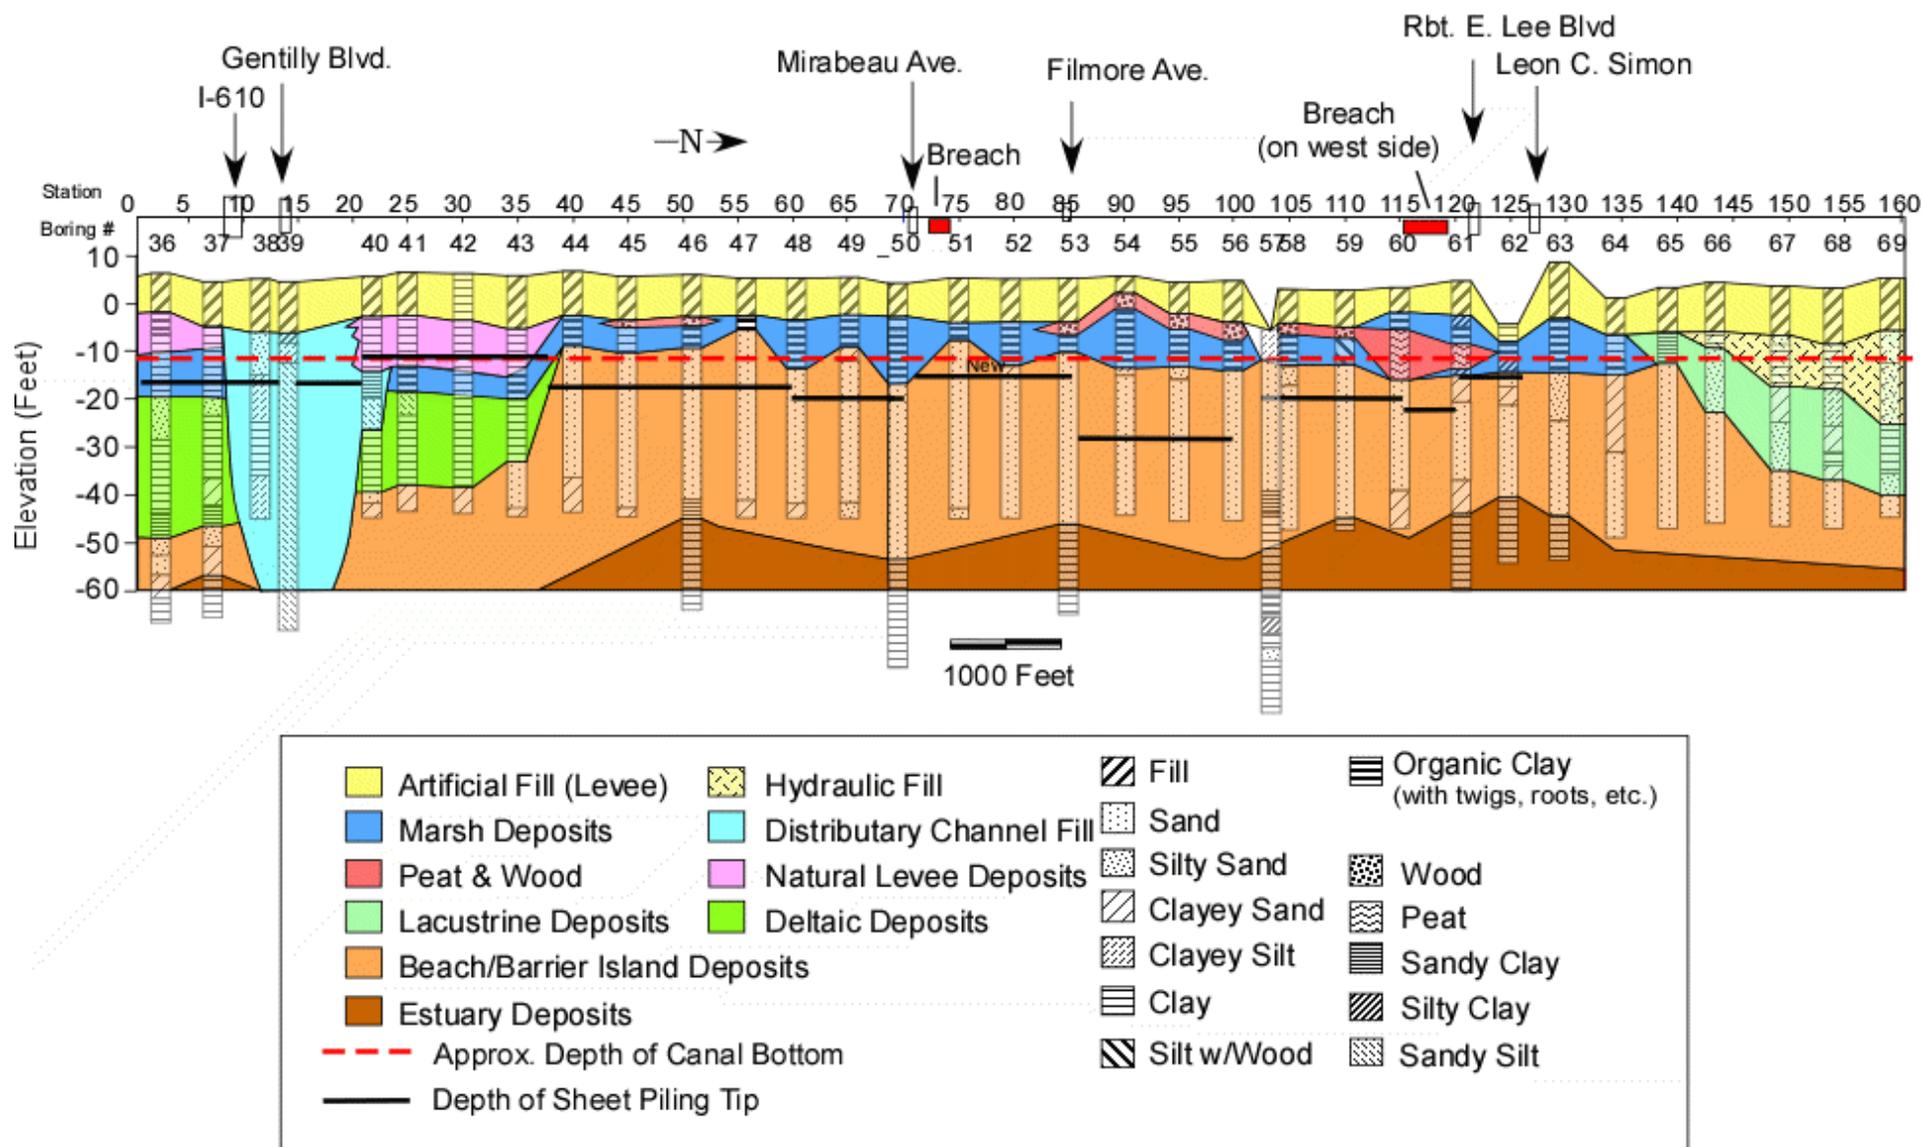
Figure 19. Geological cross-section along the east side of the London Avenue Canal constructed from data in U.S. Army Corps of Engineers (1989).

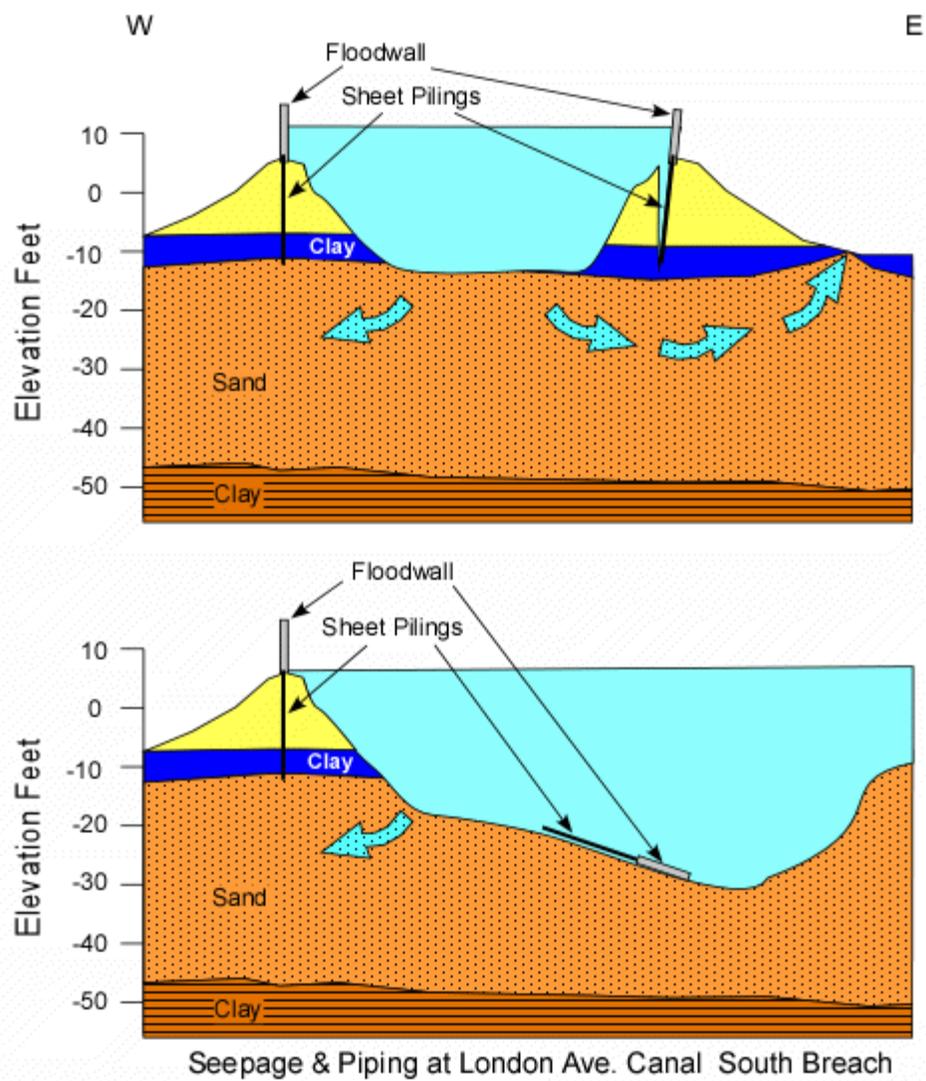
Sand is a highly permeable material. This means that water can easily be transported between the sand grains, especially when the weight due to overlying water is increased due to the added height of the water column during a storm surge. This increases the pressure and could force the water through the pore spaces in the sand and back up to the surface on the other side of the levee. If enough flow takes place the sand will be picked up by the flowing groundwater and eventually form an underground channel. This could undermine the levee and cause it to collapse. The principle is illustrated in Figure 20 with a simple thought experiment. The underflow (called seepage or siphoning) is the apparent cause of the collapse at this section of the London Ave. Canal. The "As built" design specifications indicate that the sheet pilings (which should form an impermeable barrier to pressure induced flow in the sand) were placed to a depth of 14 feet below sea level (U.S. Army Corps of Engineers, 1994), one can see from the cross section in Figure 21, that the water still has a path back to the surface if it flows as groundwater beneath the sheet pilings. Note that in order to prevent such siphoning, the sheet pilings would need to be placed to a depth of about 50 feet below sea-level where they would penetrate a layer of clay. Clay, because the individual mineral grains stick together and thus reduce pore space and interconnection between pores, is much more impermeable than is sand.

Figure 21. Geological cross section across the London Ave. Canal based on borings 16 and 51 (Figs. 19 and 26), shown at time of estimated high water during Katrina's storm surge. The sands form a permeable layer through which groundwater originating in the canal can penetrate and move below the sheet piling and up to the surface (top diagram), eventually undermining the levee and causing a blowout completely removing a section of levee and carrying sand into the neighborhood.

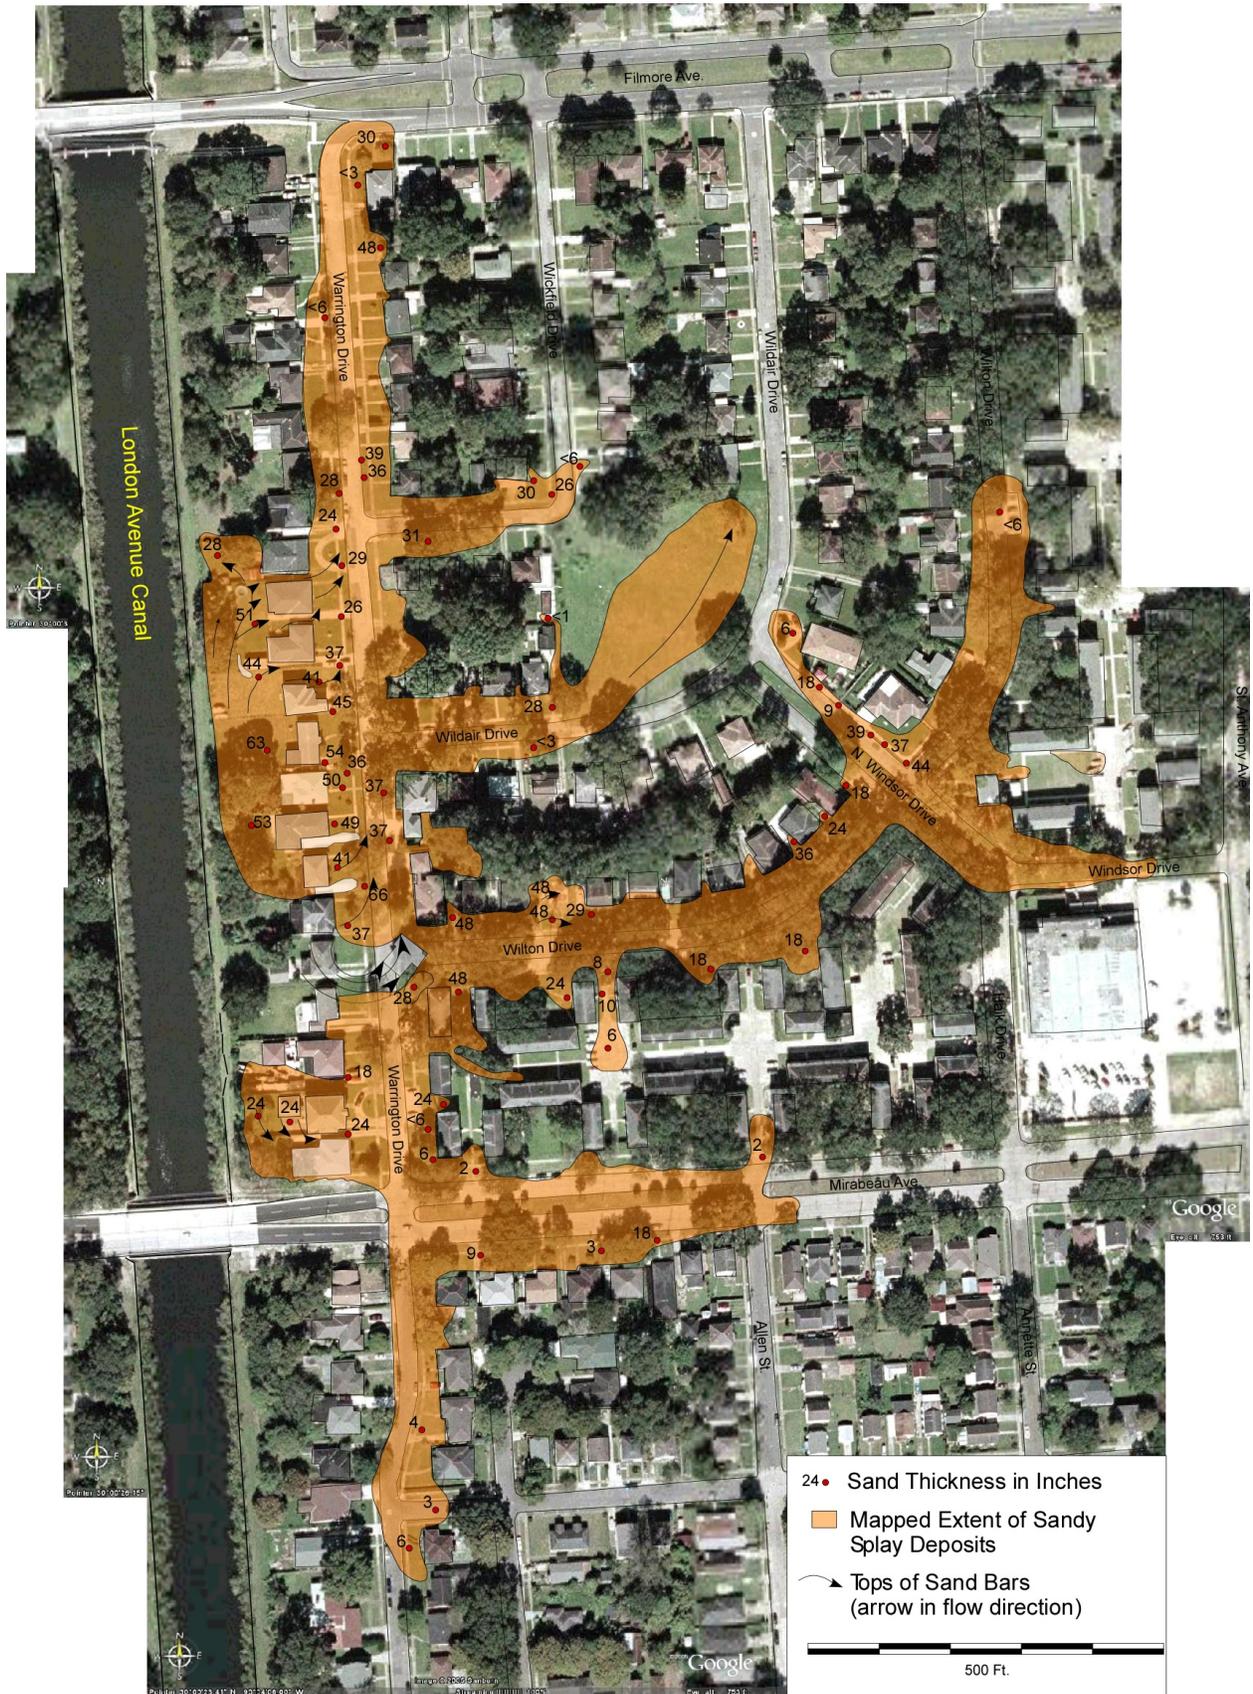
Figure 22 is a view looking down Warrington Drive before the sand deposits were removed in mid-February, 2006. Figure 23 shows our preliminary map of the extent of the sand that scoured from the bottom of the London Ave. Canal and the blowout hole beneath the levee and deposited throughout the neighborhood. The distribution and thickness of the actual deposit was controlled by current velocity and barriers such as houses, fences, and hedges. For more information on the sand deposits at this locality, see Nelson and Leclair (2006).

Our estimate of the volume of sand deposited in the neighborhood is about 932,000 ft³. Such a volume would cover a football field, from end to end (including the end zones) with over 16 feet of sand. Engineers working on the breach repair have reported that they had to dig to a depth of 30 feet below sea level to completely remove gravel and sand bags used to plug the breach in the first few days after Katrina. A conservative estimate of the volume of this hole is about 330,000 ft³. This only accounts for about 35% of the volume of sand found in the neighborhood, and implies that the canal bottom, both upstream and downstream from the breach, was scoured to an unknown depth. This raises questions about the stability of the levee/floodwall system outside the breach area if the canal bottom is now in permeable sand in these areas.

Figure 23. Preliminary map of sand deposits (by S. A. Nelson) from the Mirabeau Ave. Breach on the London Ave. Canal. Underlying image is a composite from Google Earth.

The repair operation is only taking place in the area of the breach. The operation has involved digging out the material used in the initial emergency repair, filling it with clay and constructing a T-wall to replace the missing I-wall. Fortunately, the Corps of Engineers is now completing removable floodgates near the mouths of the London Ave, Orleans, and 17th St. canals near Lake Pontchartrain. These floodgates will be closed in the event of a hurricane and should prevent storm surge from reaching onto the floodwalls in the canals. If the gates are closed, however, the pumps at the southern end of the canals cannot be used to pump rainwater out of the city. Thus, the Corps is in the process of building pumping stations at the Lake (where they should have been built in the first place), but full pumping capacity will not be available for the 2006 hurricane season. Still rainwater flooding is better than having Lake Pontchartrain drain into the city.

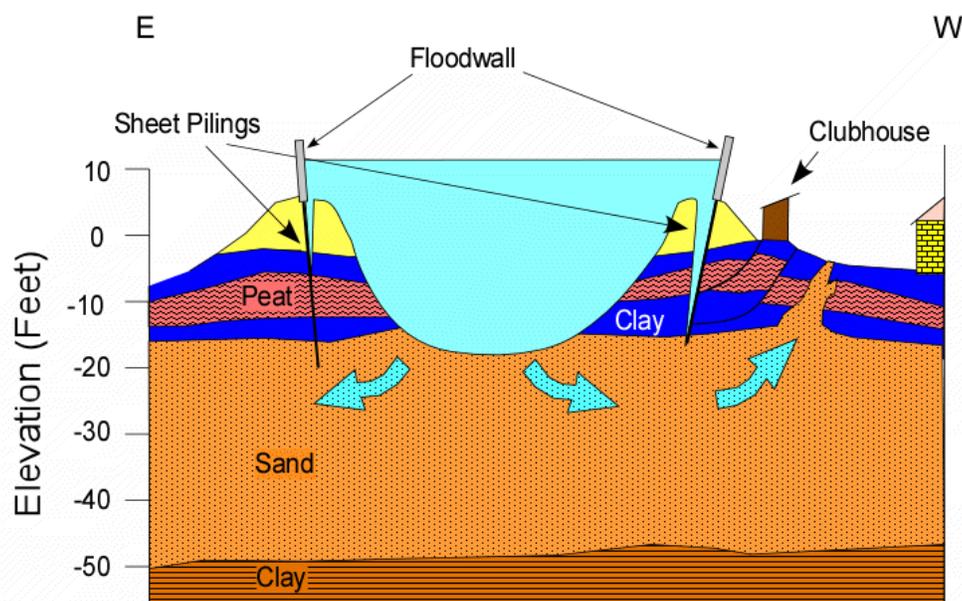
Heaving at London Ave. Canal North Breach

Figure 28. Water in the canal at the north breach of the London Ave. Canal puts lateral pressure on the floodwall and sheet piling along with water driven through sand under the sheet pilings (and possibly through peat, depending on the depth to which the sheet pilings actually were driven) pushes up the ground outside of the canal in a phenomenon known as heave. This could eventually provide a flow path for water which would undermine the levee and cause its collapse. This may have responsible for the eventual collapse of the floodwall on the west side of the canal resulting in the breach. The floodwall on the east side of the canal was distressed, but did not breach.

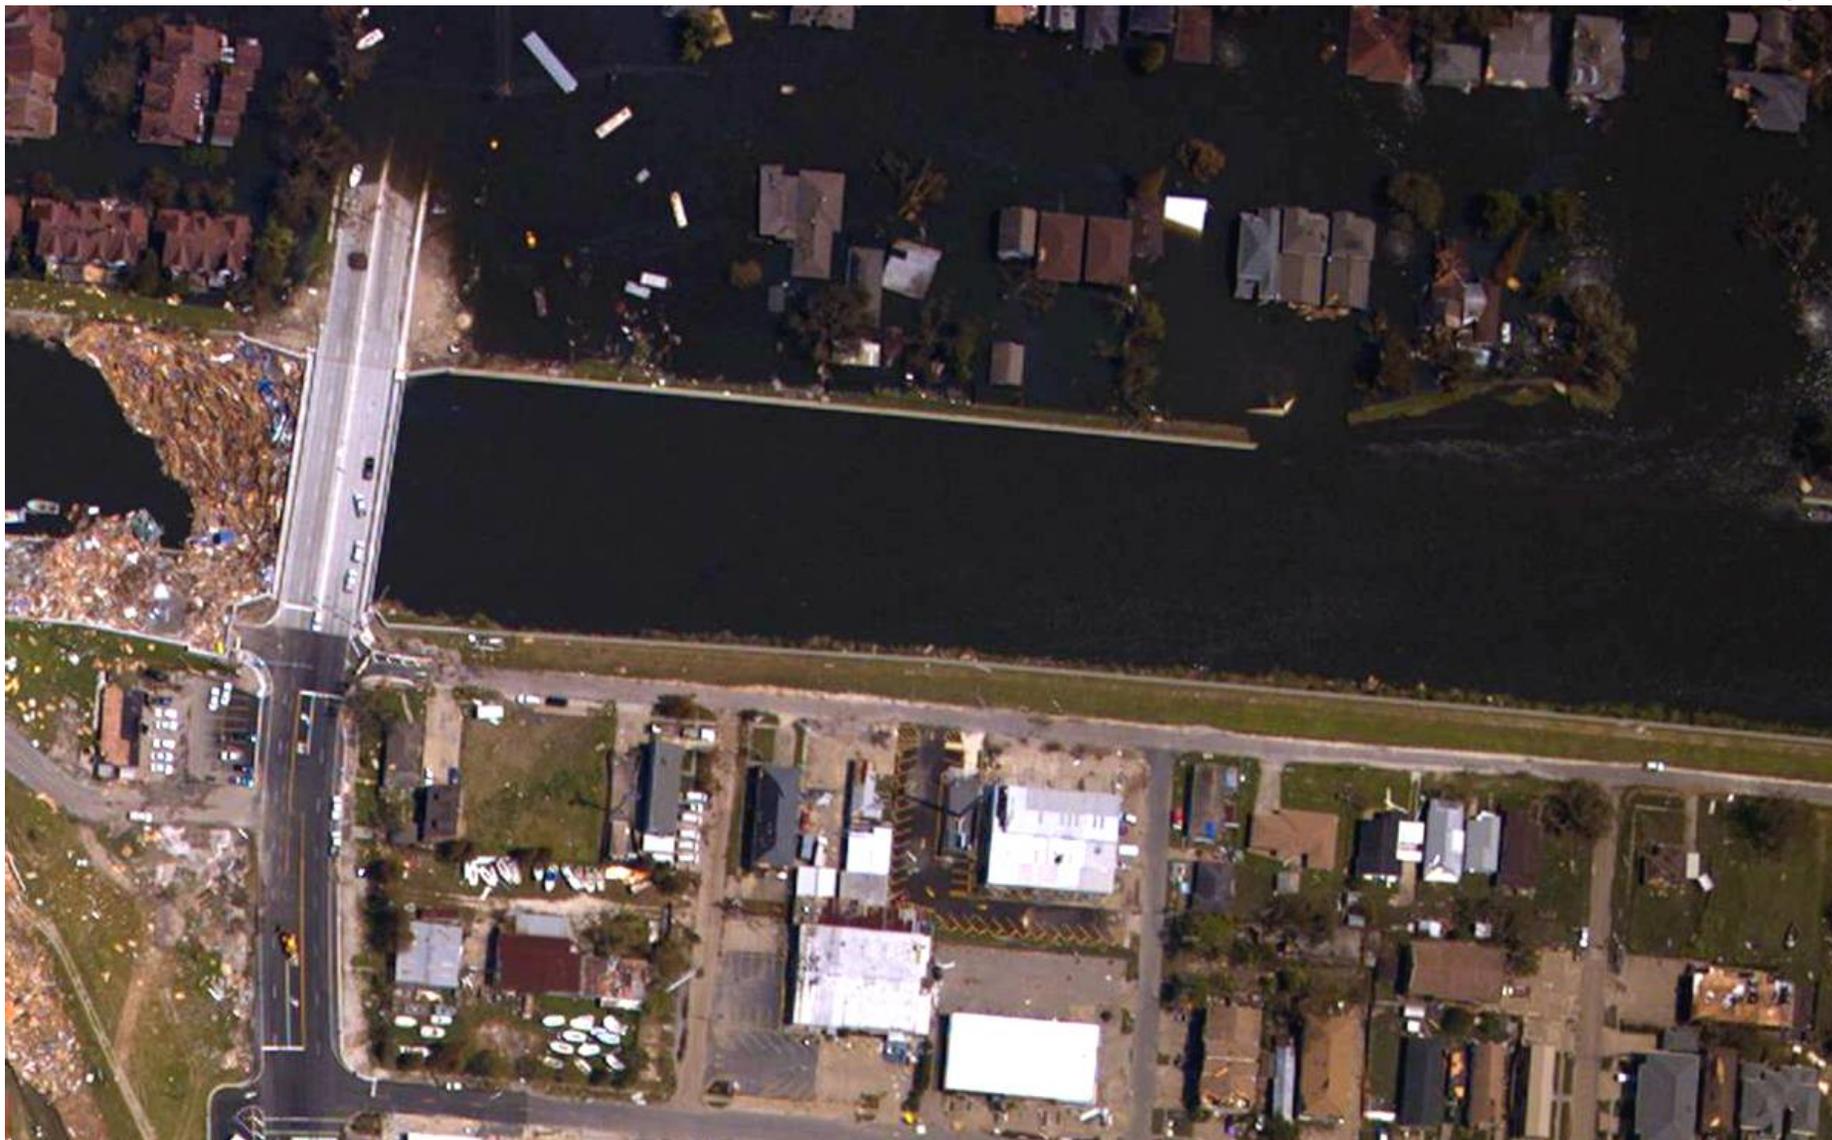
Note that the breach occurred along Belaire Drive where, like the along the London Avenue Canal, houses are backed up against the levee. Here, the main part of the breach occurred in a recently cleared empty lot. A house to the south of the main part of the breach, built on a chain wall foundation, was completely removed (see also the photo in the lower right of Figure 38). Natural gas from a line that fed the house can be seen bubbling up through the floodwater. Another house to the north of the empty lot was built on a slab. The house was destroyed, but the slab remains.

Also visible in Figure 30 is a section of the levee that was displaced eastward by about 45 feet. Figures 31 and 32 show oblique aerial views of this displaced levee and floodwall. The area in front of the displaced levee was pushed horizontally outward near the position of the yellow school bus. This can also be seen in Figure 33 where the toe of the slide block is seen as an abrupt change in slope of the ground surface.

Figure 30. Air photograph of the area where the 17th Street Canal Levee was breached near Belaire Drive (stop 5). Image acquired Aug. 31, 2005. Source: National Oceanic and Atmospheric Administration's National Geodetic Survey, Katrina Images - <http://ngs.woc.noaa.gov/katrina/>

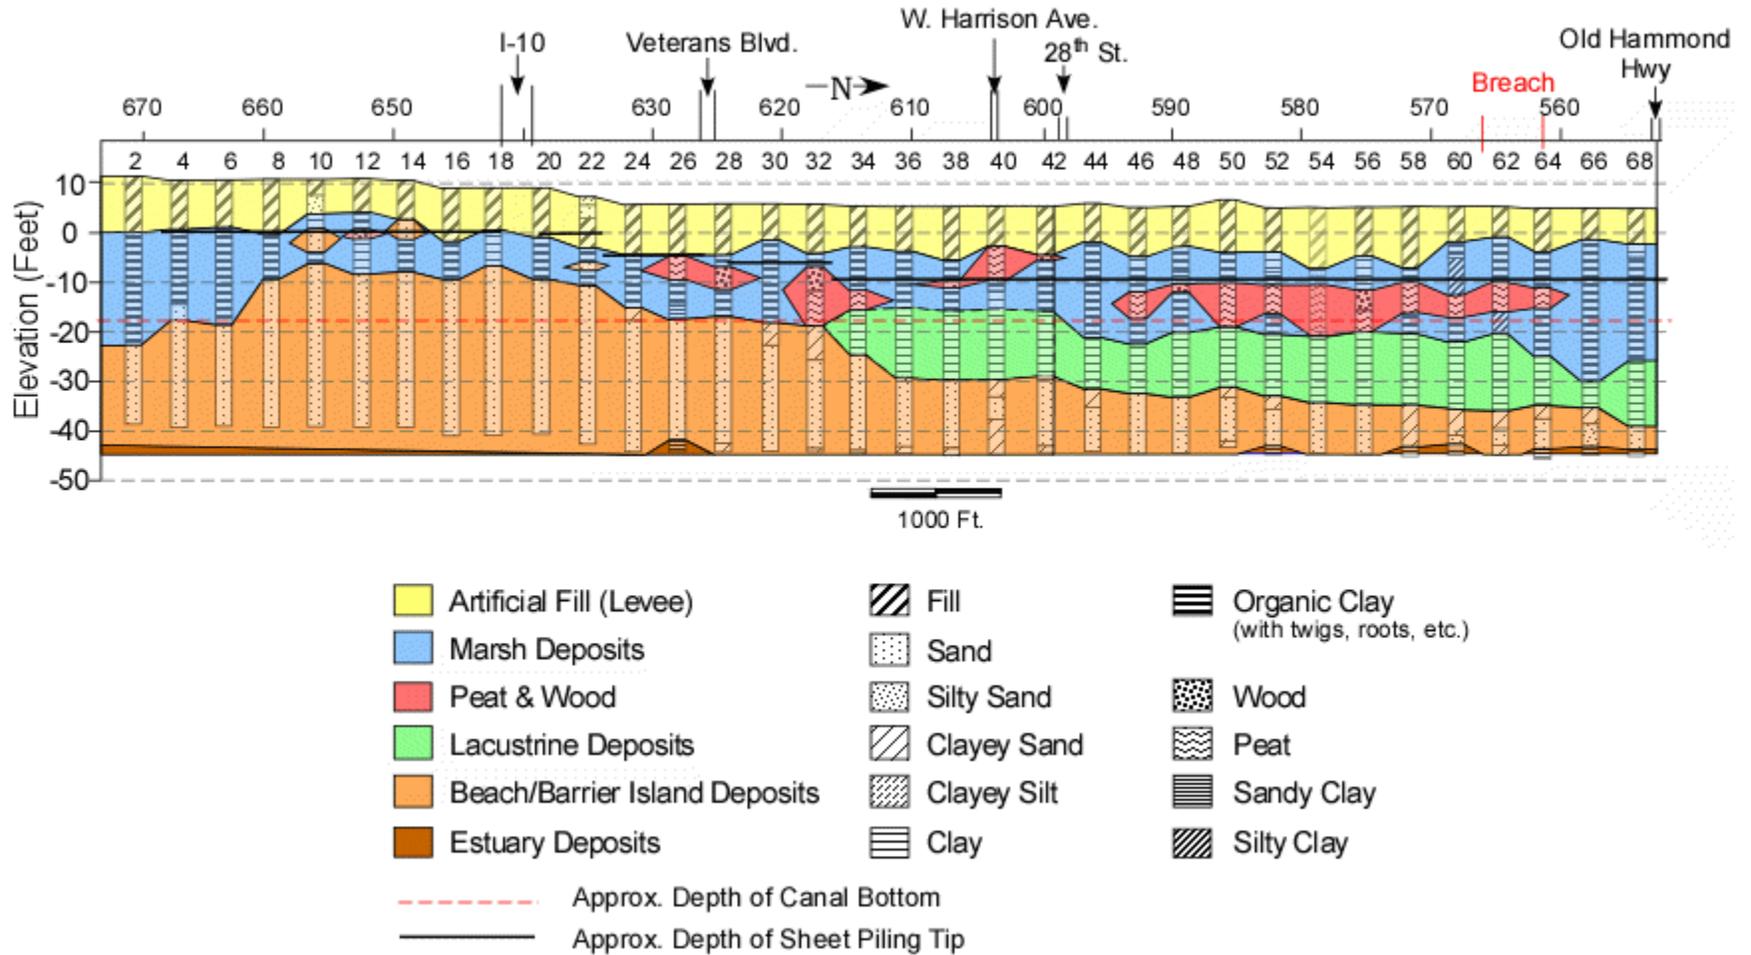
17th St. Canal East Side (Orleans Parish)

Figure 35 shows a geological cross section along the levee of the 17th street canal. The most notable feature of the cross section is the peat layer observed at depths between about 8 and 15 feet below sea level in the area of and to the south of the breach.

Figure 35. Geological cross-section along the eastern side of the 17th St. Canal (based on data in the U.S. Army Corps of Engineers design documents (1990). Notable in the cross-section is the peat layer that occurs in the area of the breach.

In years prior to Katrina, seepage through the levee was noted by residents along the 17th St. Canal, a clear sign of potential problems, but was never pursued (Marshall, November 18, 2005). Furthermore, the annual inspections of the levees is now seen to have been a ceremonial gathering rather than a detailed inspection (Marshall, December 5, 2005).

The most recent information from the Interagency Performance Evaluation Task Force (IPET) [2006] suggests that the floodwall and levee failed at the 17th St. Canal as a result of water level rising to an elevation of about 8 feet above sea level in the canal. The floodwalls were designed to have tops at an elevation of 14 feet above sea level, but IPET data indicate that by the time of Katrina the tops of the floodwalls on the 17th Street Canal were about 12.5 feet above sea level. Thus, IPET estimates that water levels in the canal were still 4 feet below the tops. IPET has collected eyewitness accounts and scoured the neighborhood for clocks that were stopped as a result of the flooding in order to determine the time of the breach. One eyewitness account suggests that the floodwall at the breach area was leaning to the protected side at about 6:30 AM on August 29 and other accounts suggest that the breach was open by about 9:00 AM. This, along with levee breach experiments conducted on scale models in a large centrifuge led IPET to suggest that as water levels rose in the canal, the floodwall and sheet piling was pushed outward toward the land side, opening a gap between the levee and the floodwall on the canal side. This gap allowed water to seep down along the sheet piling and eventually push the levee on the protected side outward away from the canal. Based on sections of the breached levee observed in the breach area, IPET suggests that the failure did not occur along the peat layer, but along a layer of weak clay at the base of the peat. This clay layer was thrust over and through the peat as illustrated in Figure 36.

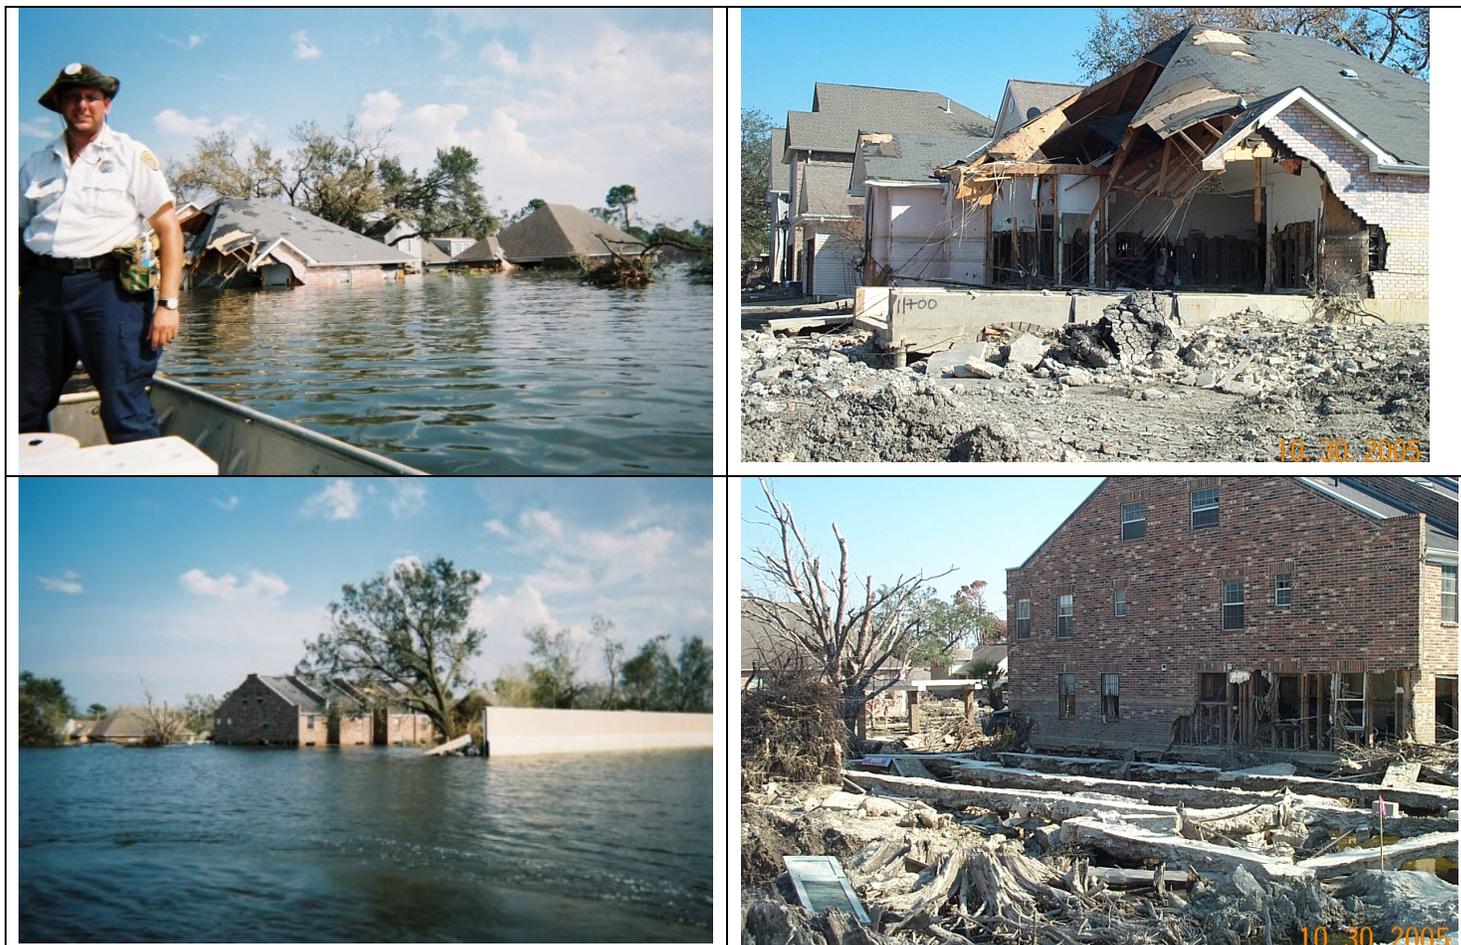
Figure 38. Comparison of water levels on Sept.1, 2005 (photos on left by Kevin Himmel), with water lines on same structures indicate lines left by standing water are about 1.5 to 2 feet lower than the maximum water level. Note large block of peat in photo at the upper right. In photo at lower right, note the chainwall foundation of a house that was removed by the burst of water when the levee was breached and the cypress stump from a tree that was probably cut down 100 years ago when this Lakeview neighborhood was reclaimed from the cypress swamp.

Although throughout the field trip we have seen the water line (scum line) left by standing water, this line does not represent the maximum flood depth. As seen in Figure 38, comparison of the photos on the left, taken when the water level was near its maximum with the water line left on the same structures (photos on the right) indicate that the maximum flood depth was about 1.5 to 2 feet higher than the line left by standing water.

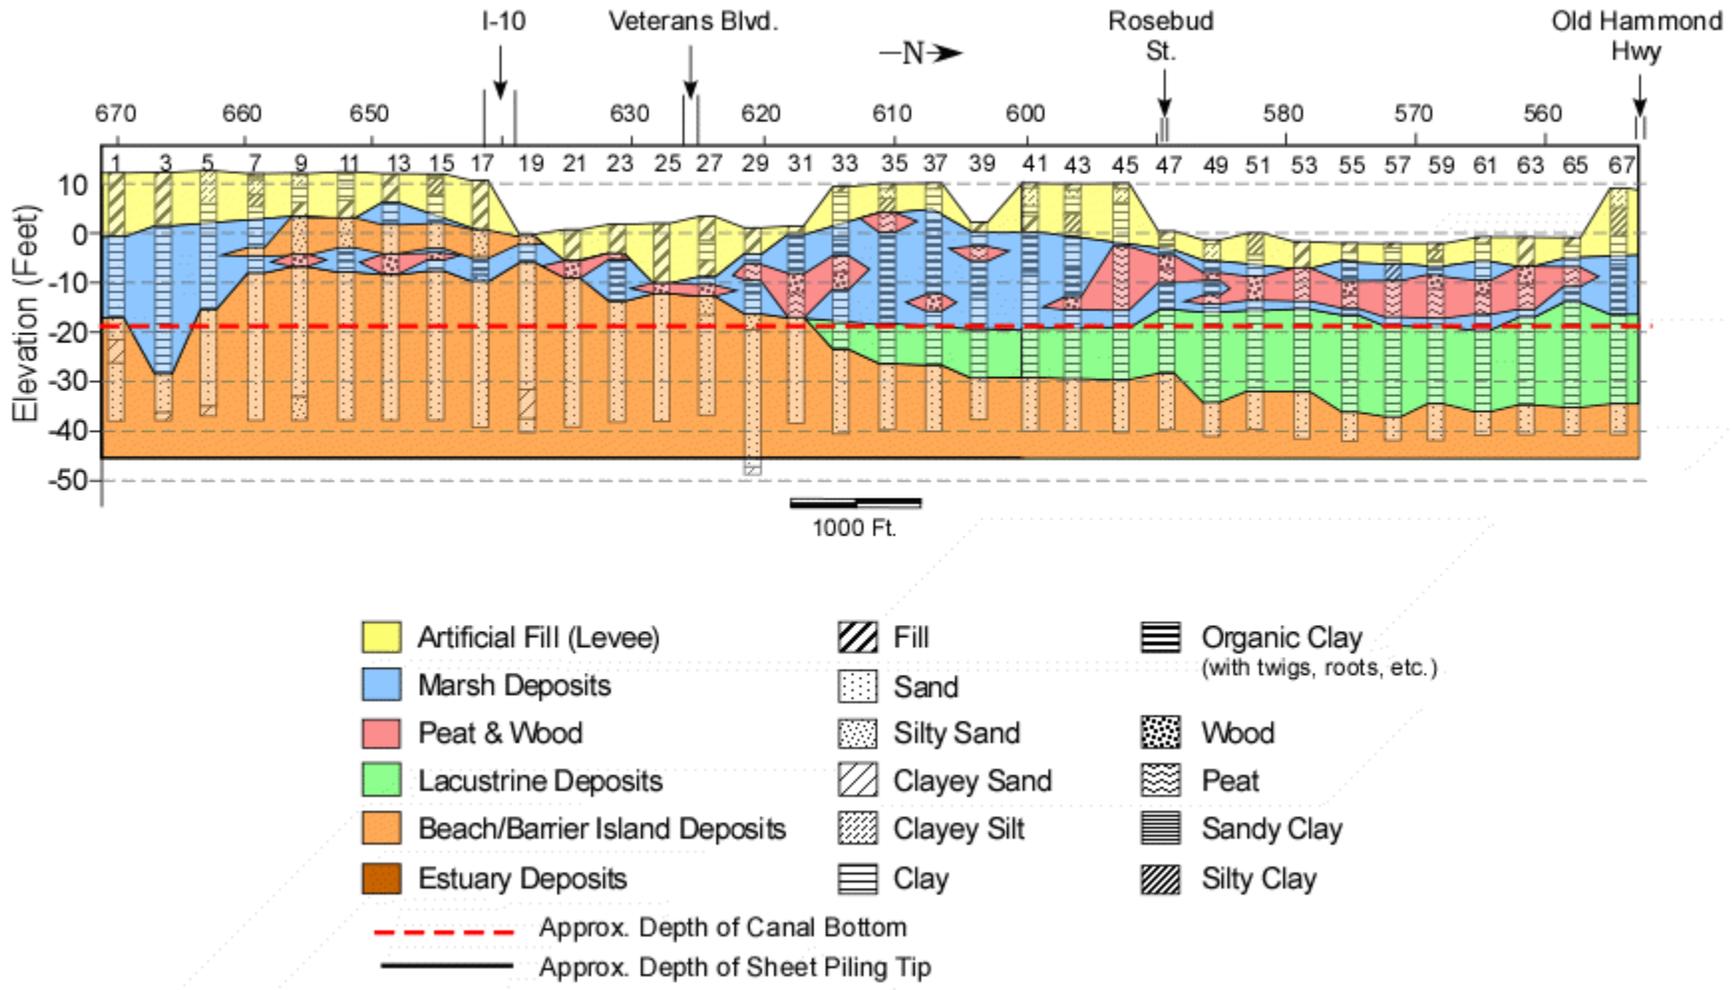
17th St. Canal West Side (Jefferson Parish)

It is notable that the same peat layer and the same levee design and construction are present on the Jefferson Parish side of the canal, which by luck or the path of the storm, did not breach on August 29. Figures 39 shows a geological cross section of the west bank (Jefferson Parish side) of the 17th St. Canal constructed from data provided on the Army Corps of Engineers IPET web site - <https://ipet.wes.army.mil/> where it can be seen that the same geologic materials are present beneath the Jefferson Parish side as are found on the Orleans Parish side (compare with Figure 35). One major difference on the Jefferson Parish side is that a street occupies the area next to the levee and there are no trees, houses or swimming pools abutting the levee on that side.

Figure 39 Geologic cross section of the west bank of the 17th St. Canal constructed from data provided to the U.S. Army Corps of Engineers (1990).

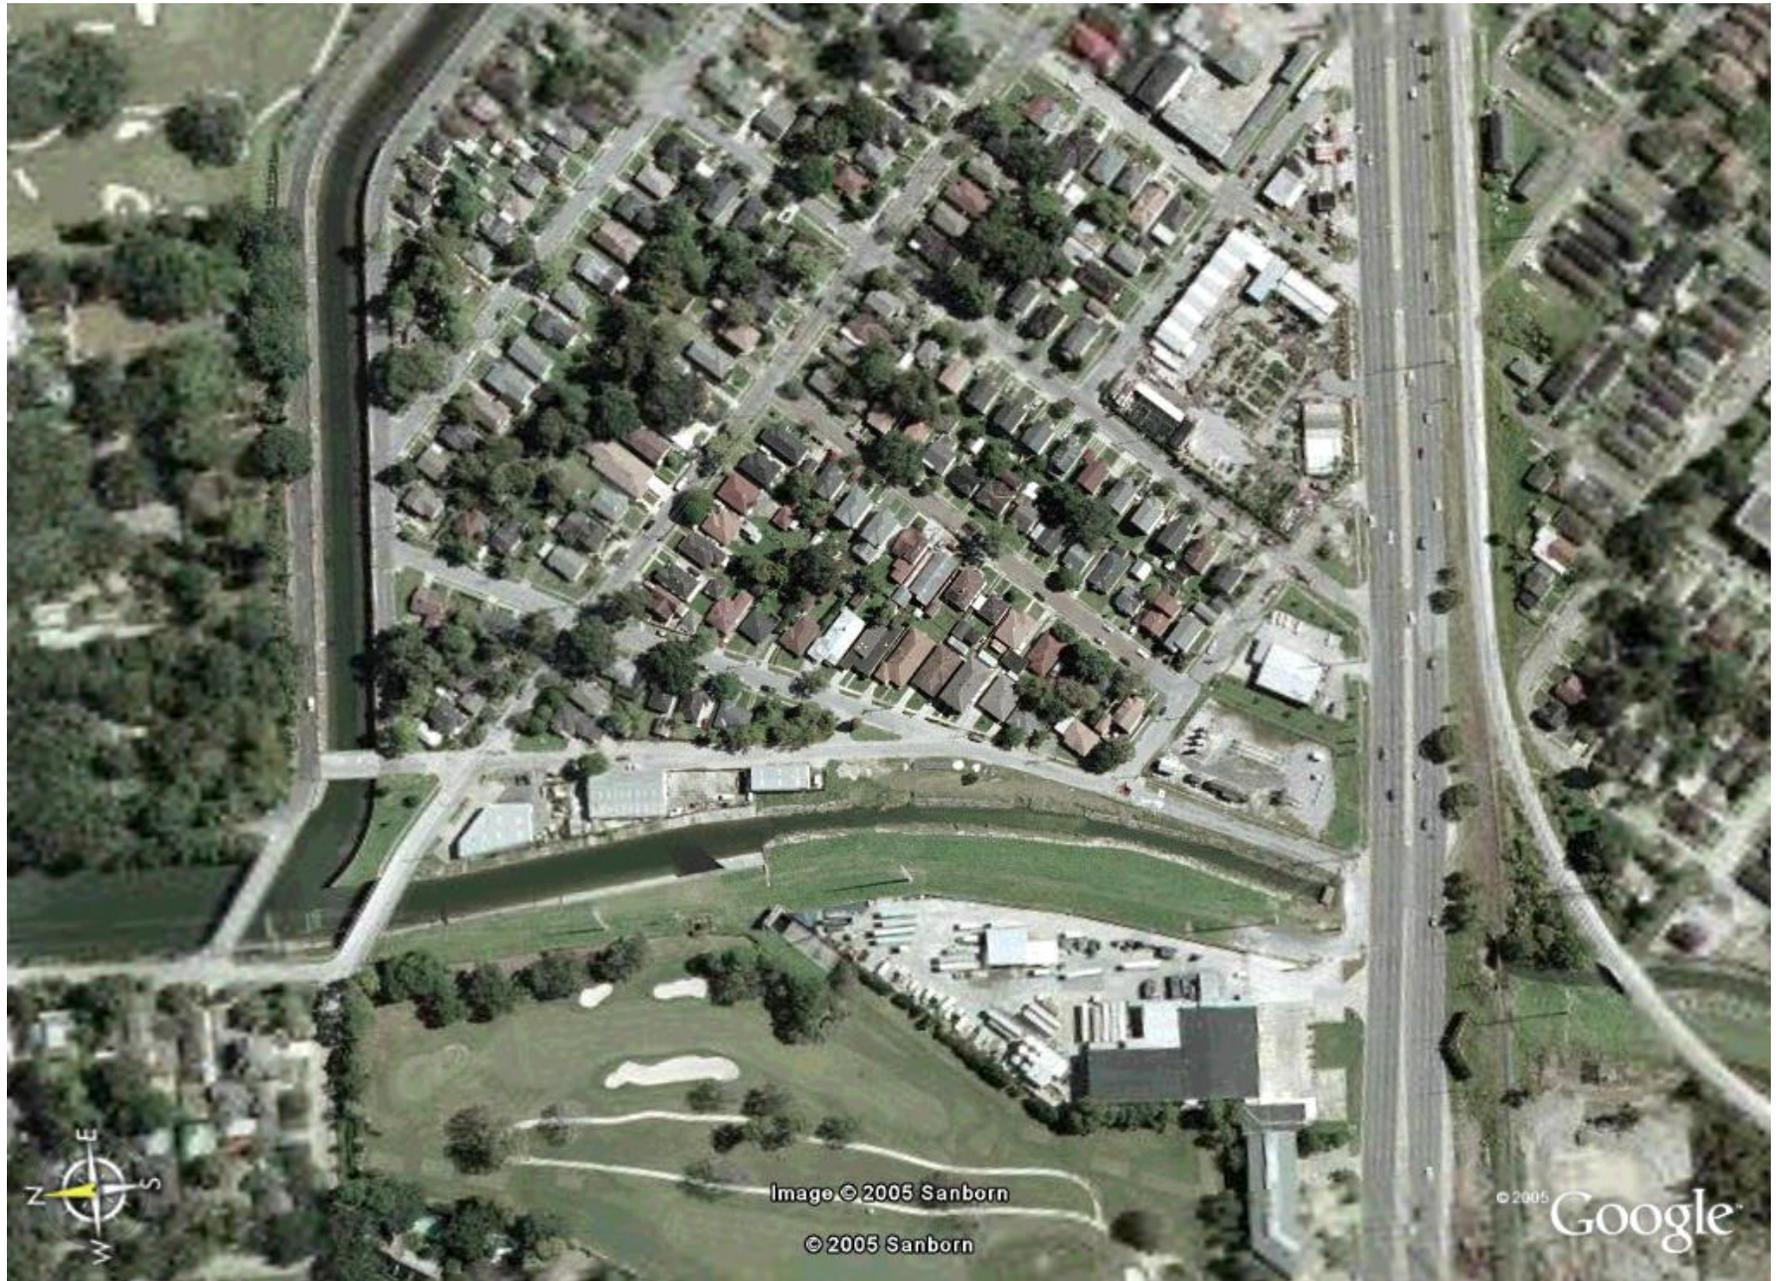
Stop 7 is that the corner of Orpheum Avenue and Northline Street. It is through this area and along Airline Drive south of here, that flood waters from the levee breaches in Orleans Parish reached into Jefferson Parish. The flooding occurred south of the Metairie Road (on the Metairie Ridge) and extended west to Causeway Blvd. and south to near the River. Figure 42 is a Google Earth image of the area at the junction of the Palmetto canal and the 17th St. canal before Katrina and Figure 43 shows approximately the same area on August 31. This area is at the southern end of the 17th St. Canal where the Palmetto Canal brings water from Pump Station #1 on Broad Street (Figure 7) into the 17th St. Canal where it is lifted by Pump Station #6 about 8 feet in elevation and pumped out to the Lake (or through the breach in the 17th St. Canal). The Palmetto Canal has a short floodwall (about 3 feet higher than the roadway). Note in Figure 43, how the floodwalls on the Palmetto Canal are completely covered by water. The two bridges over the 17th St. Canal are barely above water, but it is clear that water flowed over and around these bridges into Old Metairie. It is also clear that Airline Drive, to the south, was a conduit for water to enter Jefferson Parish.

Figure 42. Satellite image of the area near the southern end of the 17th Street Canal near Old Metairie where water would enter Jefferson Parish from levee breaches in Orleans Parish during Hurricane Katrina (Stop 7). (Source - Google Earth)

Within a few days after the August 31 image was taken, Jefferson Parish constructed temporary rock and sandbag levees over these two bridges, across Airline Drive, and across Claiborne Ave./Jefferson Highway at the Jefferson/Orleans Parish boundary. These temporary levees were apparently constructed to prevent more flood water originating at the levee breaches in Orleans Parish from further flooding Jefferson Parish. Although the levee breaches in Orleans Parish were mostly stopped by the time the temporary levees at the Parish line were constructed, the damage had already been done. There are, however, reports that once these temporary levees were built, Jefferson Parish started pumping water out of Jefferson and back into Orleans Parish. If true, this would have increased the amount of water over that already standing in Orleans Parish while the levee breaches were being patched and before the pumps in Orleans parish could be started to remove the water from the severely flooded areas.

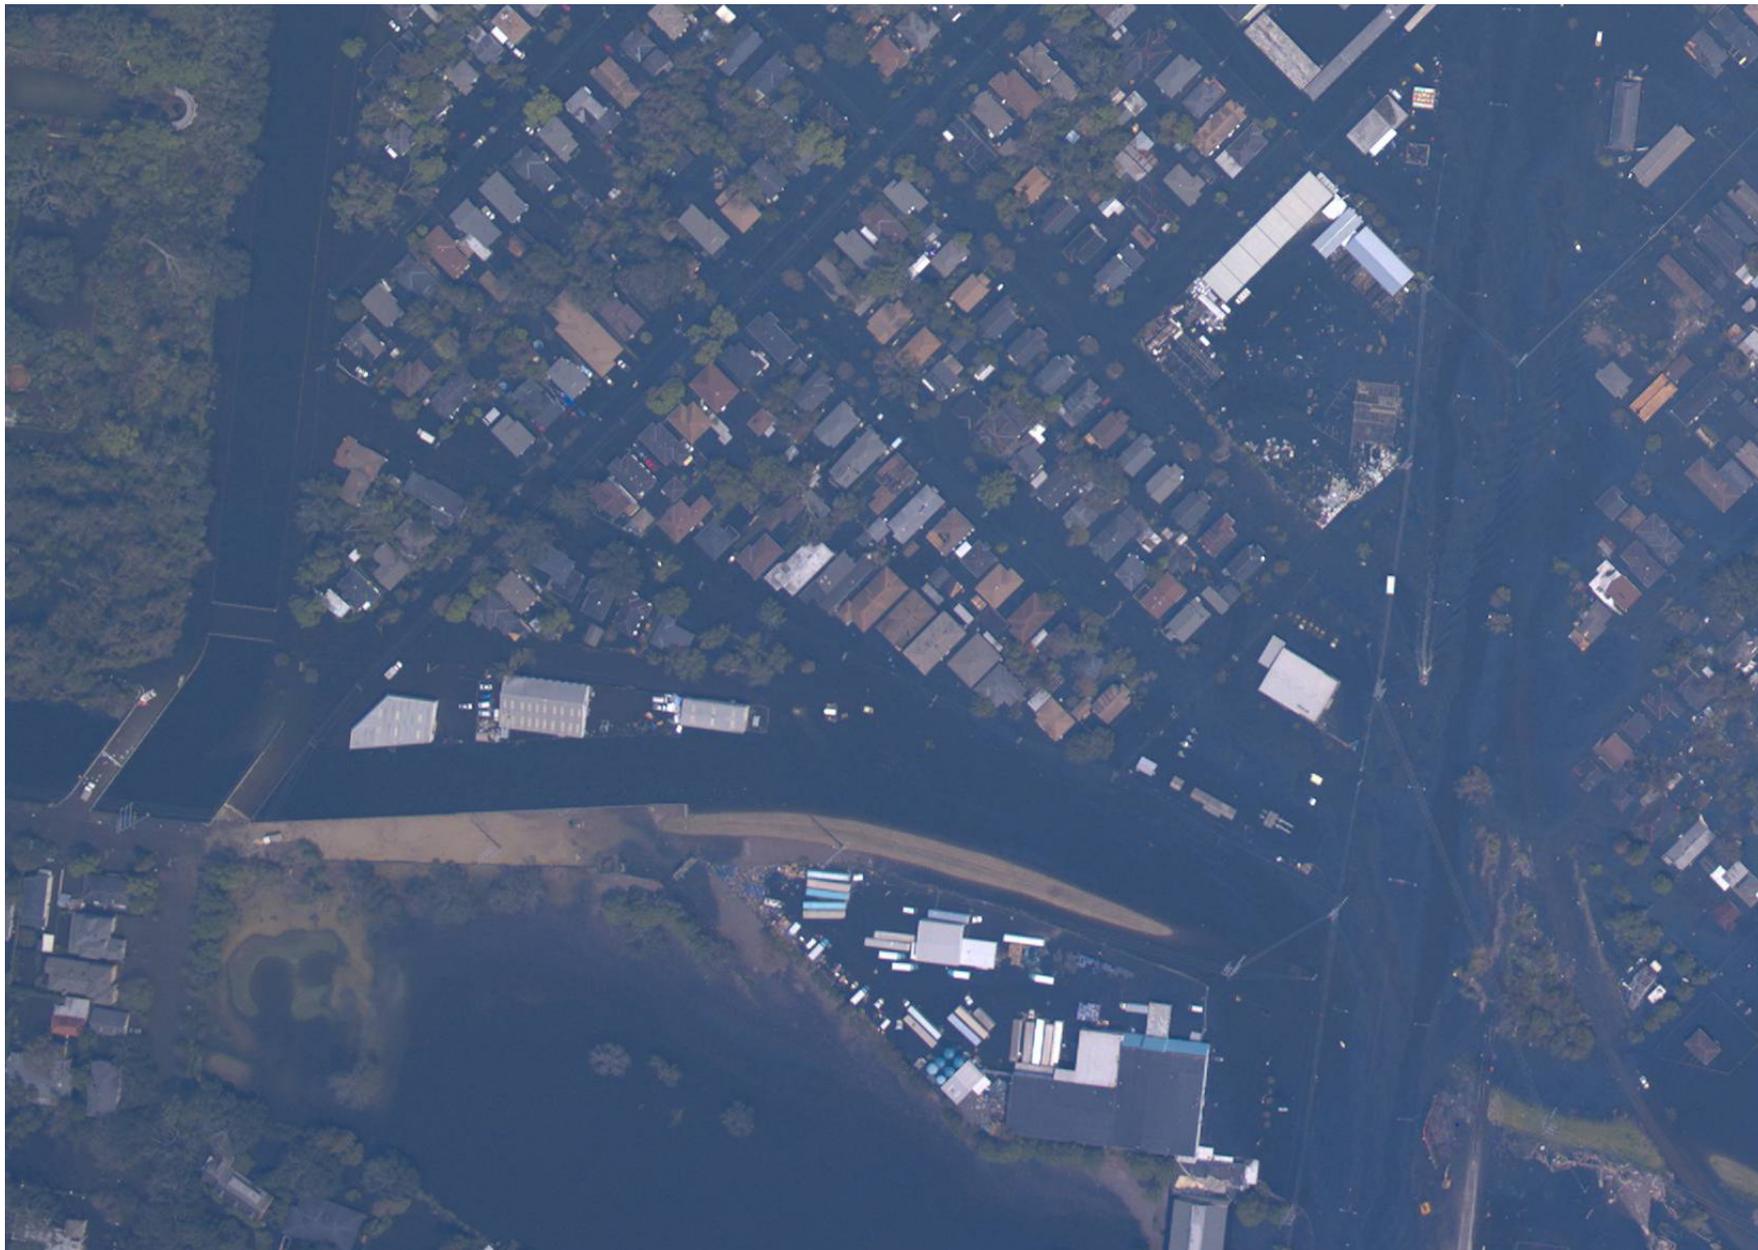
Figure 43. Air photograph of the area where the water from the 17th Street Canal Levee Breach ran back into Old Metairie, near Orpheum and Palm (stop 6). Image acquired Aug. 31, 2005. Source: National Oceanic and Atmospheric Administration's National Geodetic Survey, Katrina Images - <http://ngs.woc.noaa.gov/katrina/>
