Hurricane Katrina - What Happened? The Geology of the Katrina Disaster in New Orleans Field Trip Guide

April 21, 2013

Stephen A. Nelson
Department of Earth &
Environmental Sciences
Tulane University
New Orleans, LA
snelson@tulane.edu

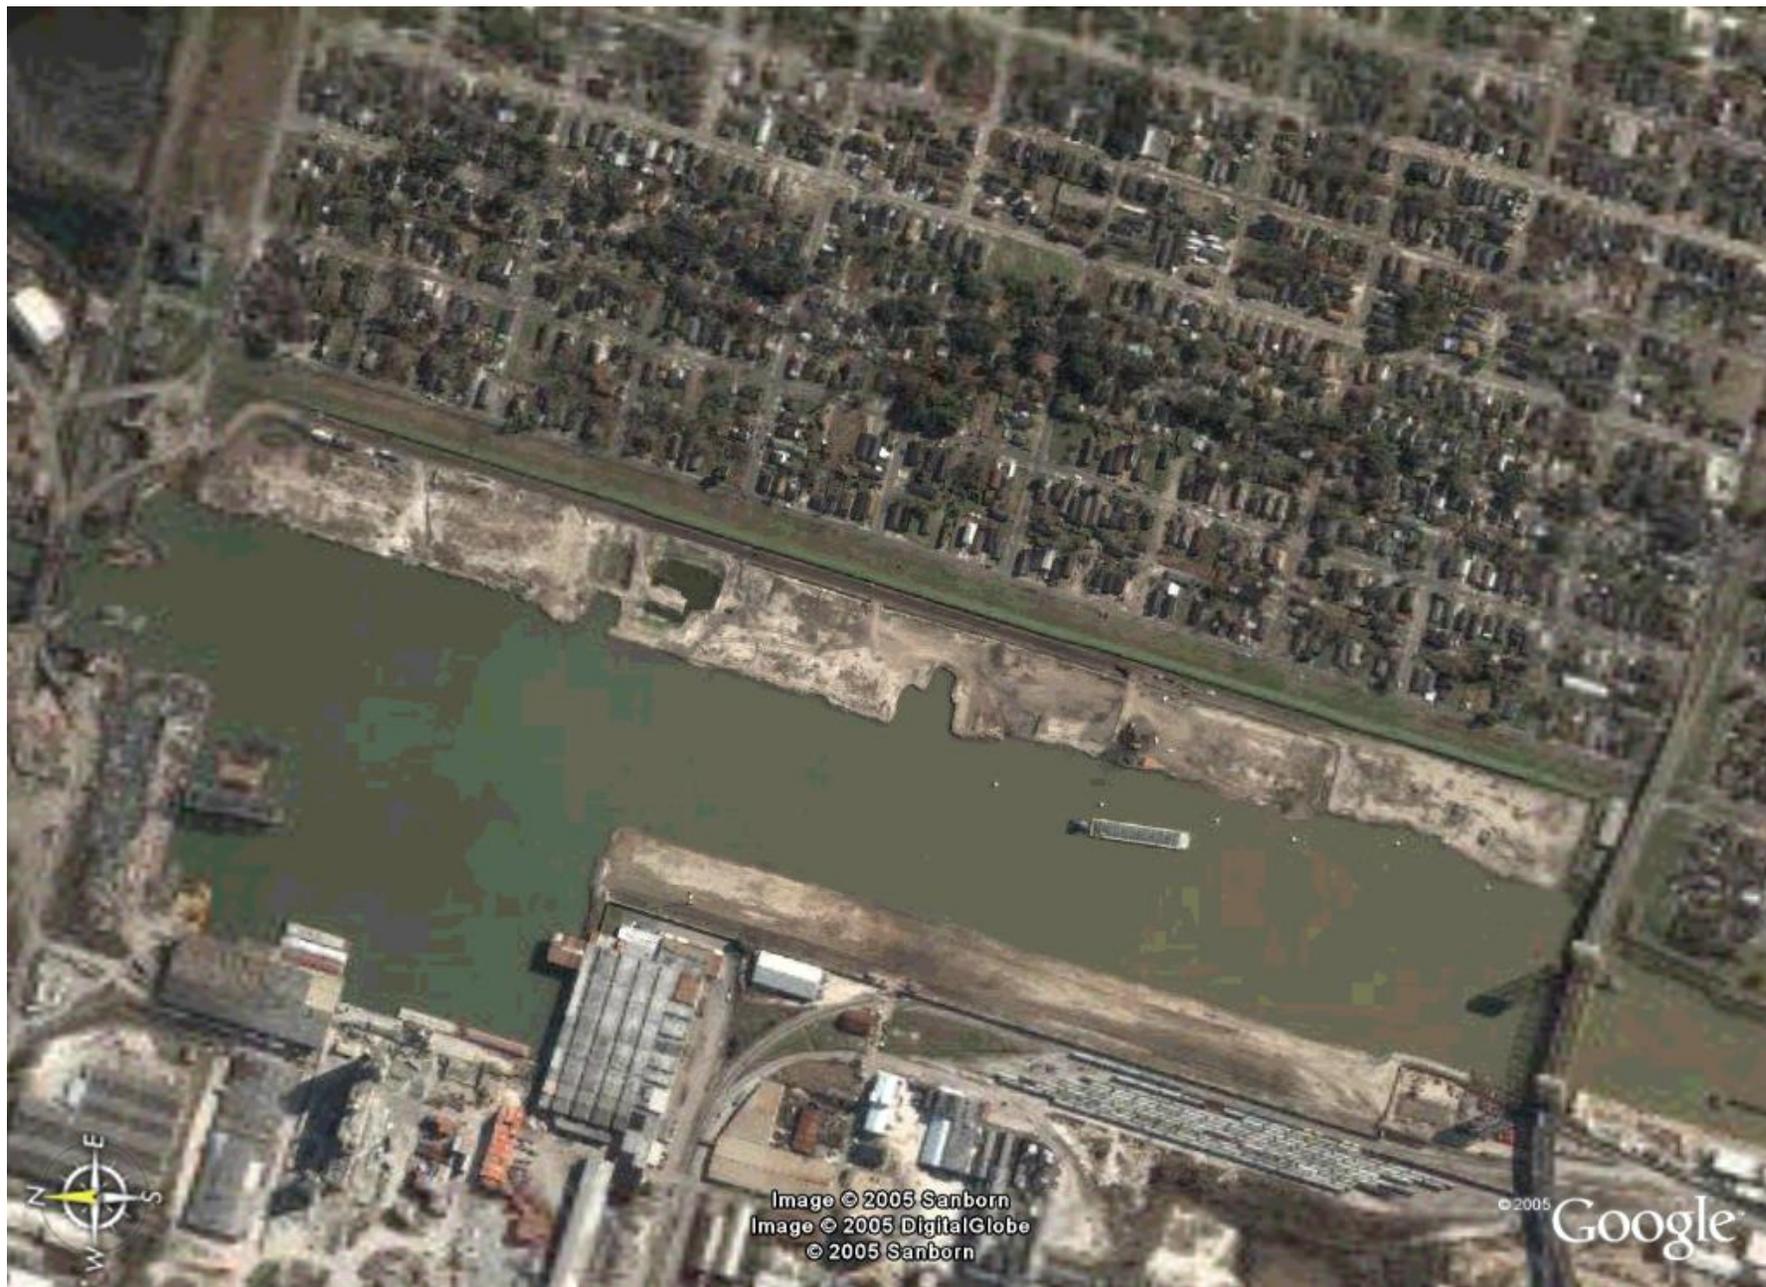
Figure 10. Satellite image of the area along the Industrial Canal where the levee was later breached during Hurricane Katrina. (Source - Google Earth)

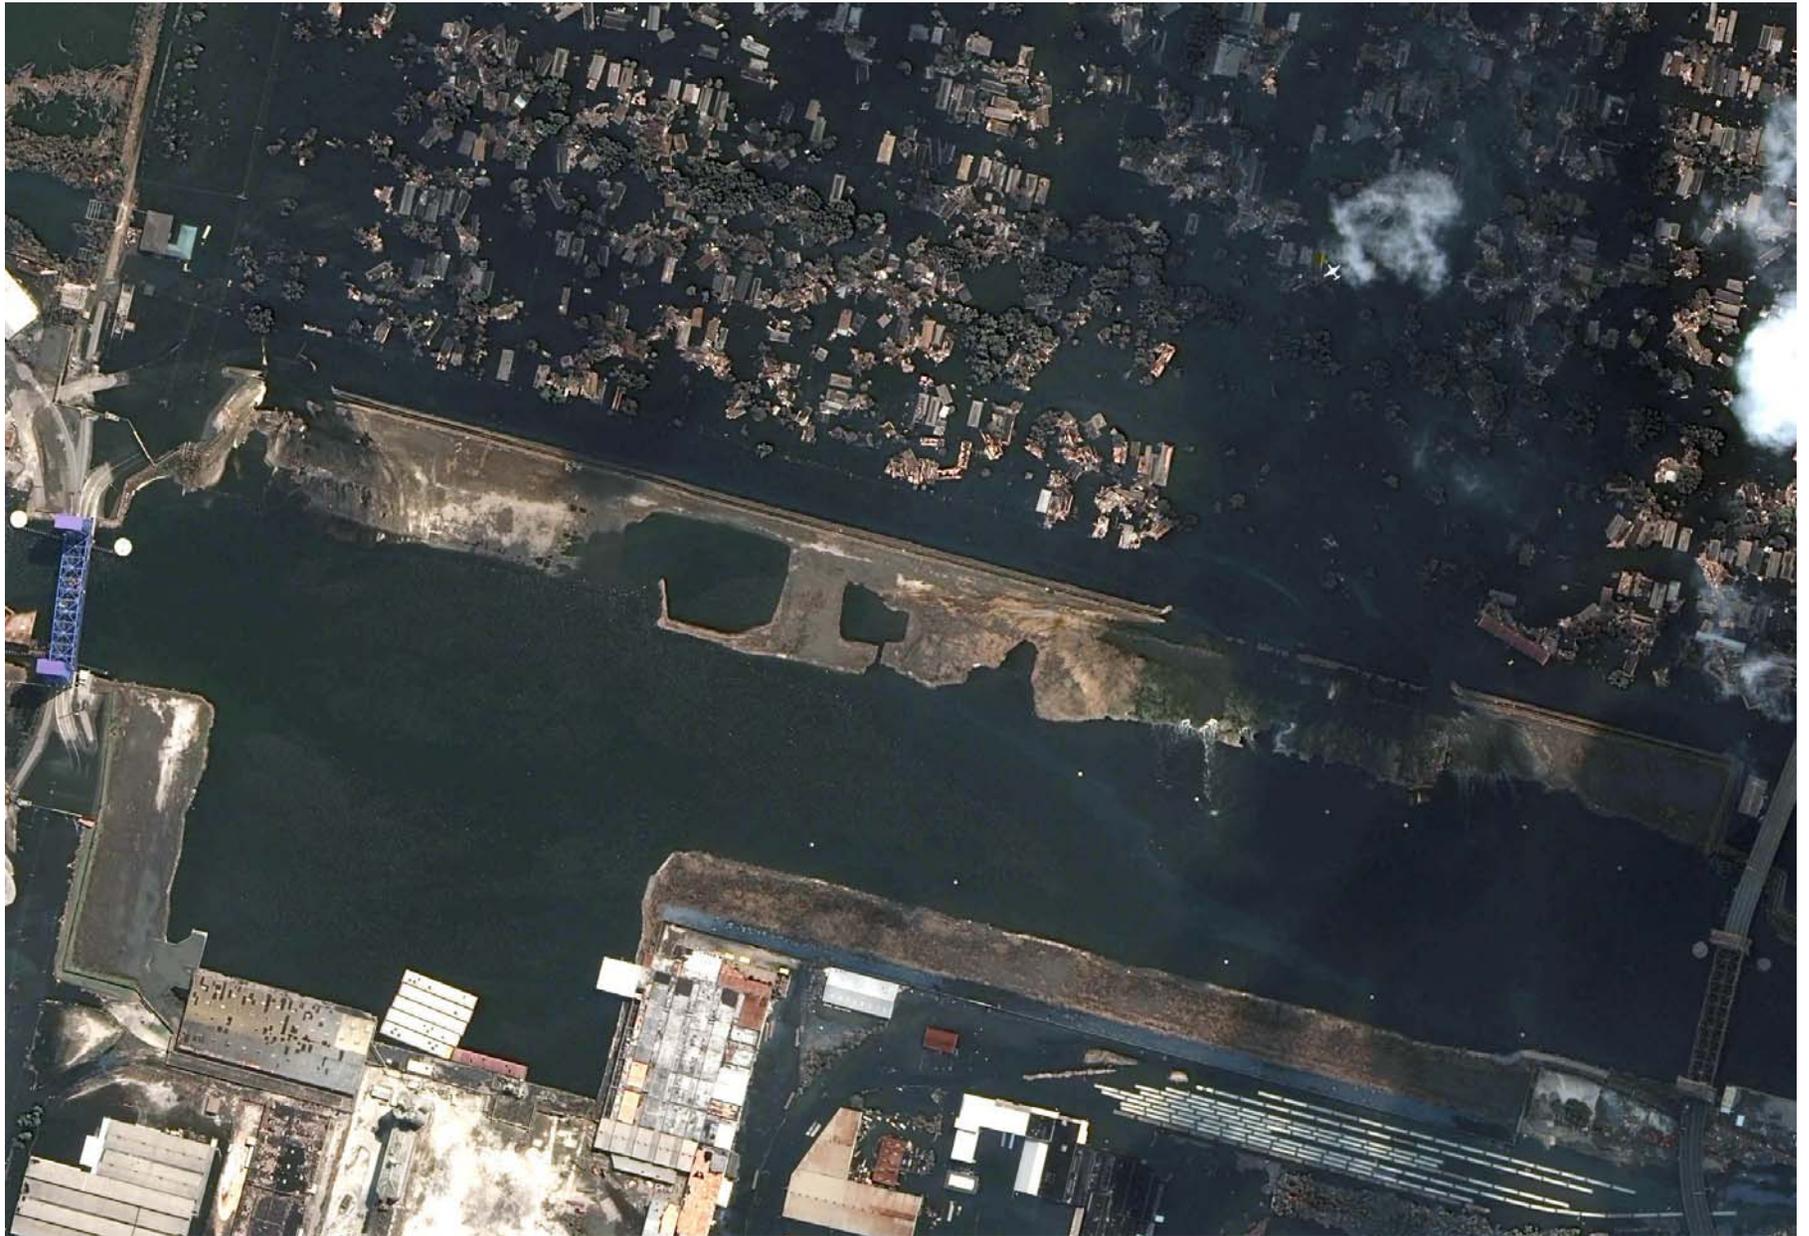
All houses and most trees were removed by the incoming water in the areas immediately in front of the breaches (Figs. 11, 12, 13, & 14) and in areas between the breaches the rush of water was forceful enough to lift houses off their foundations and float them around until they collided with other houses and either came to rest or broke apart to form piles of rubble (Fig. 11). The floodwall and underlying sheet pilings were strewn into the first few blocks of the Lower 9th Ward like a ribbon (Figures 14, 15, and 16).

Figure 11. Air photograph of the area where the Industrial Canal Levee was breached to flood the Lower Ninth Ward. Image acquired Sept. 3, 2005 Source: National Oceanic and Atmospheric Administration's National Geodetic Survey, Katrina Images - <http://ngs.woc.noaa.gov/katrina/>

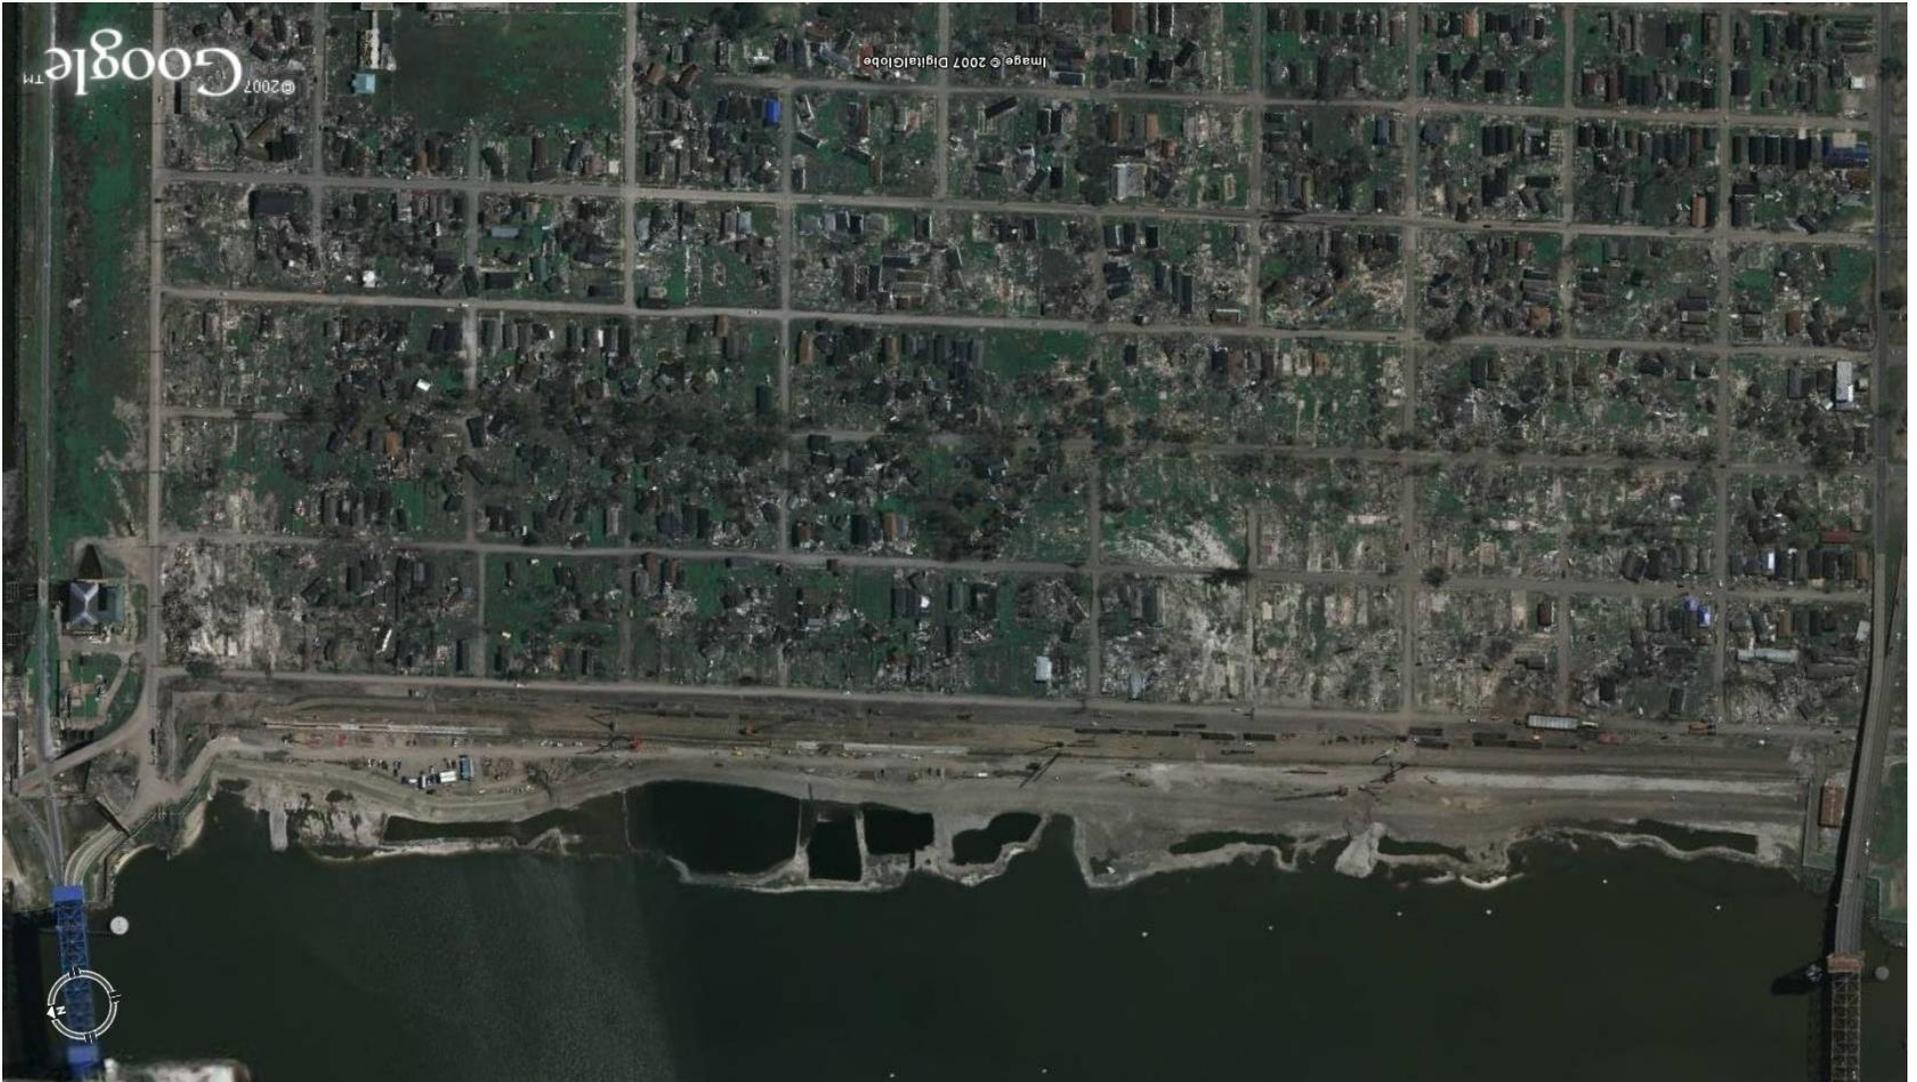
Figure 12. Google Earth image of the area where the Industrial Canal Levee was breached to flood the Lower Ninth Ward. Image acquired around mid-March, 2006.

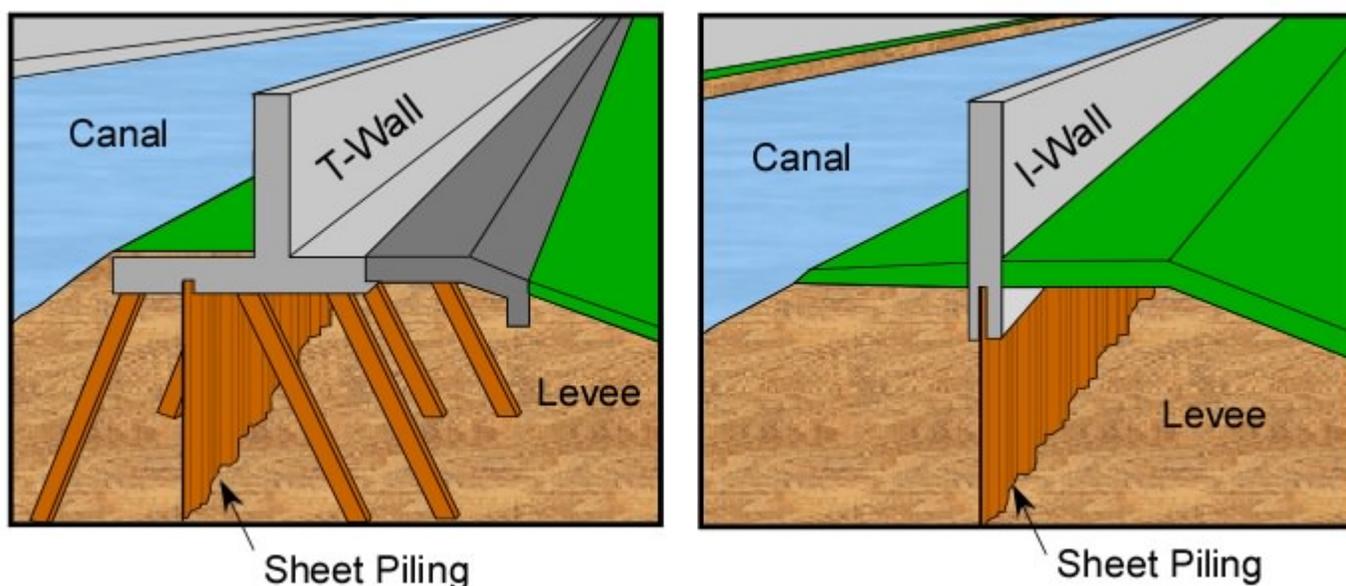
Figure 19. Most pre-Katrina floodwalls in New Orleans were built with the I-wall design (right). In repairing failed floodwall sections after Katrina, the T-wall design (left) was used.

At Stop 1 in the Lower 9th Ward, one now sees that the entire floodwall between the two bridges (Claiborne to the south and Florida Avenue to the North – the blue colored bridge) has been replaced with a T-wall with a top elevation at 14.5 feet above sea level, the level it was supposed to have attained prior to Katrina. This new floodwall was completed in mid-June, 2006. The original I-wall is still present along the other side of the Industrial Canal as well as to the south and north of the new T-wall. The only improvement made to the levees where the I-walls still exist is concrete armoring has been added to the base of the I-wall to prevent the erosion of the levee should water come over the top of the wall again.

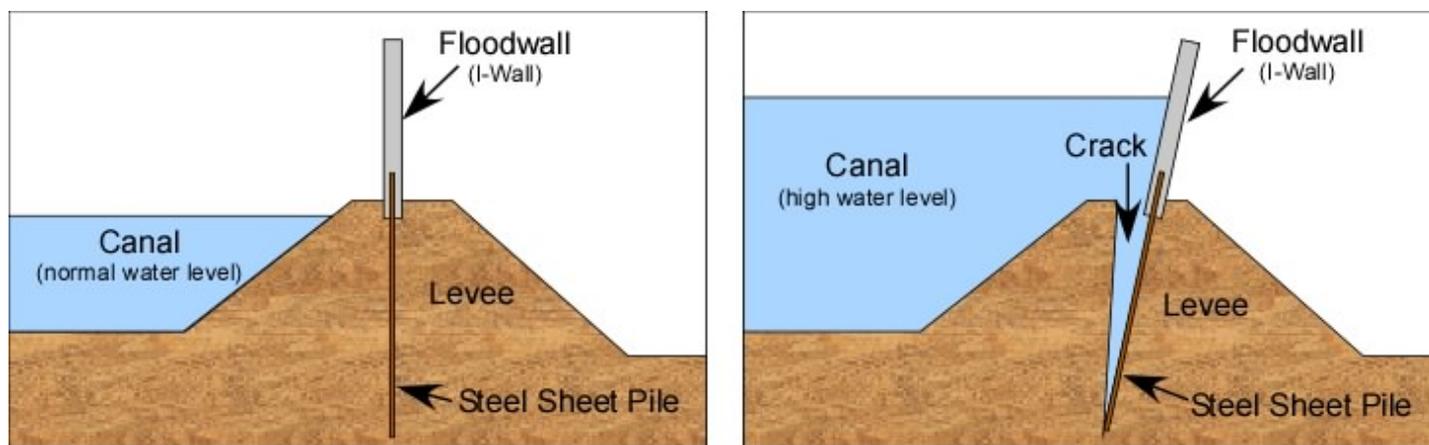
Although the floodwalls along the Industrial Canal were built in the 1970s, in 1985, the research branch of the Army Corps of Engineers conducted experiments on the I-wall design. They constructed a levee and enclosure in the Atchafalaya Basin (to the southwest of New Orleans) and began filling the area next to the levee and sheet pile floodwall with water. As the water rose against the floodwall, deflections of the floodwall began to occur and a gap opened on the water side of the floodwall which allowed the full hydrostatic force of the water to penetrate to the tip of the sheet piling (Jackson, 1988, Oner and others, 1997). This type of floodwall failure is illustrated in Figure 20. These findings were apparently never communicated to those in the Corps responsible for the design and construction of floodwalls in New Orleans (Marshall, March 14, 2006). The leaning floodwall seen in Figure 18 clearly shows that this also happened on the Industrial Canal floodwall during Hurricane Katrina. The force of the water pushing the wall outward toward the protected side coupled with removal of support by erosion caused by the water pouring over the top of the floodwall was the most likely cause of the catastrophic failures on the east side of the Industrial Canal (Fig. 21).

Figure 20. Illustration of crack development as water in a canal rises on the floodwall and pushes outward on the floodwall as observed in 1985 experiments by U.S. Army Corps of Engineers.

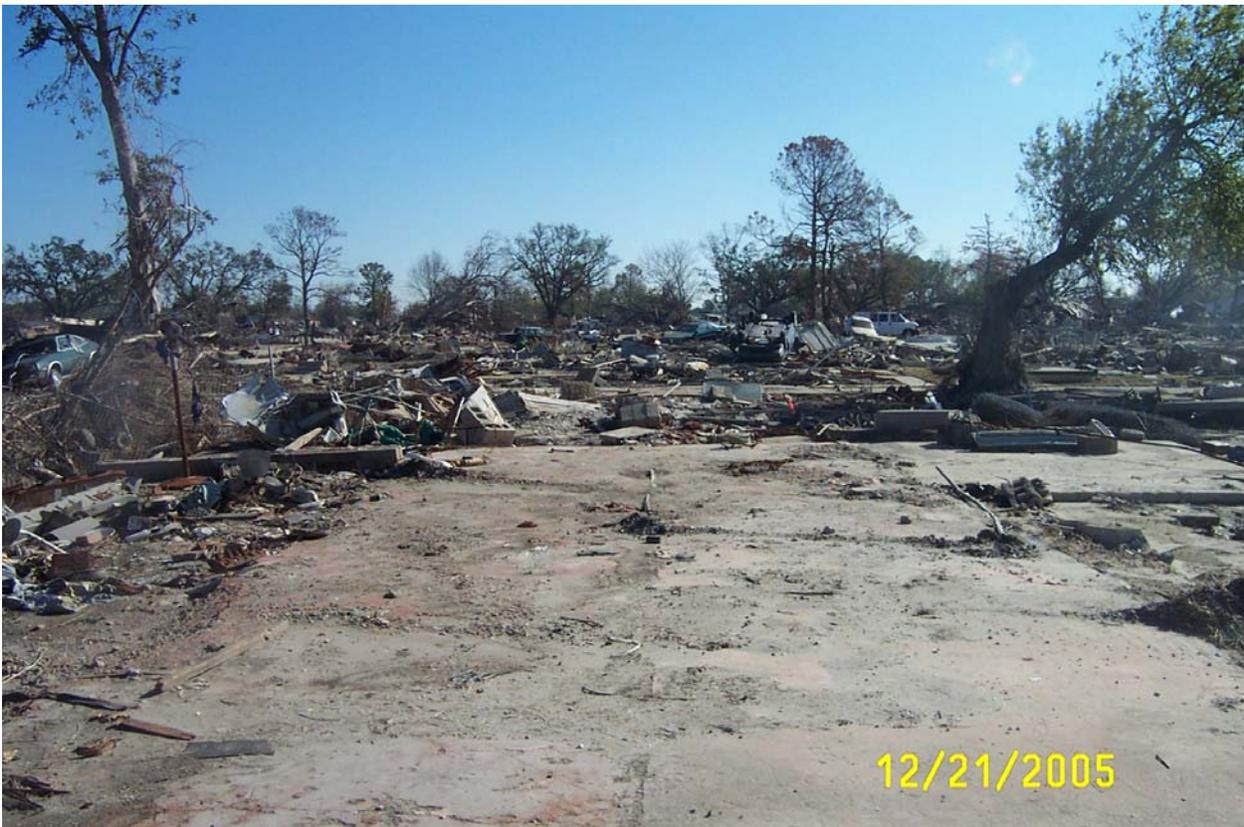
Figure 22. View of Lower Ninth Ward looking East as it appeared in December, 2005.

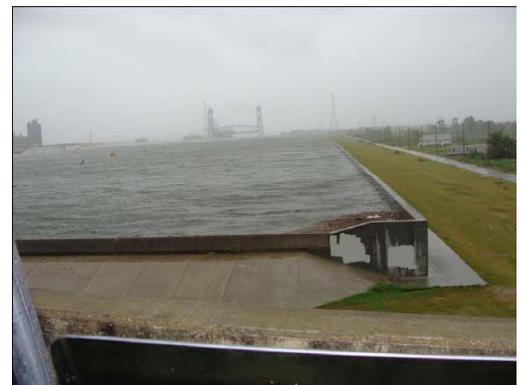
Hurricane Gustav in September of 2008 showed just how vulnerable this area is to storm surge. Gustav made landfall as a Category 2 hurricane about 65 miles southwest of here. Nevertheless, it produced storm surge in the Industrial Canal that reached near the top of the old floodwall, (Fig. 23) and television news coverage showed waves overtopping the floodwall on the west side near the Claiborne Avenue Bridge. Debris strand lines from this event can still be observed between the top of levee here and the new T-wall.

Figure 23. View of the Industrial Canal from the Claiborne Ave. Bridge looking North toward Stop 7 with the Florida Ave. Bridge (blue bridge) on the horizon. Photo as taken on the morning of Sept. 1, 2008 during the passage of Hurricane Gustav. Note the elevation drop from the post-Katrina floodwall (on the right) to the original floodwall to the left. Photo from U.S. Army Corps of Engineers.

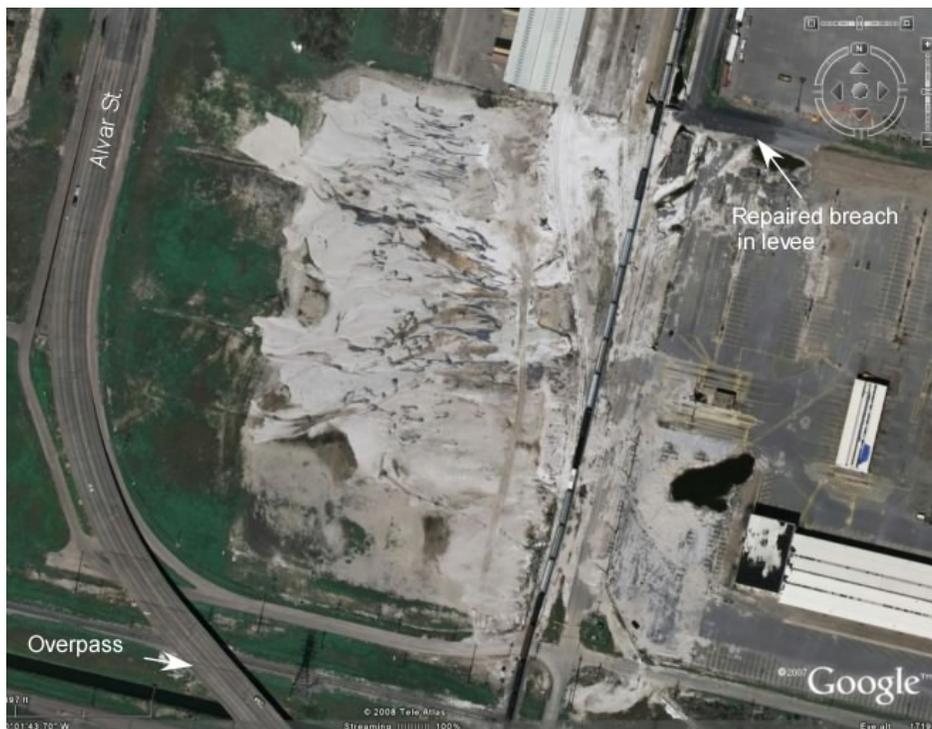
Before reaching the underpass, turn right on France Road and then left after crossing the railroad tracks. Along here (point A in Figure 1), look off to the right to view deposits of white shells that were emplaced during the breach of a levee constructed mostly of shells on the west side of the Industrial Canal (one of two breaches on this side). Figure 25 is a Google Earth Image of these deposits.

Figure 25. Google Earth Image (acquired around May, 2006) of area near overpass to Alvar St. (point A in Figure 1) showing location of breached levee and deposits of shells (white material in center of image) that resulted from the breach. Industrial Canal is off the image to the right (east).

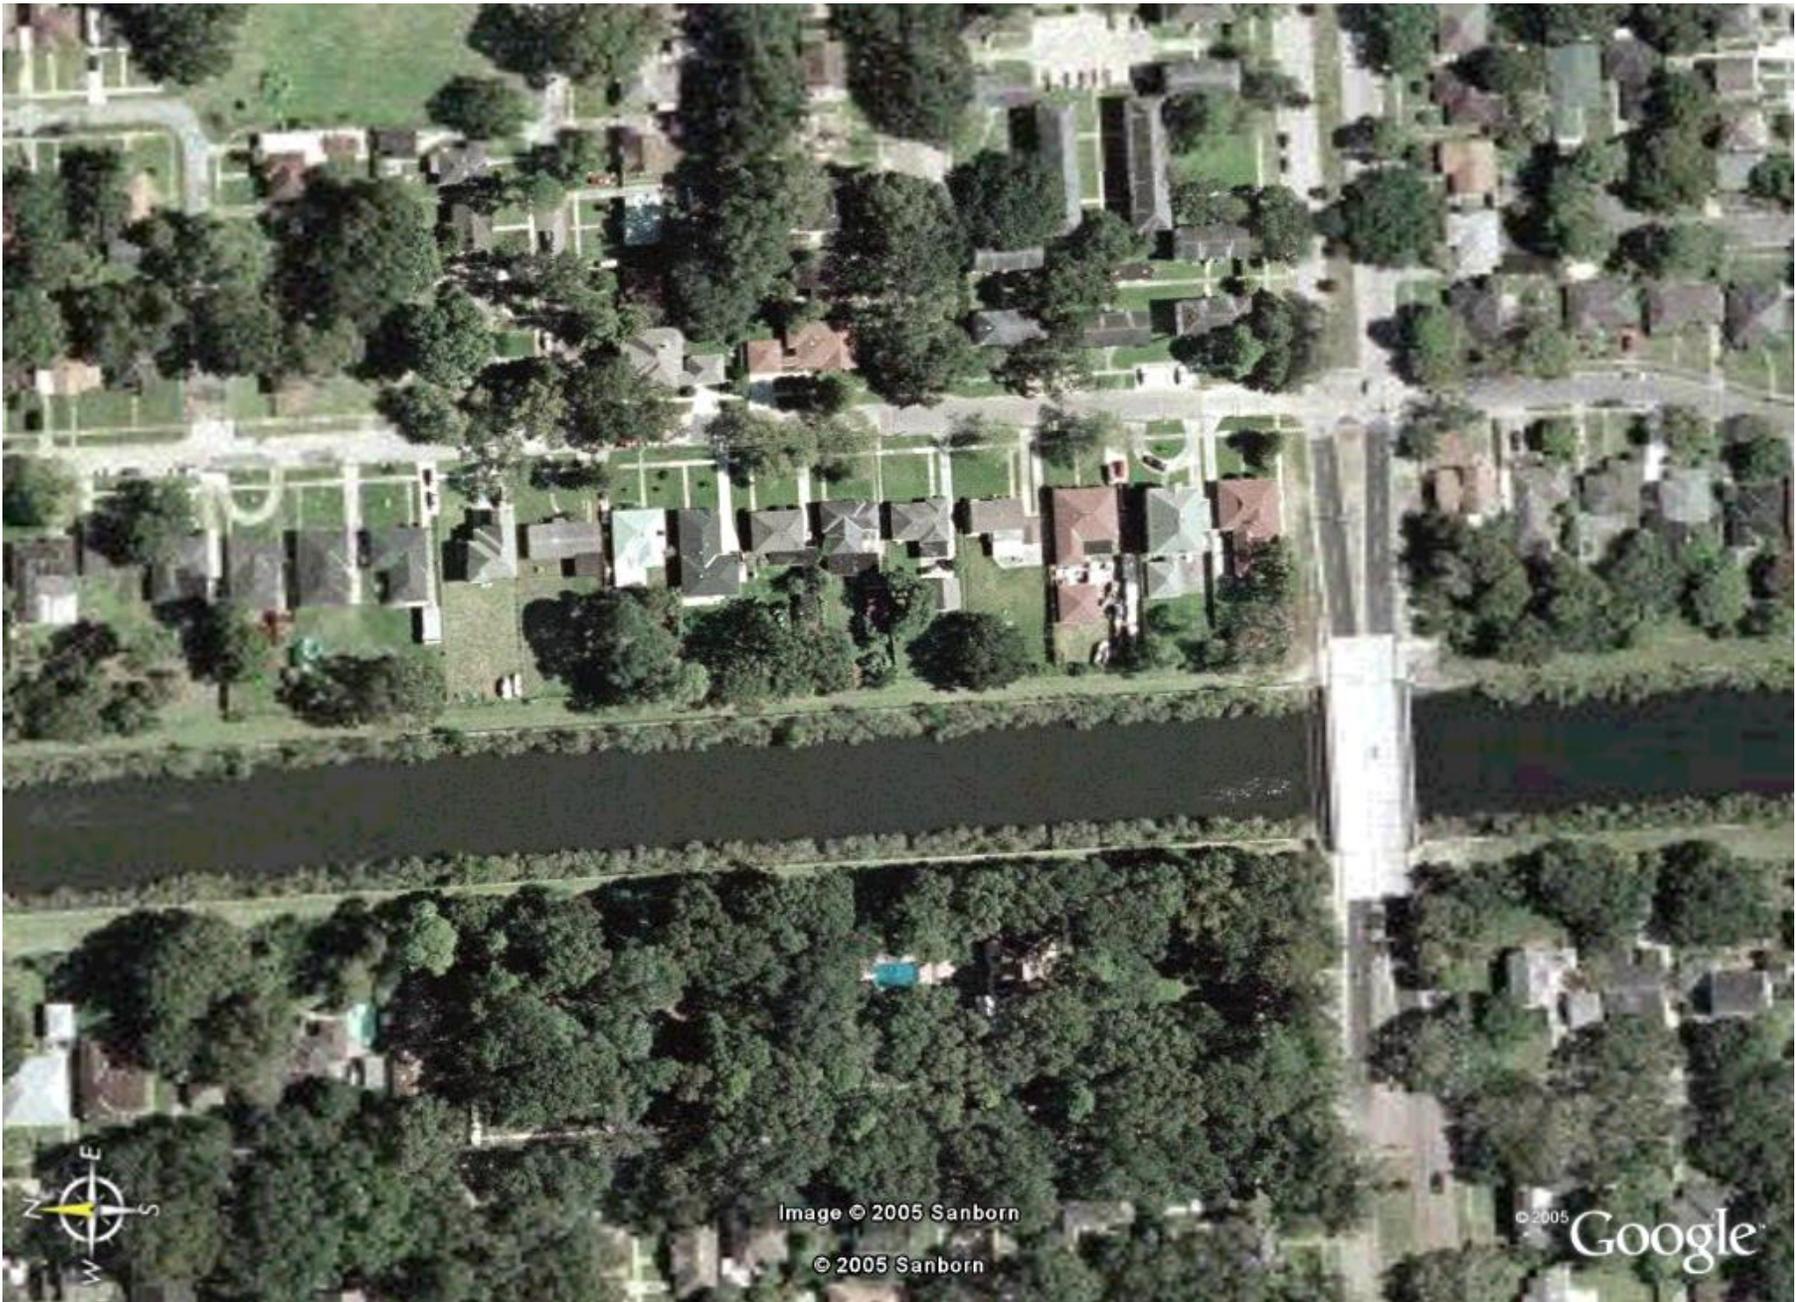
Figure 27. Satellite image of the area along the London Avenue Canal near Mirabeau Ave. and Warrington Drive (Stop 4), where the levee was later breached during Hurricane Katrina. (Source - Google Earth)

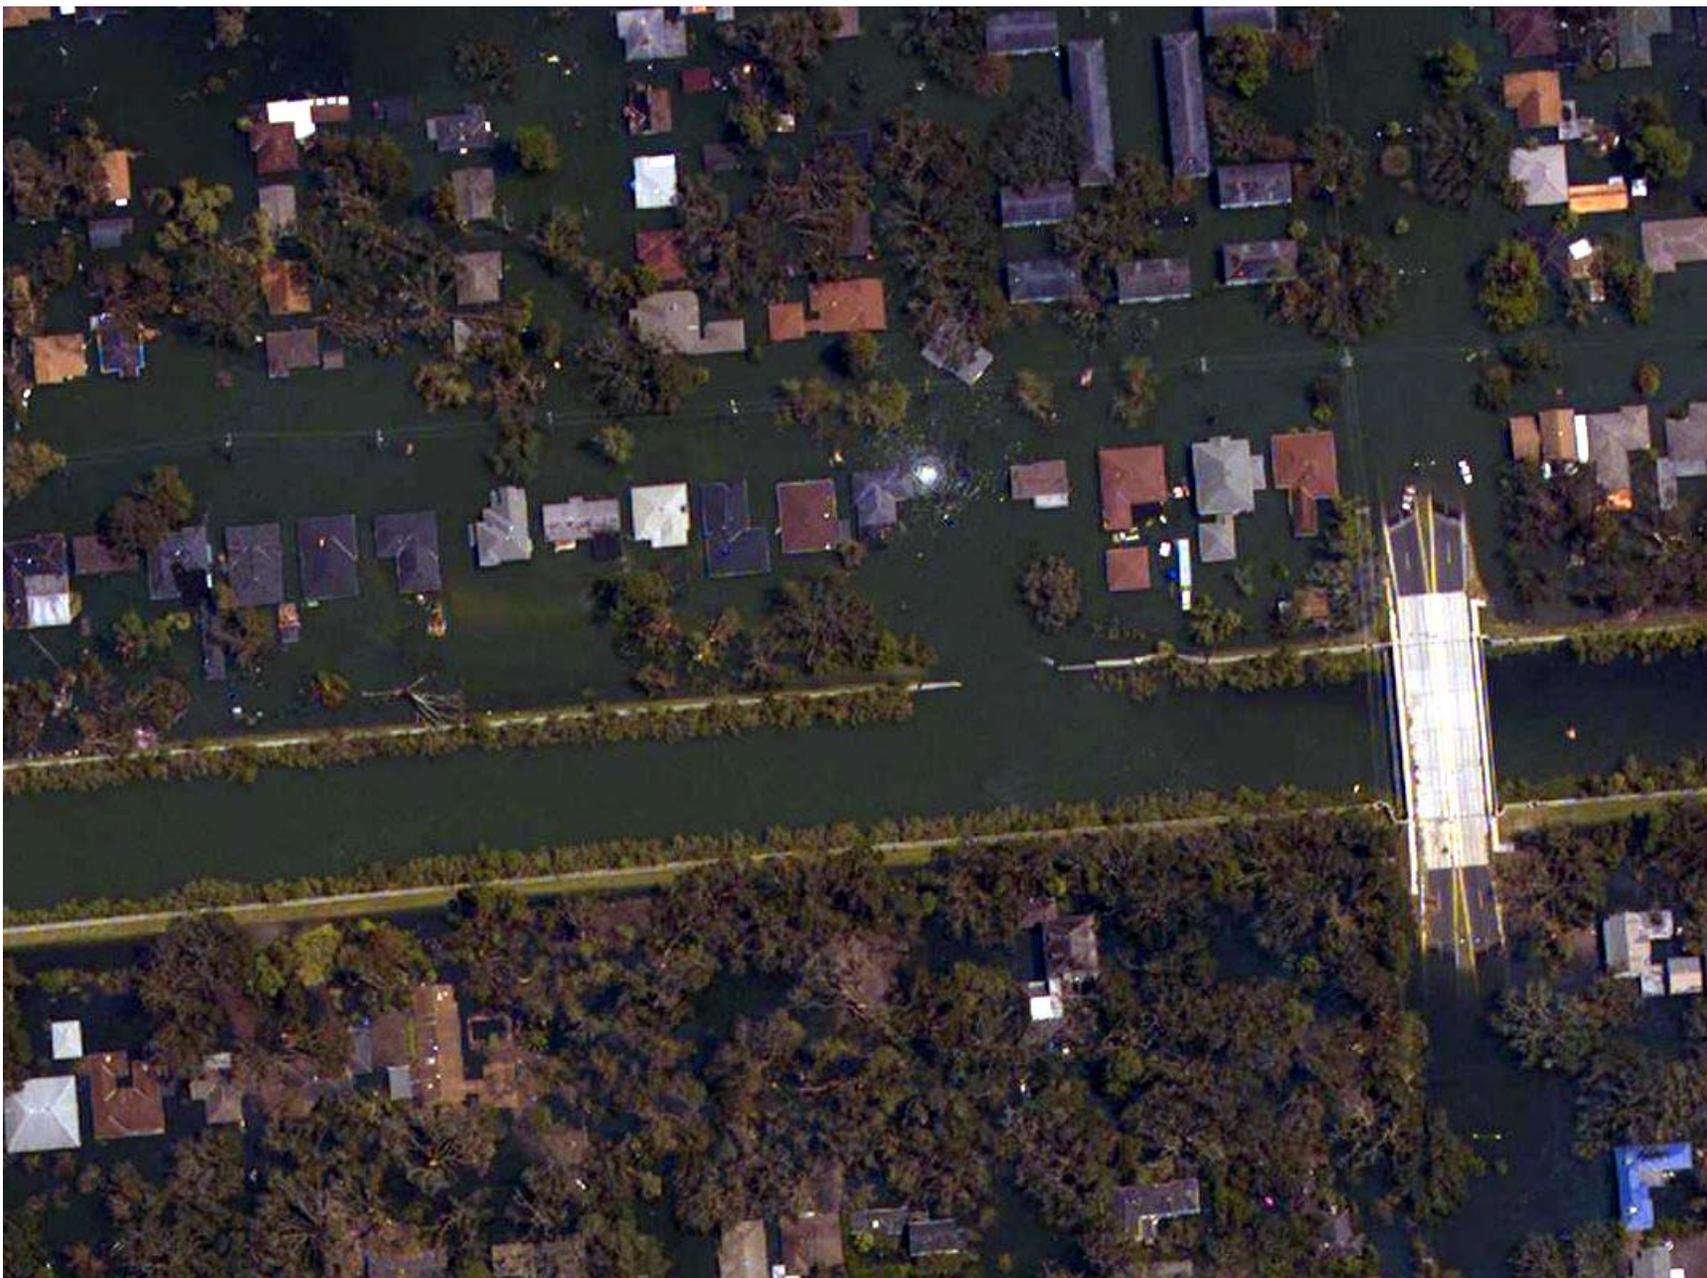
Also noticeable by comparison of Figures 27 and 28 is that before Katrina a tree stood at the toe of the levee adjacent to the part that breached. That tree is laying on its side in the image taken on August 31, 2005 (Fig. 28). It is notable that

Figure 28. Air photograph of the area where the London Avenue Canal levee was breached near Mirabeau Ave. and Warrington Drive (Stop 4). Image acquired Aug. 31, 2005. Source: National Oceanic and Atmospheric Administration's National Geodetic Survey, Katrina Images - <http://ngs.woc.noaa.gov/katrina/>

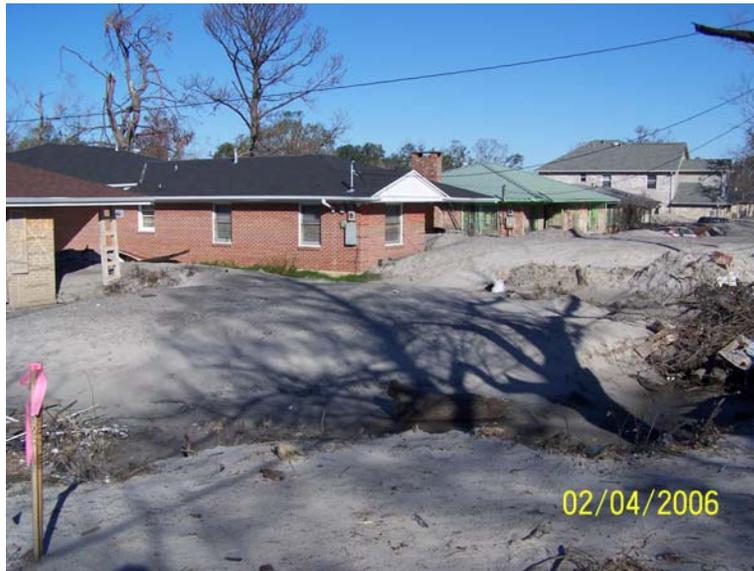
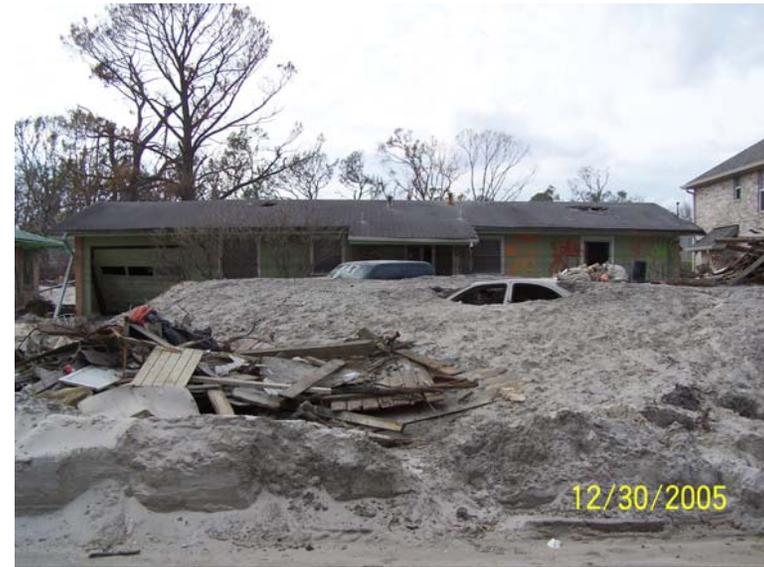
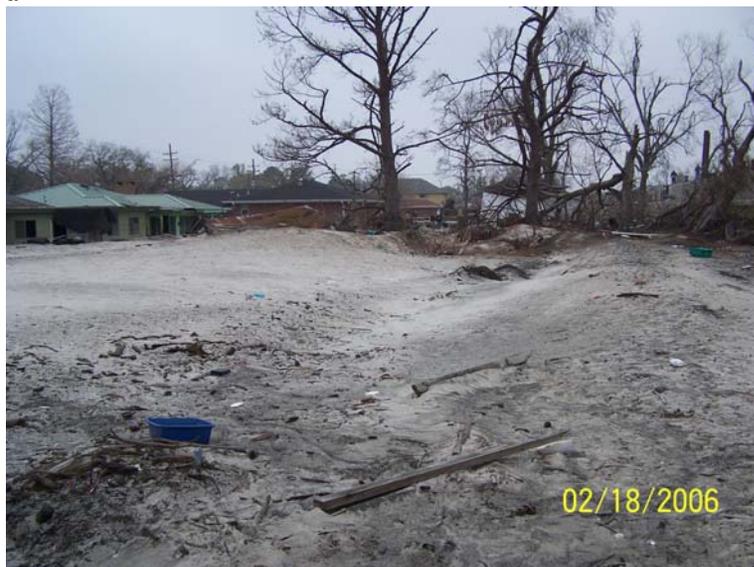
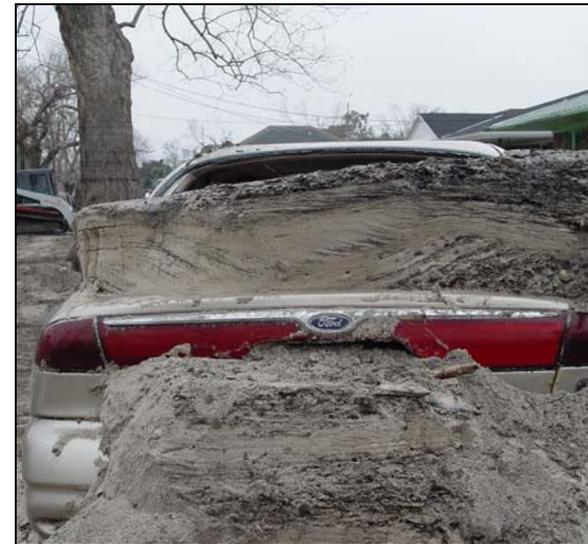
After the flood waters were pumped out, large deposits of sand were seen throughout the neighborhood. As of March 1, 2006 most of the sand had been removed from in front of the houses, and the back yards were cleared by January, 2007. Fig. 29 shows the sand deposits as they appeared before removal.

The sand in these deposits did not originate from the canal water or lake water that was pushed into the canal during Katrina. Instead, it originated from beneath the levee. A geologic cross-section constructed from data on soil borings (done in 1986) (U.S. Army Corps of Engineers, 1989) from the banks of the London Avenue Canal is shown Figure 30. The cross-sections clearly show the presence of sand at a depth beginning between 10 and 15 feet below sea level. This sand is the same Pine Island beach sand that was deposited in the area between 4,000 and 5,000 years ago as shown in Figures. 2, 5 and 6.

Figure 29. Sand deposits near the south breach of the London Avenue canal. (a) sand ridges deposited in the wake of houses as the currents flowed down the driveways between the houses. (b) Sand deposits that buried two cars in front of house on Warrington Drive. (c) Ridges of sand filling the back yards of houses along Warrington Drive, just north of the breach. As of March 1, 2006, most of the sand in the front yards had been removed and as of mid January, 2007 most of the sand in the backyards had been removed.(d) one of the cars buried by sand in (b) during excavation.

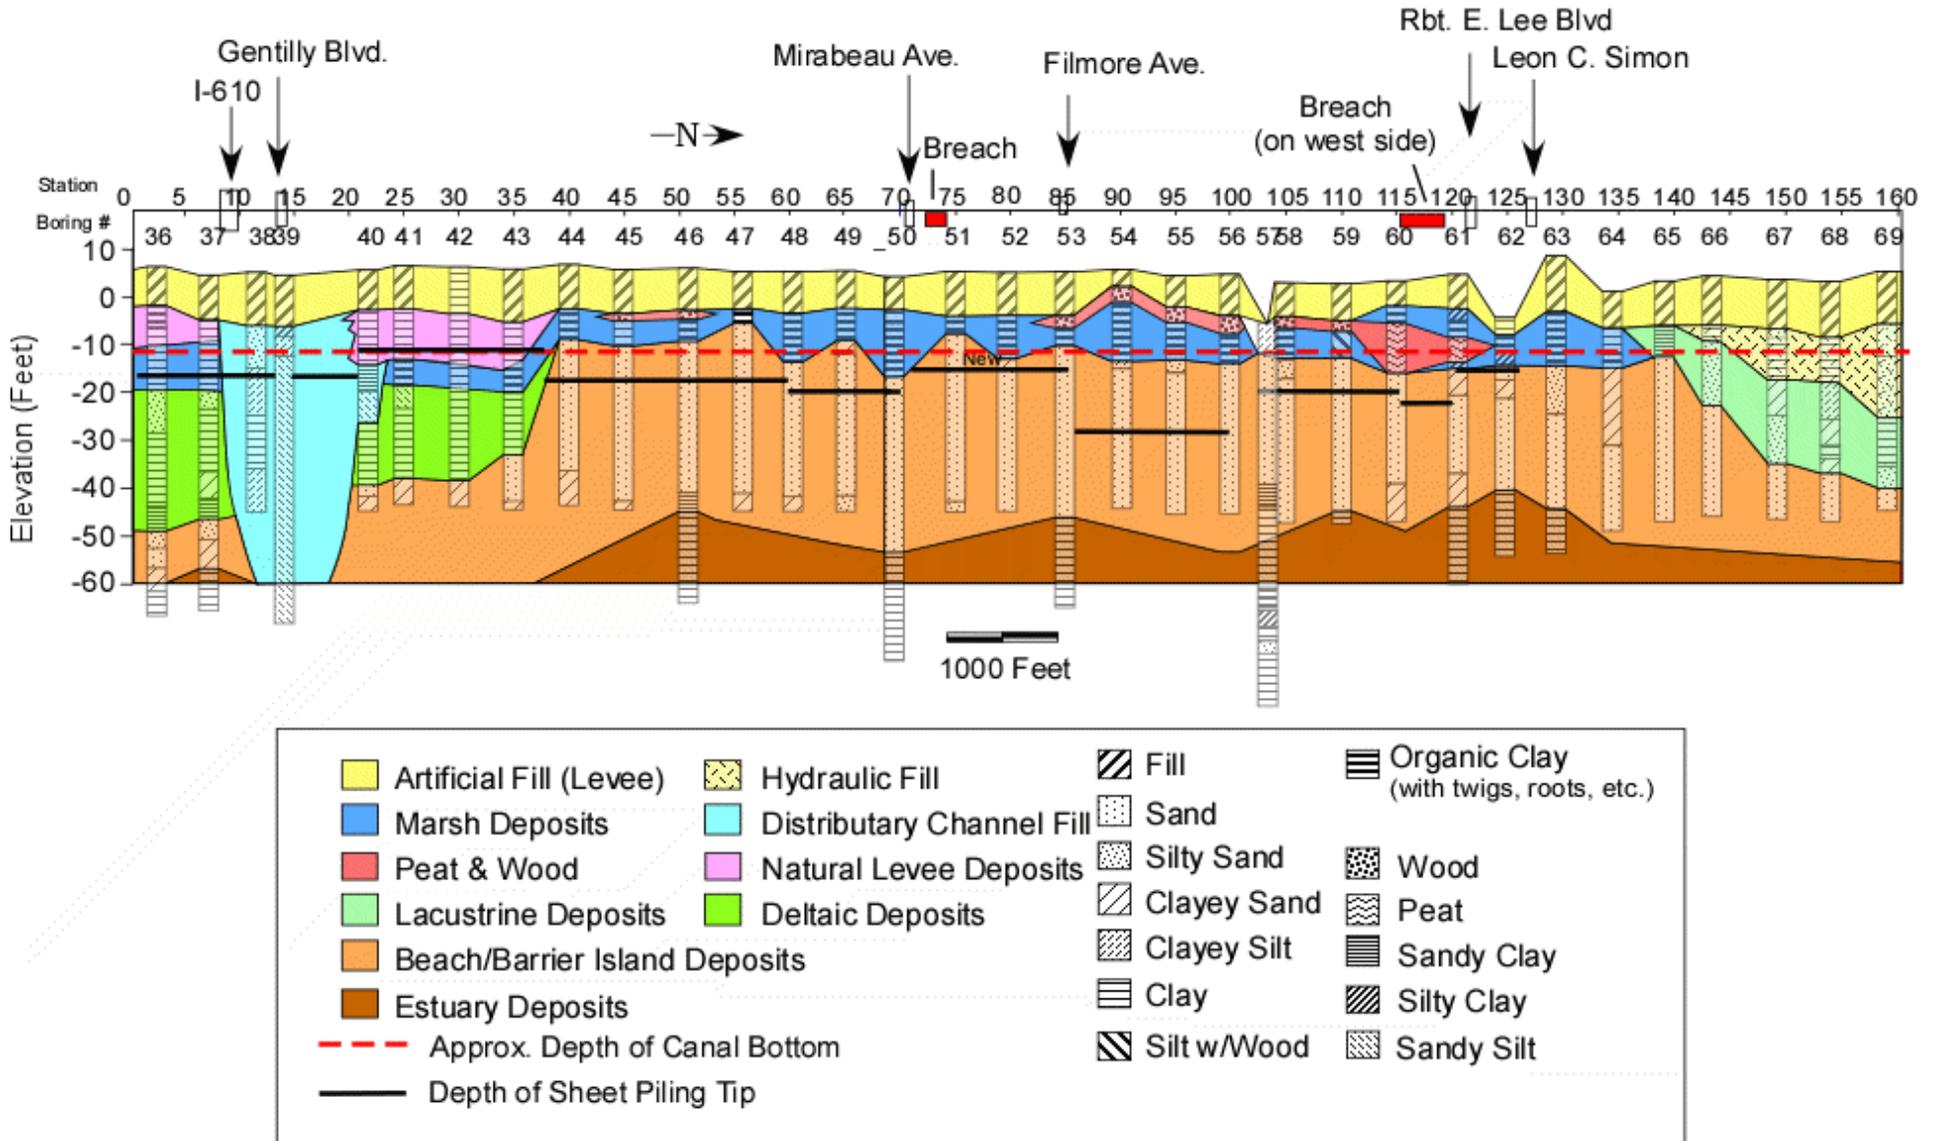
London Avenue Canal - East Side

Figure 30. Geological cross-section along the east side of the London Avenue Canal constructed from data in U.S. Army Corps of Engineers (1989).

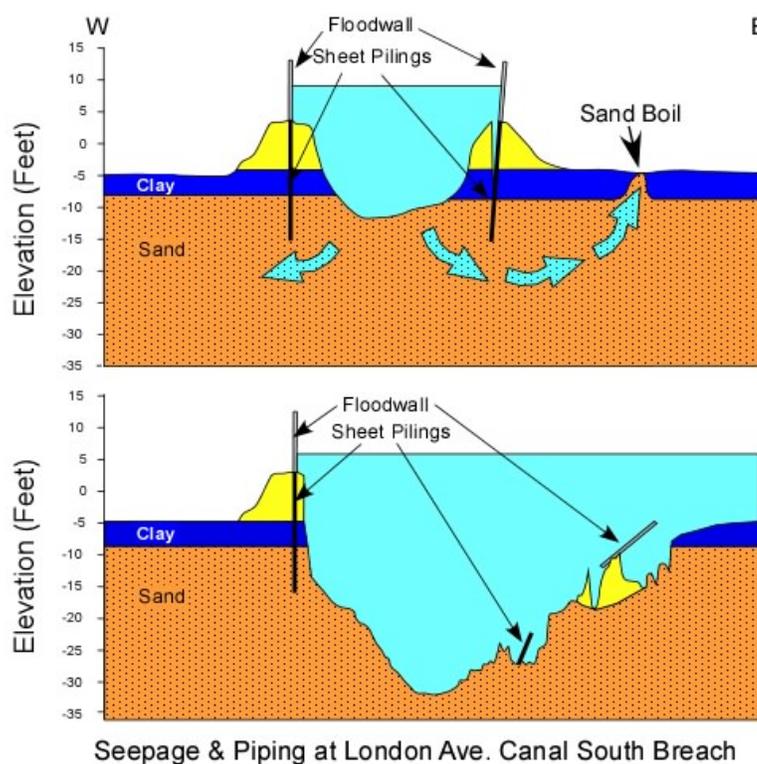
Figure 32. Geological cross section across the London Ave. Canal based on borings 16 and 51 (Figs. 29 and 36), shown at time of estimated high water during Katrina's storm surge. The sands form a permeable layer through which groundwater originating in the canal can penetrate and move below the sheet pilings and up to the surface (top diagram), eventually undermining the levee and causing a blowout completely removing a section of levee and carrying sand into the neighborhood. The shape of the canal bottom is based on depth soundings undertaken by the U.S. Army Corps of Engineers on September 5, 2005.

The repair operation has only been done in the area of the breach. The operation involved digging out the material used in the initial emergency repair, filling it with clay and construction a T-wall to replace the missing I-wall. Fortunately, the Corps of Engineers has now completed removable floodgates near the mouths of the London Ave, Orleans, and 17th St. canals near Lake Pontchartrain. These floodgates are closed in the event of a hurricane and prevent storm surge from reaching onto the floodwalls in the canals. If the gates are closed, however, the pumps at the southern end of the canals cannot be used to pump rainwater out of the city. Thus, the Corps has built pumping stations at the Lake (where they should have been built in the first place), but full pumping capacity is not yet available. Still rainwater flooding is better than having Lake Pontchartrain drain into the city.

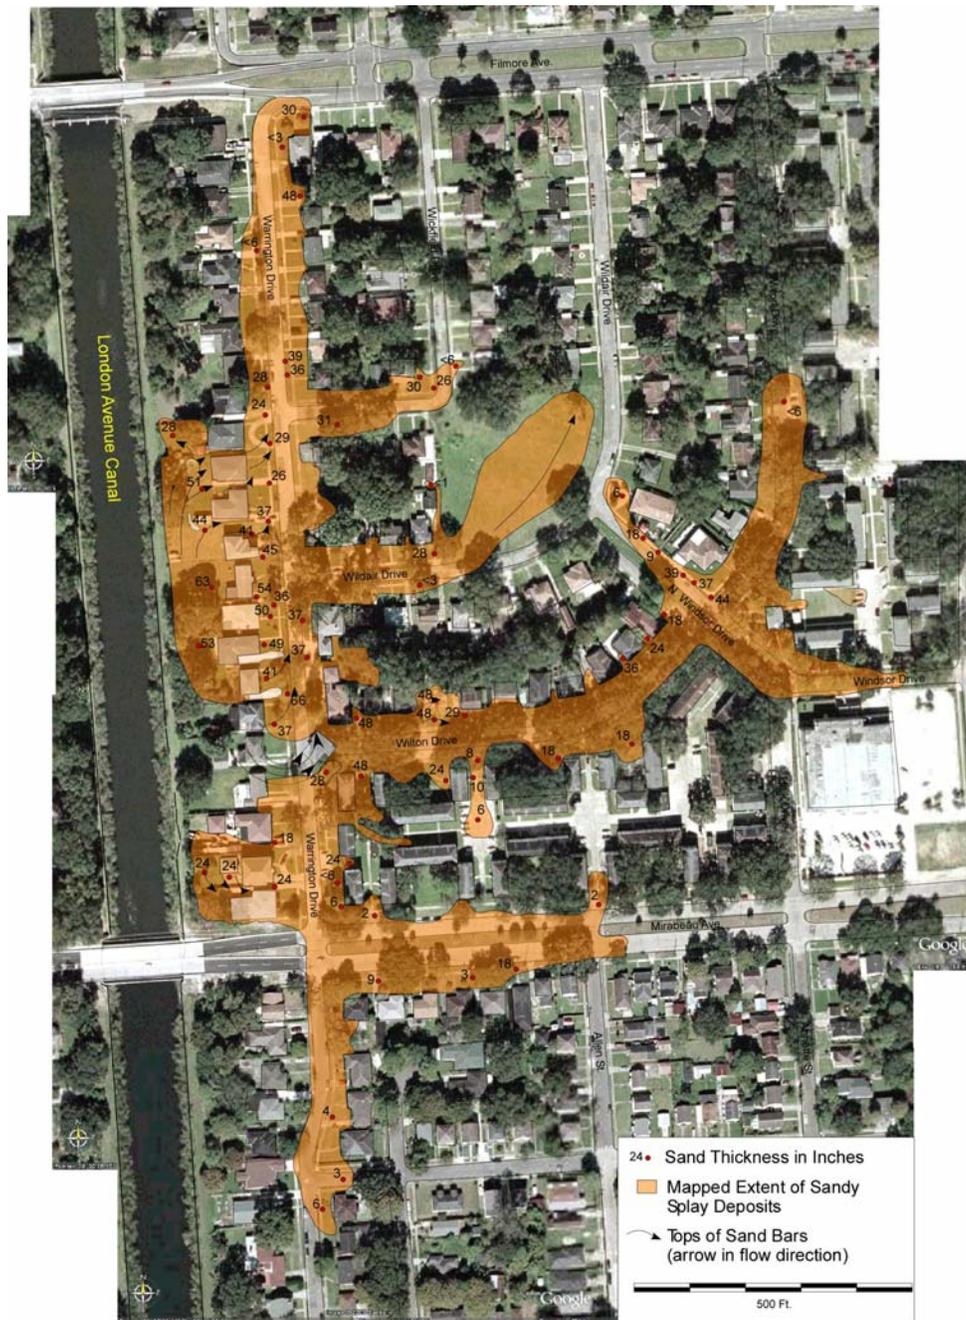
Figure 33. Preliminary map of sand deposits (by S. A. Nelson) from the Mirabeau Ave. breach on the London Ave. Canal. Underlying image is a composite from Google Earth.
