Hurricane Katrina - What Happened? The Geology of the Katrina Disaster in New Orleans Field Trip Guide

April 21, 2013

Stephen A. Nelson
Department of Earth &
Environmental Sciences
Tulane University
New Orleans, LA
snelson@tulane.edu

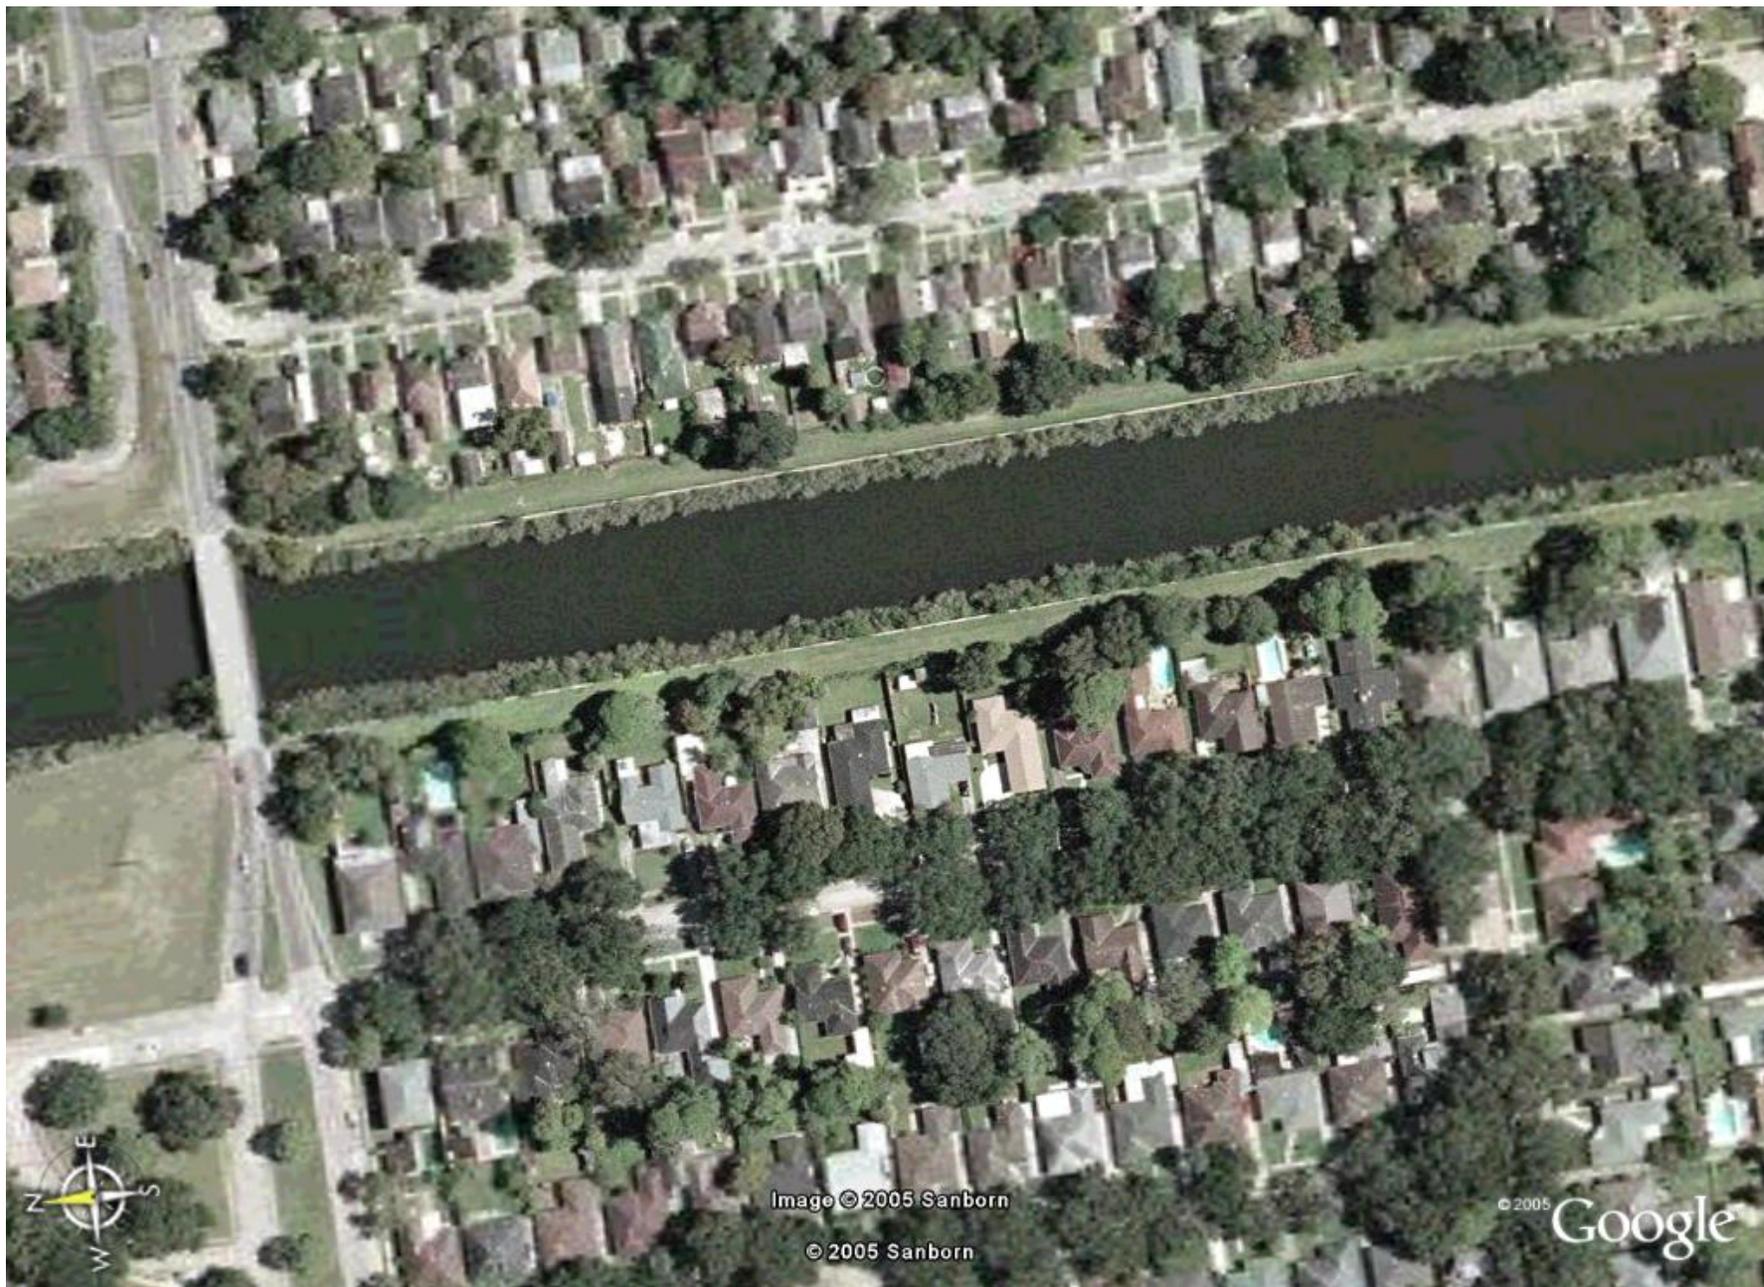
Stop 5 is on Pratt Drive near the intersection with Robert E. Lee Blvd. where the London Avenue Canal levee was breached on the west side of the canal. The estimated chronology determined by IPET (2006) suggests that this breach occurred sometime before 9:00 AM on August 29, 2005. Figure 34 shows an image of this area before Katrina. Figure 35 shows approximately the same area in an image taken on August 31, 2005 after the breach occurred and before the floodwaters had been pumped out.

Note in Figures 34 and 35 that there is abundant vegetation along the banks of the canal inside the floodwalls. During the surge event in the canal, this vegetation trapped debris flowing in the canal and the height of this trapped debris in the vegetation could be used to estimate water level. Such evidence observed shortly after the storm indicates that the water level in the canal was no higher than about 3 feet from the top of the floodwall. Note also in Figure 35 how the vegetation along the bank of the failed floodwall shows a distinct edge marking the pre-failure position of the floodwall. During the failure, the floodwall slid away to the west as a result of the water pressure against the floodwall and sheet pilings.

Figure 34. Satellite image of the area along the London Avenue Canal near Robert E. Lee Blvd. and Pratt Drive (Stop 5), where the levee was later breached during Hurricane Katrina. (Source - Google Earth)

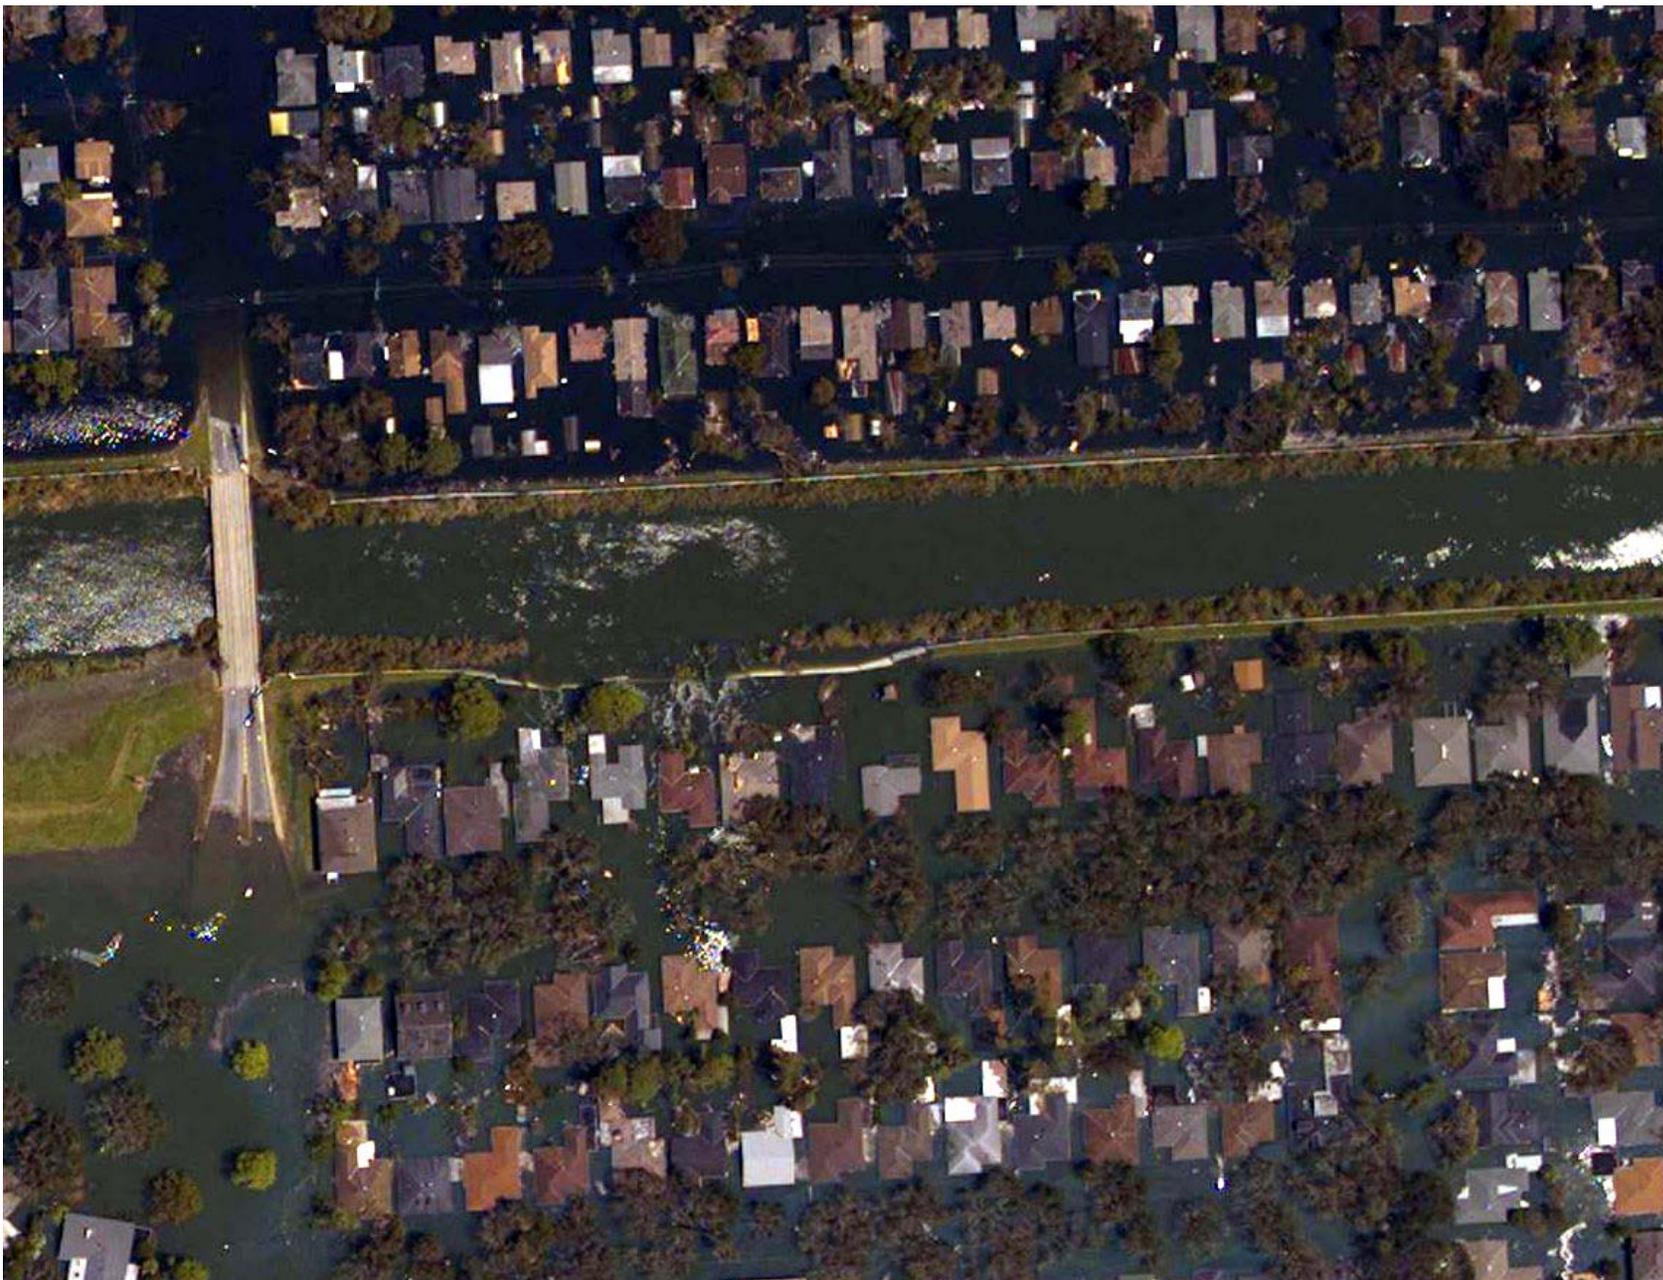
Figure 35. Air photograph of the area where the London Avenue Canal levee was breached near Robert E. Lee Ave. and Pratt Drive (Stop 5). Drive. Image acquired Aug. 31, 2005. Source: National Oceanic and Atmospheric Administration's National Geodetic Survey, Katrina Images - <http://ngs.woc.noaa.gov/katrina/>

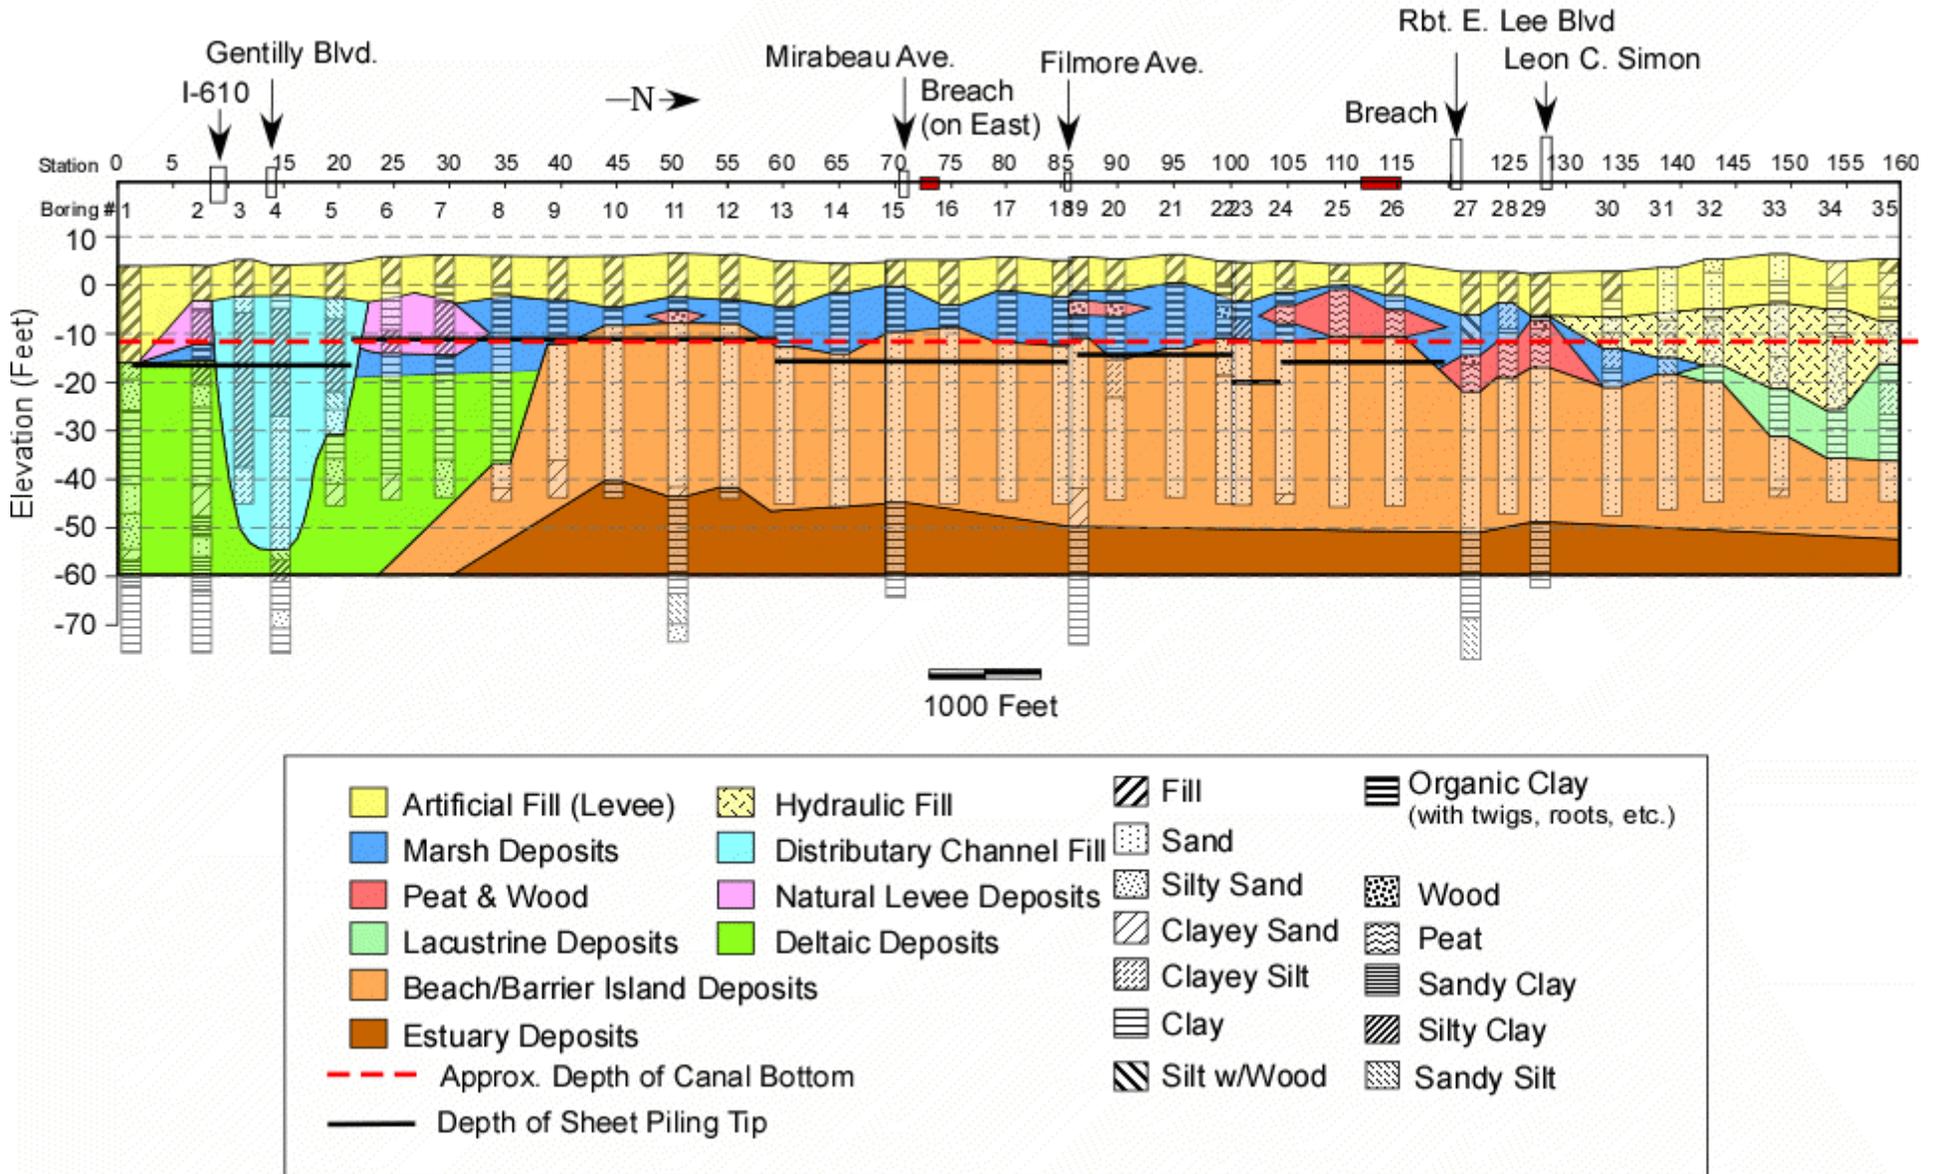
London Avenue Canal - West Side

A geologic cross section of the west side of the levee is shown in Figure 36. Note that the conditions beneath the surface are similar to those at the Mirabeau Ave. breach, with a sand layer about 12 feet below sea-level. Here a peat layer is also observed. Peat is organic matter (vegetation that is in the process of decay). It represents material accumulated in swampy areas and indicates that this area was a swamp in the not too distant past. Peat is very porous and has the additional property that it shrinks when it is dried out and expands when water is added. The presence of peat can make for very unstable soil conditions.

Although the “as built” design documents (U.S. Army Corps of Engineers, 1994) show that the depth of the sheet pilings were at 14 feet below sea-level, water still had access to the peat layer and thus the peat layer could have played a role in the collapse of the levee. Another phenomenon that was observed here was that of ground heave in the area of collapse. Water, and perhaps expanding peat, apparently pushed up the levee and land surface on the west side of the canal prior to collapse of the levee. This is illustrated in Figures 37 and 38. Although the clubhouse shown in Figure 37 has been removed during the repair of the levee, the house (with the mispositioned air conditioner compressor) is the 5th house south of Robert E. Lee Blvd. on Pratt Drive (this house was demolished in early November, 2006).

Figure 36. Geological cross-section along the west side of the London Avenue Canal constructed from data in U.S. Army Corps of Engineers (1989).

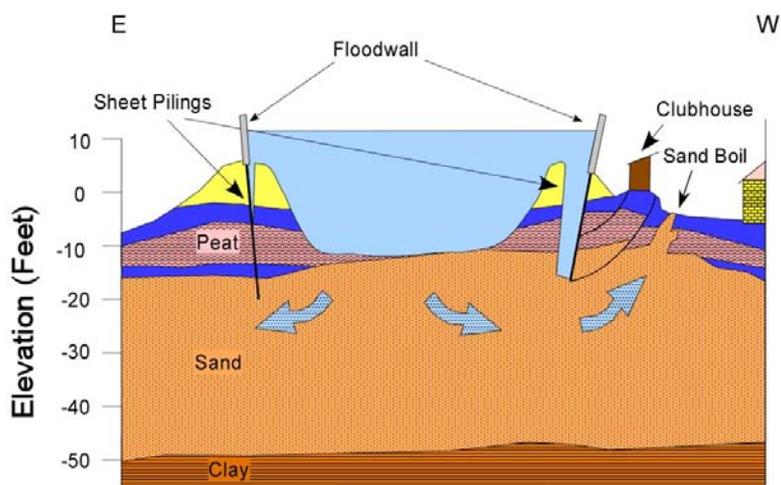
Heaving at London Ave. Canal North Breach

Figure 38. Water in the canal at the north breach of the London Ave. Canal puts lateral pressure on the floodwall and sheet piling along with water driven through sand under the sheet pilings (and possibly through peat, depending on the depth to which the sheet pilings actually were driven) pushes up the ground outside of the canal in a phenomenon known as heave. This would eventually provide a flow path for water which would undermine the levee and cause its collapse. This may have been responsible for the eventual collapse of the floodwall on the west side of the canal resulting in the breach. The floodwall on the east side of the canal was leaning, but did not fail to create a breach.

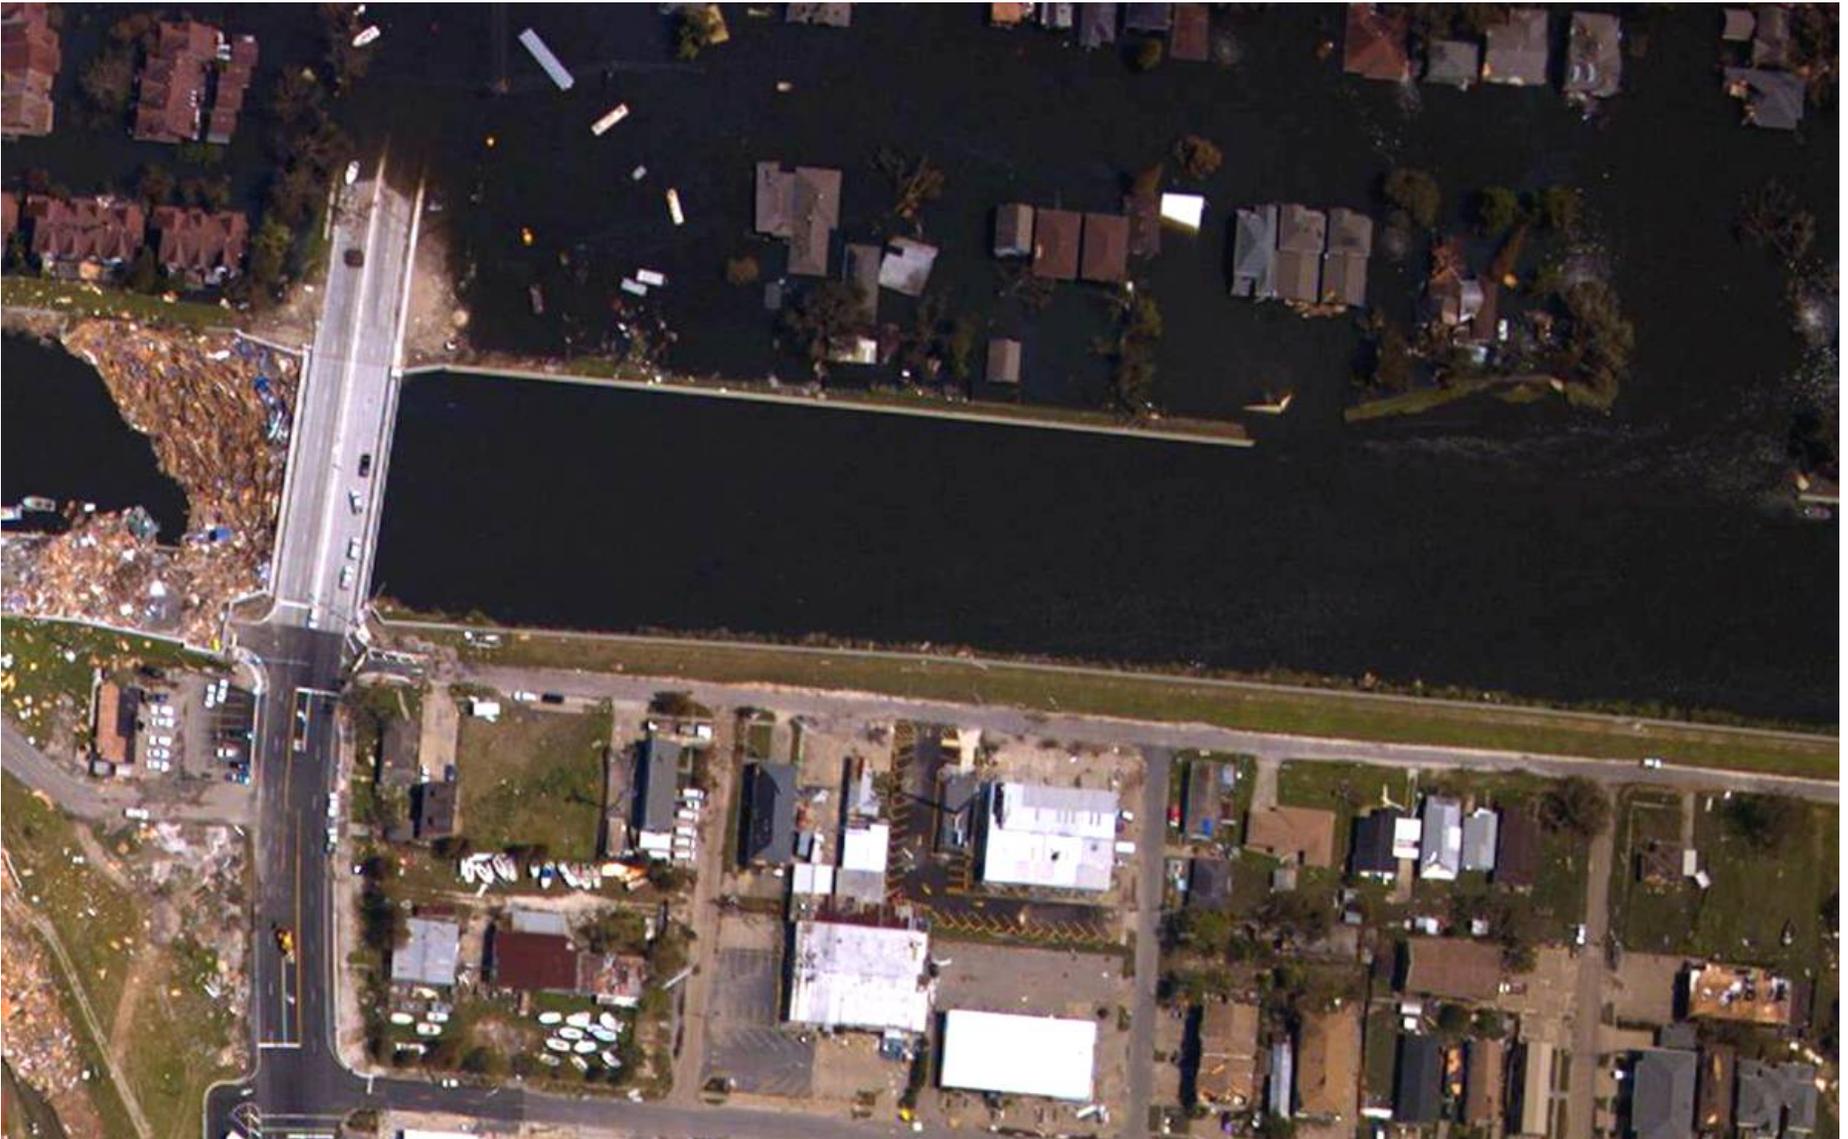
Note that the breach occurred along Belaire Drive where, like the along the London Avenue Canal, houses are backed up against the levee. (All houses bordering the breach area on the west side of Belaire Drive were demolished by the Corps of Engineers in July, 2006). Here, the main part of the breach occurred in a recently cleared empty lot. A tree in that empty lot, close to the levee toe (Fig. 41) can be seen to be toppled in the August 31 image (Fig. 42). Just as at the Mirabeau breach, no eyewitness are available to tell us if the tree toppled due to the hurricane force winds on August 29 or as a result of the levee breach. Without such observations, we note that it is entirely possible that if the tree was toppled by the winds it could have been responsible for the breach at this locality. A house to the south of the main part of the breach, built on a chain wall foundation, was completely removed (see also the photo in the lower right of Figure 51). Natural gas from a line that fed the house can be seen bubbling up through the floodwater in Figure 42. Another house to the north of the empty lot was built on a slab and was also removed by the rushing floodwaters. The natural gas line that fed that house can also be seen bubbling up natural gas, just to the right of the yellow spot (roof of a school bus) in Figure 42.

Also visible in Figure 42 is a section of the levee that was displaced eastward by about 45 feet. Figures 43 and 44 are oblique aerial views of this displaced levee and floodwall. The area in front of the displaced levee was pushed horizontally outward near the position of the yellow school bus. This can also be seen in Figure 45 where the toe of the slide block is seen as an abrupt change in slope of the ground surface.

Figure 42. Air photograph of the area where the 17th Street Canal Levee was breached near Belaire Drive (Stop 8). Image acquired Aug. 31, 2005. Source: National Oceanic and Atmospheric Administration's National Geodetic Survey, Katrina Images - <http://ngs.woc.noaa.gov/katrina/>

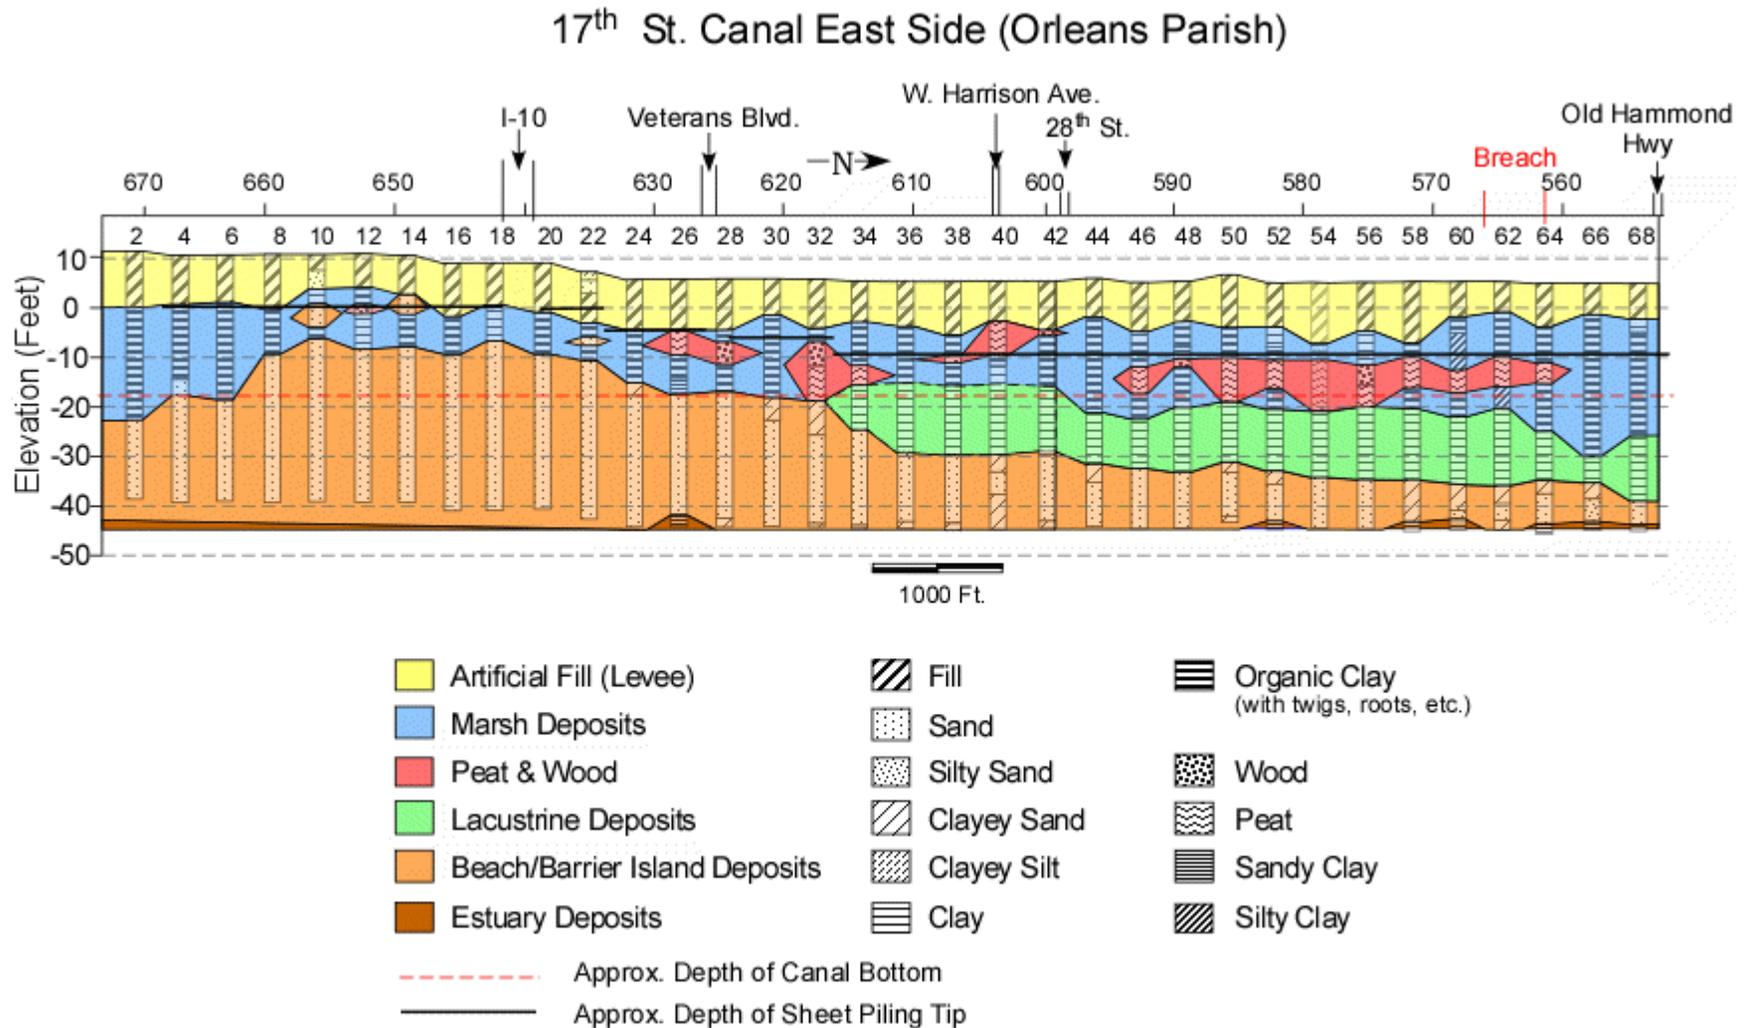
Figure 47 shows a geological cross section along the levee of the 17th street canal. The most notable feature of the cross section is the peat layer observed at depths between about 8 and 15 feet below sea level in the area of and to the south of the breach.

Figure 47. Geological cross-section along the eastern side of the 17th St. Canal (based on data in the U.S. Army Corps of Engineers design documents (1990)). Notable in the cross-section is the peat layer that occurs in the area of the breach. Depth to sheet piling tips is highly uncertain due to inconsistent information available from the U.S. Army Corps of Engineers. The set of as built available on the IPET web site plans (from which the sheet piling depths in this figure were used), show a depth of 10 feet in the area of the breach, yet the Corps claimed and later confirmed by pulling a sheet pile near the breach, that the sheet piles actually extended to 17.5 ft. below sea-level.

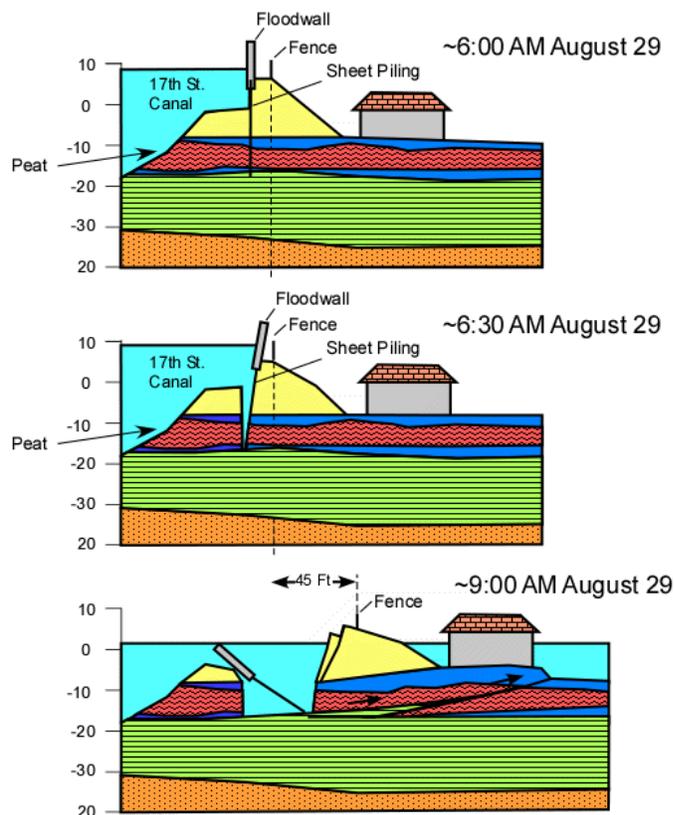
Failure of the 17th St. Canal Levee & Floodwall

The most recent information from the Interagency Performance Evaluation Task Force (IPET) [2006] suggests that the floodwall and levee failed at the 17th St. Canal as a result of the water level rising to an elevation of about 8 feet above sea level in the canal. The floodwalls were designed to have tops at an elevation of 14 feet above sea level, but IPET data indicate that by the time of Katrina the tops of the floodwalls on the 17th Street Canal were about 12.5 feet above sea level. Thus, IPET estimates that water levels in the canal were still 4 feet below the tops. IPET has collected eyewitness accounts and scoured the neighborhood for clocks that were stopped as a result of the flooding in order to determine the time of the breach. One eyewitness account suggests that the floodwall at the breach area was leaning to the protected side at about 6:30 AM on August 29 and other accounts suggest that the breach was open by about 9:00 AM. This, along with levee breach experiments conducted on scale models in a large centrifuge led IPET to suggest that as water levels rose in the canal, the floodwall and sheet piling was pushed outward toward the land side, opening a gap between the levee and the floodwall on the canal side. This gap allowed water to seep down along the sheet piling and eventually push the levee on the protected side outward away from the canal. Based on sections of the breached levee observed in the breach area, IPET suggests that the failure did not occur along the peat layer, but along a layer of weak clay at the base of the peat. This clay layer was thrust over and through the peat as illustrated in Figure 48.

Figure 48. Diagrammatic cross sections across the 17th St. Canal in the vicinity of the breach. Based partially on a sketch in Seed and others (2005), ILIT (2006) and IPET (2006).

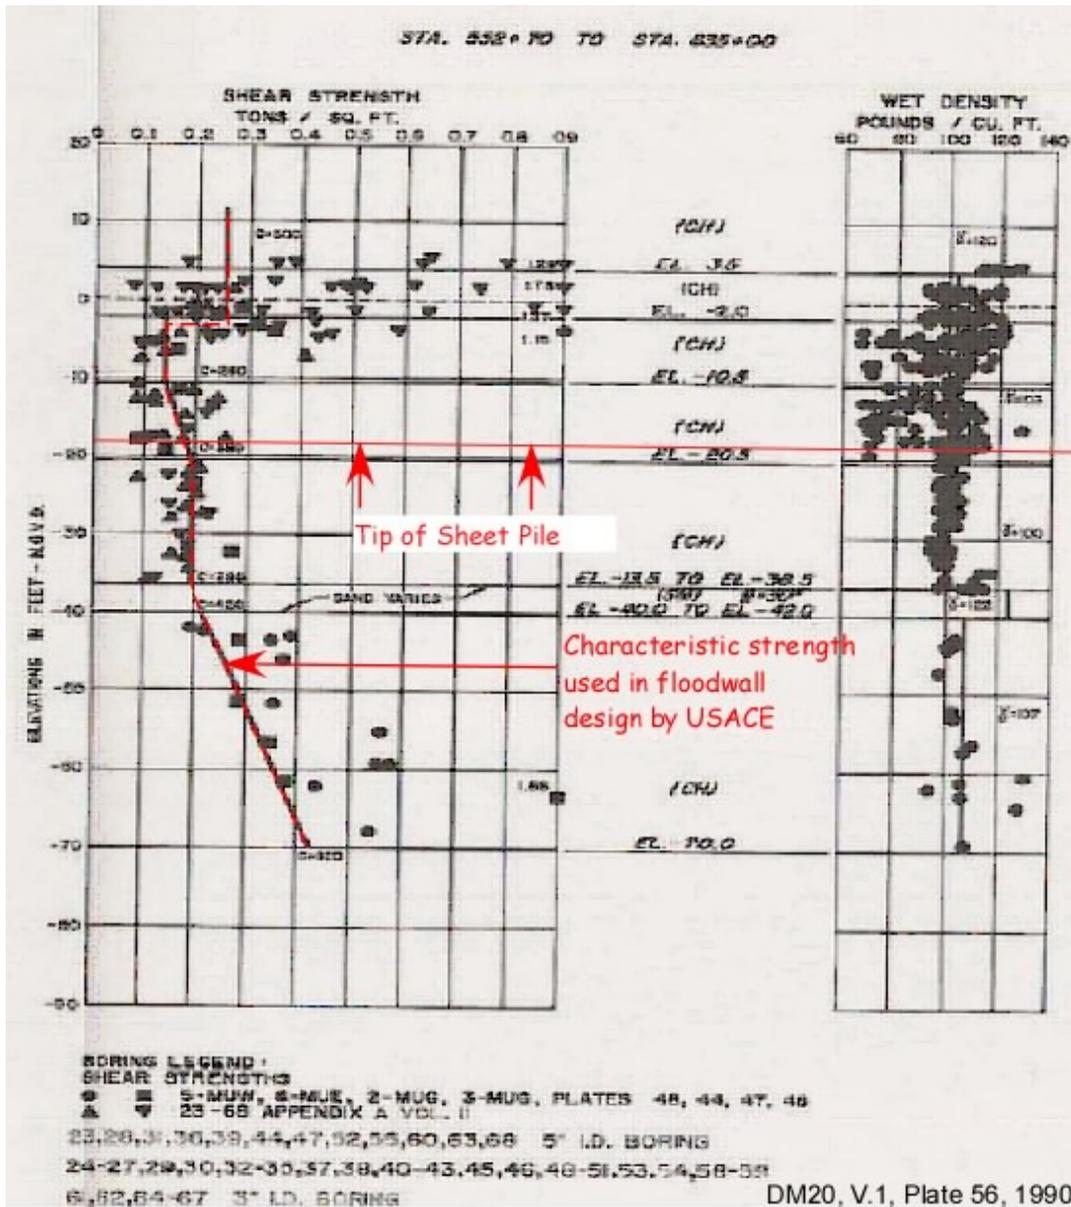
Figure 50 shows graphs of shear strength and wet density versus depth as obtained on samples from soil borings (done before 1990) along an 1800 foot section of the 17th St. Canal, which includes the area of the breach. Red lines have been added for emphasis, one showing the depth to the tip of the sheet piling within the breach zone (17.5 feet below sea level) and the other highlighting the characteristic strengths used by the designers to determine the stability of the floodwall. Between the two graphs are lines separating the different kinds of soils. Note that all soils above about -37 feet are shown as CH soils, which are clays with high plasticity. If one looks at the geologic cross-section in Figure 47, there is an interval between about -10 and -18 shown as peaty clays (the same peat that came to the surface as a result of the levee breach). Peats have low density and thus the wet density data in Figure 50 clearly shows a zone of low density material in the depth range between 0 and -20. The strengths in this zone show a range, but the designers chose to use an average value. What is even more troubling, however is that in the depth range between about -15 and -37, the nearly all of the measured strengths fall below the characteristic strength line used in calculations of FS. This is the critical zone, where all investigators think the failure occurred during Katrina. If the strengths were overestimated by 30%, then the true FS value would fall below 1.0 and the structure would be unstable (just as it was during Katrina).

Figure 50. Shear strength and wet density versus depth along an 1800 foot section of the 17th St. Canal which includes the area of the breach (from U.S. Army Corps of Engineers, 1990, the Design documents for the 17th St. Canal floodwall). The author has added the red lines and red labeling showing the depth to the tip of the sheet piles in the breach zone and the characteristic strength values as a function of depth that the Corps used to determine the stability of the floodwall system.

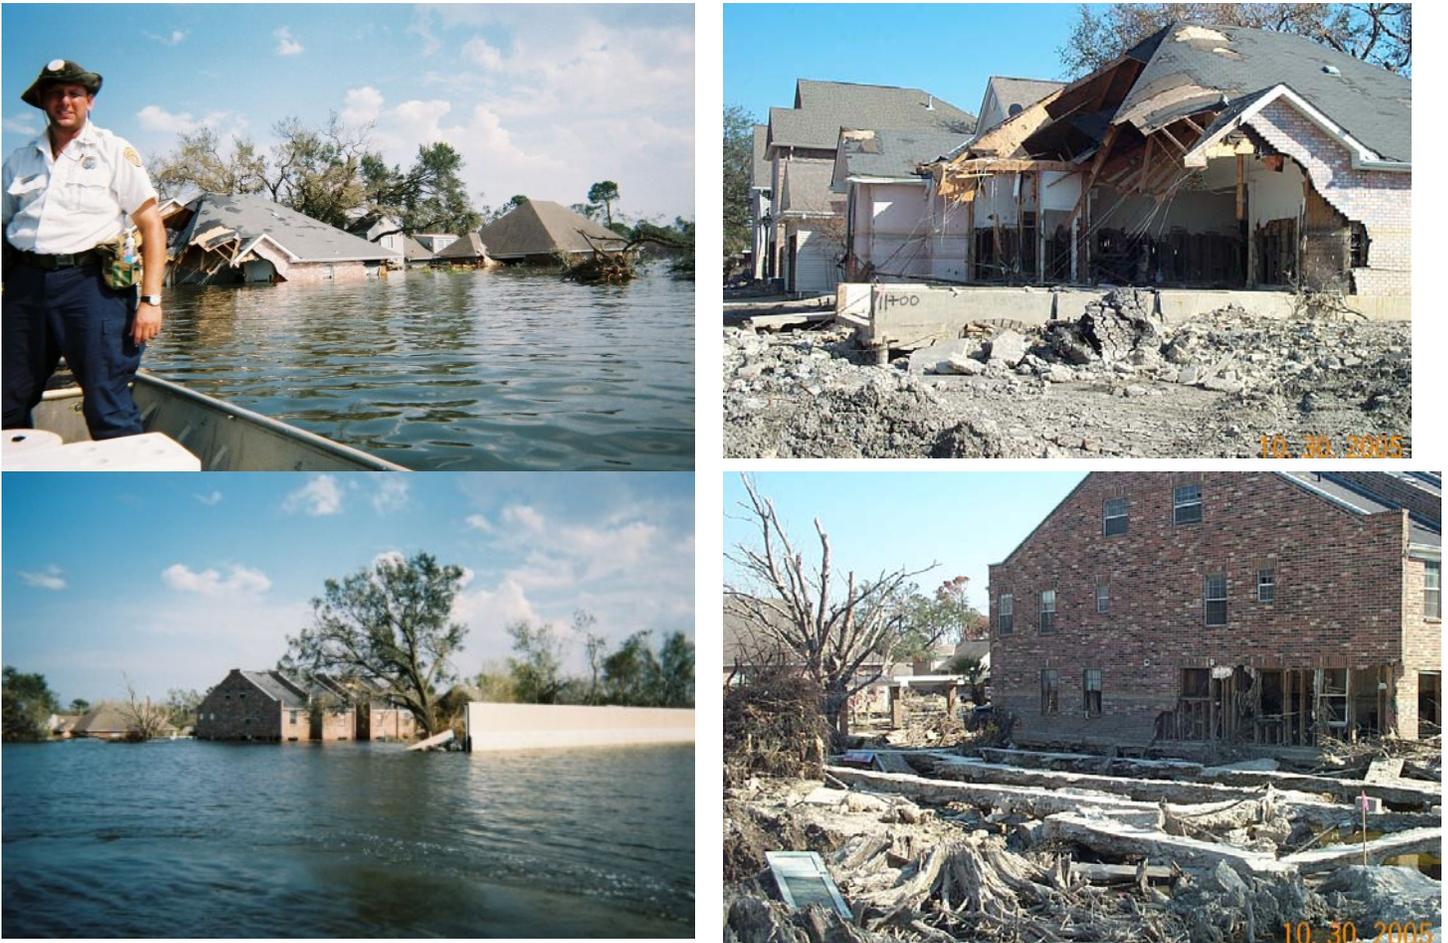
Although throughout the field trip we have seen the water line (scum line) left by standing water, this line does not represent the maximum flood depth. As seen in Figure 51, comparison of the photos on the left, taken when the water level was near its maximum with the water line left on the same structures (photos on the right) indicate that the maximum flood depth was about 1.5 to 2 feet higher than the line left by standing water.

Figure 51. Comparison of water levels on Sept.1, 2005 (photos on left by Kevin Himmel), with water lines on same structures indicate lines left by standing water are about 1.5 to 2 feet lower than the maximum water level. Note large block of peat in photo at the upper right. In photo at lower right, note the chainwall foundation of a house that was removed by the burst of water when the levee was breached and the cypress stump from a tree that was probably cut down 100 years ago when this Lakeview neighborhood was reclaimed from the cypress swamp.

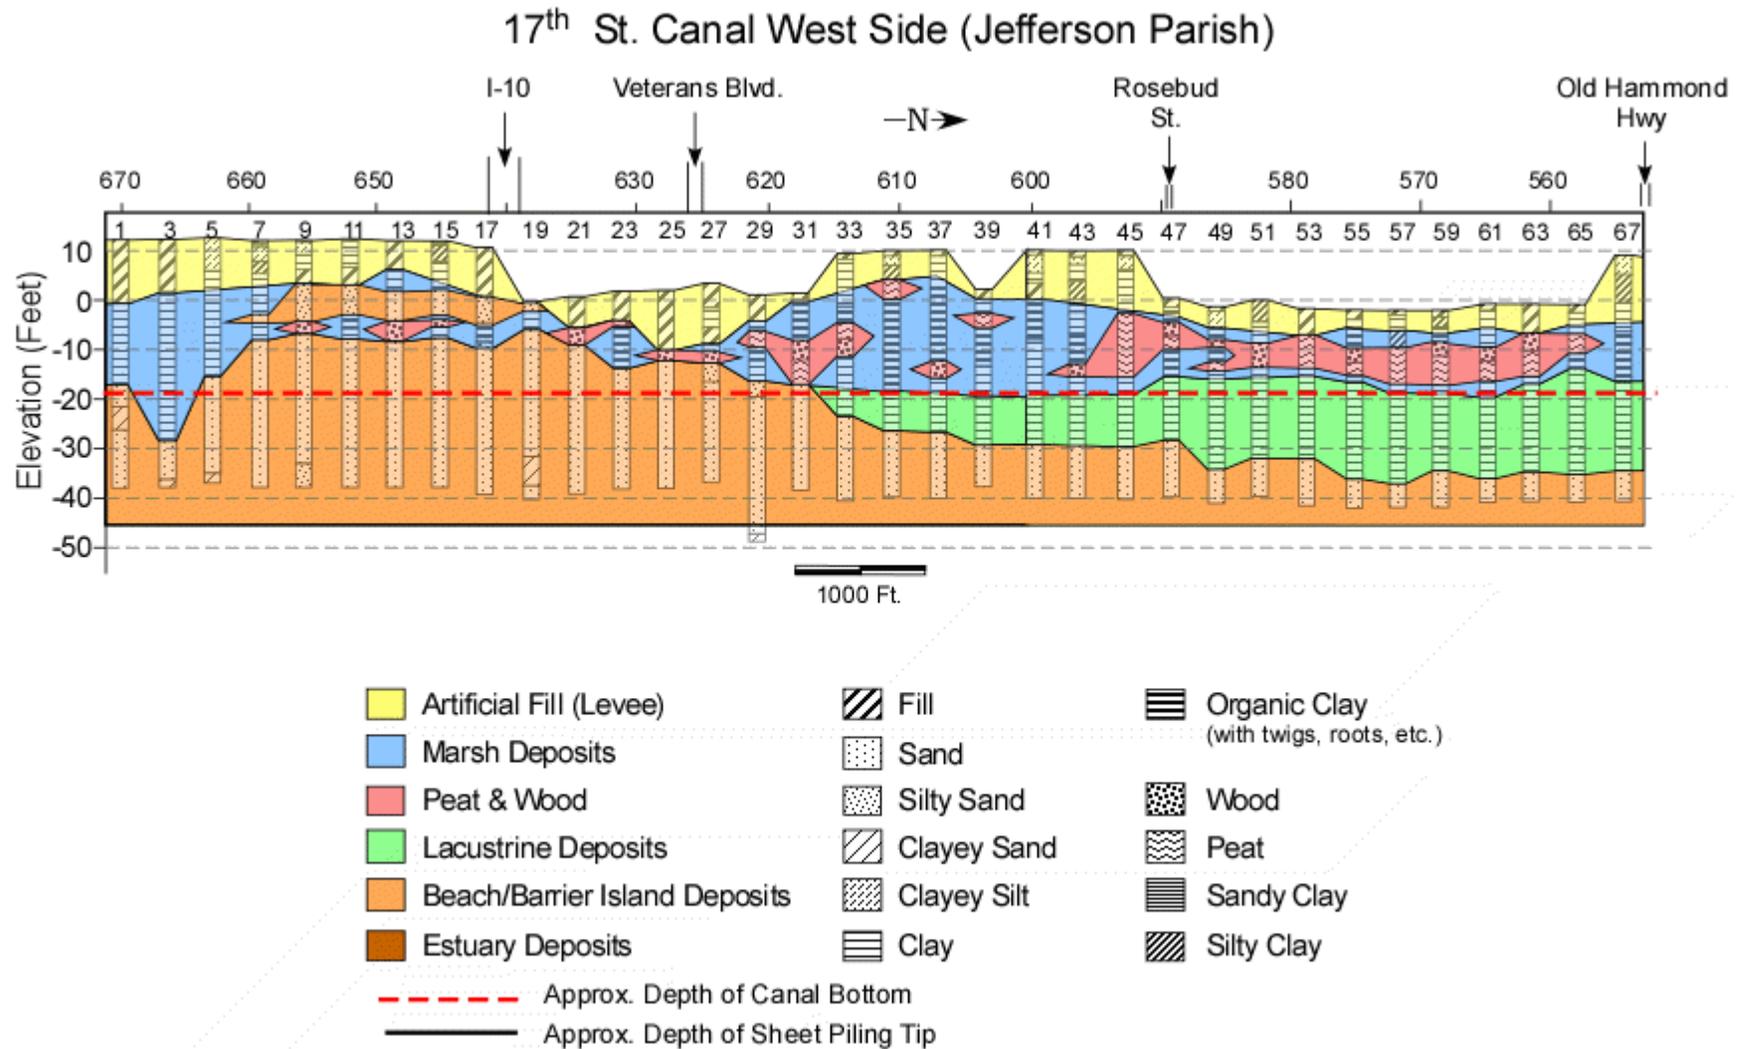
It is notable that the same peat layer and the same levee design and construction are present on the Jefferson Parish side of the canal, which by luck or the path of the storm, did not breach on August 29, 2005. Figure 52 shows a geological cross section of the west bank (Jefferson Parish side) of the 17th St. Canal constructed from data provided on the Army Corps of Engineers IPET web site where it can be seen that the same geologic materials are present beneath the Jefferson Parish side as are found on the Orleans Parish side (compare with Figure 47). One major difference on the Jefferson Parish side is that a street occupies the area next to the levee and there are no trees, houses or swimming pools abutting the levee on that side.

Figure 52. Geologic cross section of the west bank of the 17th St. Canal constructed from data provided to the U.S. Army Corps of Engineers (1990). Note that levee heights appear inconsistent because some of the borings were taken at the toe of the levee rather than on the levee crest. Depth to the tip of the sheet pilings is currently not available for the west side of the 17th St. Canal, although Grissett (April 14, 2007) has information that the sheet pile tips extend only to about 4 feet below sea-level at southern end of the canal (south of Veterans Blvd.).

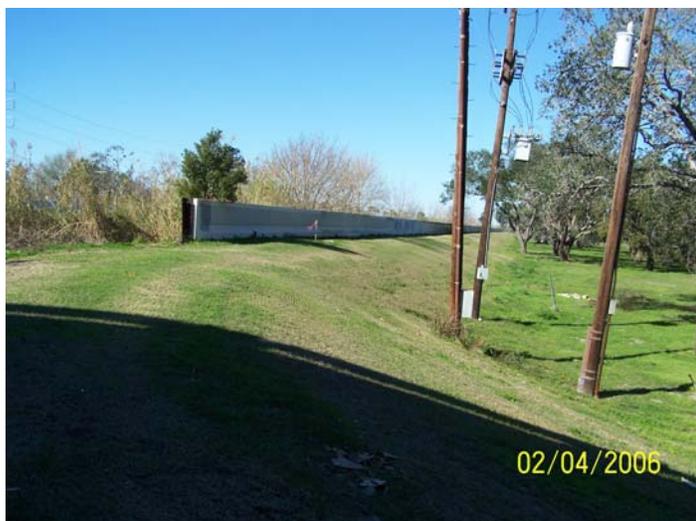
Stop 9 is at the levee of the Orleans Canal just under the I-610 overpass. As we walk up to the levee, note that the floodwall on the top of the levee abruptly ends about 40 yards north of the overpass (Fig. 53). An approximately 100 yard gap thus exists in the flood protection on the canal between the end of the floodwall and Pump Station Number 7 to south on the other side of the overpass. A smaller gap exists on the other side of the canal as well. During Katrina, water from the Orleans Canal was flowing freely through this gap as evidenced by the erosion that occurred around the support structures for the freeway overpass (Figure 54). Fresh concrete has since been poured around the support structures and the levee has been raised about 2 feet from its pre-Katrina level in an attempt to fix the problem. Why was such an obvious gap in the flood protection system allowed to remain? The Independent Levee Investigation Team (2006) offers the following explanation. Apparently, the Orleans Sewerage and Water Board, who run the pump station, objected to the Corps of Engineers plan to build the floodwall right up to the wall of the pump station. They argued that the wall of the pump station was not strong enough to withstand the force of the water if it backed up in the canal, and would fail with the result that the city would flood when the wall failed. Of course the net result was that the city flooded as the water poured through the gap. Nevertheless, the relief of pressure in the canal may have prevented the floodwalls and levees elsewhere on the canal from failing.

Figure 53. End of floodwall on Orleans Canal just north of I-610 overpass near Marconi Ave. (Stop 9)
