Hurricane Katrina - What Happened? The Geology of the Katrina Disaster in New Orleans

AEG Field Trip
September 16 & 20, 2008

Stephen A. Nelson
Department of Earth &
Environmental Sciences
snelson@tulane.edu

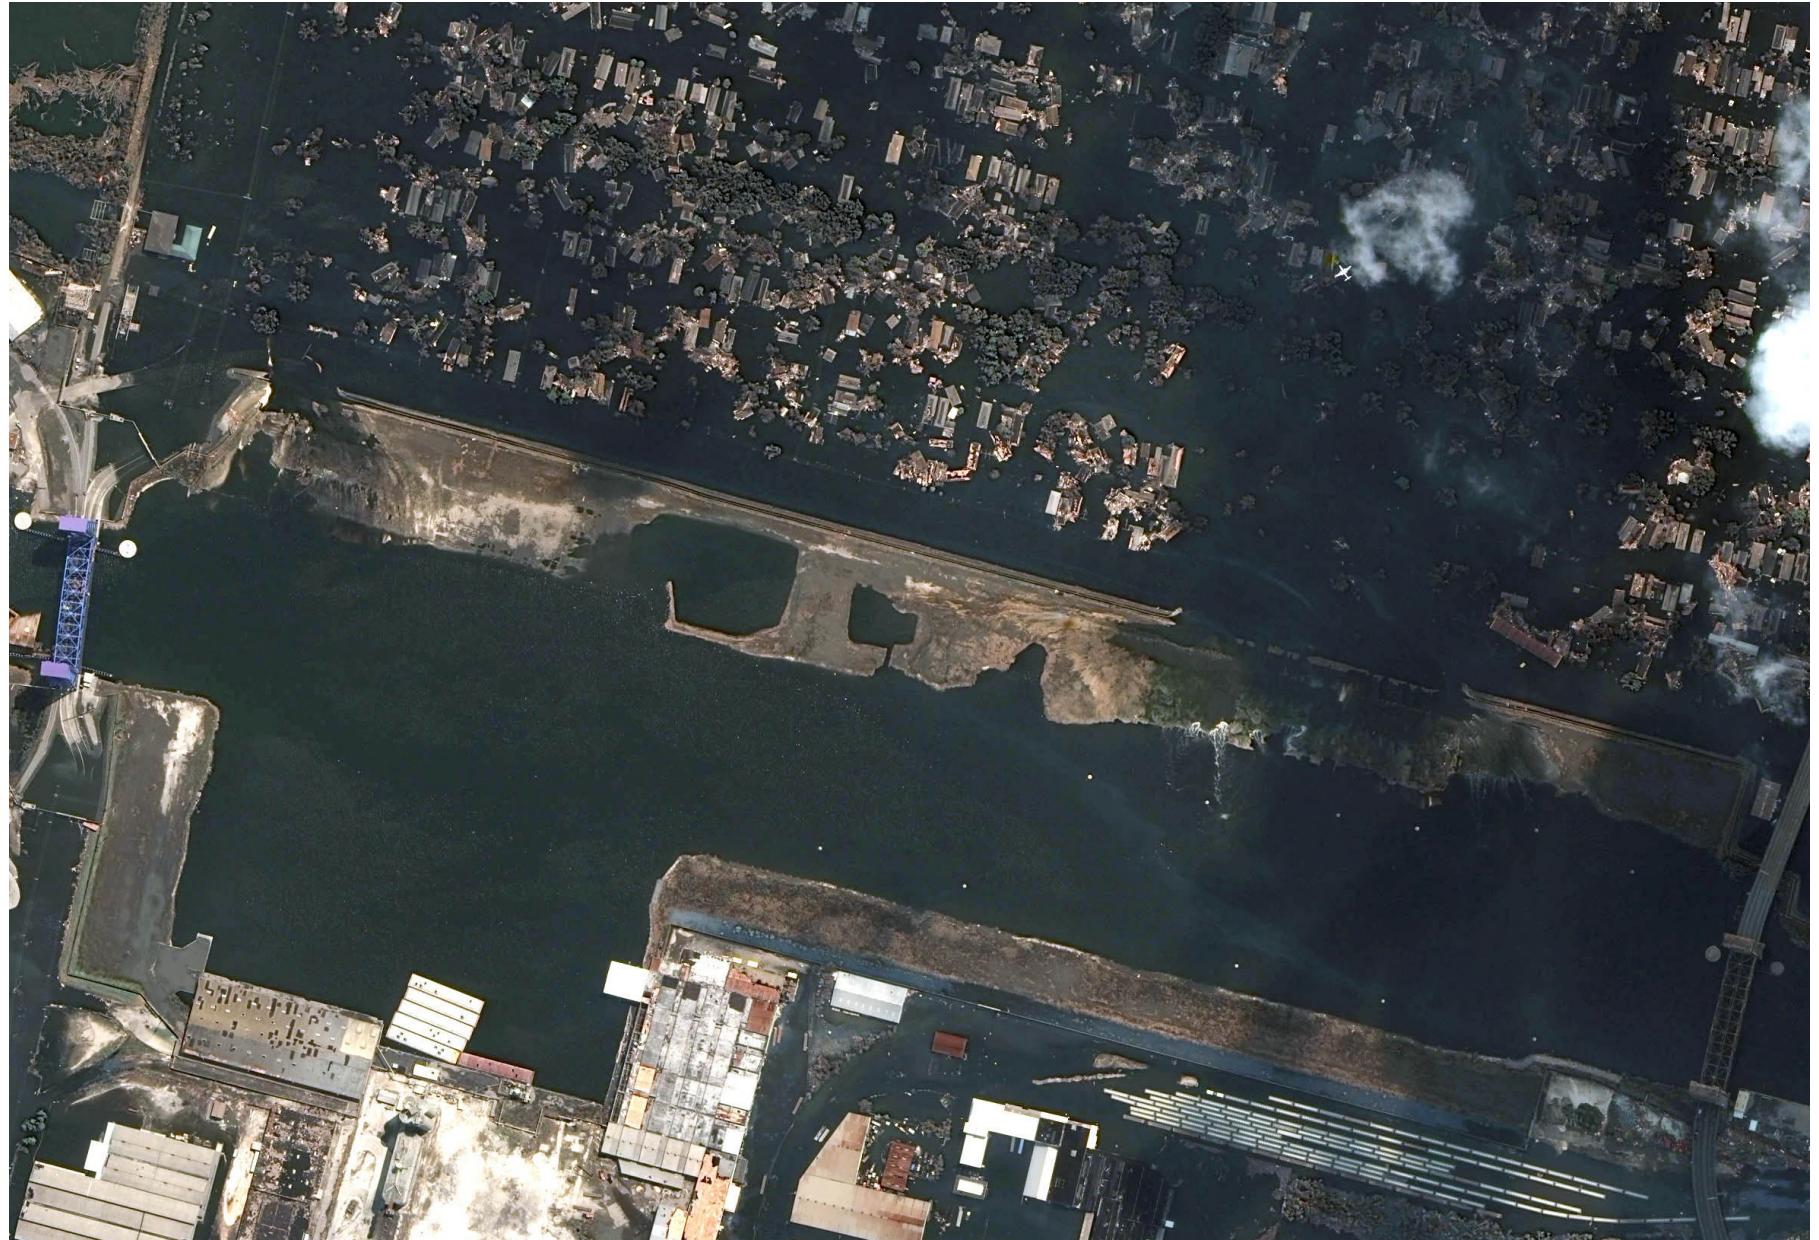
Figure 11. Air photograph of the area where the Industrial Canal Levee was breached to flood the Lower Ninth Ward. Image acquired Sept. 3, 2005 Source: National Oceanic and Atmospheric Administration's National Geodetic Survey, Katrina Images - <http://ngs.woc.noaa.gov/katrina/>

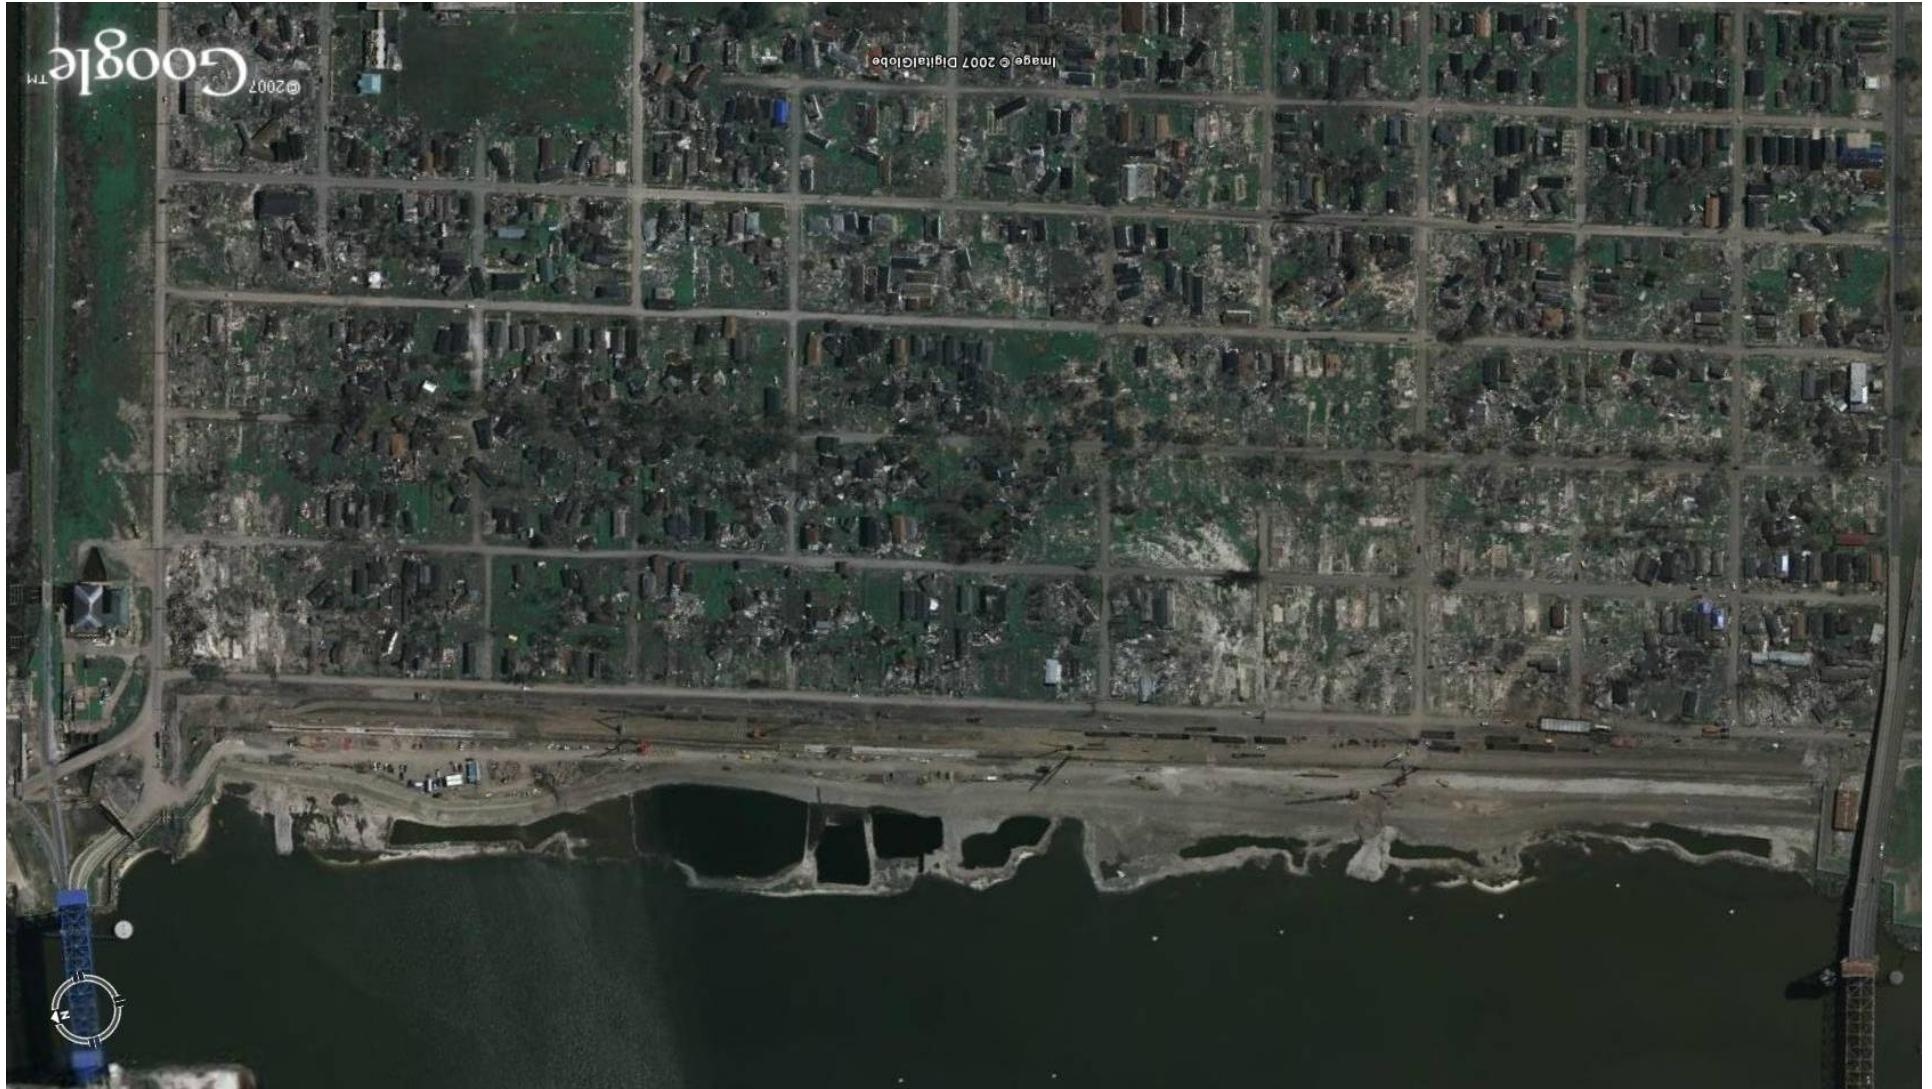
Figure 12. Google Earth image of the area where the Industrial Canal Levee was breached to flood the Lower Ninth Ward. Image acquired around mid-March, 2006.

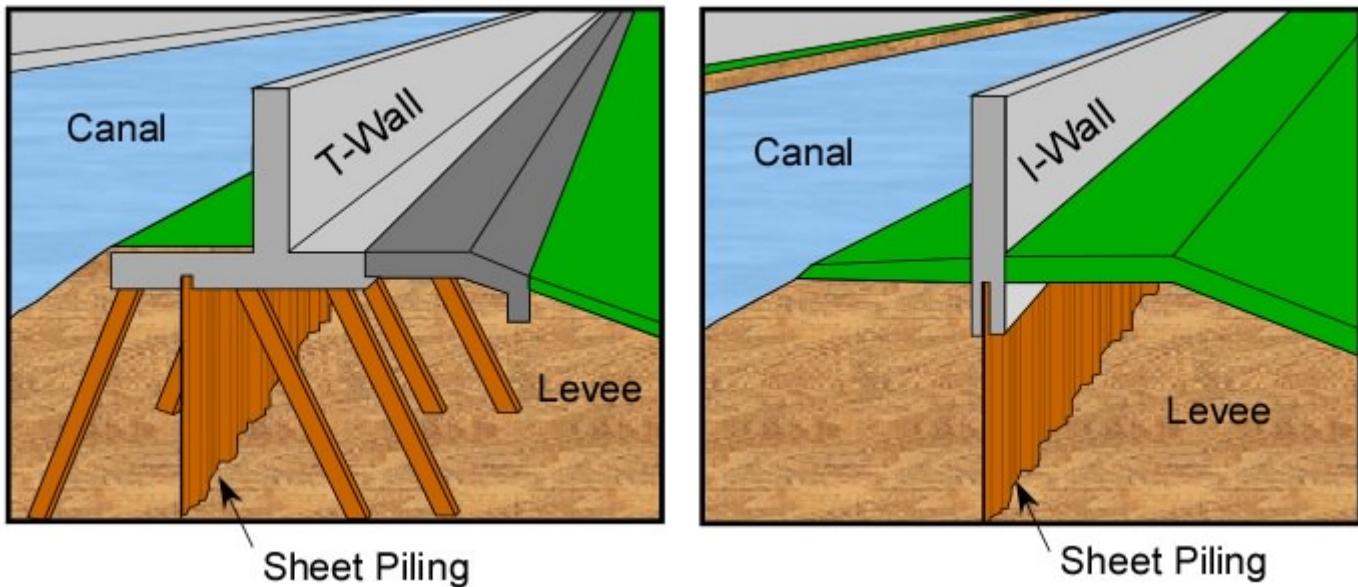
Figure 18 shows the floodwall between the two breaches on the Industrial Canal where the floodwall was not breached, but was leaning outward toward the Lower 9th Ward. One can easily see that the top of the levee has dropped down along side of the leaning floodwall. This type of floodwall was an I-wall, one of two designs used in the New Orleans hurricane protection system (Fig. 19).

Figure 19. Most pre-Katrina floodwalls in New Orleans were built with the I-wall design (right). In repairing failed floodwall sections after Katrina, the T-wall design (left) was used.

At Stop 1 in the Lower 9th Ward, one now sees that the entire floodwall between the two bridges (Claiborne to the south and Florida Avenue to the North – the blue colored bridge) has been replaced with a T-wall with a top elevation at 14.5 feet above sea level, the level it was supposed to have attained prior to Katrina. This new floodwall was completed in mid-June, 2006. The original I-wall is still present along the other side of the Industrial Canal as well as to the south and north of the new T-wall. The only improvement made to the levees where the I-walls still exist is concrete armoring has been added to the base of the I-wall to prevent the erosion of the levee should water come over the top of the wall again.

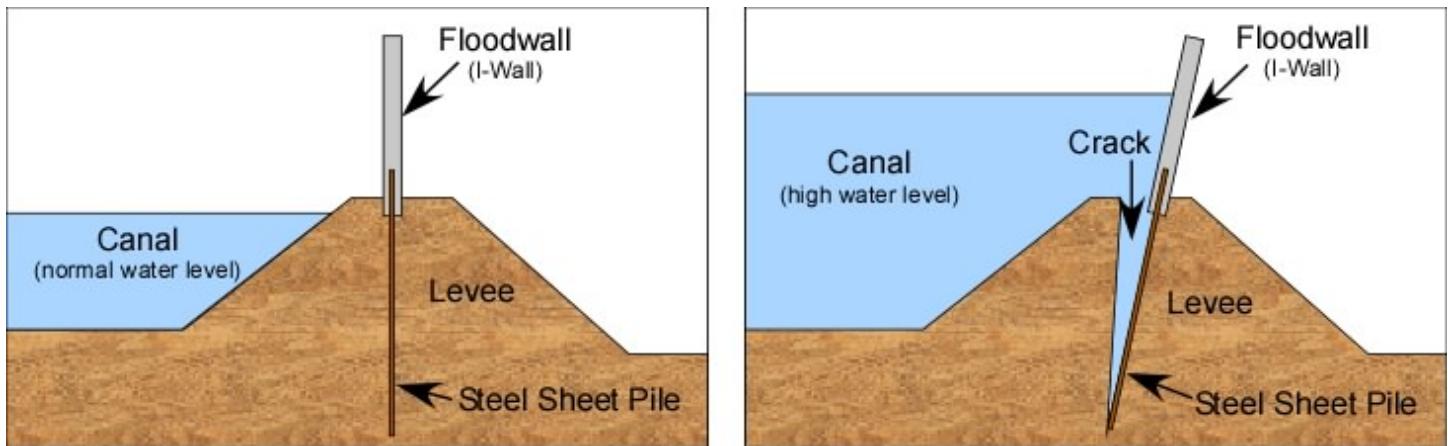
Although the floodwalls along the Industrial Canal were built in the 1970s, in 1985, the research branch of the Army Corps of Engineers conducted experiments on the I-wall design. They constructed a levee and enclosure in the Atchafalaya Basin (to the southwest of New Orleans) and began filling the area next to the levee and sheet pile floodwall with water. As the water rose against the floodwall, deflections of the floodwall began to occur and a gap opened on the water side of the floodwall which allowed the full hydrostatic force of the water to penetrate to the tip of the sheet piling (Jackson, 1988, Oner and others, 1997). This type of floodwall failure is illustrated in Figure 20. These findings were apparently never communicated to those in the Corps responsible for the design and construction of floodwalls in New Orleans (Marshall, March 14, 2006). The leaning floodwall seen in Figure 18 clearly shows that this also happened on the Industrial Canal floodwall during Hurricane Katrina. The force of the water pushing the wall outward toward the protected side coupled with removal of support by erosion caused by the water pouring over the top of the floodwall was the most likely cause of the catastrophic failures on the east side of the Industrial Canal (Fig. 21).

Figure 20. Illustration of crack development as water in a canal rises on the floodwall and pushes outward on the floodwall as observed in 1985 experiments by U.S. Army Corps of Engineers.

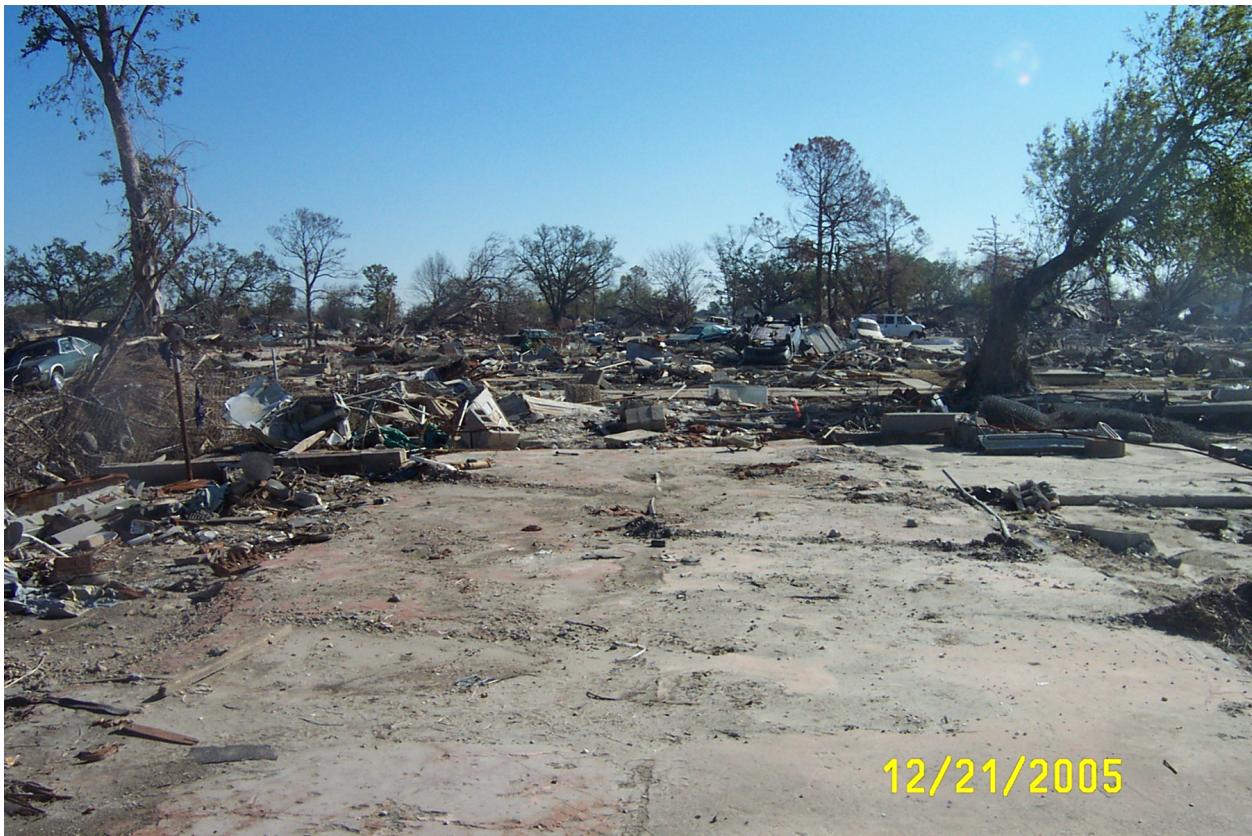
As of August, 2008, nearly 3 years after Katrina, rebuilding progress has been very slow in the Lower 9th ward in front of the breaches. Most of the rubble piles have been cleared, all of the damaged cars and trees have been removed, but a few heavily damaged houses and the remains of foundations still can be found throughout the neighborhood. Figure 22 shows a ground view of the Lower 9th Ward destruction as it appeared in December of 2005. The barge that went through the breach was removed near the beginning of March, 2006.

Figure 22. View of Lower Ninth Ward looking East as it appeared in December, 2005.

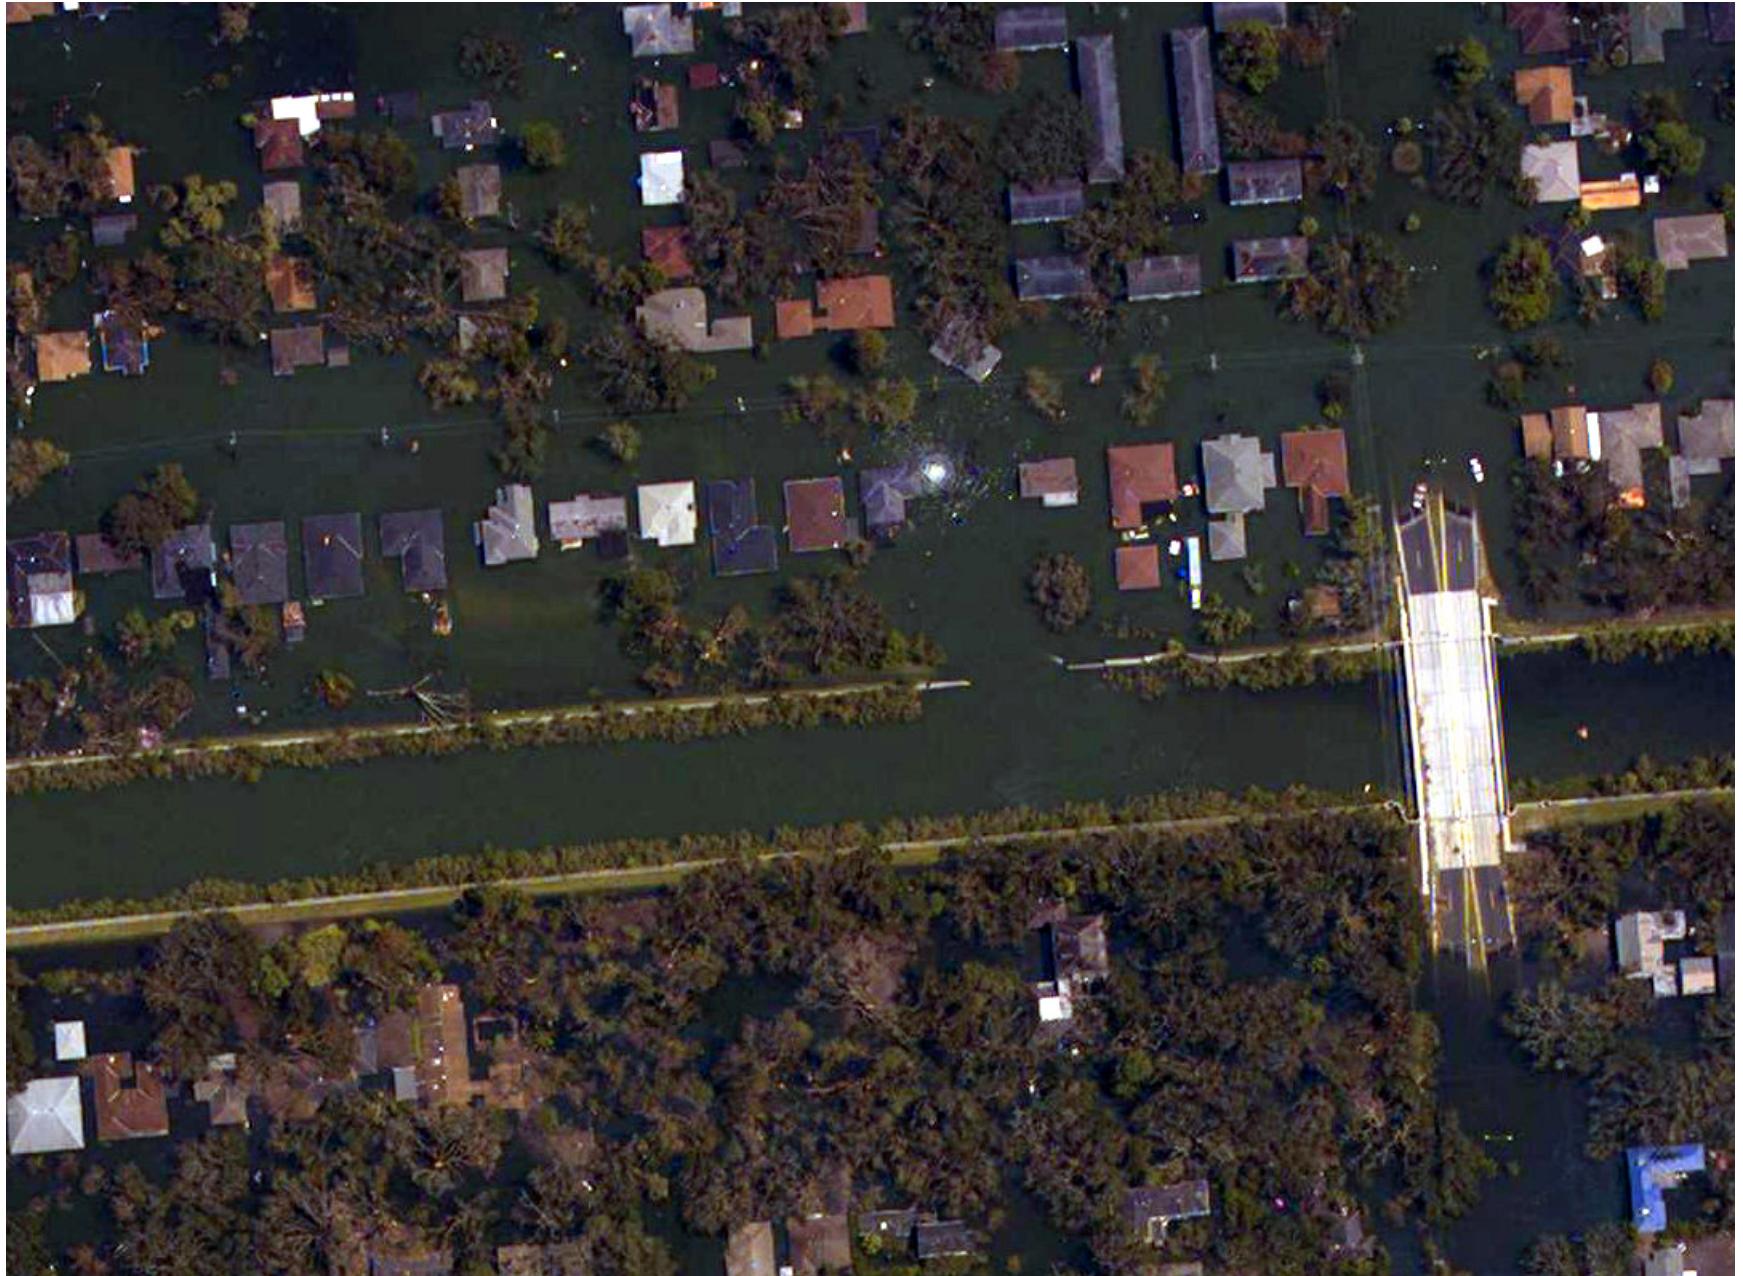
Figure 25. Air photograph of the area where the London Avenue Canal levee was breached near Mirabeau Ave. and Warrington Drive (Stop 2). Image acquired Aug. 31, 2005. Source: National Oceanic and Atmospheric Administration's National Geodetic Survey, Katrina Images - <http://ngs.woc.noaa.gov/katrina/>

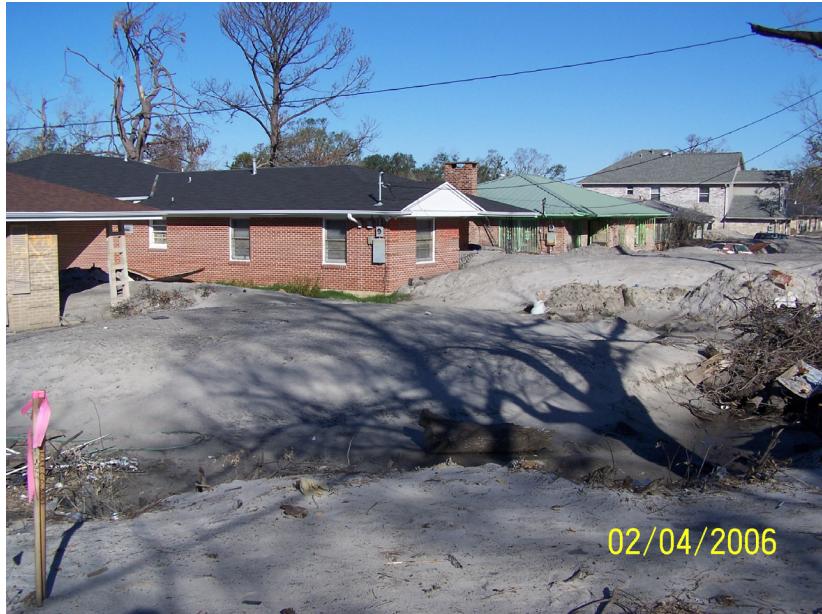
a

After the flood waters were pumped out, large deposits of sand were seen throughout the neighborhood. As of March 1, 2006 most of the sand had been removed from in front of the houses, and the back yards were cleared by January, 2007. Fig. 26 shows the sand deposits as they appeared before removal.

Figure 26. Sand deposits near the south breach of the London Avenue canal. (a) sand ridges deposited in the wake of houses as the currents flowed down the driveways between the houses. (b) Sand deposits that buried two cars in front of house on Warrington Drive . (c) Ridges of sand filling the back yards of houses along Warrington Drive, just north of the breach. As of March 1, 2006, most of the sand in the front yards had been removed and as of mid January, 2007 most of the sand in the backyards had been removed.

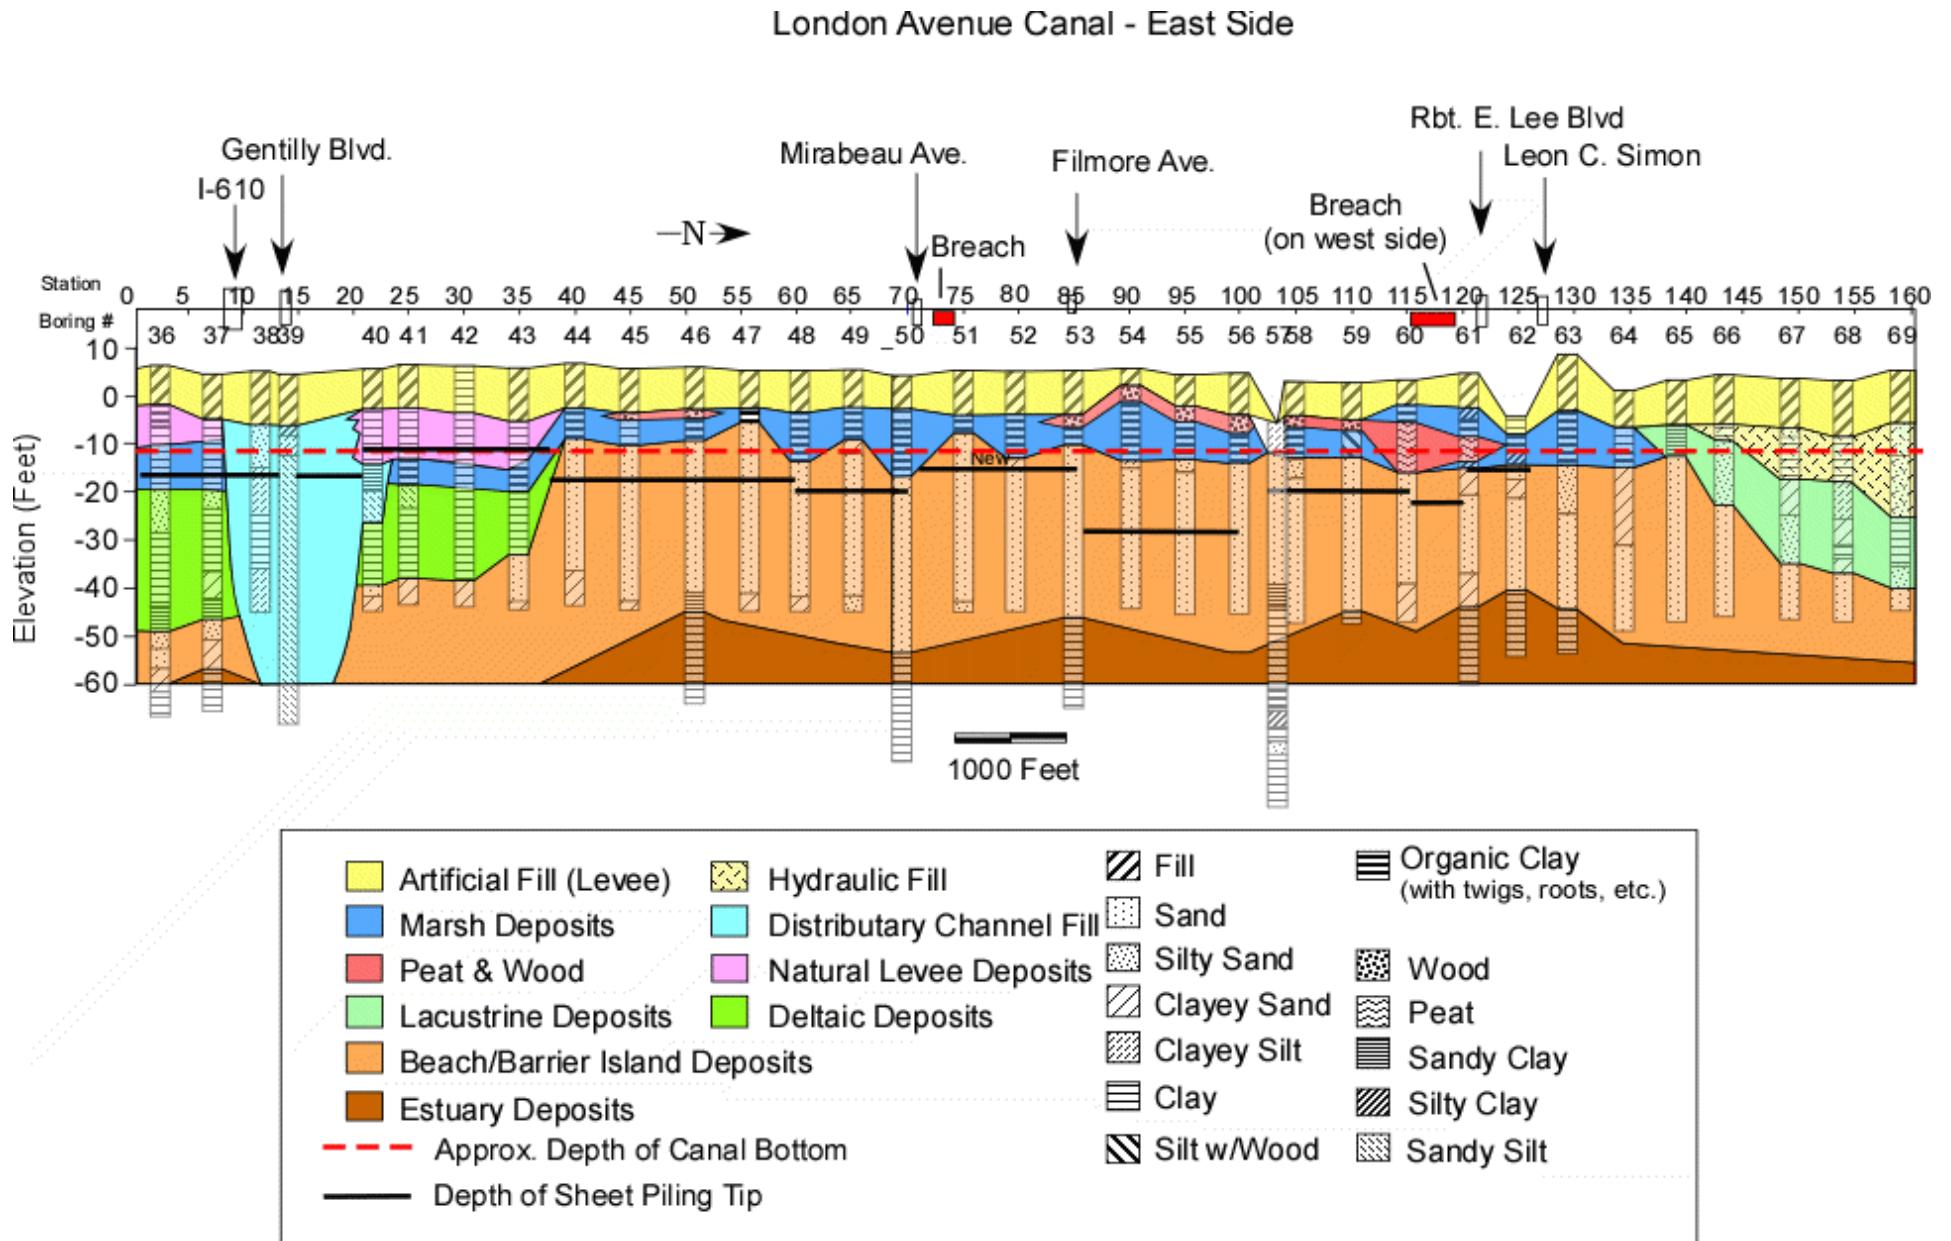
The sand in these deposits did not originate from the canal water or lake water that was pushed into the canal during Katrina. Instead, it originated from beneath the levee. A geologic cross-section constructed from data on soil borings (done in 1986) (U.S. Army Corps of Engineers, 1989) from the banks of the London Avenue Canal is shown Figure 27. The cross-sections clearly show the presence of sand at a depth beginning between 10 and 15 feet below sea level. This sand is the same Pine Island beach sand that was deposited in the area between 4,000 and 5,000 years ago as shown in Figures. 2, 5 and 6.

Figure 27. Geological cross-section along the east side of the London Avenue Canal constructed from data in U.S. Army Corps of Engineers (1989).

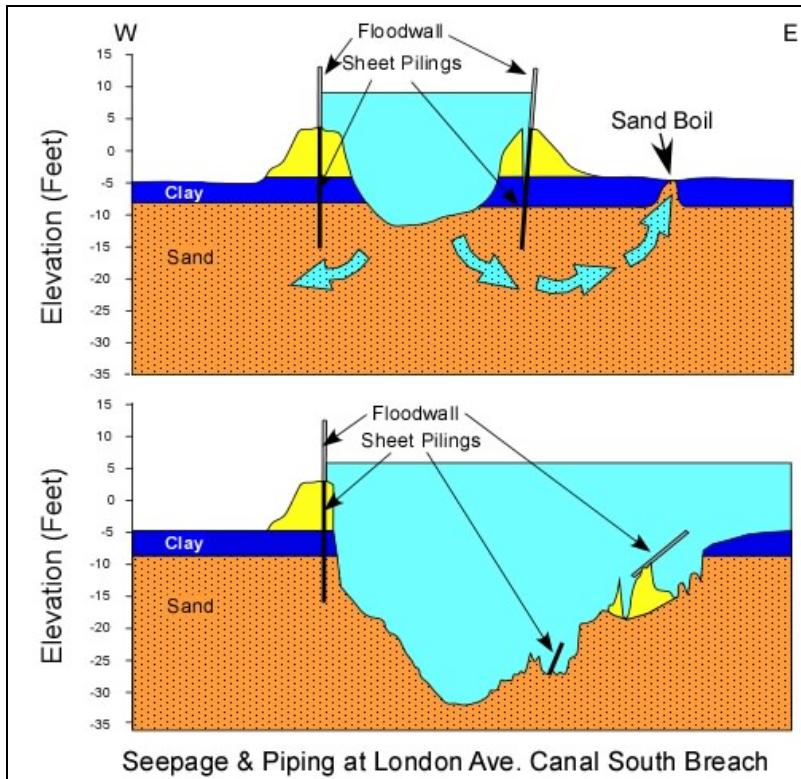
Sand is a highly permeable material. This means that water can easily be transported between the sand grains, especially when the weight due to overlying water is increased due to the added height of the water column during a storm surge. This increases the pressure and could force the water through the pore spaces in the sand and back up to the surface on the other side of the levee. If enough flow takes place the sand will be picked up by the flowing groundwater and eventually form an underground channel. This could undermine the levee and cause it to collapse. The principle is illustrated in Figure 28 with a simple thought experiment. The underflow (called seepage or siphoning) is the apparent cause of the collapse at this section of the London Ave. Canal. The "As built" design specifications indicate that the sheet pilings (which should form an impermeable barrier to pressure induced flow in the sand) were placed to a depth of 14 feet below sea level (U.S. Army Corps of Engineers, 1994), one can see from the cross section in Fig. 29, that the water still has a path back to the surface if it flows as groundwater beneath the sheet pilings. Note that in order to prevent such siphoning, the sheet pilings would need to be placed to a depth of about 50 feet below sea-level where they would penetrate a layer of clay. Clay, because the individual mineral grains stick together and thus reduce pore space and interconnection between pores, is much more impermeable than is sand.

Figure 29. Geological cross section across the London Ave. Canal based on borings 16 and 51 (Figs. 27 and 33), shown at time of estimated high water during Katrina's storm surge. The sands form a permeable layer through which groundwater originating in the canal can penetrate and move below the sheet pilings and up to the surface (top diagram), eventually undermining the levee and causing a blowout completely removing a section of levee and carrying sand into the neighborhood. The shape of the canal bottom is based on depth soundings undertaken by the U.S. Army Corps of Engineers on September 5, 2005.

The repair operation has only been done in the area of the breach. The operation involved digging out the material used in the initial emergency repair, filling it with clay and construction a T-wall to replace the missing I-wall. Fortunately, the Corps of Engineers has now completed removable floodgates near the mouths of the London Ave, Orleans, and 17th St. canals near Lake Pontchartrain. These floodgates will be closed in the event of a hurricane and should prevent storm surge from reaching onto the floodwalls in the canals. If the gates are closed, however, the pumps at the southern end of the canals cannot be used to pump rainwater out of the city. Thus, the Corps has built c pumping stations at the Lake (where they should have been built in the first place), but full pumping capacity is not yet available. Still rainwater flooding is better than having Lake Pontchartrain drain into the city.

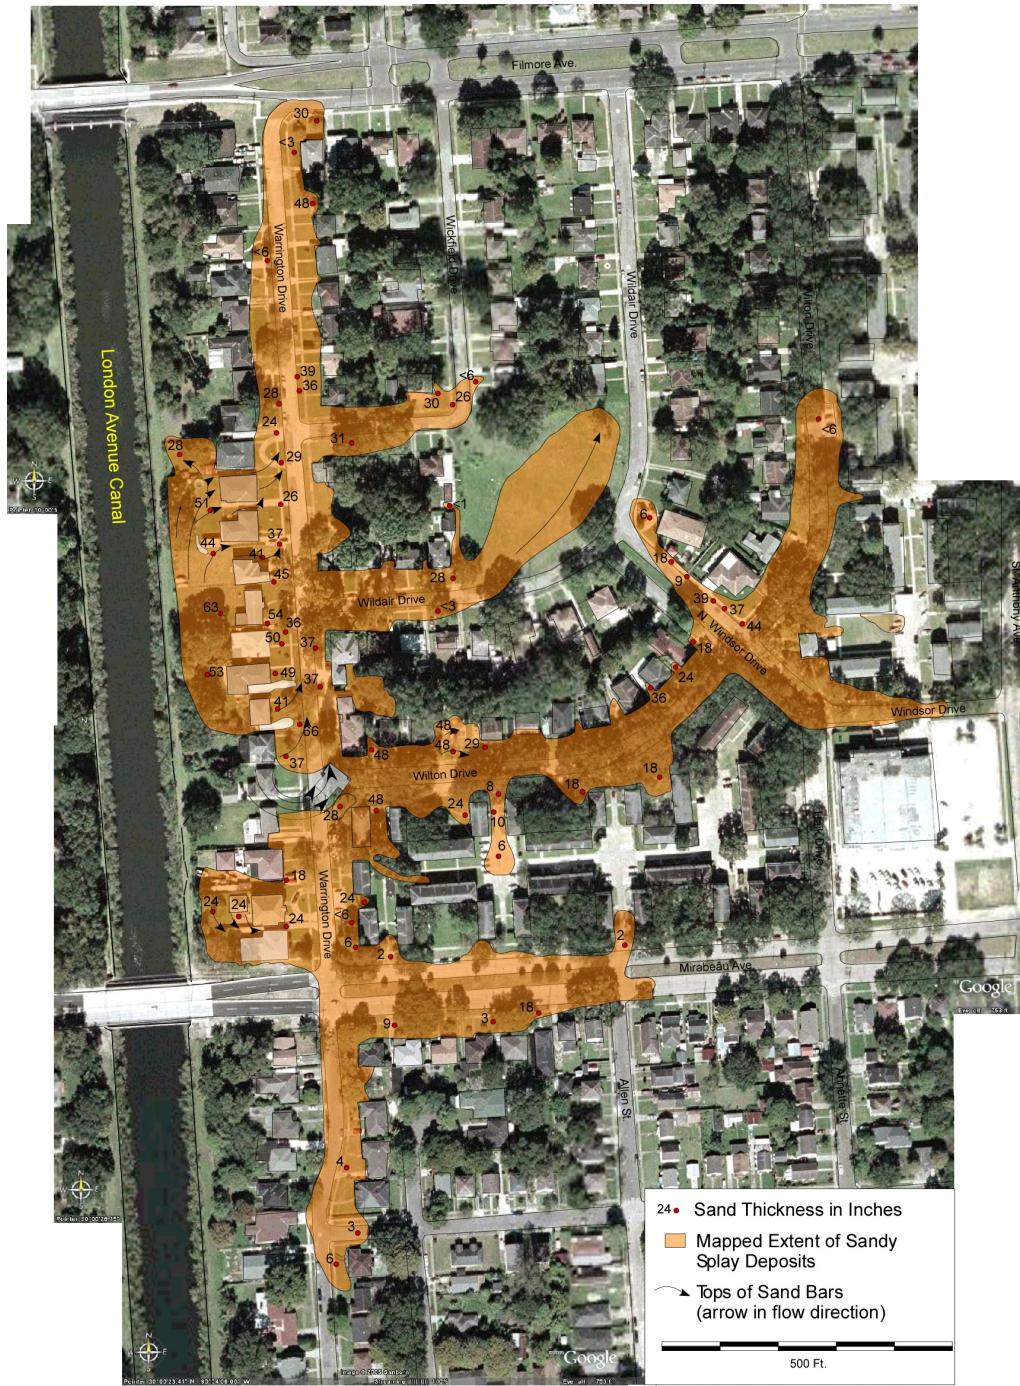
Figure 30 shows our preliminary map of the extent of the sand that scoured from the bottom of the London Ave. Canal and the blowout hole beneath the levee and deposited throughout the neighborhood. The distribution and thickness of the actual deposit was controlled by current velocity and barriers such as houses, fences, and hedges. For more information on the sand deposits at this locality, see Nelson and Leclair (2006).

Our estimate of the volume of sand deposited in the neighborhood is about 932,000 ft³. Such a volume would cover a football field, from end to end (including the end zones) with over 16 feet of sand. Engineers working on the breach repair have reported that they had to dig to a depth of 30 feet below sea level to completely remove gravel and sand bags used to plug the breach in the first few days after Katrina. A conservative estimate of the volume of this hole is about 365,000 ft³. This only accounts for about 39% of the volume of sand found in the neighborhood, and implies that the canal bottom, both upstream and downstream from the breach, was scoured to an unknown depth. This raises questions about the stability of the levee/floodwall system outside the breach area if the canal bottom is now in permeable sand in these areas.

Figure 30. Preliminary map of sand deposits (by S. A. Nelson) from the Mirabeau Ave. Breach on the London Ave. Canal. Underlying image is a composite from Google Earth.

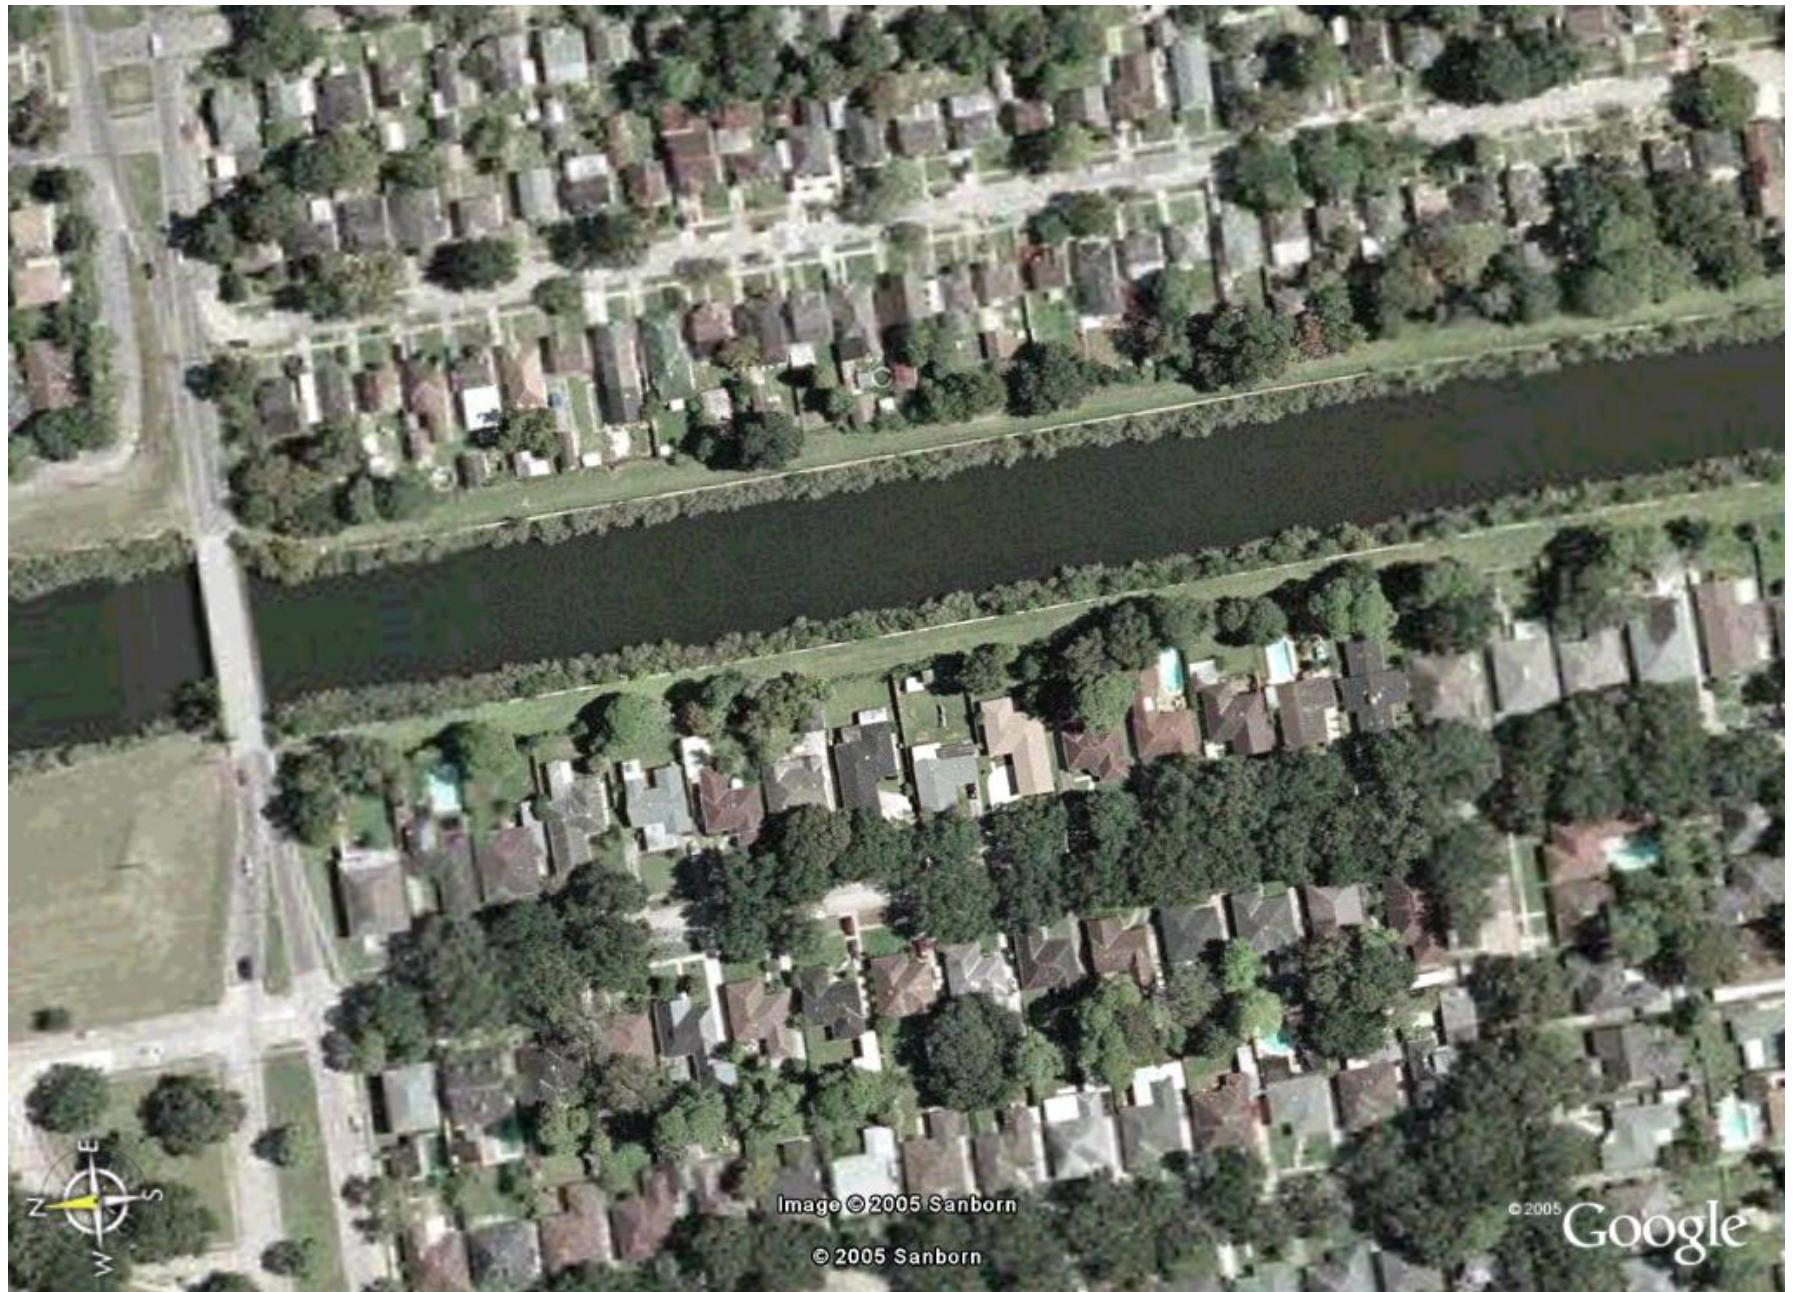
Note in Figures 31 and 32 that there is abundant vegetation along the banks of the canal inside the floodwalls. During the surge event in the canal, this vegetation trapped debris flowing in the canal and the height of this trapped debris in the vegetation could be used to estimate water level. Such evidence observed shortly after the storm indicates that the water level in the canal was no higher than about 3 feet from the top of the floodwall. Note also in figure 32 how the vegetation along the bank of the failed floodwall shows a distinct edge marking the pre-failure position of the floodwall. During the failure, the floodwall slid away to the west as a result of the water pressure against the floodwall and sheet pilings.

Figure 31. Satellite image of the area along the London Avenue Canal near Robert E. Lee Blvd. and Pratt Drive (Stop 3), where the levee was later breached during Hurricane Katrina. (Source - Google Earth)

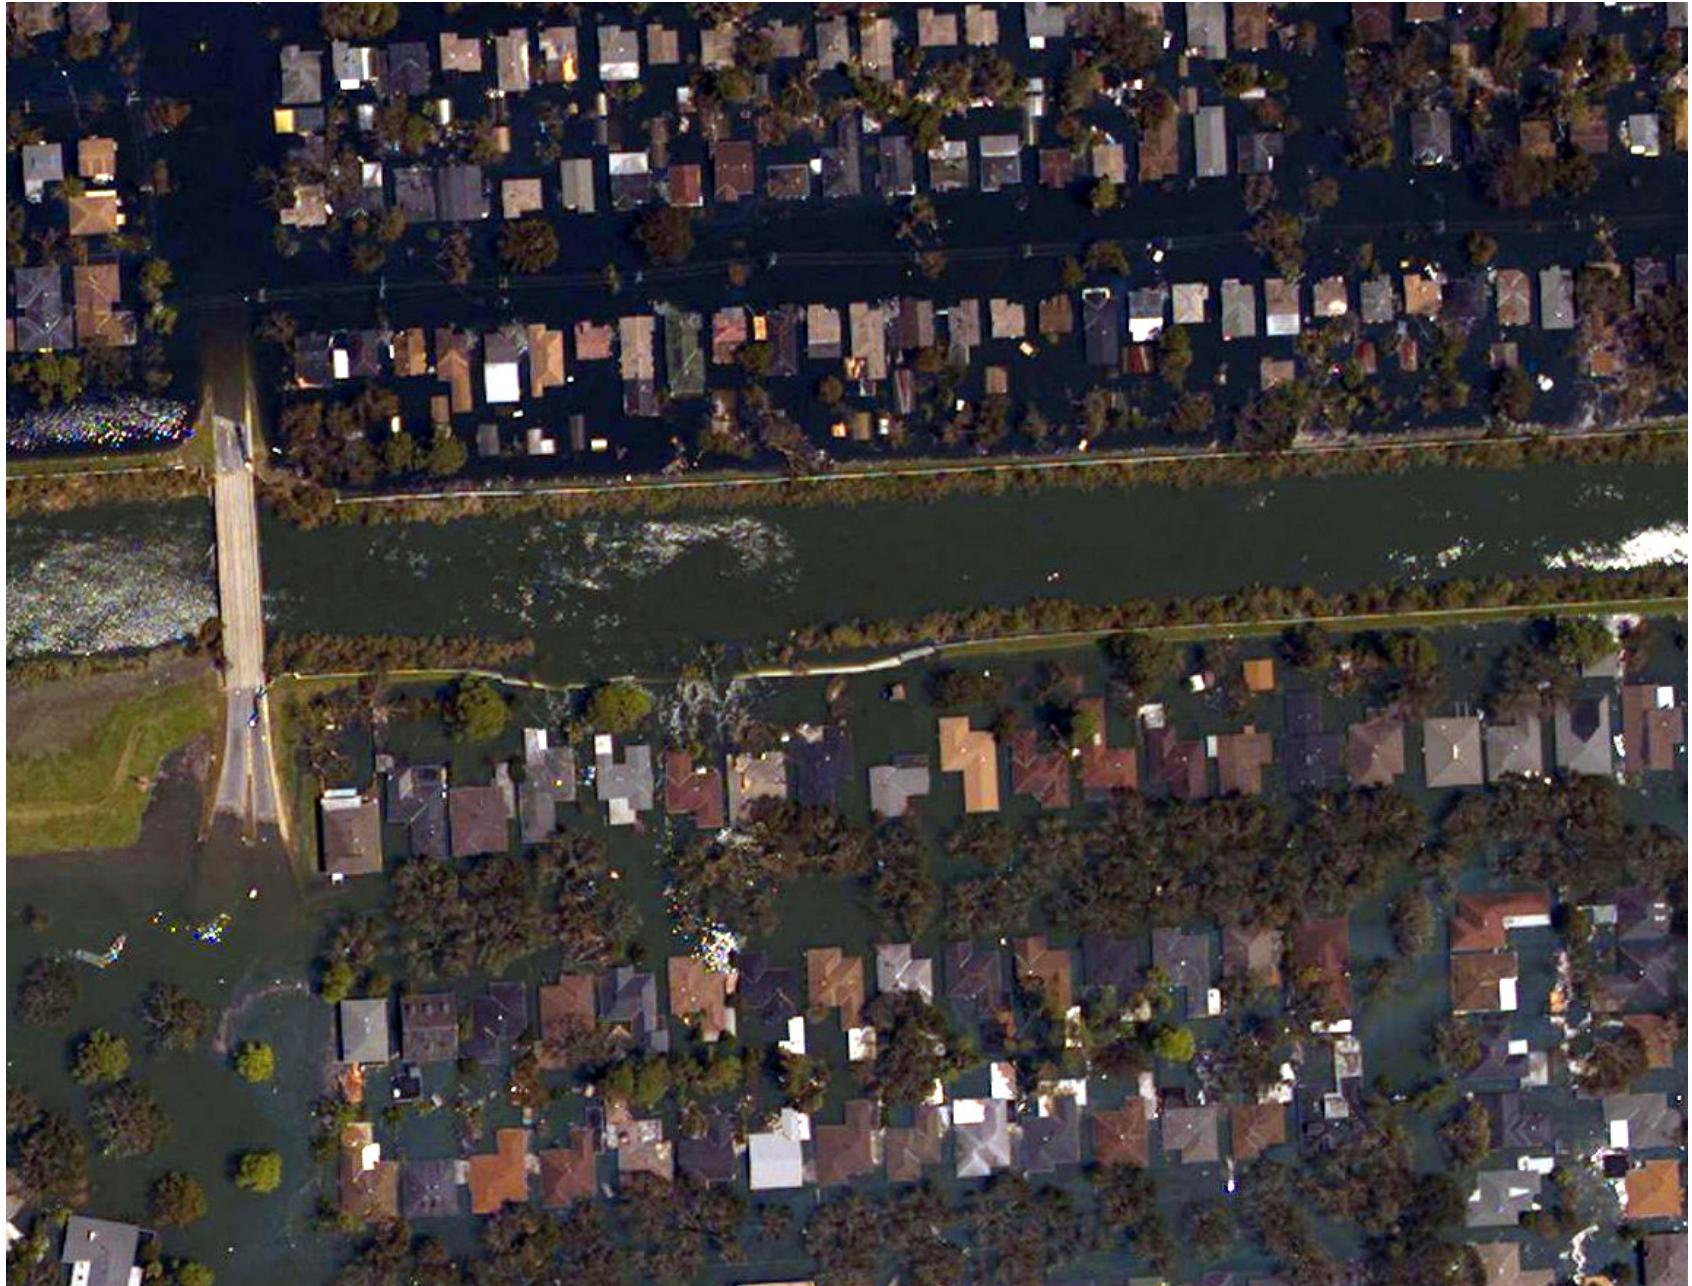
Figure 32. Air photograph of the area where the London Avenue Canal levee was breached near Robert E. Lee Ave. and Pratt Drive (Stop 3). Drive. Image acquired Aug. 31, 2005. Source: National Oceanic and Atmospheric Administration's National Geodetic Survey, Katrina Images - <http://ngs.woc.noaa.gov/katrina/>
