Hurricane Katrina - What Happened? The Geology of the Katrina Disaster in New Orleans

AEG Field Trip
September 16 & 20, 2008

Stephen A. Nelson
Department of Earth &
Environmental Sciences
snelson@tulane.edu

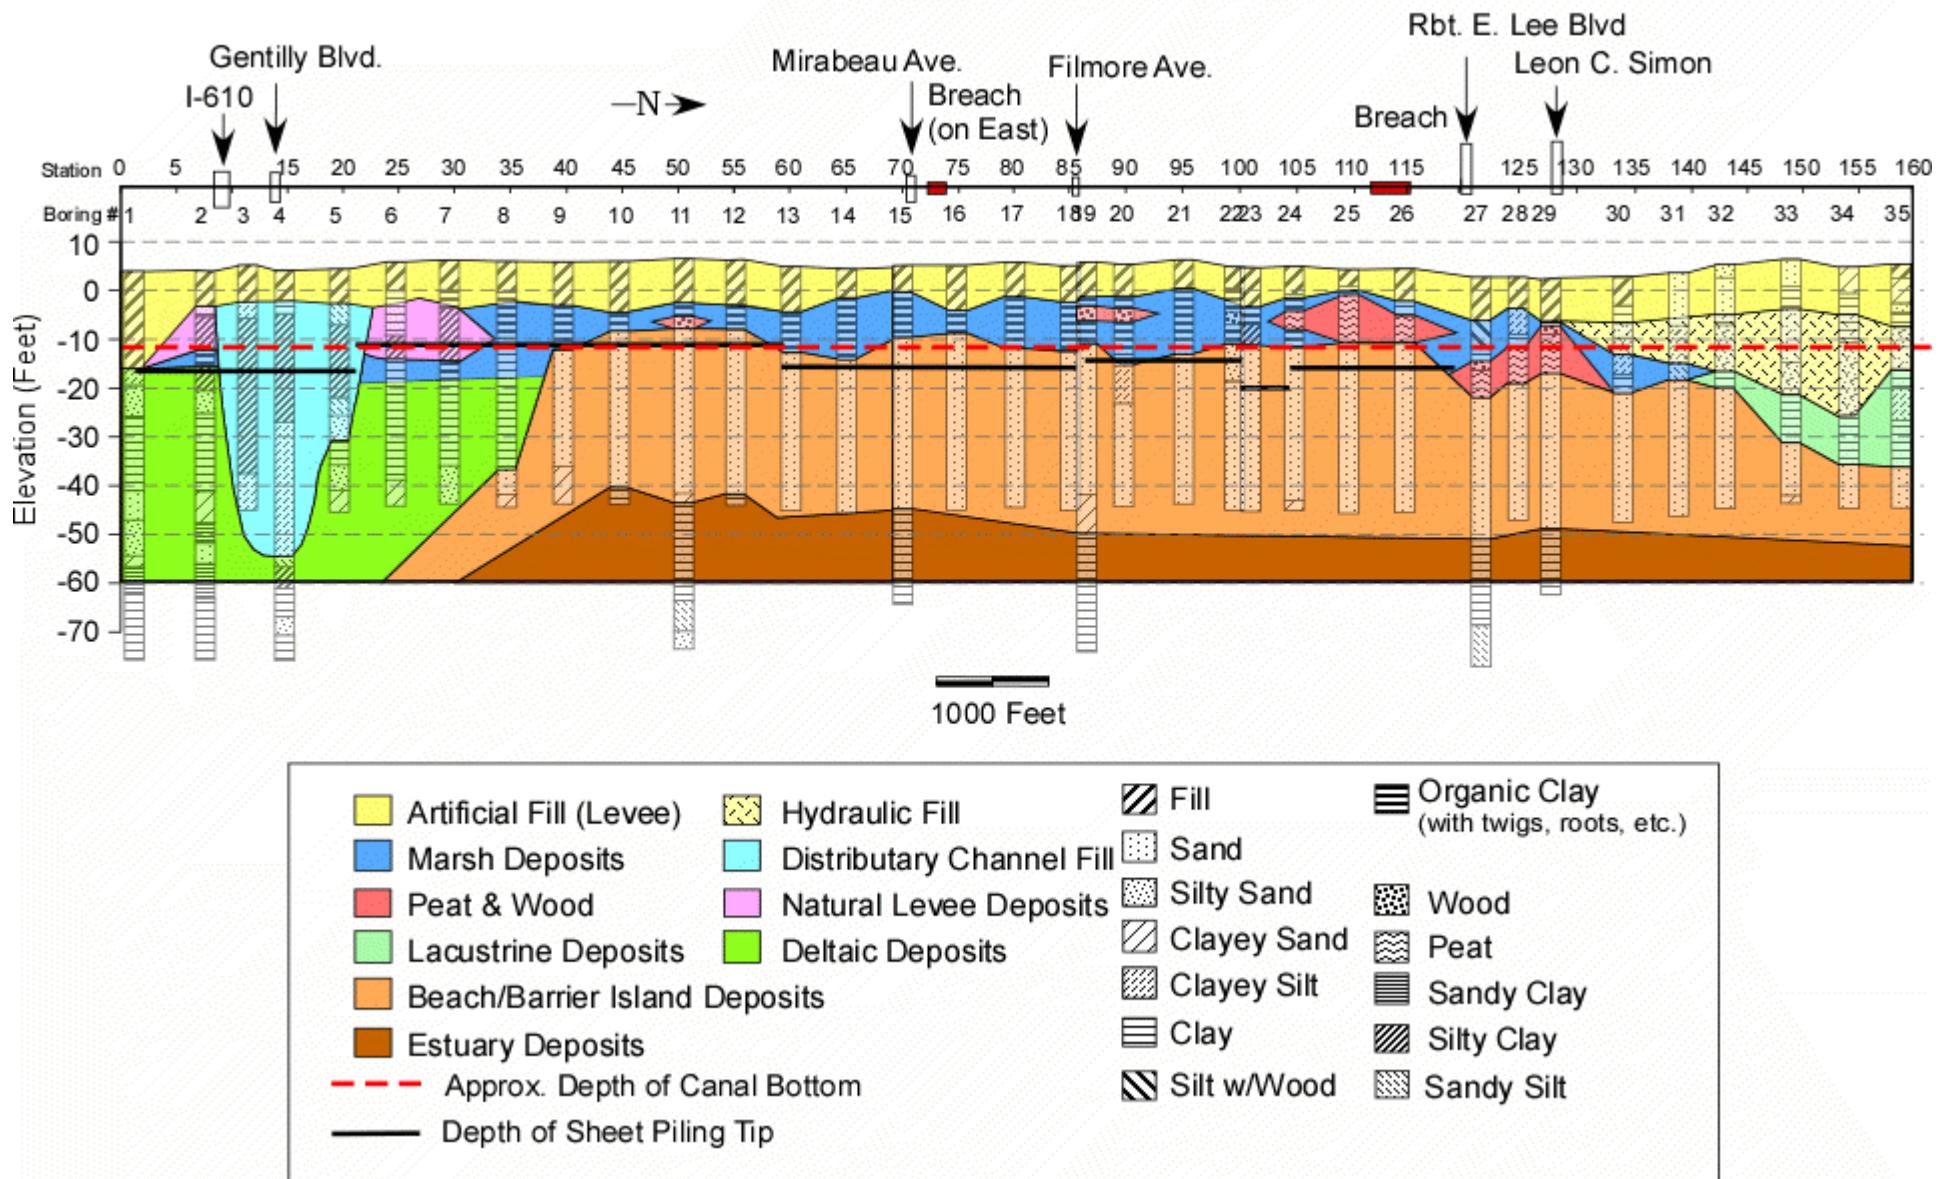
A geologic cross section of the west side of the levee is shown in Figure 33. Note that the conditions beneath the surface are similar to those at the Mirabeau Ave. breach, with a sand layer about 12 feet below sea-level. Here a peat layer is also observed. Peat is organic matter (vegetation that is in the process of decay). It represents material accumulated in swampy areas and indicates that this area was a swamp in the not too distant past. Peat is very porous and has the additional property that it shrinks when it is dried out and expands when water is added. The presence of peat can make for very unstable soil conditions.

Although the “as built” design documents (U.S. Army Corps of Engineers, 1994) show that the depth of the sheet pilings were at 14 feet below sea-level, water still had access to the peat layer and thus the peat layer could have played a role in the collapse of the levee. Another phenomenon that was observed here was that of ground heave in the area of collapse. Water, and perhaps expanding peat, apparently pushed up the levee and land surface on the west side of the canal prior to collapse of the levee. This is illustrated in Figures 34 and 35. Although the clubhouse shown in Figure 34 has been removed during the repair of the levee, the house (with the mispositioned air conditioner compressor) is the 5th house south of Robert E. Lee Blvd. on Pratt Drive (this house was demolished in early November, 2006).

Figure 33. Geological cross-section along the west side of the London Avenue Canal constructed from data in U.S. Army Corps of Engineers (1989).

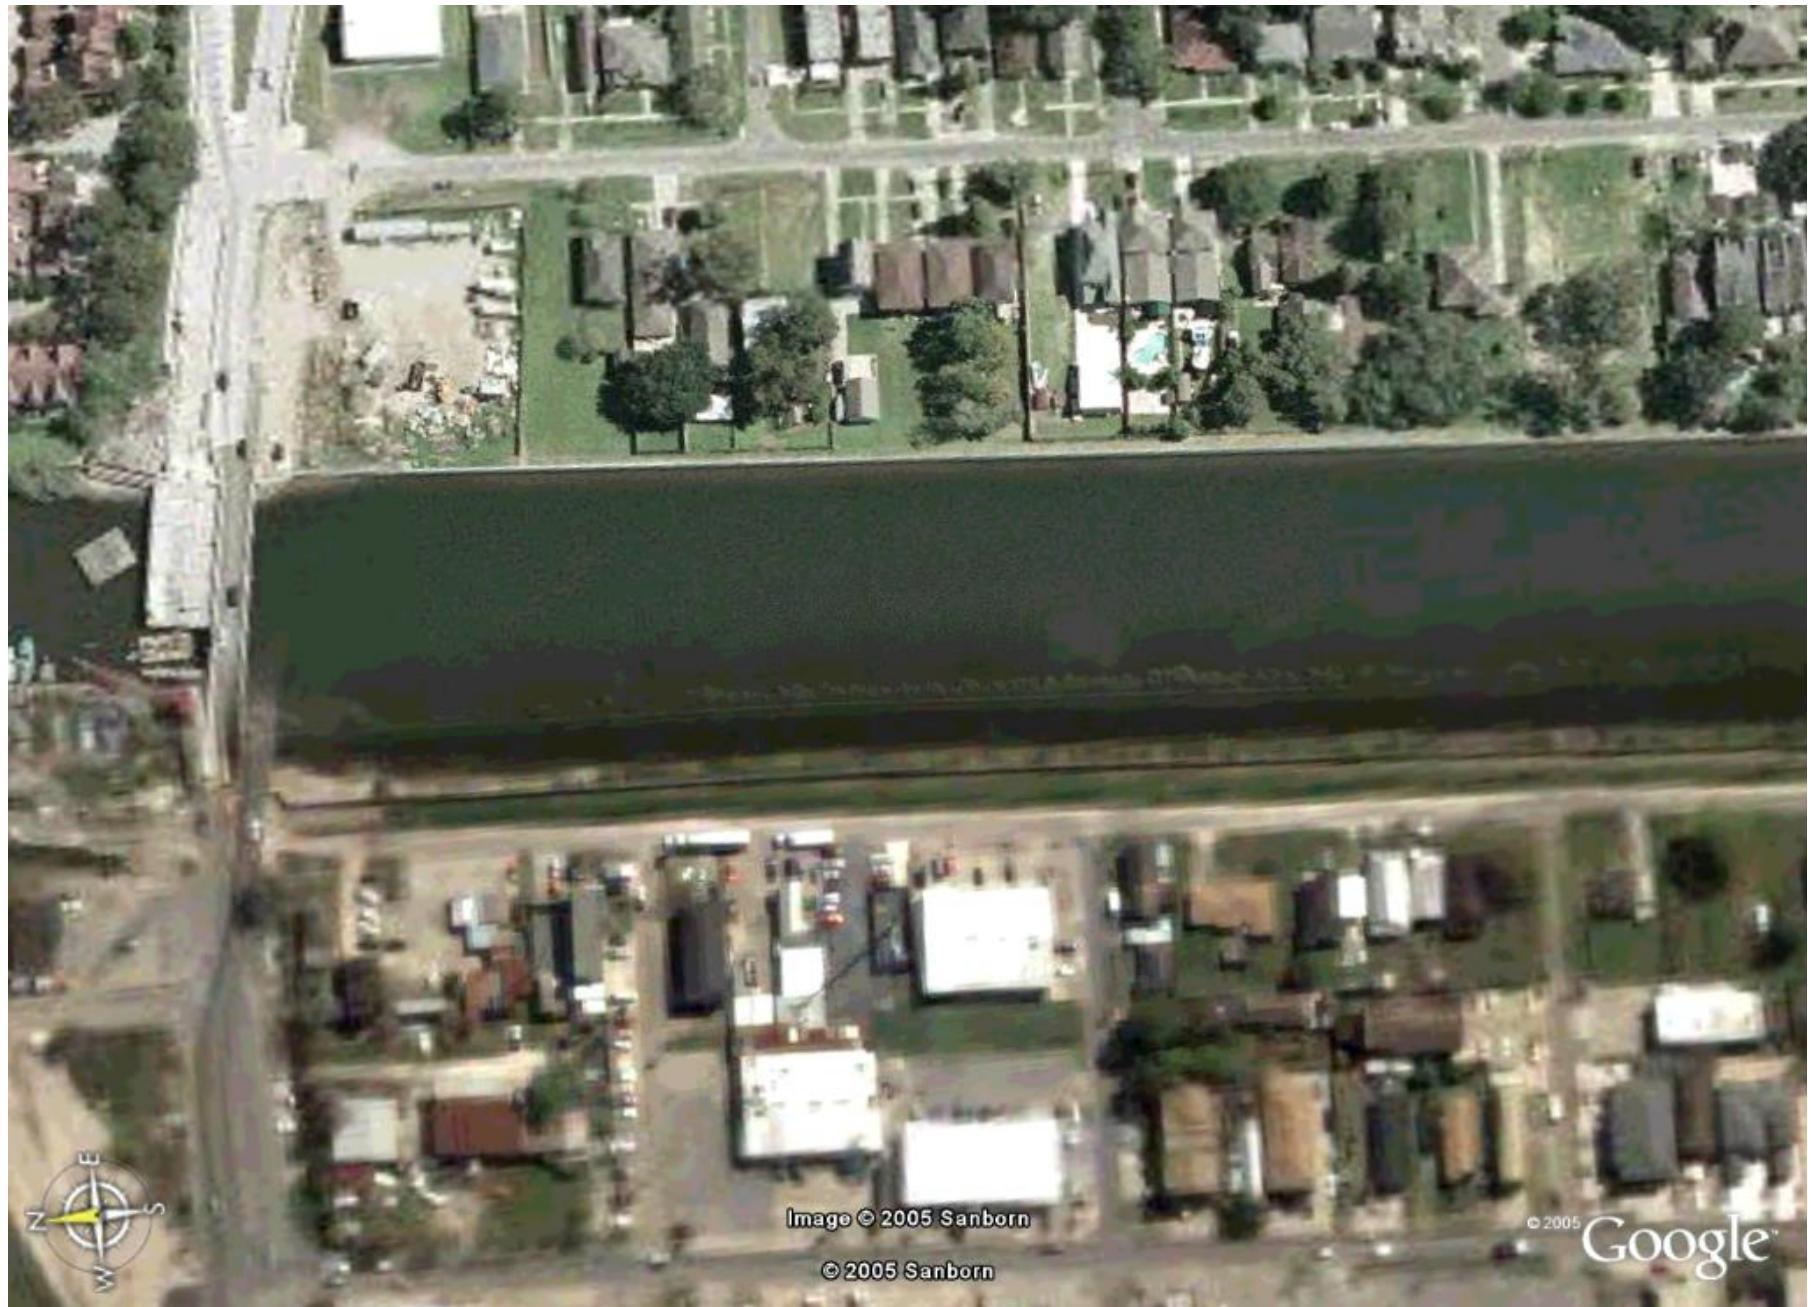
Note that the breach occurred along Belaire Drive where, like the along the London Avenue Canal, houses are backed up against the levee (all houses bordering the breach area on the west side of Belaire Drive were demolished by the Corps of Engineers in July, 2006). Here, the main part of the breach occurred in a recently cleared empty lot. A tree in that empty lot, close to the levee toe (Fig. 38) can be seen to be toppled in the August 31 image (Fig. 39). Just as at the Mirabeau breach, no eyewitness are available to tell us if the tree toppled due to the hurricane force winds on August 29 or as a result of the levee breach. Without such observations, we note that it is entirely possible that if the tree was toppled by the winds it could have been responsible for the breach at this locality. A house to the south of the main part of the breach, built on a chain wall foundation, was completely removed (see also the photo in the lower right of Figure 48). Natural gas from a line that fed the house can be seen bubbling up through the floodwater in Figure 39. Another house to the north of the empty lot was built on a slab and was also removed by the rushing floodwaters. The natural gas line that fed that house can also be seen bubbling up natural gas, just to the right of the yellow spot (roof of a school bus) in Figure 38.

Figure 38. Satellite image of the area along the 17th Street Canal near the Old Hammond Highway Bridge (under construction), where the levee was later breached during Hurricane Katrina (stop 5). (Source - Google Earth)

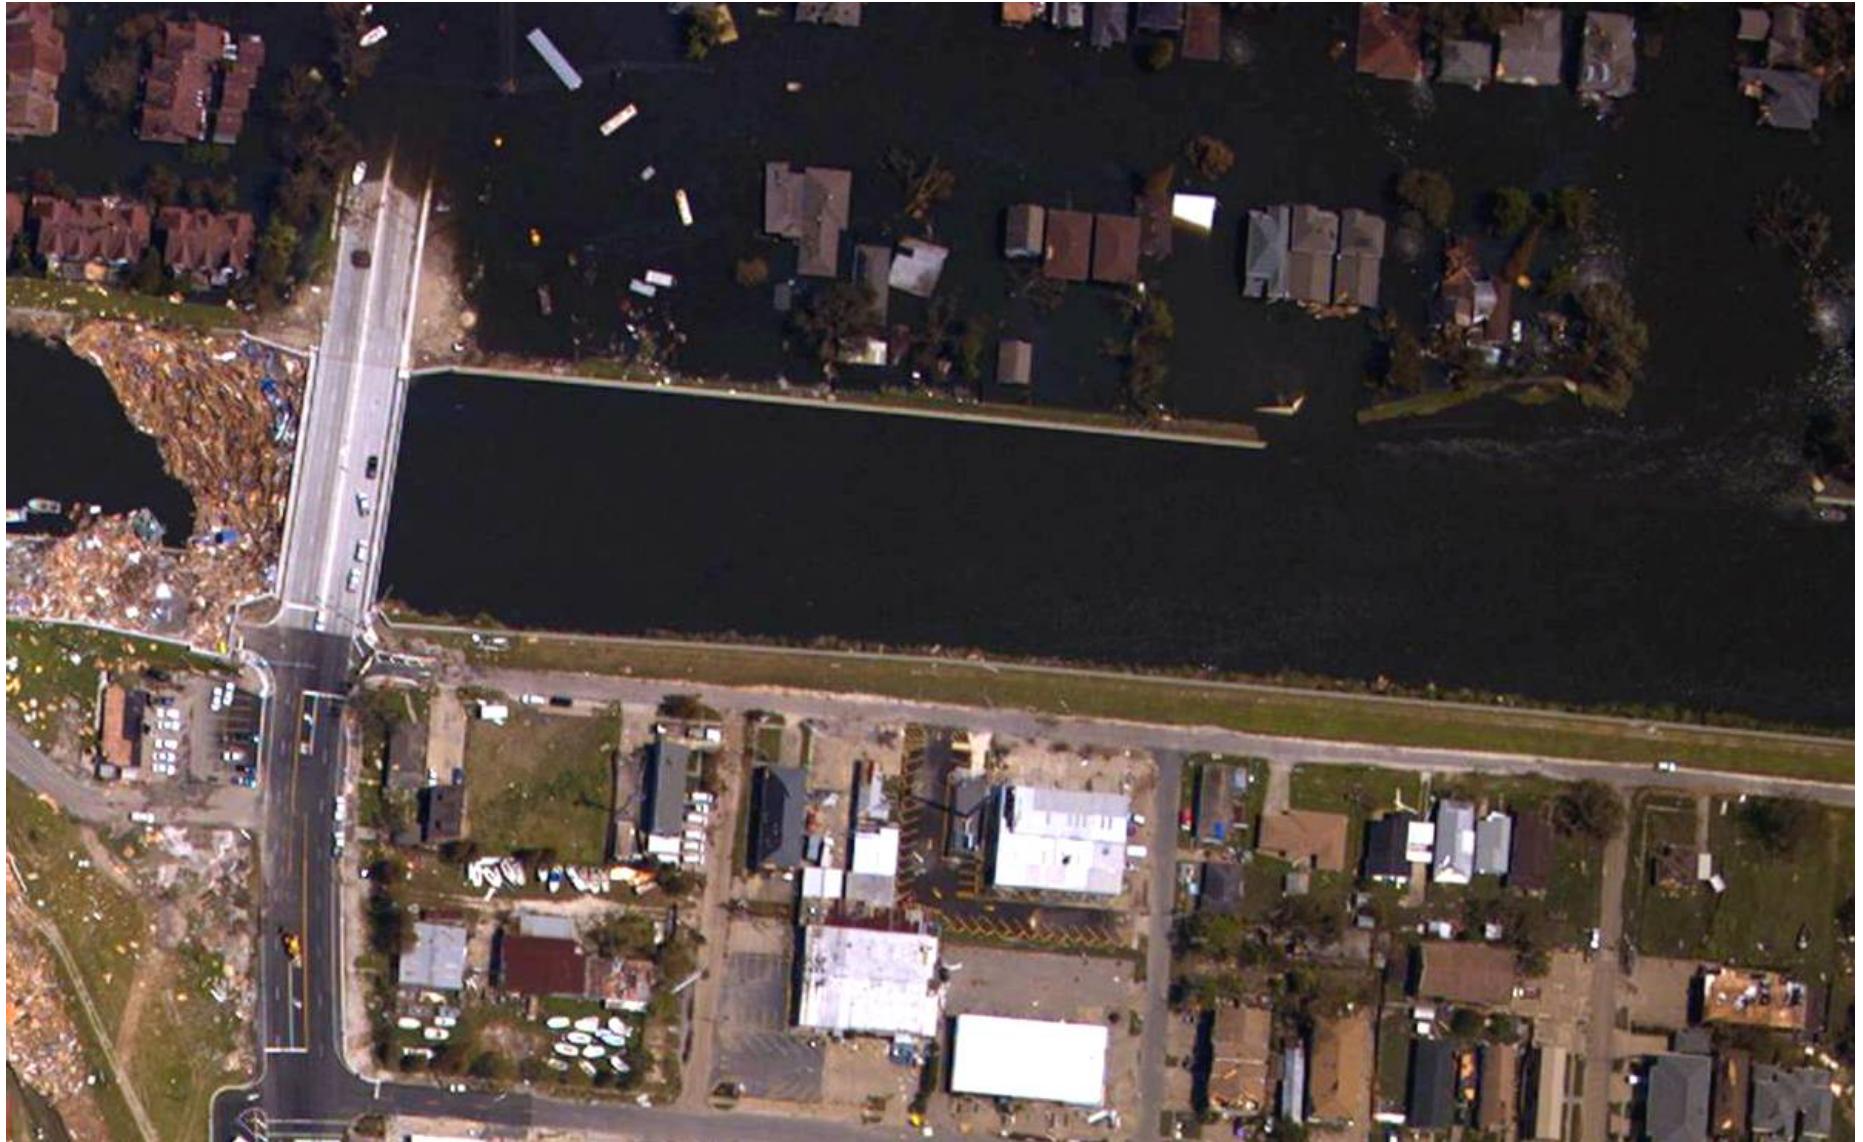
Also visible in Figure 39 is a section of the levee that was displaced eastward by about 45 feet. Figures 40 and 41 are oblique aerial views of this displaced levee and floodwall. The area in front of the displaced levee was pushed horizontally outward near the position of the yellow school bus. This can also be seen in Figure 42 where the toe of the slide block is seen as an abrupt change in slope of the ground surface.

Figure 39. Air photograph of the area where the 17th Street Canal Levee was breached near Belaire Drive (stop 5). Image acquired Aug. 31, 2005. Source: National Oceanic and Atmospheric Administration's National Geodetic Survey, Katrina Images - <http://ngs.woc.noaa.gov/katrina/>

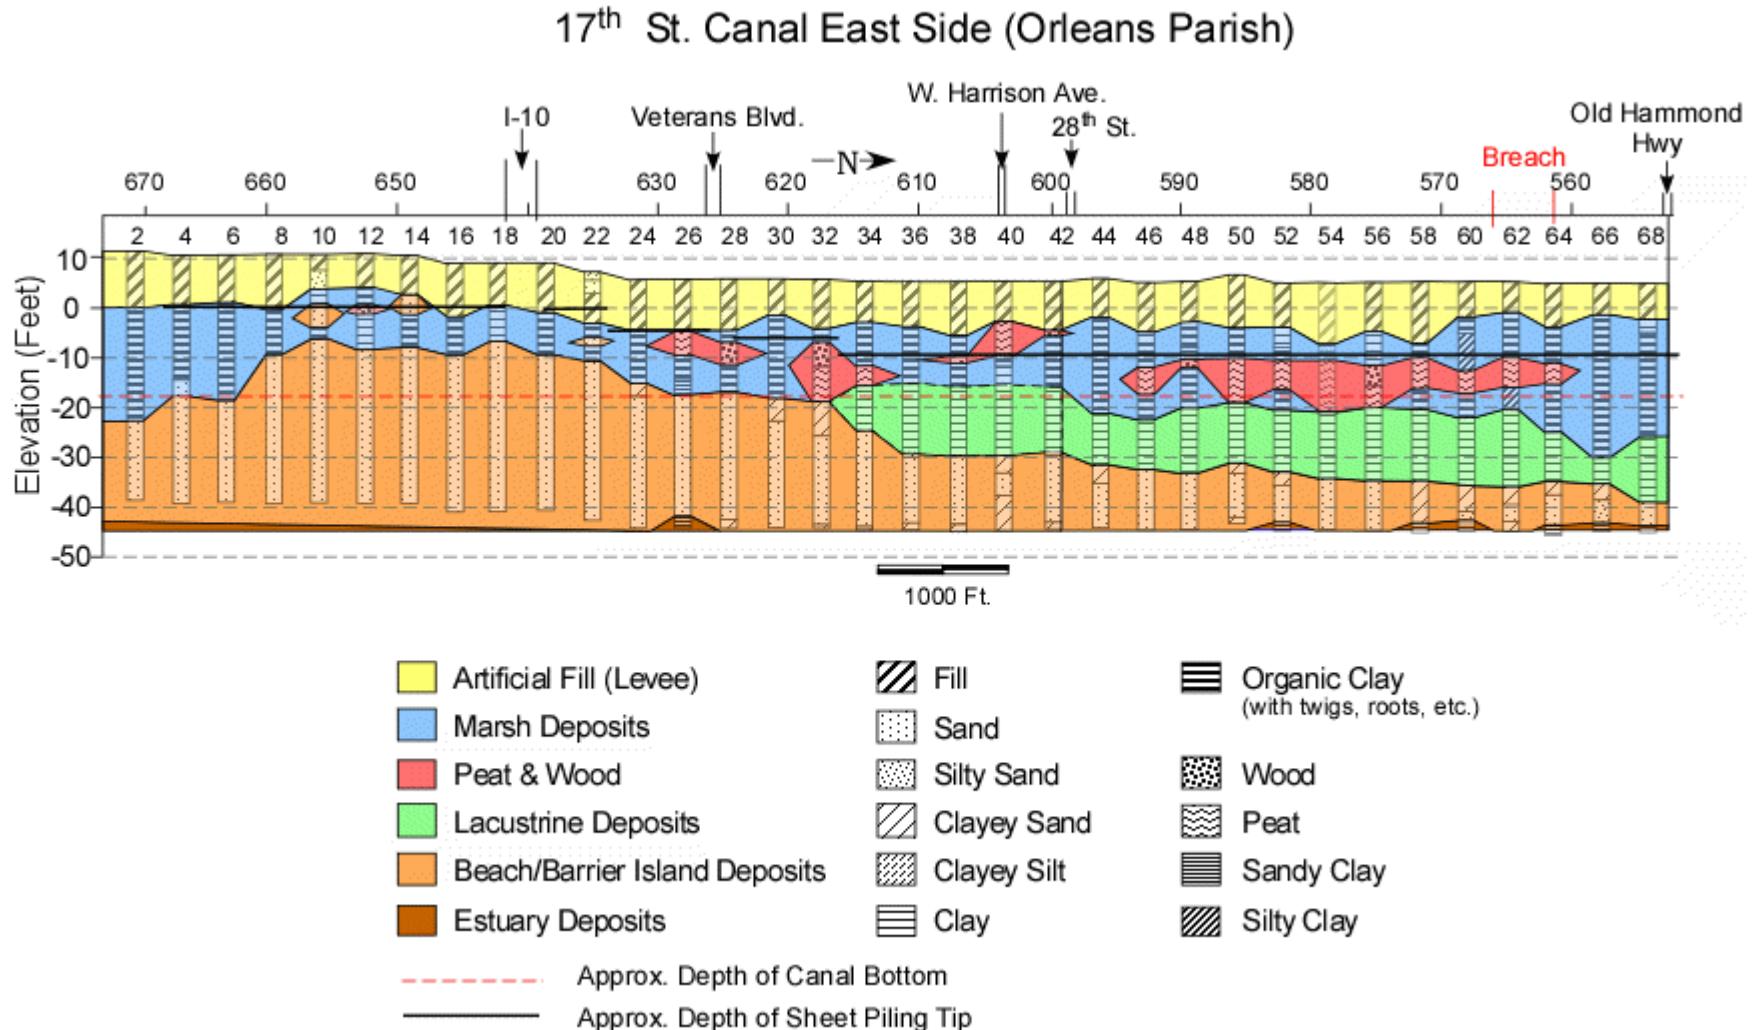
Figure 44 shows a geological cross section along the levee of the 17th street canal. The most notable feature of the cross section is the peat layer observed at depths between about 8 and 15 feet below sea level in the area of and to the south of the breach.

Figure 44. Geological cross-section along the eastern side of the 17th St. Canal (based on data in the U.S. Army Corps of Engineers design documents (1990). Notable in the cross-section is the peat layer that occurs in the area of the breach. Depth to sheet piling tips is highly uncertain due to inconsistent information available from the U.S. Army Corps of Engineers. The set of as built available on the IPET web site plans (from which the sheet piling depths in this figure were used), show a depth of 10 feet in the area of the breach, yet the Corps claimed and later confirmed by pulling a sheet pile near the breach, that the sheet piles actually extended to 17.5 ft. below sea-level.

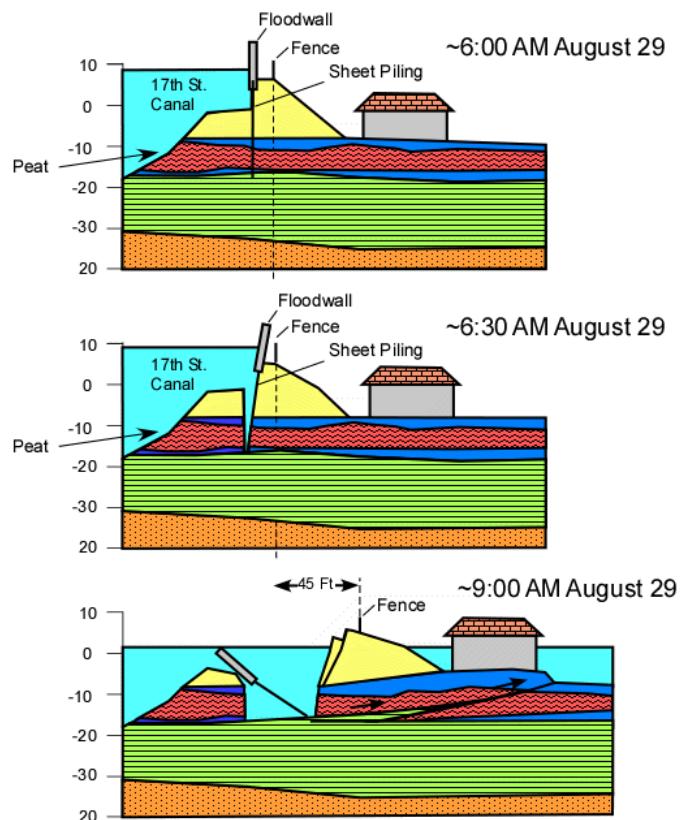
Failure of the 17th St. Canal Levee & Floodwall

The most recent information from the Interagency Performance Evaluation Task Force (IPET) [2006] suggests that the floodwall and levee failed at the 17th St. Canal as a result of the water level rising to an elevation of about 8 feet above sea level in the canal. The floodwalls were designed to have tops at an elevation of 14 feet above sea level, but IPET data indicate that by the time of Katrina the tops of the floodwalls on the 17th Street Canal were about 12.5 feet above sea level. Thus, IPET estimates that water levels in the canal were still 4 feet below the tops. IPET has collected eyewitness accounts and scoured the neighborhood for clocks that were stopped as a result of the flooding in order to determine the time of the breach. One eyewitness account suggests that the floodwall at the breach area was leaning to the protected side at about 6:30 AM on August 29 and other accounts suggest that the breach was open by about 9:00 AM. This, along with levee breach experiments conducted on scale models in a large centrifuge led IPET to suggest that as water levels rose in the canal, the floodwall and sheet piling was pushed outward toward the land side, opening a gap between the levee and the floodwall on the canal side. This gap allowed water to seep down along the sheet piling and eventually push the levee on the protected side outward away from the canal. Based on sections of the breached levee observed in the breach area, IPET suggests that the failure did not occur along the peat layer, but along a layer of weak clay at the base of the peat. This clay layer was thrust over and through the peat as illustrated in Figure 45.

Figure 45. Diagrammatic cross sections across the 17th St. Canal in the vicinity of the breach. Based partially on a sketch in Seed and others (2005), ILIT (2006) and IPET (2006).

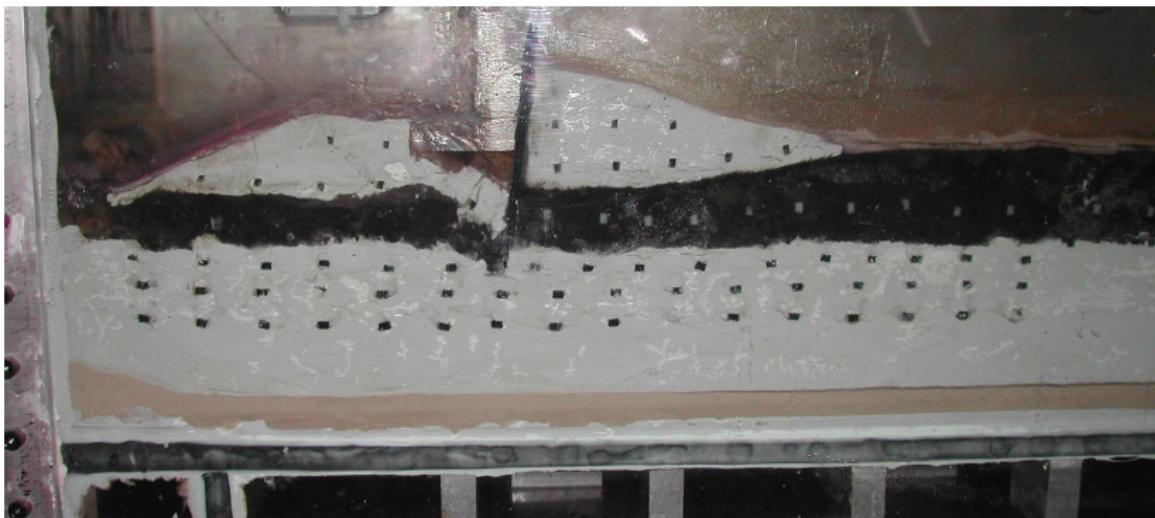
A photograph of the end result of IPET's scale model centrifuge experiment is shown in Figure 44. The canal side (on the left in the photograph) next to the sheet piling is seen to have dropped down as a result of the floodwall moving toward the right (toward the protected side). Indeed in the end result of the experiment, the levee, peat layer, and upper part of the underlying clay layer all have moved to the protected side. Viewing the complete video of the experimental run (<https://ipet.wes.army.mil/>), however, shows that the initial failure occurred either in the peat layer or at the peat – clay interface, and only when the sheet pile started to move to the right, away from the canal, did the upper part of the clay layer also move. Furthermore, the only part of the clay layer that moved was the part immediately in front of the tip of the sheet pile, and it only moved because it was being pushed along by the sheet pile.

Figure 46. Photograph of failed levee and floodwall in IPET's scale model centrifuge experiment representing the 17th St. Canal. The white at the top is clay and represents the levee. This overlies the dark peat layer, which in turn overlies another white clay layer meant to represent the estuary deposits beneath the peaty marsh deposits. Small rectangles were initially laid out in a rectangular grid and can be used to determine how much deformation has occurred during the experiment. (IPET, 2006).

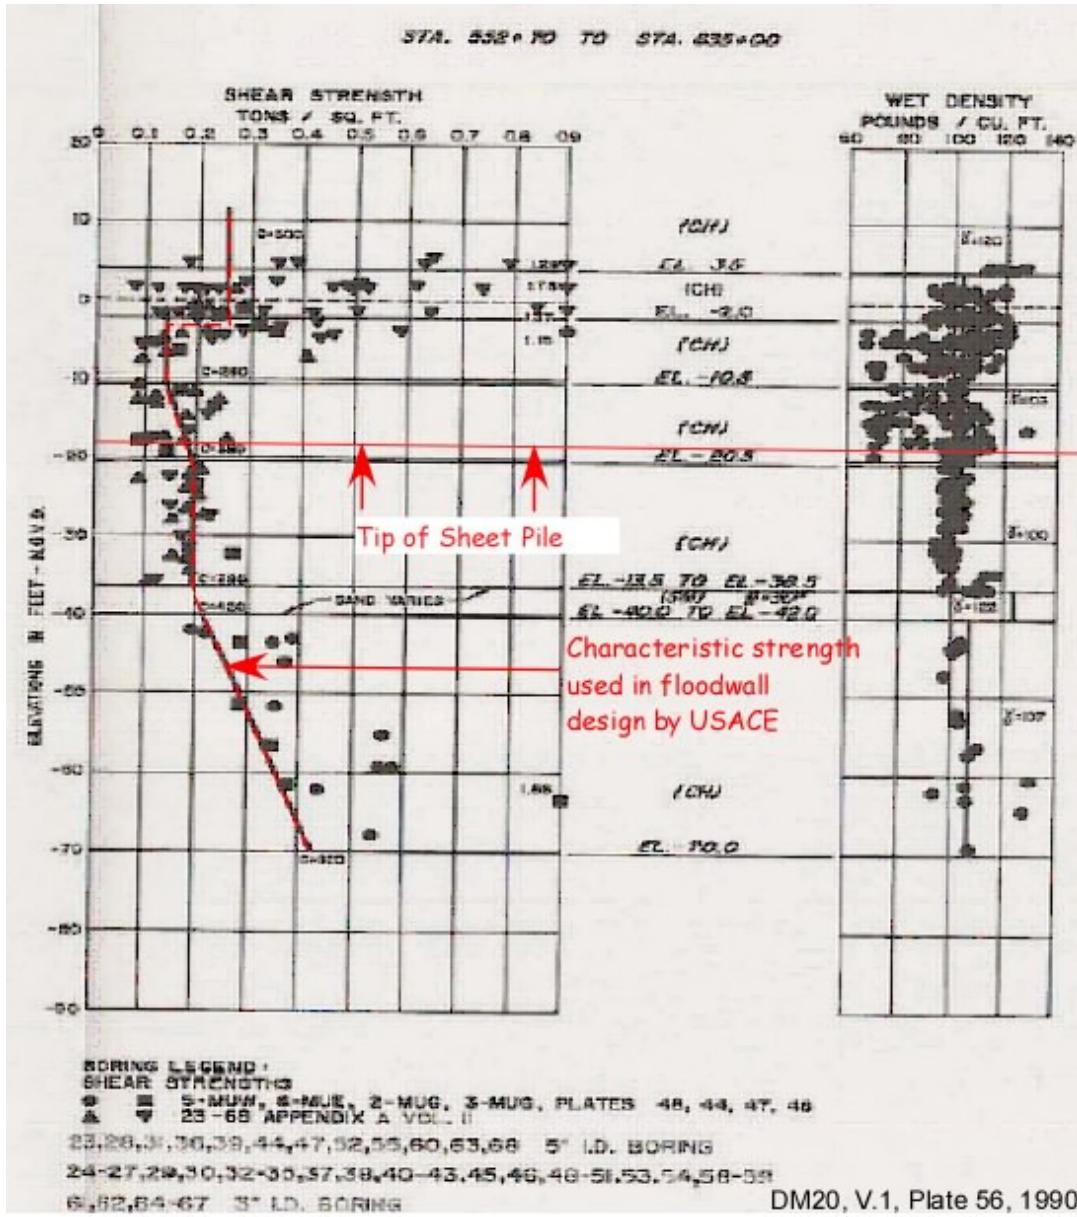
Figure 47. Shear strength and wet density versus depth along an 1800 foot section of the 17th St. Canal which includes the area of the breach (from U.S. Army Corps of Engineers, 1990, the Design documents for the 17th St. Canal floodwall). The author has added the red lines and red labeling showing the depth to the tip of the sheet piles in the breach zone and the characteristic strength values as a function of depth that the Corps used to determine the stability of the floodwall system.

Figure 47 shows graphs of shear strength and wet density versus depth as obtained on samples from soil borings (done before 1990) along an 1800 foot section of the 17th St. Canal, which includes the area of the breach. Red lines have been added for emphasis, one showing the depth to the tip of the sheet piling within the breach zone (17.5 feet below sea level) and the other highlighting the characteristic strengths used by the designers to determine the stability of the floodwall. Between the two graphs are lines separating the different kinds of soils. Note that all soils above about -37 feet are shown as CH soils, which are clays with high plasticity. If one looks at the geologic cross-section in Figure 44, there is an interval between about -10 and -18 shown as peaty clays (the same peat that came to the surface as a result of the levee breach). Peats have low density and thus the wet density data in Figure 47 clearly shows a zone of low density material in the depth range between 0 and -20. The strengths in this zone show a range, but the designers chose to use an average value. What is even more troubling, however is that in the depth range between about -15 and -37, the nearly all of the measured strengths fall below the characteristic strength line used in calculations of FS. This is the critical zone, where all investigators think the failure occurred during Katrina. If the strengths were overestimated by 30%, then the true FS value would fall below 1.0 and the structure would be unstable (just as it was during Katrina).

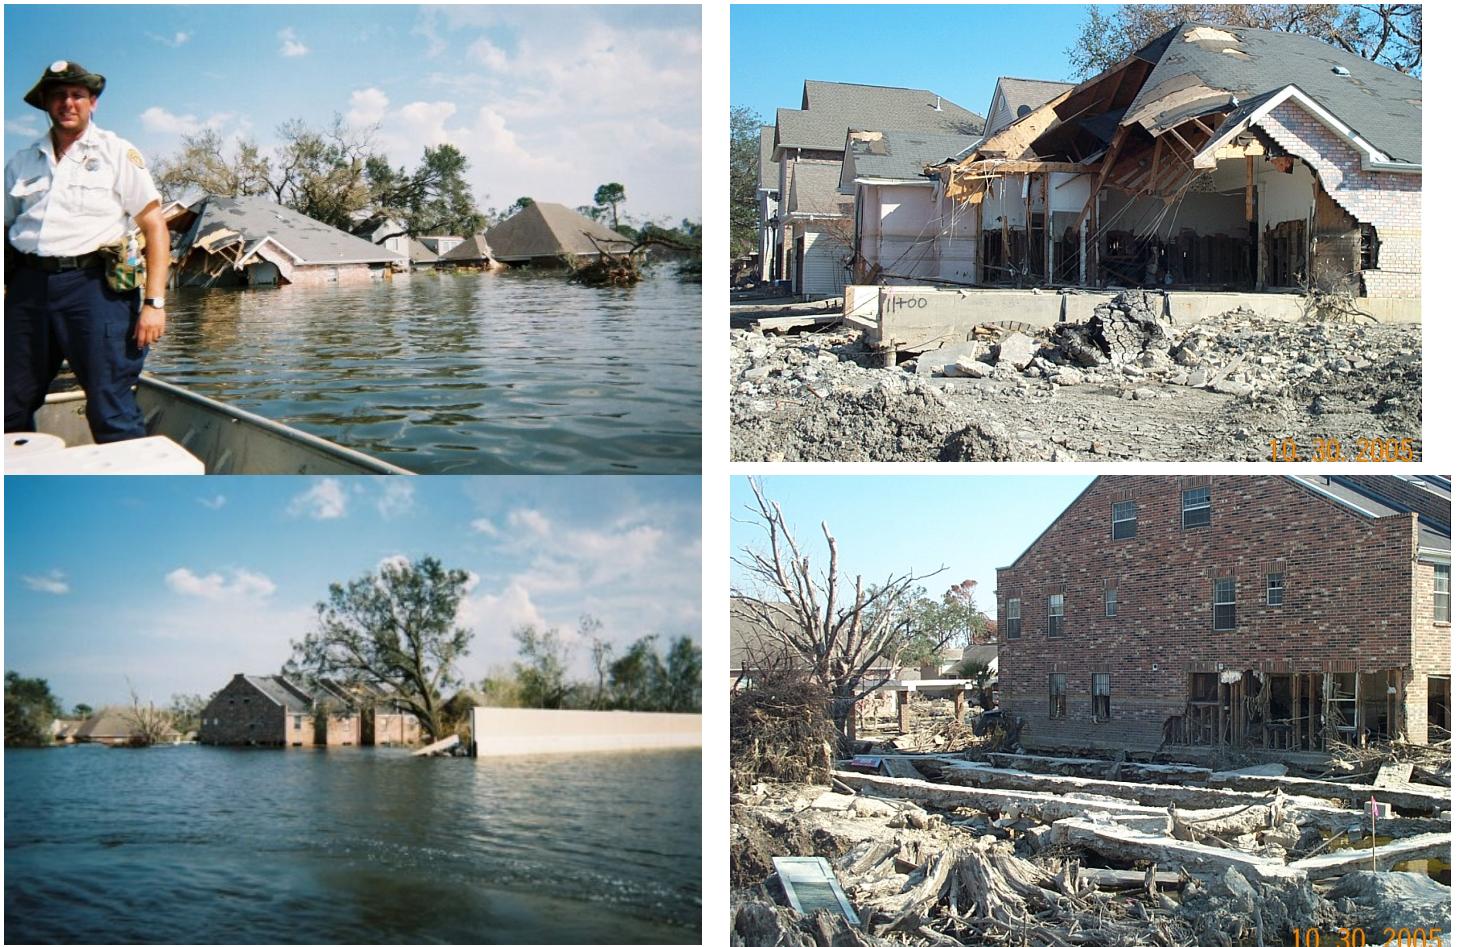
Figure 48. Comparison of water levels on Sept. 1, 2005 (photos on left by Kevin Himmel), with water lines on same structures indicate lines left by standing water are about 1.5 to 2 feet lower than the maximum water level. Note large block of peat in photo at the upper right. In photo at lower right, note the chainwall foundation of a house that was removed by the burst of water when the levee was breached and the cypress stump from a tree that was probably cut down 100 years ago when this Lakeview neighborhood was reclaimed from the cypress swamp.

Although throughout the field trip we have seen the water line (scum line) left by standing water, this line does not represent the maximum flood depth. As seen in Figure 46, comparison of the photos on the left, taken when the water level was near its maximum with the water line left on the same structures (photos on the right) indicate that the maximum flood depth was about 1.5 to 2 feet higher than the line left by standing water.

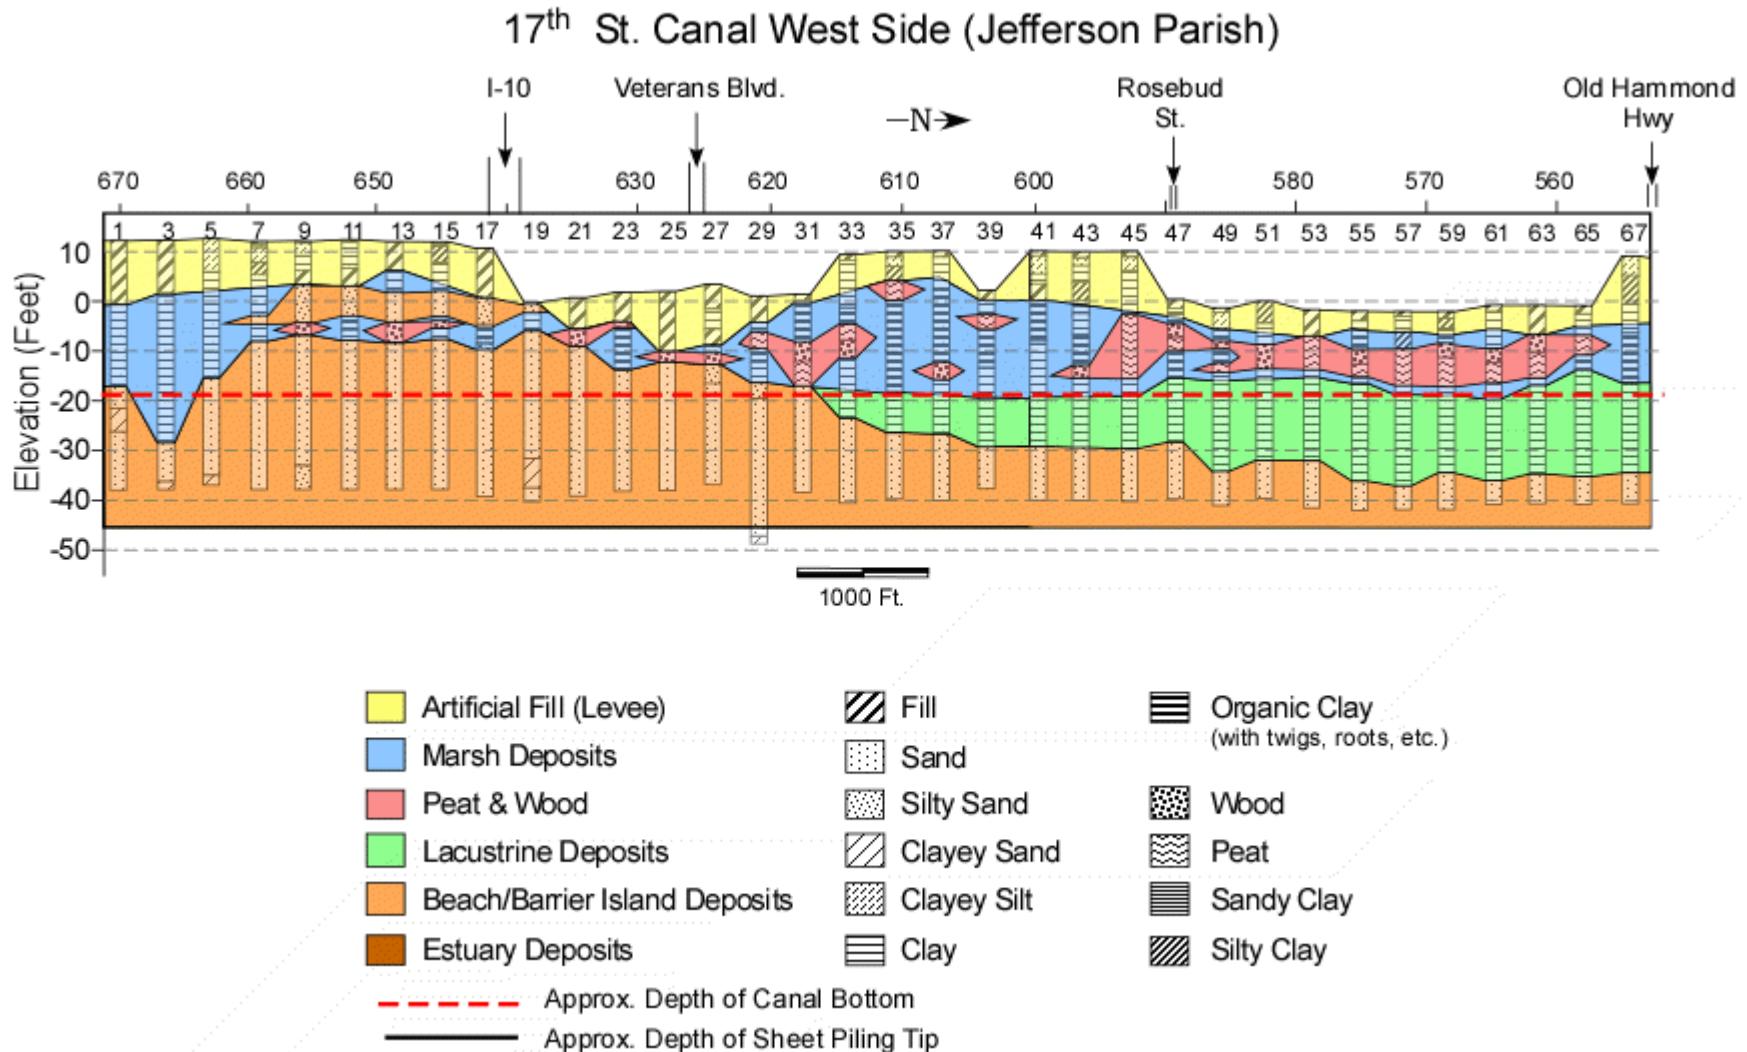
It is notable that the same peat layer and the same levee design and construction are present on the Jefferson Parish side of the canal, which by luck or the path of the storm, did not breach on August 29, 2005. Figure 47 shows a geological cross section of the west bank (Jefferson Parish side) of the 17th St. Canal constructed from data provided on the Army Corps of Engineers IPET web site - <https://ipet.wes.army.mil/> where it can be seen that the same geologic materials are present beneath the Jefferson Parish side as are found on the Orleans Parish side (compare with Figure 42). One major difference on the Jefferson Parish side is that a street occupies the area next to the levee and there are no trees, houses or swimming pools abutting the levee on that side.

Figure 49. Geologic cross section of the west bank of the 17th St. Canal constructed from data provided to the U.S. Army Corps of Engineers (1990). Note that levee heights appear inconsistent because some of the borings were taken at the toe of the levee rather than on the levee crest. Depth to the tip of the sheet piles is currently not available for the west side of the 17th St. Canal, although Grissett (April 14, 2007) has information that the sheet pile tips extend only to about 4 feet below sea-level at southern end of the canal (south of Veterans Blvd.).

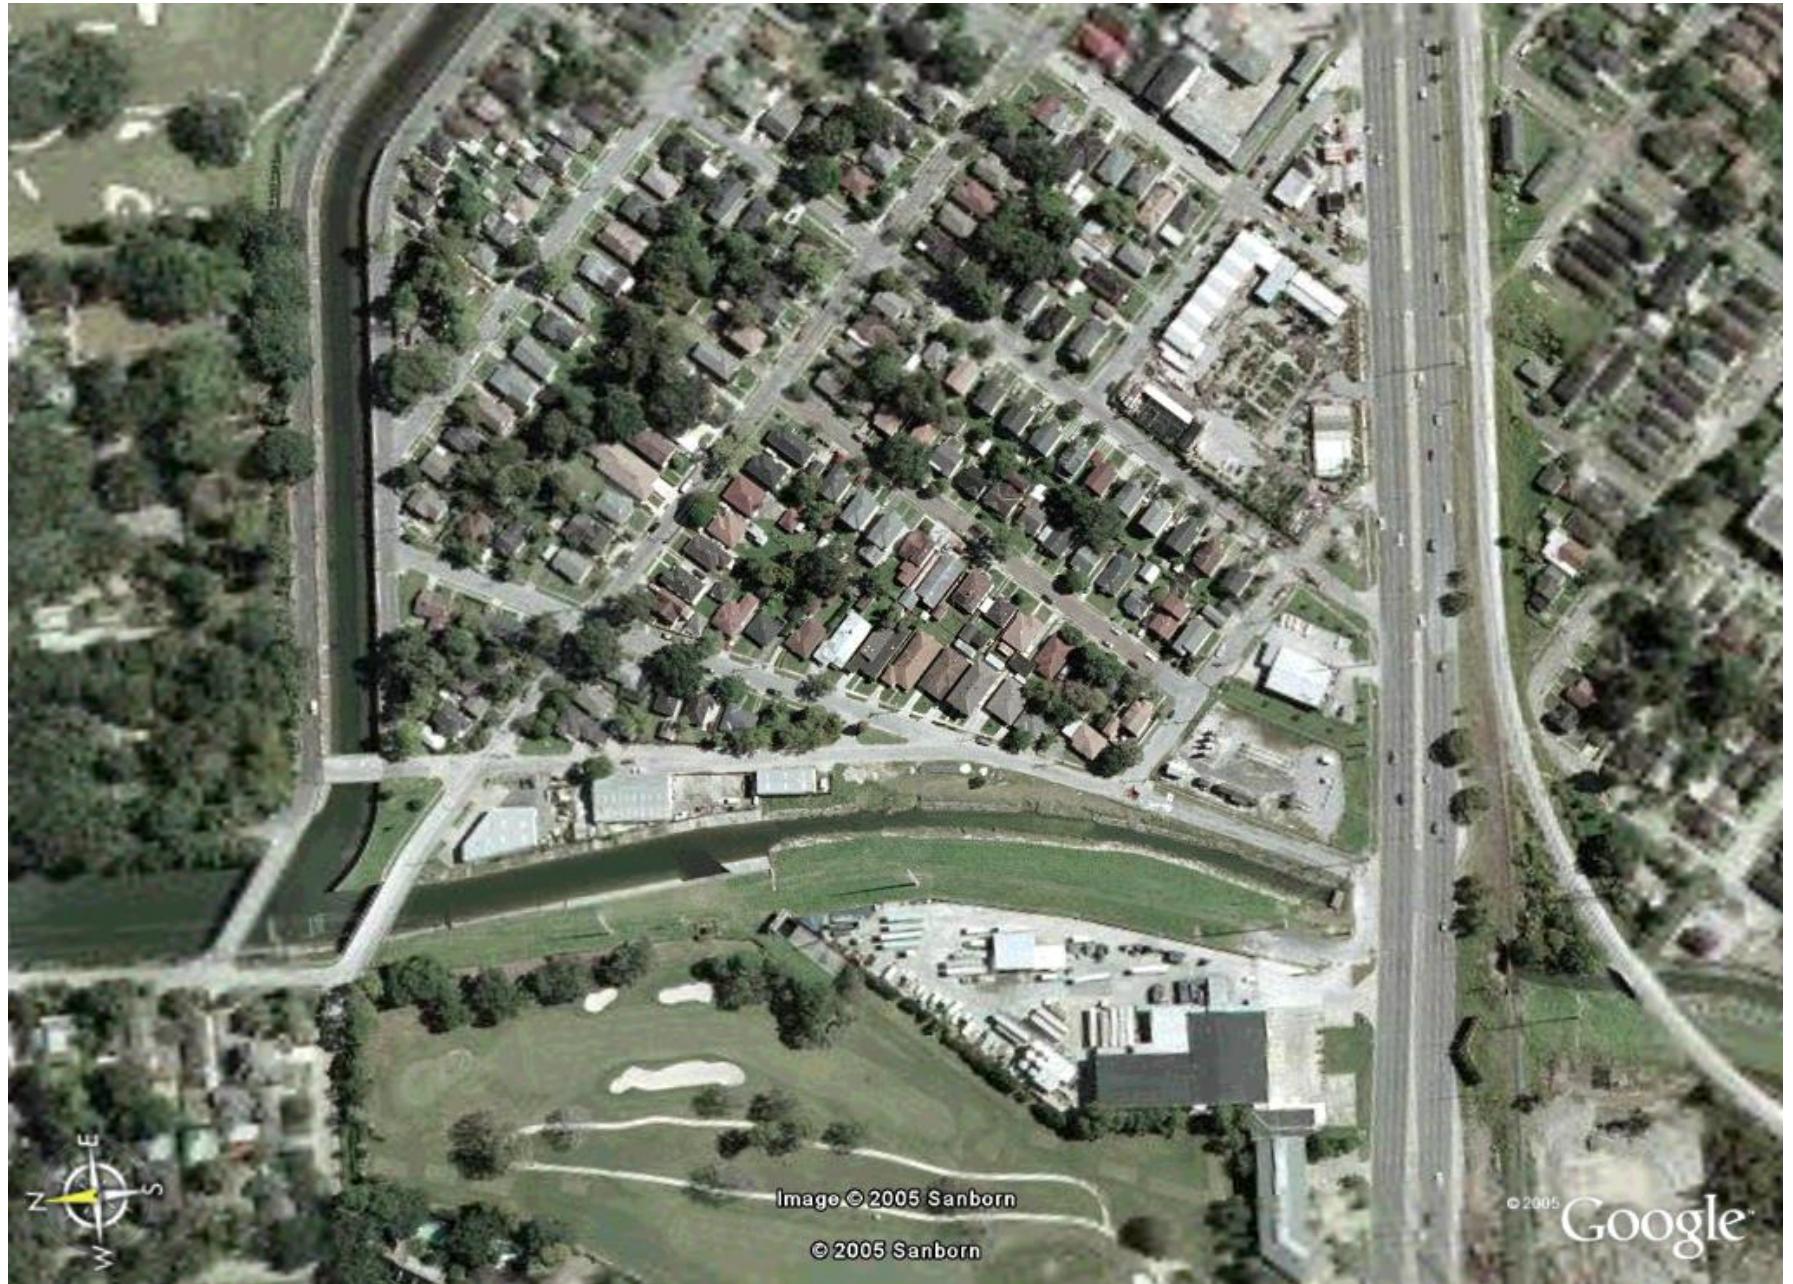
Stop 7 is that the corner of Orpheum Avenue and Northline Street. It is through this area and along Airline Drive south of here, that flood waters from the levee breaches in Orleans Parish reached into Jefferson Parish. The flooding occurred south of the Metairie Road (on the Metairie Ridge) and extended west to Causeway Blvd. and south to near the River. Figure 52 is a Google Earth image of the area at the junction of the Palmetto canal and the 17th St. canal before Katrina and Figure 53 shows approximately the same area on August 31, 2005. This area is at the southern end of the 17th St. Canal where the Palmetto Canal brings water from Pump Station #1 on Broad Street (Fig. 9) into the 17th St. Canal where it is lifted by Pump Station #6 about 8 feet in elevation and pumped out to the Lake (or through the breach in the 17th St. Canal). The Palmetto Canal has a short floodwall (about 3 feet higher than the roadway). Note in Figure 53, how the floodwalls on the Palmetto Canal are completely covered by water. The two bridges over the 17th St. Canal are barely above water, but it is clear that water flowed over and around these bridges into Old Metairie. It is also clear that Airline Drive, to the south, was a conduit for water to enter Jefferson Parish.

Figure 52. Satellite image of the area near the southern end of the 17th Street Canal near Old Metairie where water would enter Jefferson Parish from levee breaches in Orleans Parish during Hurricane Katrina (Stop 7). (Source - Google Earth)
