Hurricane Katrina - What Happened? The Geology of the Katrina Disaster in New Orleans

AEG Field Trip
September 16 & 20, 2008

Stephen A. Nelson
Department of Earth &
Environmental Sciences
snelson@tulane.edu

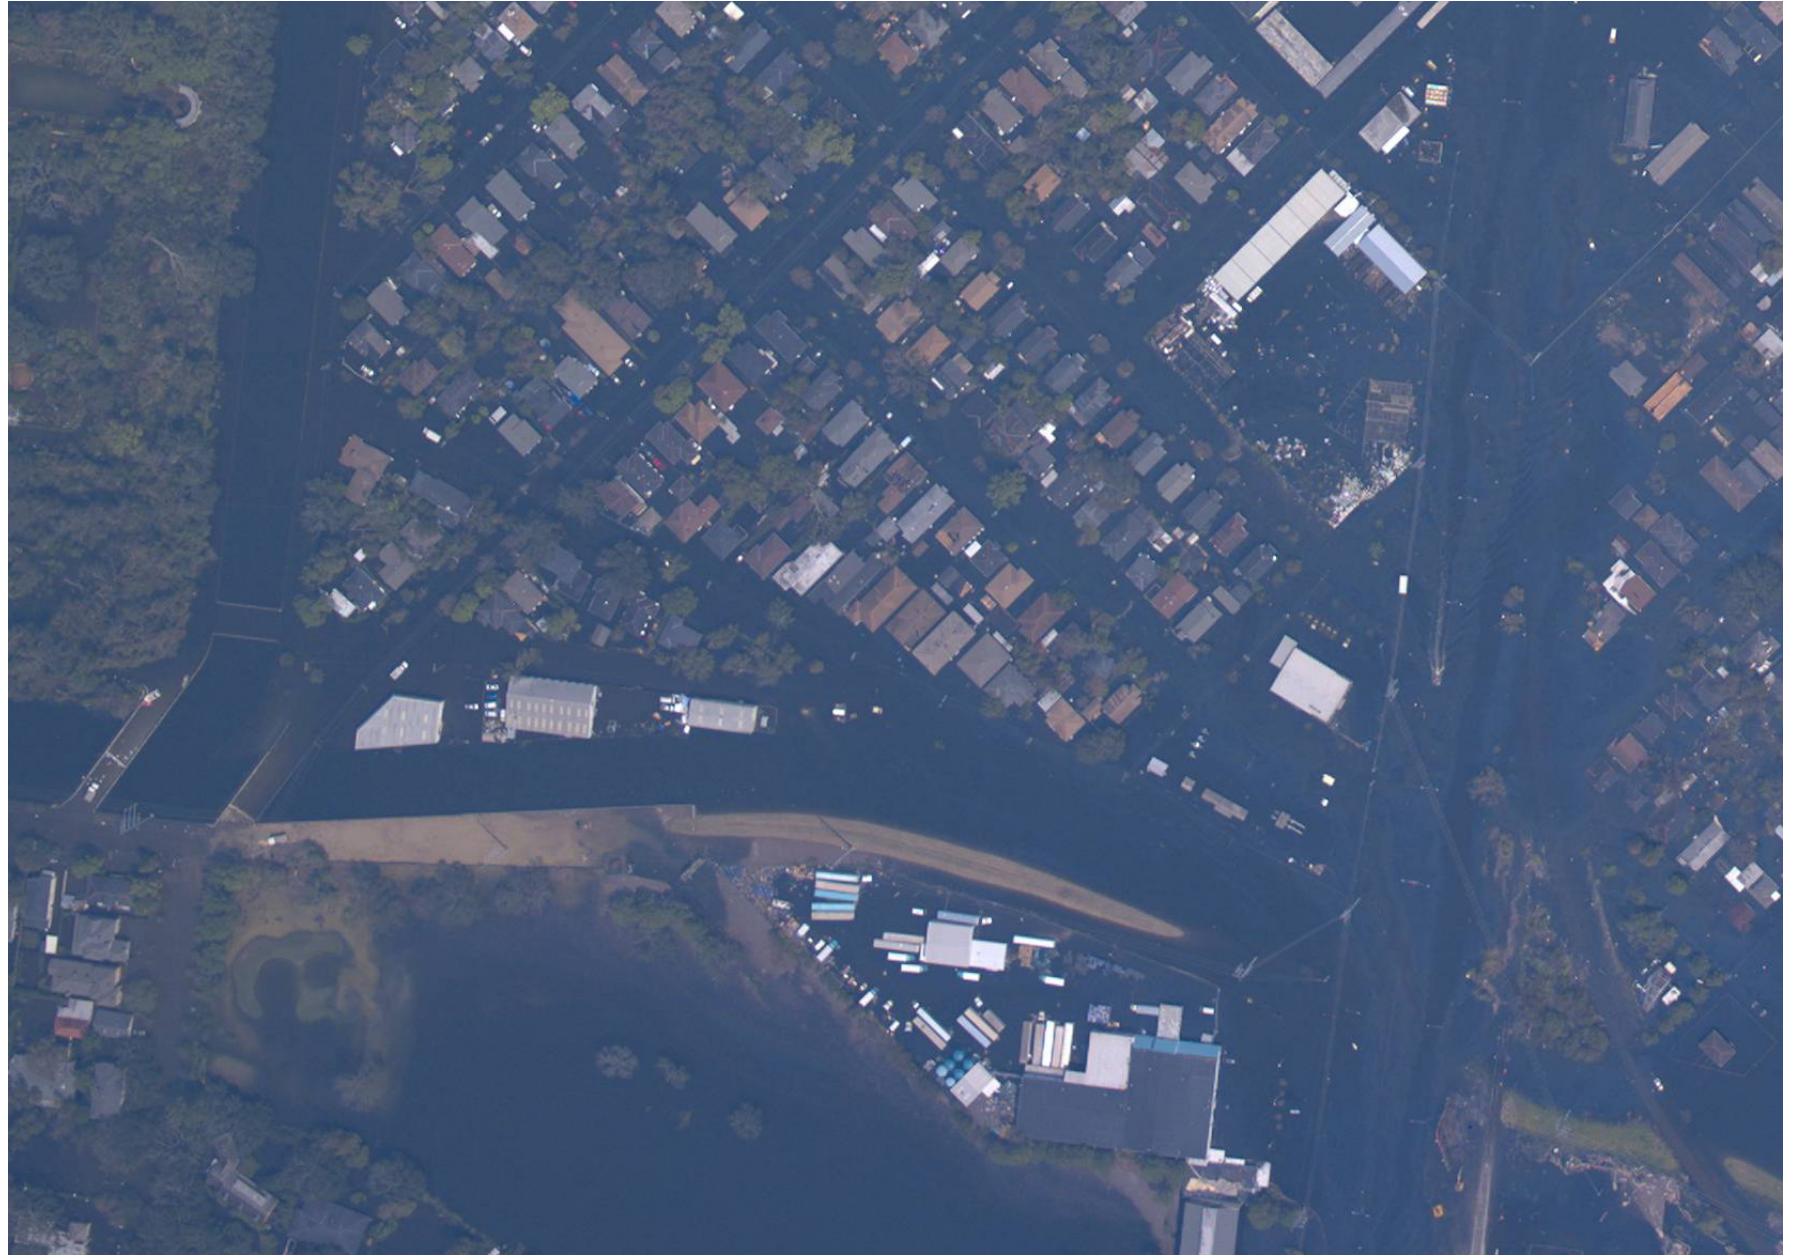
Within a few days after the August 31 image was taken, Jefferson Parish constructed temporary rock and sandbag levees over these two bridges, across Airline Drive, and across Claiborne Ave./Jefferson Highway at the Jefferson/Orleans Parish boundary. These temporary levees were apparently constructed to prevent more flood water originating at the levee breaches in Orleans Parish from further flooding Jefferson Parish. Although the levee breaches in Orleans Parish were mostly stopped by the time the temporary levees at the Parish line were constructed, the damage had already been done. There are, however, reports that once these temporary levees were built, Jefferson Parish started pumping water out of Jefferson and back into Orleans Parish. If true, this would have increased the amount of water over that already standing in Orleans Parish while the levee breaches were being patched and before the pumps in Orleans parish could be started to remove the water from the severely flooded areas.

Figure 53. Air photograph of the area where the water from the 17th Street Canal Levee Breach ran back into Old Metairie, near Orpheum and Palm (stop 6). Image acquired Aug. 31, 2005. Source: National Oceanic and Atmospheric Administration's National Geodetic Survey, Katrina Images - <http://ngs.woc.noaa.gov/katrina/>
