Hurricane Katrina - What Happened? The Geology of the Katrina Disaster in New Orleans

Field Trip Guide Updated 9-17-2009

Stephen A. Nelson
Department of Earth &
Environmental Sciences
snelson@tulane.edu

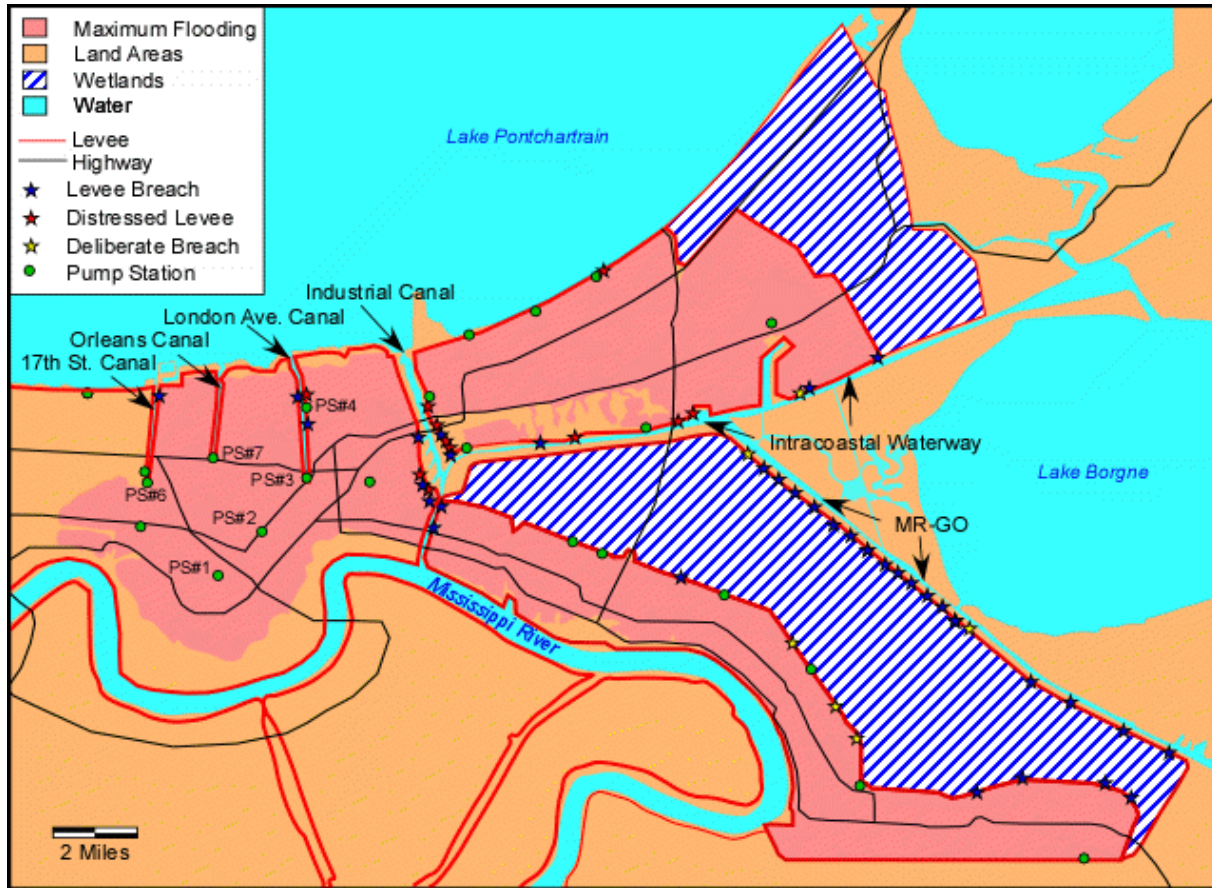
Figure 9. Map of maximum extent of flooding during Katrina modified and locations of breached levees after U.S. Army Corps of engineers and Seed et al. (2005)

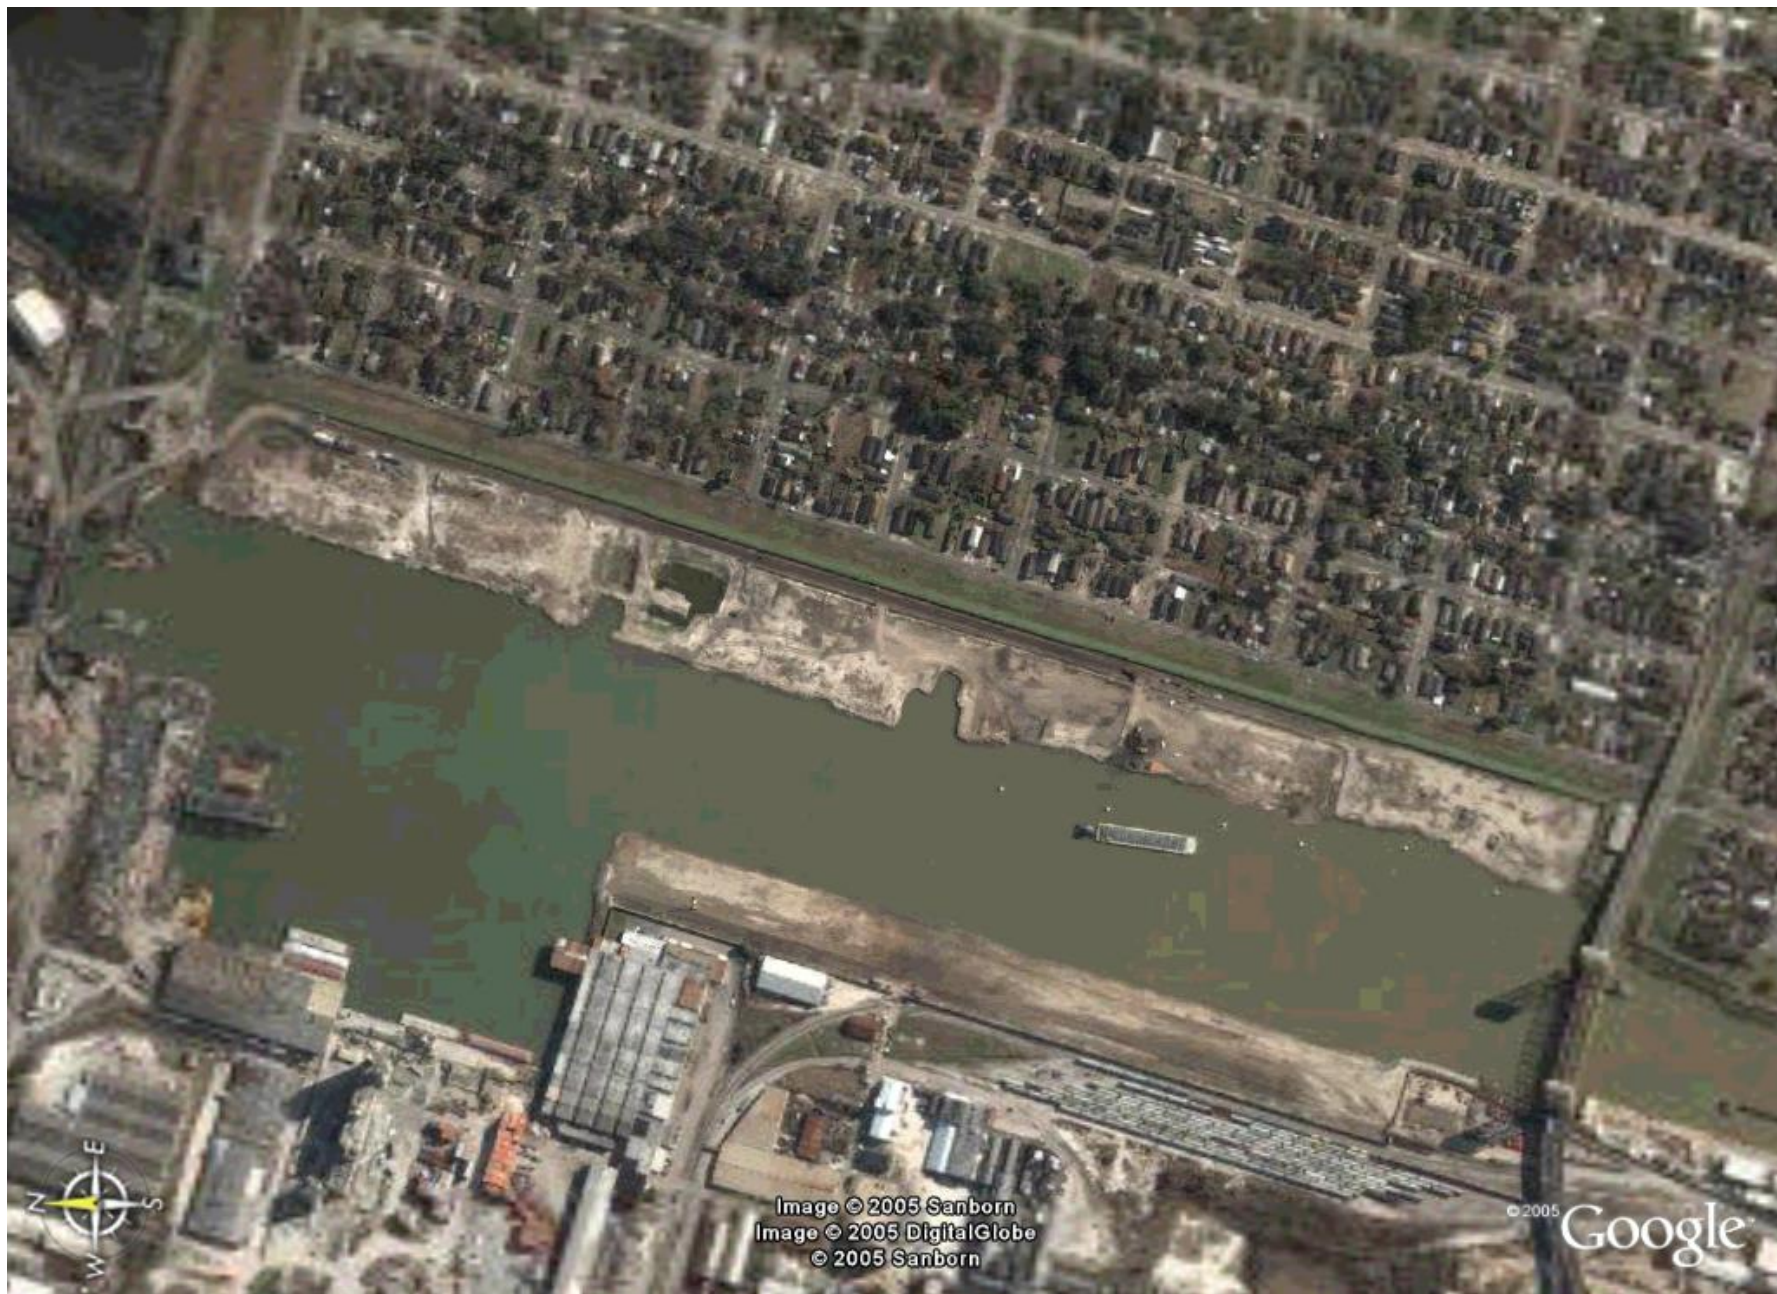
Figure 10. Satellite image of the area along the Industrial Canal where the levee was later breached during Hurricane Katrina. (Source - Google Earth)

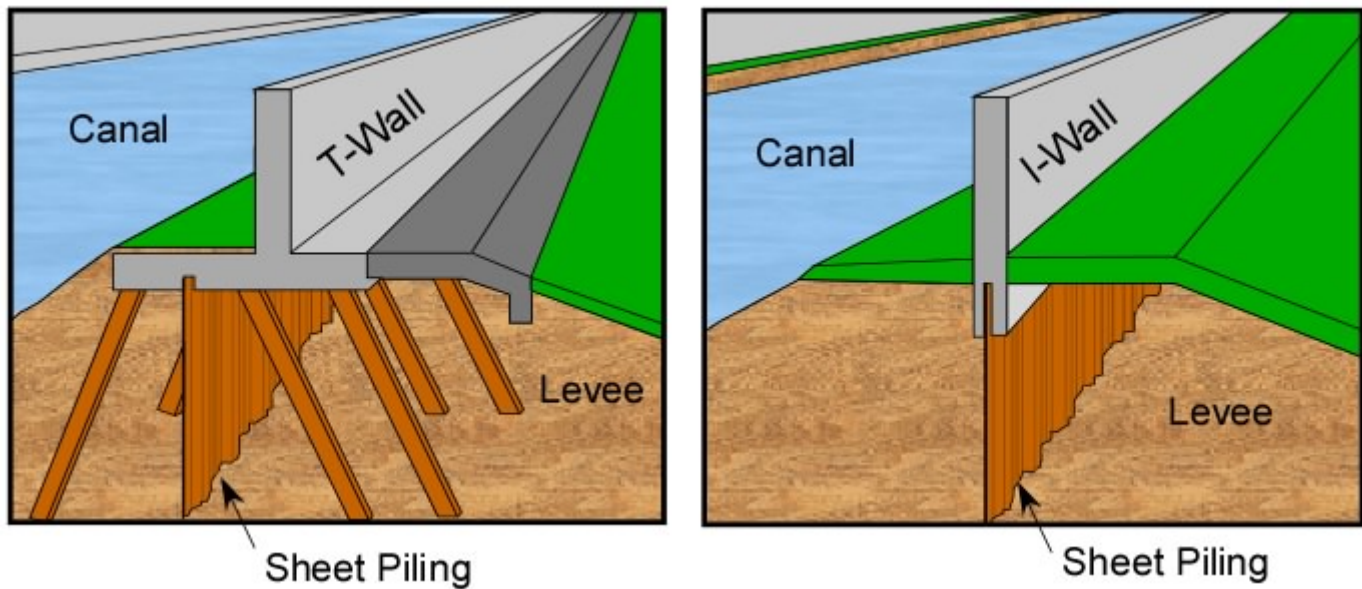
Figure 18 shows the floodwall between the two breaches on the Industrial Canal where the wall was not breached, but was leaning outward toward the Lower 9th Ward. One can easily see that the top of the levee has dropped down along side of the leaning floodwall. This type of floodwall was an I-wall, one of two designs used in the New Orleans hurricane protection system (Fig. 19).

Figure 19. Most pre-Katrina floodwalls in New Orleans were built with the I-wall design (right). In repairing failed floodwall sections after Katrina, the T-wall design (left) was used.

At Stop 1 in the Lower 9th Ward, one now sees that the entire floodwall between the two bridges (Claiborne to the south and Florida Avenue to the North – the blue colored bridge) has been replaced with a T-wall with a top elevation at 14.5 feet above sea level, the level it was supposed to have attained prior to Katrina. This new floodwall was completed in mid-June, 2006. The original I-wall is still present along the other side of the Industrial Canal as well as to the south and north of the new T-wall. The only improvement made to the levees where the I-walls still exist is concrete armoring has been added to the base of the I-wall to prevent the erosion of the levee should water come over the top of the wall again.

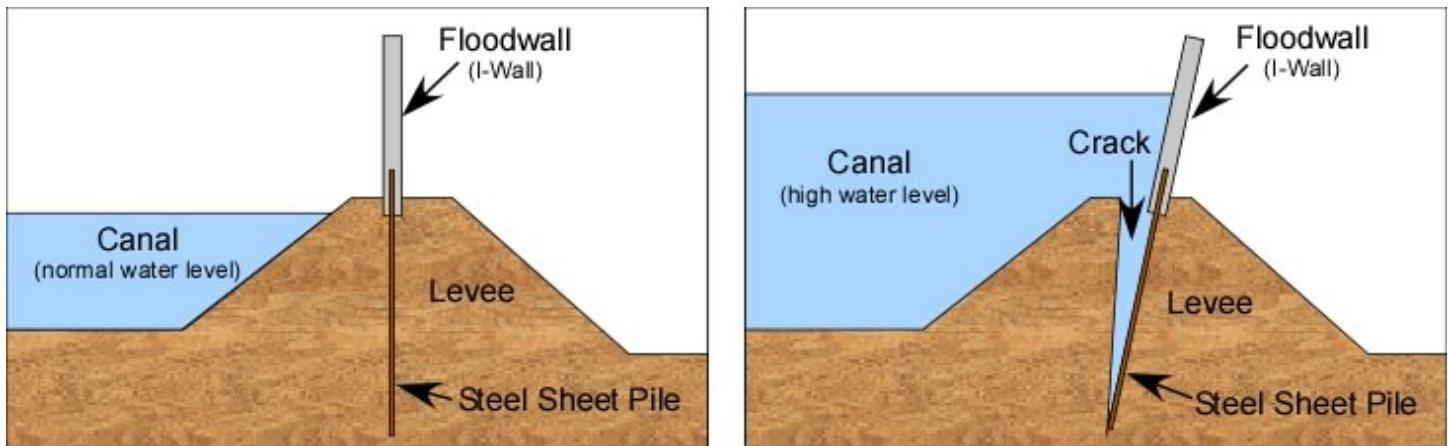
Although the floodwalls along the Industrial Canal were built in the 1970s, in 1985, the research branch of the Army Corps of Engineers conducted experiments on the I-wall design. They constructed a levee and enclosure in the Atchafalaya Basin (to the southwest of New Orleans) and began filling the area next to the levee and sheet pile floodwall with water. As the water rose against the floodwall, deflections of the floodwall began to occur and a gap opened on the water side of the floodwall which allowed the full hydrostatic force of the water to penetrate to the tip of the sheet piling (Jackson, 1988, Oner and others, 1997). This type of floodwall failure is illustrated in Figure 20. These findings were apparently never communicated to those in the Corps responsible for the design and construction of floodwalls in New Orleans (Marshall, March 14, 2006). The leaning floodwall seen in Figure 18 clearly shows that this also happened on the Industrial Canal floodwall during Hurricane Katrina. The force of the water pushing the wall outward toward the protected side coupled with removal of support by erosion caused by the water pouring over the top of the floodwall was the most likely cause of the catastrophic failures on the east side of the Industrial Canal (Fig. 21).

Figure 20. Illustration of crack development as water in a canal rises on the floodwall and pushes outward on the floodwall as observed in 1985 experiments by U.S. Army Corps of Engineers.

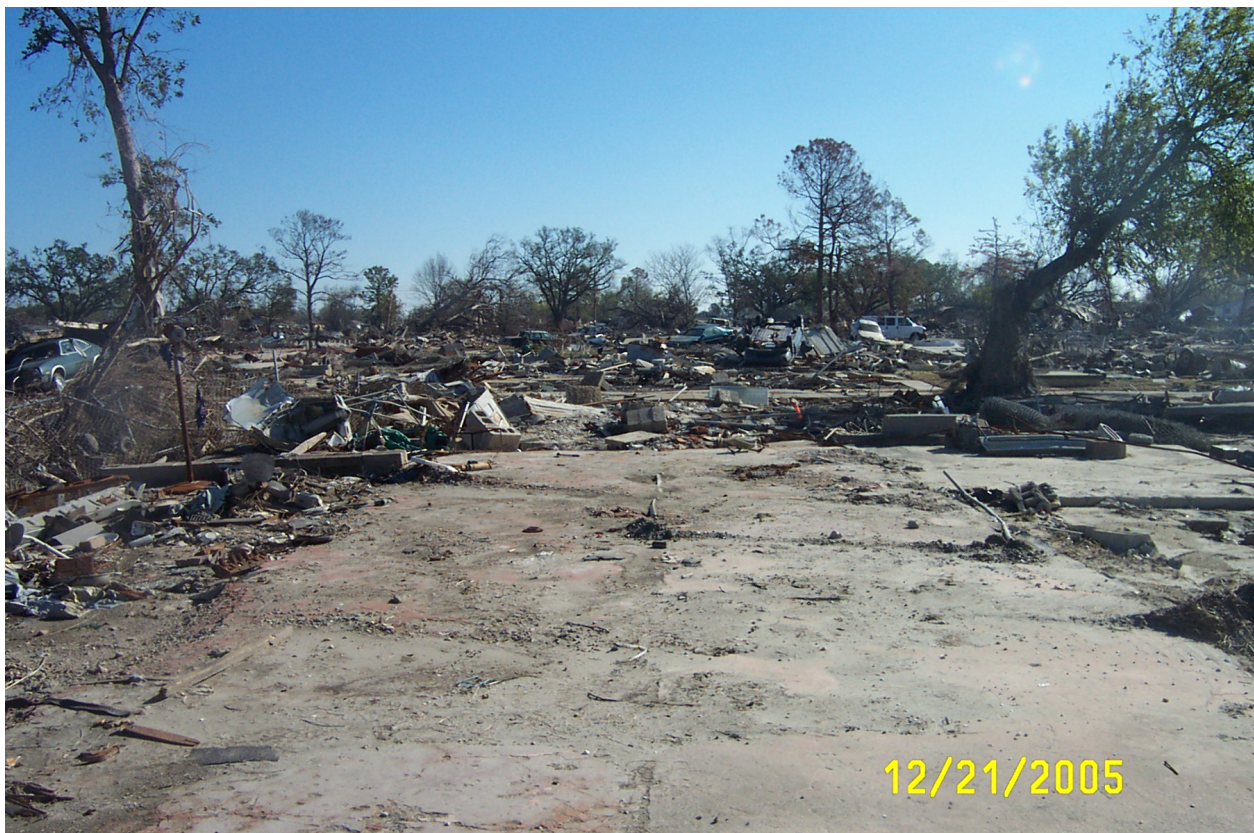
Figure 22. View of Lower Ninth Ward looking East as it appeared in December, 2005.

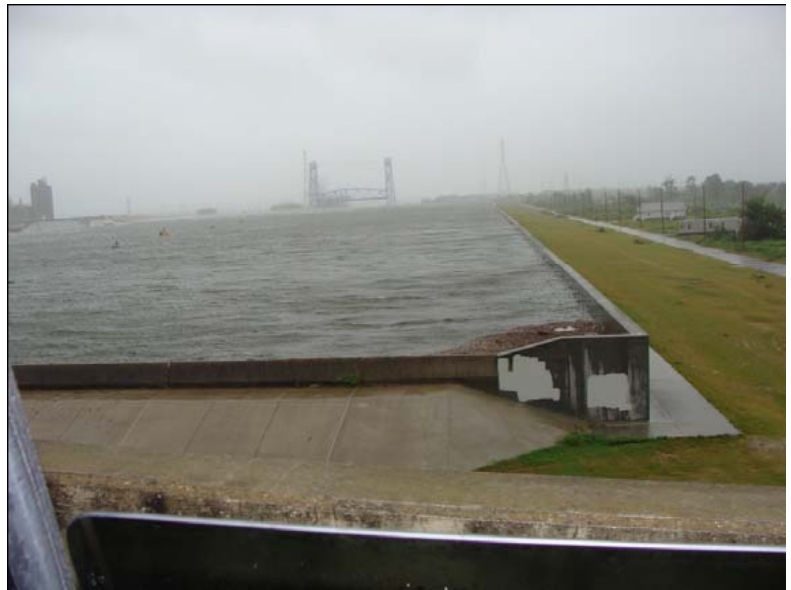
Hurricane Gustav in September of 2008 showed just how vulnerable this area is to storm surge. Gustav made landfall as a Category 2 hurricane about 65 miles southwest of here. Nevertheless, it produced storm surge in the Industrial Canal that reached near the top of the old floodwall,(Fig. 23) and television news coverage showed waves overtopping the floodwall on the west side near the Claiborne Avenue Bridge. Debris strand lines from this event can still be observed between the top of levee here and the new T-wall.

Figure 23. View of the Industrial Canal from the Claiborne Ave. Bridge looking North toward Stop 7 with the Florida Ave. Bridge (blue bridge) on the horizon. Photo as taken on the morning of Sept. 1, 2008 during the passage of Hurricane Gustav. Note the elevation drop from the post-Katrina floodwall (on the right) to the original floodwall to the left. Photo from U.S. Army Corps of Engineers.

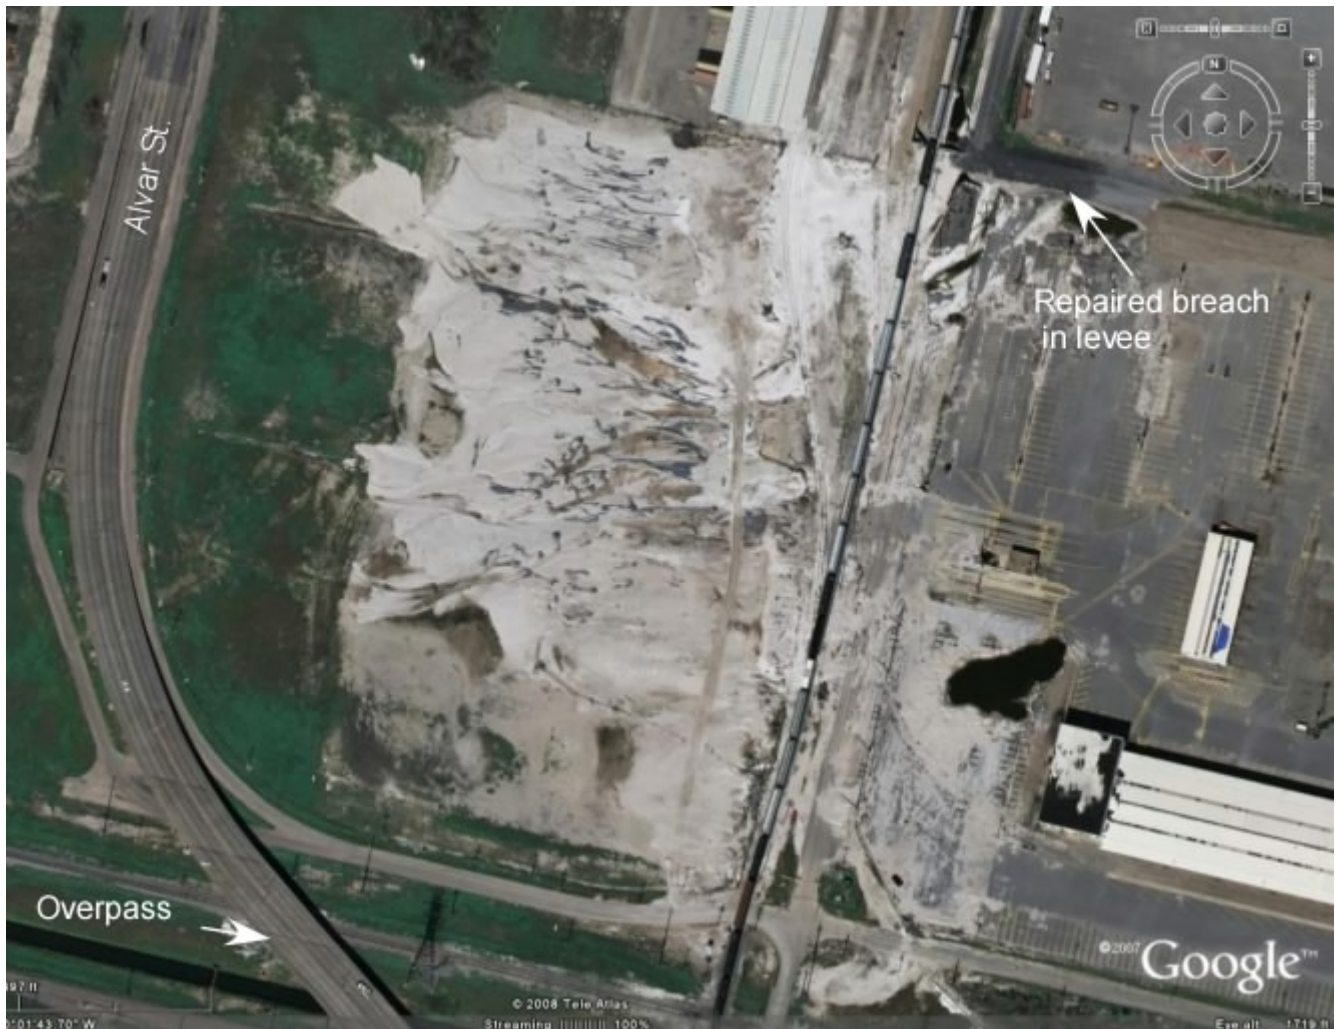
After crossing the Claiborne Ave. bridge and proceeding North along Poland Avenue, upon crossing the overpass (point A in Figure 1), look off to the right to view deposits of white shells that were emplaced during the breach of a levee constructed mostly of shells on the west side of the Industrial Canal (one of two breaches on this side). Figure 24 is a Google Earth Image of these deposits.

Figure 24. Google Image (acquired around May, 2006) of area near overpass to Alvar St. (point A in Figure 1) showing location of breached levee and deposits of shells (white material in center of image) that resulted from the breach. Industrial Canal is off the image to the right (east).

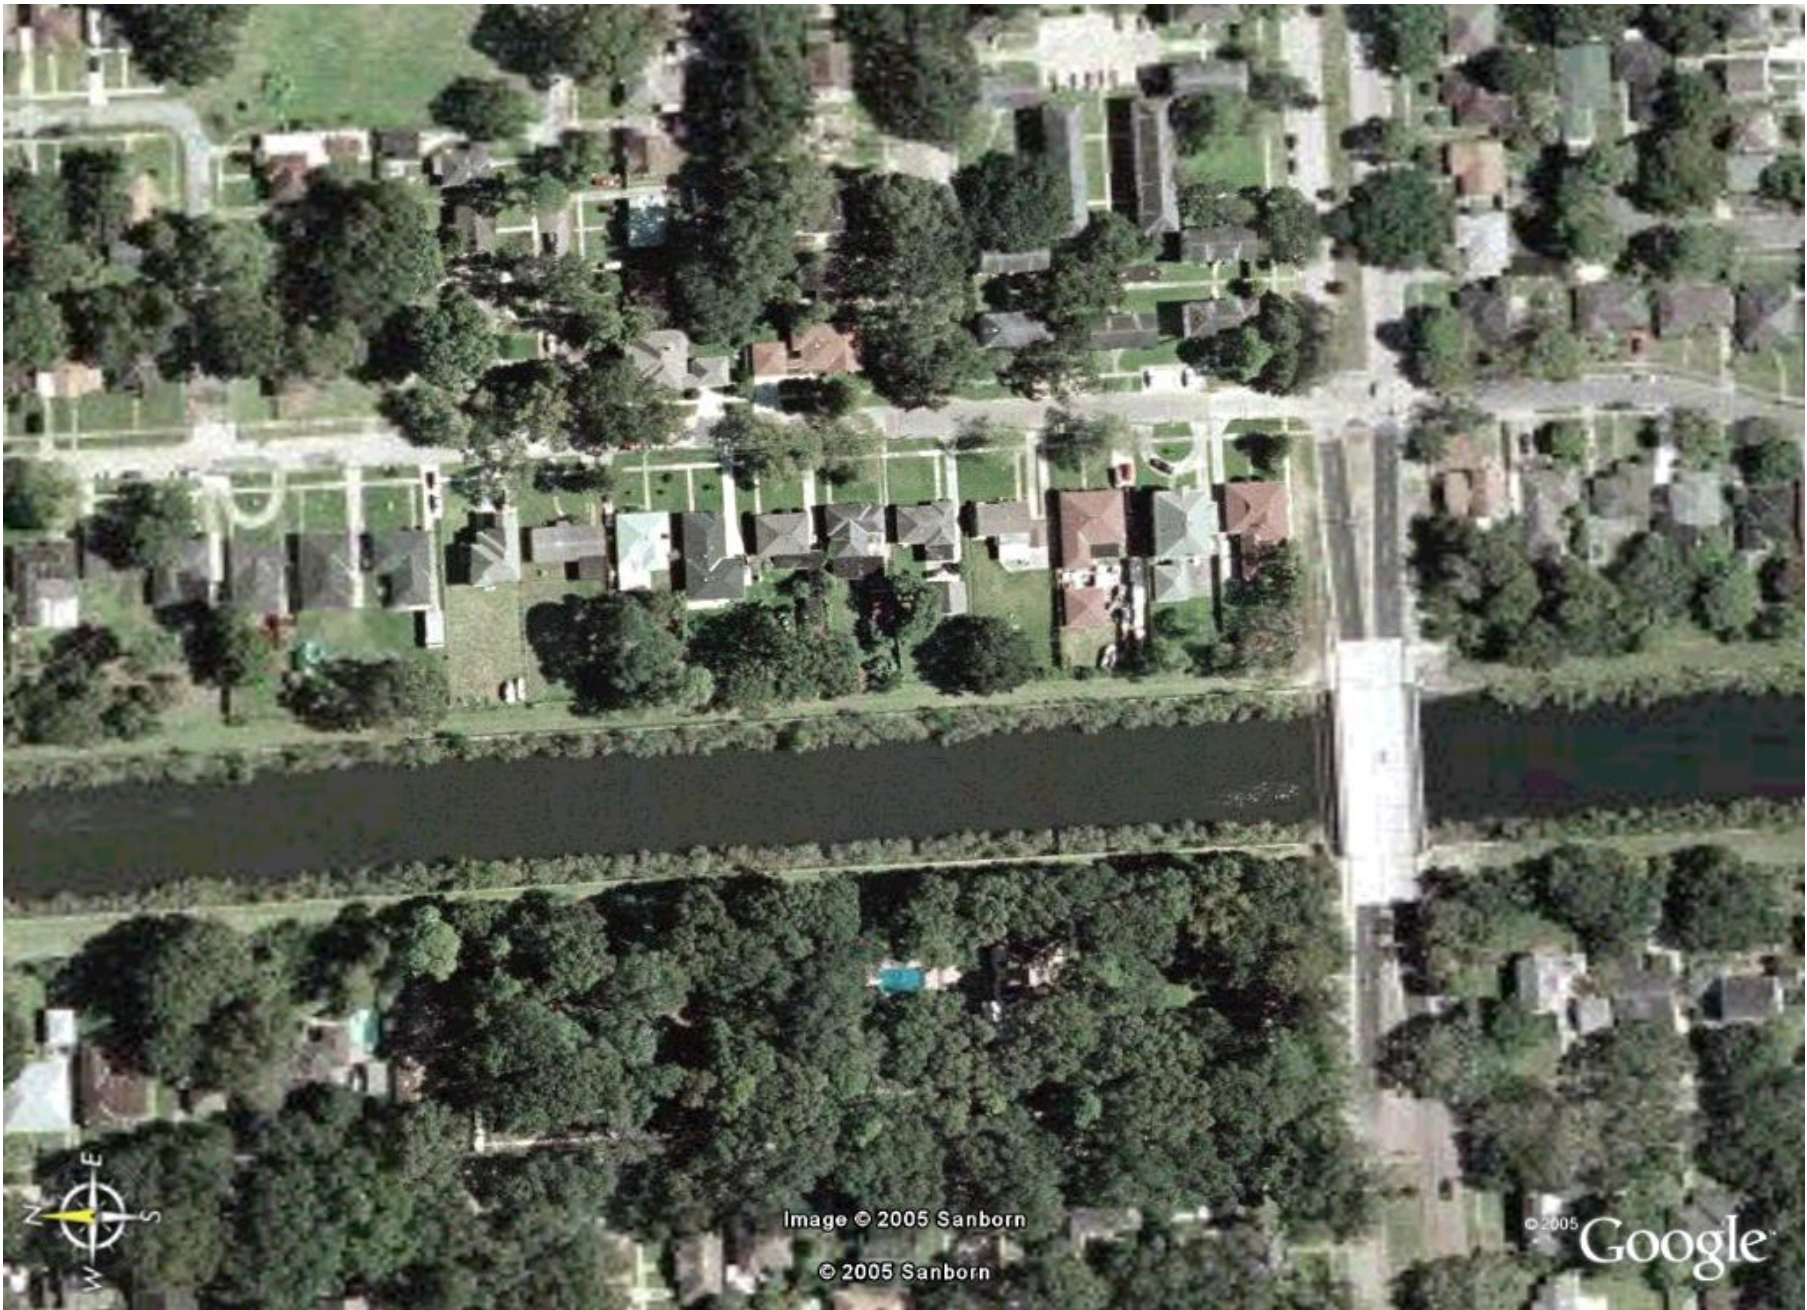
Stop 4 is at Mirabeau Avenue and the London Avenue Canal. According to the IPET Final Report (IPET, 2006), the breach at this site occurred between 7:00 and 8:00 AM on August 29, when winds were blowing out of the northeast pushing water from Lake Pontchartrain into the drainage canals. Figure 25 shows the area of the breach before Katrina and Figure 26 shows approximately the same view on August 31, 2005 when the breach was still active. A house in the center of the breach was moved out onto Warrington Drive (this house was demolished on about March 10, 2006). In Figure 26, natural gas can be seen bubbling up through the flood waters at the location of the now displaced house. The breach here is about 200 feet wide and has now been replaced by a T-wall. (Construction of the T-wall was completed in October, 2006).

Figure 25. Satellite image of the area along the London Avenue Canal near Mirabeau Ave. and Warrington Drive (Stop 4), where the levee was later breached during Hurricane Katrina. (Source - Google Earth)

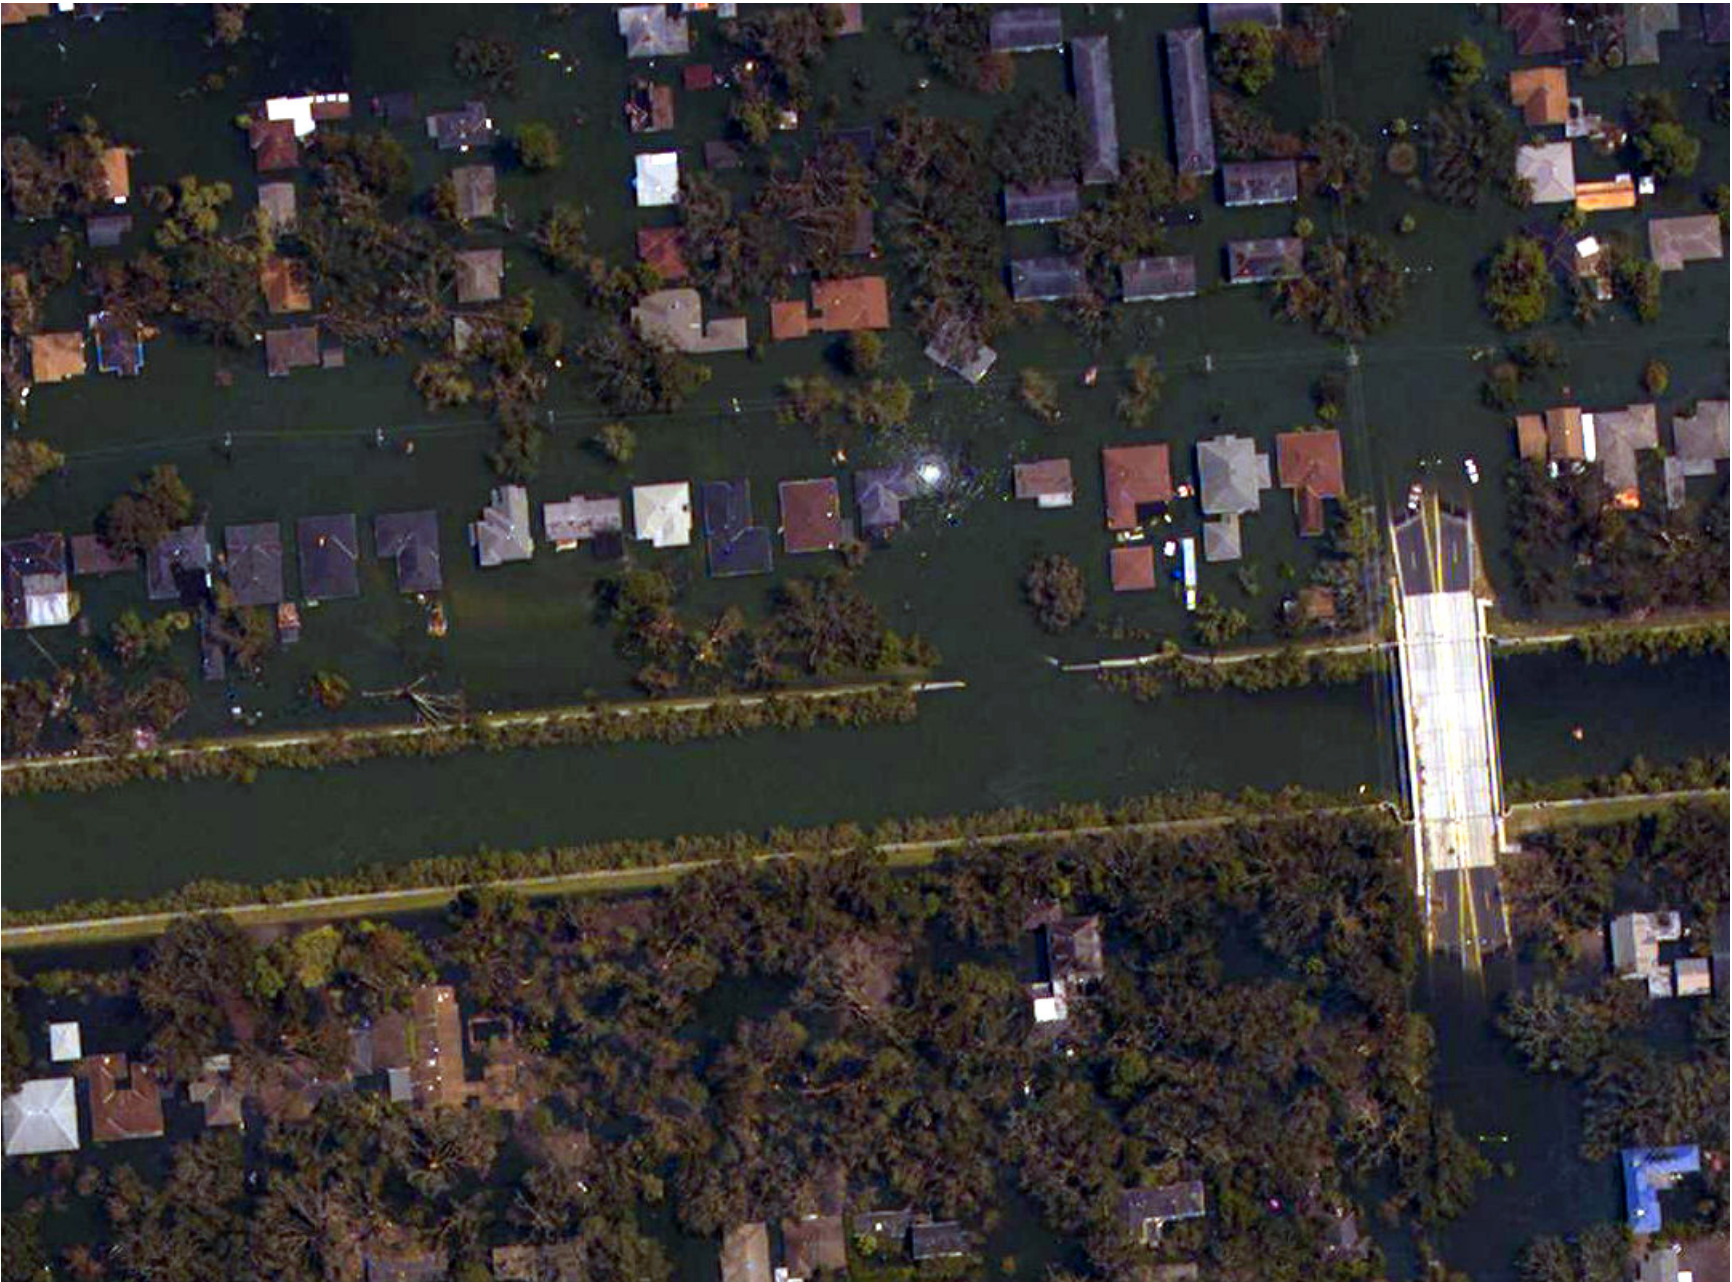
Also noticeable by comparison of Figures 25 and 26 is that before Katrina a tree stood at the toe of the levee adjacent to the part that breached. That tree is laying on its side in the image taken on August 31, 2005 (Fig. 26). It is notable that

Figure 26. Air photograph of the area where the London Avenue Canal levee was breached near Mirabeau Ave. and Warrington Drive (Stop 4). Image acquired Aug. 31, 2005. Source: National Oceanic and Atmospheric Administration's National Geodetic Survey, Katrina Images - <http://ngs.woc.noaa.gov/katrina/>

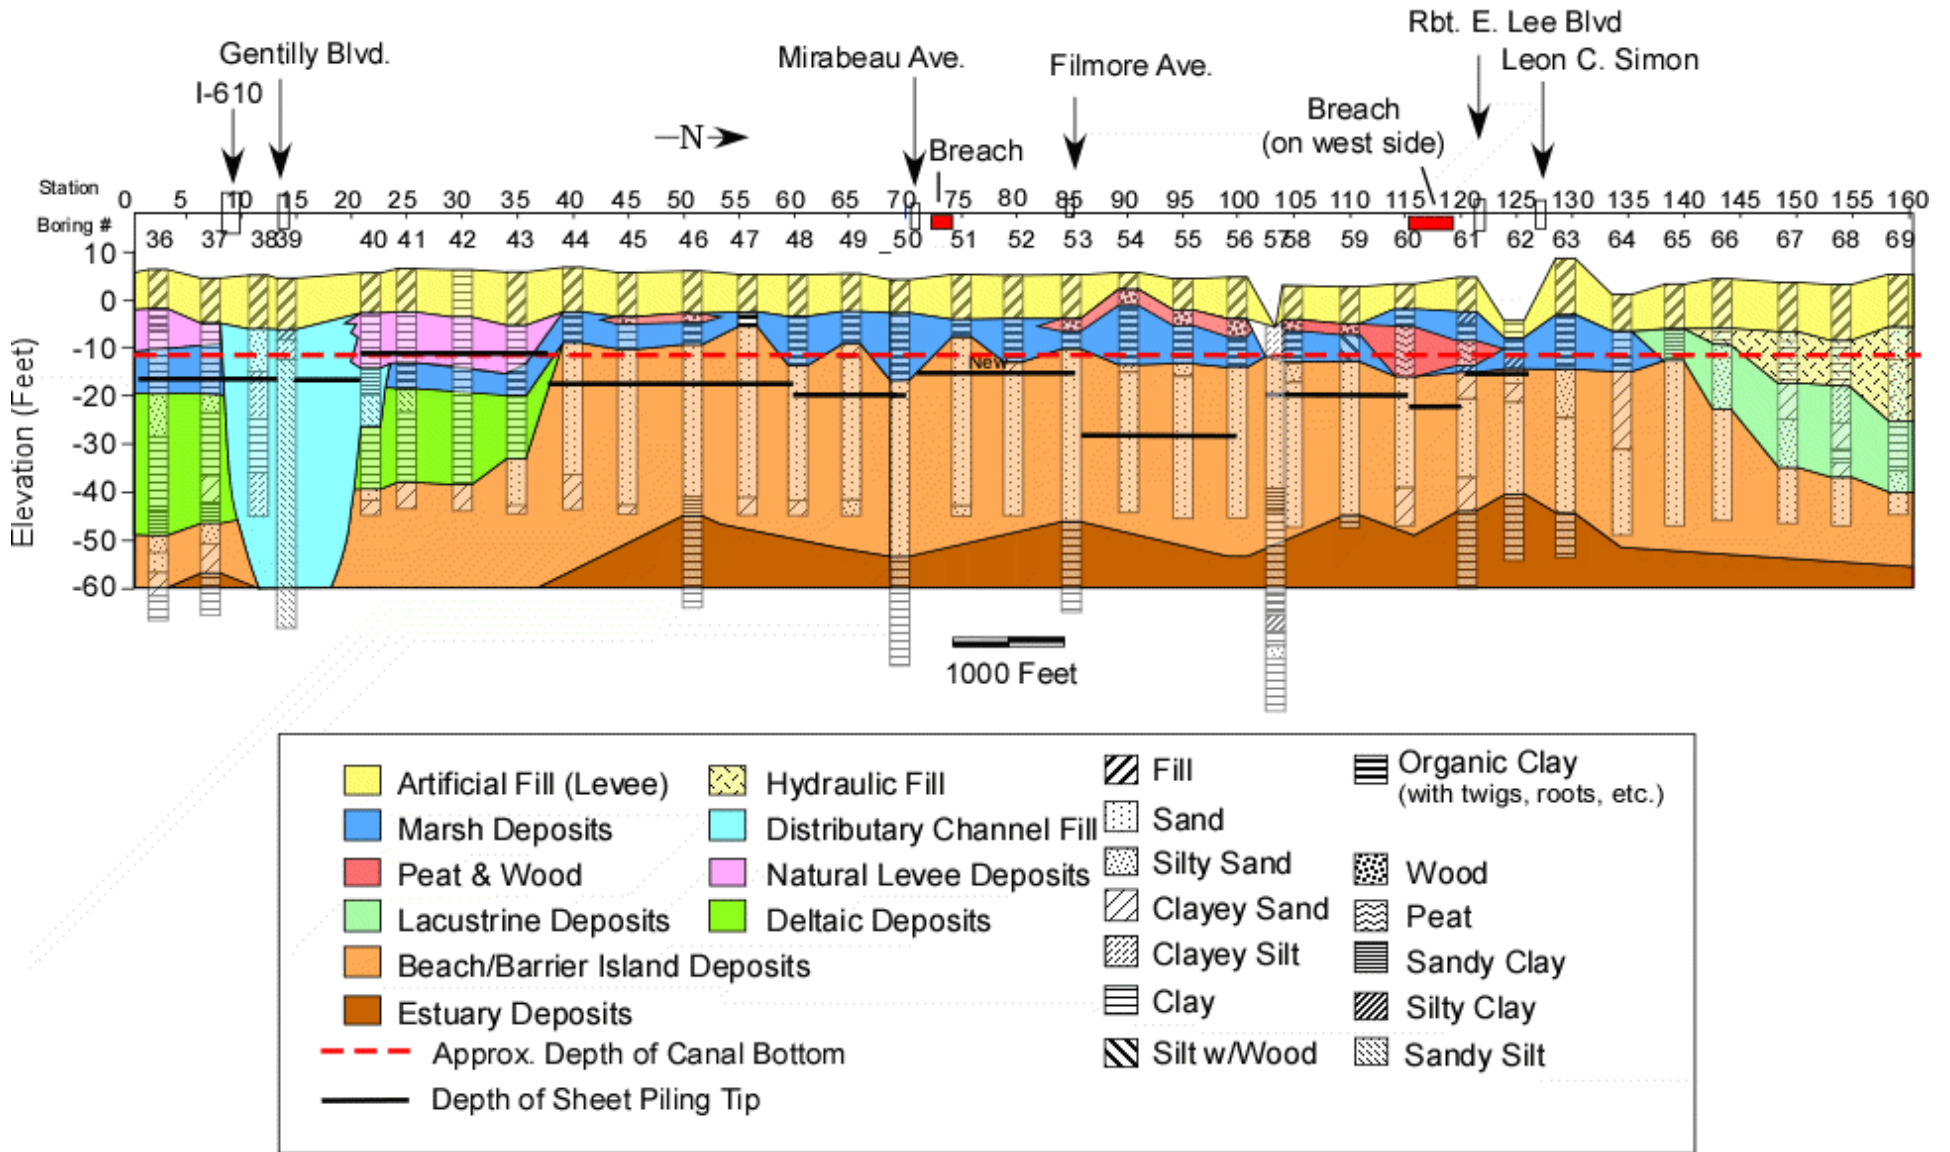
The sand in these deposits did not originate from the canal water or lake water that was pushed into the canal during Katrina. Instead, it originated from beneath the levee. A geologic cross-section constructed from data on soil borings (done in 1986) (U.S. Army Corps of Engineers, 1989) from the banks of the London Avenue Canal is shown Figure 28. The cross-sections clearly show the presence of sand at a depth beginning between 10 and 15 feet below sea level. This sand is the same Pine Island beach sand that was deposited in the area between 4,000 and 5,000 years ago as shown in Figures. 2, 5 and 6.

Figure 28. Geological cross-section along the east side of the London Avenue Canal constructed from data in U.S. Army Corps of Engineers (1989).

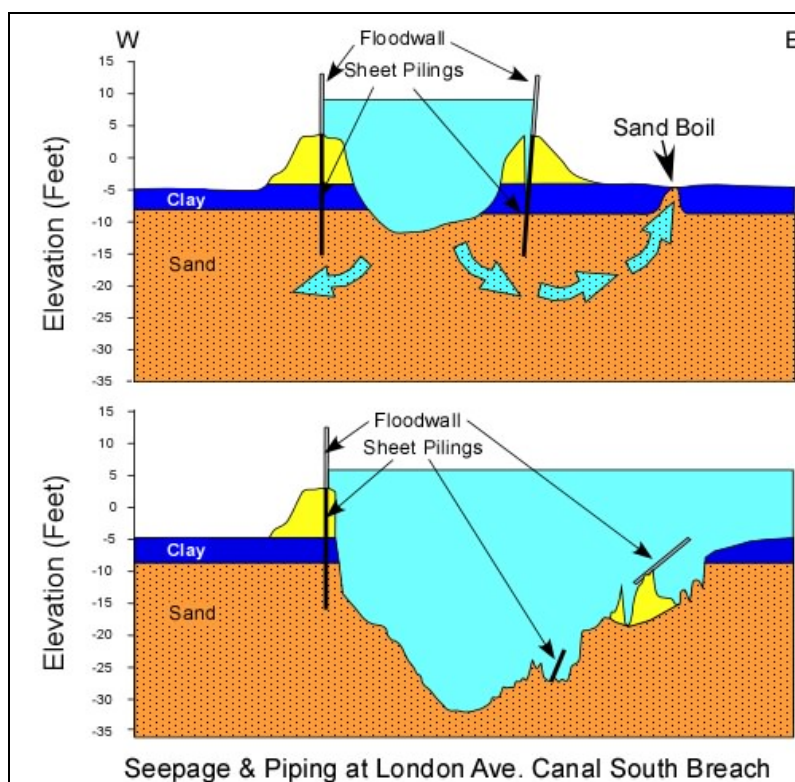
Figure 30. Geological cross section across the London Ave. Canal based on borings 16 and 51 (Figs. 27 and 33), shown at time of estimated high water during Katrina's storm surge. The sands form a permeable layer through which groundwater originating in the canal can penetrate and move below the sheet pilings and up to the surface (top diagram), eventually undermining the levee and causing a blowout completely removing a section of levee and carrying sand into the neighborhood. The shape of the canal bottom is based on depth soundings undertaken by the U.S. Army Corps of Engineers on September 5, 2005.

The repair operation has only been done in the area of the breach. The operation involved digging out the material used in the initial emergency repair, filling it with clay and construction a T-wall to replace the missing I-wall. Fortunately, the Corps of Engineers has now completed removable floodgates near the mouths of the London Ave, Orleans, and 17th St. canals near Lake Pontchartrain. These floodgates will be closed in the event of a hurricane and should prevent storm surge from reaching onto the floodwalls in the canals. If the gates are closed, however, the pumps at the southern end of the canals cannot be used to pump rainwater out of the city. Thus, the Corps has built pumping stations at the Lake (where they should have been built in the first place), but full pumping capacity is not yet available. Still rainwater flooding is better than having Lake Pontchartrain drain into the city.

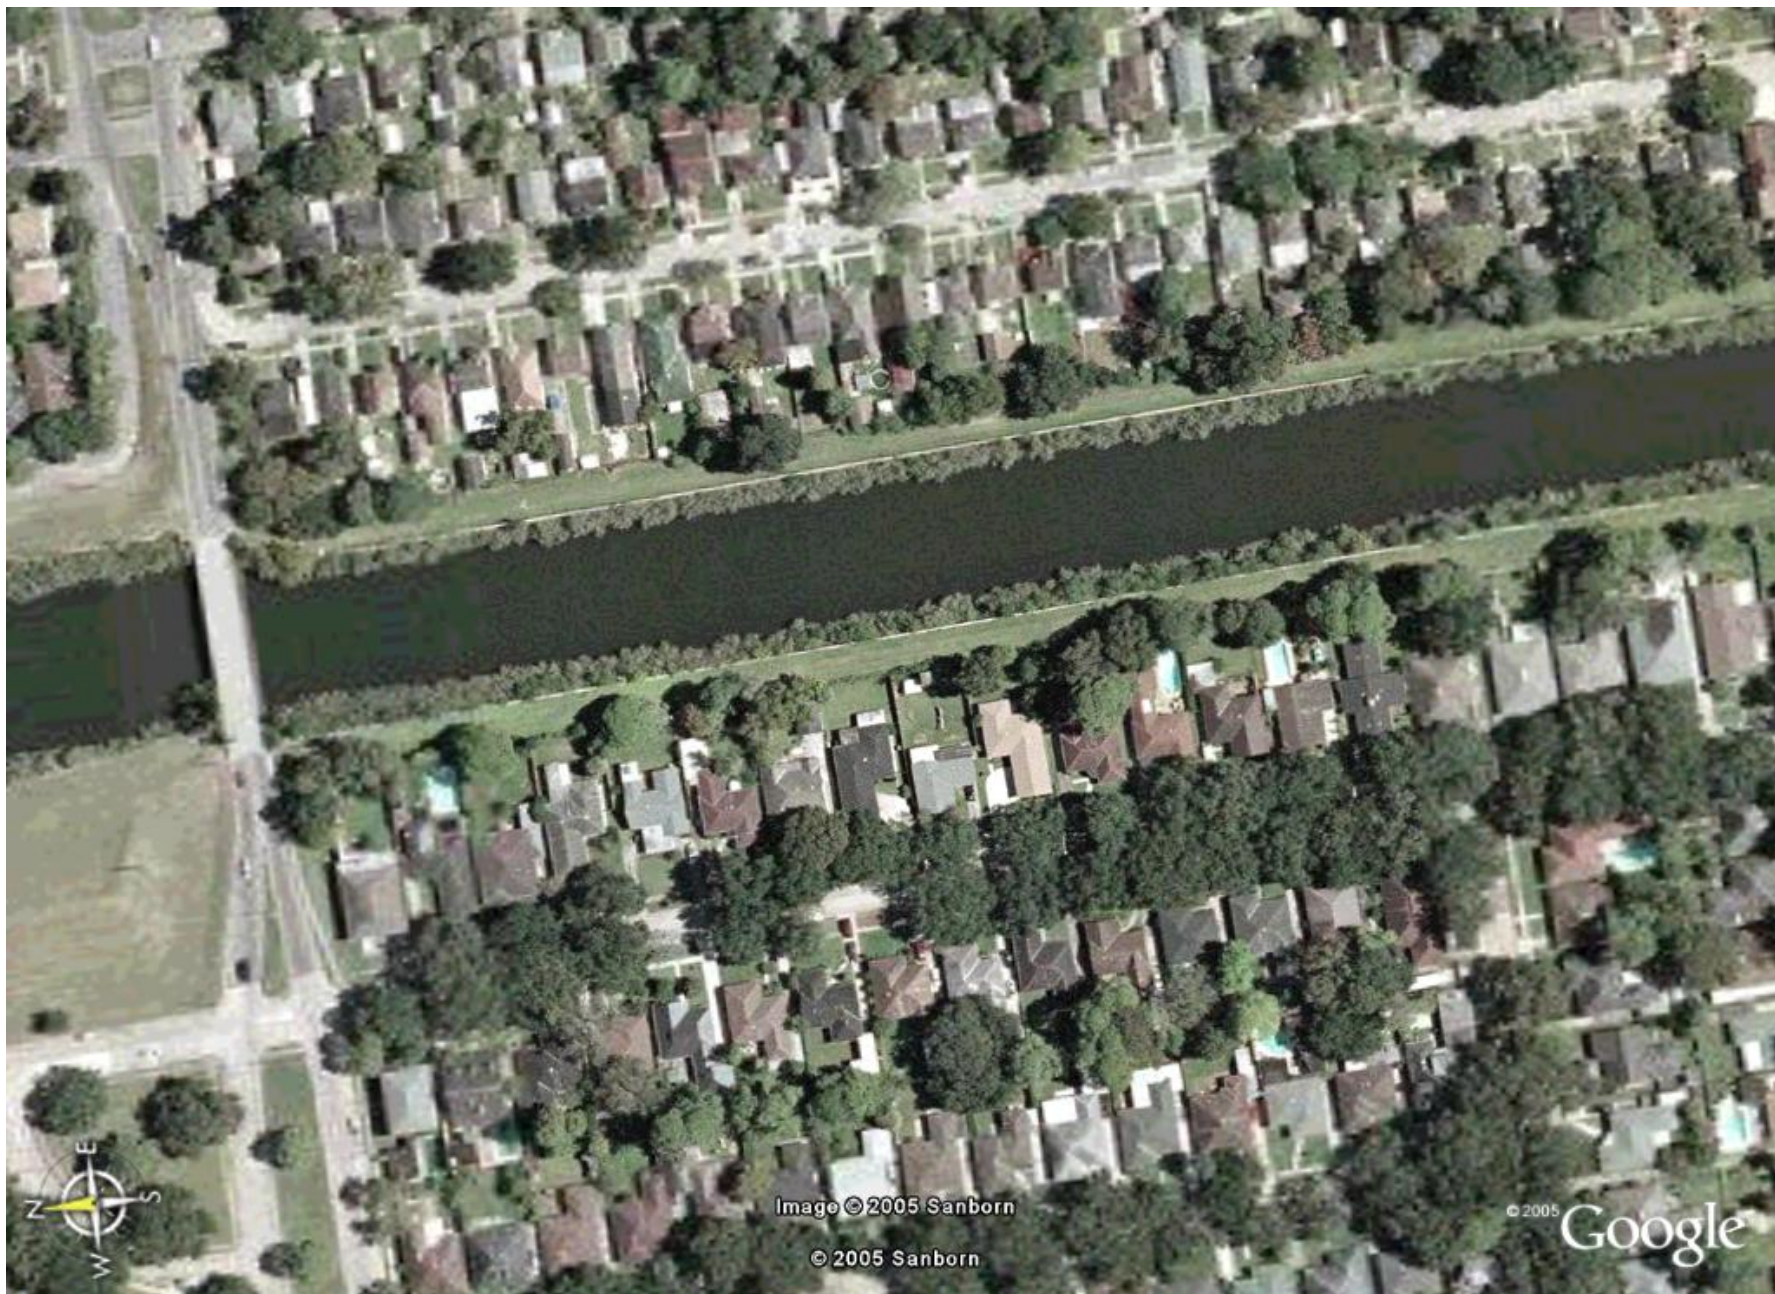
Note in Figures 32 and 33 that there is abundant vegetation along the banks of the canal inside the floodwalls. During the surge event in the canal, this vegetation trapped debris flowing in the canal and the height of this trapped debris in the vegetation could be used to estimate water level. Such evidence observed shortly after the storm indicates that the water level in the canal was no higher than about 3 feet from the top of the floodwall. Note also in Figure 33 how the vegetation along the bank of the failed floodwall shows a distinct edge marking the pre-failure position of the floodwall. During the failure, the floodwall slid away to the west as a result of the water pressure against the floodwall and sheet pilings.

Figure 32. Satellite image of the area along the London Avenue Canal near Robert E. Lee Blvd. and Pratt Drive (Stop 5), where the levee was later breached during Hurricane Katrina. (Source - Google Earth)

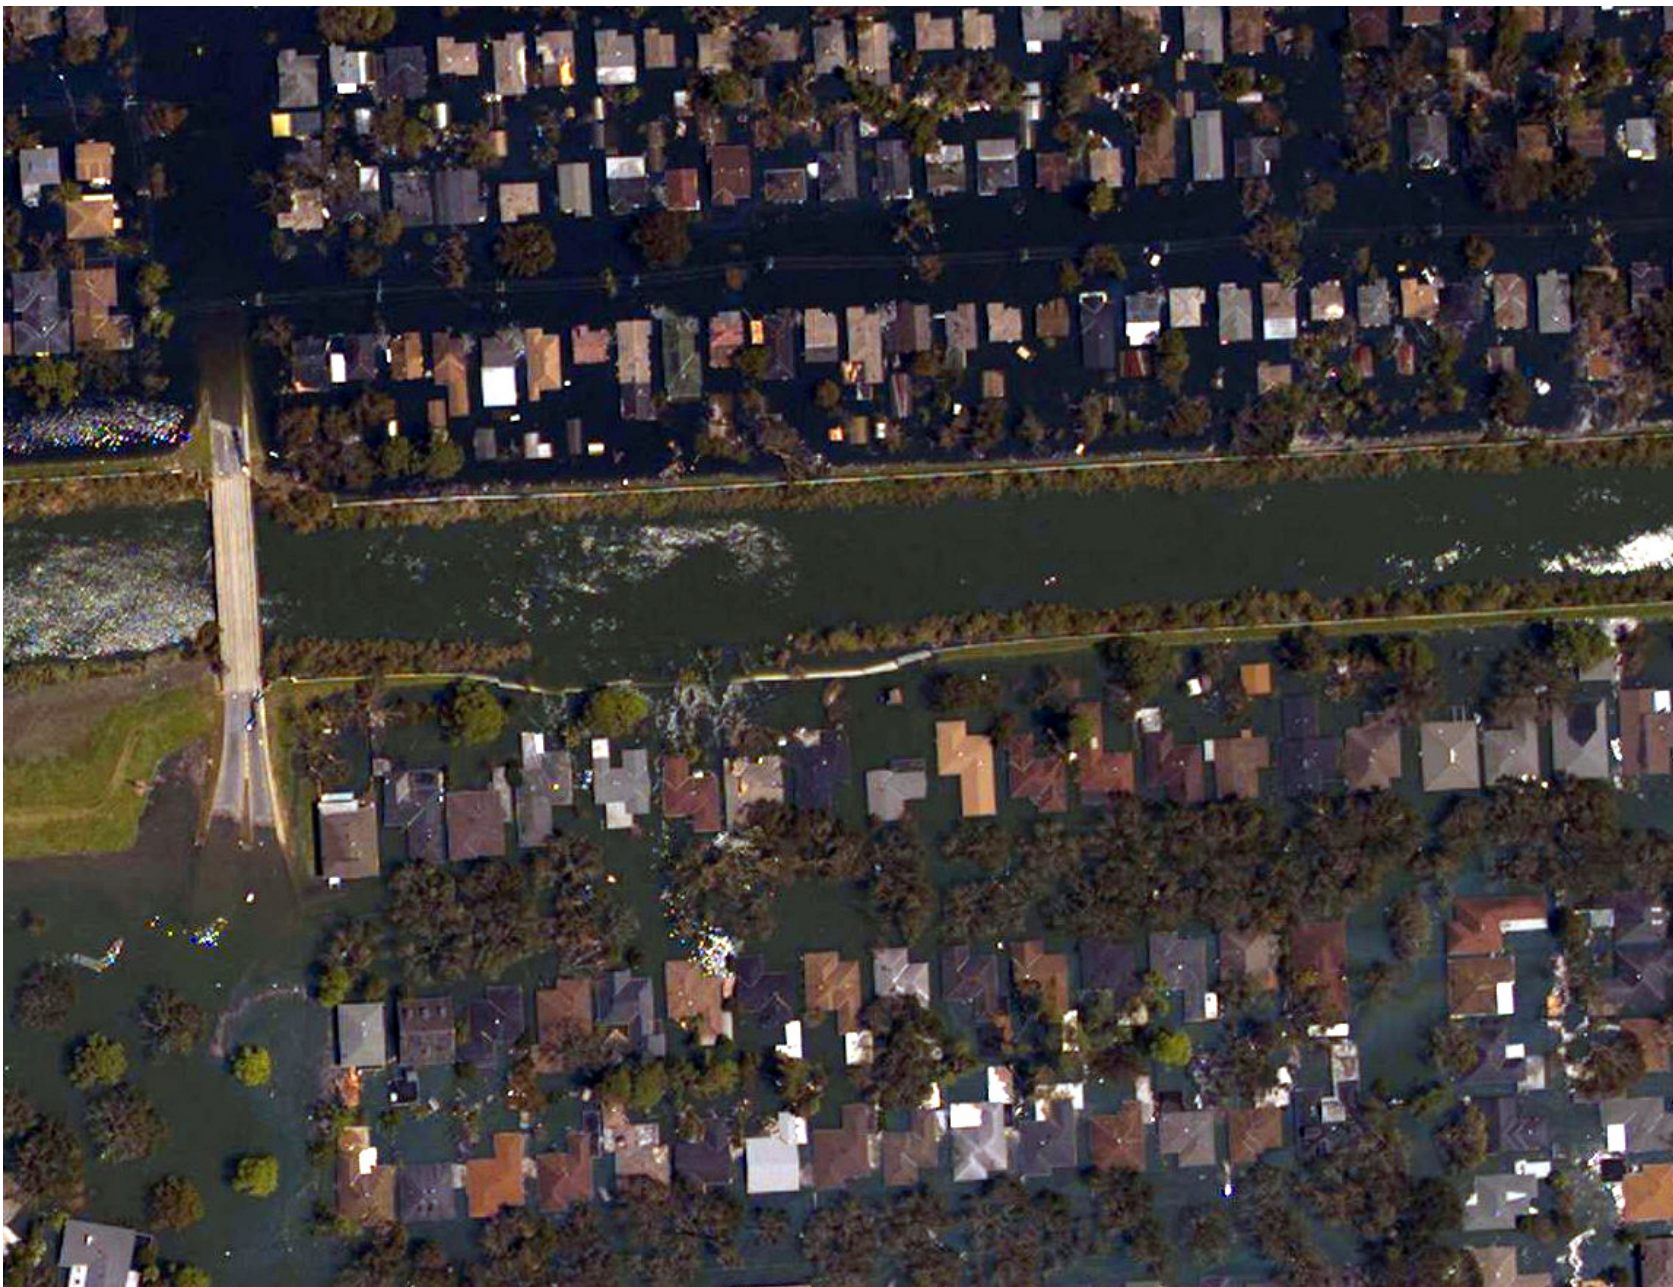
Figure 33. Air photograph of the area where the London Avenue Canal levee was breached near Robert E. Lee Ave. and Pratt Drive (Stop 5). Drive. Image acquired Aug. 31, 2005. Source: National Oceanic and Atmospheric Administration's National Geodetic Survey, Katrina Images - <http://ngs.woc.noaa.gov/katrina/>
