Hurricane Katrina - What Happened? The Geology of the Katrina Disaster in New Orleans

Field Trip Guide Updated 9-17-2009

Stephen A. Nelson
Department of Earth &
Environmental Sciences
snelson@tulane.edu

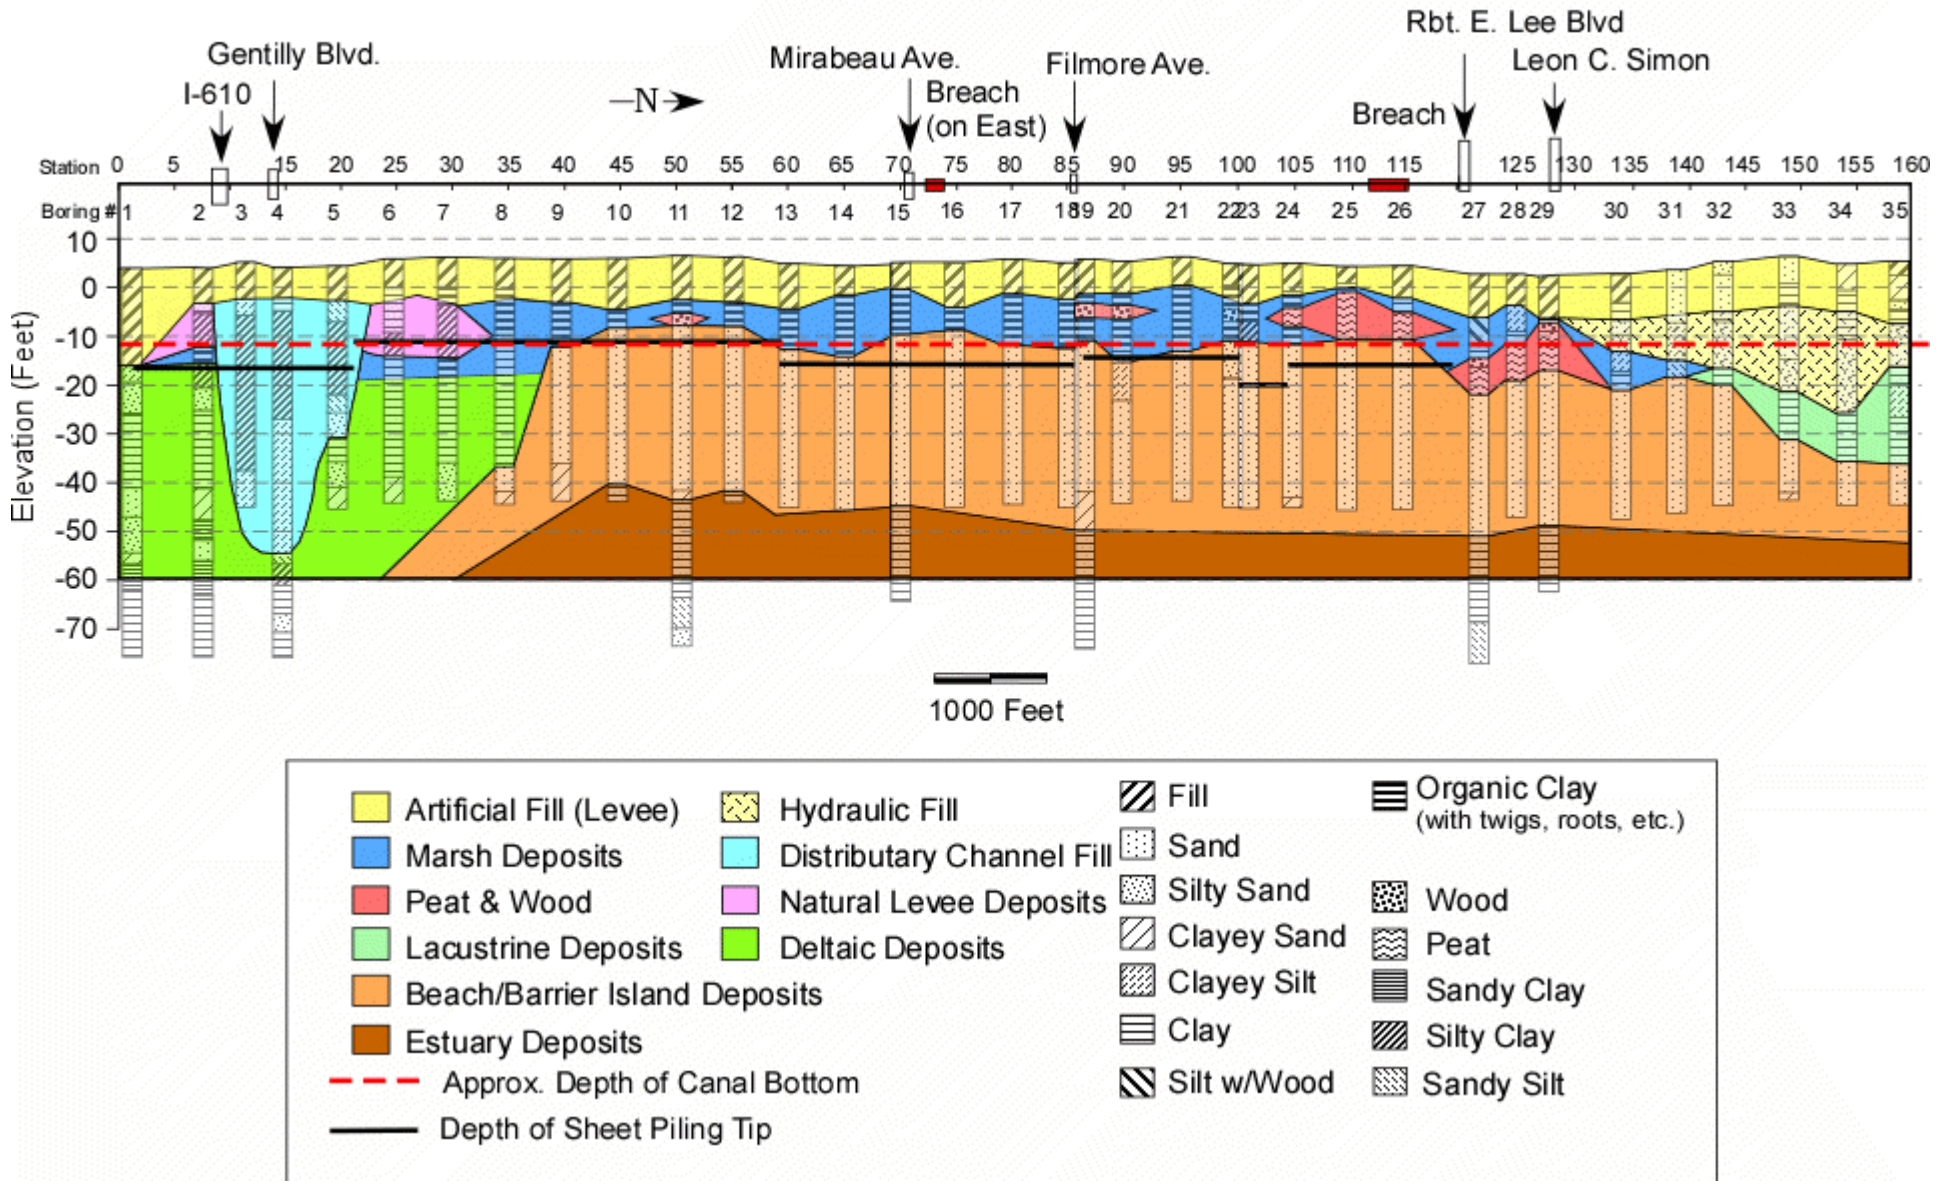
London Avenue Canal - West Side

A geologic cross section of the west side of the levee is shown in Figure 34. Note that the conditions beneath the surface are similar to those at the Mirabeau Ave. breach, with a sand layer about 12 feet below sea-level. Here a peat layer is also observed. Peat is organic matter (vegetation that is in the process of decay). It represents material accumulated in swampy areas and indicates that this area was a swamp in the not too distant past. Peat is very porous and has the additional property that it shrinks when it is dried out and expands when water is added. The presence of peat can make for very unstable soil conditions.

Although the “as built” design documents (U.S. Army Corps of Engineers, 1994) show that the depth of the sheet pilings were at 14 feet below sea-level, water still had access to the peat layer and thus the peat layer could have played a role in the collapse of the levee. Another phenomenon that was observed here was that of ground heave in the area of collapse. Water, and perhaps expanding peat, apparently pushed up the levee and land surface on the west side of the canal prior to collapse of the levee. This is illustrated in Figures 35 and 36. Although the clubhouse shown in Figure 35 has been removed during the repair of the levee, the house (with the mispositioned air conditioner compressor) is the 5th house south of Robert E. Lee Blvd. on Pratt Drive (this house was demolished in early November, 2006).

Figure 34. Geological cross-section along the west side of the London Avenue Canal constructed from data in U.S. Army Corps of Engineers (1989).

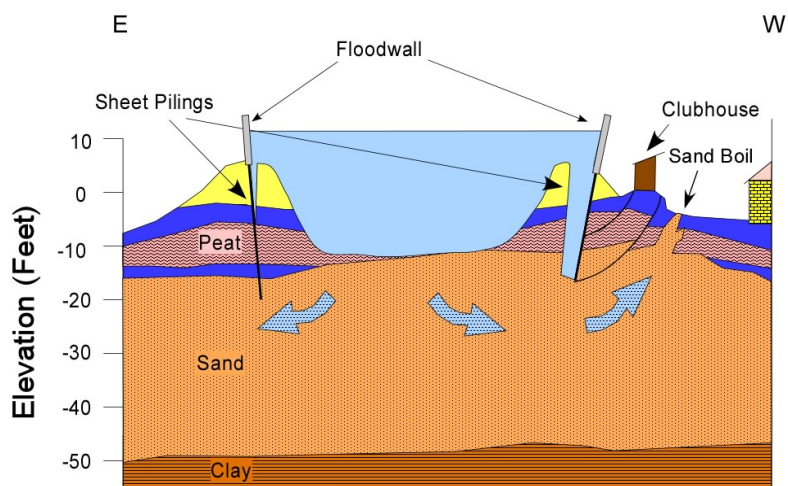
Heaving at London Ave. Canal North Breach

Figure 36. Water in the canal at the north breach of the London Ave. Canal puts lateral pressure on the floodwall and sheet piling along with water driven through sand under the sheet pilings (and possibly through peat, depending on the depth to which the sheet pilings actually were driven) pushes up the ground outside of the canal in a phenomenon known as heave. This would eventually provide a flow path for water which would undermine the levee and cause its collapse. This may have been responsible for the eventual collapse of the floodwall on the west side of the canal resulting in the breach. The floodwall on the east side of the canal was leaning, but did not fail to create a breach.

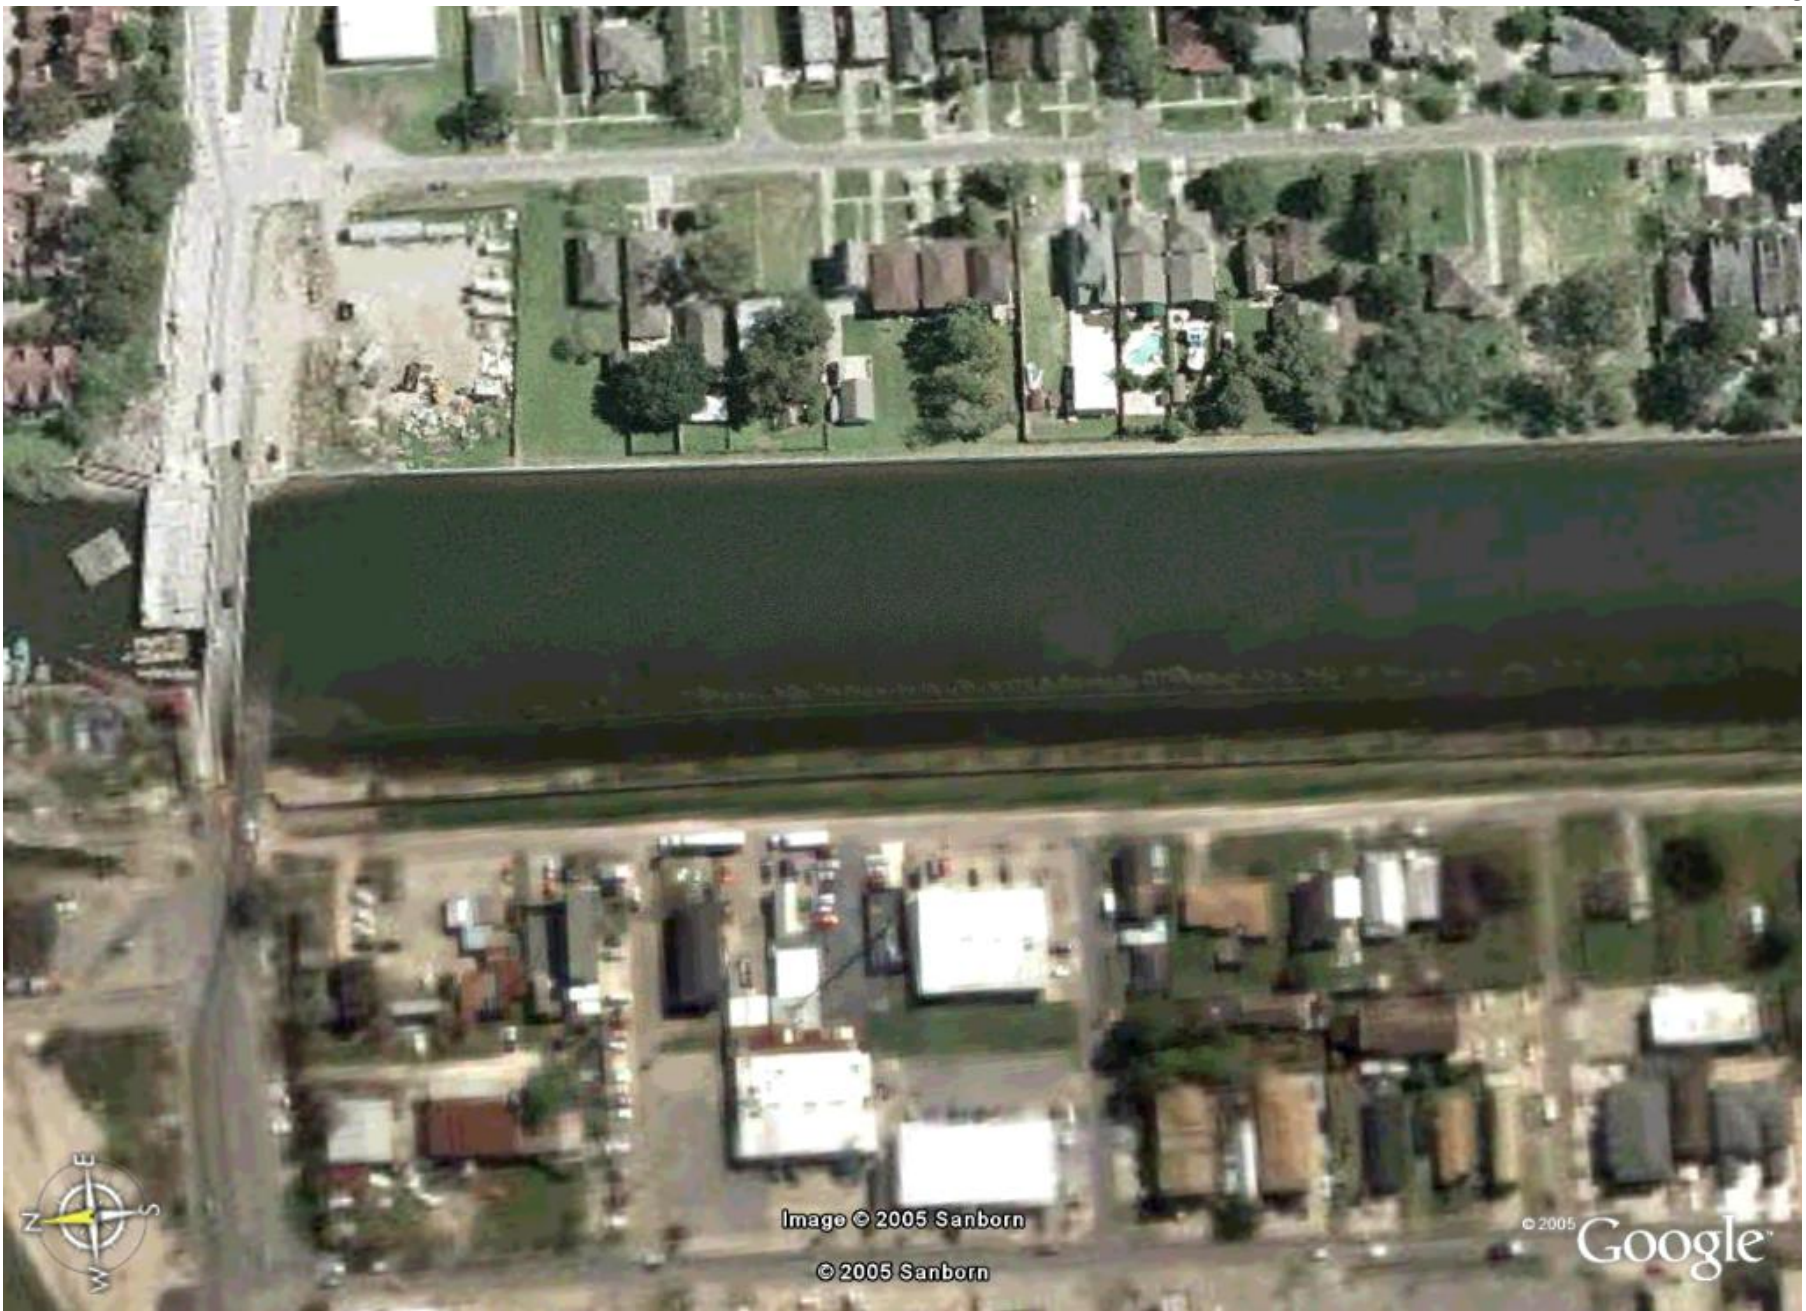
Figure 39. Satellite image of the area along the 17th Street Canal near the Old Hammond Highway Bridge (under construction), where the levee was later breached during Hurricane Katrina (Stop 7). (Source - Google Earth)

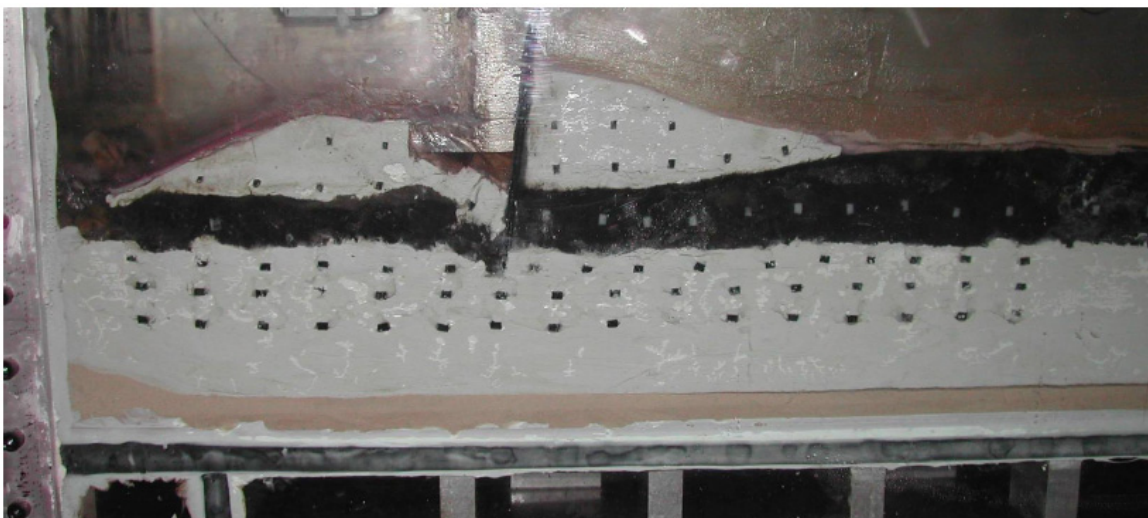
A photograph of the end result of IPET's scale model centrifuge experiment is shown in Figure 47. The canal side (on the left in the photograph) next to the sheet piling is seen to have dropped down as a result of the floodwall moving toward the right (toward the protected side). Indeed in the end result of the experiment, the levee, peat layer, and upper part of the underlying clay layer all have moved to the protected side. Viewing the complete video of the experimental run (<https://ipet.wes.army.mil/>), however, shows that the initial failure occurred either in the peat layer or at the peat – clay interface, and only when the sheet pile started to move to the right, away from the canal, did the upper part of the clay layer also move. Furthermore, the only part of the clay layer that moved was the part immediately in front of the tip of the sheet pile, and it only moved because it was being pushed along by the sheet pile.

Figure 47. Photograph of failed levee and floodwall in IPET's scale model centrifuge experiment representing the 17th St. Canal. The white at the top is clay and represents the levee. This overlies the dark peat layer, which in turn overlies another white clay layer meant to represent the estuary deposits beneath the peaty marsh deposits. Small rectangles were initially laid out in a rectangular grid and can be used to determine how much deformation has occurred during the experiment. (IPET, 2006).

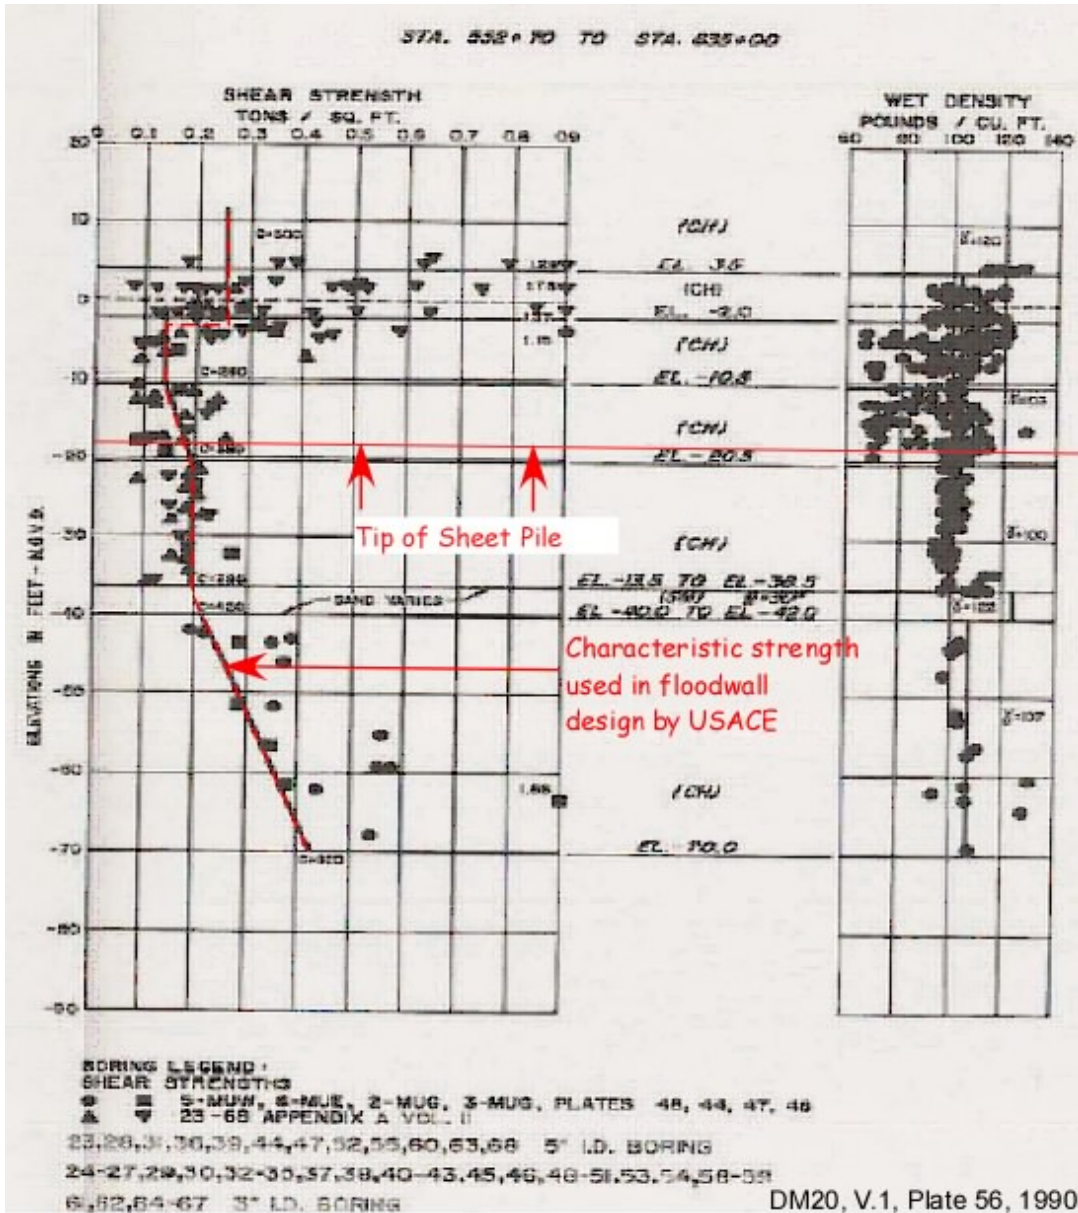
Figure 48 shows graphs of shear strength and wet density versus depth as obtained on samples from soil borings (done before 1990) along an 1800 foot section of the 17th St. Canal, which includes the area of the breach. Red lines have been added for emphasis, one showing the depth to the tip of the sheet piling within the breach zone (17.5 feet below sea level) and the other highlighting the characteristic strengths used by the designers to determine the stability of the floodwall. Between the two graphs are lines separating the different kinds of soils. Note that all soils above about -37 feet are shown as CH soils, which are clays with high plasticity. If one looks at the geologic cross-section in Figure 45, there is an interval between about -10 and -18 shown as peaty clays (the same peat that came to the surface as a result of the levee breach). Peats have low density and thus the wet density data in Figure 48 clearly shows a zone of low density material in the depth range between 0 and -20. The strengths in this zone show a range, but the designers chose to use an average value. What is even more troubling, however is that in the depth range between about -15 and -37, the nearly all of the measured strengths fall below the characteristic strength line used in calculations of FS. This is the critical zone, where all investigators think the failure occurred during Katrina. If the strengths were overestimated by 30%, then the true FS value would fall below 1.0 and the structure would be unstable (just as it was during Katrina).

Figure 48. Shear strength and wet density versus depth along an 1800 foot section of the 17th St. Canal which includes the area of the breach (from U.S. Army Corps of Engineers, 1990, the Design documents for the 17th St. Canal floodwall). The author has added the red lines and red labeling showing the depth to the tip of the sheet piles in the breach zone and the characteristic strength values as a function of depth that the Corps used to determine the stability of the floodwall system.

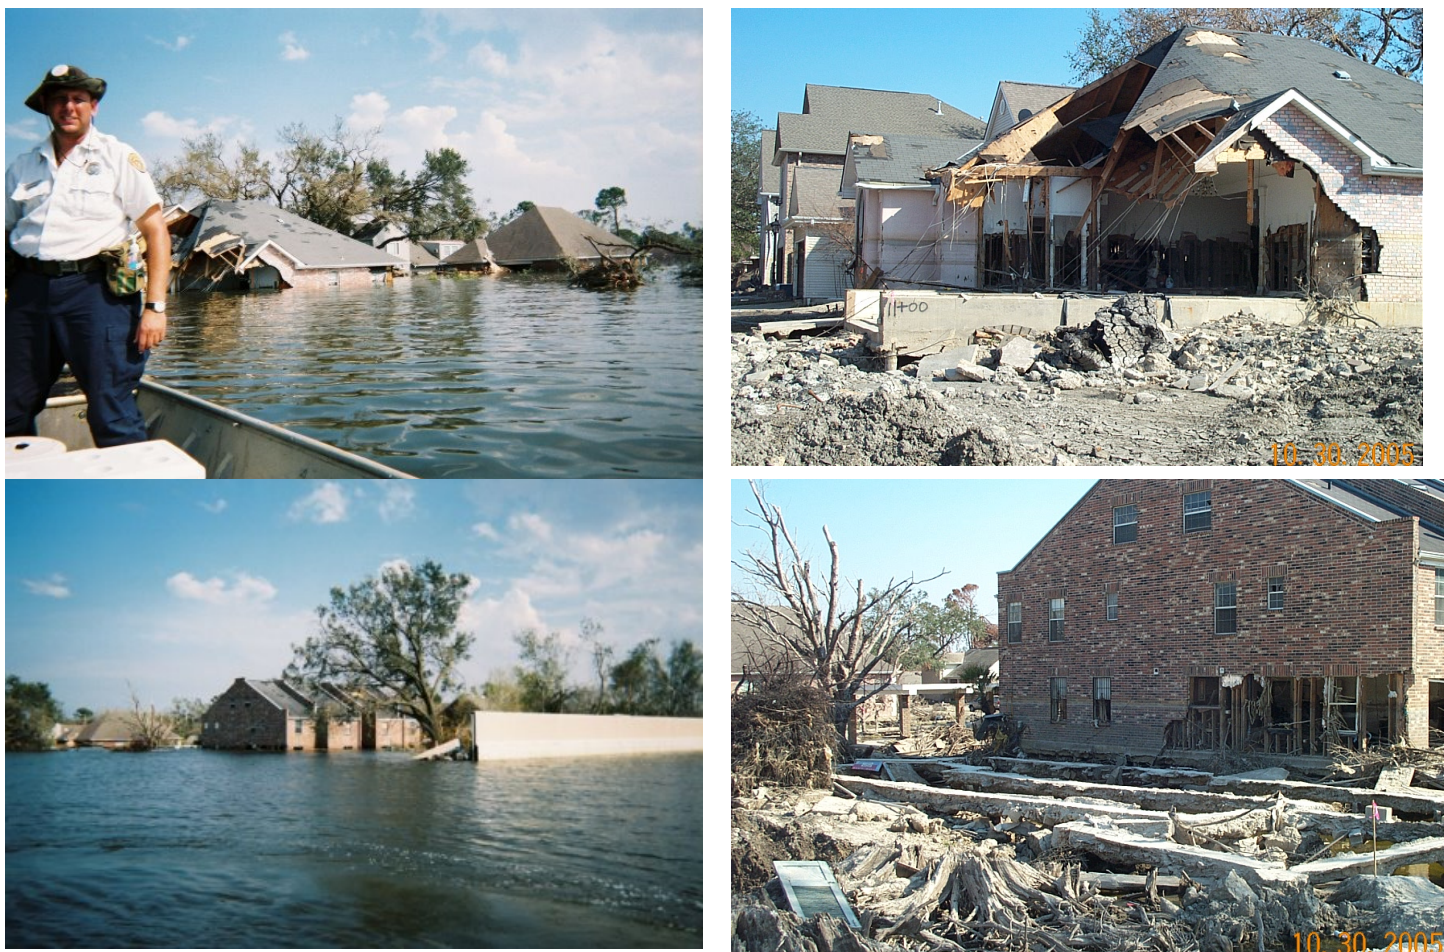
Although throughout the field trip we have seen the water line (scum line) left by standing water, this line does not represent the maximum flood depth. As seen in Figure 49, comparison of the photos on the left, taken when the water level was near its maximum with the water line left on the same structures (photos on the right) indicate that the maximum flood depth was about 1.5 to 2 feet higher than the line left by standing water.

Figure 49. Comparison of water levels on Sept.1, 2005 (photos on left by Kevin Himmel), with water lines on same structures indicate lines left by standing water are about 1.5 to 2 feet lower than the maximum water level. Note large block of peat in photo at the upper right. In photo at lower right, note the chainwall foundation of a house that was removed by the burst of water when the levee was breached and the cypress stump from a tree that was probably cut down 100 years ago when this Lakeview neighborhood was reclaimed from the cypress swamp.

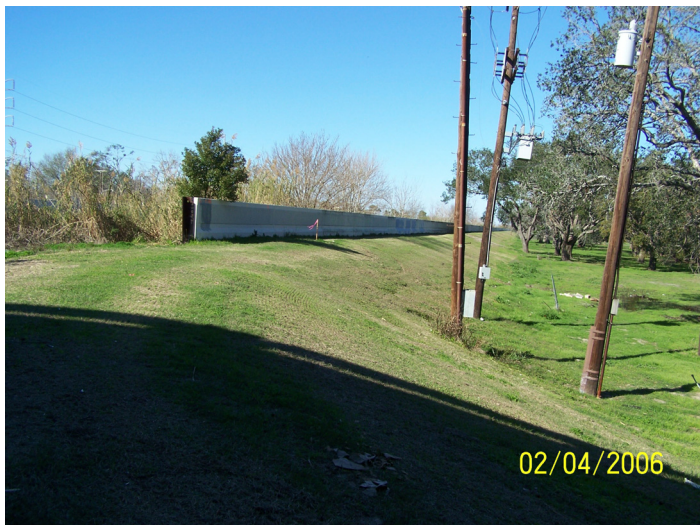
Stop 8 is at the levee of the Orleans Canal just under the I-610 overpass. As we walk up to the levee, note that the floodwall on the top of the levee abruptly ends about 40 yards north of the overpass (Fig. 51). An approximately 100 yard gap thus exists in the flood protection on the canal between the end of the floodwall and Pump Station Number 7 to south on the other side of the overpass. A smaller gap exists on the other side of the canal as well. During Katrina, water from the Orleans Canal was flowing freely through this gap as evidenced by the erosion that occurred around the support structures for the freeway overpass (Figure 52). Fresh concrete has since been poured around the support structures and the levee has been raised about 2 feet from its pre-Katrina level in an attempt to fix the problem. Why was such an obvious gap in the flood protection system allowed to remain? The Independent Levee Investigation Team (2006) offers the following explanation. Apparently, the Orleans Sewerage and Water Board, who run the pump station, objected to the Corps of Engineers plan to build the floodwall right up to the wall of the pump station. They argued that the wall of the pump station was not strong enough to withstand the force of the water if it backed up in the canal, and would fail with the result that the city would flood when the wall failed. Of course the net result was that the city flooded as the water poured through the gap. Nevertheless, the relief of pressure in the canal may have prevented the floodwalls and levees elsewhere on the canal from failing.

Figure 50. End of floodwall on Orleans Canal just north of I-610 overpass near Marconi Ave. (Stop 6)
