# Hurricane Katrina - What Happened?

Tulane University  
Field Trip  
November 12, 2006

Stephen A. Nelson  
Department of Earth &  
Environmental Sciences  
snelson@tulane.edu

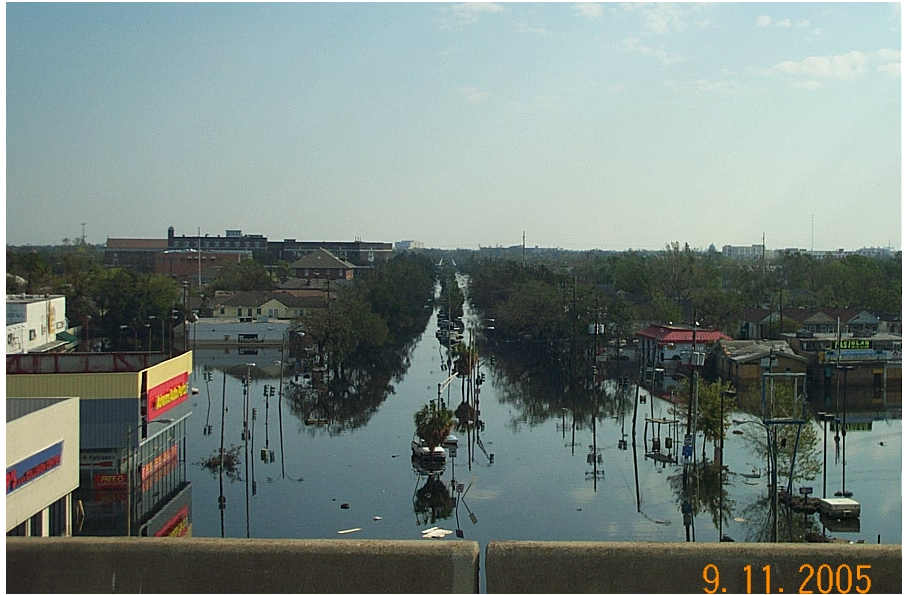
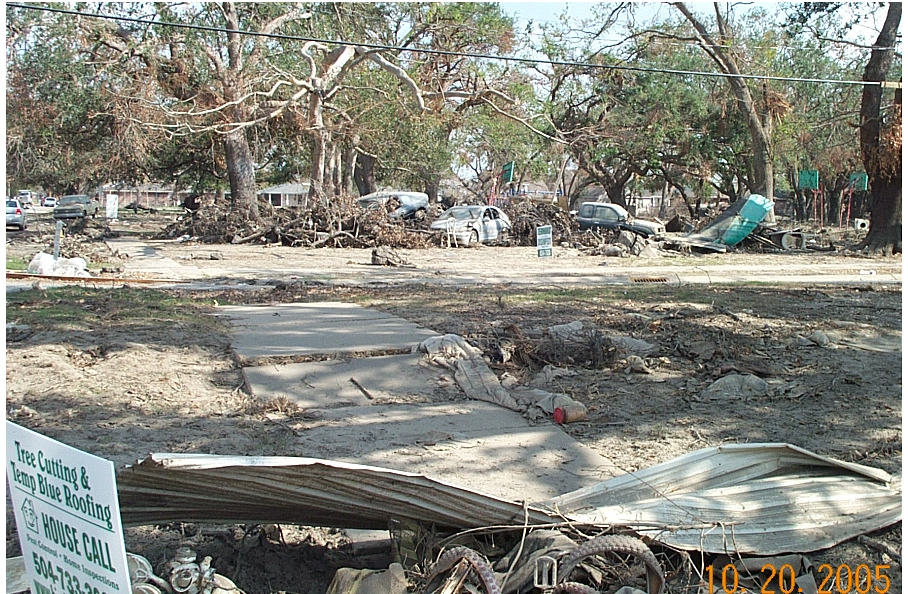
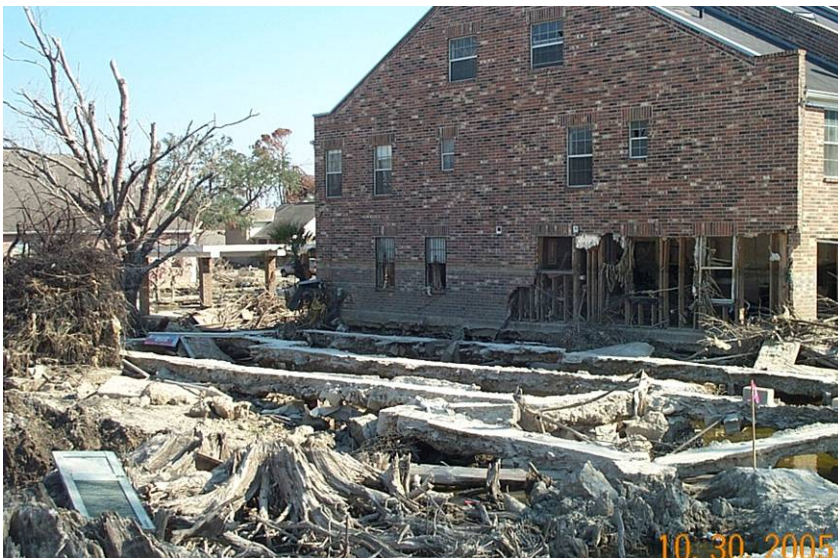
Photos - Top - looking north from I-10 overpass over Carrollton Ave. Middle - cars and other debris in park on Fleur de Lis near 17th St. Canal breach. Bottom - missing house and Cypress stumps at 17th St. Canal Breach (photos by Stephen Nelson)

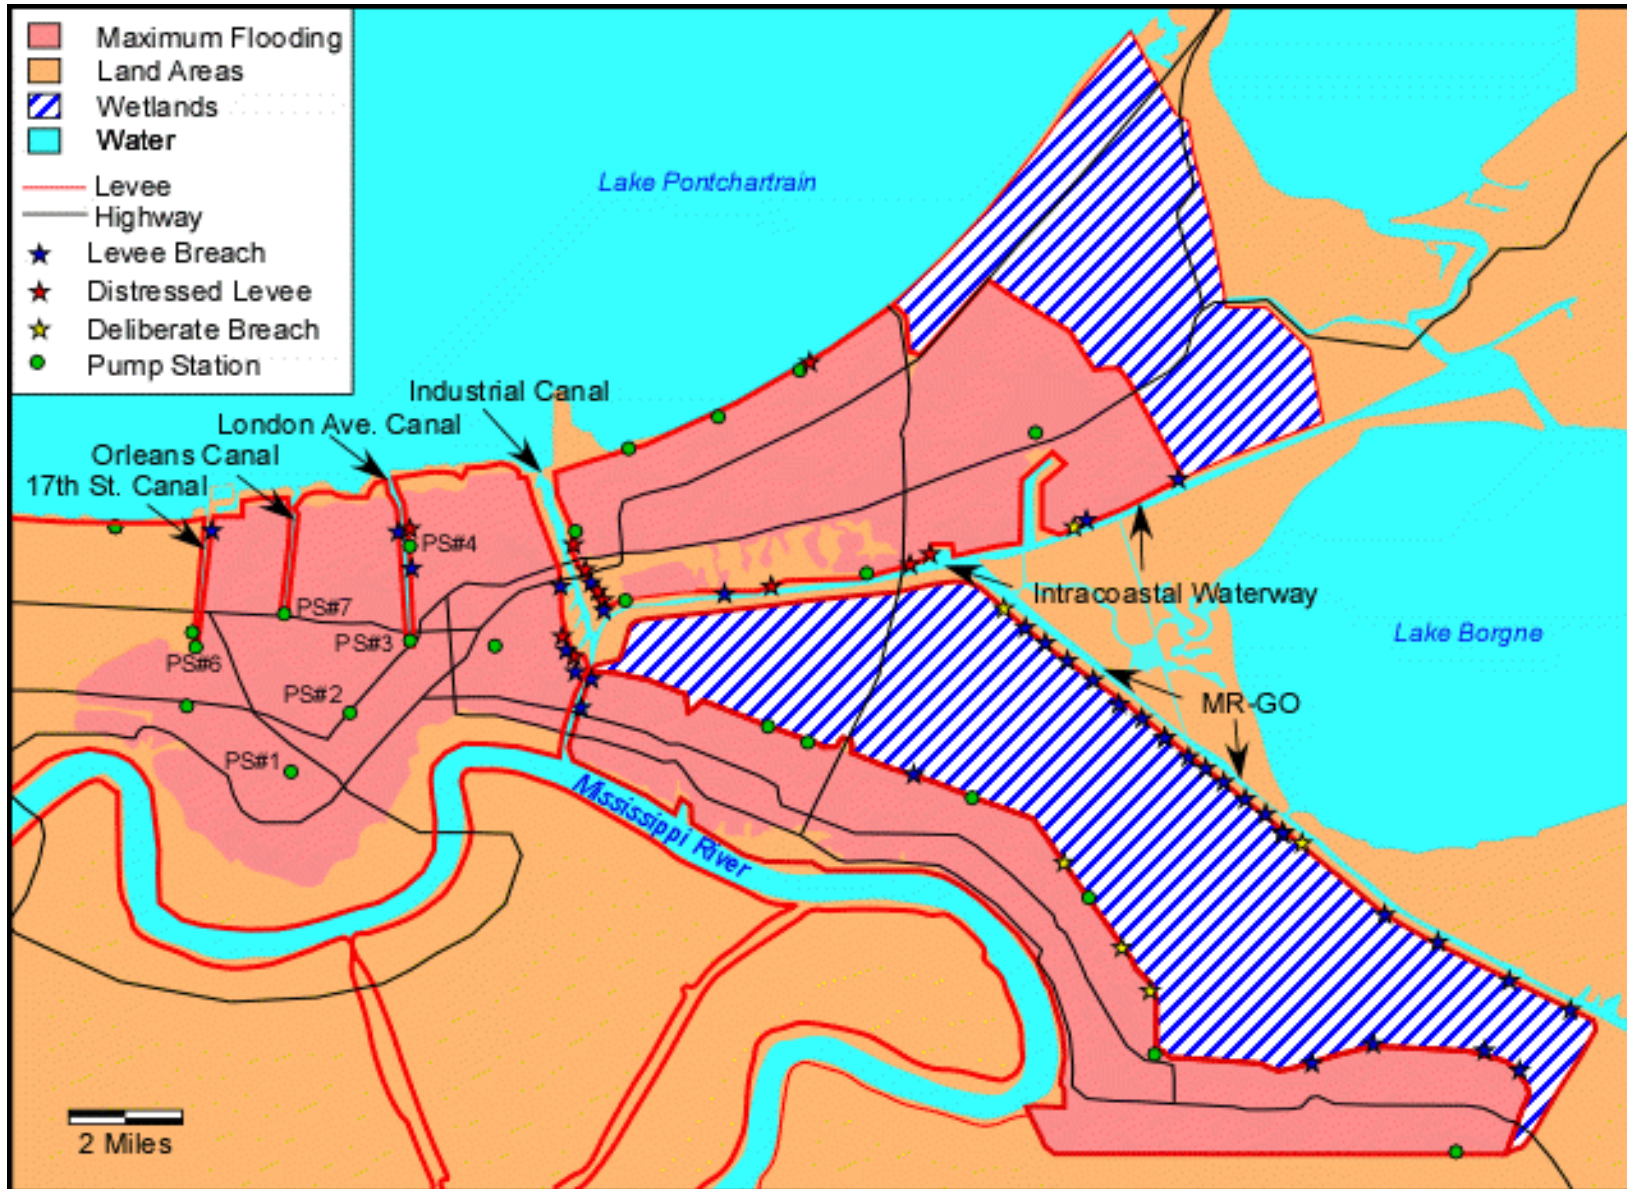
**Figure 7.** Map of maximum extent of flooding during Katrina modified and locations of breached levees after U.S. Army Corps of engineers-  
<http://www.hq.usace.army.mil/cepa/katrina/pumps/pumps.html#New%20Orleans%20Pump%20Status> and Seed et al. (2005).

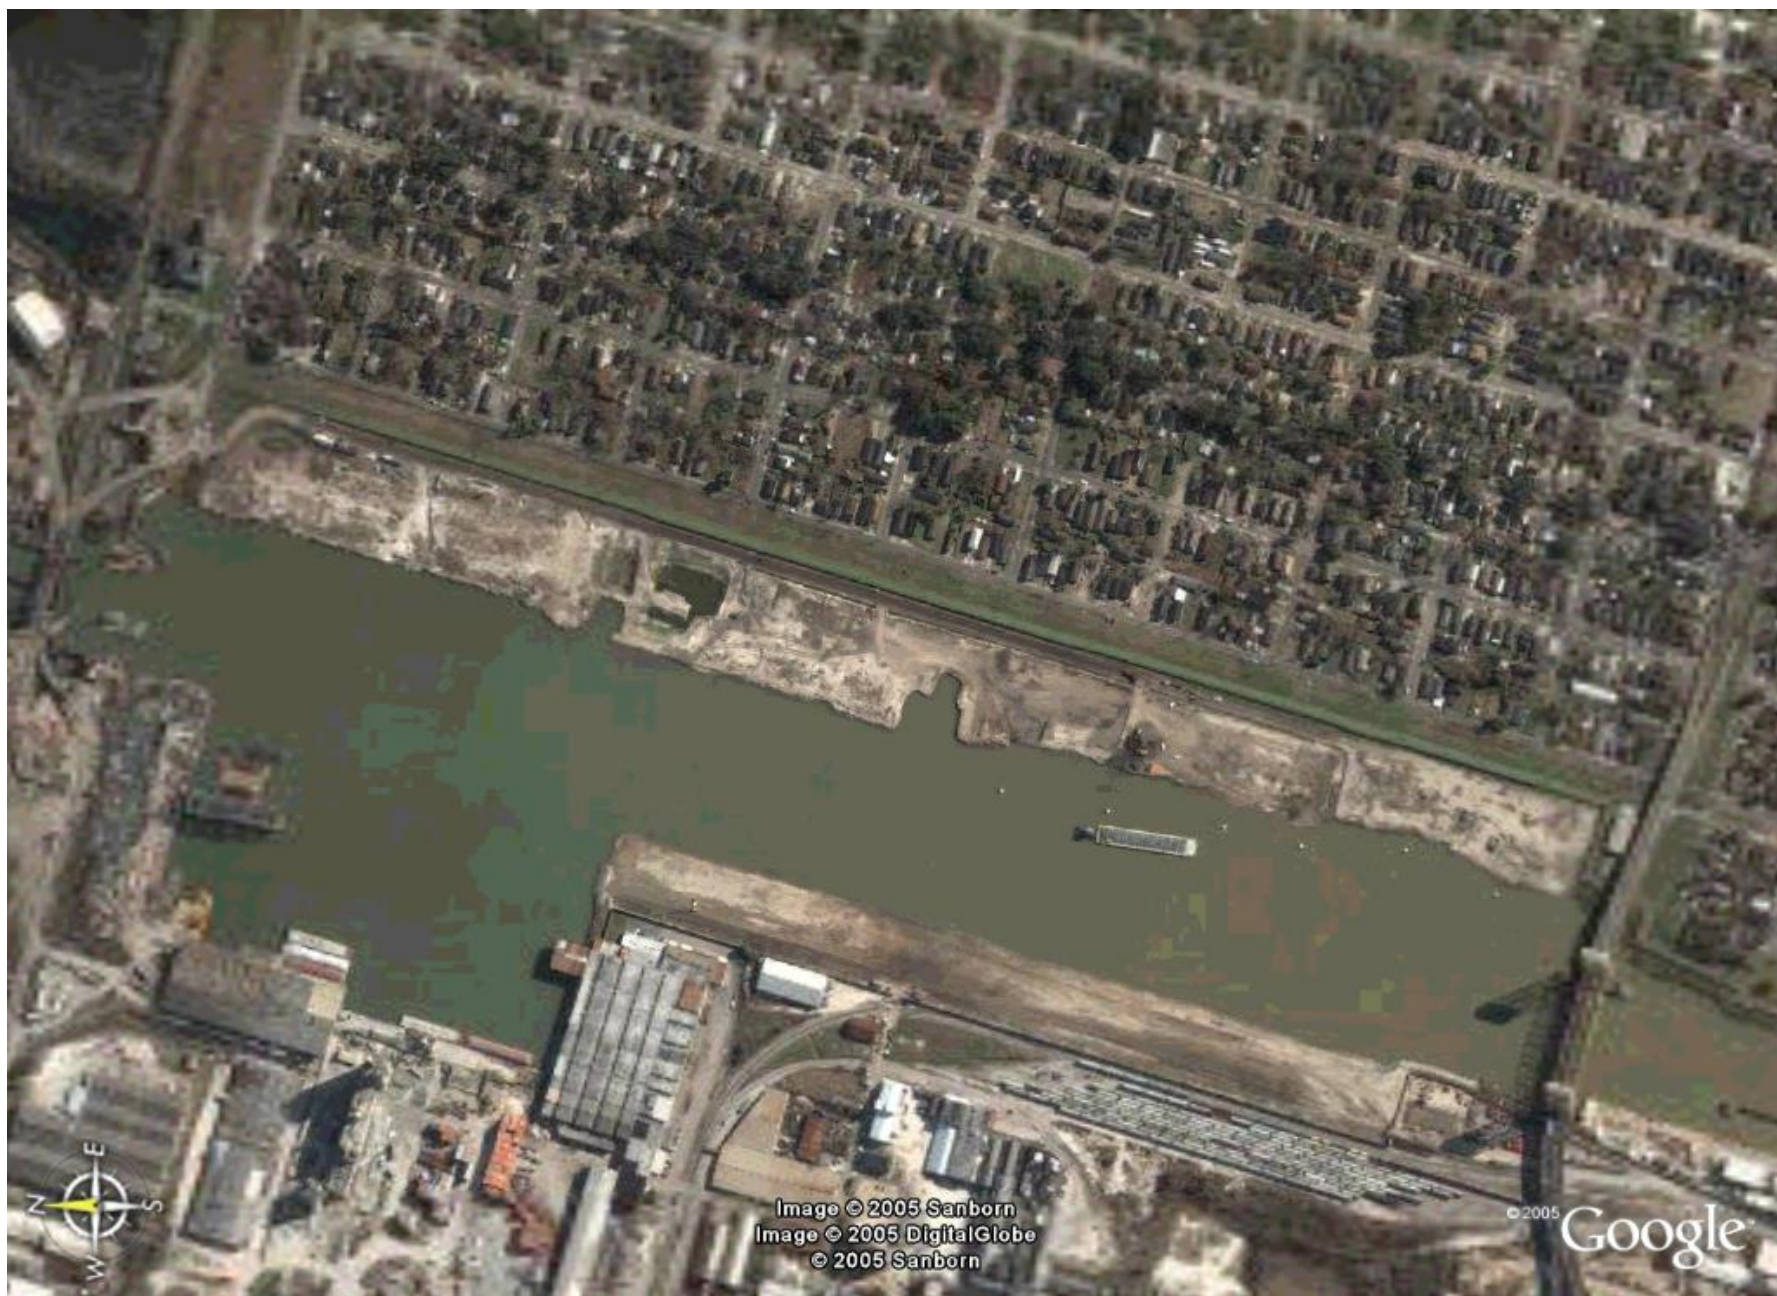
**Figure 9.** Satellite image of the area along the Industrial Canal where the levee was later breached during Hurricane Katrina. (Source - Google Earth)

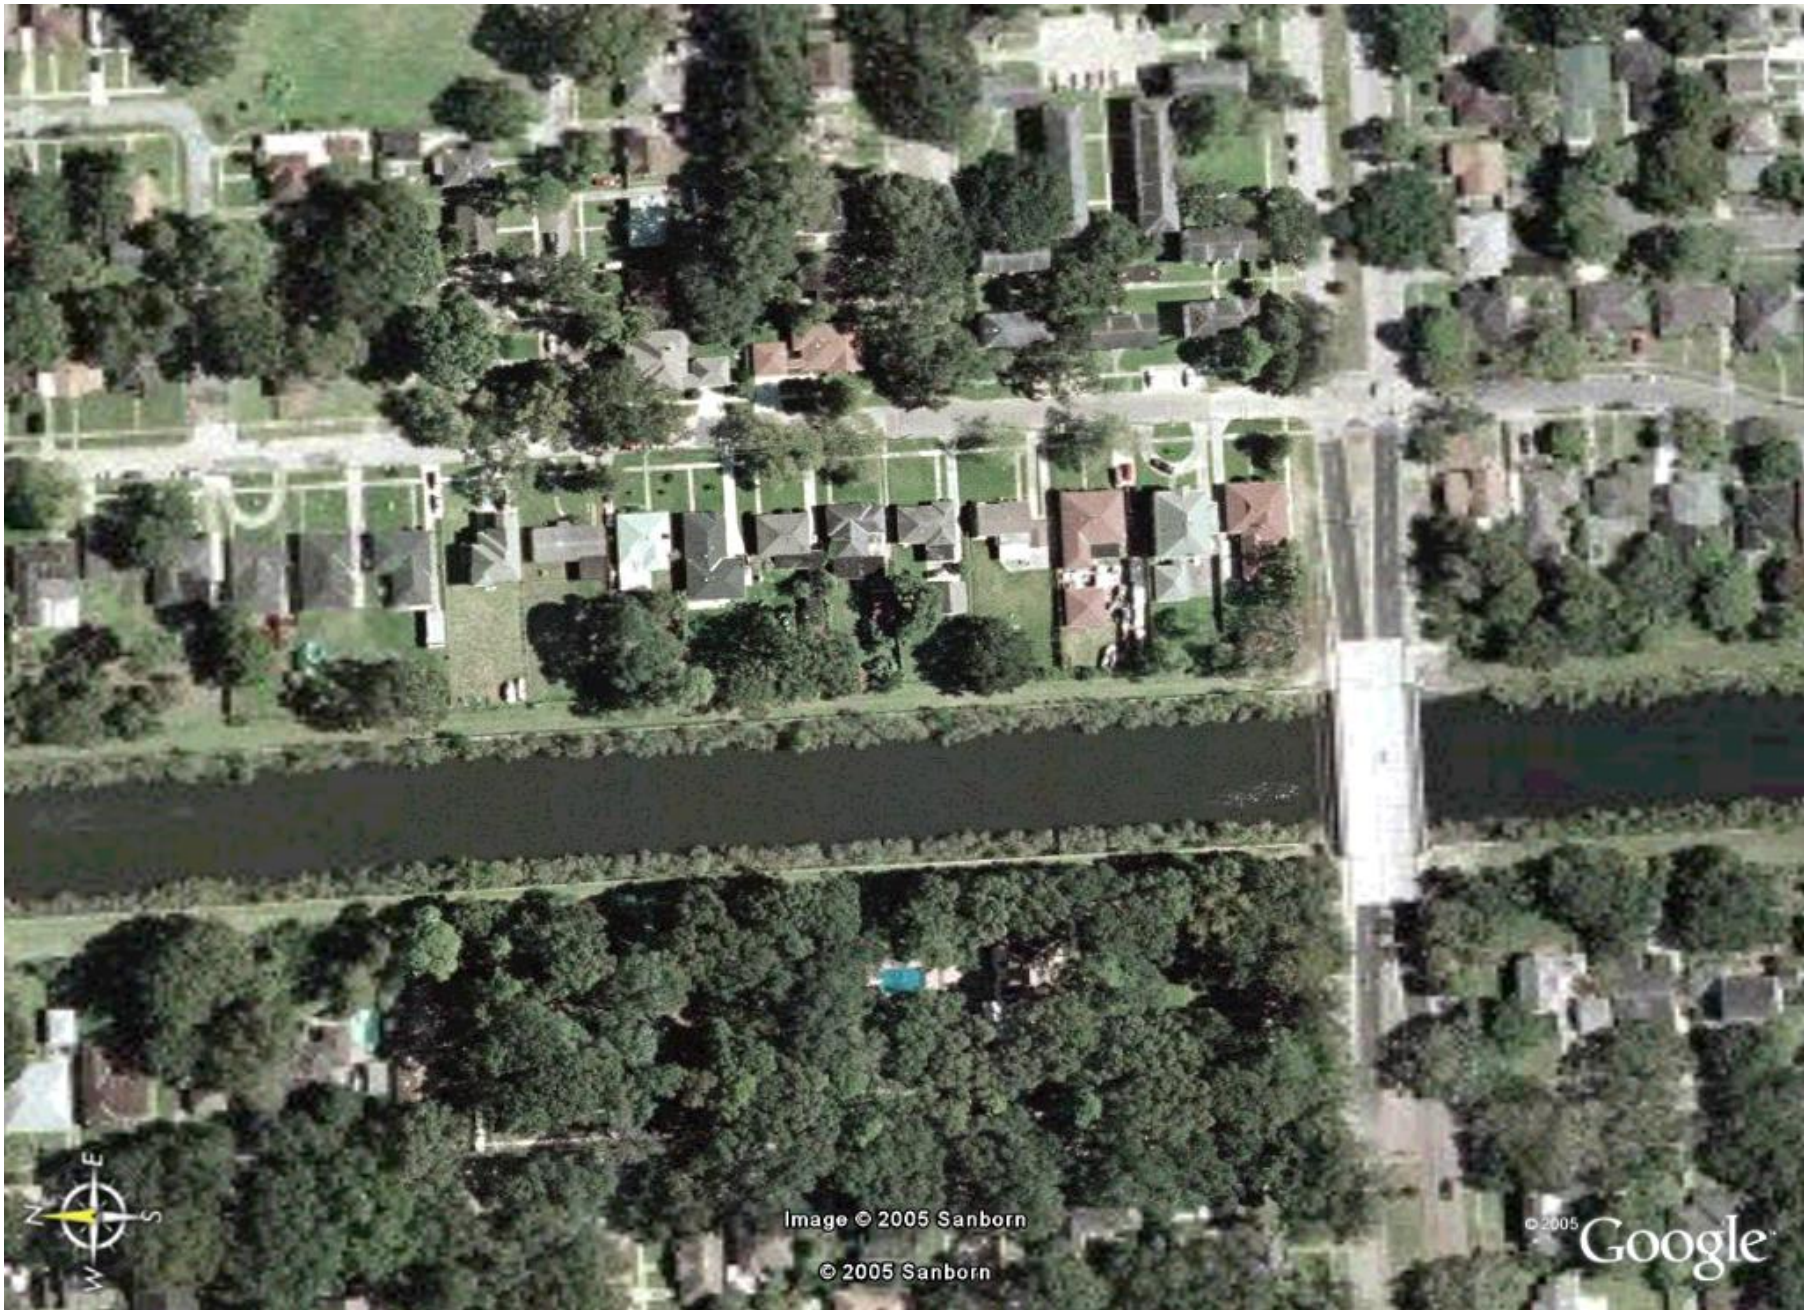
**Figure 17.** Satellite image of the area along the London Avenue Canal near Mirabeau Ave. and Warrington Drive (Stop 1), where the levee was later breached during Hurricane Katrina. (Source - Google Earth)

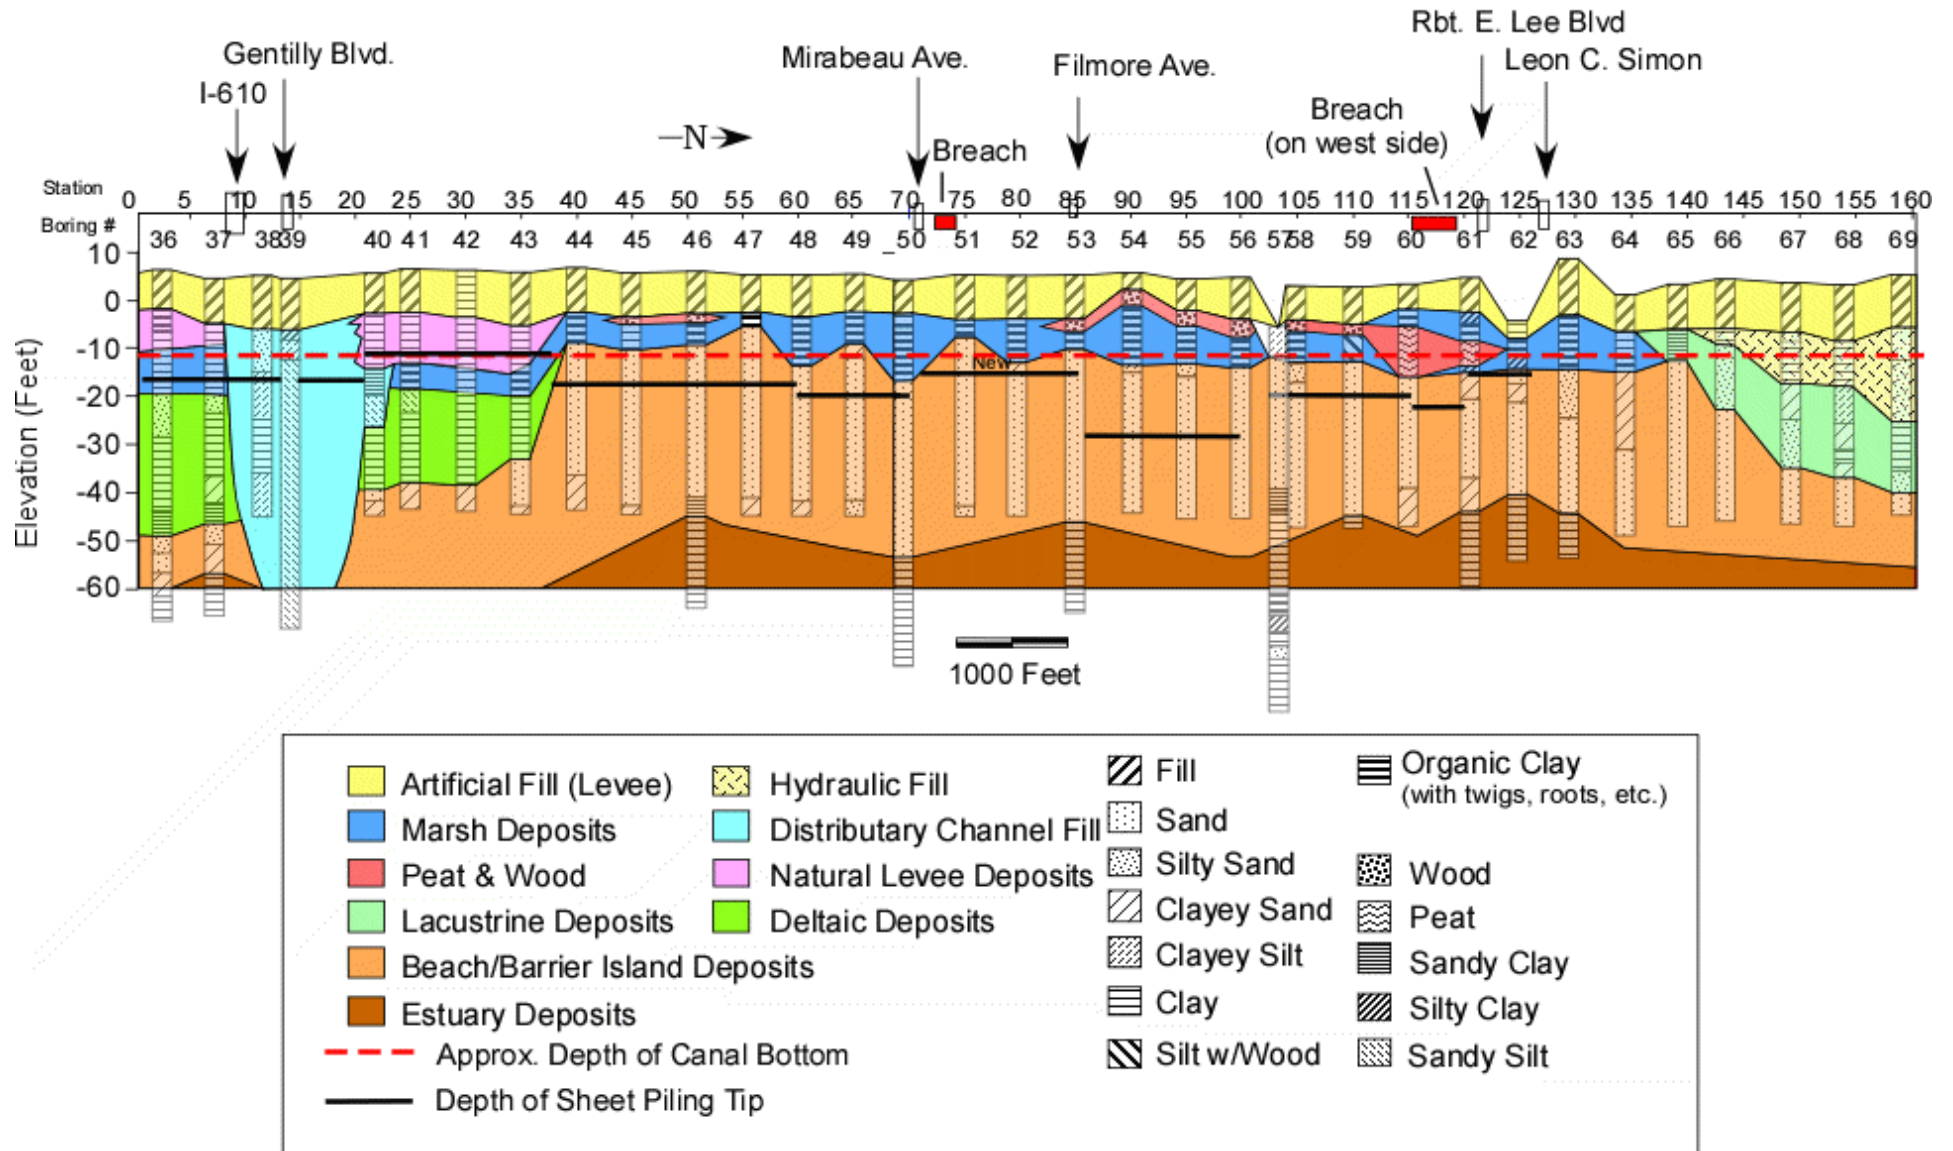
Figure 19. Geological cross-section along the east side of the London Avenue Canal constructed from data in U.S. Army Corps of Engineers (1989).

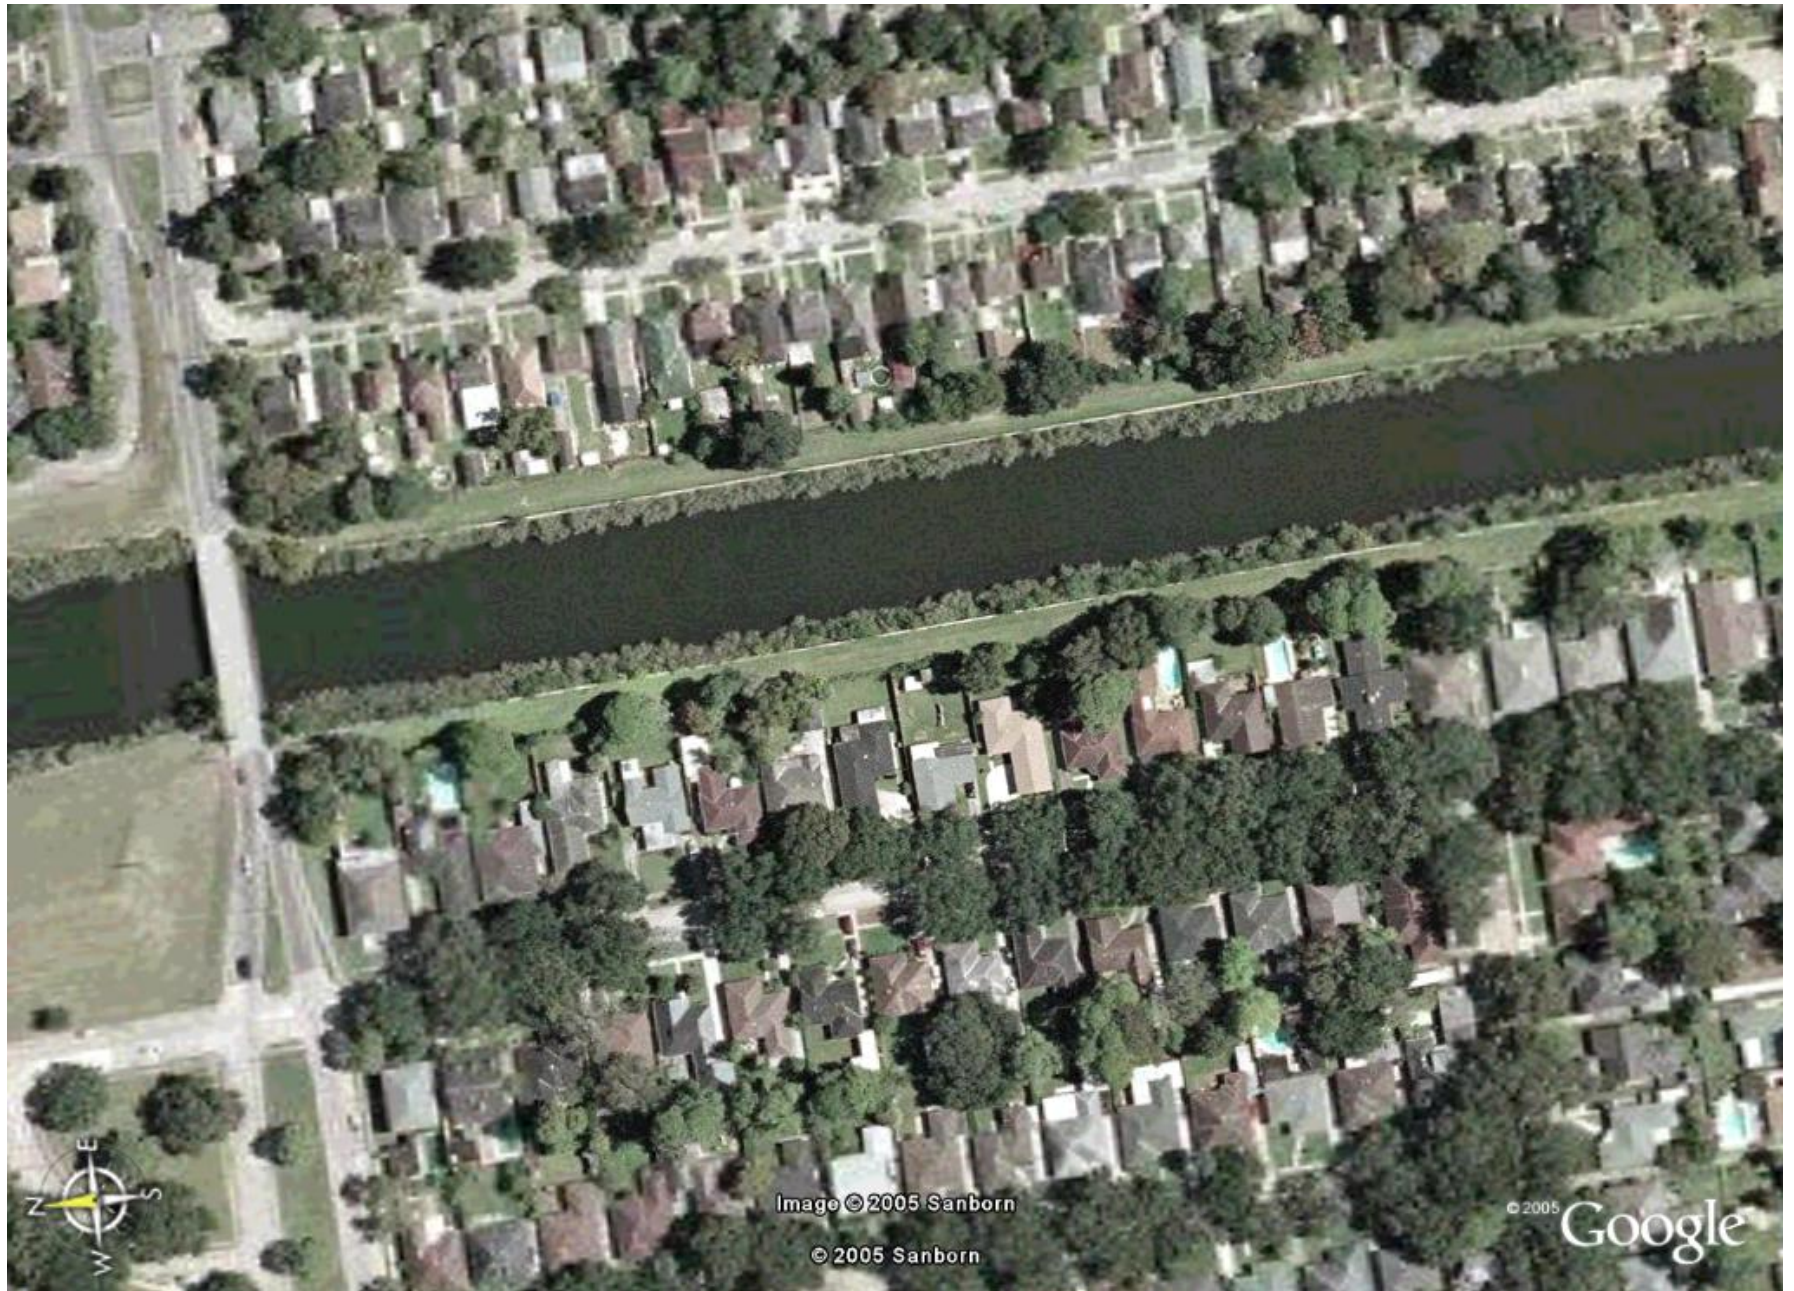
Stop 3 is near the intersection of Pratt Drive and Robert E. Lee Blvd. where the London Avenue Canal levee was breached on the west side of the canal. The estimated chronology suggested by IPET (2006) suggests that this breach also occurred sometime before 9:00 AM on August 29. Figure 24 shows an image of this area before Katrina. Figure 25 shows approximately the same area in an image taken on August 31 after the breach occurred and before the floodwaters had been pumped out.

**Figure 24.** Satellite image of the area along the London Avenue Canal near Robert E. Lee Blvd. and Pratt Drive (Stop 2), where the levee was later breached during Hurricane Katrina. (Source - Google Earth)

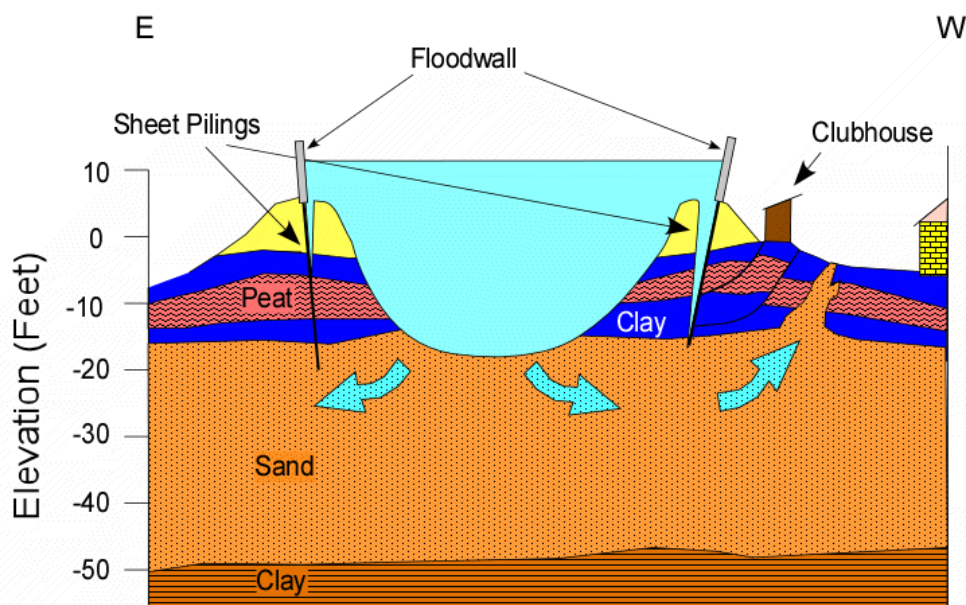
Heaving at London Ave. Canal North Breach

**Figure 28.** Water in the canal at the north breach of the London Ave. Canal puts lateral pressure on the floodwall and sheet piling along with water driven through sand under the sheet pilings (and possibly through peat, depending on the depth to which the sheet pilings actually were driven) pushes up the ground outside of the canal in a phenomenon known as heave. This could eventually provide a flow path for water which would undermine the levee and cause its collapse. This may have responsible for the eventual collapse of the floodwall on the west side of the canal resulting in the breach. The floodwall on the east side of the canal was distressed, but did not breach.

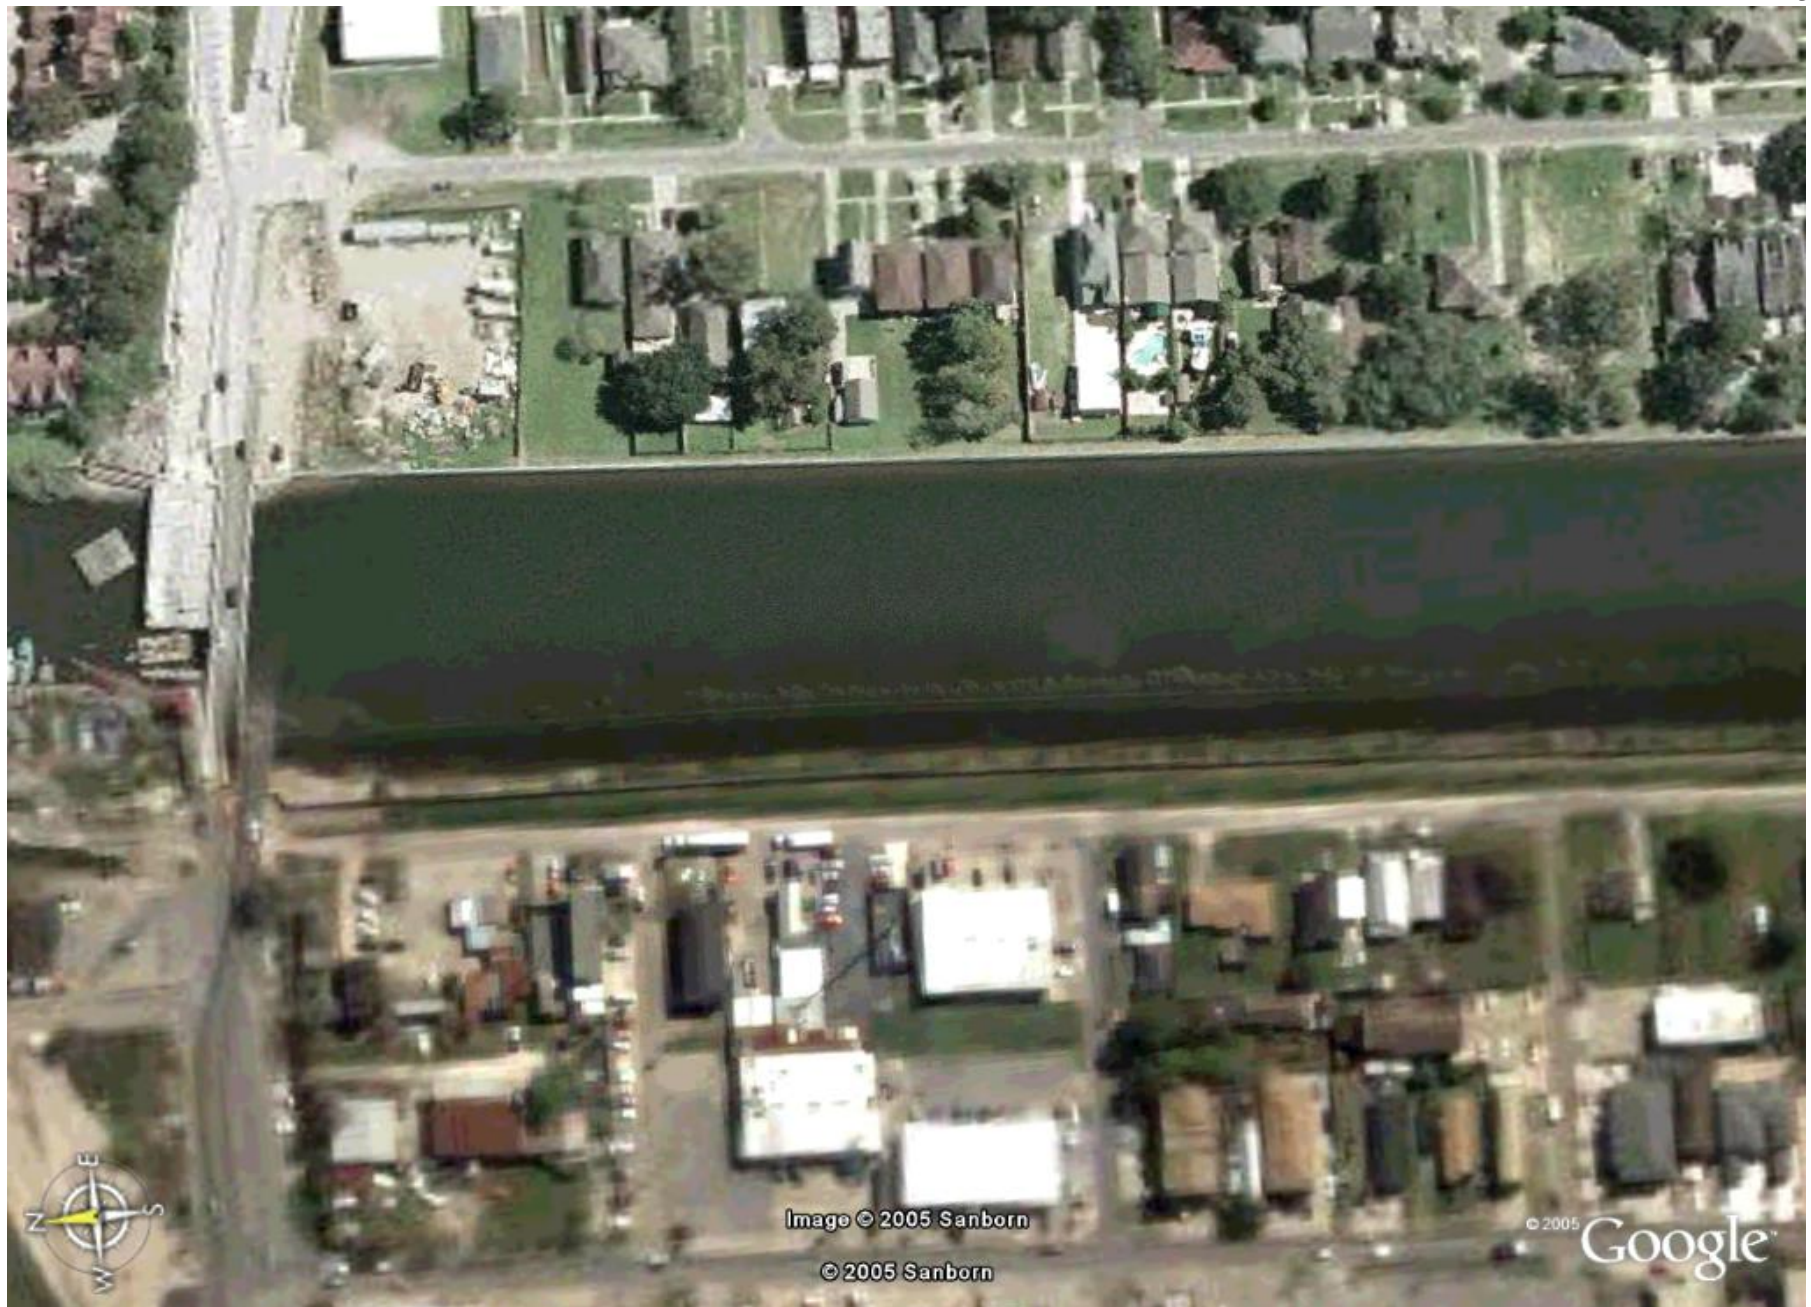
**Figure 29.** Satellite image of the area along the 17th Street Canal near the Old Hammond Highway Bridge (under construction), where the levee was later breached during Hurricane Katrina (stop 5). (Source - Google Earth)

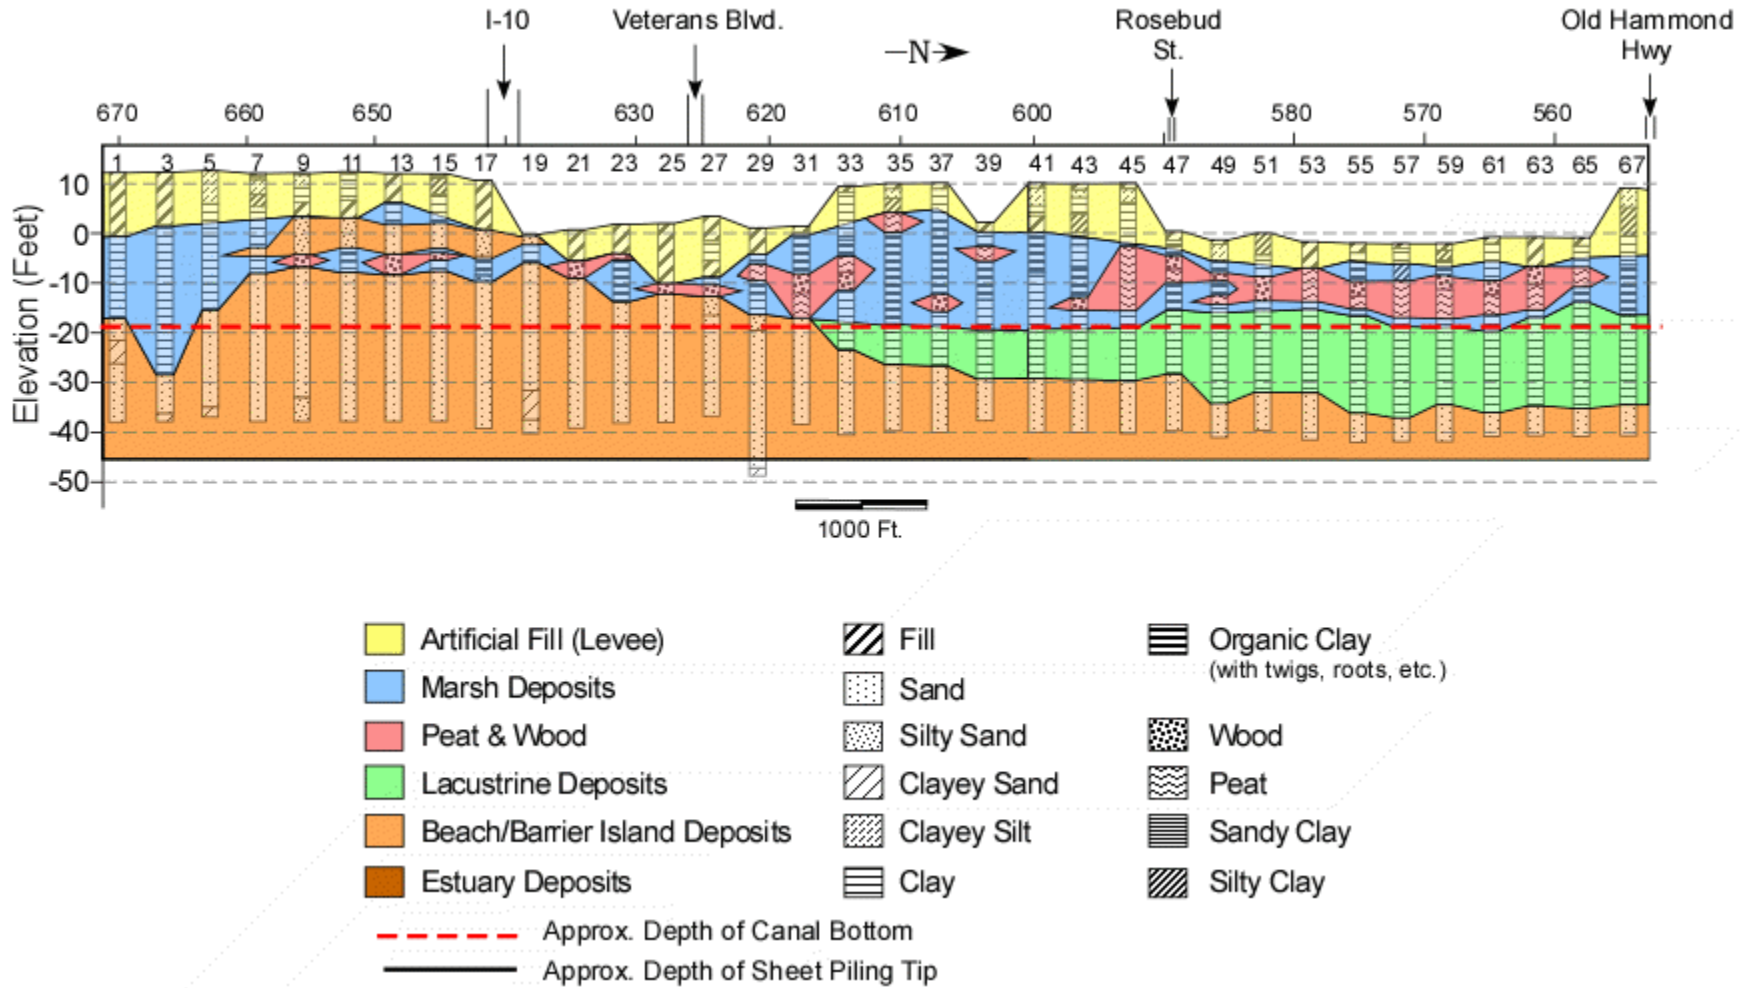
It is notable that the same peat layer and the same levee design and construction are present on the Jefferson Parish side of the canal, which by luck or the path of the storm, did not breach on August 29. Figures 39 shows a geological cross section of the west bank (Jefferson Parish side) of the 17<sup>th</sup> St. Canal constructed from data provided on the Army Corps of Engineers IPET web site - <https://ipet.wes.army.mil/> where it can be seen that the same geologic materials are present beneath the Jefferson Parish side as are found on the Orleans Parish side (compare with Figure 35). One major difference on the Jefferson Parish side is that a street occupies the area next to the levee and there are no trees, houses or swimming pools abutting the levee on that side.

**Figure 39** Geologic cross section of the west bank of the 17<sup>th</sup> St. Canal constructed from data provided to the U.S. Army Corps of Engineers (1990).

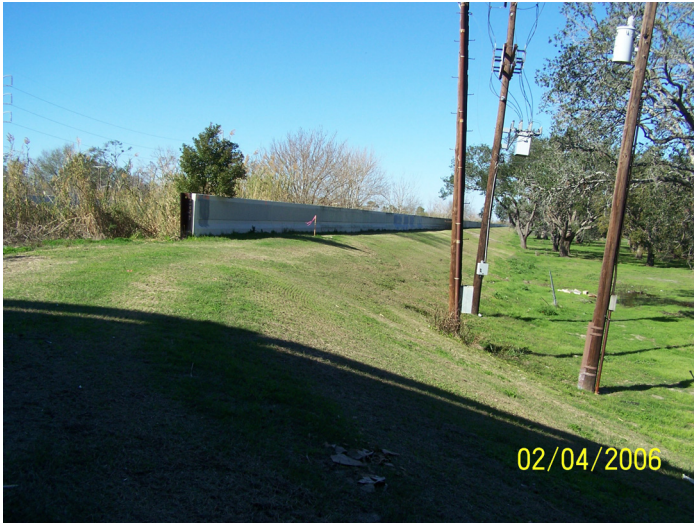
Stop 6 is at the levee of the Orleans Canal just under the I-610 overpass. As we walk up to the levee, note that the floodwall on the top of the levee abruptly ends about 40 yards north of the overpass (Figure 40). An approximately 200 yard gap thus exists in the flood protection on the canal between the end of the floodwall and Pump Station Number 7 to south on the other side of the overpass. A smaller gap exists on the other side of the canal as well. During Katrina, water from the Orleans Canal was flowing freely through this gap as evidenced by the erosion that occurred around the support structures for the freeway overpass (Figure 41). Fresh concrete has since been poured around the support structures and the levee has been raised about 2 feet from its pre-Katrina level in an attempt to fix the problem. Why was such an obvious gap in the flood protection system allowed to remain? The Independent Levee Investigation Team (2006) offer the following explanation. Apparently, the Orleans Sewerage and Water Board, who run the pump station, objected to the Corps of Engineers plan to build the floodwall right up to the wall of the pump station. They argued that the wall of the pump station was not strong enough to withstand the force of the water if it backed up in the canal, and would fail with the result that the city would flood when the wall failed. Of course the net result was that the city flooded as the water poured through the gap. Nevertheless, the relief of pressure in the canal may have prevented the floodwalls and levees elsewhere on the canal from failing.

**Figure 40.** End of floodwall on Orleans Canal just north of I-610 overpass near Marconi Ave.

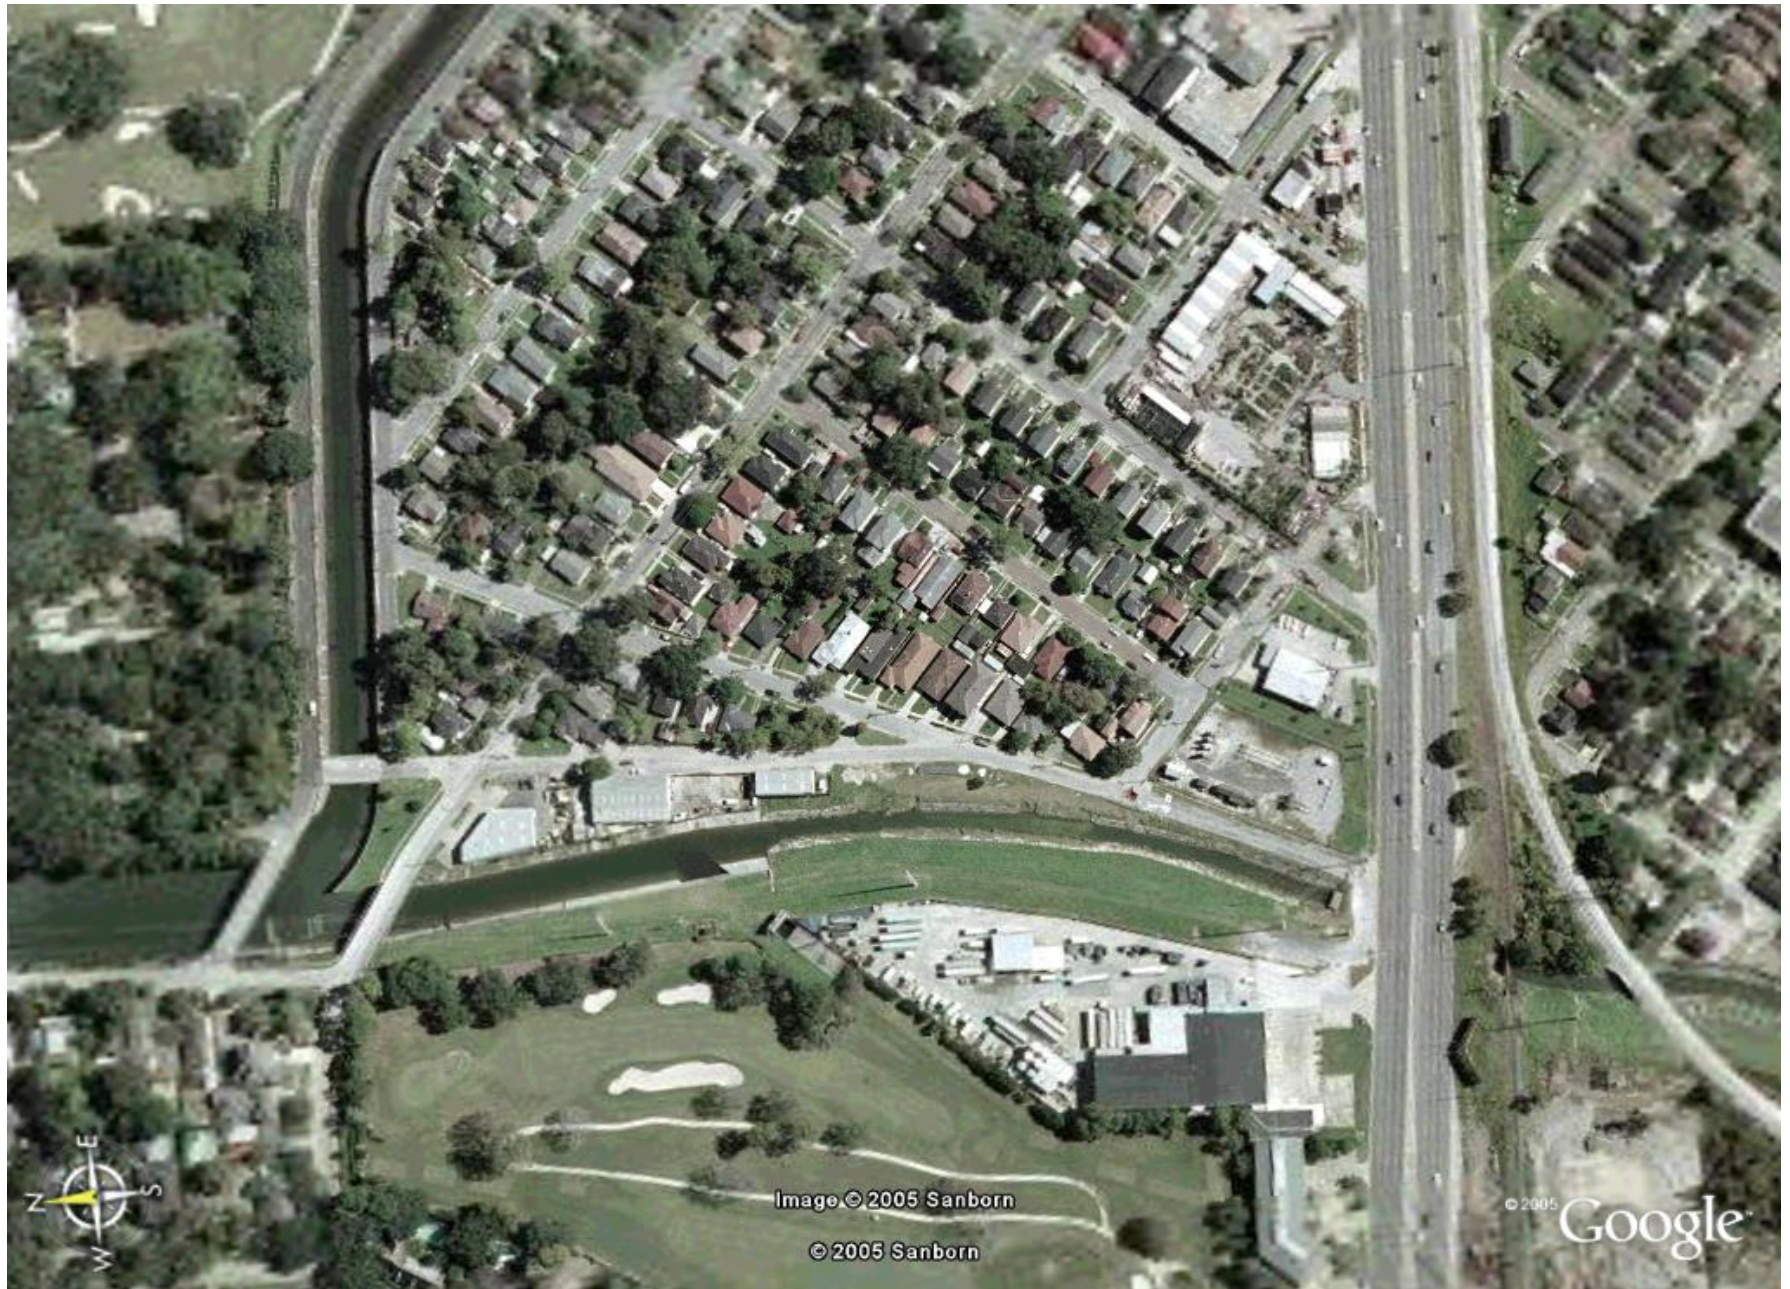
**Figure 42.** Satellite image of the area near the southern end of the 17th Street Canal near Old Metairie where water would enter Jefferson Parish from levee breaches in Orleans Parish during Hurricane Katrina (Stop 7). (Source - Google Earth)
