# Hurricane Katrina - What Happened?

Tulane University  
Field Trip  
November 12, 2006

Stephen A. Nelson  
Department of Earth &  
Environmental Sciences  
snelson@tulane.edu

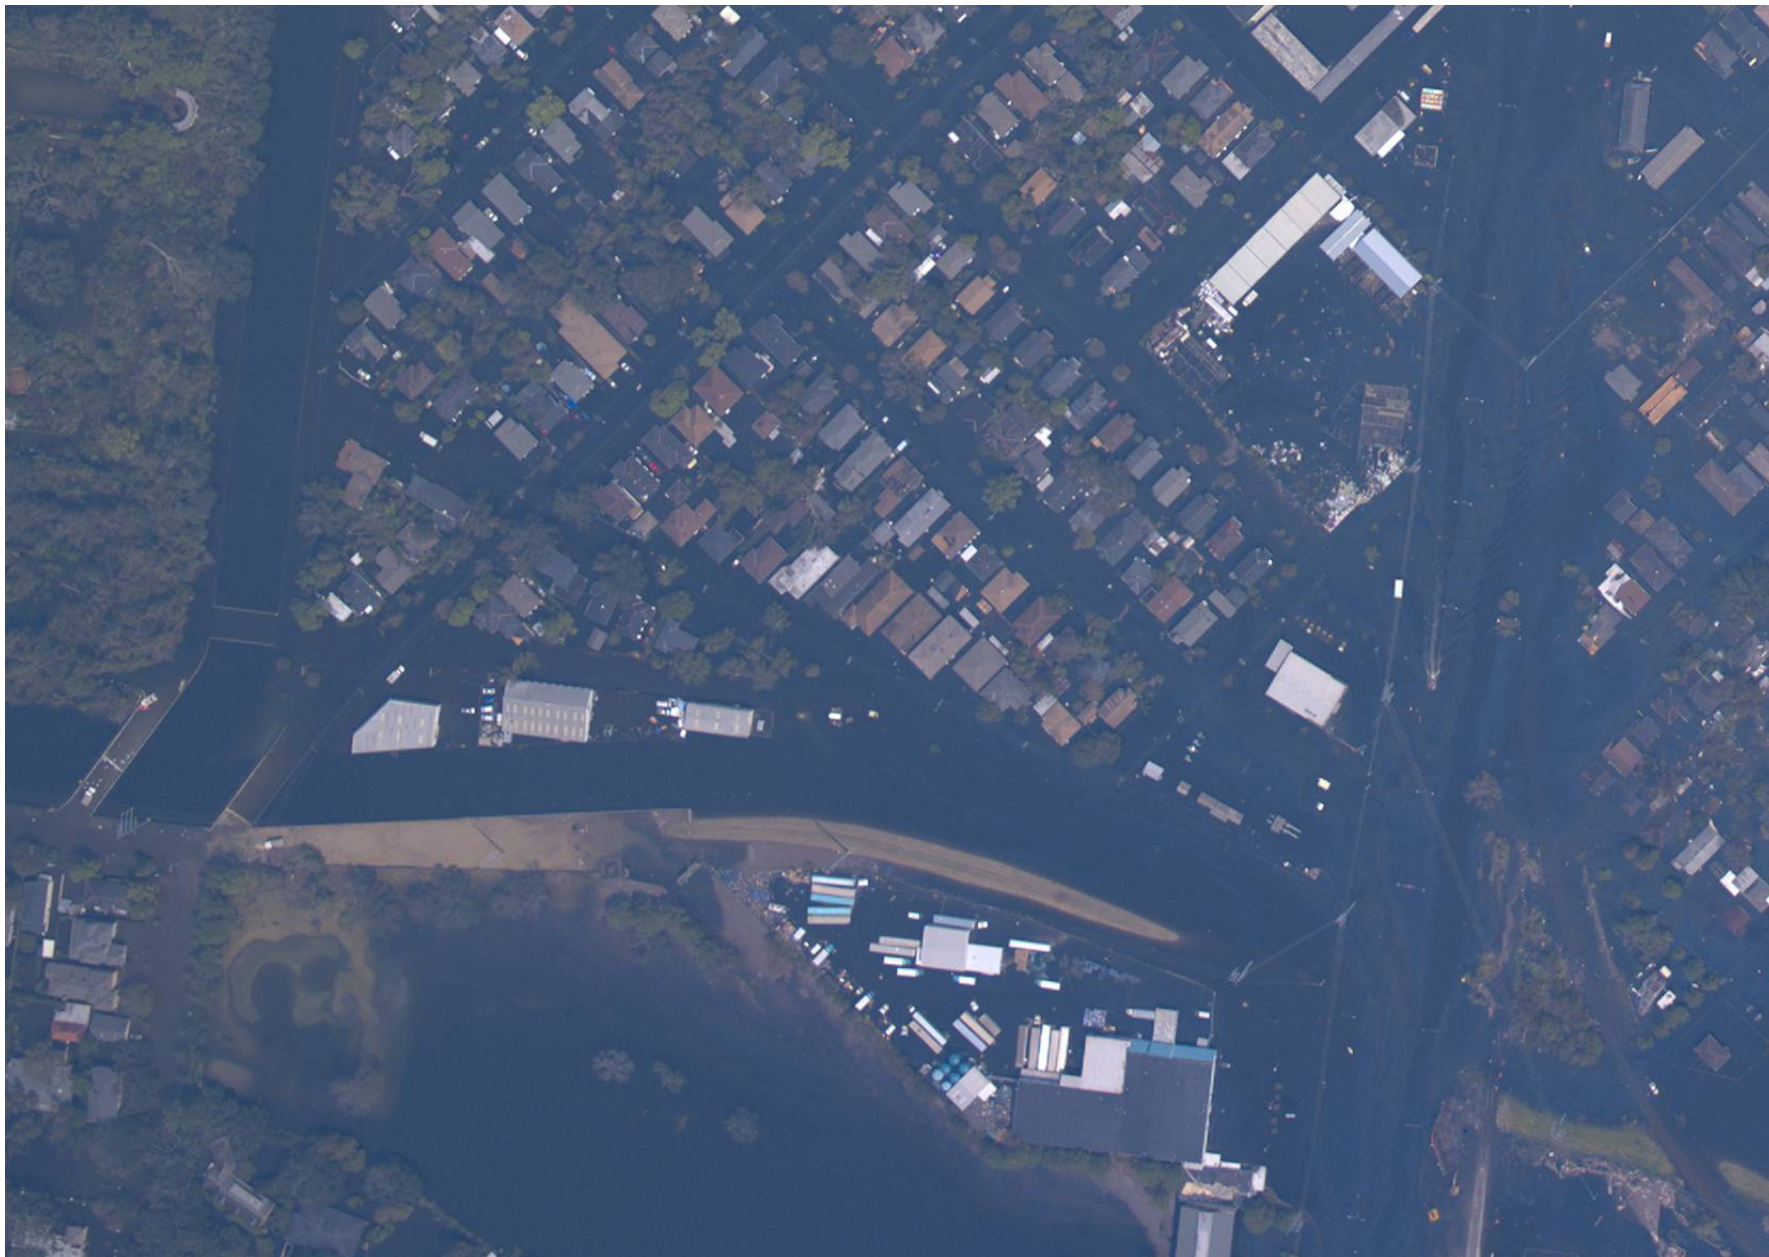
Stop 7 is that the corner of Orpheum Avenue and Northline Street. It is through this area and along Airline Drive south of here, that flood waters from the levee breaches in Orleans Parish reached into Jefferson Parish. The flooding occurred south of the Metairie Road (on the Metairie Ridge) and extended west to Causeway Blvd. and south to near the River. Figure 42 is a Google Earth image of the area at the junction of the Palmetto canal and the 17<sup>th</sup> St. canal before Katrina and Figure 43 shows approximately the same area on August 31. This area is at the southern end of the 17<sup>th</sup> St. Canal where the Palmetto Canal brings water from Pump Station #1 on Broad Street (Figure 7) into the 17<sup>th</sup> St. Canal where it is lifted by Pump Station #6 about 8 feet in elevation and pumped out to the Lake (or through the breach in the 17<sup>th</sup> St. Canal). The Palmetto Canal has a short floodwall (about 3 feet higher than the roadway). Note in Figure 43, how the floodwalls on the Palmetto Canal are completely covered by water. The two bridges over the 17<sup>th</sup> St. Canal are barely above water, but it is clear that water flowed over and around these bridges into Old Metairie. It is also clear that Airline Drive, to the south, was a conduit for water to enter Jefferson Parish.

Within a few days after the August 31 image was taken, Jefferson Parish constructed temporary rock and sandbag levees over these two bridges, across Airline Drive, and across Claiborne Ave./Jefferson Highway at the Jefferson/Orleans Parish boundary. These temporary levees were apparently constructed to prevent more flood water originating at the levee breaches in Orleans Parish from further flooding Jefferson Parish. Although the levee breaches in Orleans Parish were mostly stopped by the time the temporary levees at the Parish line were constructed, the damage had already been done. There are, however, reports that once these temporary levees were built, Jefferson Parish started pumping water out of Jefferson and back into Orleans Parish. If true, this would have increased the amount of water over that already standing in Orleans Parish while the levee breaches were being patched and before the pumps in Orleans parish could be started to remove the water from the severely flooded areas.

**Figure 43.** Air photograph of the area where the water from the 17th Street Canal Levee Breach ran back into Old Metairie, near Orpheum and Palm (stop 6). Image acquired Aug. 31, 2005. Source: National Oceanic and Atmospheric Administration's National Geodetic Survey, Katrina Images - <http://ngs.woc.noaa.gov/katrina/>
