Hurricane Katrina - What Happened? The Geology of the Katrina Disaster in New Orleans

Field Trip Guide Updated 8-08-2008

Stephen A. Nelson
Department of Earth &
Environmental Sciences
snelson@tulane.edu

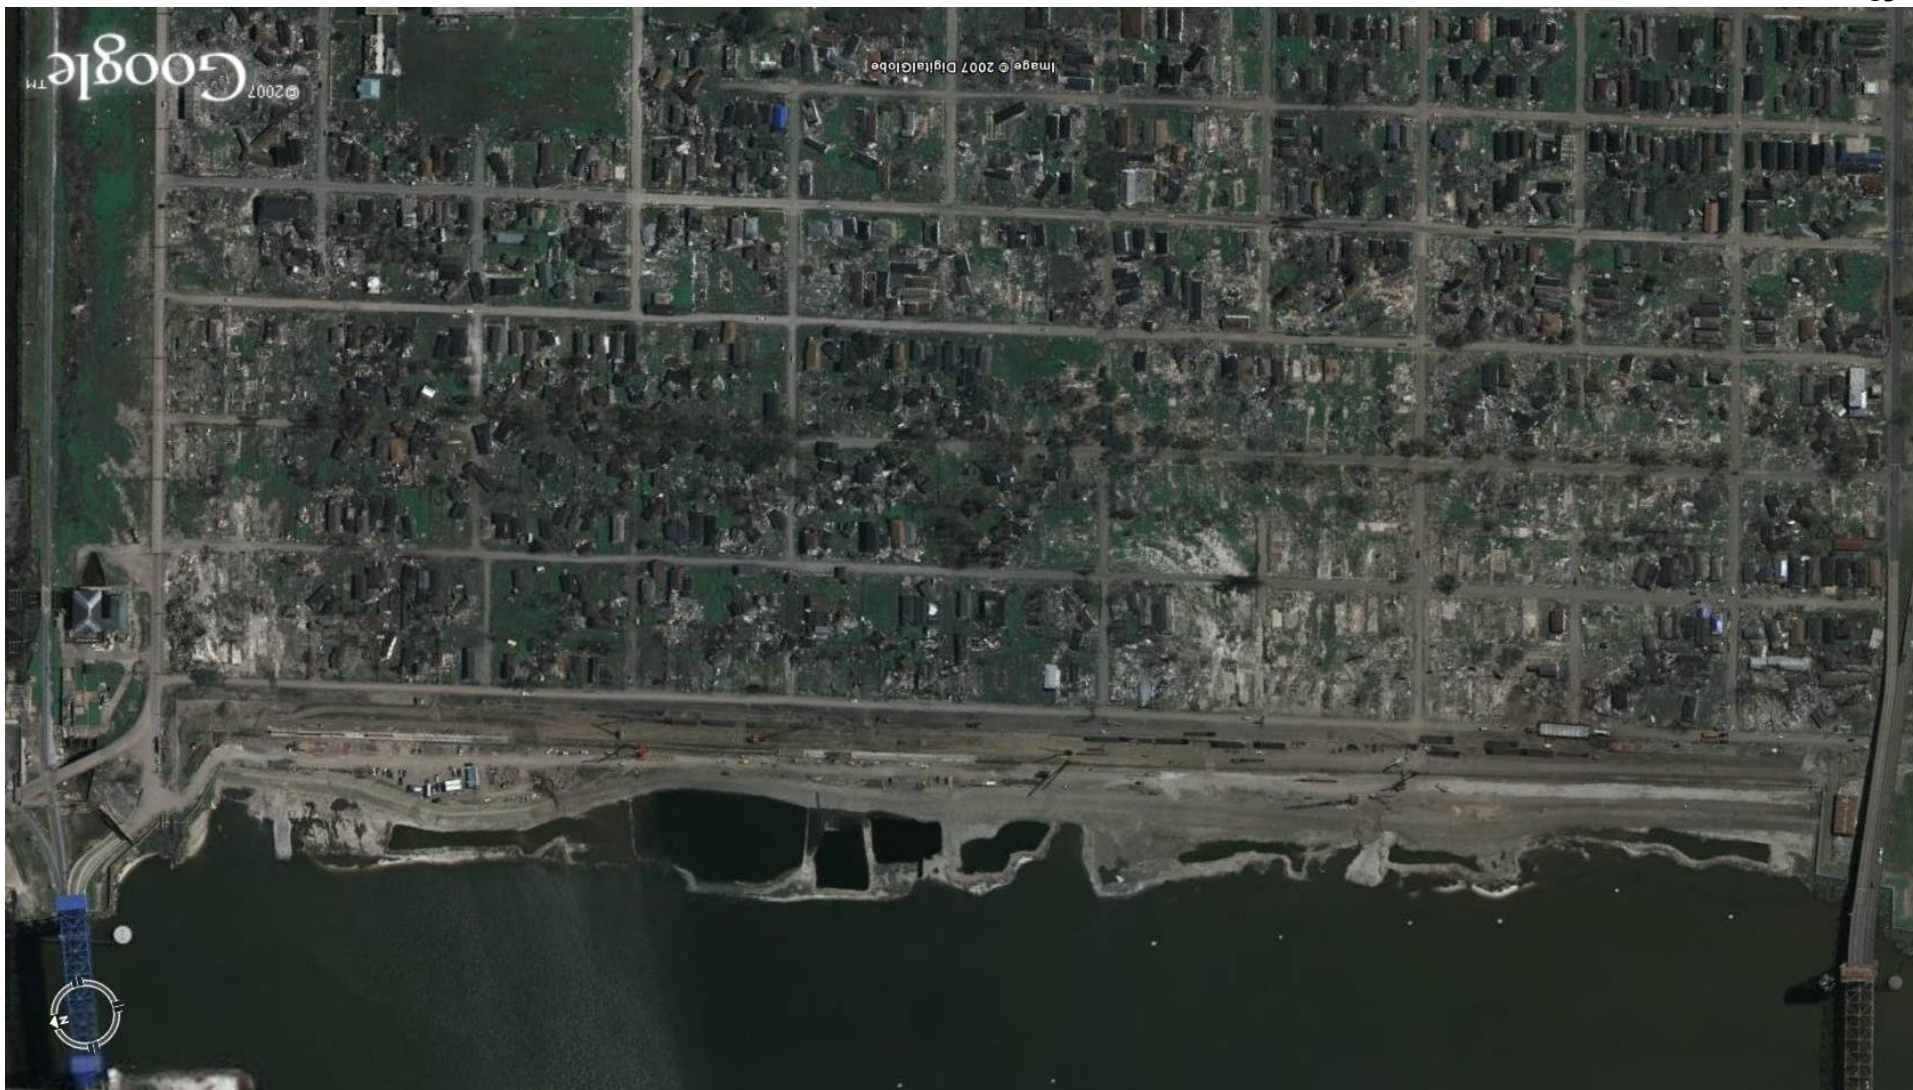
All houses and most trees were removed in the areas immediately in front of the breaches (Figs. 11, 12, 13, & 14) and in areas between the breaches the rush of water was forceful enough to lift houses off their foundations and float them around until they collided with other houses and either came to rest or broke apart to form piles of rubble (Fig. 11). The floodwall and underlying sheet pilings were strewn into the first few blocks of the Lower 9th Ward like a ribbon (Figures 14, 15, and 16).

Figure 12. Google Earth image of the area where the Industrial Canal Levee was breached to flood the Lower Ninth Ward. Image acquired around mid-March, 2006.

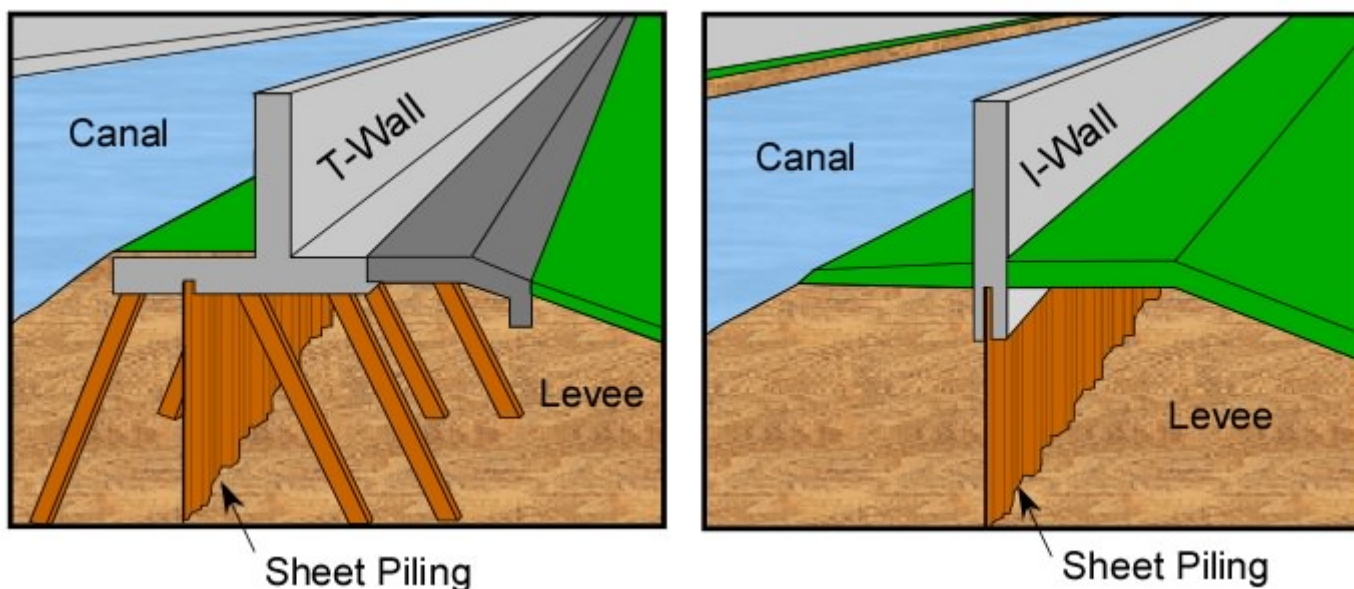
Figure 19. Most pre-Katrina floodwalls in New Orleans were built with the I-wall design (right). In repairing failed floodwall sections after Katrina, the T-wall design (left) was used.

At Stop 1 in the Lower 9th Ward, one now sees that the entire floodwall between the two bridges (Claiborne to the south and Florida Avenue to the North – the blue colored bridge) has been replaced with a T-wall with a top elevation at 14.5 feet above sea level, the level it was supposed to have attained prior to Katrina. This new floodwall was completed in mid-June, 2006. The original I-wall is still present along the other side of the Industrial Canal as well as to the south and north of the new T-wall. The only improvement made to the levees where the I-walls still exist is concrete armoring has been added to the base of the I-wall to prevent the erosion of the levee should water come over the top of the wall again.

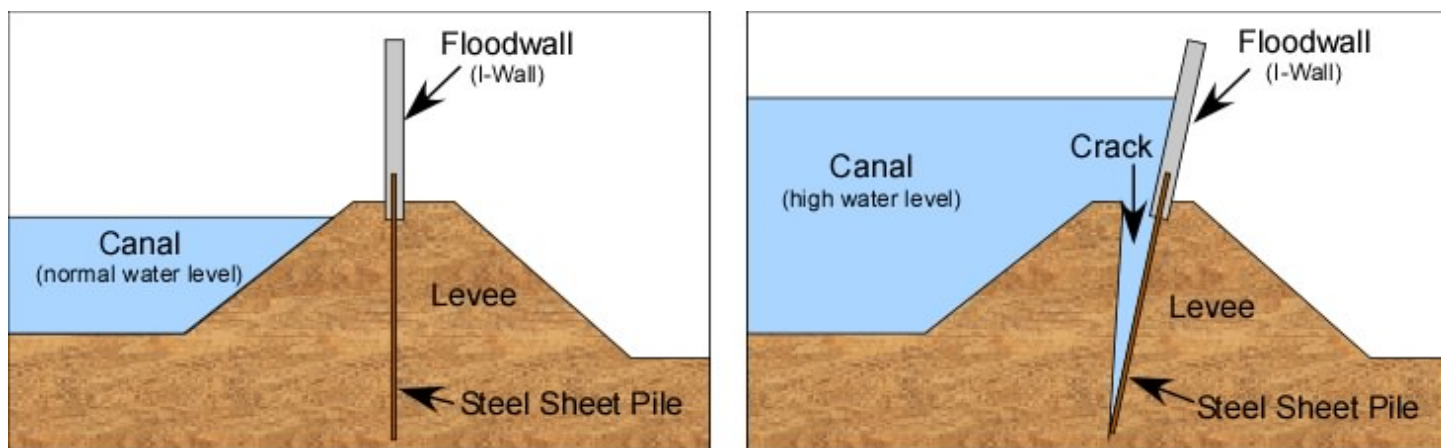
Although the floodwalls along the Industrial Canal were built in the 1970s, in 1985, the research branch of the Army Corps of Engineers conducted experiments on the I-wall design. They constructed a levee and enclosure in the Atchafalaya Basin (to the southwest of New Orleans) and began filling the area next to the levee and sheet pile floodwall with water. As the water rose against the floodwall, deflections of the floodwall began to occur and a gap opened on the water side of the floodwall which allowed the full hydrostatic force of the water to penetrate to the tip of the sheet piling (Jackson, 1988, Oner and others, 1997). This type of floodwall failure is illustrated in Figure 20. These findings were apparently never communicated to those in the Corps responsible for the design and construction of floodwalls in New Orleans (Marshall, March 14, 2006). The leaning floodwall seen in Figure 18 clearly shows that this also happened on the Industrial Canal floodwall during Hurricane Katrina. The force of the water pushing the wall outward toward the protected side coupled with removal of support by erosion caused by the water pouring over the top of the floodwall was the most likely cause of the catastrophic failures on the east side of the Industrial Canal (Fig. 21).

Figure 20. Illustration of crack development as water in a canal rises on the floodwall and pushes outward on the floodwall as observed in 1985 experiments by U.S. Army Corps of Engineers.

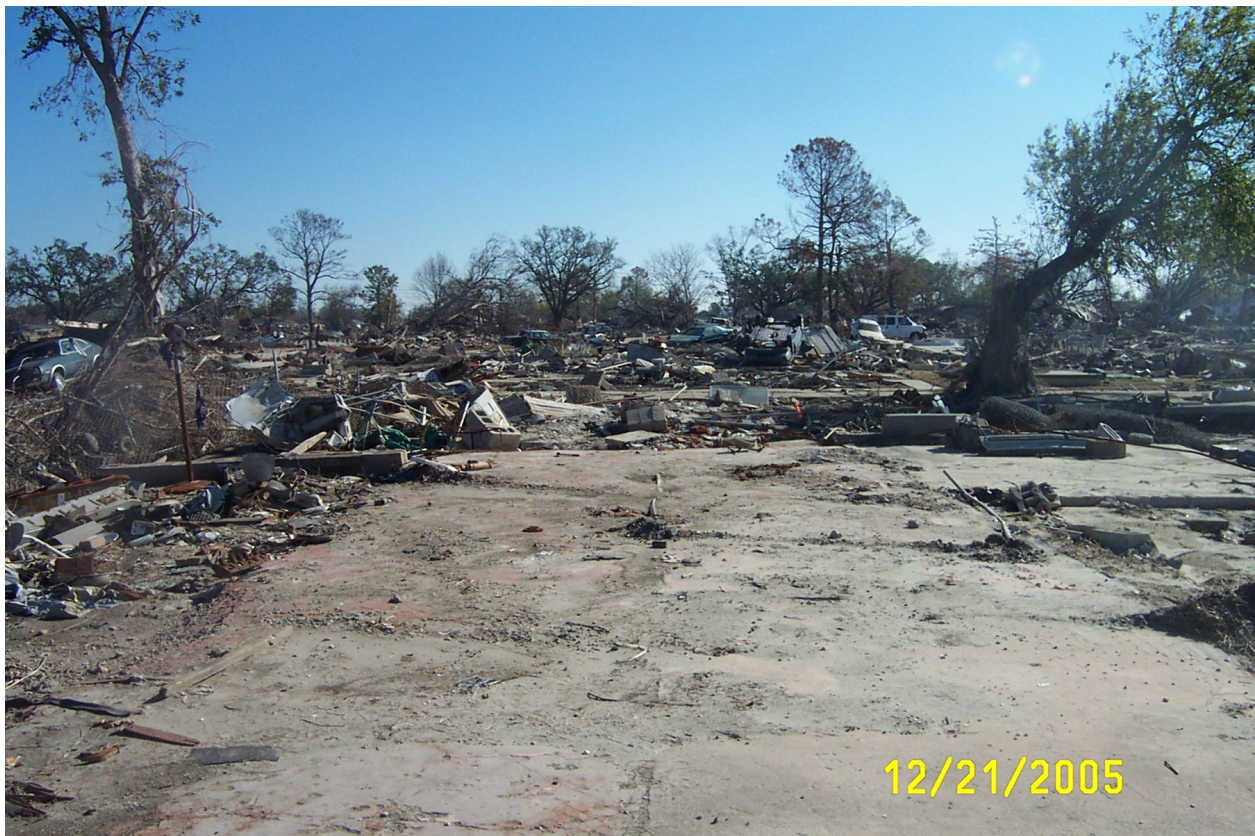
From Stop 1, we will proceed to the North passing through the part of the Lower Ninth Ward between the two levee breaches. Note that in general, homes built on slab foundations were not moved by the force of the flood waters in this part of the neighborhood. Homes built on pier foundations, however, were, in almost all cases lifted off their foundations and floated around the neighborhood. Note also that debris deposited on the roofs of single story homes indicates that the maximum of depth of the flood water was in excess of the roof line. This contrasts with the standing water line left on the houses, which was at a much lower elevation. At the northern end of the neighborhood, near Florida Avenue, note that nearly all structures were removed from the area to the east of the northern breach.

Figure 22. View of Lower Ninth Ward looking East as it appeared in December, 2005.

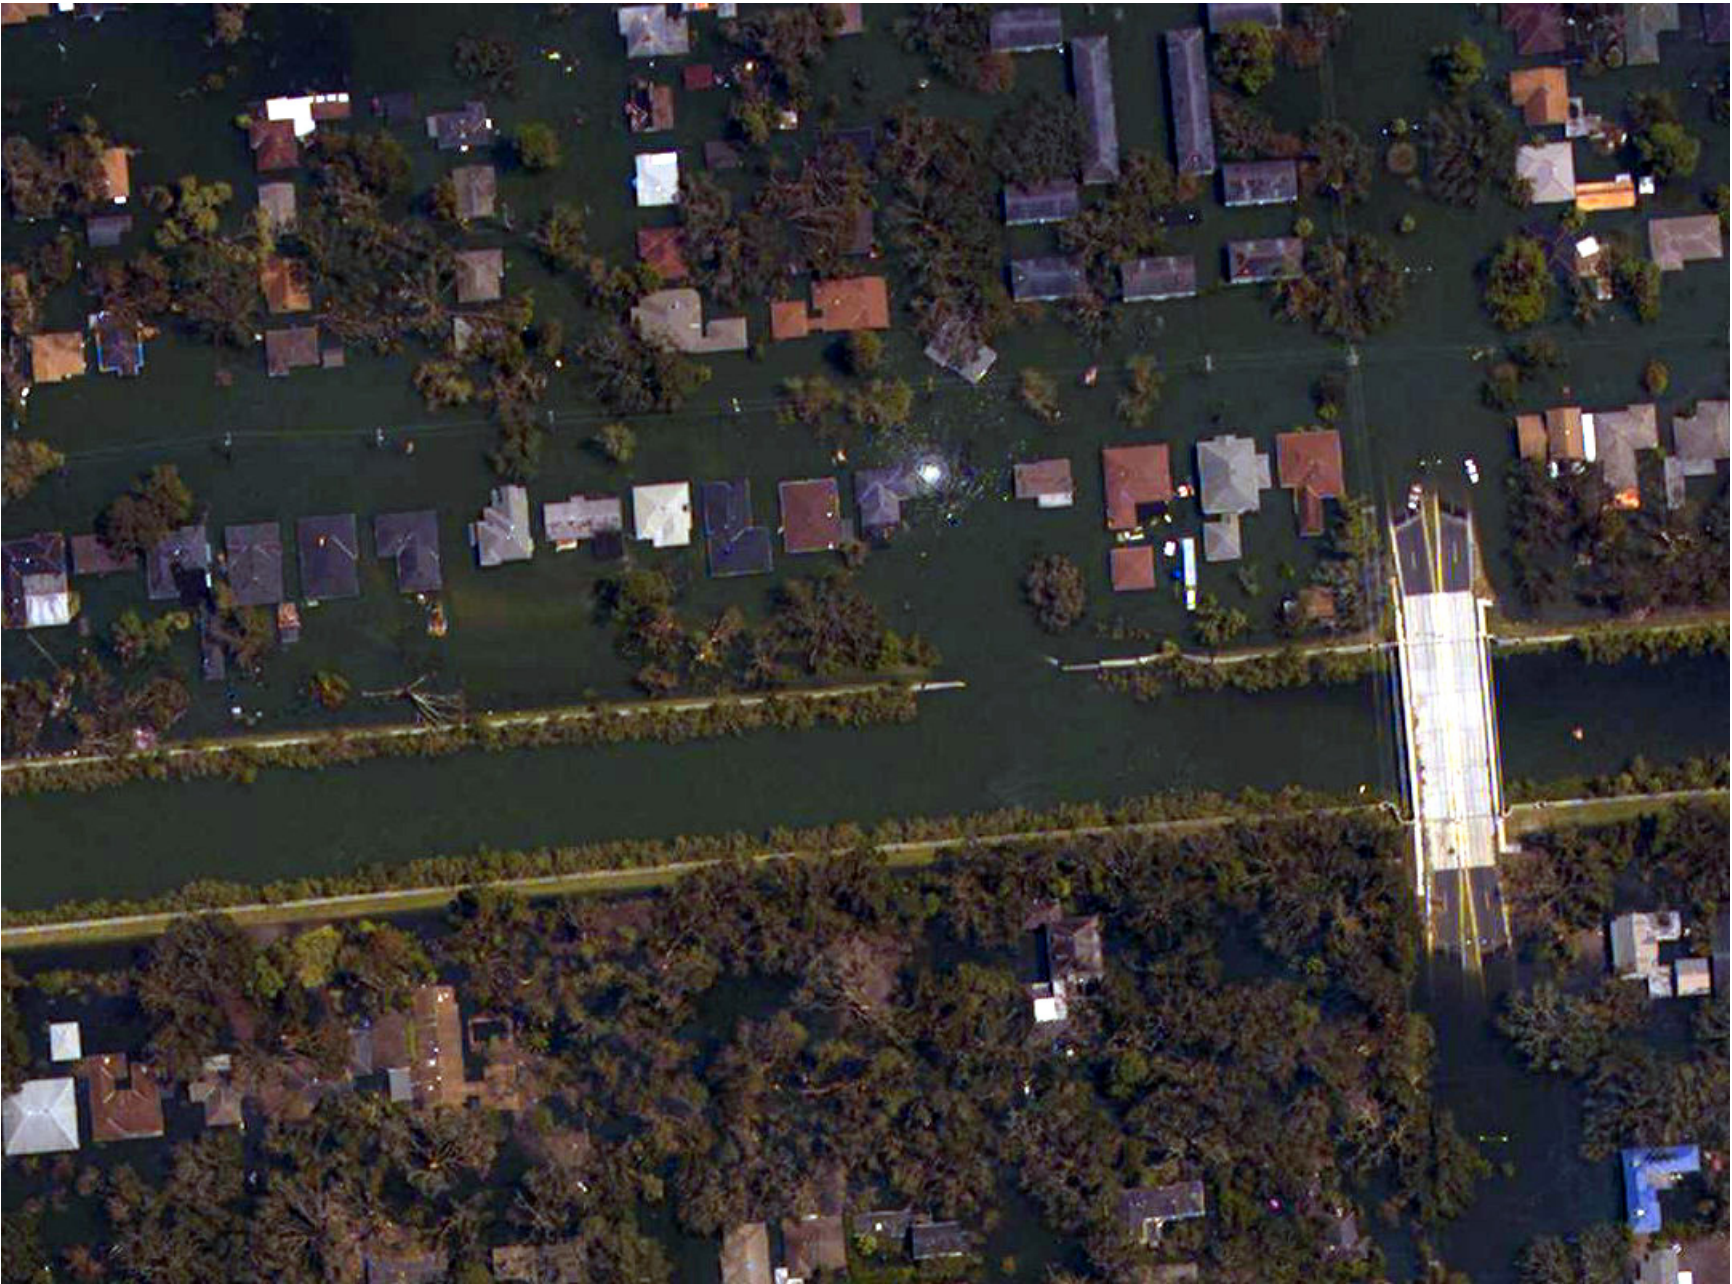
Also noticeable by comparison of Figures 24 and 25 is that before Katrina a tree stood at the toe of the levee adjacent to the part that breached. That tree is laying on its side in the image taken on August 31, 2005 (Fig. 25). It is notable that many trees in the New Orleans area were blown over by the hurricane force winds on the morning of August 29 and when they are blown over they bring up a large root ball leaving a large hole in the ground. If this tree was one of those that were blown over, it is entirely possible that because of its location at the toe of the levee, it could have destabilized the levee and been responsible for the breach. Unfortunately, there were no eye-witnesses to the levee breach at this location, so it is not known if the tree was blown over prior to the breach or if it was simply knocked down during the breach.

Figure 25. Air photograph of the area where the London Avenue Canal levee was breached near Mirabeau Ave. and Warrington Drive (Stop 2). Image acquired Aug. 31, 2005. Source: National Oceanic and Atmospheric Administration's National Geodetic Survey, Katrina Images - <http://ngs.woc.noaa.gov/katrina/>

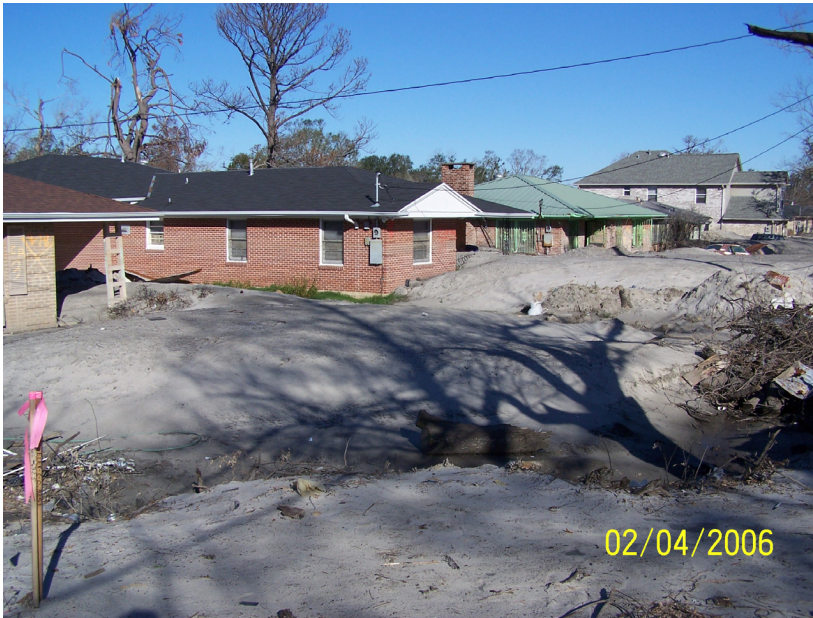
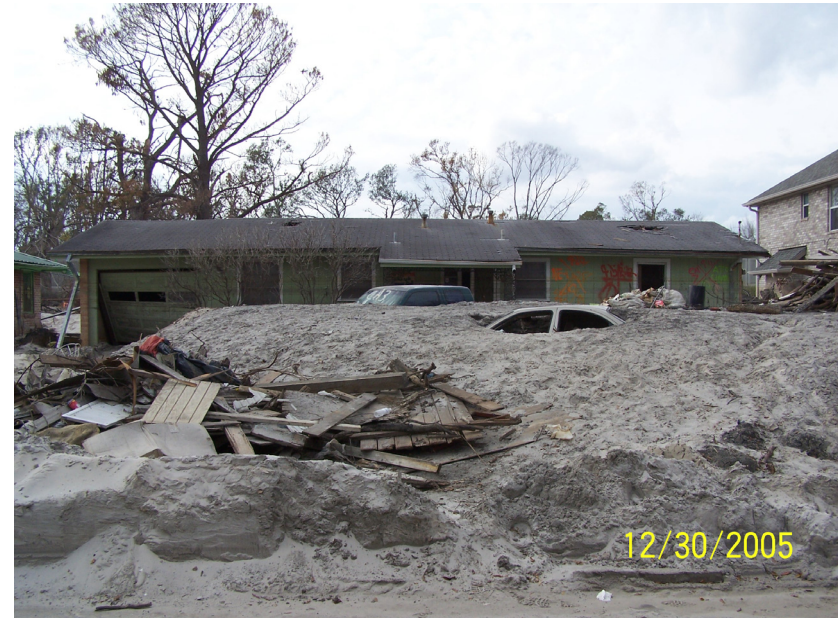
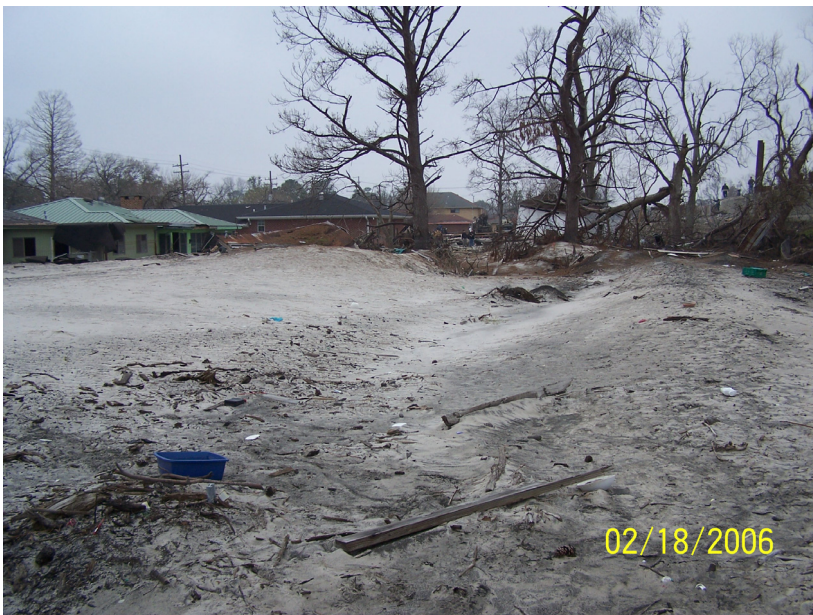
After the flood waters were pumped out, large deposits of sand were seen throughout the neighborhood. As of March 1, 2006 most of the sand had been removed from in front of the houses, and the back yards were cleared by January, 2007. Fig. 26 shows the sand deposits as they appeared before removal.

The sand in these deposits did not originate from the canal water or lake water that was pushed into the canal during Katrina. Instead, it originated from beneath the levee. A geologic cross-section constructed from data on soil borings (done in 1986) (U.S. Army Corps of Engineers, 1989) from the banks of the London Avenue Canal is shown Figure 27. The cross-sections clearly show the presence of sand at a depth beginning between 10 and 15 feet below sea level. This sand is the same Pine Island beach sand that was deposited in the area between 4,000 and 5,000 years ago as shown in Figures. 2, 5 and 6.

Figure 26. Sand deposits near the south breach of the London Avenue canal. (a) sand ridges deposited in the wake of houses as the currents flowed down the driveways between the houses. (b) Sand deposits that buried two cars in front of house on Warrington Drive . (c) Ridges of sand filling the back yards of houses along Warrington Drive, just north of the breach. As of March 1, 2006, most of the sand in the front yards had been removed and as of mid January, 2007 most of the sand in the backyards had been removed.

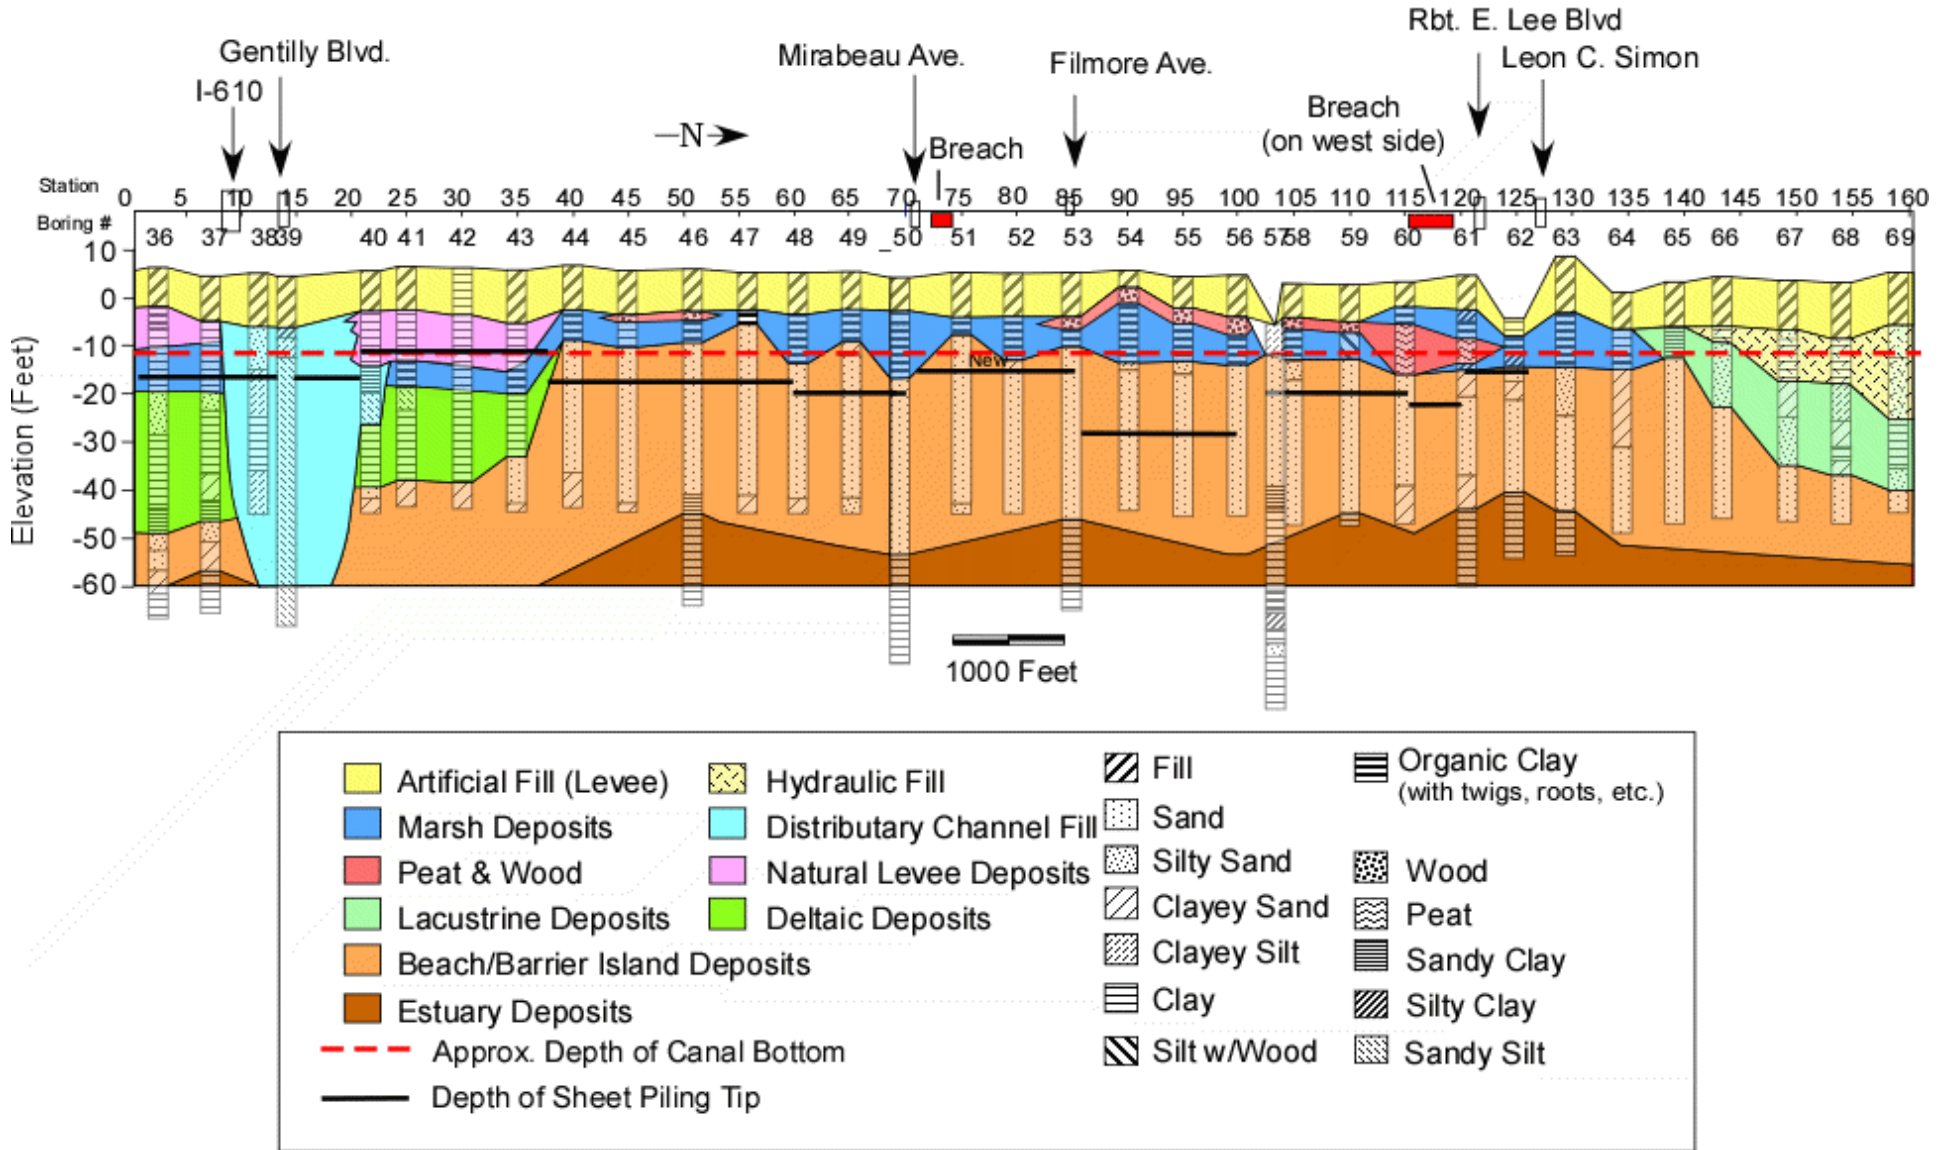
Figure 27. Geological cross-section along the east side of the London Avenue Canal constructed from data in U.S. Army Corps of Engineers (1989).

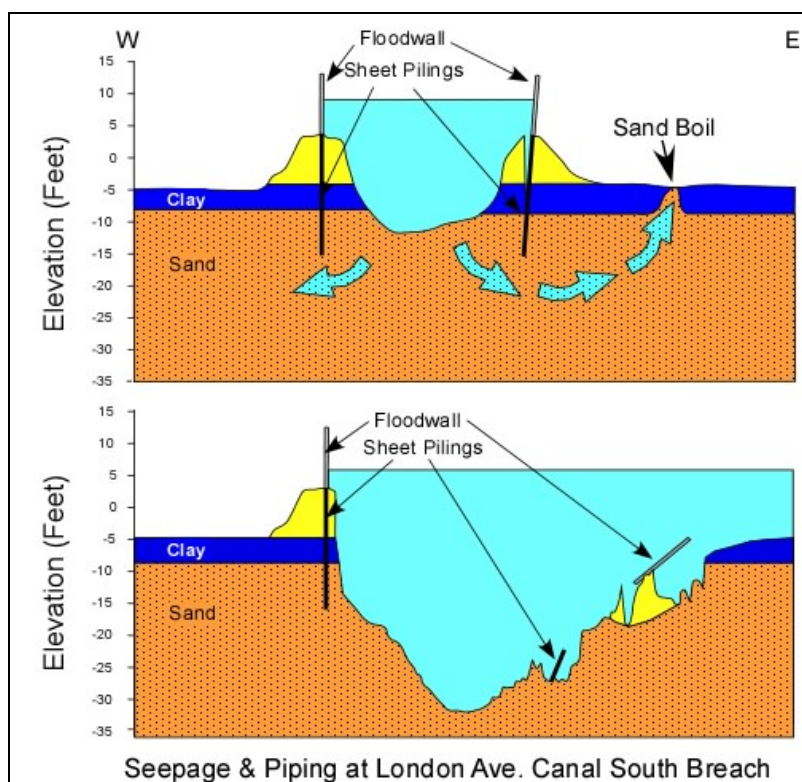
Sand is a highly permeable material. This means that water can easily be transported between the sand grains, especially when the weight due to overlying water is increased due to the added height of the water column during a storm surge. This increases the pressure and could force the water through the pore spaces in the sand and back up to the surface on the other side of the levee. If enough flow takes place the sand will be picked up by the flowing groundwater and eventually form an underground channel. This could undermine the levee and cause it to collapse. The principle is illustrated in Figure 28 with a simple thought experiment. The underflow (called seepage or siphoning) is the apparent cause of the collapse at this section of the London Ave. Canal. The "As built" design specifications indicate that the sheet pilings (which should form an impermeable barrier to pressure induced flow in the sand) were placed to a depth of 14 feet below sea level (U.S. Army Corps of Engineers, 1994), one can see from the cross section in Fig. 29, that the water still has a path back to the surface if it flows as groundwater beneath the sheet pilings. Note that in order to prevent such siphoning, the sheet pilings would need to be placed to a depth of about 50 feet below sea-level where they would penetrate a layer of clay. Clay, because the individual mineral grains stick together and thus reduce pore space and interconnection between pores, is much more impermeable than is sand.

Figure 29. Geological cross section across the London Ave. Canal based on borings 16 and 51 (Figs. 27 and 33), shown at time of estimated high water during Katrina's storm surge. The sands form a permeable layer through which groundwater originating in the canal can penetrate and move below the sheet pilings and up to the surface (top diagram), eventually undermining the levee and causing a blowout completely removing a section of levee and carrying sand into the neighborhood. The shape of the canal bottom is based on depth soundings undertaken by the U.S. Army Corps of Engineers on September 5, 2005.

The repair operation has only been done in the area of the breach. The operation involved digging out the material used in the initial emergency repair, filling it with clay and construction a T-wall to replace the missing I-wall. Fortunately, the Corps of Engineers has now completed removable floodgates near the mouths of the London Ave, Orleans, and 17th St. canals near Lake Pontchartrain. These floodgates will be closed in the event of a hurricane and should prevent storm surge from reaching onto the floodwalls in the canals. If the gates are closed, however, the pumps at the southern end of the canals cannot be used to pump rainwater out of the city. Thus, the Corps has built a pumping station at the Lake (where they should have been built in the first place), but full pumping capacity is not yet available. Still rainwater flooding is better than having Lake Pontchartrain drain into the city.

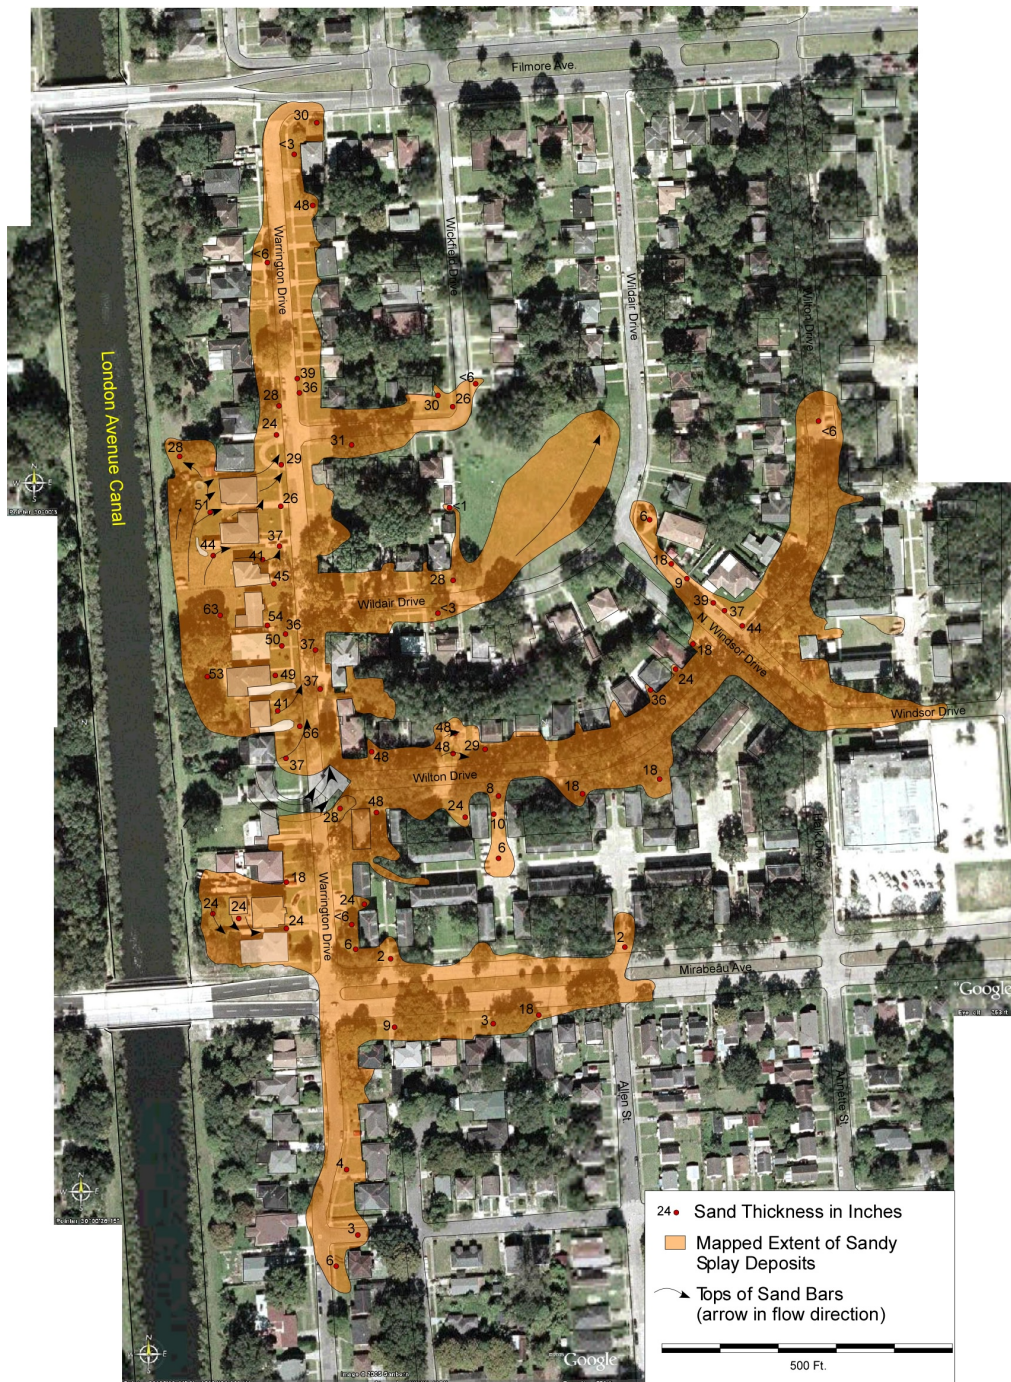
Figure 30 shows our preliminary map of the extent of the sand that scoured from the bottom of the London Ave. Canal and the blowout hole beneath the levee and deposited throughout the neighborhood. The distribution and thickness of the actual deposit was controlled by current velocity and barriers such as houses, fences, and hedges. For more information on the sand deposits at this locality, see Nelson and Leclair (2006).

Our estimate of the volume of sand deposited in the neighborhood is about 932,000 ft³. Such a volume would cover a football field, from end to end (including the end zones) with over 16 feet of sand. Engineers working on the breach repair have reported that they had to dig to a depth of 30 feet below sea level to completely remove gravel and sand bags used to plug the breach in the first few days after Katrina. A conservative estimate of the volume of this hole is about 365,000 ft³. This only accounts for about 39% of the volume of sand found in the neighborhood, and implies that the canal bottom, both upstream and downstream from the breach, was scoured to an unknown depth. This raises questions about the stability of the levee/floodwall system outside the breach area if the canal bottom is now in permeable sand in these areas.

Figure 30. Preliminary map of sand deposits (by S. A. Nelson) from the Mirabeau Ave. Breach on the London Ave. Canal. Underlying image is a composite from Google Earth.

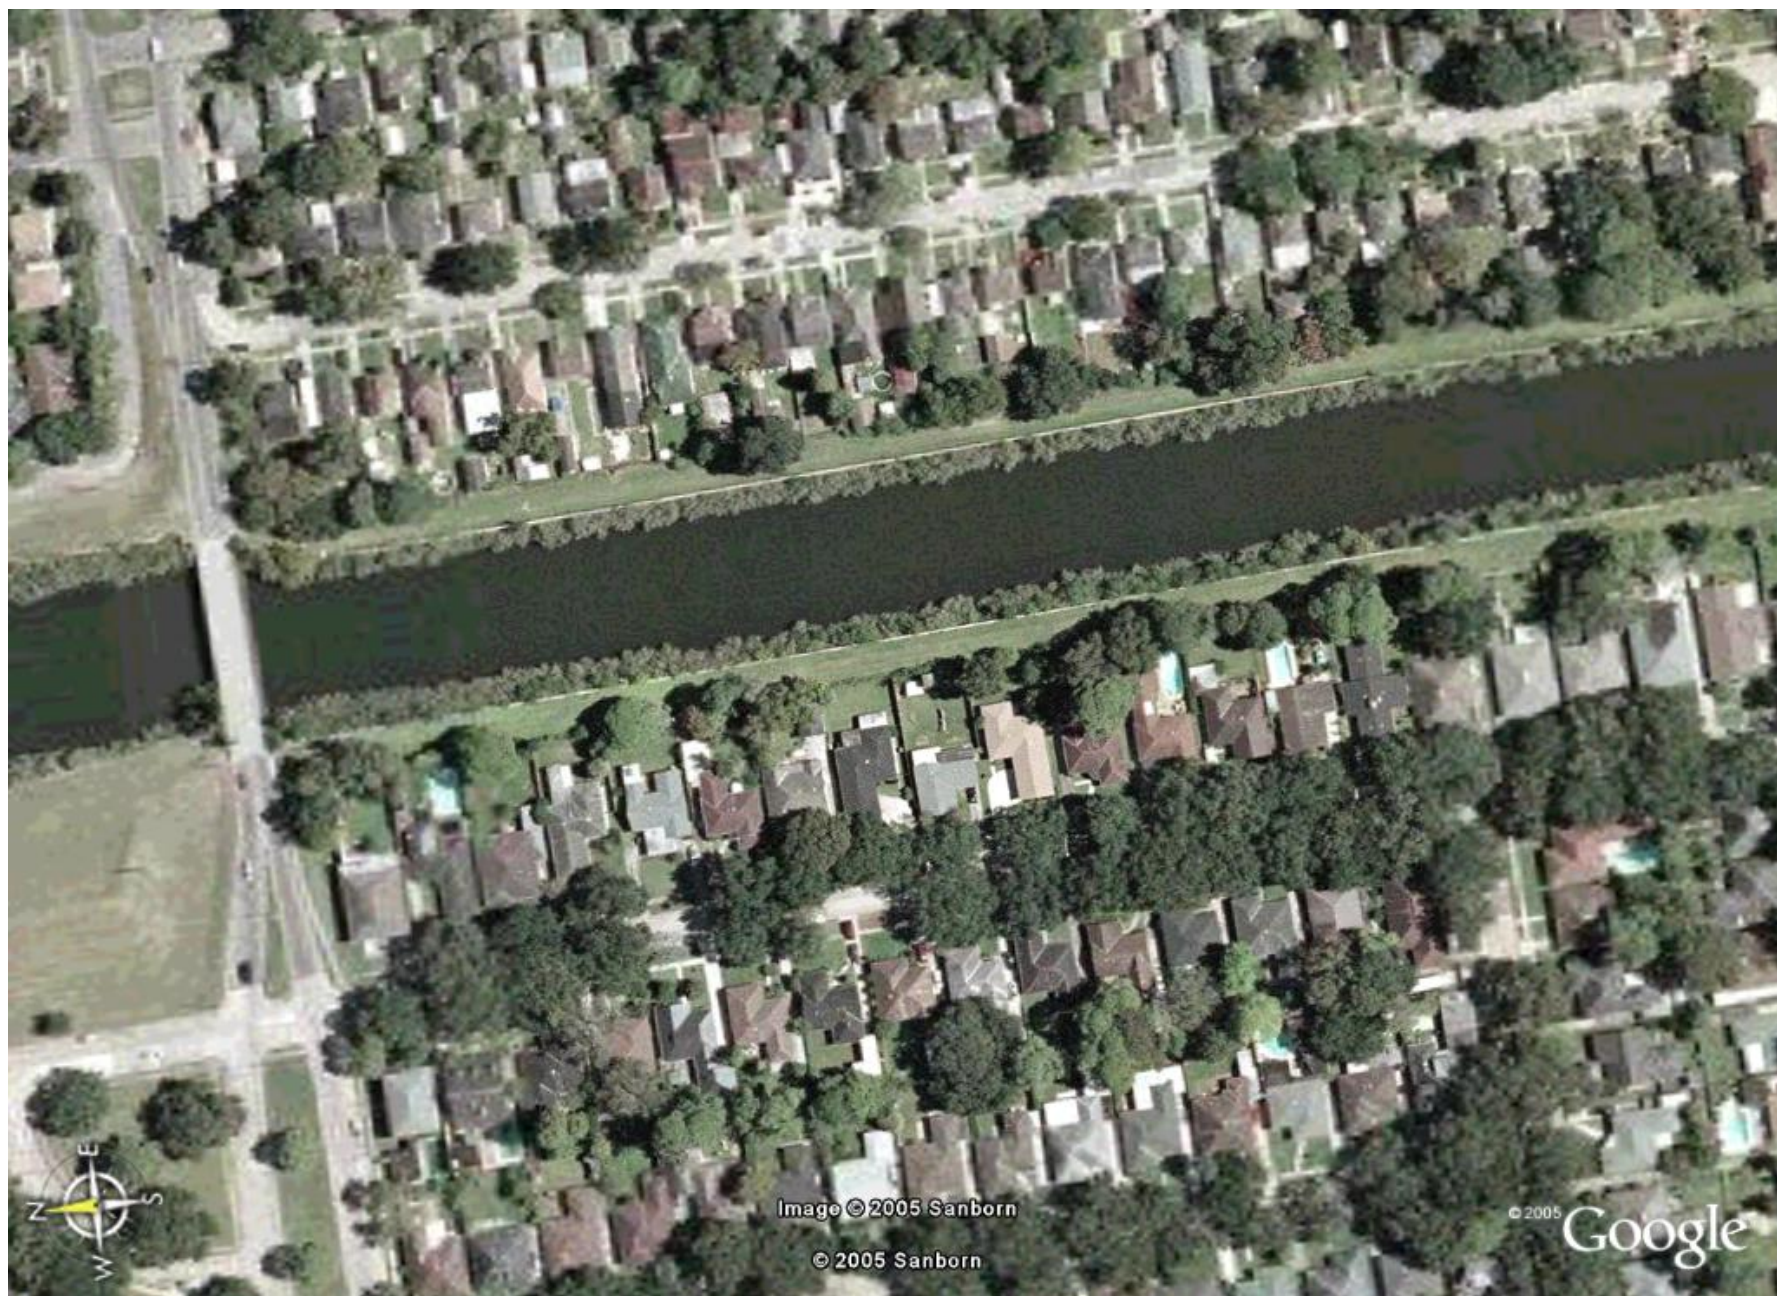
Note in Figures 31 and 32 that there is abundant vegetation along the banks of the canal inside the floodwalls. During the surge event in the canal, this vegetation trapped debris flowing in the canal and the height of this trapped debris in the vegetation could be used to estimate water level. Such evidence observed shortly after the storm indicates that the water level in the canal was no higher than about 3 feet from the top of the floodwall. Note also in figure 32 how the vegetation along the bank of the failed floodwall shows a distinct edge marking the pre-failure position of the floodwall. During the failure, the floodwall slid away to the west as a result of the water pressure against the floodwall and sheet pilings.

Figure 31. Satellite image of the area along the London Avenue Canal near Robert E. Lee Blvd. and Pratt Drive (Stop 3), where the levee was later breached during Hurricane Katrina. (Source - Google Earth)

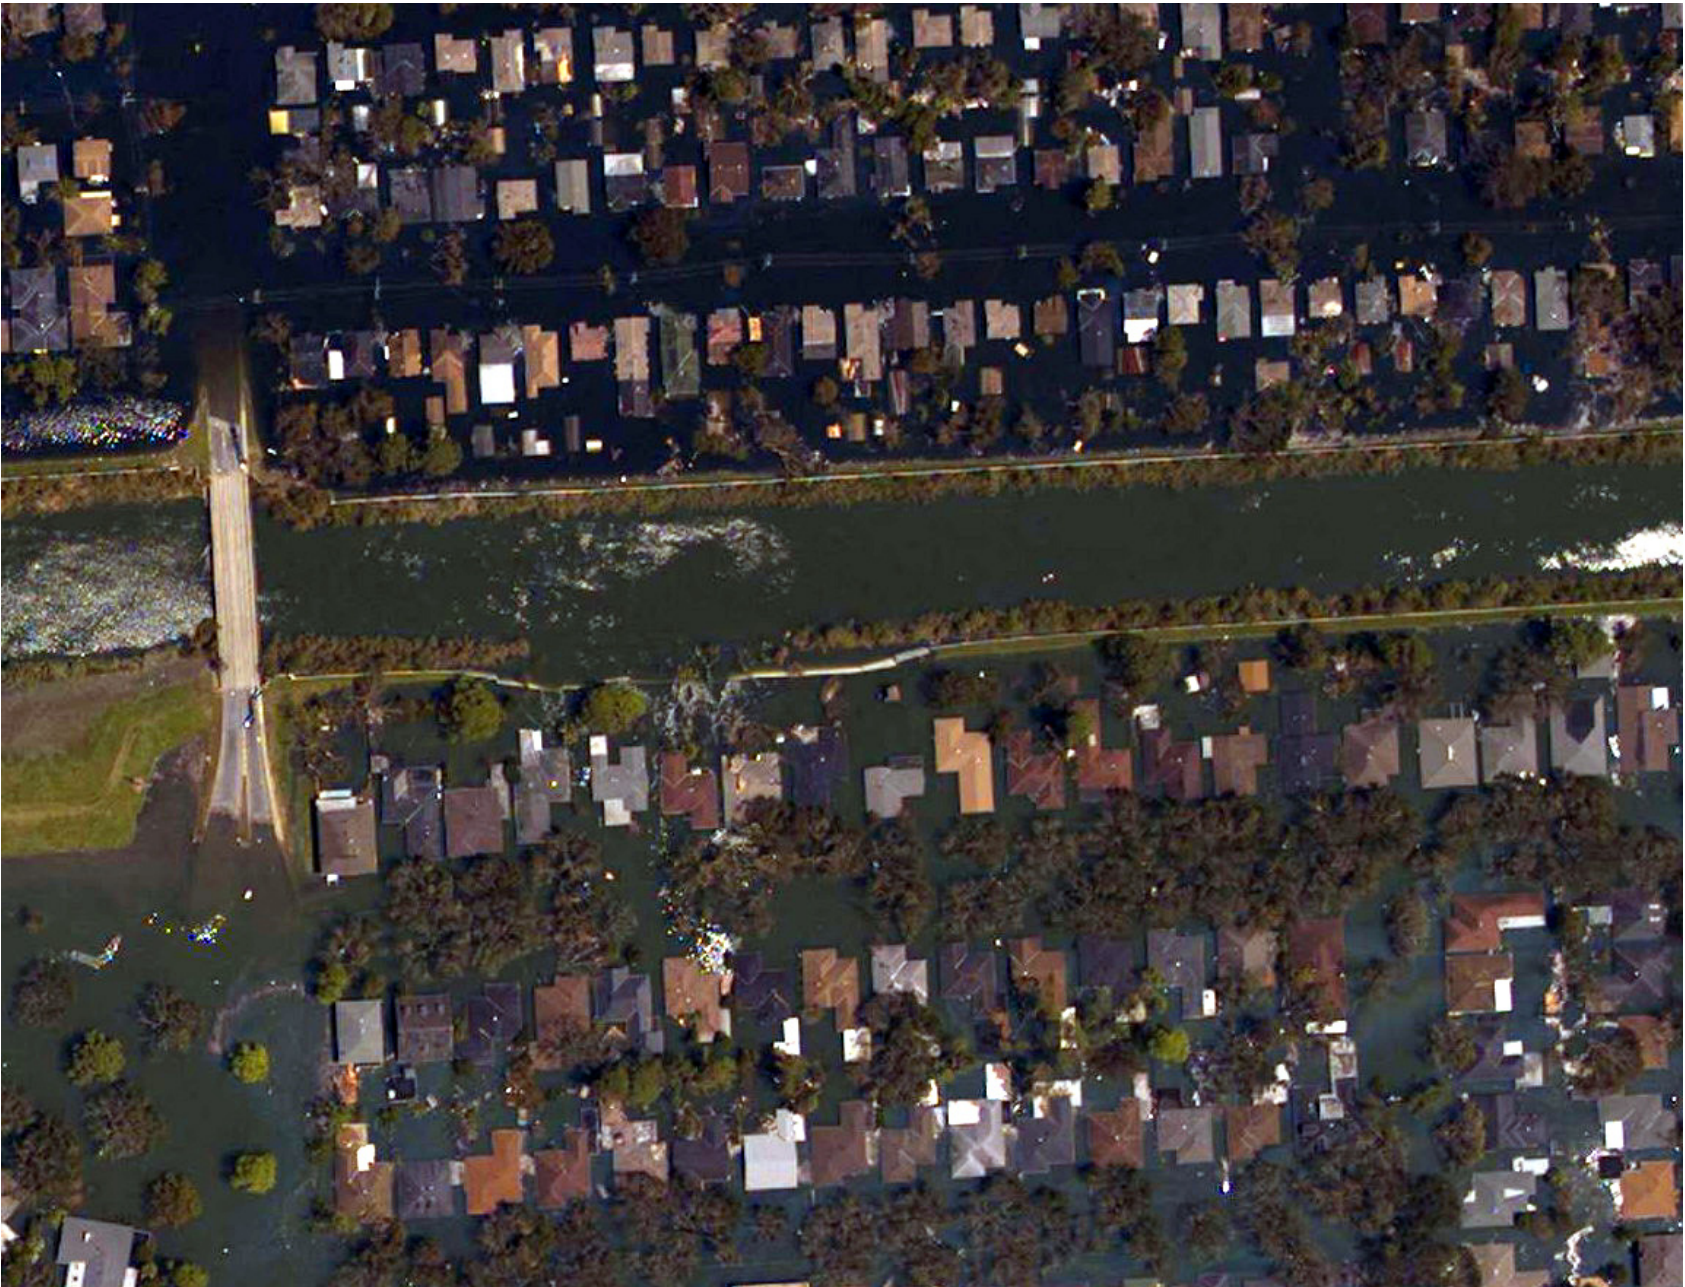
Figure 32. Air photograph of the area where the London Avenue Canal levee was breached near Robert E. Lee Ave. and Pratt Drive (Stop 3). Drive. Image acquired Aug. 31, 2005. Source: National Oceanic and Atmospheric Administration's National Geodetic Survey, Katrina Images - <http://ngs.woc.noaa.gov/katrina/>
