Hurricane Katrina - What Happened? The Geology of the Katrina Disaster in New Orleans

Field Trip Guide Updated 8-08-2008

Stephen A. Nelson
Department of Earth &
Environmental Sciences
snelson@tulane.edu

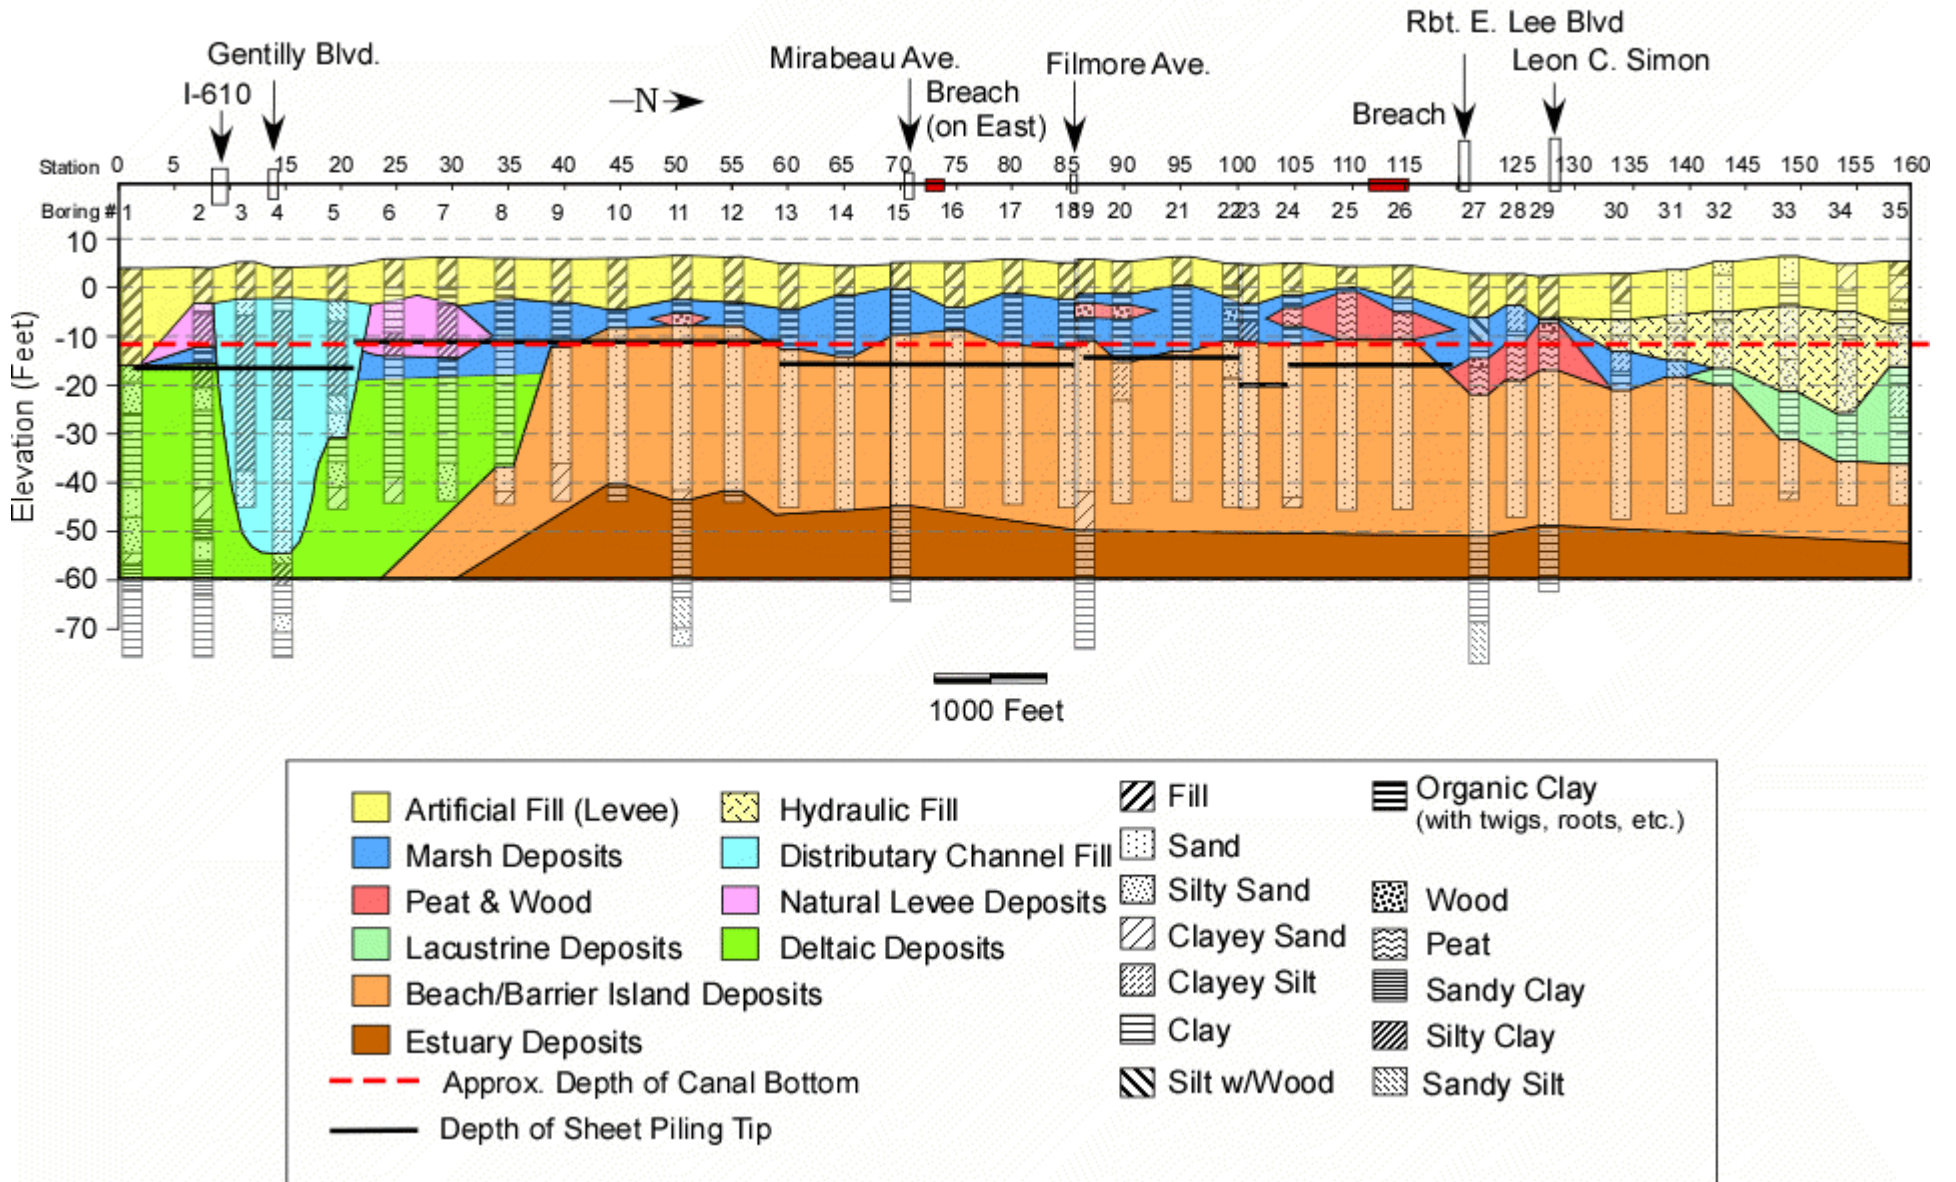
London Avenue Canal - West Side

A geologic cross section of the west side of the levee is shown in Figure 33. Note that the conditions beneath the surface are similar to those at the Mirabeau Ave. breach, with a sand layer about 12 feet below sea-level. Here a peat layer is also observed. Peat is organic matter (vegetation that is in the process of decay). It represents material accumulated in swampy areas and indicates that this area was a swamp in the not too distant past. Peat is very porous and has the additional property that it shrinks when it is dried out and expands when water is added. The presence of peat can make for very unstable soil conditions.

Figure 33. Geological cross-section along the west side of the London Avenue Canal constructed from data in U.S. Army Corps of Engineers (1989).

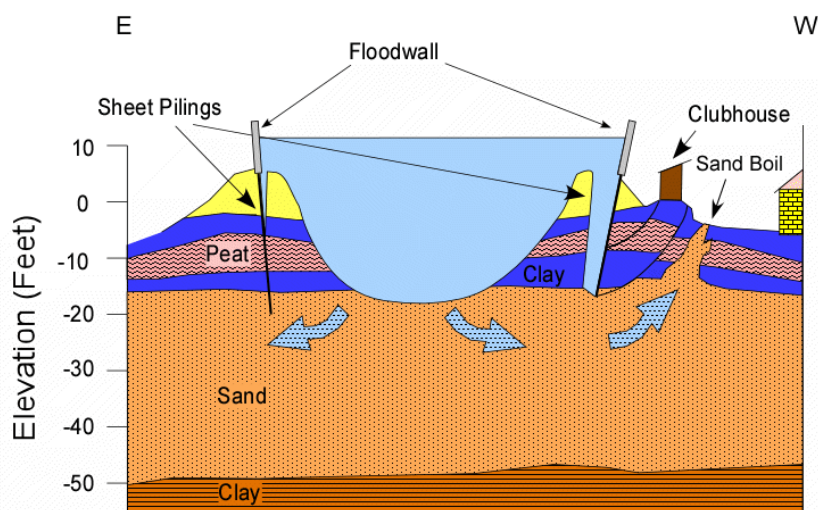
Heaving at London Ave. Canal North Breach

Figure 35. Water in the canal at the north breach of the London Ave. Canal puts lateral pressure on the floodwall and sheet piling along with water driven through sand under the sheet pilings (and possibly through peat, depending on the depth to which the sheet pilings actually were driven) pushes up the ground outside of the canal in a phenomenon known as heave. This would eventually provide a flow path for water which would undermine the levee and cause its collapse. This may have been responsible for the eventual collapse of the floodwall on the west side of the canal resulting in the breach. The floodwall on the east side of the canal was distressed, but did not breach.

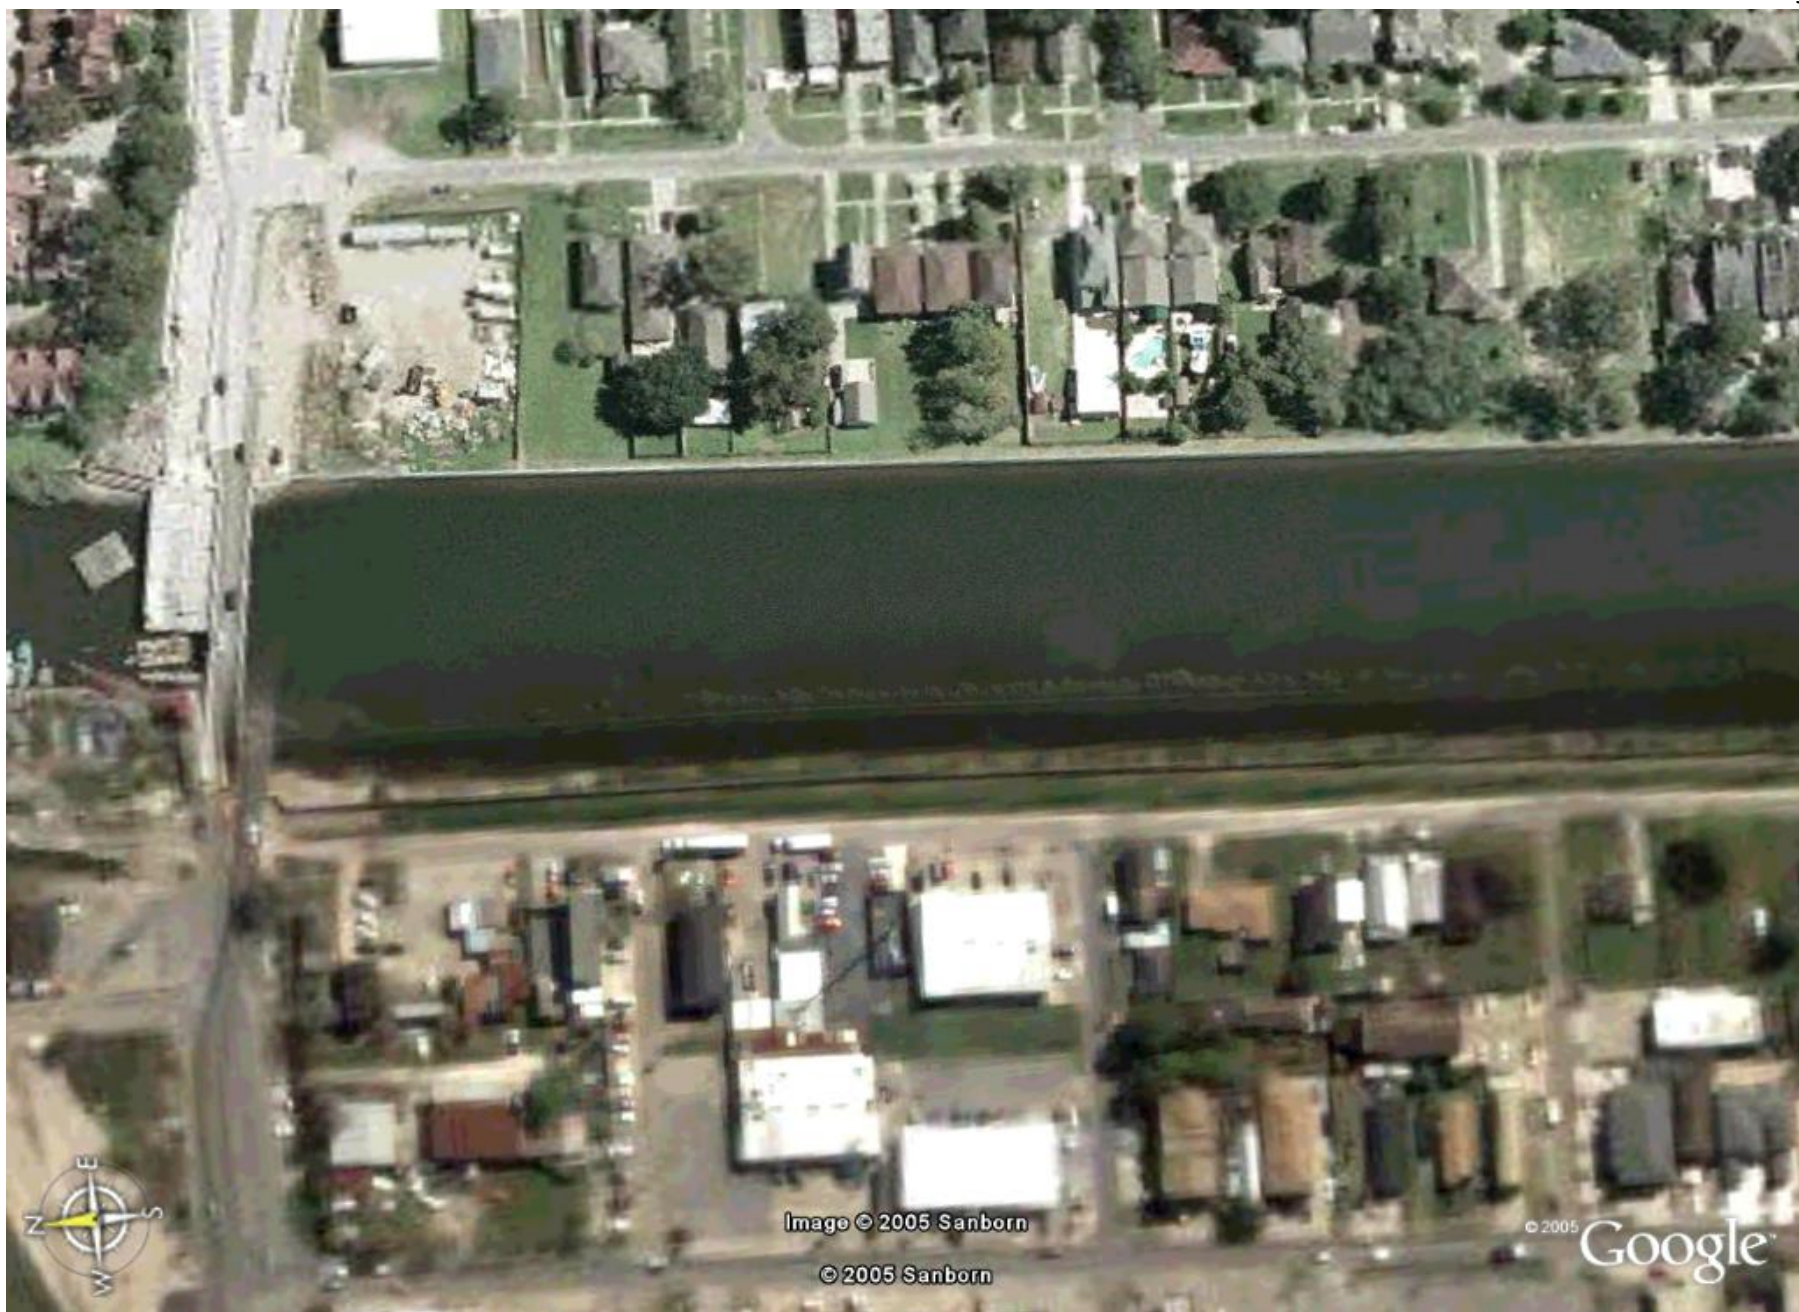
Note that the breach occurred along Belaire Drive where, like the along the London Avenue Canal, houses are backed up against the levee (all houses bordering the breach area on the west side of Belaire Drive were demolished by the Corps of Engineers in July, 2006). Here, the main part of the breach occurred in a recently cleared empty lot. A tree in that empty lot, close to the levee toe (Fig. 38) can be seen to be toppled in the August 31 image (Fig. 39). Just as at the Mirabeau breach, no eyewitness are available to tell us if the tree toppled due to the hurricane force winds on August 29 or as a result of the levee breach. Without such observations, we note that it is entirely possible that if the tree was toppled by the winds it could have been responsible for the breach at this locality. A house to the south of the main part of the breach, built on a chain wall foundation, was completely removed (see also the photo in the lower right of Figure 48). Natural gas from a line that fed the house can be seen bubbling up through the floodwater in Figure 39. Another house to the north of the empty lot was built on a slab and was also removed by the rushing floodwaters. The natural gas line that fed that house can also be seen bubbling up natural gas, just to the right of the yellow spot (roof of a school bus) in Figure 38.

Figure 38. Satellite image of the area along the 17th Street Canal near the Old Hammond Highway Bridge (under construction), where the levee was later breached during Hurricane Katrina (stop 5). (Source - Google Earth)

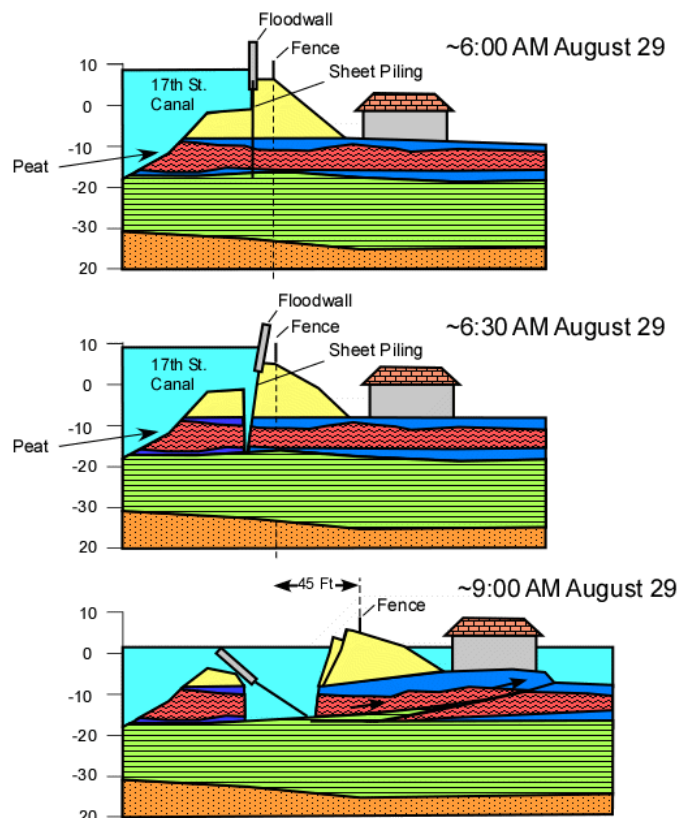
Failure of the 17th St. Canal Levee & Floodwall

The most recent information from the Interagency Performance Evaluation Task Force (IPET) [2006] suggests that the floodwall and levee failed at the 17th St. Canal as a result of the water level rising to an elevation of about 8 feet above sea level in the canal. The floodwalls were designed to have tops at an elevation of 14 feet above sea level, but IPET data indicate that by the time of Katrina the tops of the floodwalls on the 17th Street Canal were about 12.5 feet above sea level. Thus, IPET estimates that water levels in the canal were still 4 feet below the tops. IPET has collected eyewitness accounts and scoured the neighborhood for clocks that were stopped as a result of the flooding in order to determine the time of the breach. One eyewitness account suggests that the floodwall at the breach area was leaning to the protected side at about 6:30 AM on August 29 and other accounts suggest that the breach was open by about 9:00 AM. This, along with levee breach experiments conducted on scale models in a large centrifuge led IPET to suggest that as water levels rose in the canal, the floodwall and sheet piling was pushed outward toward the land side, opening a gap between the levee and the floodwall on the canal side. This gap allowed water to seep down along the sheet piling and eventually push the levee on the protected side outward away from the canal. Based on sections of the breached levee observed in the breach area, IPET suggests that the failure did not occur along the peat layer, but along a layer of weak clay at the base of the peat. This clay layer was thrust over and through the peat as illustrated in Figure 45.

Figure 45. Diagrammatic cross sections across the 17th St. Canal in the vicinity of the breach. Based partially on a sketch in Seed and others (2005), ILIT (2006) and IPET (2006).

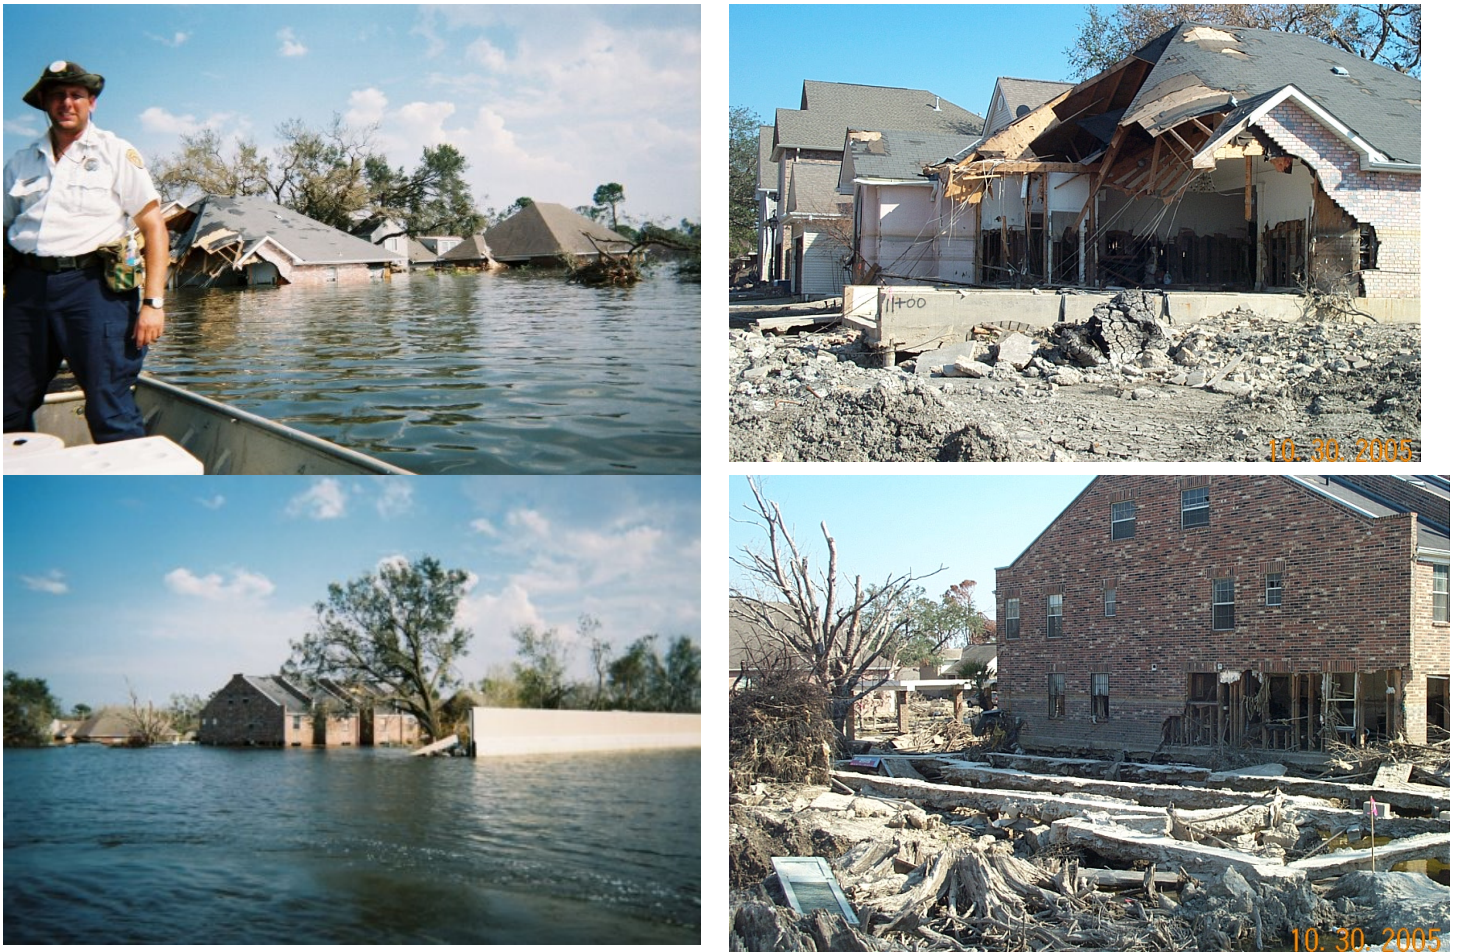
Figure 48. Comparison of water levels on Sept. 1, 2005 (photos on left by Kevin Himmel), with water lines on same structures indicate lines left by standing water are about 1.5 to 2 feet lower than the maximum water level. Note large block of peat in photo at the upper right. In photo at lower right, note the chainwall foundation of a house that was removed by the burst of water when the levee was breached and the cypress stump from a tree that was probably cut down 100 years ago when this Lakeview neighborhood was reclaimed from the cypress swamp.

Although throughout the field trip we have seen the water line (scum line) left by standing water, this line does not represent the maximum flood depth. As seen in Figure 46, comparison of the photos on the left, taken when the water level was near its maximum with the water line left on the same structures (photos on the right) indicate that the maximum flood depth was about 1.5 to 2 feet higher than the line left by standing water.

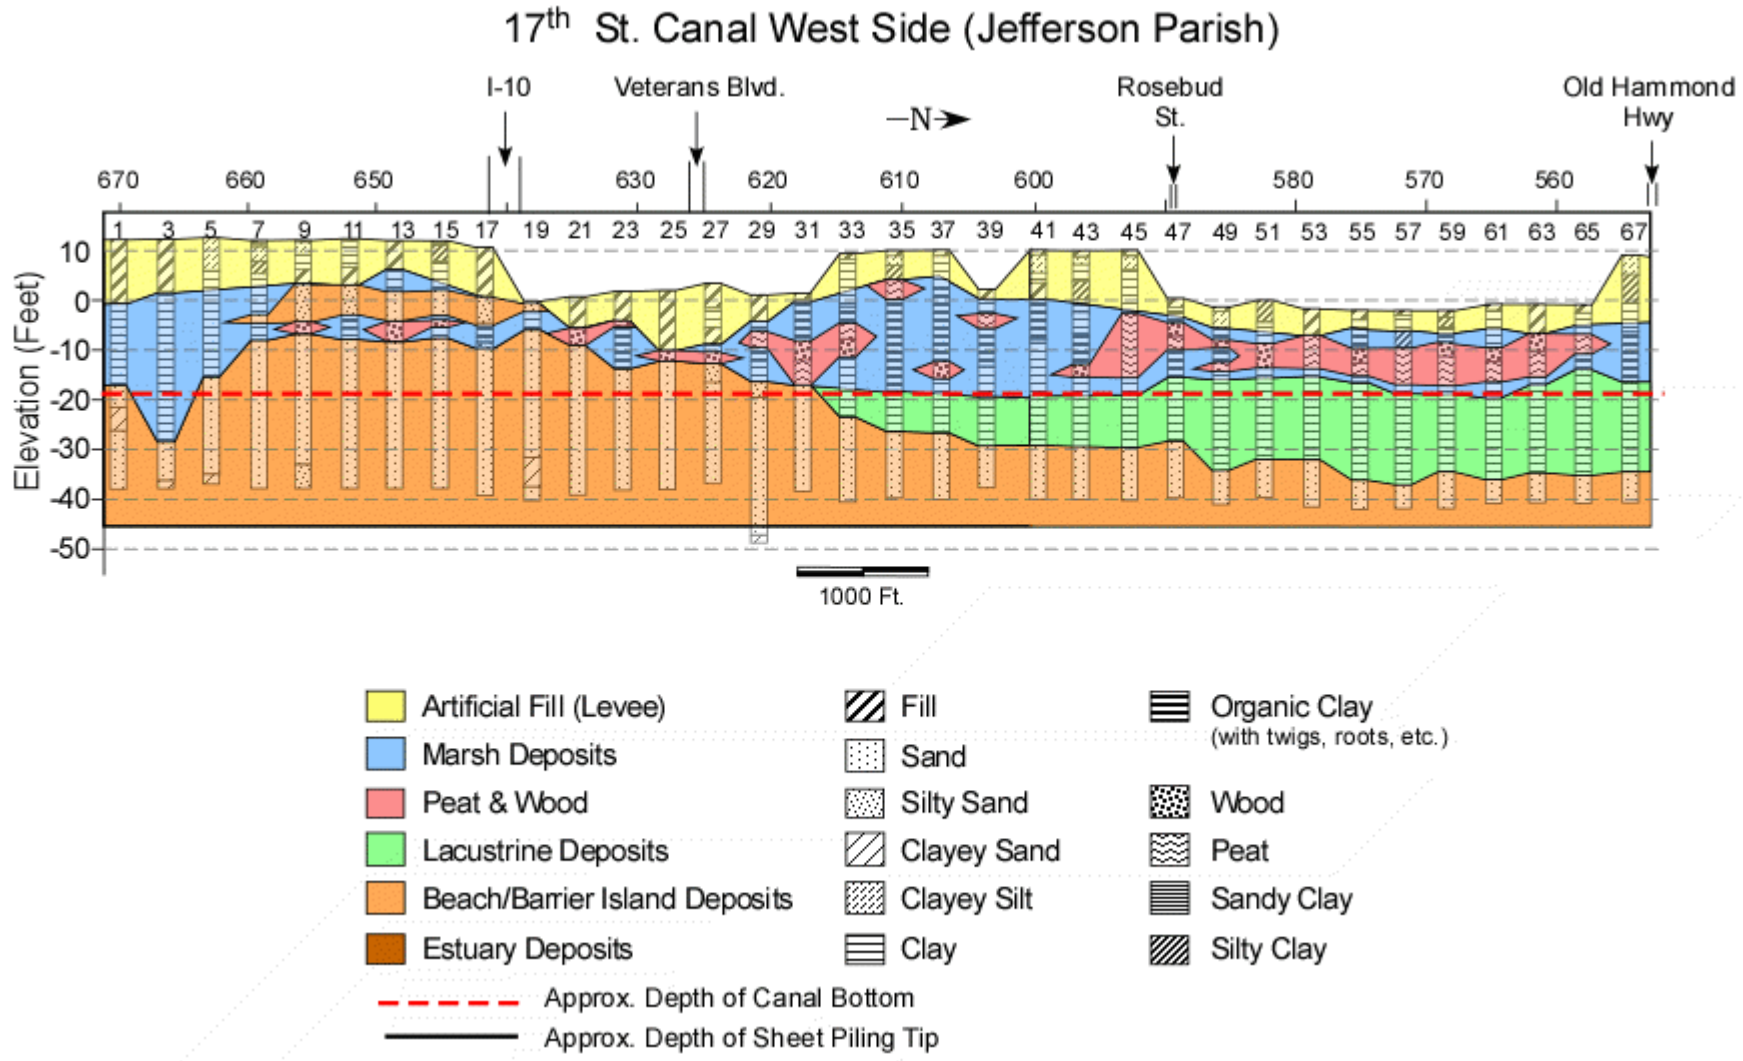
It is notable that the same peat layer and the same levee design and construction are present on the Jefferson Parish side of the canal, which by luck or the path of the storm, did not breach on August 29, 2005. Figure 47 shows a geological cross section of the west bank (Jefferson Parish side) of the 17th St. Canal constructed from data provided on the Army Corps of Engineers IPET web site - <https://ipet.wes.army.mil/> where it can be seen that the same geologic materials are present beneath the Jefferson Parish side as are found on the Orleans Parish side (compare with Figure 42). One major difference on the Jefferson Parish side is that a street occupies the area next to the levee and there are no trees, houses or swimming pools abutting the levee on that side.

Figure 49. Geologic cross section of the west bank of the 17th St. Canal constructed from data provided to the U.S. Army Corps of Engineers (1990). Note that levee heights appear inconsistent because some of the borings were taken at the toe of the levee rather than on the levee crest. Depth to the tip of the sheet pilings is currently not available for the west side of the 17th St. Canal, although Grissett (April 14, 2007) has information that the sheet pile tips extend only to about 4 feet below sea-level at southern end of the canal (south of Veterans Blvd.).

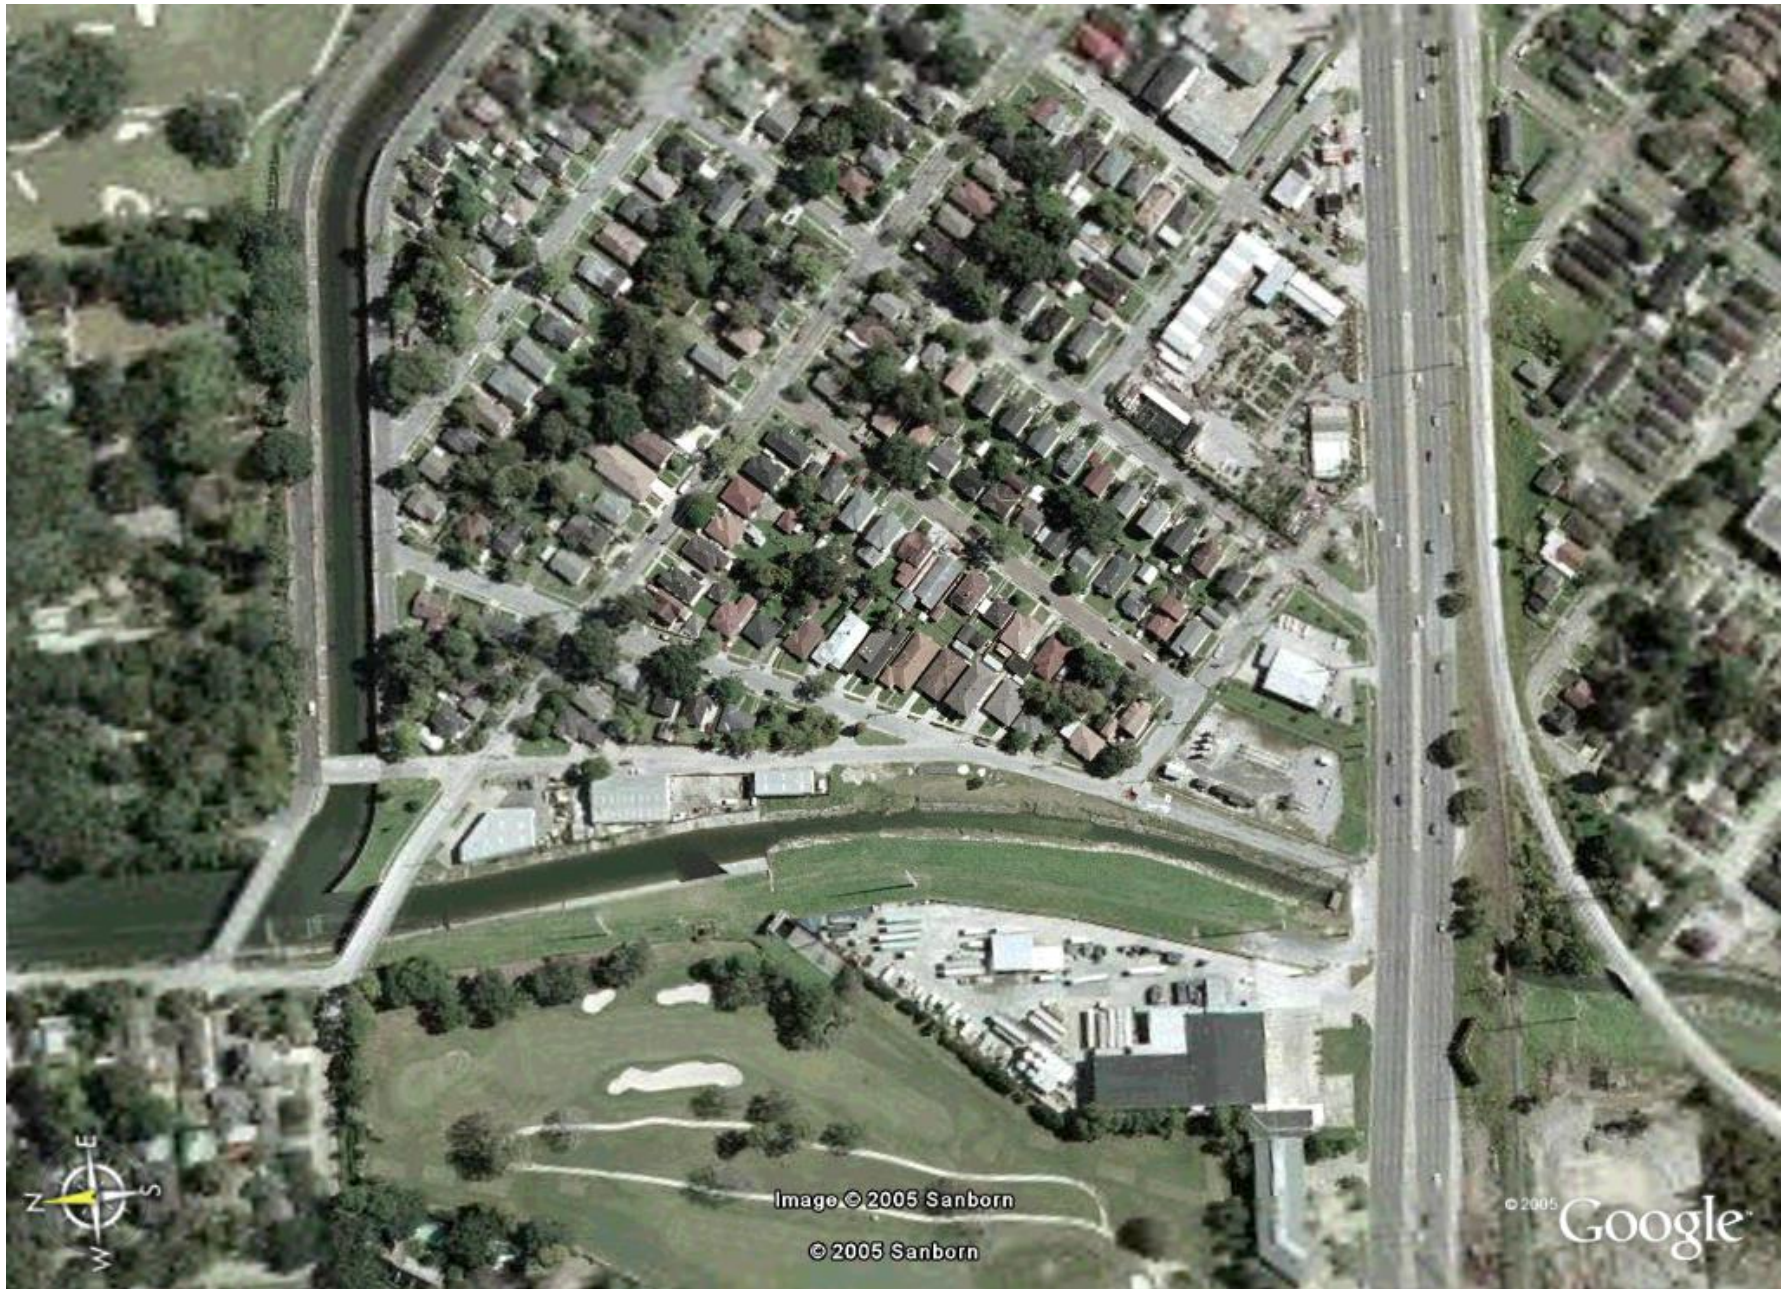
Stop 7 is that the corner of Orpheum Avenue and Northline Street. It is through this area and along Airline Drive south of here, that flood waters from the levee breaches in Orleans Parish reached into Jefferson Parish. The flooding occurred south of the Metairie Road (on the Metairie Ridge) and extended west to Causeway Blvd. and south to near the River. Figure 52 is a Google Earth image of the area at the junction of the Palmetto canal and the 17th St. canal before Katrina and Figure 53 shows approximately the same area on August 31, 2005. This area is at the southern end of the 17th St. Canal where the Palmetto Canal brings water from Pump Station #1 on Broad Street (Fig. 9) into the 17th St. Canal where it is lifted by Pump Station #6 about 8 feet in elevation and pumped out to the Lake (or through the breach in the 17th St. Canal). The Palmetto Canal has a short floodwall (about 3 feet higher than the roadway). Note in Figure 53, how the floodwalls on the Palmetto Canal are completely covered by water. The two bridges over the 17th St. Canal are barely above water, but it is clear that water flowed over and around these bridges into Old Metairie. It is also clear that Airline Drive, to the south, was a conduit for water to enter Jefferson Parish.

Figure 52. Satellite image of the area near the southern end of the 17th Street Canal near Old Metairie where water would enter Jefferson Parish from levee breaches in Orleans Parish during Hurricane Katrina (Stop 7). (Source - Google Earth)

Within a few days after the August 31 image was taken, Jefferson Parish constructed temporary rock and sandbag levees over these two bridges, across Airline Drive, and across Claiborne Ave./Jefferson Highway at the Jefferson/Orleans Parish boundary. These temporary levees were apparently constructed to prevent more flood water originating at the levee breaches in Orleans Parish from further flooding Jefferson Parish. Although the levee breaches in Orleans Parish were mostly stopped by the time the temporary levees at the Parish line were constructed, the damage had already been done. There are, however, reports that once these temporary levees were built, Jefferson Parish started pumping water out of Jefferson and back into Orleans Parish. If true, this would have increased the amount of water over that already standing in Orleans Parish while the levee breaches were being patched and before the pumps in Orleans parish could be started to remove the water from the severely flooded areas.

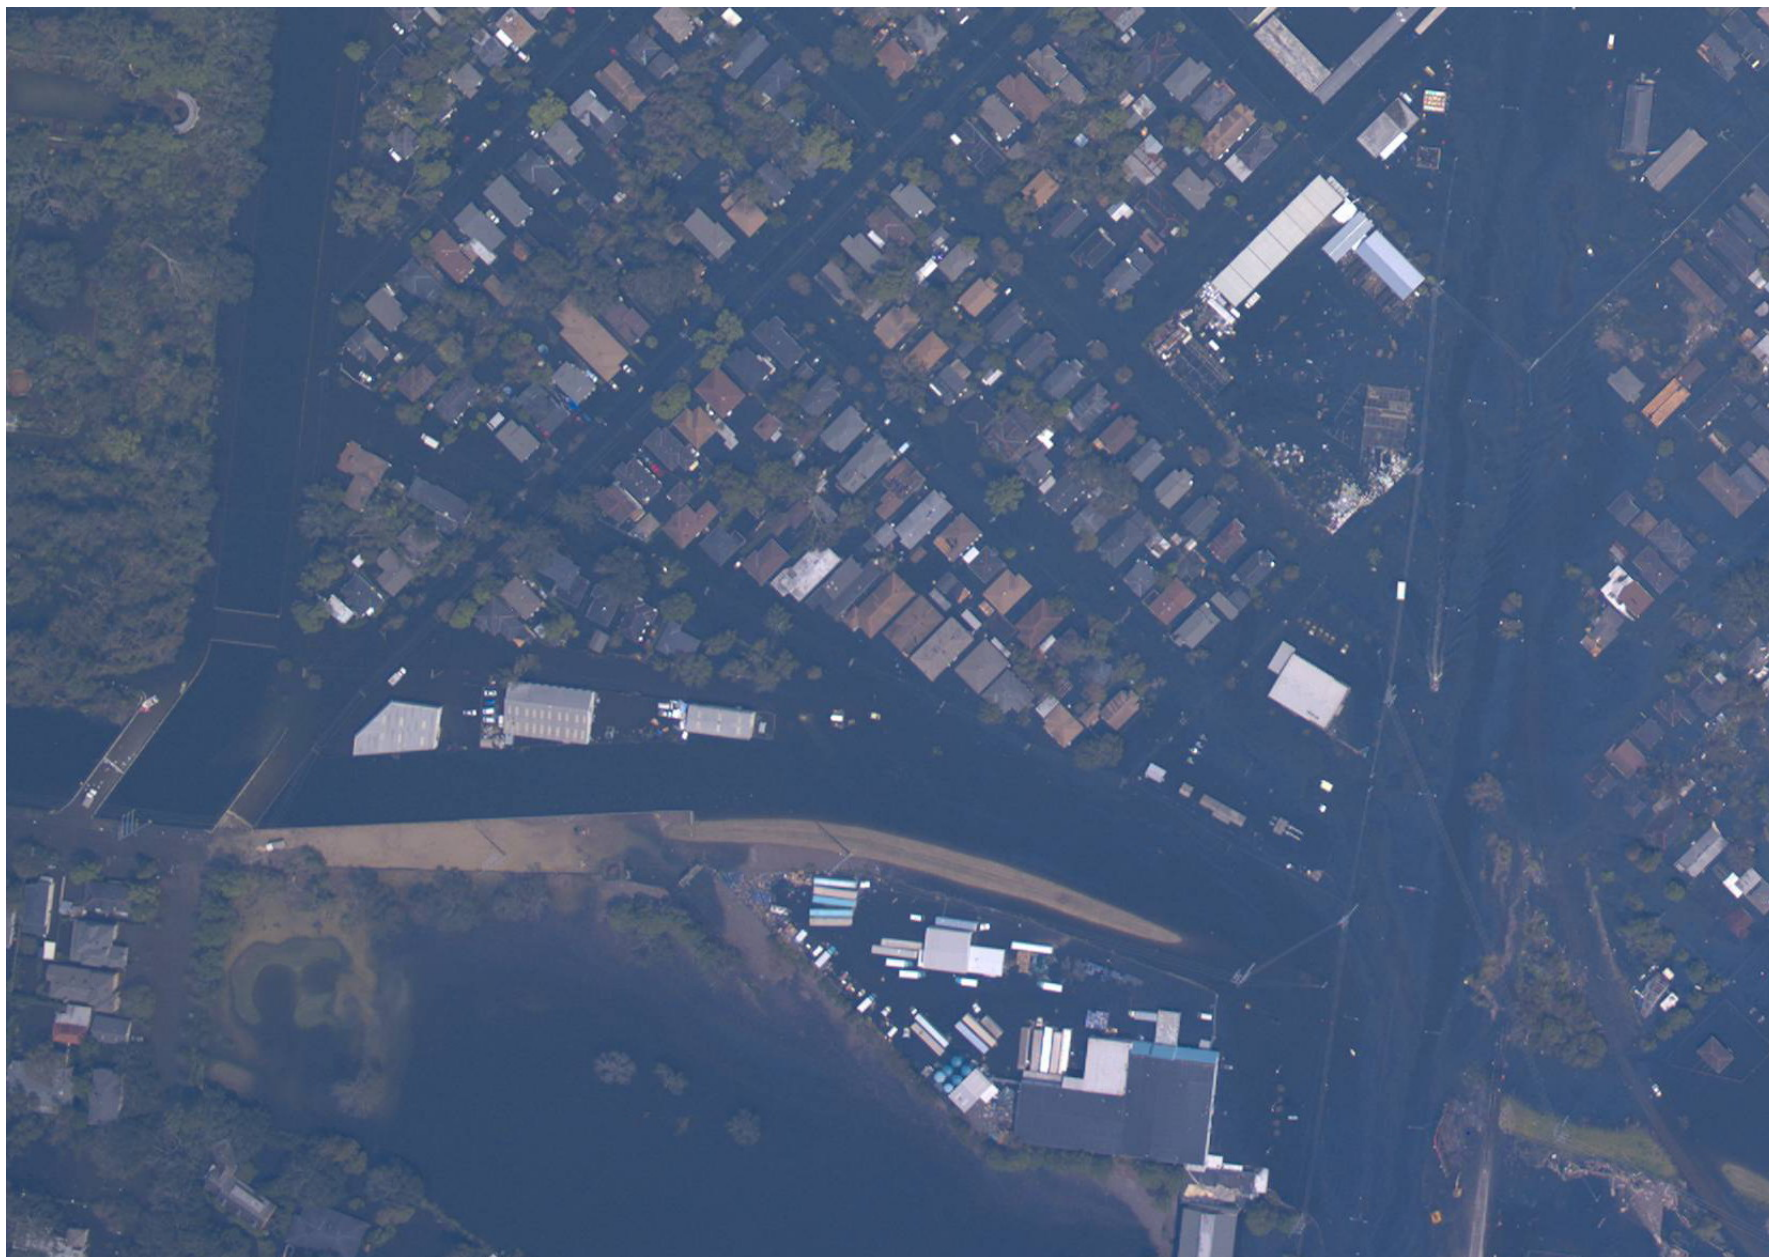
Figure 53. Air photograph of the area where the water from the 17th Street Canal Levee Breach ran back into Old Metairie, near Orpheum and Palm (stop 6). Image acquired Aug. 31, 2005. Source: National Oceanic and Atmospheric Administration's National Geodetic Survey, Katrina Images - <http://ngs.woc.noaa.gov/katrina/>
